Map 24  
**PEDESTRIAN CIRCULATION  
 WATERGATE AREA**  
 CULTURAL LANDSCAPE REPORT  
 LINCOLN MEMORIAL GROUNDS  
 PREPARED BY: M. JOSEPH DATE: OCTOBER 1996 FEB. 1997

## Structures

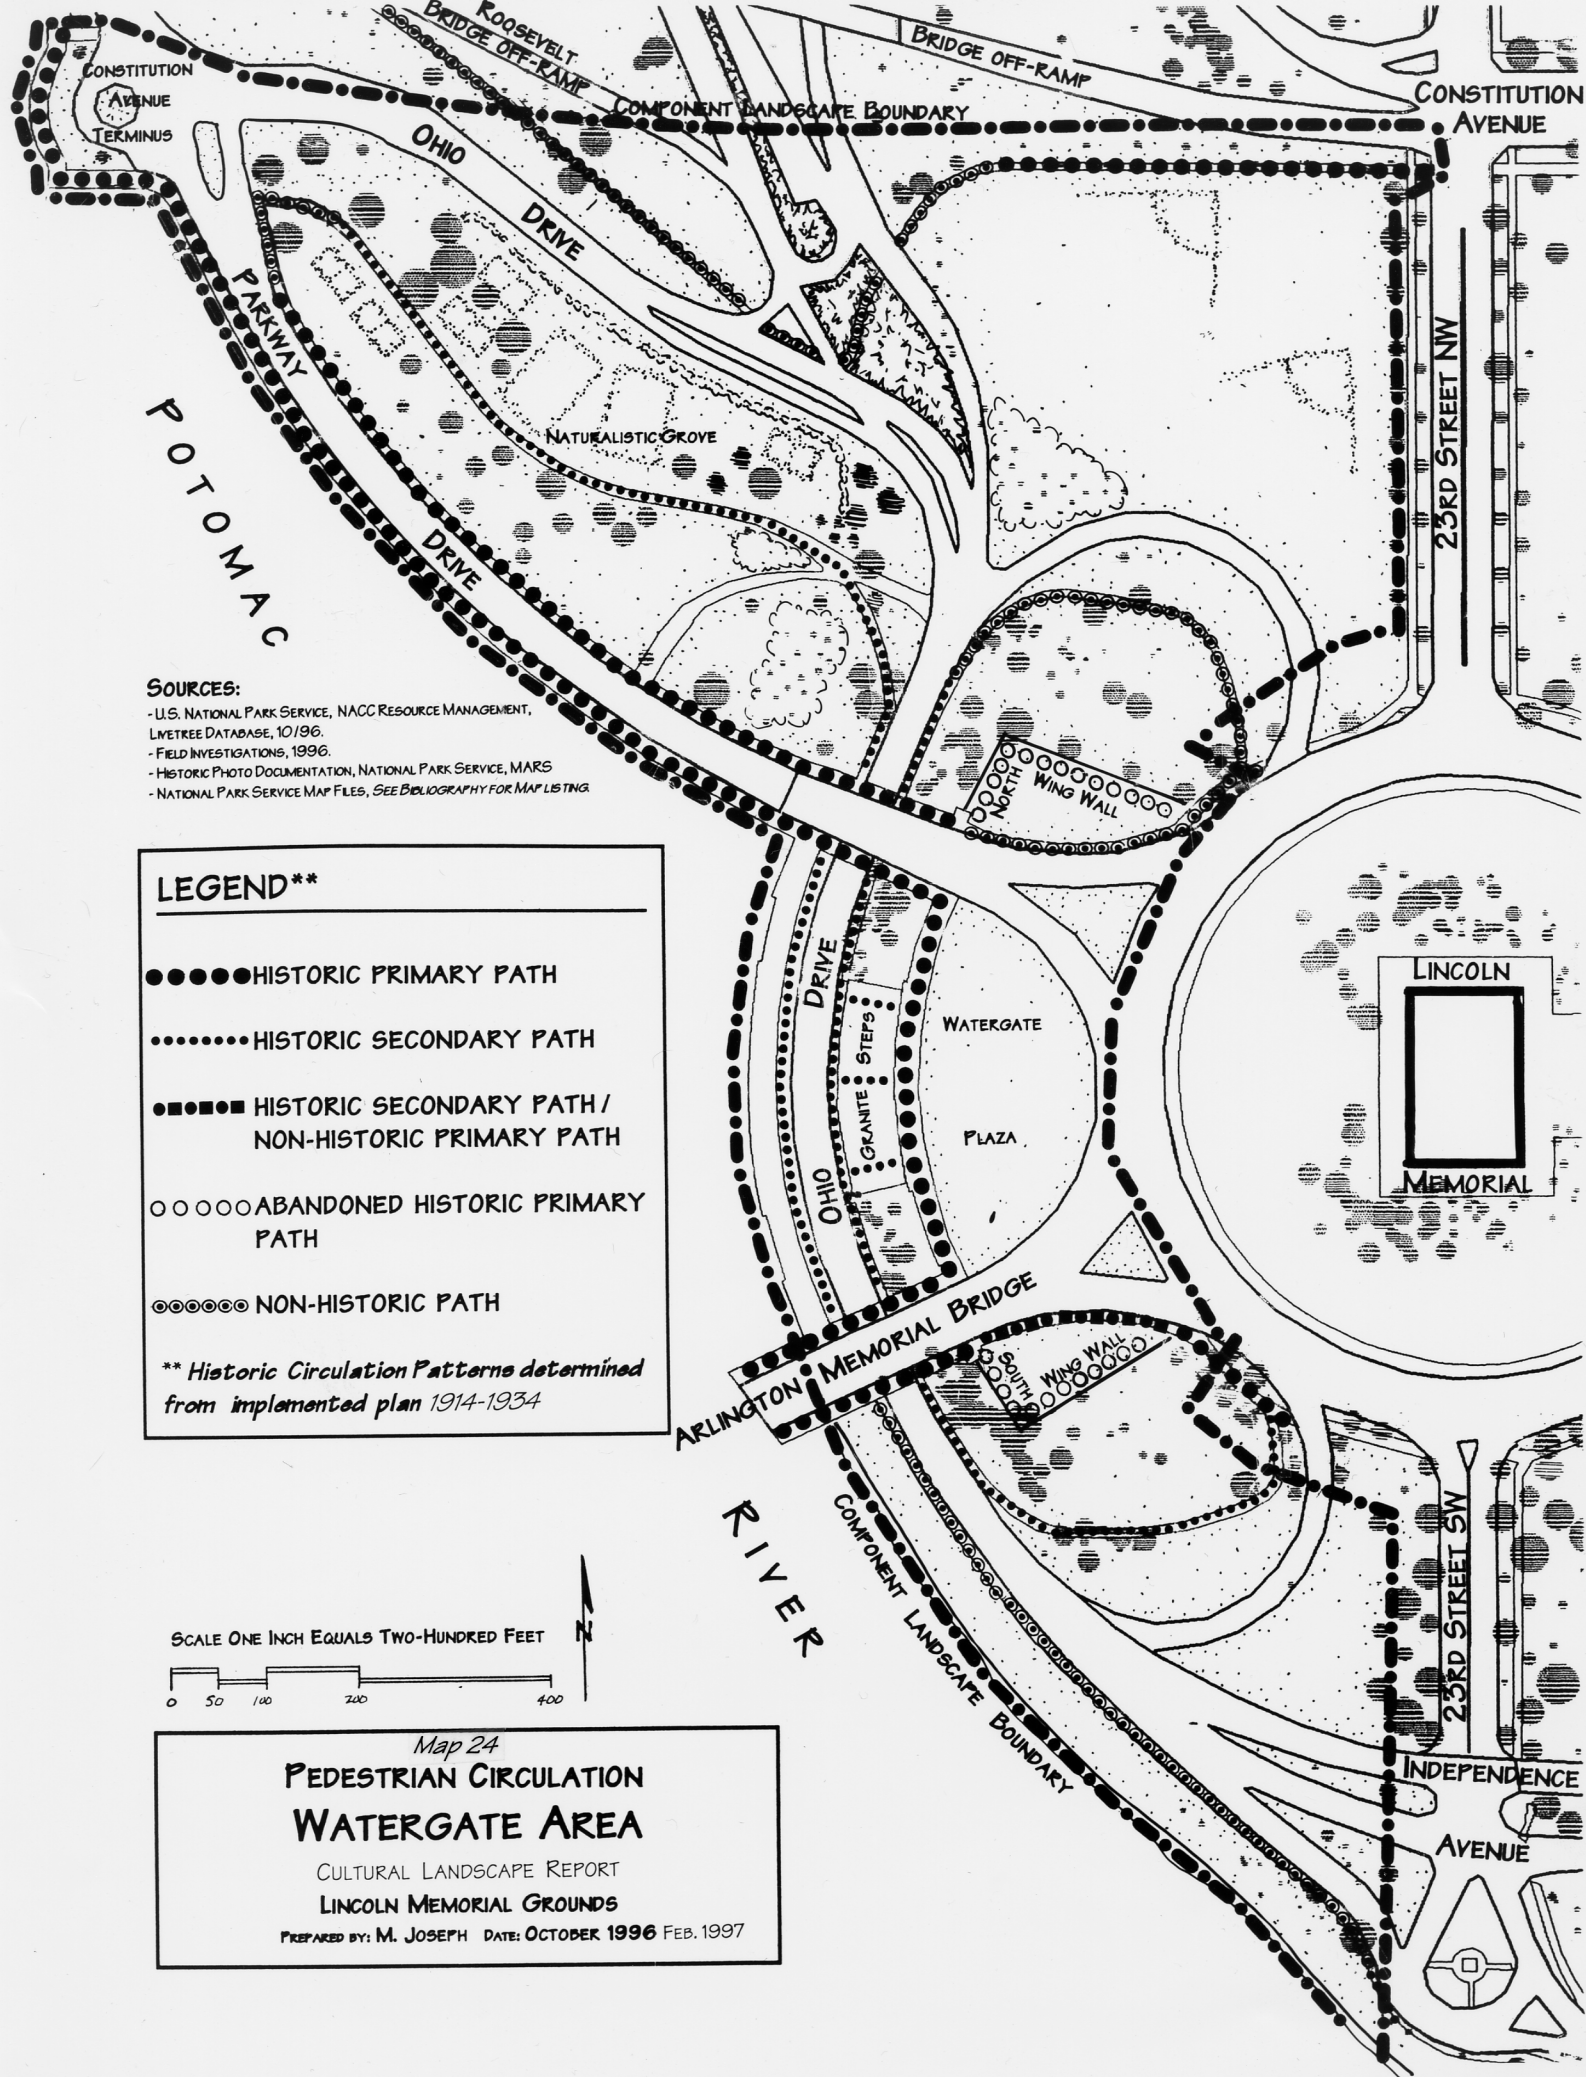
- HISTORIC PRIMARY PATH
- ..... HISTORIC SECONDARY PATH
- HISTORIC SECONDARY PATH / NON-HISTORIC PRIMARY PATH
- ○ ○ ○ ○ ABANDONED HISTORIC PRIMARY PATH
- ◎ ◎ ◎ ◎ ◎ NON-HISTORIC PATH

*\*\* Historic Circulation Patterns determined from implemented plan 1914-1934*

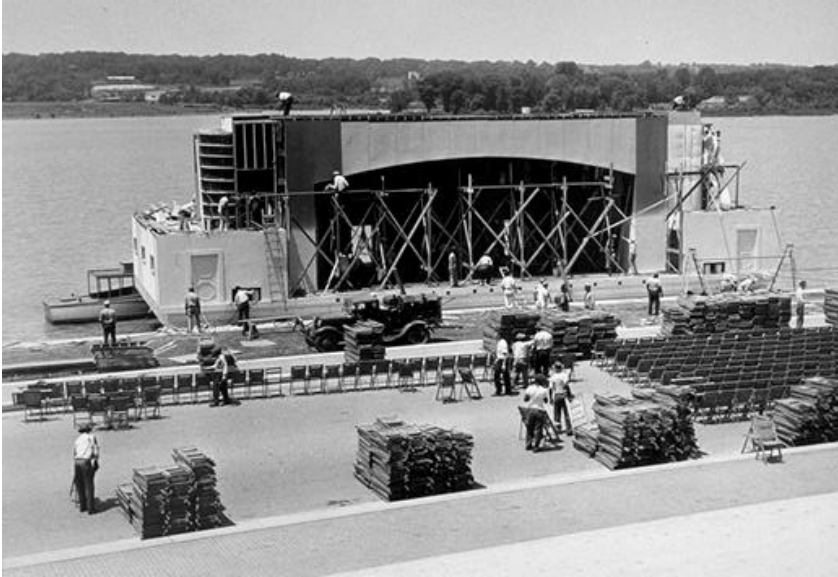
*Figure 106 - Watergate concert barge located at the base of the Watergate steps, July 19, 1939. MRC 1-1.*

Since the Watergate’s original purpose as a ceremonial entry to the nation's capital never developed, other uses were sought for the area. An open-air summer series of concerts were proposed for the steps. An orchestra shell was constructed on a barge, secured to pilings, at the water's edge in 1937 and again in 1938. A third orchestra shell was

constructed in 1947-48. Musical performances were held during the summer months until the 1970s, when traffic concerns and air traffic noise from National Airport became detrimental to the public's enjoyment of the events. Since this time the Watergate steps have been used very little, mostly standing as an architectural remnant from the McMillan plan.

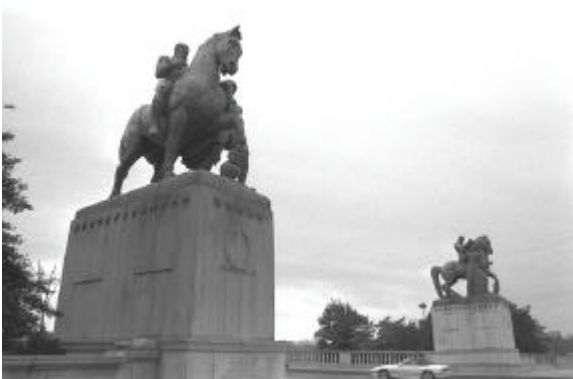
*Figure 107 - Valor and Sacrifice statues flank entrance to Arlington Memorial Bridge, February 1997. LINC 18-5.*

and south wing walls. At the entry from the plaza to the bridge and to the parkway approach, two pairs of granite pedestals were incorporated into the structure. These were intended to be the bases for four monumental sculptures. The pedestals stood empty, the sculptures awaiting funding, until 1951, when the installation and dedication finally took place. The large figural works of art were allegorical representations of Valor, Sacrifice, Music and Harvest, and Aspiration and Literature.

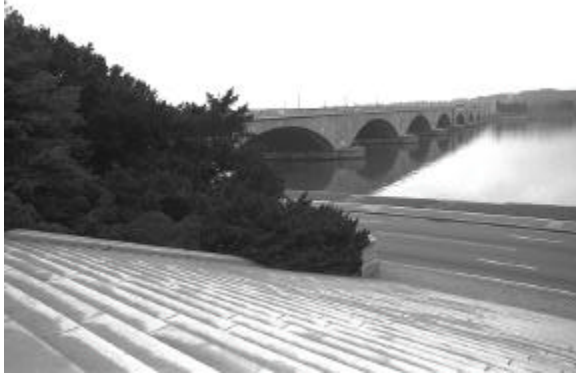
**Figure 108 - Ceremonial Watergate steps and Arlington Memorial Bridge, January 3, 1997. LINC 16-36.**

Both historic design intent and original structural integrity remain in the Watergate area. The only significant changes have been the elimination of the plaza access road, near the top of the main steps and the use of a different, non-historic color and texture on the concrete surface of the bridge sidewalks and the plaza sidewalks. See *Map 25 Watergate area - Structures* for location of structural features.
