Pedestrian Circulation

**PEDESTRIAN CIRCULATION
 REFLECTING POOL AREA**
 CULTURAL LANDSCAPE REPORT
 LINCOLN MEMORIAL GROUNDS
 PREPARED BY: M. JOSEPH DATE: OCTOBER 1996

Structures

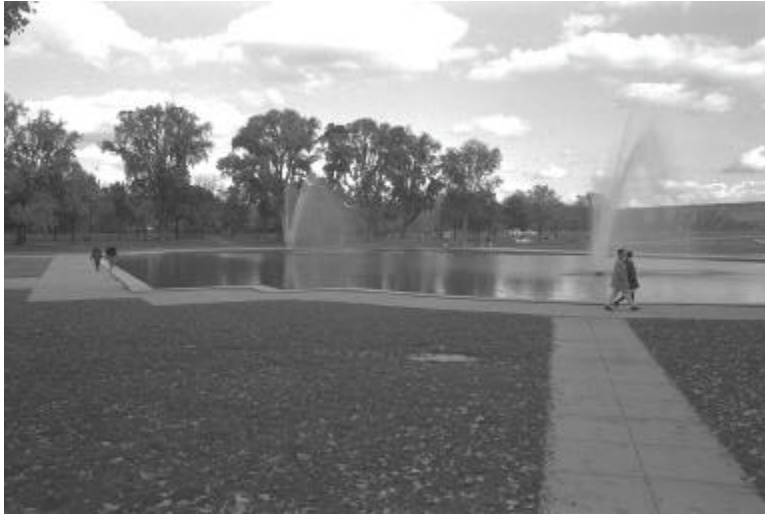
Figure 51 – Rainbow Pool fountain as it appeared on November 11, 1996. LINC 11-10.

Monument. A series of tests were conducted in 1934 to determine the most appropriate and effective display and to meet the CFA's requirements. In 1990 some of the nozzles were replaced with a straight head type. It is unknown if this has altered the jet display that was originally approved by the Commission of Fine Arts in the 1930s. Currently only the two clusters of jets on the north and south side of the pool are operating and the oval pattern on the outer edge of the pool is not used. Because of this the fountain no longer sprays at the height required to exhibit a rainbow effect but instead appears as a weak imitation of the past display.

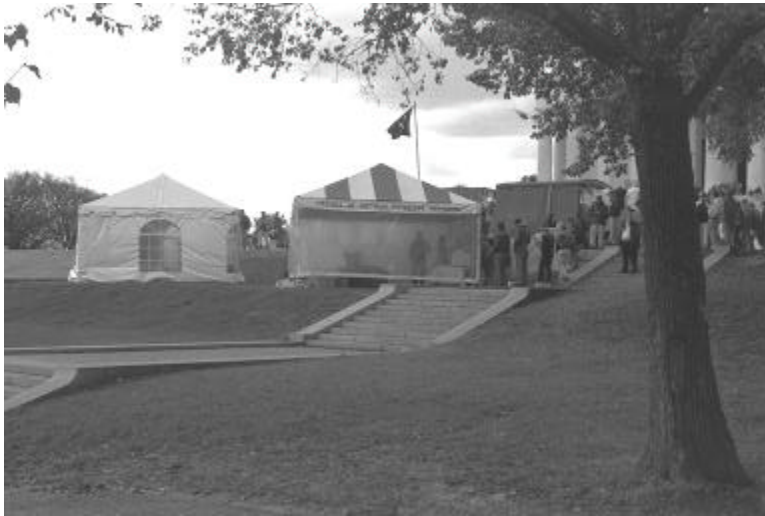
Figure 52 - Temporary structures on grassy terrace by Reflecting Pool steps, November 11, 1996. LINC 11-22.

the plaza at the top of the granite stairs. These are owned by vendors who have obtained a special use permit to sell t-shirts and other products under a First Amendment ruling. To reduce the impact on cultural and natural resources the NPS has tried to limit where the vendors operate. The unsightly tents obscure the view along east/west axis from the memorial, the approachway, and the Reflecting Pool. See Map 13 *Reflecting Pool area - Structures* for location of structural features.

In addition to the main structural features of the Reflecting Pool area, there are temporary structures located both north of the Rainbow Pool and in the northwest corner of
