LINCOLN CIRCLE - VEGETATION

LINCOLN MEMORIAL CIRCLE & RADIAL ROADS

CULTURAL LANDSCAPE REPORT

LINCOLN MEMORIAL GROUNDS

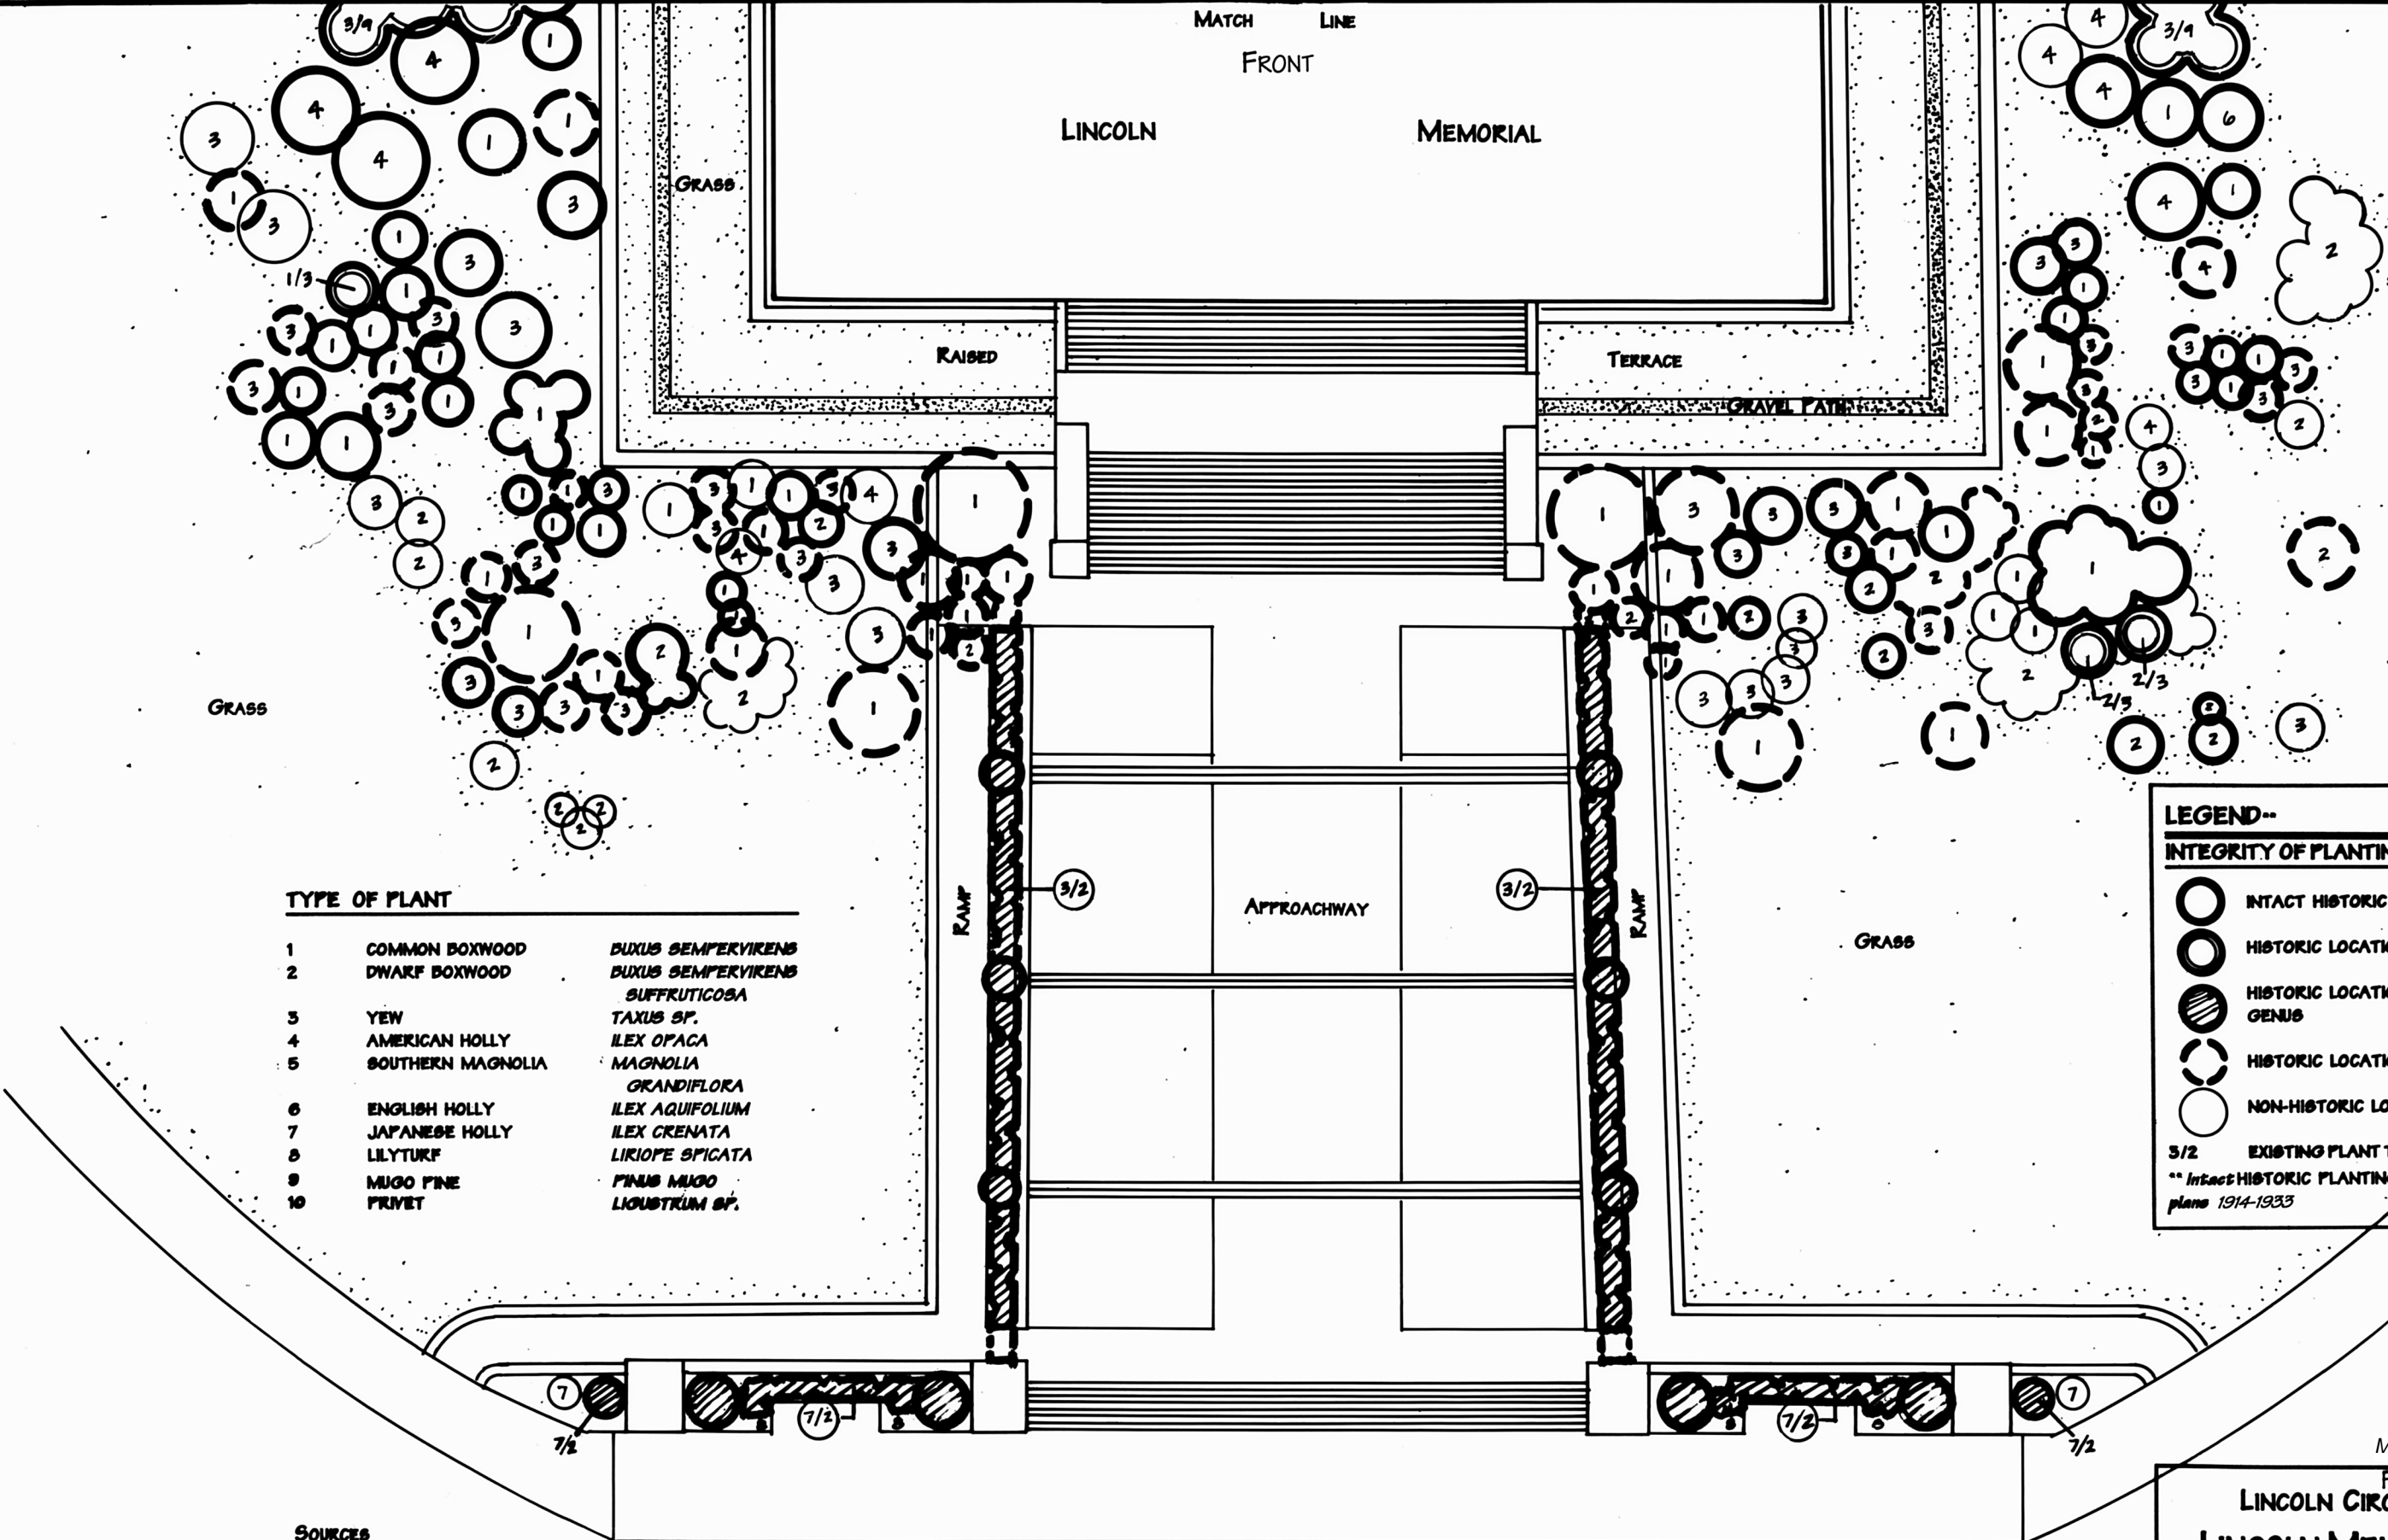
Map 15

INTEGRITY OF PLANTING

- INTACT HISTORIC PLANTING
- HISTORIC LOCATION / NON-HISTORIC GENUS
- HISTORIC LOCATION / NON-HISTORIC FORM AND GENUS
- HISTORIC LOCATION / MISSING SPECIMEN
- NON-HISTORIC LOCATION

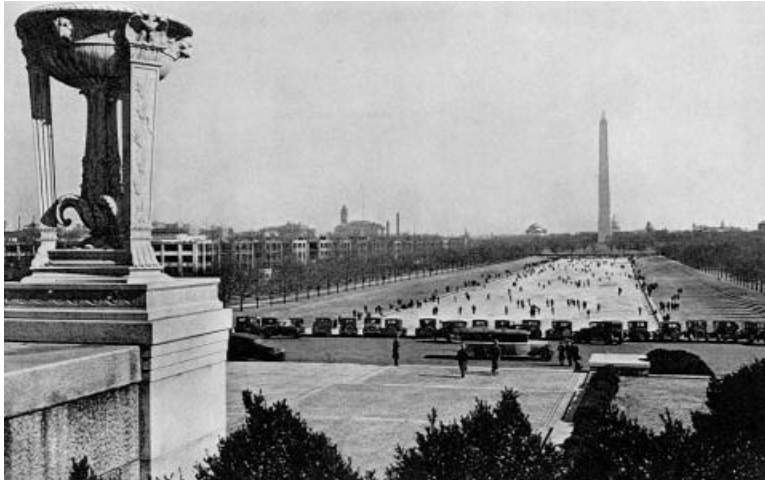
Figure 72 - Unofficial parking area at top of Reflecting Pool steps and Lincoln Circle, 1929. Used by permission from the National Geographic Society.

Parking Areas. West Potomac Park has always had a limited number of parking spaces in the areas surrounding the memorials and the Washington Monument. Onstreet parking is not only limited in the Lincoln Memorial study area, but also is restricted around the circle and the radial roads. Although a few spaces once existed on the circle where the outer curb line was squared by the design of the Reflecting Pool steps (these had never been designated for automobiles during the initial or subsequent planning). However photo documentation indicates longstanding use of this area in front of the memorial for diagonal and, later, parallel parking. In 1953 the squared curb edge was removed to create a continuous circular curb around the outside of the roadway.

The curb change displaced that small parking area.

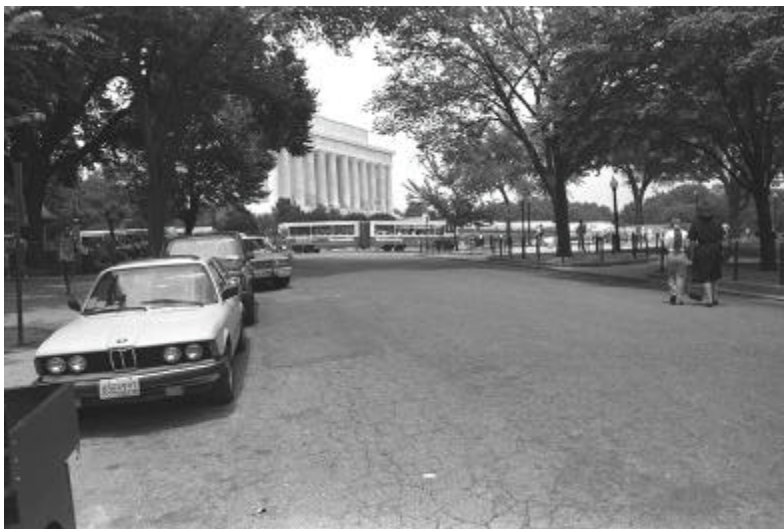
Figure 73 - Bus and taxi drop off along French Drive, July 23, 1996. LINC 10-14.

and French Drive and along the eastern side of 23rd Street SW. Other tour buses and taxis are directed to French Drive for all dropoffs and pickups, making this area very congested. See Map 17 *Lincoln Memorial circle and radial roads - Vehicular Circulation* for location of parking areas.
