Subject: Field Report for Drum and Debris Survey of the Poplar Point Site

Drum and Debris Survey

RIDOLFI ENGINEERS Inc.	Field Report for Drum and Debris Survey of Poplar Point Site	September 25, 2002	Figures 3-5.
	National Oceanic and Atmospheric Administration

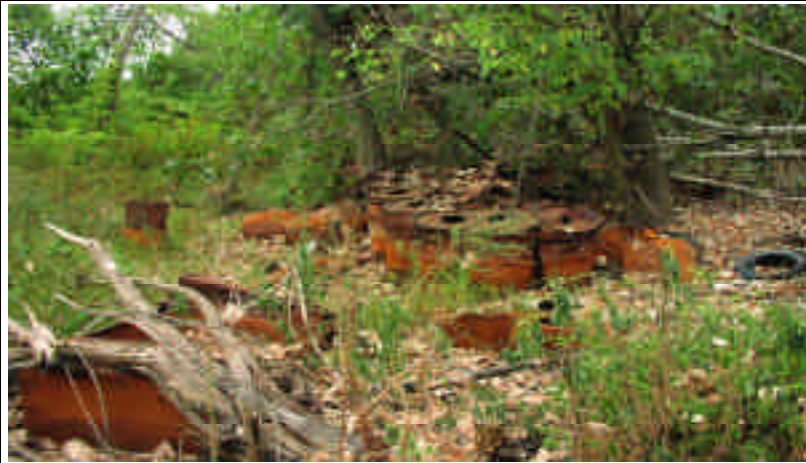
The vast majority of the drums onsite are located in the southern portion of Wetland 1 in a large "drum cluster" (location 1 on Figure 2). There are approximately 128 drums in this cluster that are bound together with steel bands in groups of 12-14 drums (Figure 3). All of the visible drums have holes cut in each end approximately 8 inches in diameter (Figure 4). The holes may have been cut to render the drums unusable. Branches and other materials made it impossible to inspect each drum, but the drums that were accessible were empty. The outer surfaces of the drums were rusted indicating that they had been onsite for at least several years.

Figure 3. Cluster of approximately 128 drums located in Wetland 1

Ridolfi recommends that we subcontract with TPH Industries to remove the drums, cylinders and some of the other materials from the DC Lanham and AOC Nursery sites. The approach for this task use historical information to identify disposal requirements and to remove the materials to an appropriate disposal facility. As noted above, most of the drums are empty and will not require characterization- these drums can be disposed of as scrap. Drums containing cuttings or purge water will be characterized based on existing sample results from the respective borings or wells.

TPH Industries would use a crew of six laborers, an equipment operator and a supervisor to remove the materials. Empty drums and other metal debris would be moved to a central, onsite staging area, placed in a roll-off bin and hauled to a local recycling facility. Soil cuttings would be labeled and transported to a Modern Sanitary landfill in York, Pennsylvania. Recoverable, non-hazardous liquids, such as drummed purge water, will be removed using a vacuum truck and transported to TPHs facility in Baltimore for treatment. Asbestos would be bagged, drummed and transported offsite to an approved disposal facility. Municipal waste and industrial debris will be removed with heavy equipment, where accessible, or by hand, and transported to a municipal landfill. The ten gas cylinders will also be taken offsite for recycling and disposal.

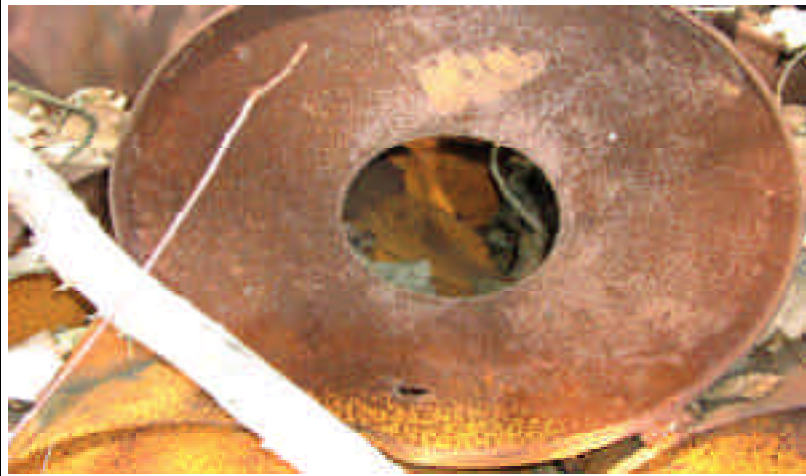
Figure 4. Close up view of a hole in one of the 128 drums located in Wetland 1

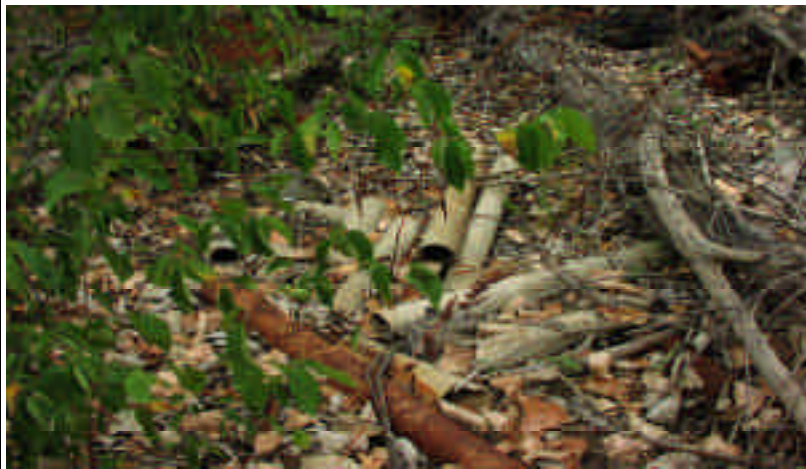
A pile of tan colored pipe (location 5) is scattered just north of the main drum cluster (Figure 5). This material had the potential to contain asbestos so a sample was collected and submitted to Prezant Associates in Seattle for characterization. Laboratory analysis indicated that the material contains asbestos at regulated levels (22 percent chrysotile and 4 percent crocidolite) and 74 percent inert material.

Figure 5. Pile of tan colored pipes containing asbestos

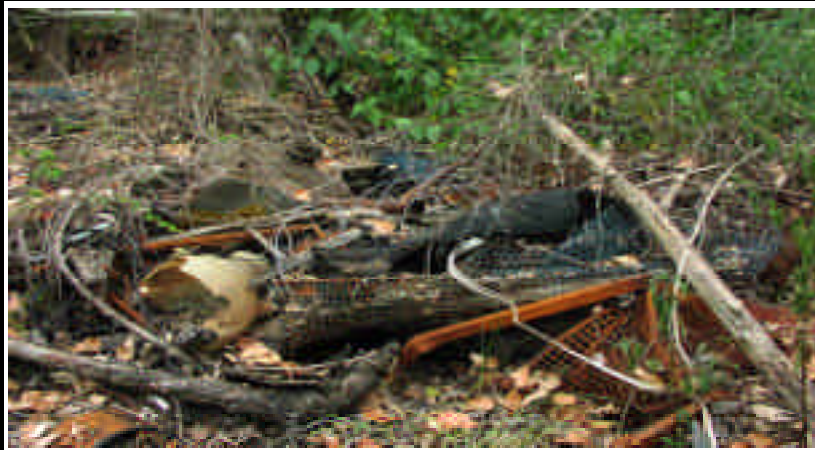
There were several other piles of debris (location 6) in the same general area as the drum cluster. Materials in these piles included tires, scrap metal, carpeting, building materials, wire mesh and other miscellaneous materials and (Figure 6). Additionally, there were isolated drums, somewhat removed from the main cluster but in the same general vicinity (locations 2, 3 and 4). A section of culvert approximately 5 feet long and 4 feet in diameter (location 8) was also in this area. The culvert is filled with concrete, which if solid, weighs approximately 5 tons (Figure 7).

Figure 6. A debris pile located in Wetland 1

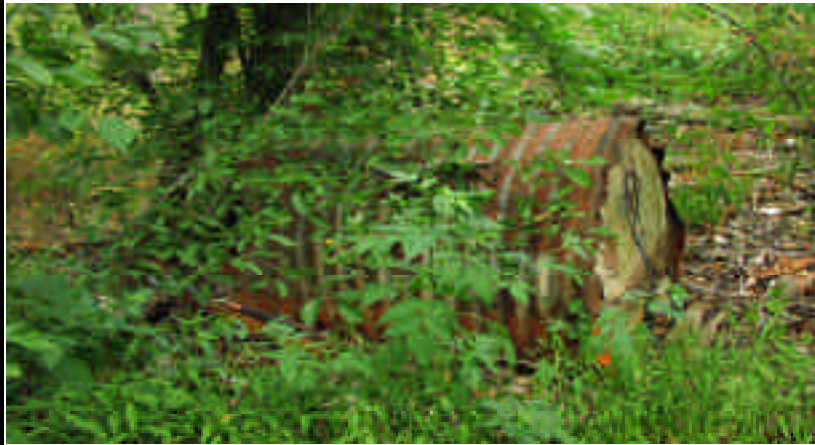
Figure 7. A section of concrete filled culvert located in Wetland 1

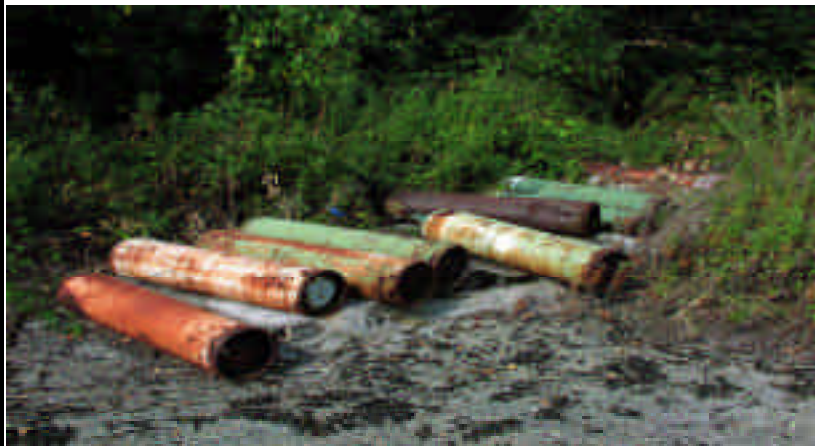
Ten, apparently empty, gas cylinders are staged near the southern property line of the DC Lanham Nursery area (location 14). Five of the cylinders are green and as such were likely to have contained oxygen. Three are white or silver and one is pink or lavender. The previous contents of these other cylinders is uncertain (Figure 8).

Figure 8. Ten apparently empty, gas cylinders near southern property line of the D.C. Lanham Nursery area

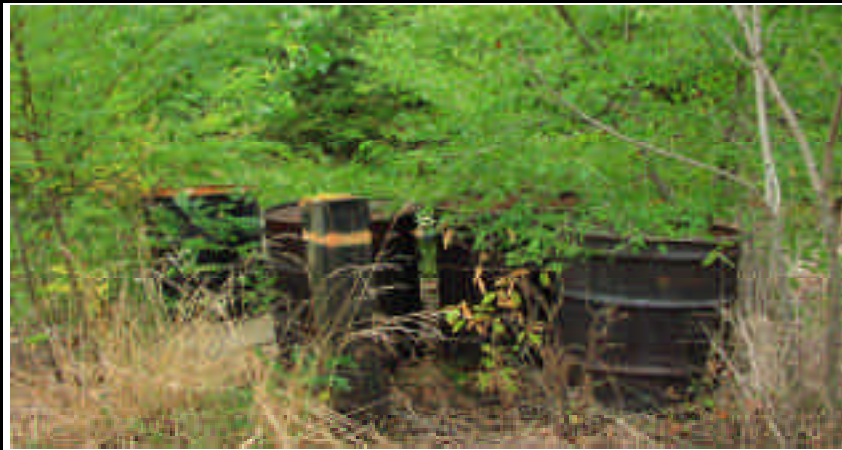
Six empty drums, in two groups, are located near the southern fence line of the site (locations 15,16, and 17). These drums are apparently empty. Four drums containing cuttings and or purge water from wells are located near MW-7 (location 18) (Figure 9).

Figure 9. Four drums located near MW-7 containing either soil cuttings or purge water from wells

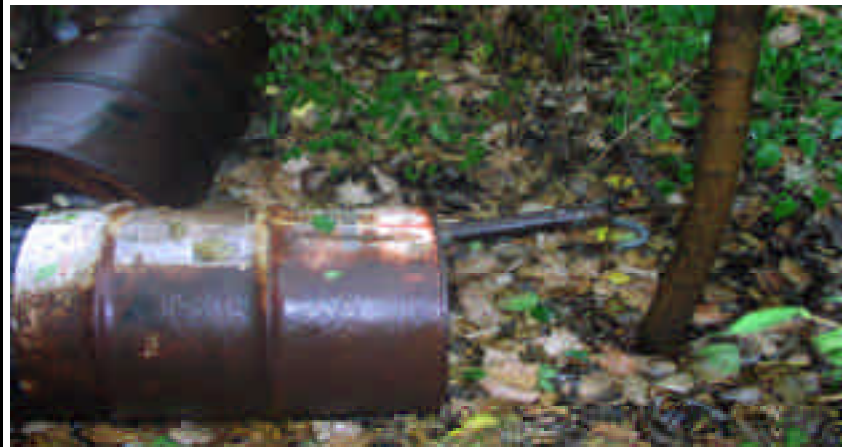
A number of items were found in the northeastern fringe of the DC Lanham Nursery. These included 5 drums (locations 20, 21, and 22) and other debris (locations 23 and 24). The drum at location 21 contained a few inches of dry sediment in it. One of the drums at location 22 had a hand pump attached at one end and may have been about $\frac{1}{2}$ full (Figure 10). The other drums were apparently empty and can probably be handled as scrap.

Figure 10. A half full drum with a hand pump attached

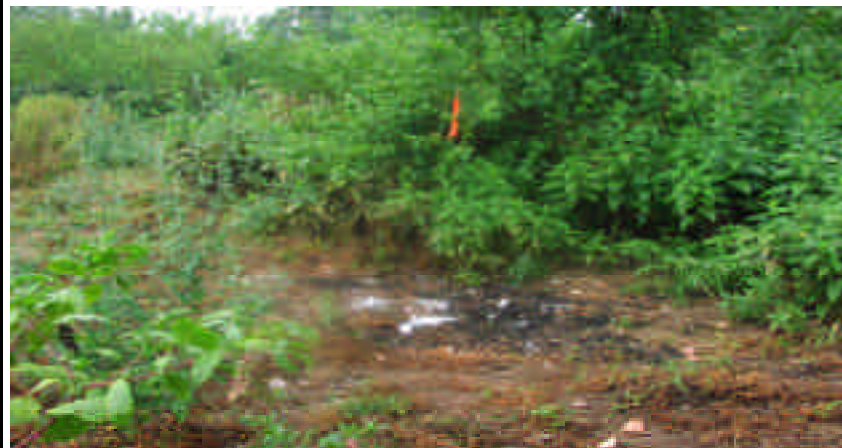
Further to the northwest in wetland 1, particularly on the fringe between the grassy "meadow" area and wooded areas there are indications of multiple dumping activities. This observation is based on mounded topography and debris. The mounds appear to consist of soil and construction debris with associated metal, tires, carpet, etc. Two drums are present at location 25. An area with stressed soil and charred material is also in this vicinity. This seemed to be evidence of surficial burning (Figure 11).

Figure 11. An area in the "meadow" with visibly stressed soil and charred material
