Monitoring Arroyos with Conventional Survey Techniques in Grand Canyon: 1996-2004

**Joe Hazel, Matt Kaplinski, and Rod Parnell
Northern Arizona University**

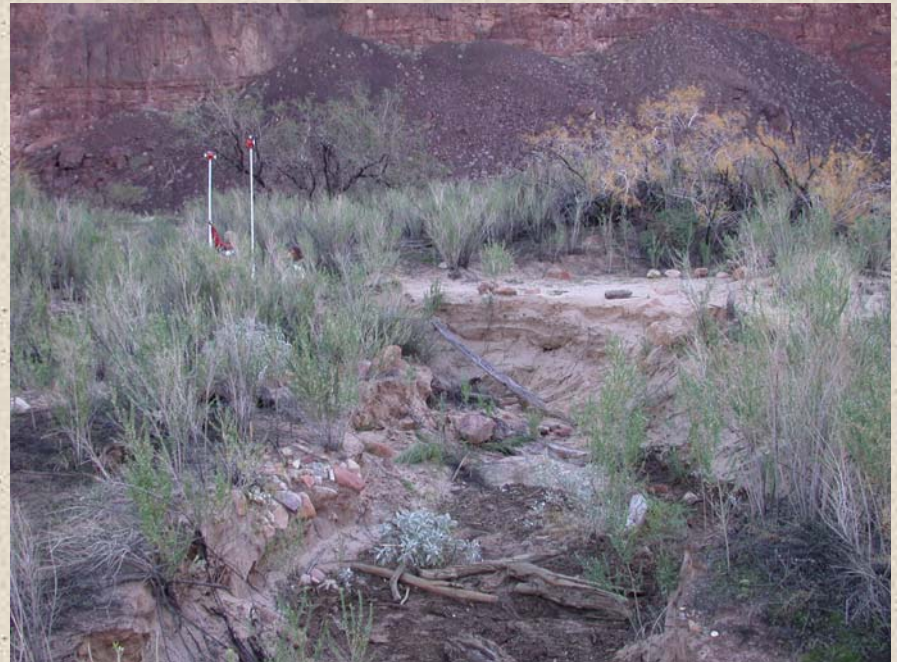
Ground points collected with conventional topographic survey in March 1996

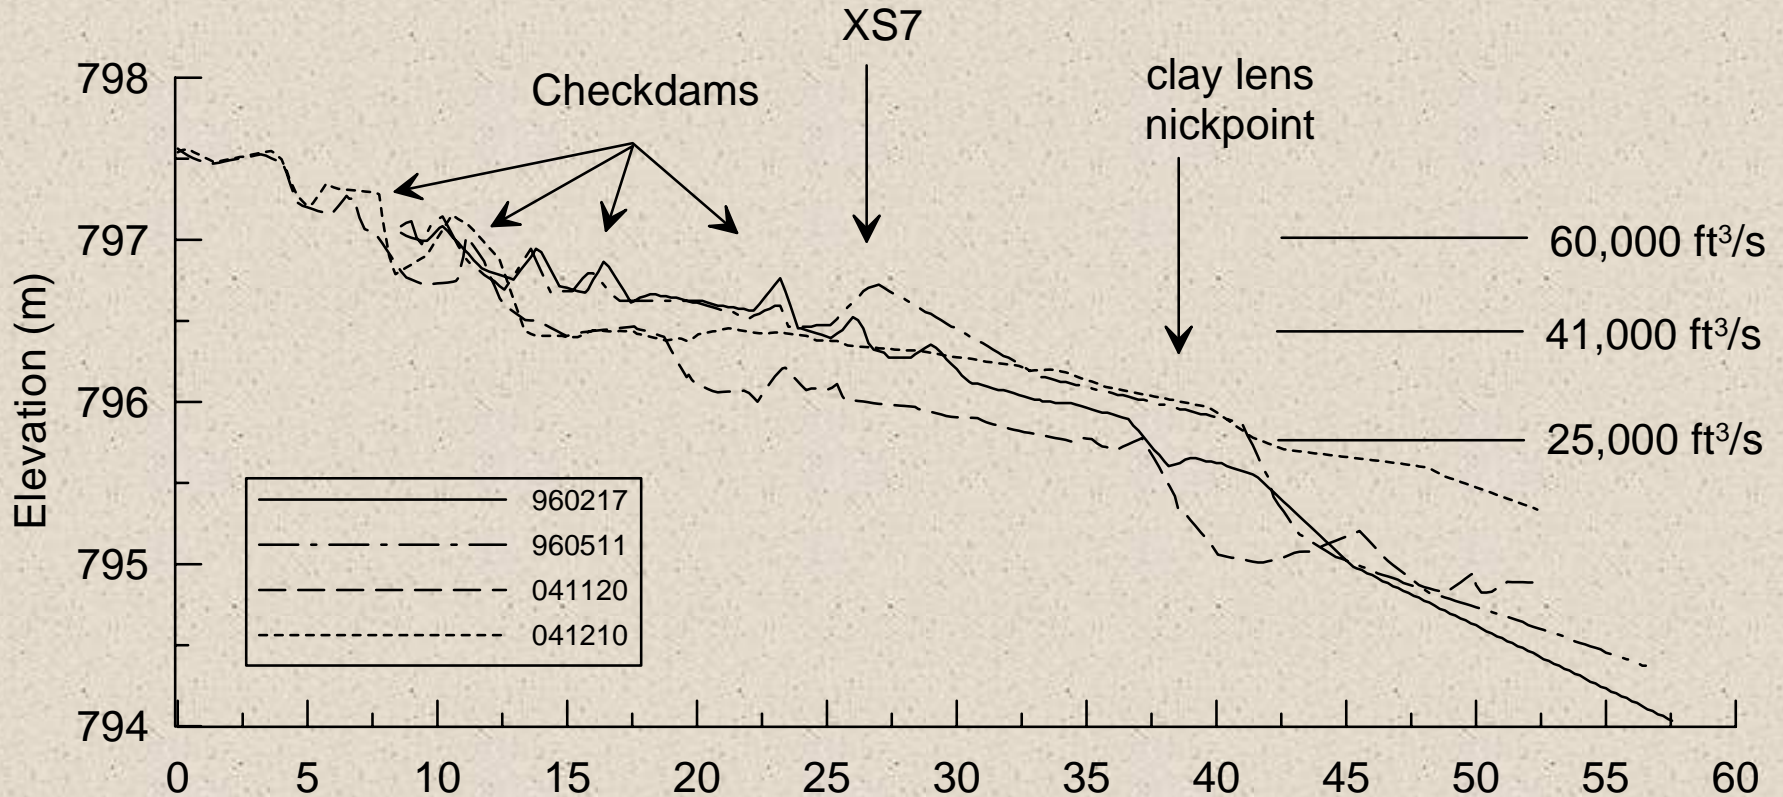
1996 controlled flood compared to the 2004 High Experimental Flow

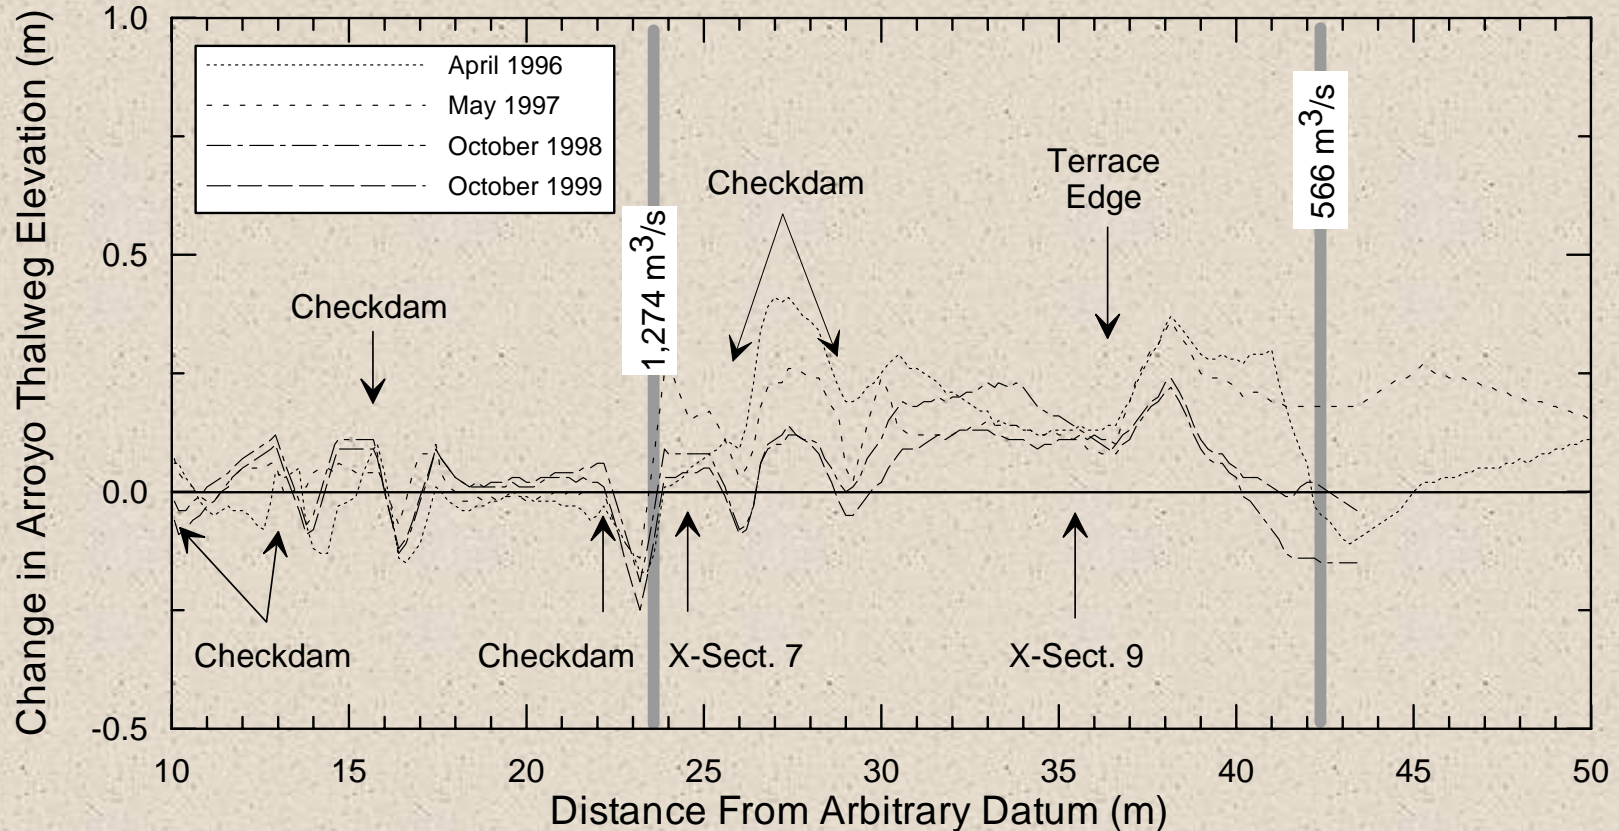
Changes in arroyo thalweg elevation: 1996-1999

Changes in thalweg elevation are with reference to a common datum defined by the 1996 pre-flood elevation; data above the horizontal solid line at 0.0 indicate deposition, data below indicate erosion.

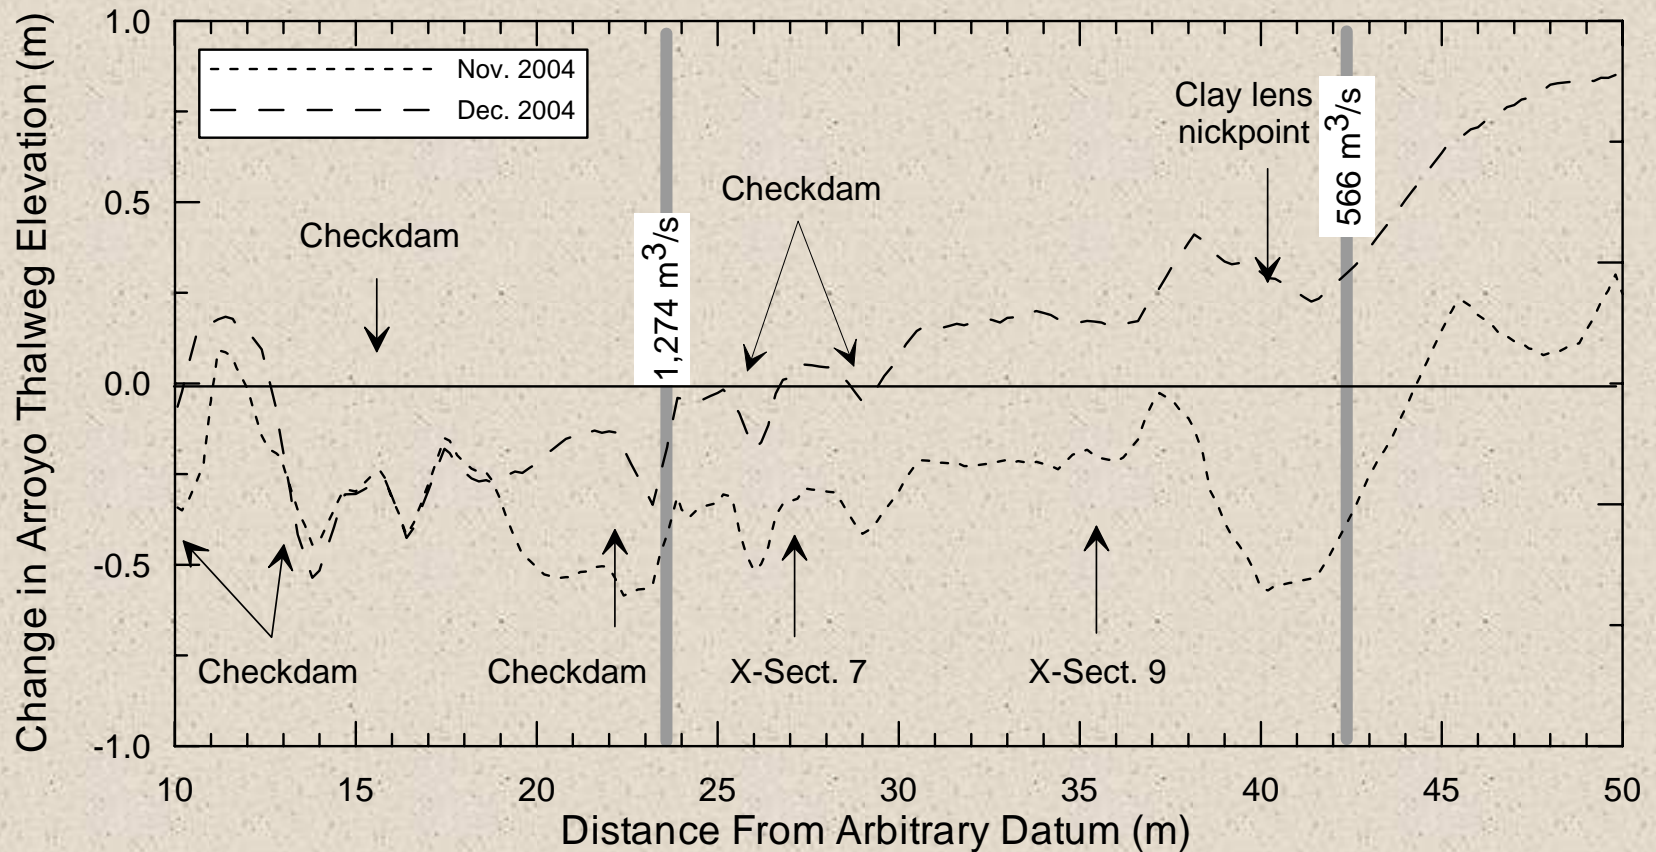
Changes in arroyo thalweg elevation: 1996-2004

Changes in thalweg elevation are with reference to a common datum defined by the 1996 pre-flood elevation; data above the horizontal solid line at 0.0 indicate deposition, data below indicate erosion.
