Occupational Safety & Health Administration

SAFETY
and
HEALTH
INJURY
PREVENTION
SHEETS

Working with the Shipyard Industry

SHIPFITTING

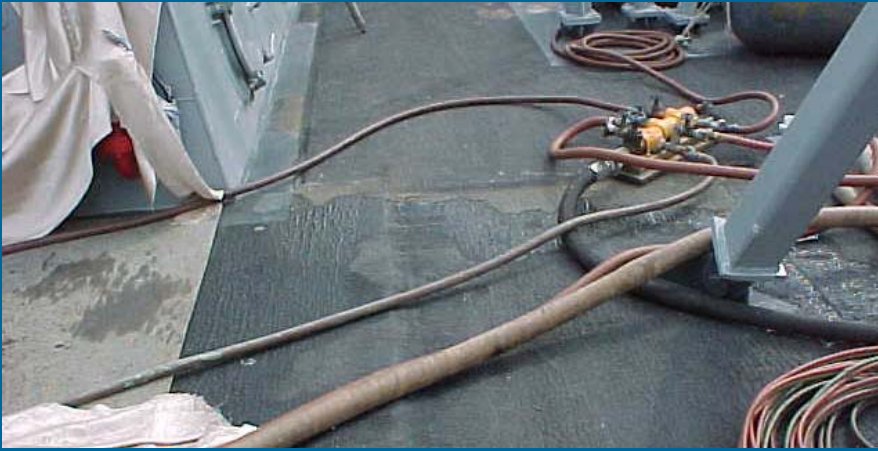
Service lines, hoses and leads on deck that cross over walkways present potential tripping hazards.

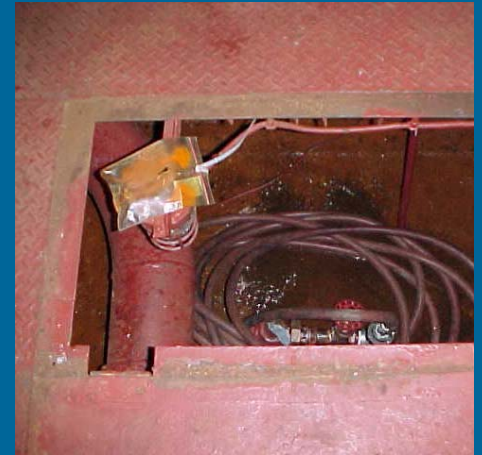
Missing plates or grating may cause injury to shipfitters, particularly if they are carrying equipment, tools, or other material that prevents them from seeing the hazard.

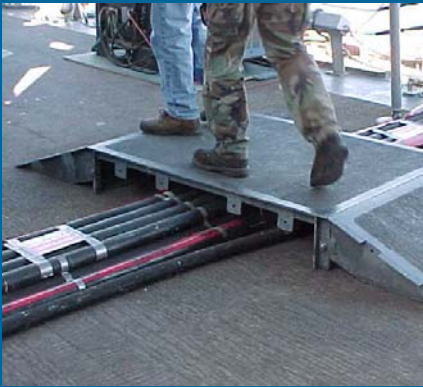
Option 1

Neatly arranging the lines, hoses and leads, and using ramps as crossovers, will help eliminate tripping hazards and lessen the possibility of damage to service lines.

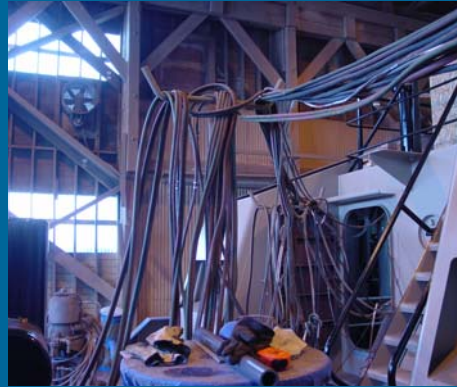
Option 2

Using brackets made of pipe, often referred to as "trees," is another method for keeping lines, hoses and leads off the deck. Below decks, hangers may be used to keep passageways free of trip and fall hazards.

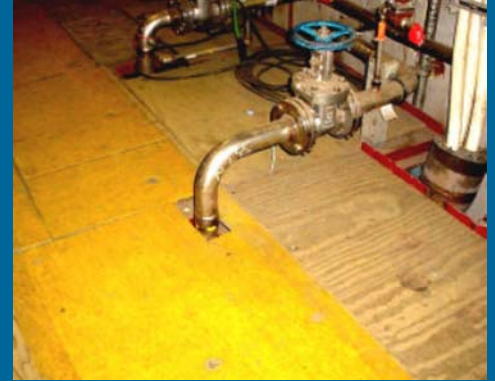
Replacing grating when leaving the work area or covering deck openings with temporary covers (as shown here) are good methods for preventing injury.

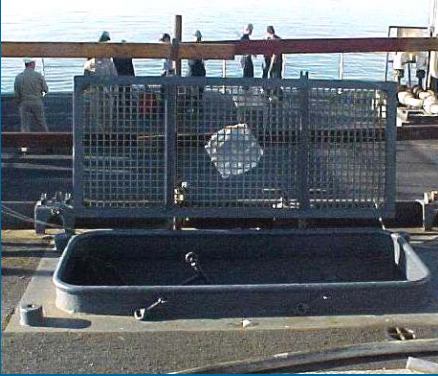
Deck openings or penetrations create fall hazards if not properly guarded.

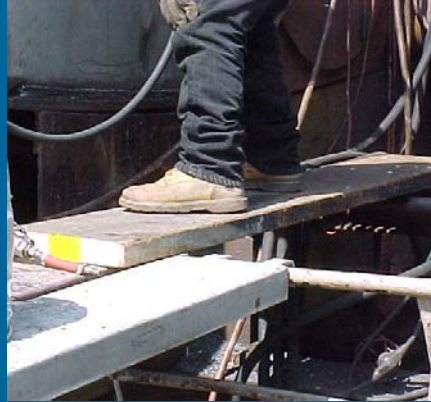
Horse staging is frequently used to access areas where work is to be done. While fall protection such as back rails is not required unless the staging is above five feet, working from a single plank is not a safe or acceptable practice. A fall of just a few feet can result in serious injury.

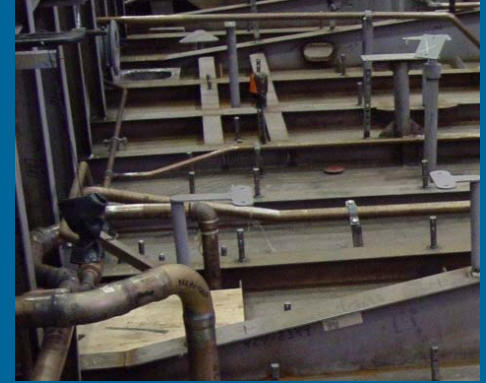
During ship construction or refitting, trip hazards may be unavoidable and may pose the potential for impalement.

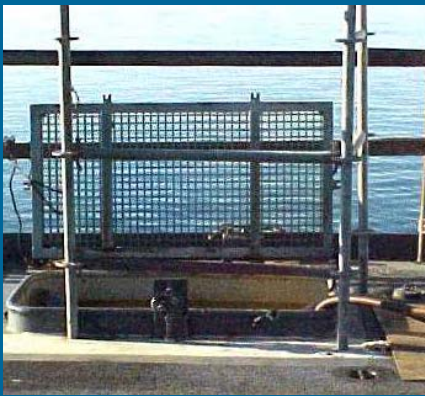
Pipe guardrails can be quickly erected to provide adequate fall protection. Make sure that the materials to provide fall protection are readily available on hand prior to removing the cover or to making an access cut. This will eliminate the need for the shipfitter to leave the unguarded opening unattended while obtaining the necessary materials for fall protection.

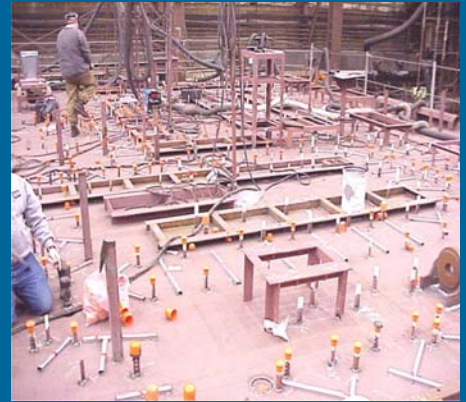
Studs and pipe caps (as seen here) can prevent trip or fall hazards from resulting in impalement.

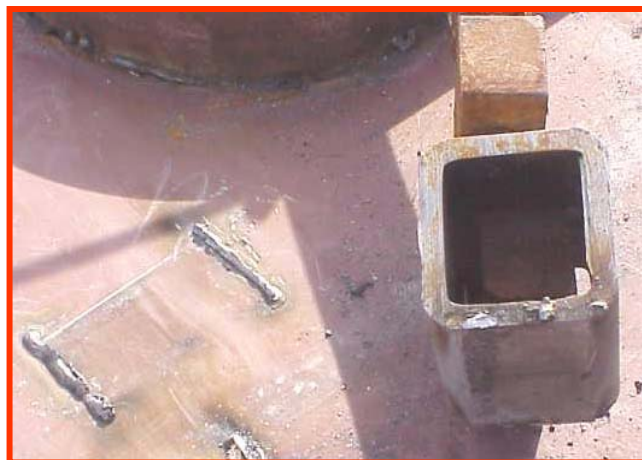
Two shipfitting employees were leaning on the same fall protection cable. A deck clip broke free and the employees fell toward a three-by six-foot deck opening.

The clip was discovered to have an inadequate weld, and the employees should not have been leaning on the cable.

The critical nature of these welds warrant a clear inspection/sign-off process on fall protection measures.

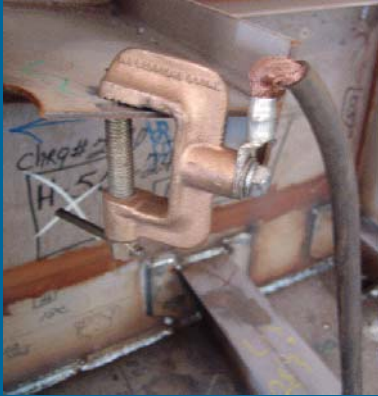
Paint build-up or corrosion can create a poor grounding condition when using welding equipment.

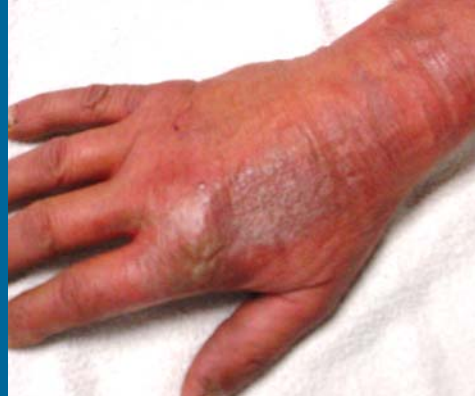
Shipfitters cutting steel usually remember to use hand protection. Unfortunately, workers assisting them may get burned if they don't wear gloves. The second-degree burns shown above resulted when a shipfitter accidentally passed the torch over the hand of a helper who was not using gloves.

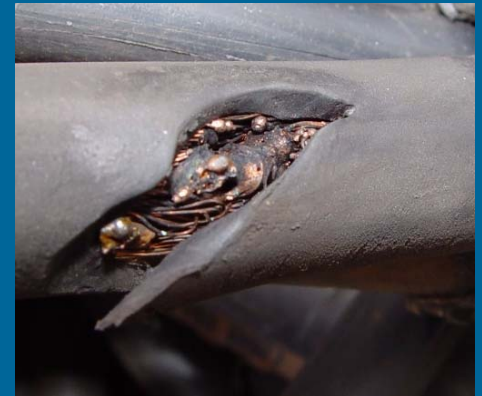
Sharp edges in the shipbuilding and ship repair workplace can easily damage cable insulation. Cable exposed by the missing insulation can create a potential for injury.

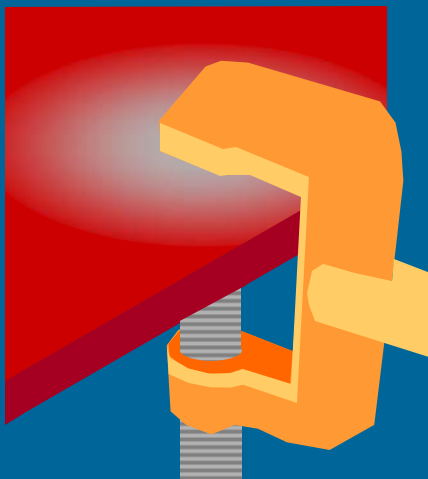
In welding operations, one of the cornerstones of shock prevention is creating a good electrical ground when using welding equipment. Removing paint build-up or corrosion from the contact area with wire brushing or a grinder will ensure successful grounding.

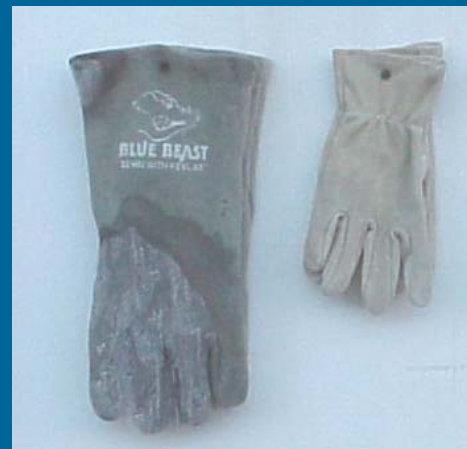
Everyone working or assisting in shipfitting activities involving hot work must wear gloves.

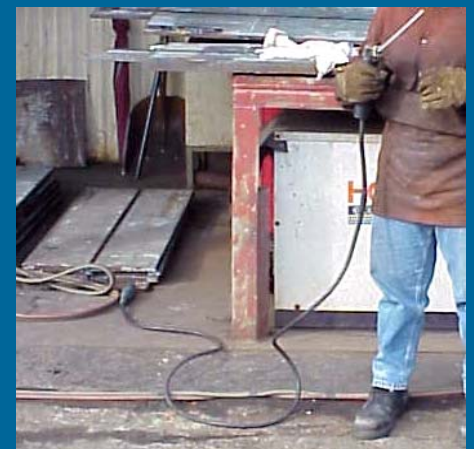
All welding cables must be completely insulated and capable of handling the maximum current requirements of the job. Before starting a welding job, a shipfitter needs to make a quick visual check of the entire cable to identify potential shock risks.

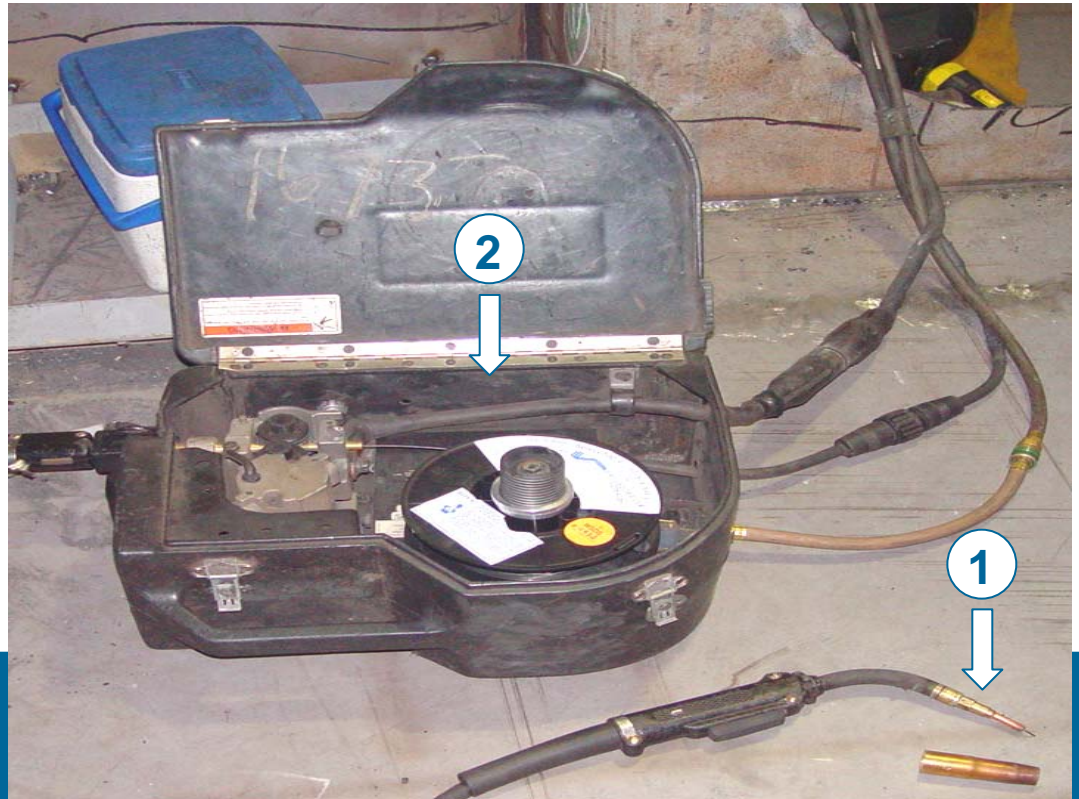
A shipfitter was setting up his welding equipment. As he installed the whip to the feeder, one hand came in contact with the metal end or nozzle of the whip (1) his other hand grasped the wire from the feeder (2). This completed the 80-volt electrical circuit which allowed the 80 volts of electricity to run across his chest.

- Before setting up equipment be sure the power source is secured.
- Be sure switches are set to the proper position for the job you are going to do.

- Wear dry, leather insulating gloves in good condition to prevent “live” parts of welding equipment from touching bare skin or wet clothing.

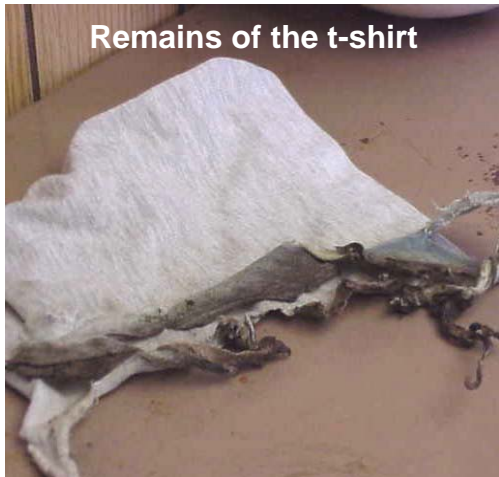
Remains of the t-shirt

The fire quickly spread to other clothing that was underneath the employee's coveralls including a t-shirt made of a synthetic material. When the fire reached the t-shirt, it burned even faster and began to melt onto the shipbuilder's skin.

- Protective clothing is only as good as its condition. Protective clothing must be intact and without frayed edges.
- Wear appropriate safety gear to protect yourself. Leather sleeves, for example, are fire retardant.
- Check your clothing to make sure it is in good condition prior to performing any hot work.
- Avoid synthetic clothing material due to the increased risk of rapid burning.

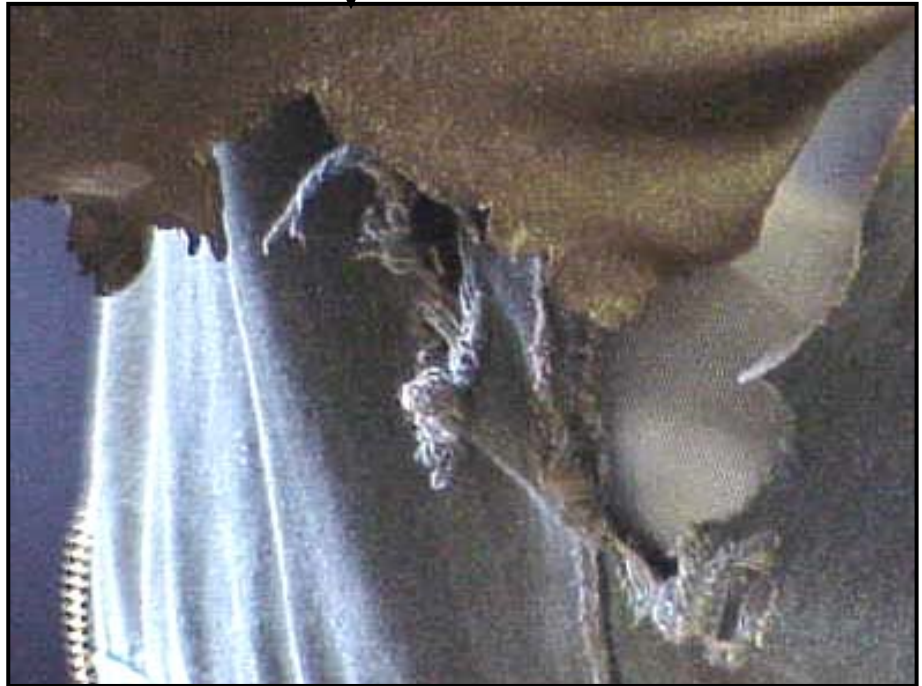
While performing hot work, sparks from the job caught in the frayed edge of an opening in the shipfitter's coveralls.

The threads acted like a candle wick and pulled the fire deeper into the fabric.

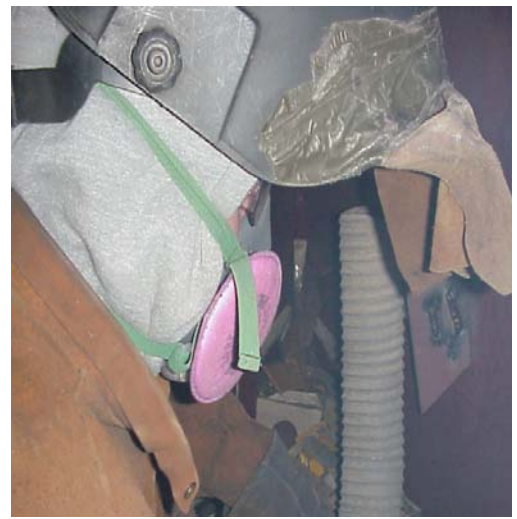
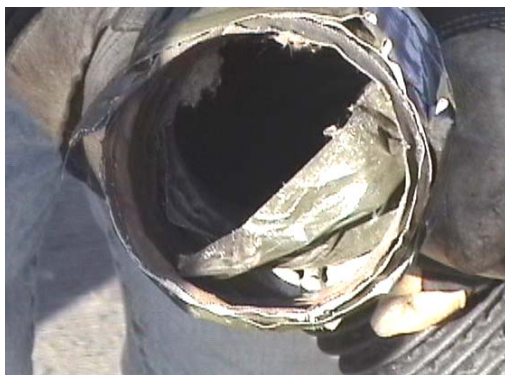
While working in a confined space, a shipfitter began to cough and feel light-headed. He lifted his welding hood and noticed excessive fumes surrounding him. He was able to get out of the space and into a more open area where co-workers helped him get outdoors. Fortunately, the only immediate result of the overexposure was that he suffered a headache.

Following the ventilation tube back through the ship, it was discovered that a splice in the vent tube had failed. As a result, there was not adequate ventilation in the confined space where the employee was working. The shipfitter should inspect the vent before and during work to ensure proper air flow.

It is also important to regularly review correct splicing techniques with crews and to encourage periodic checks of vent line condition in order to help prevent this sort of incident.

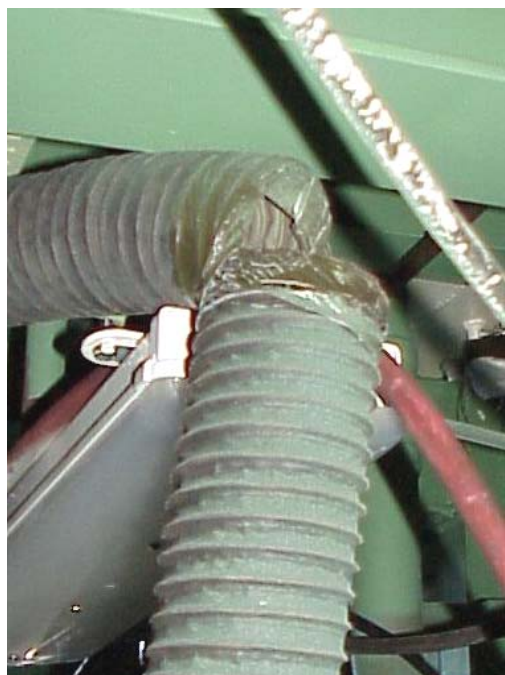
Ventilation needs to work properly to protect everybody in a space

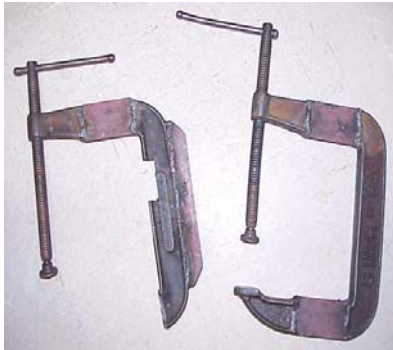
The C-clamps shown at right were modified with good intentions, but actually created a hazard.

In the top photo, the clamp on the left failed under load, causing the metal being clamped to suddenly be released.

It is imperative to establish and reinforce a policy that strictly prohibits tool modification without proper authorization, and creates the opportunity for employees to develop tools, jigs, and fixtures that are correctly engineered.

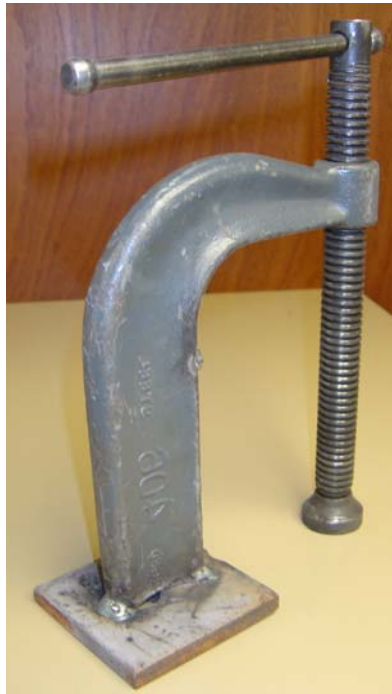
The clamp shown in the bottom photo was identified and removed from the worksite before it could be used. Later examination indicated that it would have failed under the intended load.

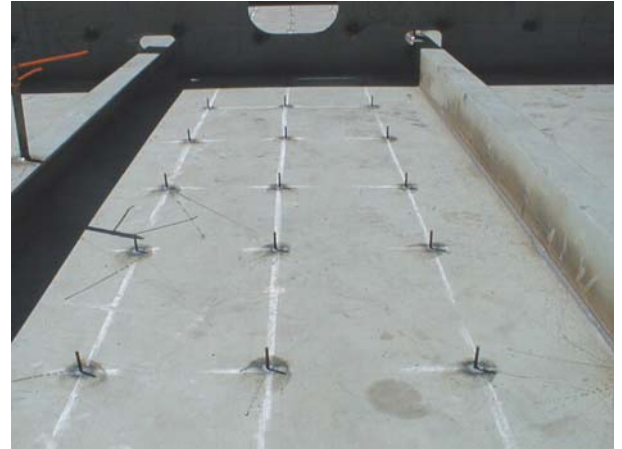
Exposed Insulation Pins

Shipfitters work in areas with exposed insulation pins that are capable of inflicting puncture wounds.

Depending on how quickly the insulation will be installed, either warning placards, plastic pin covers or bending the pins over may be used to reduce this danger.

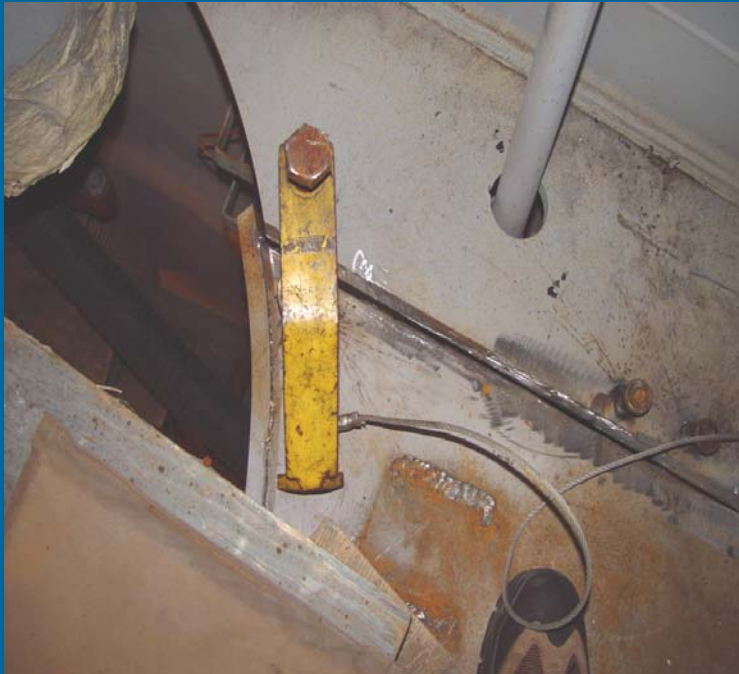
A shipfitter was fairing the deck with fishtails at the time of the accident. He was using an air ratchet to tighten the fourth fishtail when the stud holding the first fishtail broke free. The bolt from the fishtail struck him high on the left side of his forehead causing a serious head injury. At the time of the accident, the shipfitter was not wearing his hard hat.

The shipfitter did not expect the stud holding the fishtail to fail. Even though the first fishtail took a great deal of torque to fair the deck, he was still able to attach two additional fishtails without a problem. It was only when he was cinching down the fourth one that the first fishtail failed.

In this situation, several things could have prevented this accident. Shooting another stud on a piece of steel scrap might have improved the application of the first stud. The shipfitter could have put equal torque on all the studs to spread the load more evenly. The shipfitter's injury also could have been prevented if he had been wearing his hard hat.

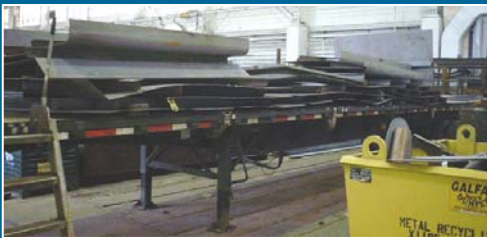
As the bulkhead pivoted on the trailer, it struck the shipfitter who was standing with his back to the load. The edge of the bulkhead struck the shipfitter on the right side of his hard hat, just above the rim. The force knocked the shipfitter down to the ground and onto a stock box beside the slump area.

The edge of the steel plate that swung out dug a furrow into the shipfitter's hard hat

While his injuries were not life-threatening, if the shipfitter had been caught between the bulkhead and another object, this situation might have caused a severe injury or possibly death. Loads being picked up (or "lifted") have the potential to swing or move from side to side, and, in this case the shipfitter was not restricted from the dangerous area.

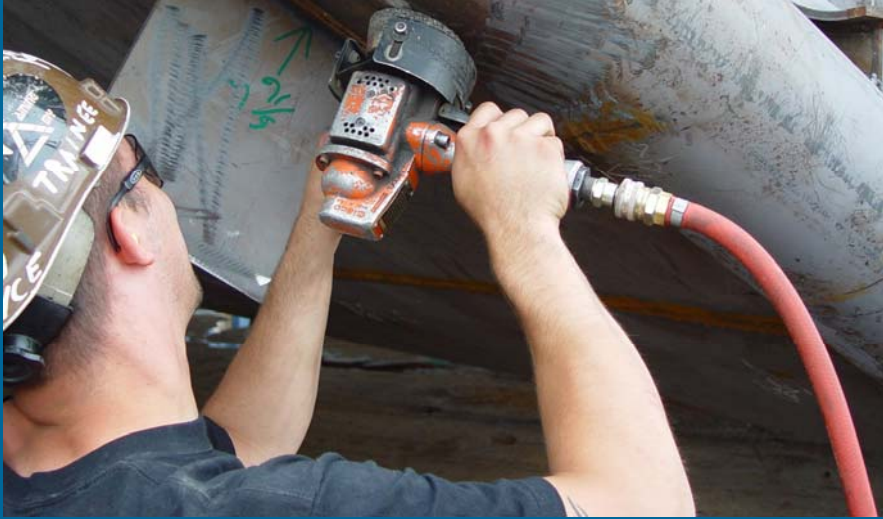
Wearing standard safety eyewear, even if it has side shield protection, may not be enough to prevent foreign bodies from getting embedded in the eyes during operations such as grinding. High-speed grinding operations can produce fast-moving particles that can fly under or over the safety glass frames and get into employees' eyes.

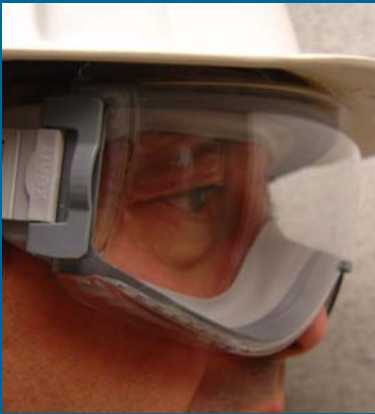
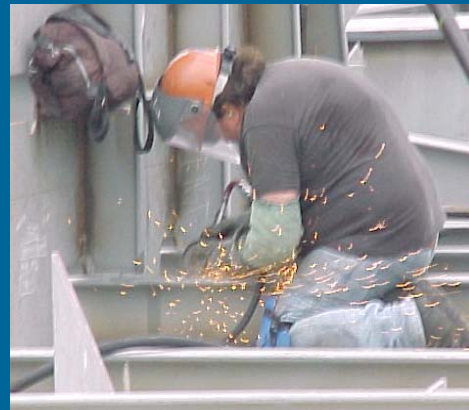
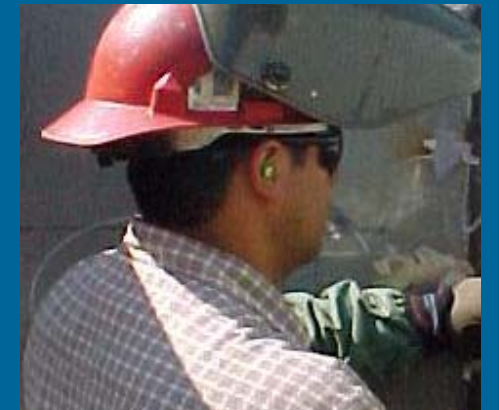
Safety goggles with a seal can provide more complete protection against grinding dust getting into employees' eyes if safety glasses with side vents are not sufficient. Goggles have ventilation and/or special lenses to prevent fogging.

Wearing a safety face shield that covers the entire face or wearing a face shield over safety glasses are options that may provide necessary additional protection from grinding dust, especially if the dust is dropping from above. If respiratory protection is required, a full-face respirator provides the needed level of protection against both grinding dust and respiratory hazards.

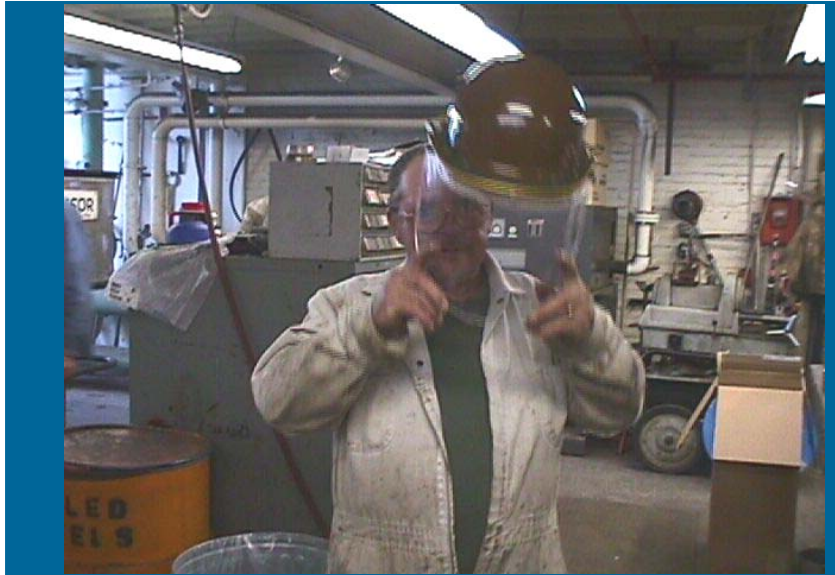
A shipfitter was grinding and wearing both safety glasses and a face shield as required by company rules. During a stretch break, he raised his face shield, causing metal particles generated by the grinding to fall onto his face behind his safety glasses and into his eyes. When his eyes became itchy and watery he reported the injury to his supervisor, who sent him to the medical department for treatment.

The frequency and potential severity of this type of injury led the shipyard to seek a permanent solution. A major safety equipment manufacturer was contacted. With input from shipyard employees, the manufacturer developed a prototype bracket frame featuring a firm rubber seal designed to form a barrier that will prevent debris from falling onto the face and into the eyes. The prototype is now being evaluated by the shipyard.

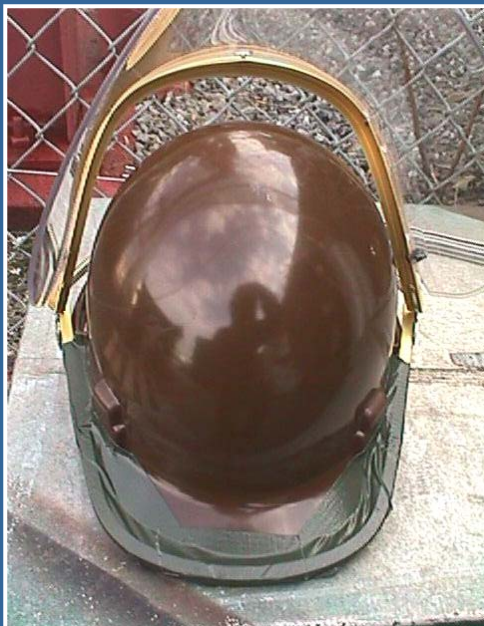
Duct tape seal

In the meantime, employees have been made aware of this problem during safety talks and are being instructed on the proper way to prepare and remove their face shield. They have been told to apply duct tape over the seam between the brim of the hard hat and the face shield bracket to form a seal. In addition, they have been told to lean forward when removing the hard hat, keeping the face-shield and seal intact instead of flipping the shield. The shield can then be inspected for debris, cleaned, and used again. Another viable solution used by other shipyards is to attach magnetic tape to the hard hat brim to prevent steel particles from falling onto the face when the hard hat and shield are removed.

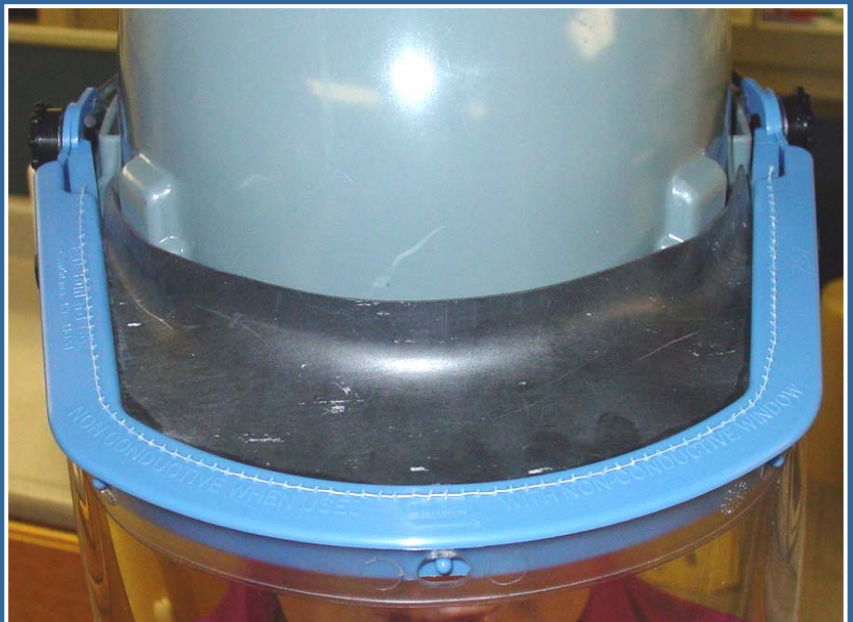
Prototype manufactured face-shield bracket with barrier
