Aztec Ruins National Monument Administrative History of an Archeological Preserve

Robert H. Lister and Florence C. Lister

1990

National Park Service
Division of History
Southwest Cultural Resources Center
Santa Fe, New Mexico
Professional Papers No. 24

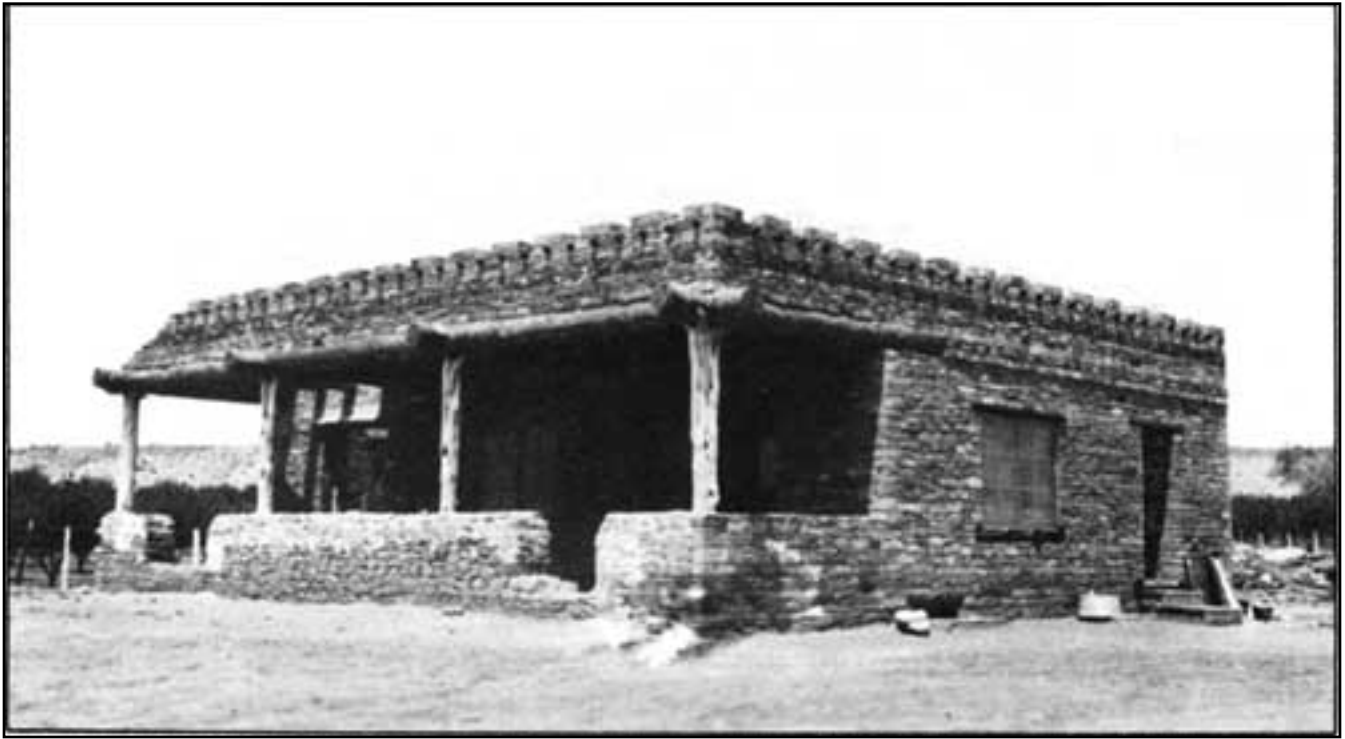
Figure 4.1. American Museum field station, built of shaped stone from Aztec Ruin and occupied by the Morris family from late 1920 to 1933, as it appeared about 1923-1924. The western room, planned as an exhibit hall, was not yet roofed.

Three months later, walls were up, roofs were on, and it was time to close in the building. Morris wired that every effort was being made to conform to Anasazi practices. He explained by adding, "My mason is building a beautiful wall which is laid without any mortar showing on the outer surface, thus heightening the similarity to the weathered portion of the ruin." [6]

A long porch covered the front, or southern, facade of the house. The top courses of stone in a low wall across its face and some of the upper house walls were set in obvious cement mortar to imitate repaired walls in the ruin. [8] The porch was supported by four cedar posts placed upside down so that the spread of roots embraced the ends of roof cross beams. Morris borrowed the idea for posts used in this way from late seventeenth-century Indian houses in the Gobernador region east of Aztec. [9] Purists considered them inappropriate for a building at Aztec Ruin. Given the fact that the concept of a porch also was foreign to the Anasazi, the complaint appears irrelevant. Harder to explain were low masonry parapets around the roof line, for which there is no known regional counterpart (see Figure 4.1).

masonry set up in the natural colored concrete so that it, too, would appear to have been repaired (see [Figure 4.1](#)).

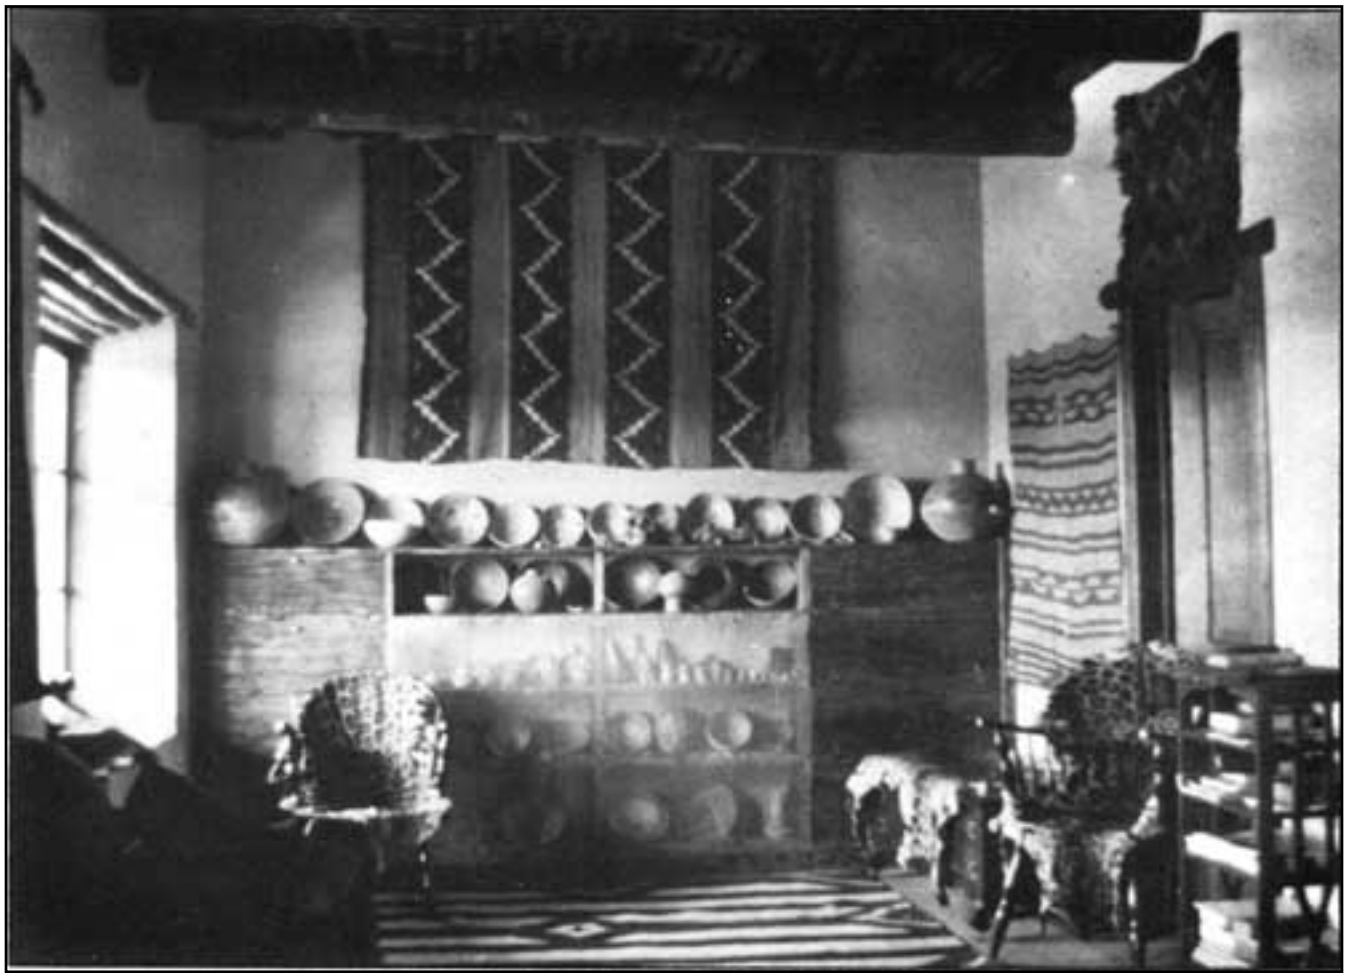
Figure 4.2. The Morris living room with collections of Indian objects. Ceiling beams are twelfth-century elements removed from the West Ruin. Window and door lintels are modern wood installed in the Anasazi way.

Although not spacious, the interior was comfortable and exhibited a Southwestern Pueblo flavor (see Figure 4.2). The floor plan was a rectangle. The eastern two-thirds was divided into four small rooms: a living room, a kitchen, and two bedrooms. During a secondary building phase, another large unpartitioned room was planned on the west side of the building. That room would provide space for a museum. As was the case in the Anasazi dwelling, interior walls were whitewashed. Ceilings were made of aged beams and smaller poles taken from downed roofs of the West Ruin. Contemporary doors and windows afforded light, ventilation, and easy access. A corner fireplace of Hispanic style in the living room and a wood range in the kitchen provided the luxury of heat, which, except for small open cooking hearths, Anasazi homes lacked. Other improvements over the Indian mode of life were household water lifted to the kitchen sink by a hand pump from a large cistern dug to one side of a cellar beneath the house, a pine floor, and artificial light from gasoline lanterns. Up to that time, the Abrams cistern

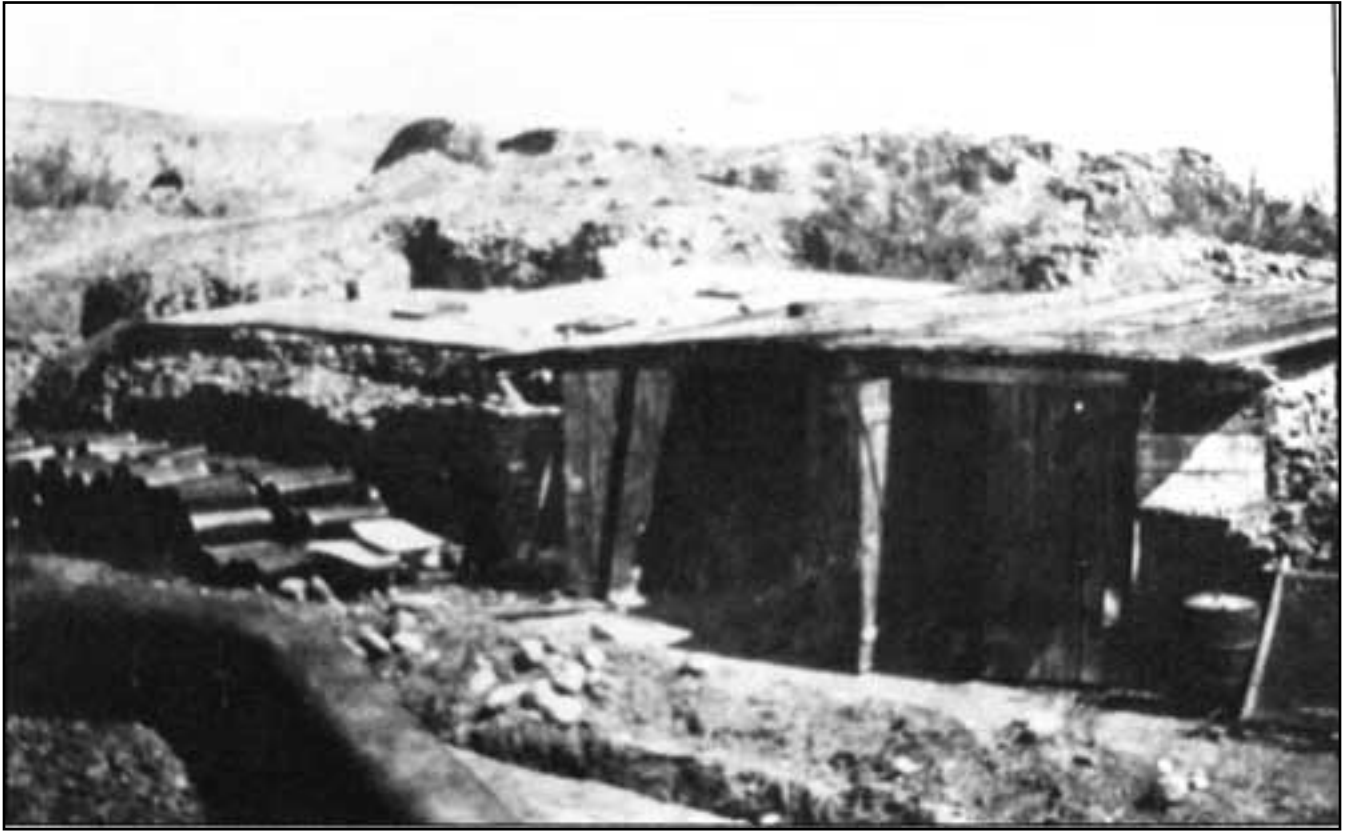
Figure 4.3. Three rooms of the southwest corner of the Aztec Ruin revamped by Morris during the 1920s for personal purposes. Unexcavated West Wing rooms are in the background.

To the rear of the American Museum building, three rooms of the West Wing of the ruin were reworked for modern purposes. One inner chamber covered with a timber-and-tar paper roof was a privy. Adjoining prehistoric cells were roofed similarly. They became a garage and a blacksmith shop. Wooden barn doors closed these spaces (see Figure 4.3). [10] In time, the courtyard shed was moved to the back of the house. A portion of the south extension of the Annex was leveled in preparing a suitable base for it. For a half dozen years, the shed was a general utility building and display space for artifacts.

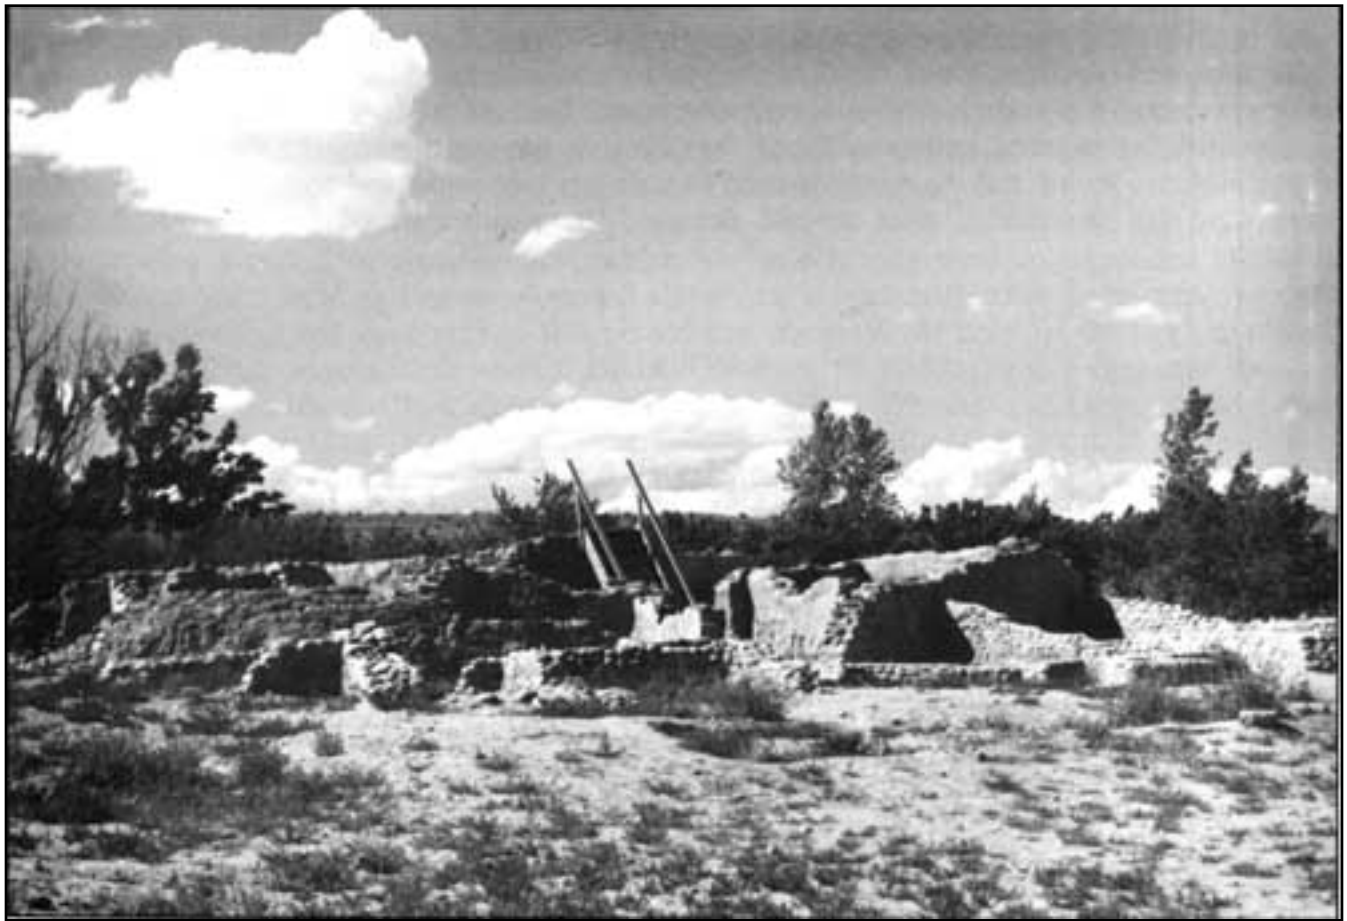
Figure 9.2. Hubbard Mound, a unique tri-wall structure, ca. 1954.

A trail leading from the northwest corner of the West Ruin to the top of Hubbard Mound allowed visitor viewing from above of 22 rooms, two kivas, and rudimentary wall features (see Figure 9.2). Visitors found the complexity of its superimposed features to be confusing, and the elements quickly ravaged the exposed structure. Since the site was not contributing to the meaningful visitor experience at Aztec Ruins and the methods used to stabilize it to withstand seepage and water drainage problems were not successful, after several decades, the major part of the Hubbard Mound was backfilled. [16]

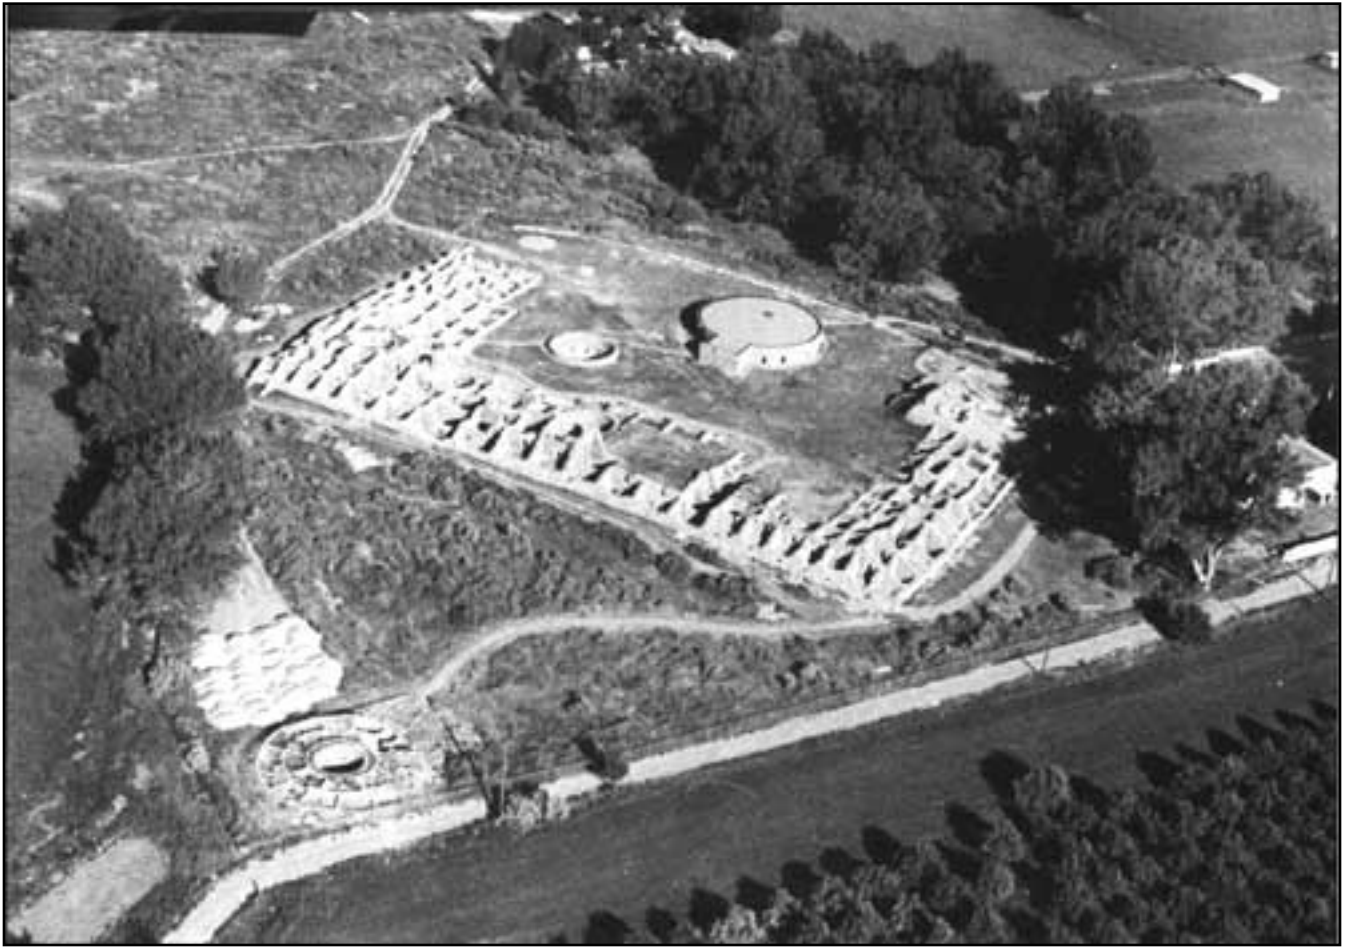
Figure 11.2. Aerial view of West Ruin and Hubbard Mound. Residential area at upper center; visitor center at right center (1984).

Within the monument itself, there were few physical changes after MISSION 66. One was the removal in 1984 of building 8, a residence that had been uninhabitable and vacant for five years. That action reduced to two the number of service or domestic buildings (see Figures 11.1 and 11.2). In 1987, lift station pumps were rebuilt, and the sewer line to building 9 was replaced. Improvements were made to facilitate access by handicapped persons. (see [Figure 10.1](#)).

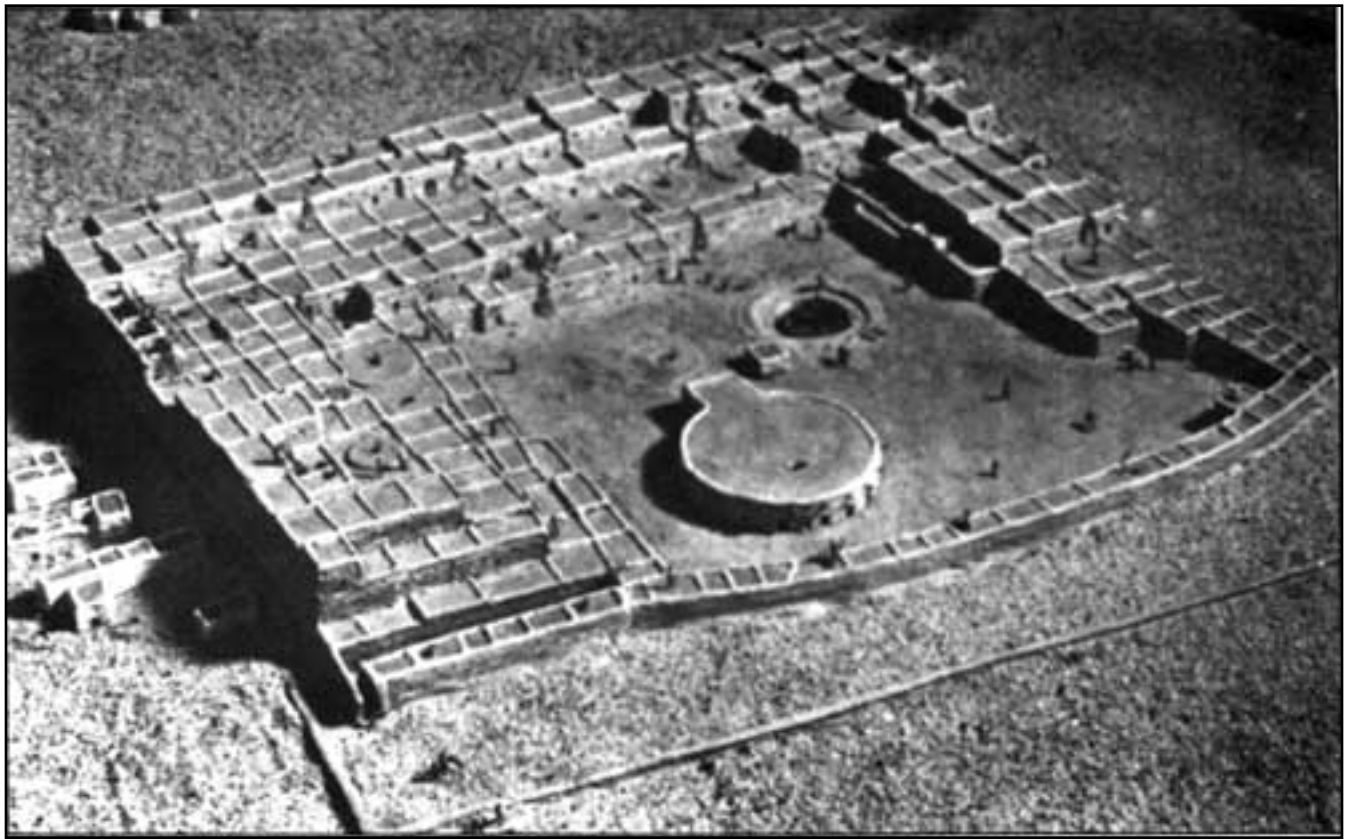
Figure 13.1. Model of the West Ruin prepared for exhibition at the American Museum of Natural History.

Some exhibits of Aztec Ruin finds were arranged. Early in the program, these were for staff only. During the 1920s, permanent exhibitions were installed in the museum's Southwest Hall. So far as is known, all that was included were two cases of pottery and a large model of the ruin (see Figure 13.1). How long these displays were mounted is unknown. [2]

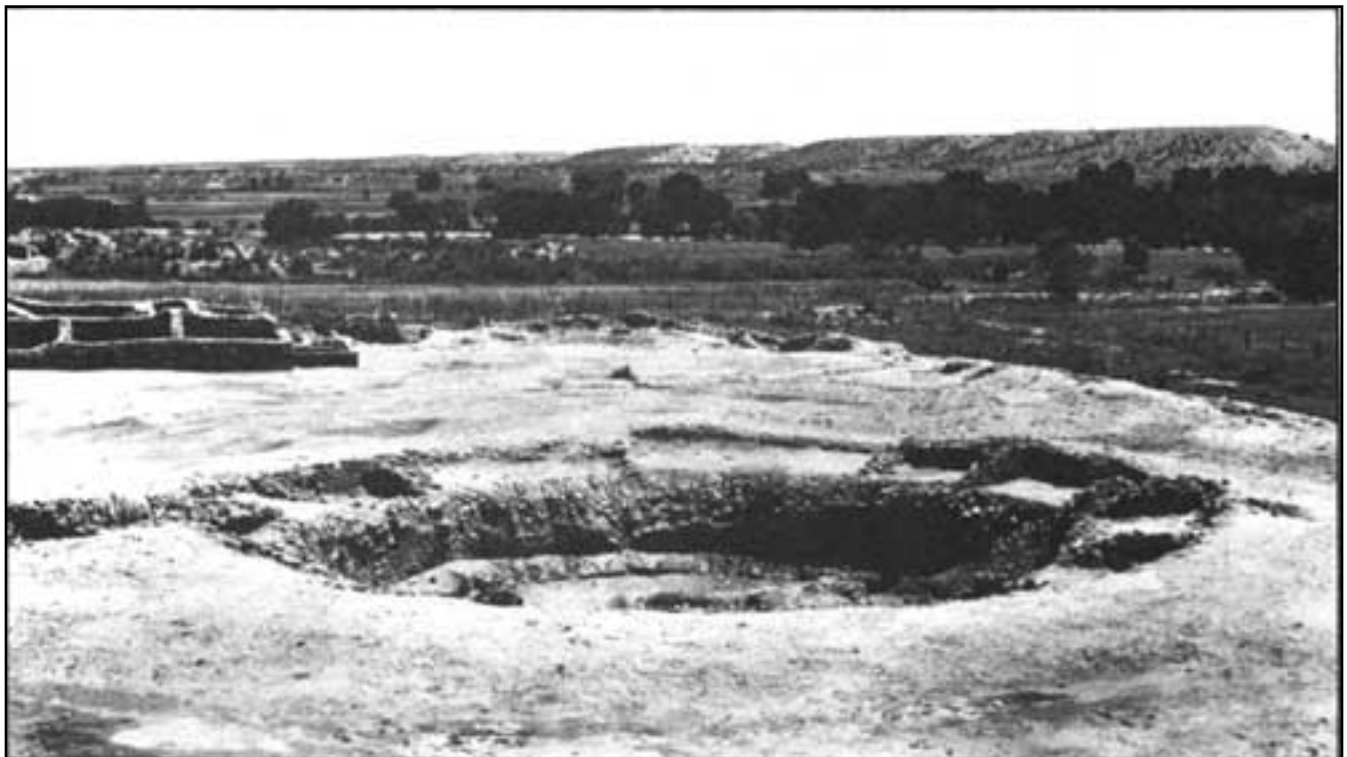
Figure 7.9. Deteriorated condition of Great Kiva prior to reconstruction in 1934.

Ten years later the Great Kiva became an offensive tumble of stones and a pond of standing water after every rain (see Figures 7.8 and 7.9). Hamilton reported that the Great Kiva in 1933 had "lost almost all form and outline." [71] He recommended the restoration of the Great Kiva, using the Morris report of 1921 on its architecture as a guide and suggesting that \$1,500 be set aside specifically for this purpose. [72]

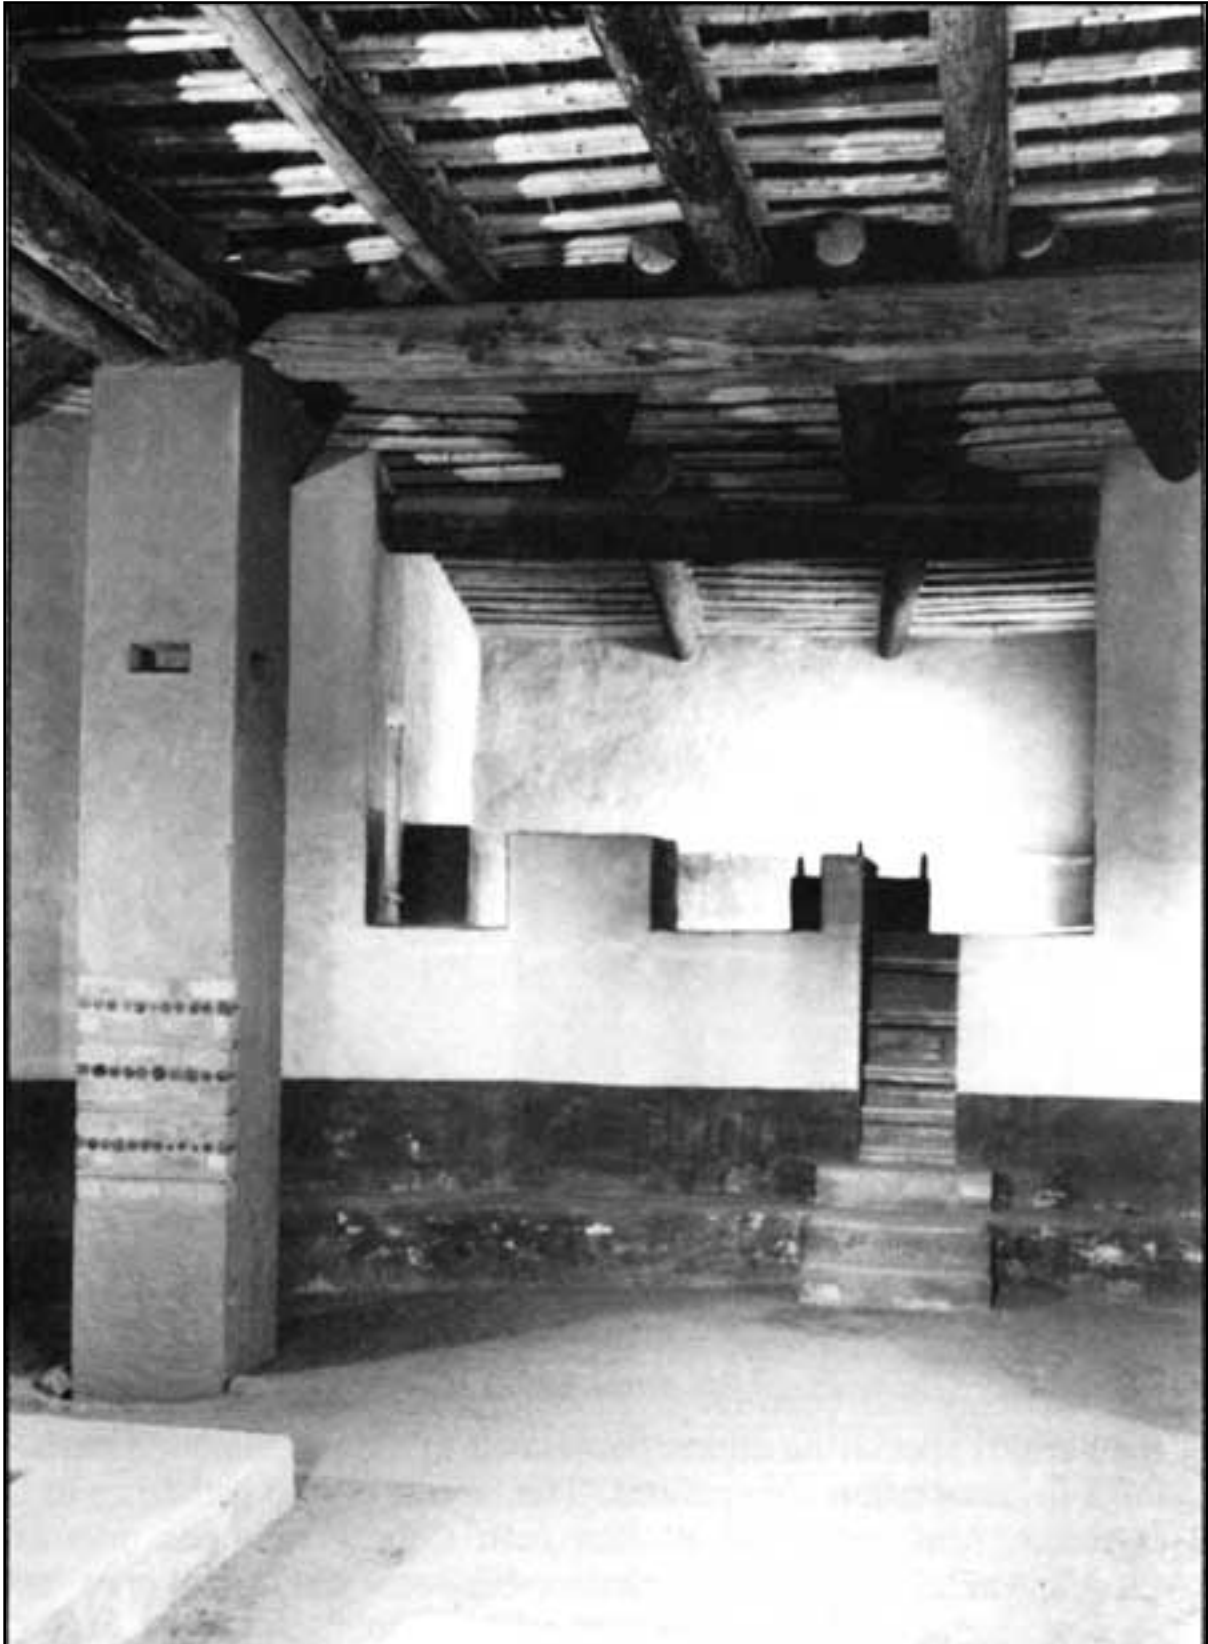
Figure 7.11. Interior of restored Great Kiva, looking toward north altar room. Crossbedded poles in roof support column left exposed to demonstrate method of construction.

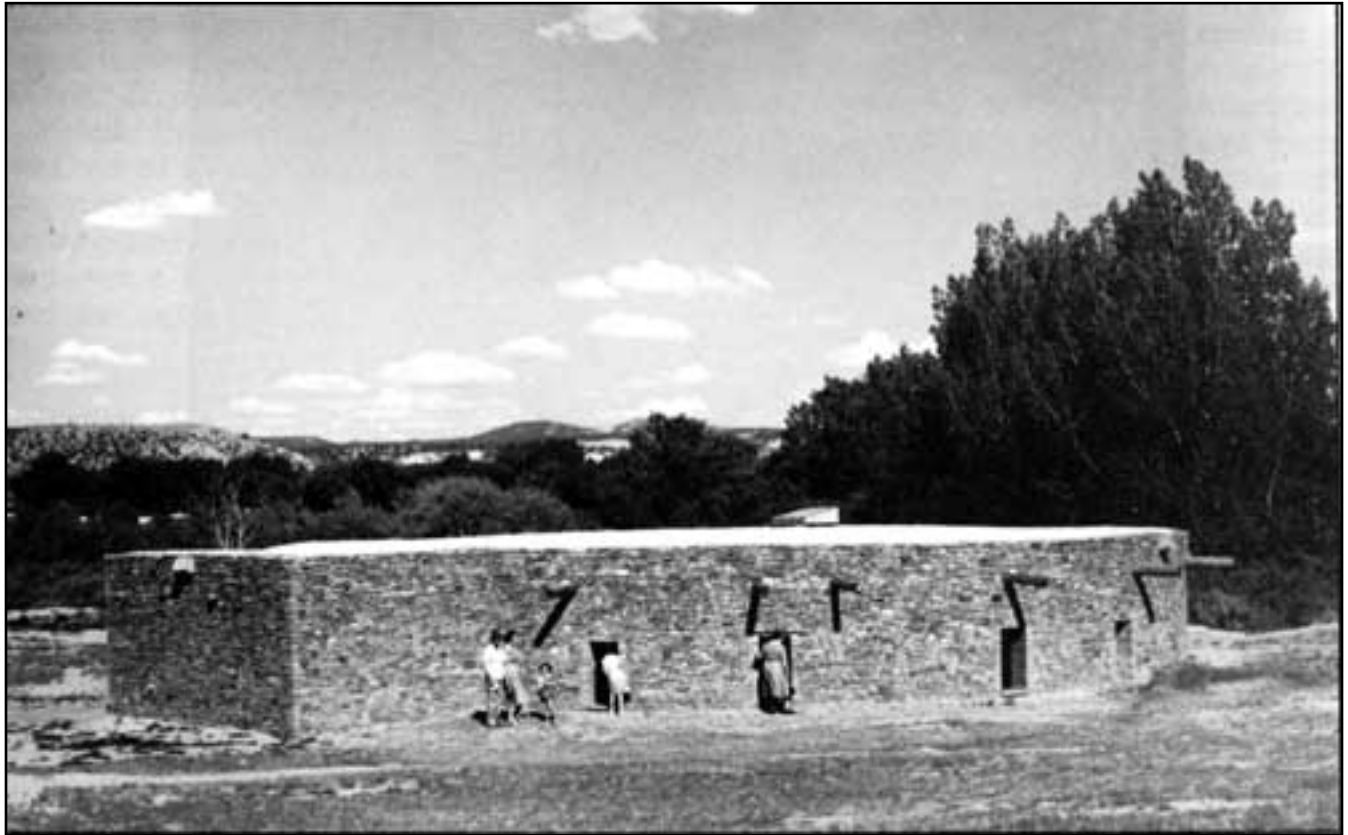
Figure 7.12. Reconstructed Great Kiva, northwest side. Doorways open into encircling surface rooms.

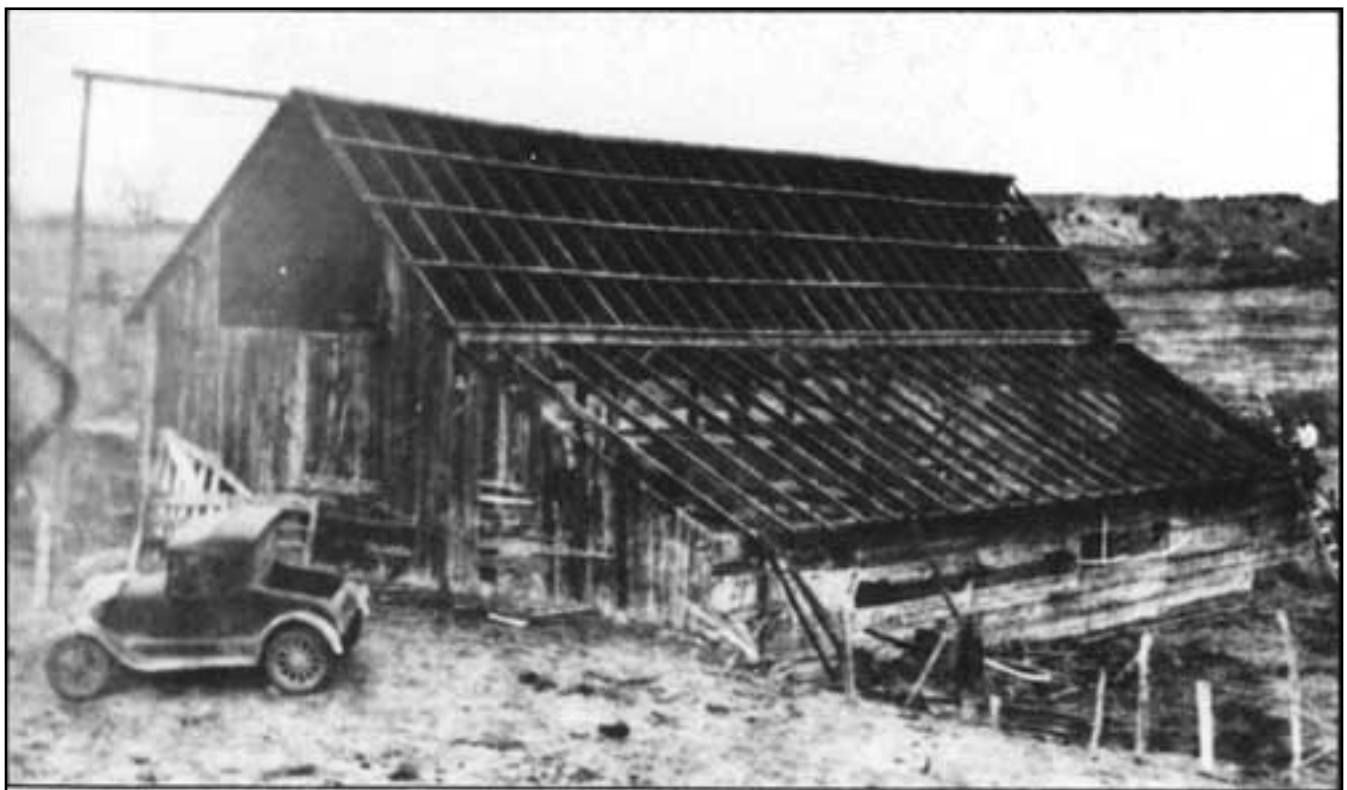
Figure 7.1. Abrams hay barn being dismantled for removal from the monument, 1933.

(1) Project 1, under direction of seasonal ranger Thomas Thompson, moved the Abrams hay barn from the edge of the East Ruin to a location on the family farm selected by Orrin Abrams, replaced its worn siding, treated the structure with old motor oil, and baled loose hay stored in it (see Figure 7.1).

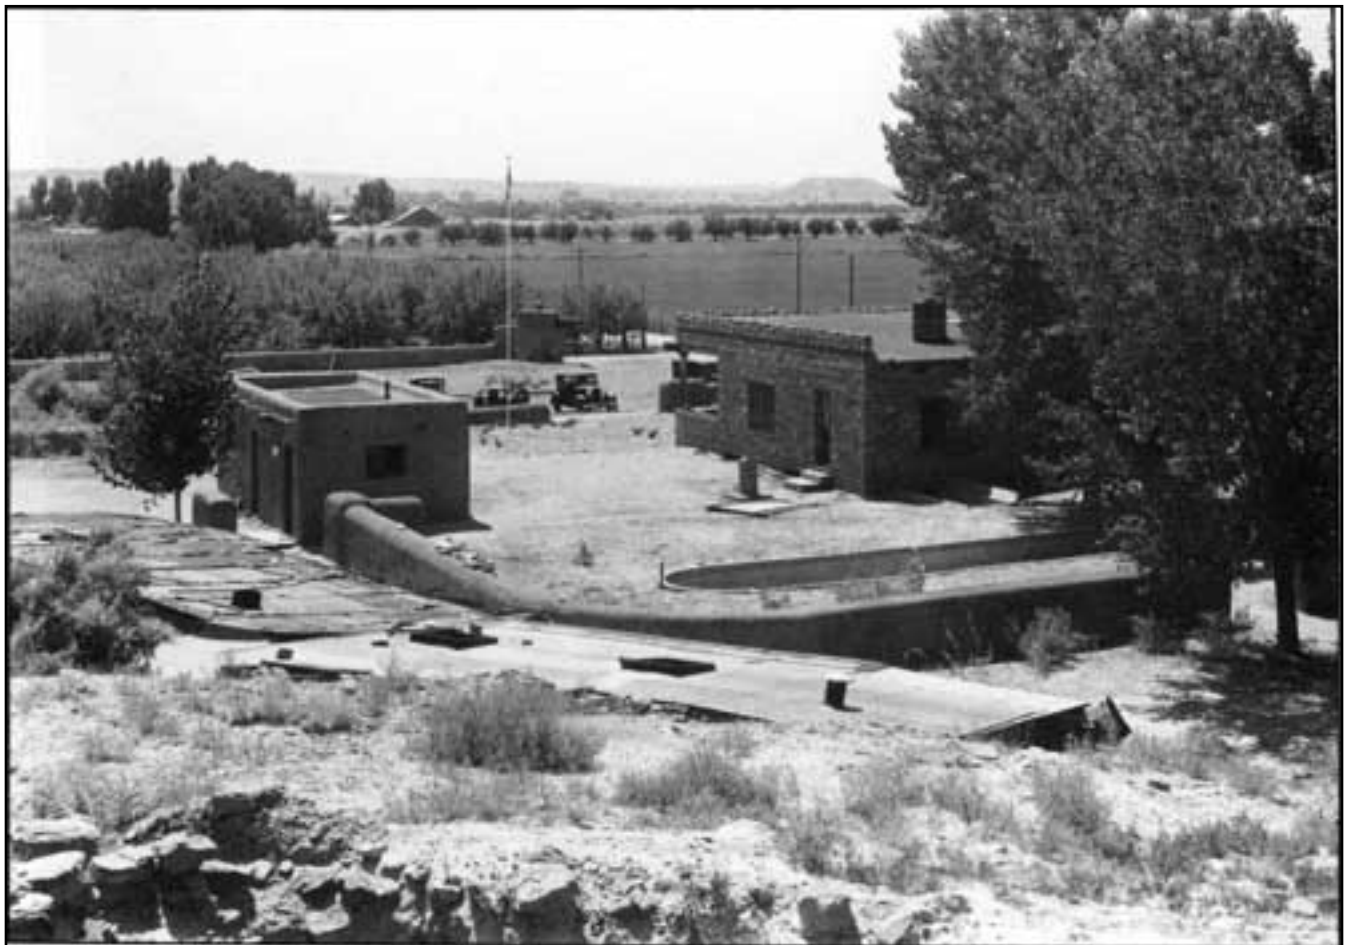
Figure 7.2. View of 1933 from southwest corner of the West Ruin showing roofs of three aboriginal

rooms

put to modern purposes, the comfort stations, the Morris house, the cistern pump at one side, the cement-lined pond at the rear, and the walled parking area in front.

A month after the American Museum plot was incorporated into Aztec Ruins National Monument, Director Albright recommended to New Mexico Senator Sam G. Bratton a budget of \$6,900 to cover cost of the four most needed improvements for the benefit of staff and visitors. [122] With apparent approval, by June 1931 a 73-foot-deep well for drinking water was drilled to replace the cistern, a pumphouse built, two rest rooms served by a septic tank to the east of the house installed, and the first telephone brought the monument in ready contact with the outside world. [123] Rest rooms (or "comfort stations" in the National Park Service terminology of the time) were planned for the west side of the stone house, but to meet objections from Morris, they were put in a small building constructed in the east yard (see [Figure 7.2](#)). [124]

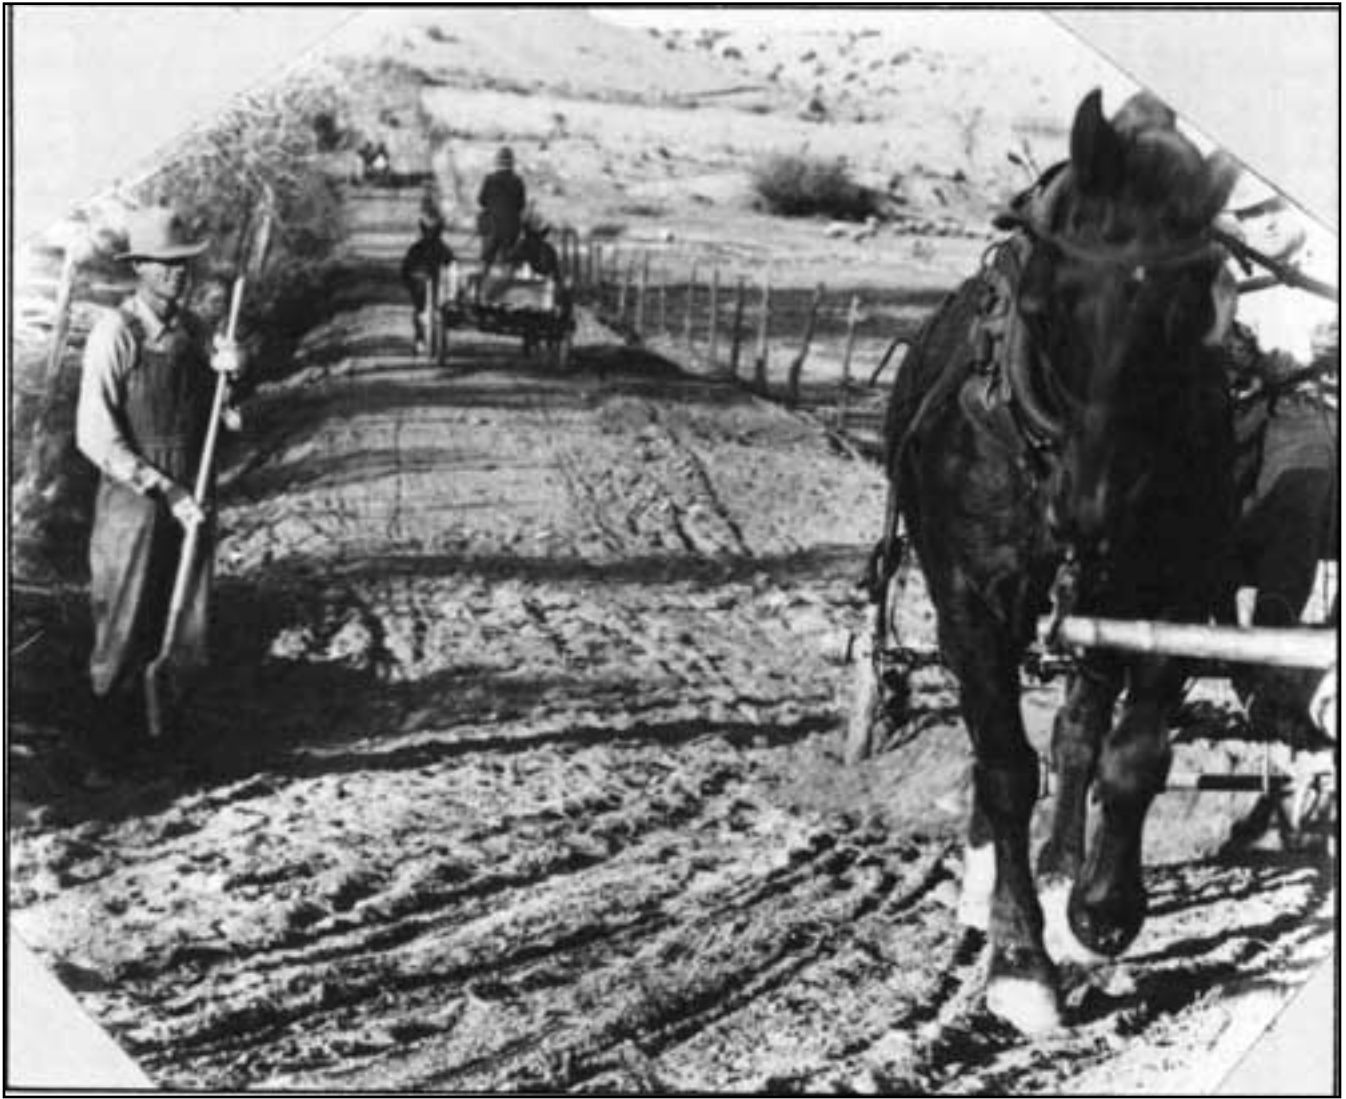
Figure 7.4. Relays of horse-drawn wagons hauling debris from West Ruin to fill ruts in entrance road, 1933.

(4) Project 4 was the cleaning of areas around the ruins of dead brush, sticks, old lengths of barbed and woven wire, and trash, and hauling off unwanted earth (see Figures 7.4 and 7.5). [24] The dense vegetational cover developing in the northeast sector of the preserve as a consequence of overflow irrigation waters was not permanently eradicated. As another aspect of this project, Tatman led an archeological reconnaissance and survey of the monument. He was in charge of partial or complete excavation of six rooms, six kivas, a two-roomed extramural structure, six burials, and the trenching of the southeastern refuse mound. Some of the results of these activities are discussed more fully below. [25]

Twenty-one men with three teams of horses and six wagons went to work to finish this part of the general program by the end of 1933. Photographs of the period show a relay of wagons moving up and down the road leading to the ruin to deposit their loads in numerous pot holes (see [Figure 7.4](#)). [32] A horse-pulled grader transferred from Mesa Verde to Aztec leveled out the dirt. [33] The desired reserve of building stones did not materialize. [34]

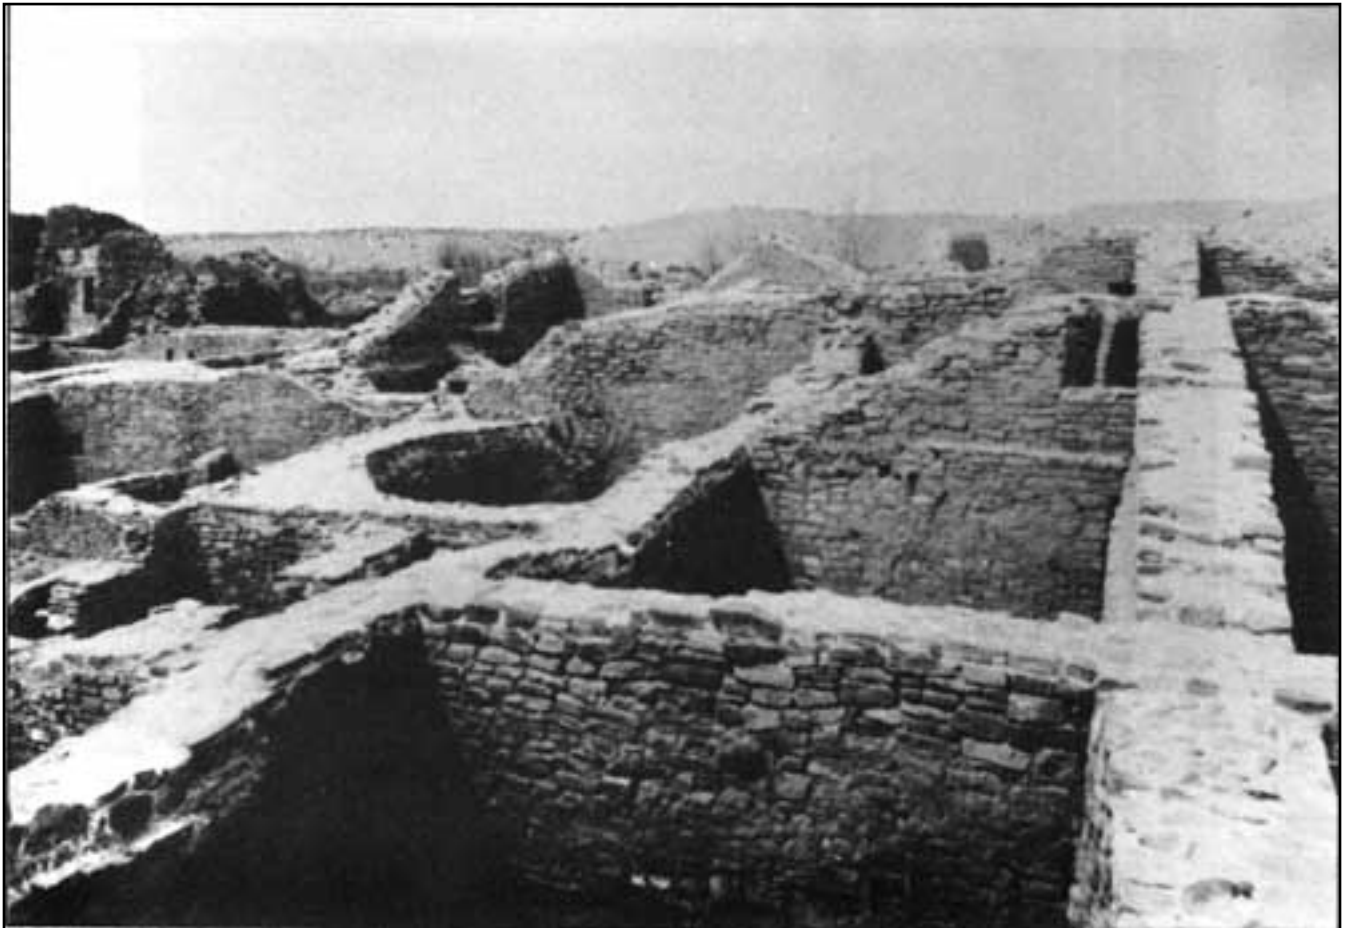
Figure 12.1. View over northeast corner of West Ruin showing cement wall capping.

Morris's workers dismantled and relaid portions of the sandstone block veneer of many of the less stable walls using Portland cement for mortar (see Figures 12.1 and 12.2). In one season alone (1918), Morris purchased an entire boxcar of this material. The cement dried to a typical grey color and was very obvious in its contrasting color to that of the brown mud used by the original masons. It readily identified reworked sections. Many persons considered that distinction between old and new work as desirable for the sake of authenticity. In response to a later inquiry from Southwest Monuments Superintendent Pinkley about using colored mortar, Morris replied that the aesthetic effect of colored mortar would be greater than the pronounced contrast of white cement and dark stone. But he added, "If the coloring is made too close to the original earth mortar, many will not be able to distinguish between the work of the aboriginal and that of the modern masons. On the contrary the use of natural colored cement would create a condition that could not fail to be understood by anyone with sufficient intelligence to wonder about it." [2] He went on to suggest recessed mortar for vertical walls and colored cement for flat areas.

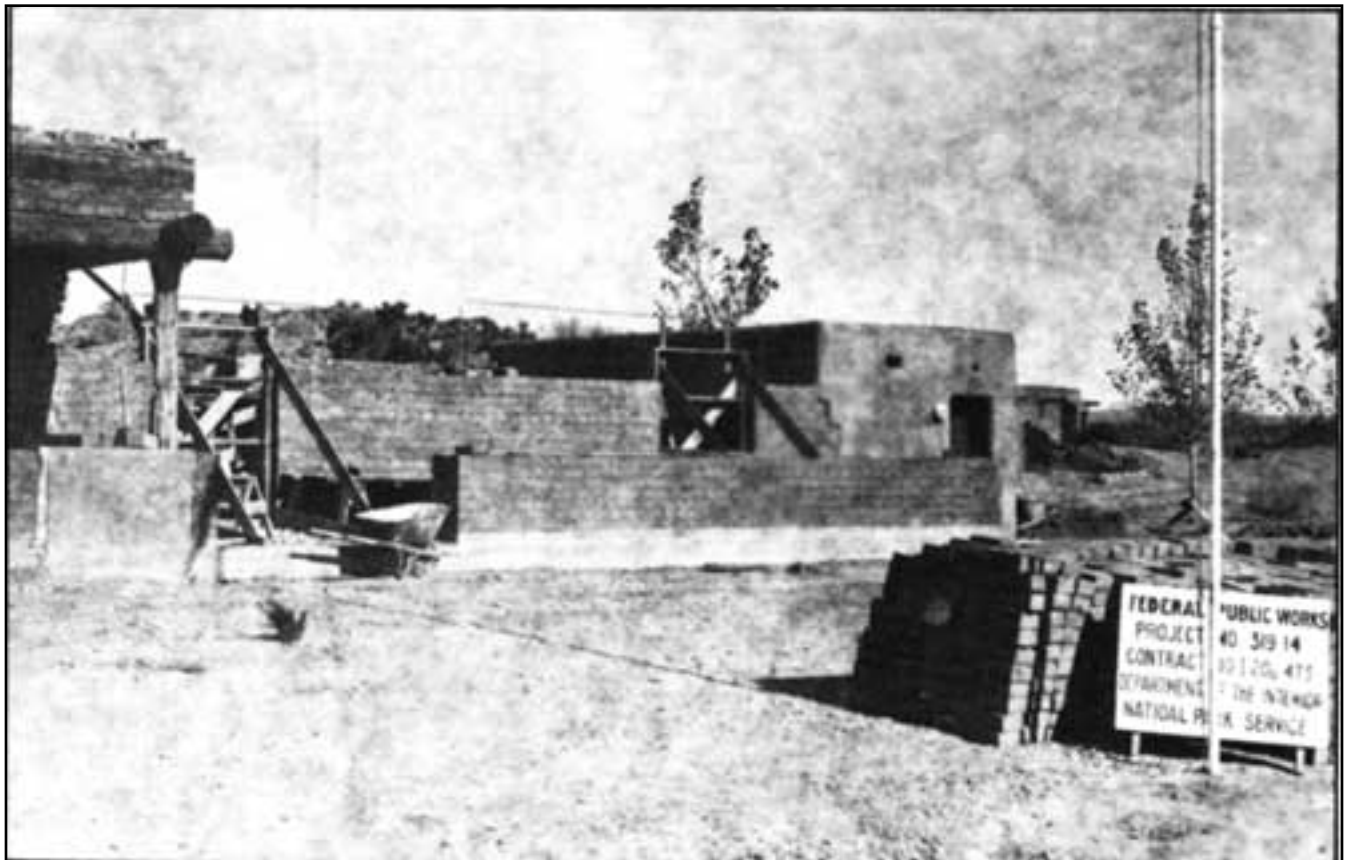
Figure 7.13. Lobby being erected between Morris house and comfort stations, 1934.

According to blueprints drawn in November 1933, the vacated five-room Morris house, including the west room the American Museum had intended as an exhibition hall, was to be remodeled into monument offices and a museum under a Public Works Administration project. A lobby of approximately 980 square feet would be built to connect this structure with the comfort station complex to the east erected two years earlier (see Figure 7.13). A 1,305-square-foot museum would be placed on the west side of the old house. A new porch would extend across the front of the lobby, a door from the museum opening on the original porch at the west. [97] As had always been the case at Aztec Ruins, it was the museum which would cause most controversy.

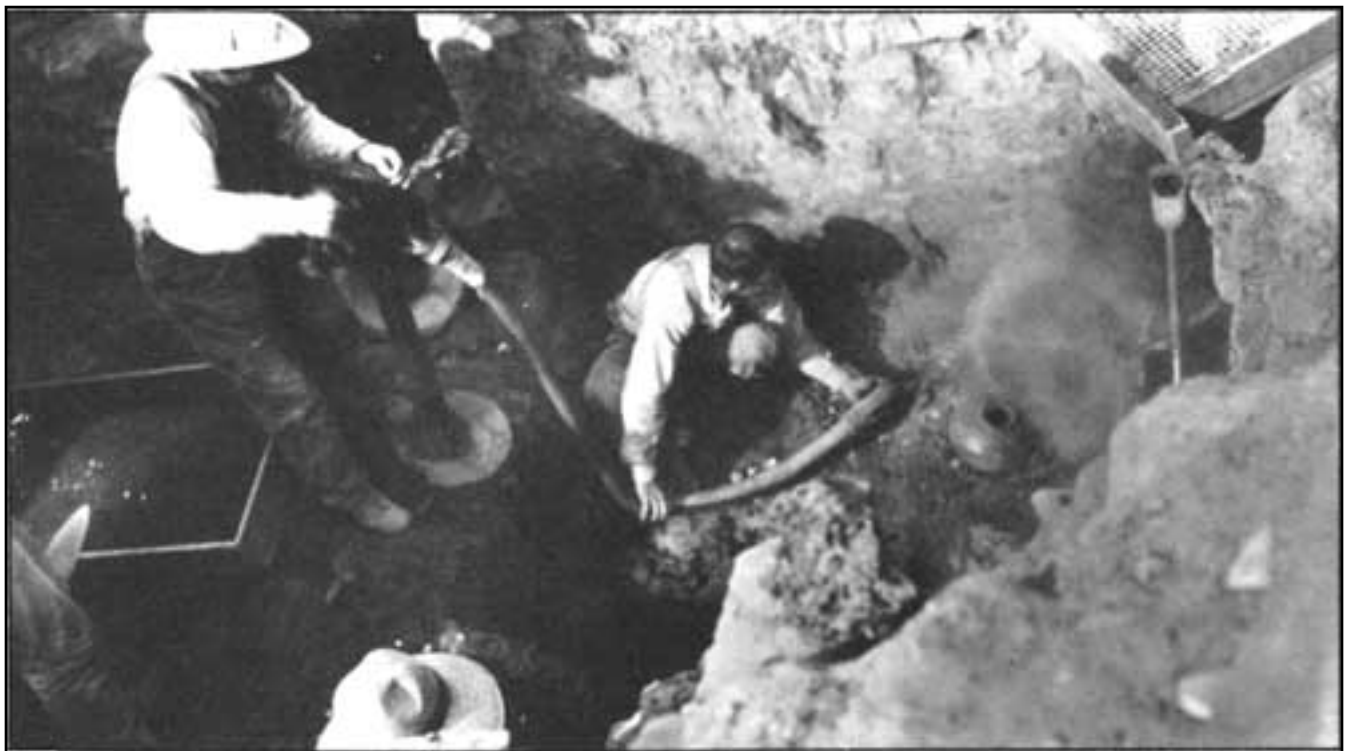
Figure 3.4. Workers removing fine fill dirt by means of a forge bellows.
(Courtesy American Museum of Natural History).

To get excavations under way, Morris assigned one group of shovelers and tenders the task of using hand tools to clear the single row of low cobblestone rooms along the south side of the pueblo. Picks, shovels, and screens were the primary instruments, but occasionally close work required more ingenuity. For example, Morris resorted to the blast pipe off his blacksmith forge to remove fine soil from around delicate objects (see Figure 3.4).

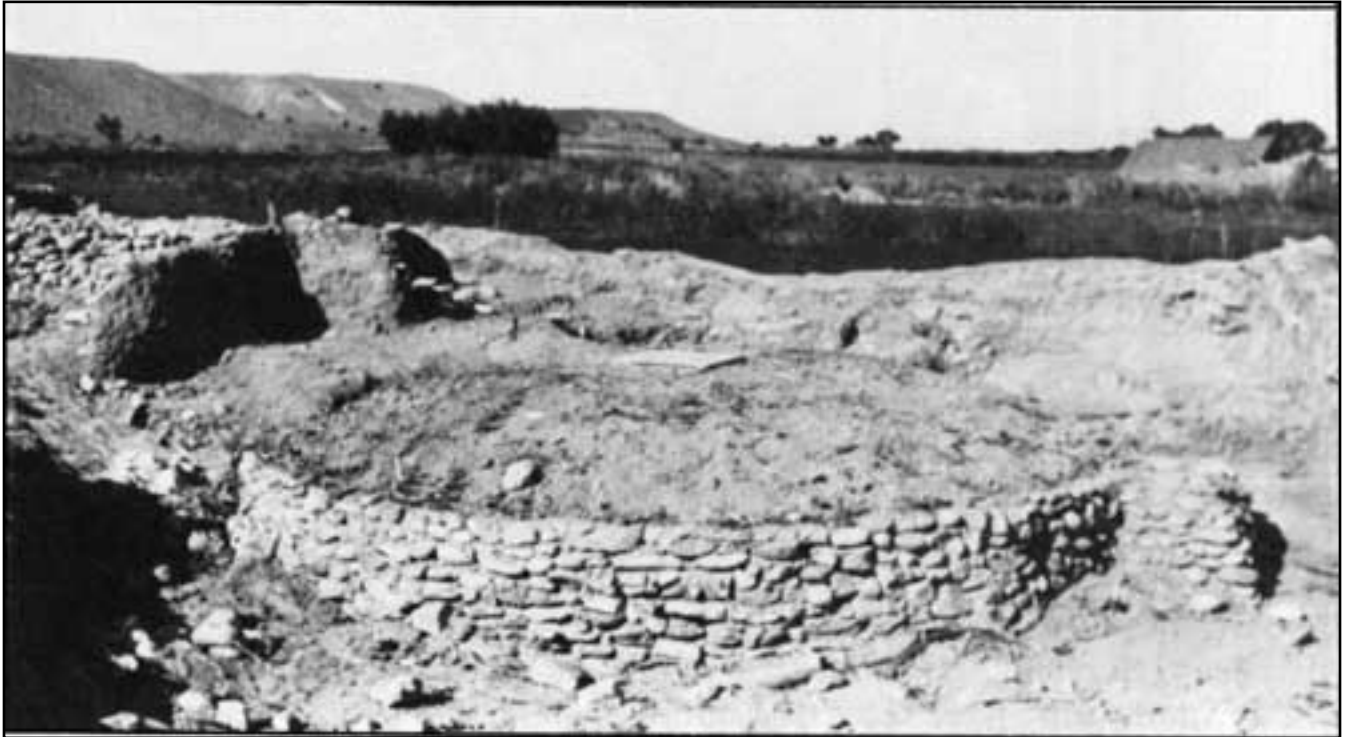
Figure 3.5. Roofed Kiva B, 1916. (Courtesy American Museum of Natural History).

Morris arbitrarily elected to roof Kiva B. For unclear reasons, he used a partially intact, cribbed-log kiva roof at Peabody House (now Square Tower House) in Mesa Verde as a model. [12] He justified the reconstruction to Nelson as being less costly than resetting the kiva's cobblestone walls in cement to withstand exposure. Up until 1984, the replaced flat roof, with its central hatchway at ground level, was noticeable in the southeast court (see Figure 3.5). However, reroofing this relatively minor construction proved to be a mistake. Because of the slope of the terrain and the kiva's situation in the lowest part of the site, underground water percolated into it. The roof prevented natural evaporation, making eventual backfilling of the structure the only possible solution for its preservation. It lies hidden beneath a thick layer of earth along a service road exiting from the southeast corner of the house compound.
