Aztec Ruins National Monument Administrative History of an Archeological Preserve

Robert H. Lister and Florence C. Lister

1990

National Park Service
Division of History
Southwest Cultural Resources Center
Santa Fe, New Mexico
Professional Papers No. 24

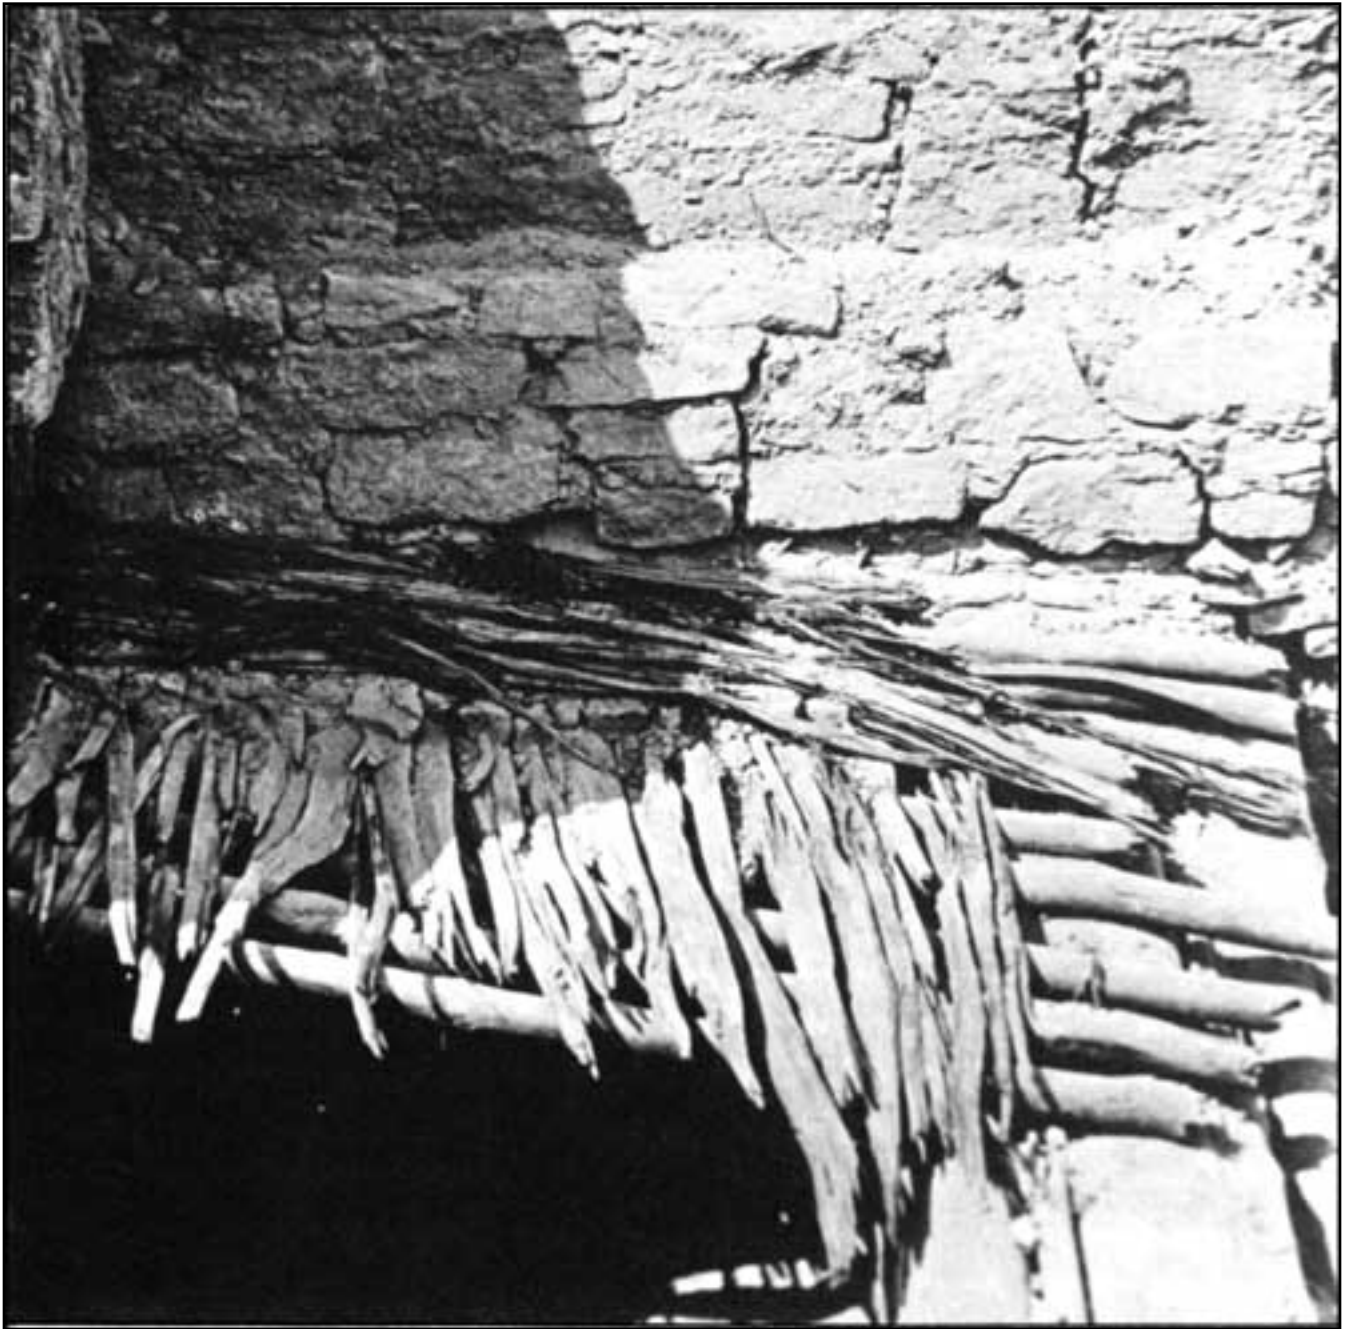
Figure 3.6. Exposed first-story roof of primary beams, cross poles, and strips of cedar bark.

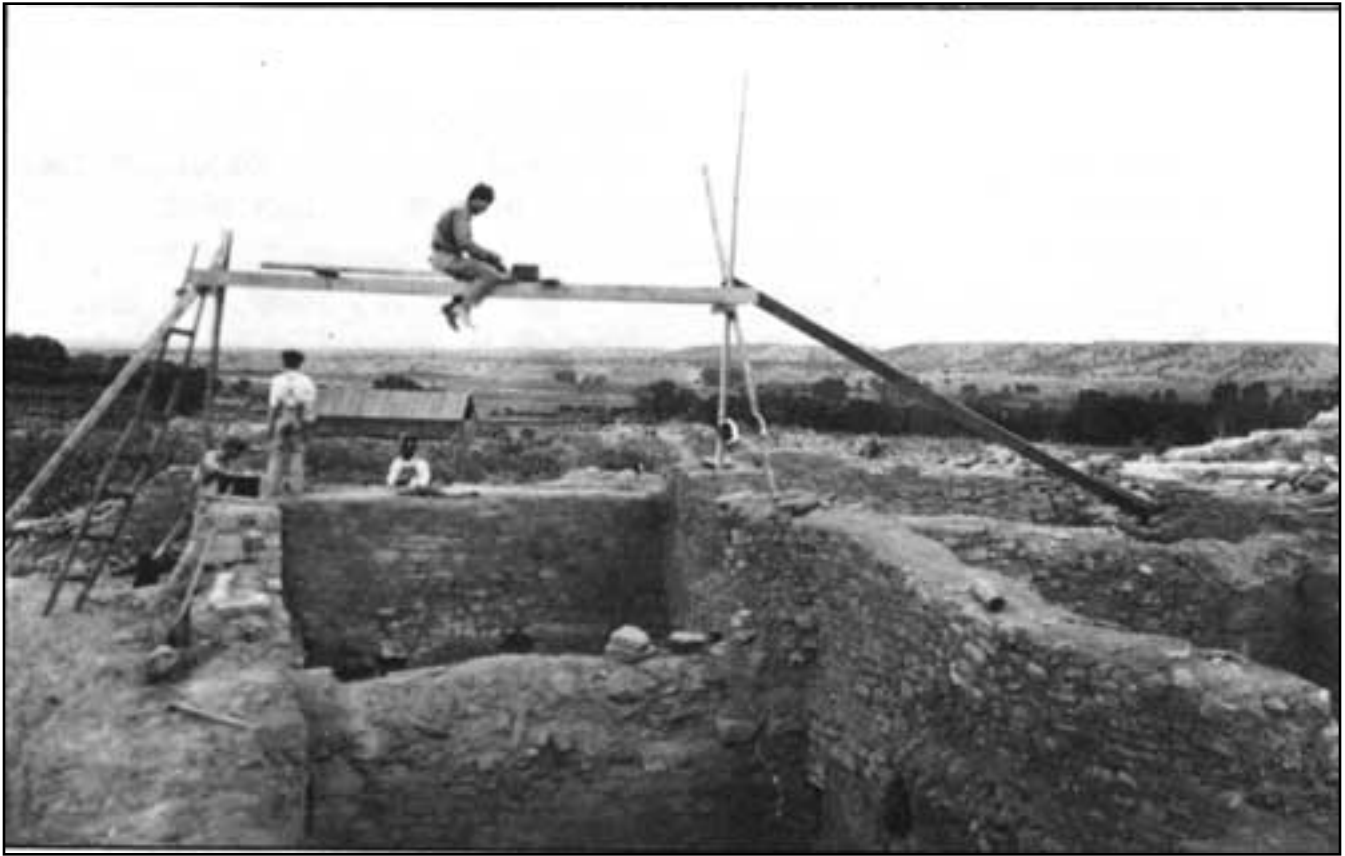
Figure 3.7. Morris on an elevated scaffold photographing the ruin. (Courtesy University of Colorado Museum).

In order to photograph the lower portions of the East Wing rooms, Morris had to sit astraddle the crossbeam of a flimsy, high-legged sawhorse placed over the excavated shafts and point his camera straight down (see Figure 3.7).

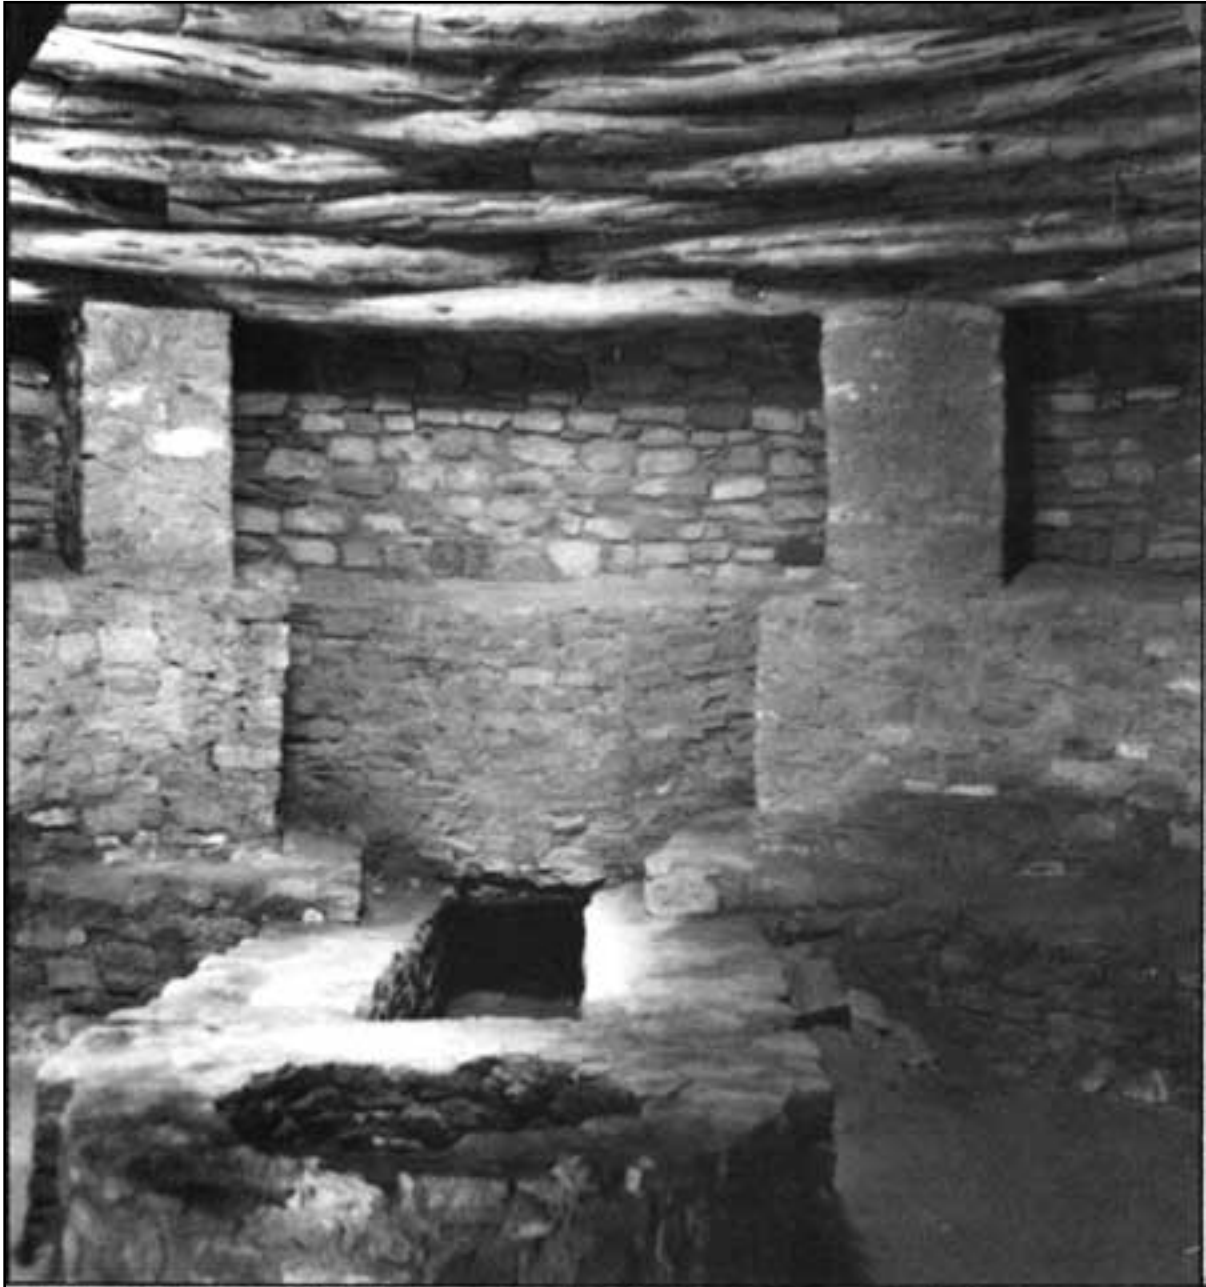
Figure 3.12. Interior of Kiva E, showing reconstructed cribbed log roof.

ordered a new cribbed-log roof, again based on that in Peabody House at Mesa Verde (see Figure 3.12). [29] Unlike the ground-level roof on Kiva B, this one was elevated above the surface of the court. That was because an aboriginal retaining wall at least seven feet high upon which the roof structure rested encircled the kiva. The reason for the roof style was that Morris believed a Mesa Verde structure was superimposed over an earlier Chaco kiva in the same location. All that remained of the lower kiva was the foundation stones. Recovered artifacts discarded on the floor of the upper kiva were four bone awls, two stone pendants, one obsidian projectile point, and one piece of quartzite.

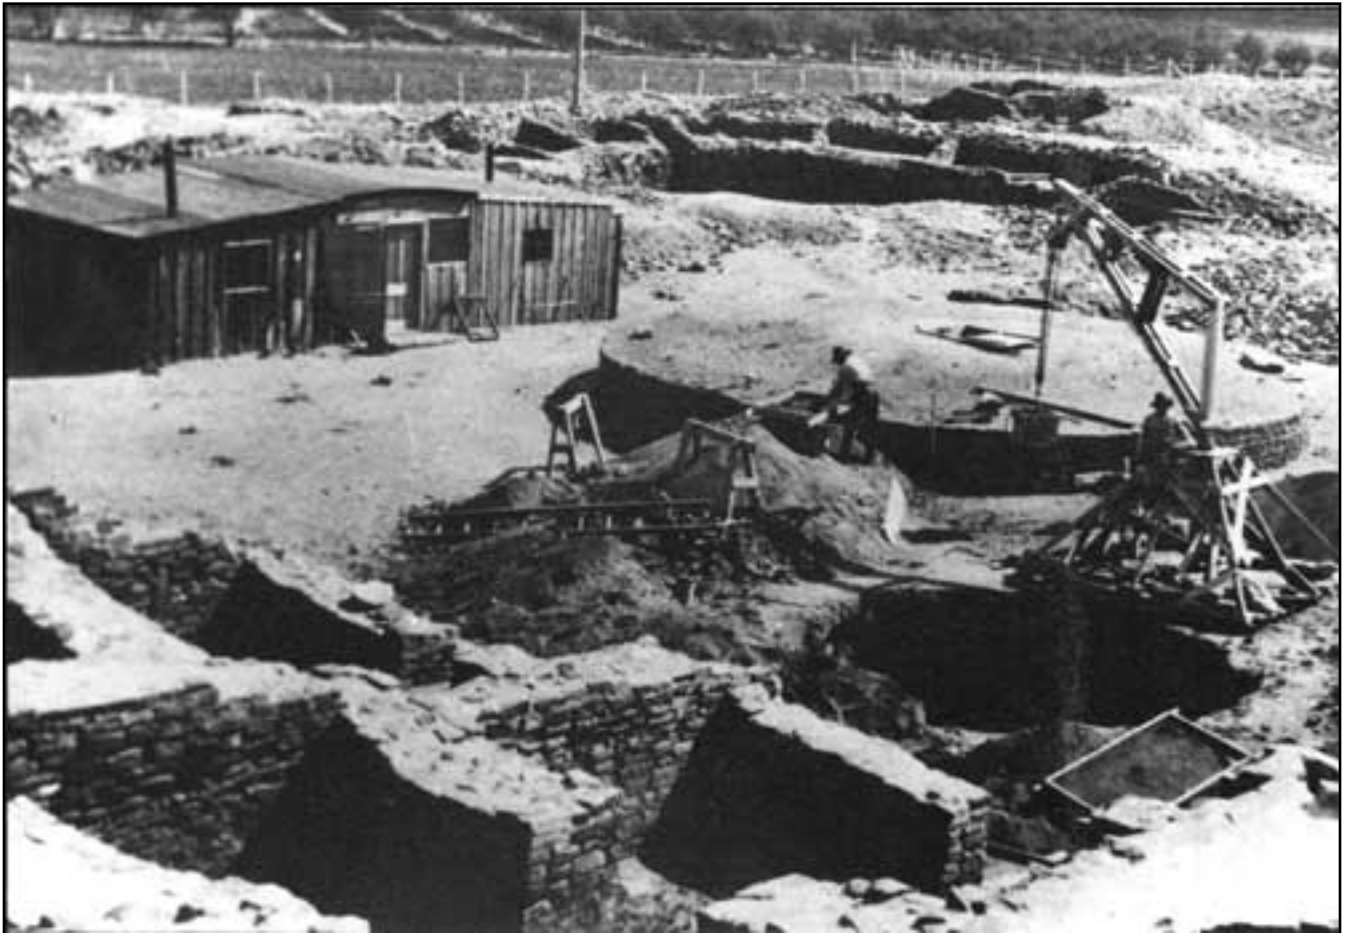
Figure 3.13. Overview of the West Ruin in 1918 showing roofed Kiva E, Kiva I being cleared with hoist and bucket, storage shed, and capped walls.

The next phase of the season's work entailed further clearing of the major room block of the East Wing. Work there was slowed by the physical exertions required to mine room shafts from the top of the mound down to lowest room floors and hoist out the debris (see Figure 3.13). Each room was filled with tangled masses of wooden ceiling elements, collapsed walls, drifts of household dust and windblown

sand, and some deep strata of consolidated refuse that reached to the mound surface. The workers dumped buckets of spoil dirt into wheelbarrows, outside of walls, or directly into large, flat-bedded farm wagons, which carted the loads to an embankment of an abandoned river channel along the east side of Abrams's farm. Several floor boards of the wagon bed were removable so that contents could pour out. [30]

Arriving in late June, Hyde and his wife set up housekeeping in a large, white, walled tent placed in the lee of the unexcavated West Wing. Meanwhile, Morris moved into a newly erected frame shed east of the courtyard Kiva E (see [Figure 3.13](#)). This structure was to provide storage and office space as well as temporary living quarters for the field director.

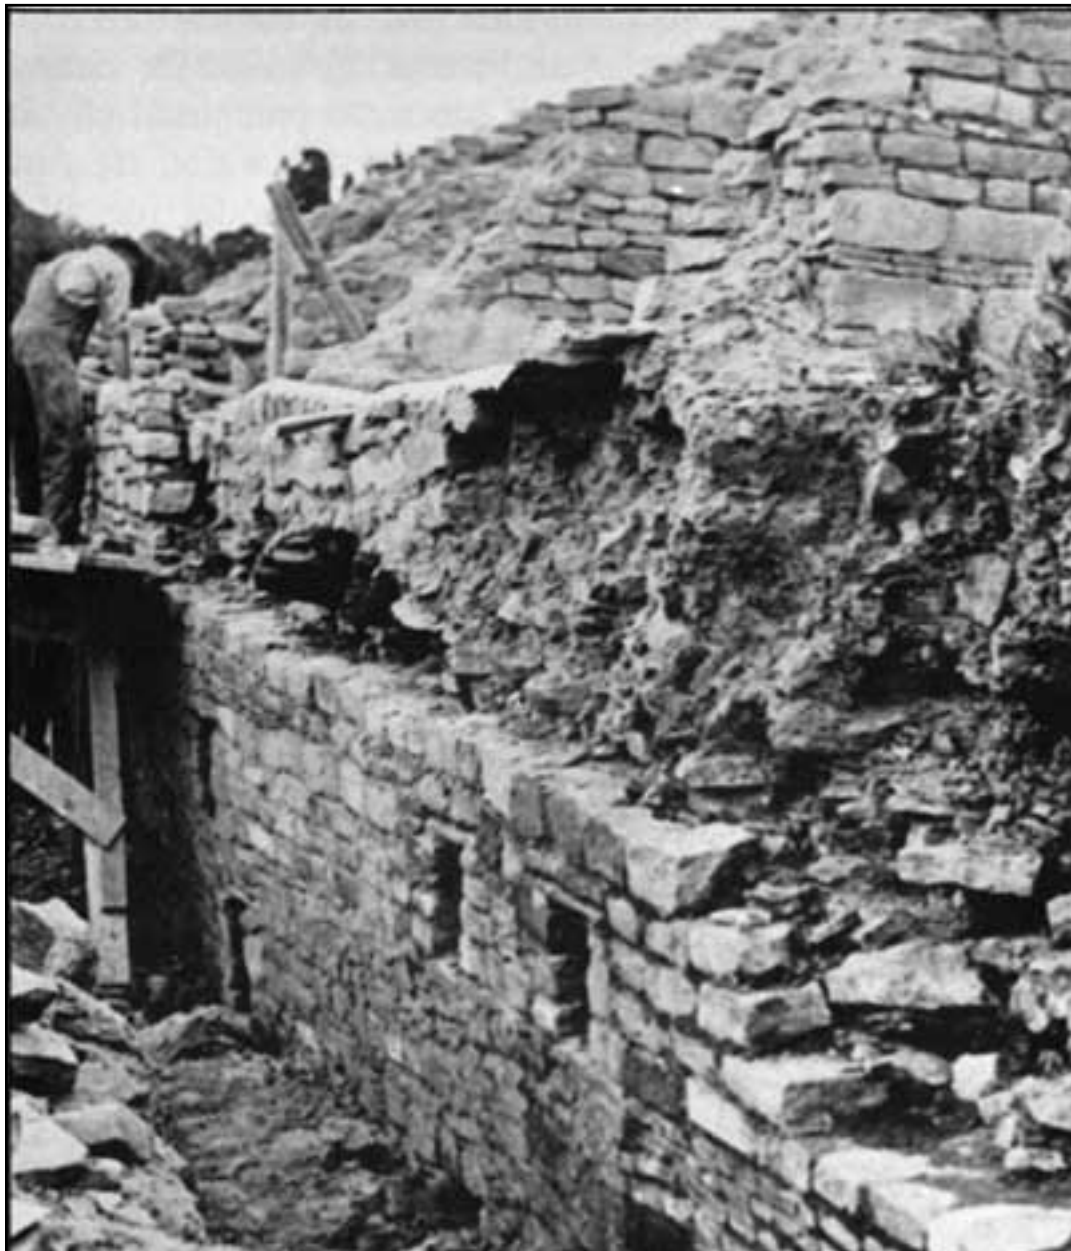
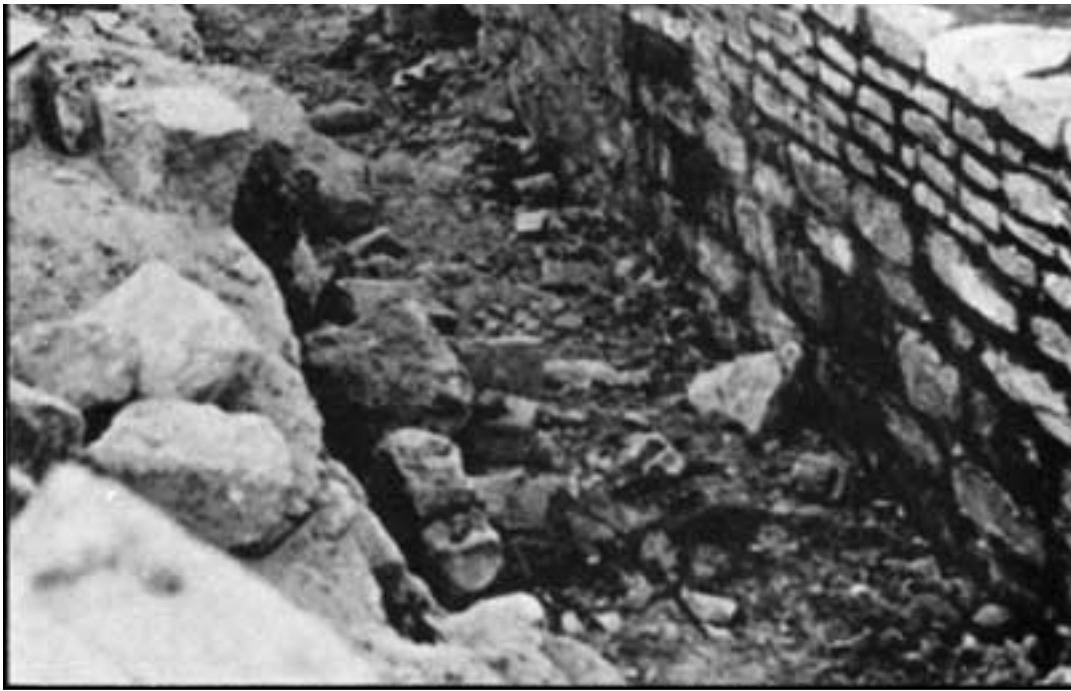
Figure 7.7. Resetting exterior wall of North Wing, 1934. Rubble core and shaped sandstone veneer evident.

Public Works Administration repairs concentrated on the northwest part of the village. The outer north wall was in such deplorable shape that water worked its way into rooms used as a museum, dampening lower stones and dirt floors. Exterior veneer loosened from the wall core or fell. As a flood control measure, workers scraped earth and debris well back from this corner and then hauled it away. They removed the facing stones for 117 feet of the north facade from the northwest corner, working vertically from a height of nine feet down to the foundation (see Figure 7.7). The stones were reset in cement. [56] The exterior base of the wall remained six to eight feet above the level of floors of first-story rooms inside the building. The men installed a drain system with vitrified tile to the north of the ruin after auger holes confirmed the soil's heavy moisture content at about a depth of 12 feet. [57] The drain ceased to function properly and was abandoned after several months.

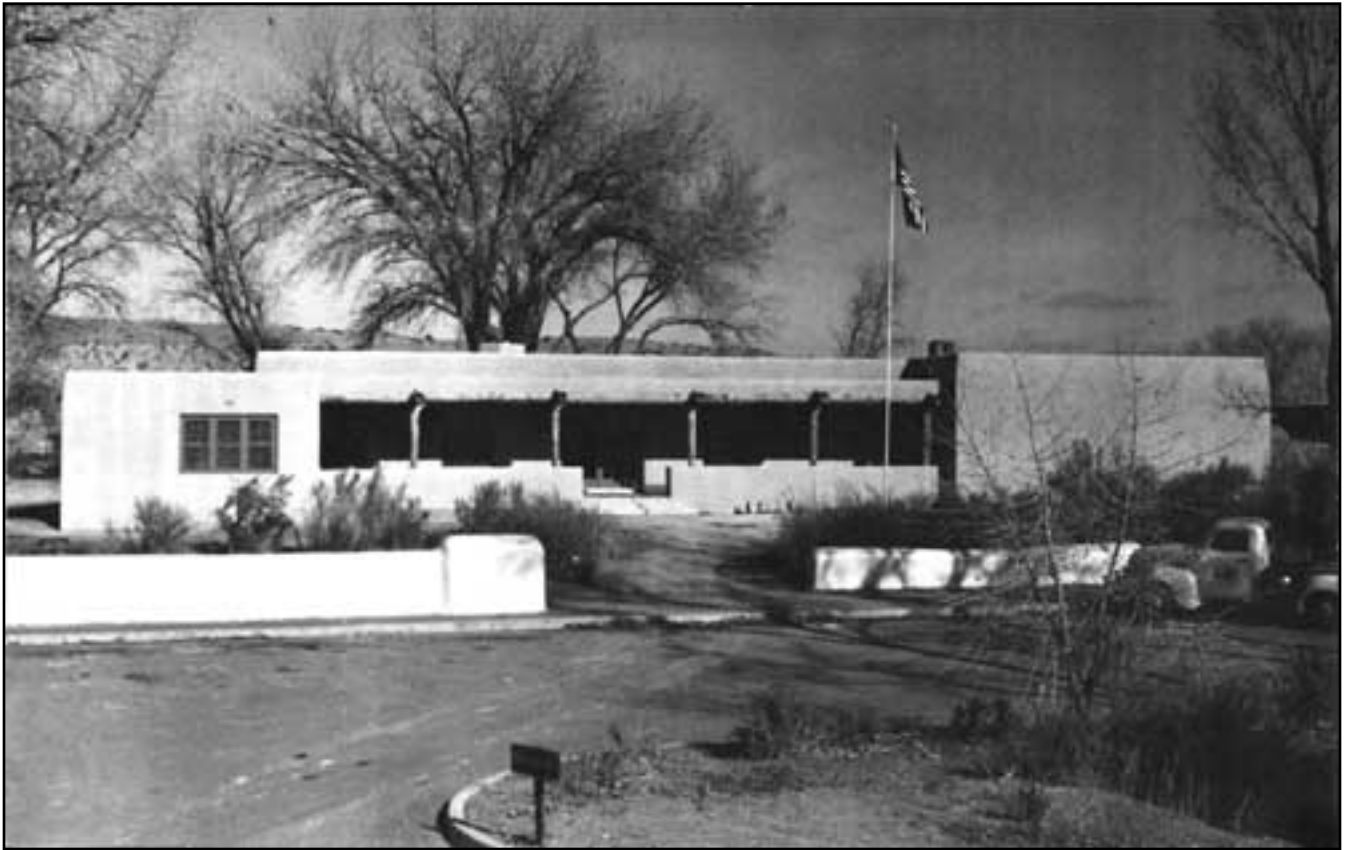
Figure 10.3. Visitor Center, Aztec Ruins National Monument, 1959. Museum addition at right center; rest rooms at left center. Original American Museum field station, or Morris house, is at center rear left; lobby constructed in 1934 is at center rear right.

A MISSION 66 project once again remodeled the old American Museum field station to provide more breathing space for the daily administrative business of the monument. [50] Doubtless, Morris would have been amused at the cyclic changes imposed on his structure, and doubtless, he would have been pleased to see a memorial plaque dedicated to him in July 1957 placed in a prominent place there. [51] Walls were rearranged to create a reception and information area with a sales counter in the two front rooms of the original house. Offices were made out of the rear rooms and the former museum. West windows and the south T-shaped doorway of the west room were reopened after having been sealed during the 1935-1958 museum interlude. The rear, or north, T-shaped doorway through which tours entered the museum gave access into a new work room added to the northwest corner. This room opened to a covered porch across the rear of the building. Two rest rooms and a plumbing alley were put on the southwest front corner, from where they were connected to Aztec city water and sewer lines (see Figures 10.1 and 10.3). [52]

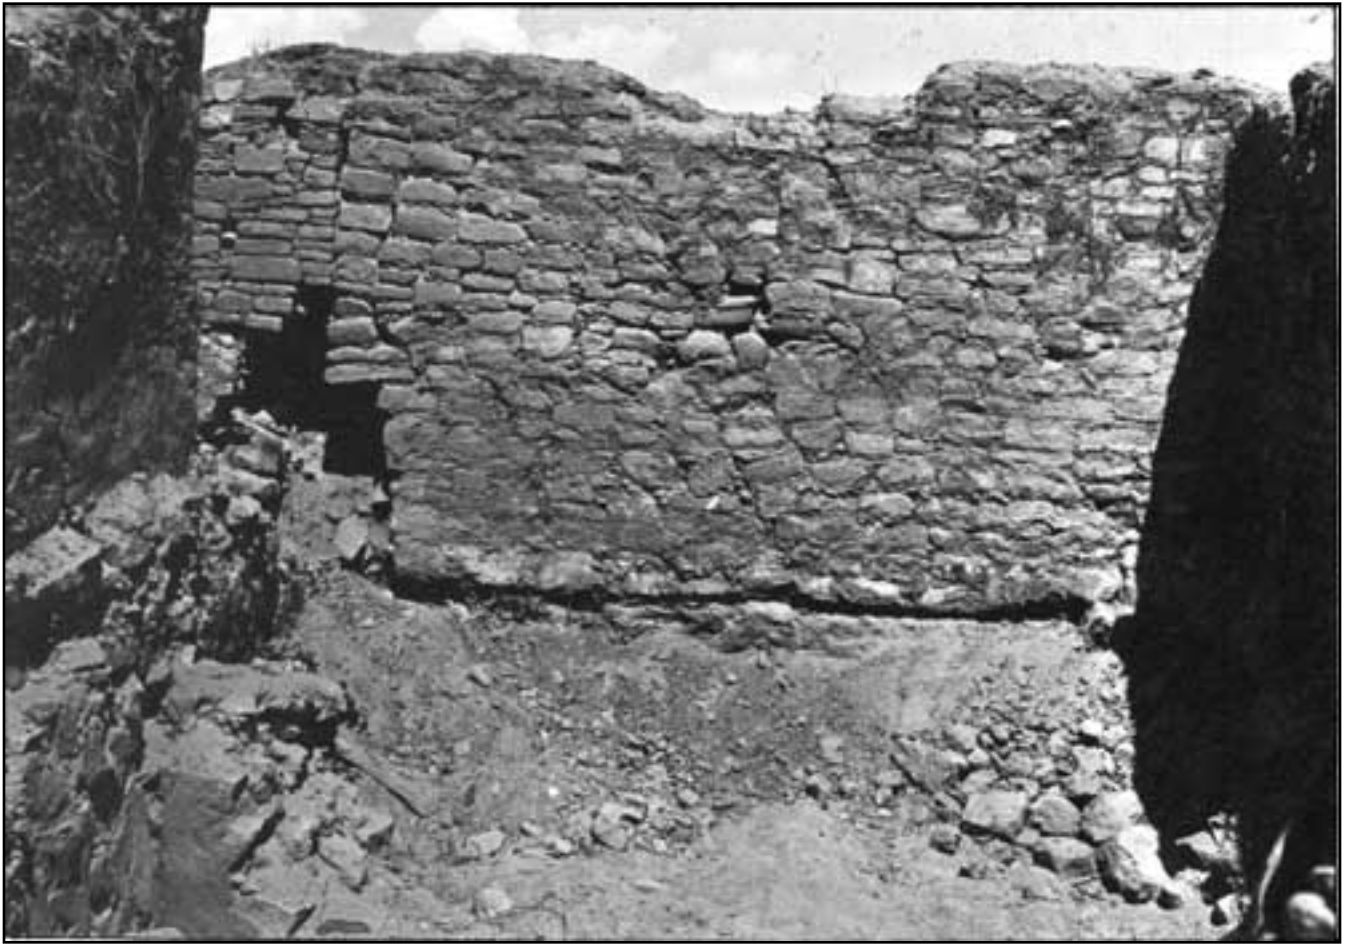
Figure 3.14. Mesa Verde-style wall built on top of Chaco debris in unidentified West Ruin room. (Courtesy American Museum of Natural History).

Applying the Nelson stratigraphic principles, Morris concluded that Chacoans had come and gone before Mesa Verdians moved in. The interval between the two occupations must have been substantial in order for the large volume of trash to have accumulated. With only four rooms thus far studied with demonstrable layered deposits of what appeared to be Chacoan material below Mesa Verde material, Morris admitted the evidence remained inconclusive (see Figure 3.14).

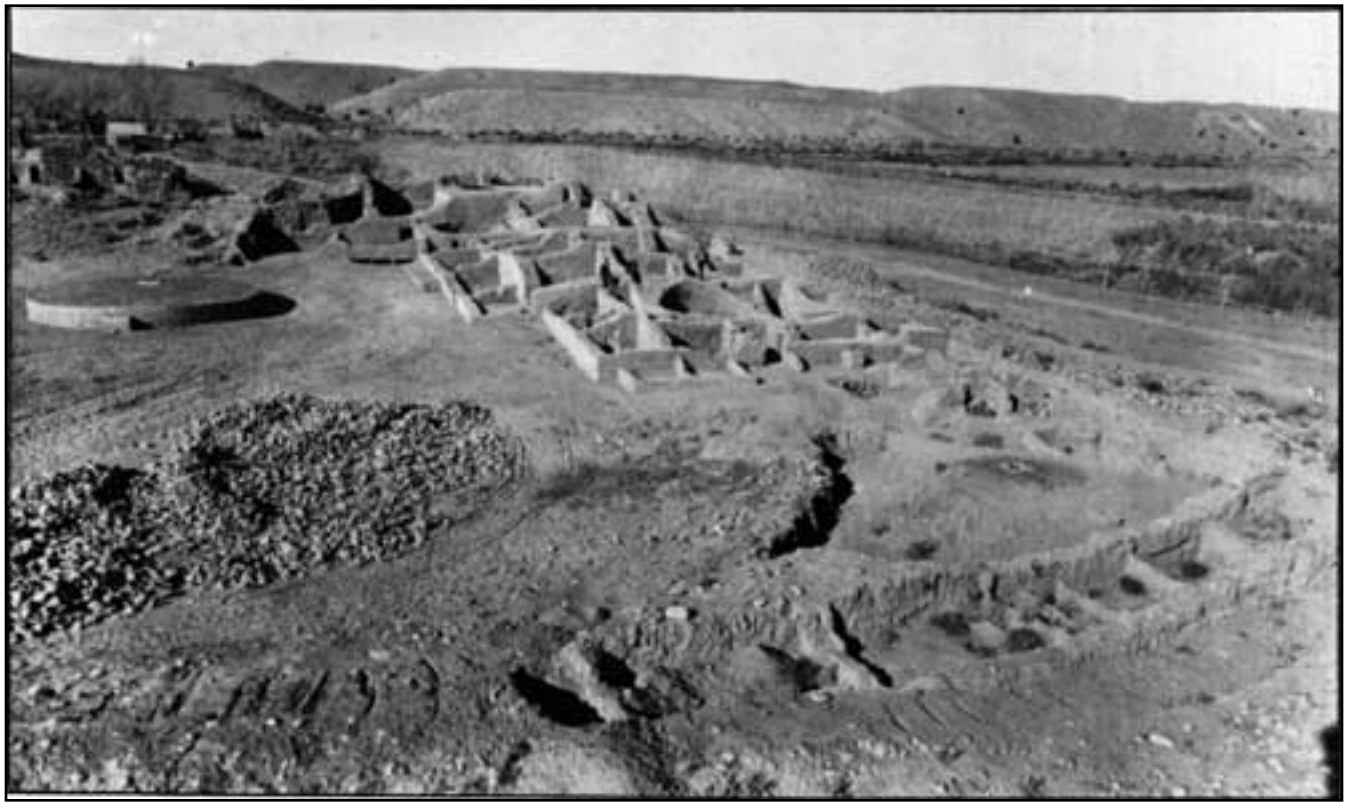
Figure 3.15. Excavated rooms and two roofed kivas of the West Ruin at the end of the field season of 1917.

At the end of the season of 1917, the crew had opened 30 more rooms of the East Wing (Rooms 31 through 58), three rooms of the North Wing (Rooms 99, 112/122, 113/123), and six kivas (see Figures [3.11](#) and 3.15). They had repaired the most unstable walls. Less than half of the site had been explored. Wissler had hoped for greater progress, but difficult excavation made for slow going. [37] Four kivas (Kivas D, E, F, and H) had Mesa Verde characteristics, one (Kiva G) was Chacoan, and the style of one (backfilled Kiva I) is unknown. Its four-pilaster plan was unusual. Kiva E exhibited a Mesa Verde chamber placed over a lower Chaco chamber.

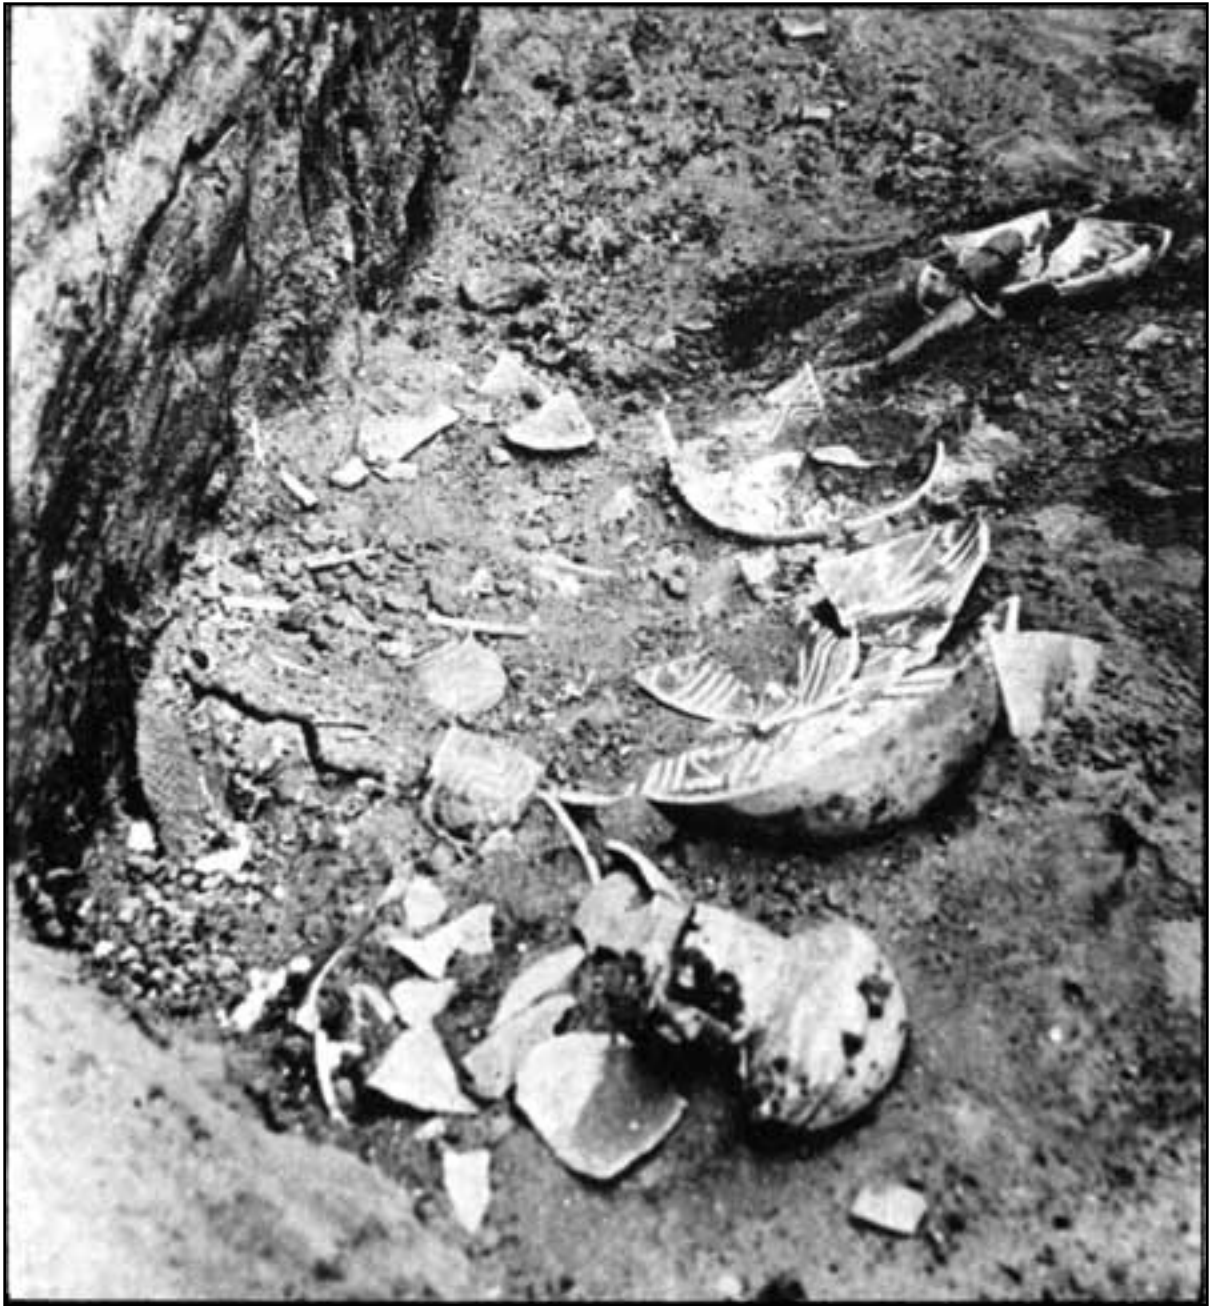
Figure 3.16. Room fill contained many shattered ceramic vessels.

By far the most abundant category of artifacts was pottery (see Figures 3.16-3.19). [38] Presumably, it was made of local clays. At the time of the Aztec project, there had been none of the detailed ceramic studies destined to become central to Southwestern archeology. Even so, Morris had sufficient years of experience with the Animas valley pottery that he felt confident in identifications. He recognized two stylistic schools among the decorated whitewares, or what he called "two-color ware." Combinations of design format and elements, pigment, vessel shape, wall and rim treatments, and degree of excellence in manufacture distinguished Chacoan pottery from Mesa Verdian pottery. By Morris's calculations, a mere five percent of the whiteware ceramic sample was Chacoan or Chaco-esque. Its presence precluded other considerations, such as secondary deposition. Although it now would be considered questionable interpretation, Morris counted any level containing Chaco pottery as a Chaco-related level. He regarded the remaining 95 percent of the pottery from Aztec Ruin as being of the Mesa Verde tradition. He used descriptive terms, such as archaic, nascent, or degenerate, to express some of the stylistic variations of the decorated types through time. Morris felt that he could suggest a relative temporal outline of the site's utilization based on pottery recovered and, through extension of the data, could supply a working chronology for the entire San Juan Basin. [39]

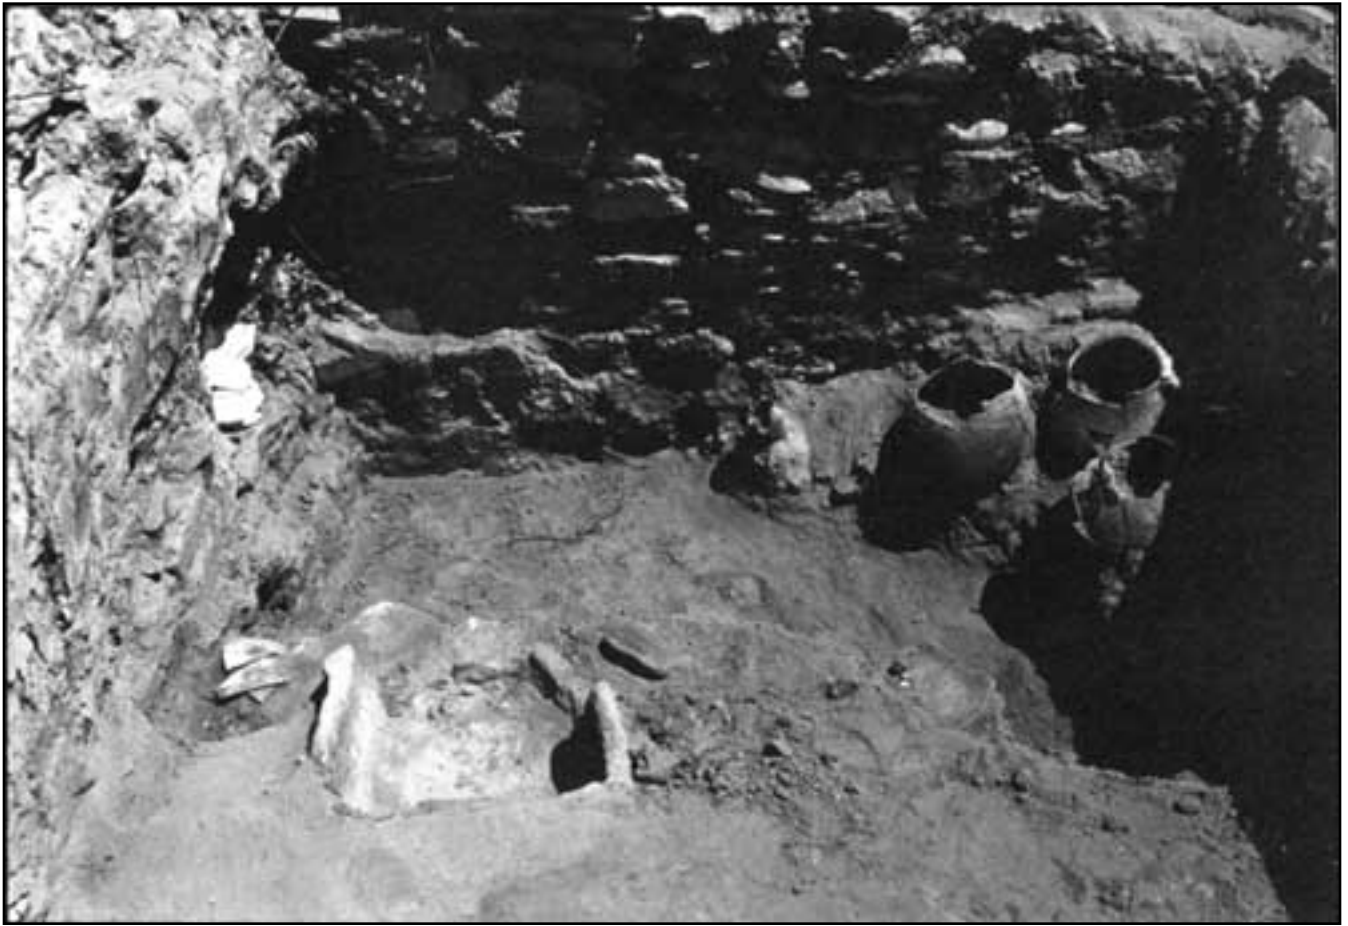
Figure 3.18. Three corrugated jars and a stone-lined mealing bin sunk into a room floor.

Utilitarian pottery was abundant in the debris of the West Ruin. It was a greyware (Morris's "coil ware"), which was both plain-surfaced and corrugated. Large corrugated jars commonly were encountered beneath floors, where they had been sunk to their orifices to serve as storage cists.

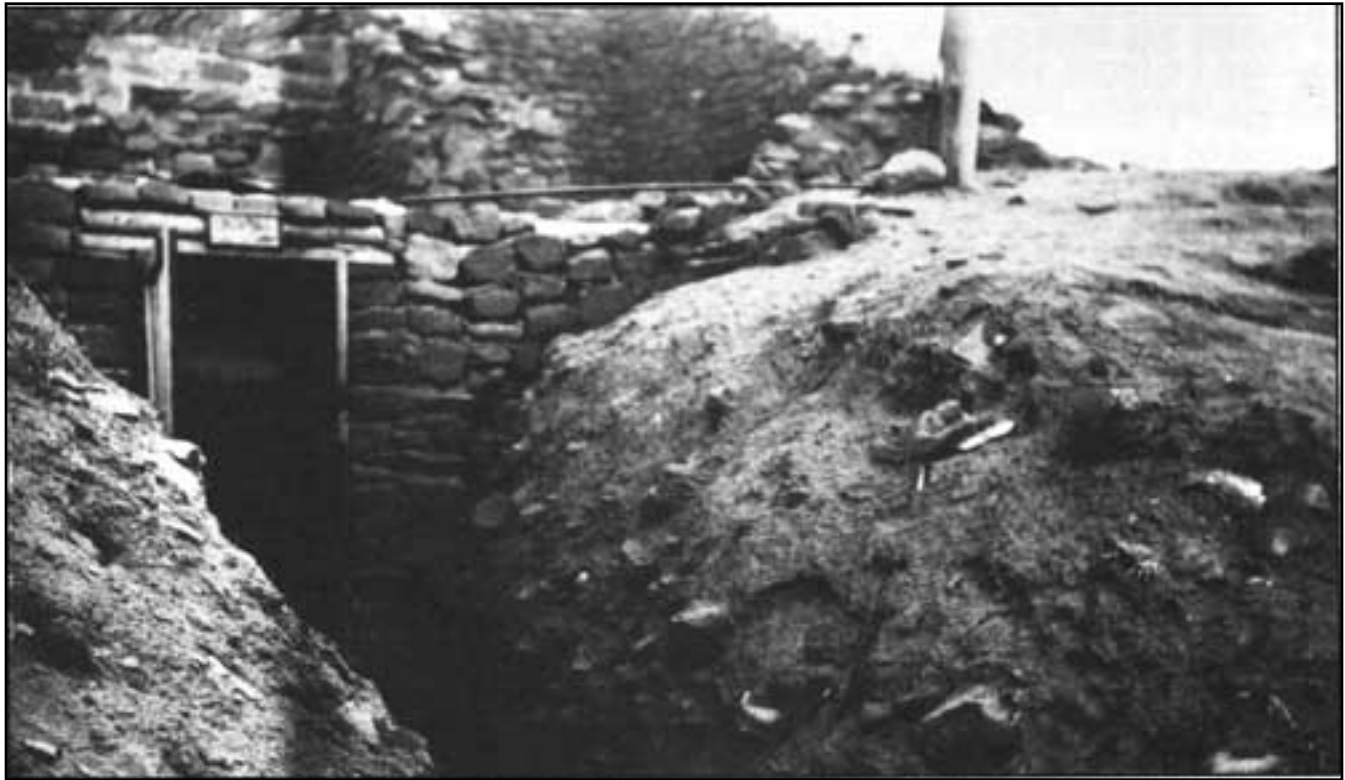
Figure 6.5. West exit from roofed rooms of North Wing used from 1927 through 1937 as the second museum at Aztec Ruin.

east to west through seven rooms by shaping the irregular settler breaches into doorways (see Figure 6.4). [85] Locked wooden doors were put at each end of this passage (see Figure 6.5). [86] Light from kerosene lanterns provided artificial illumination until the unroofed quarters along the southern side of the museum rooms were cleared in order that natural daylight could pour into the darkened recesses. [87] Electricity was extended to the monument in 1928. A planned wooden plank floor to cover the packed earth original never was laid. Winter visitation was expected to be uncomfortable, consequently brief, since the interior stone chambers retained numbing cold and dampness.

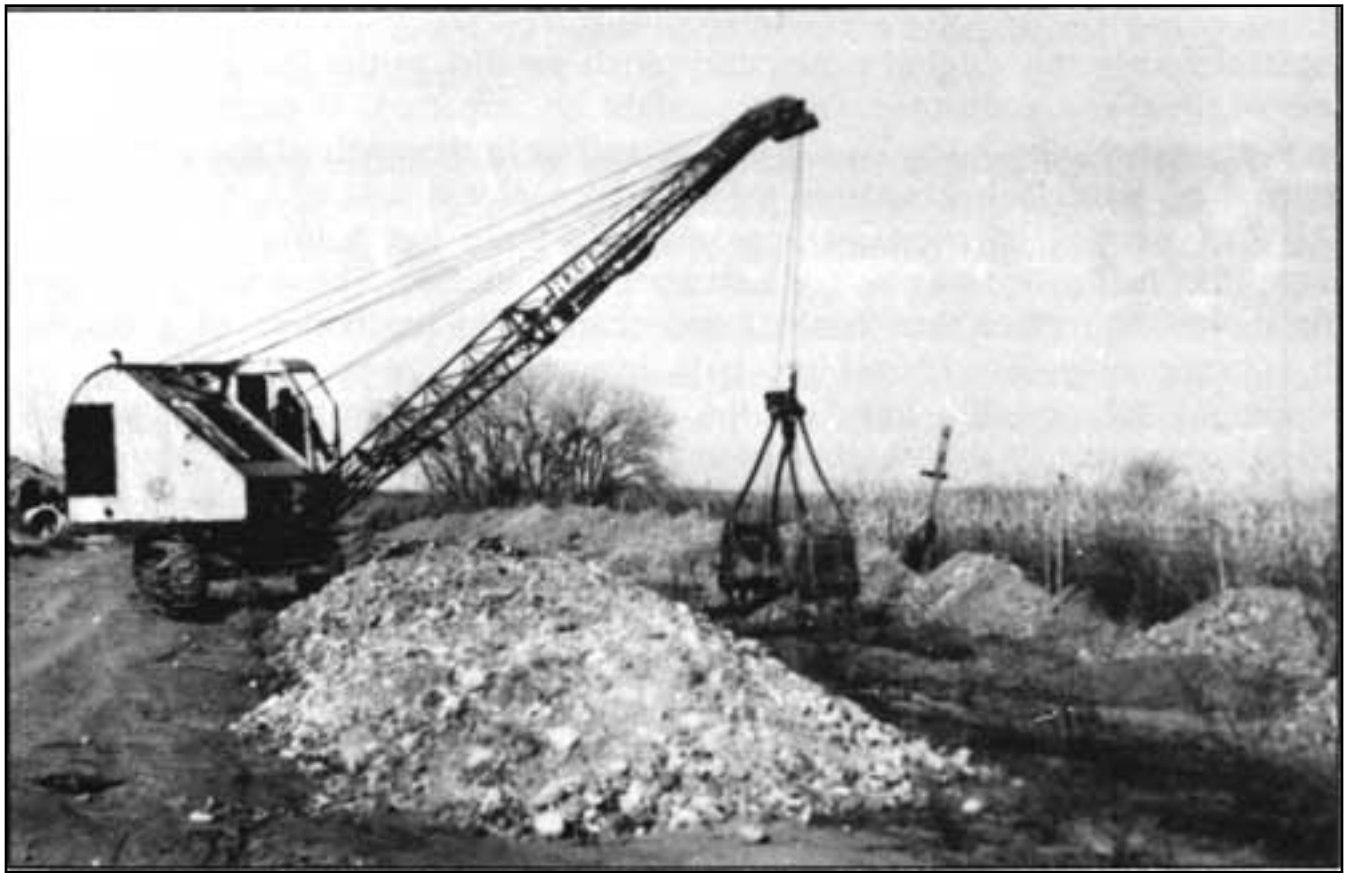
Figure 12.5. Dragline digging deep north drainage trench, 1946.

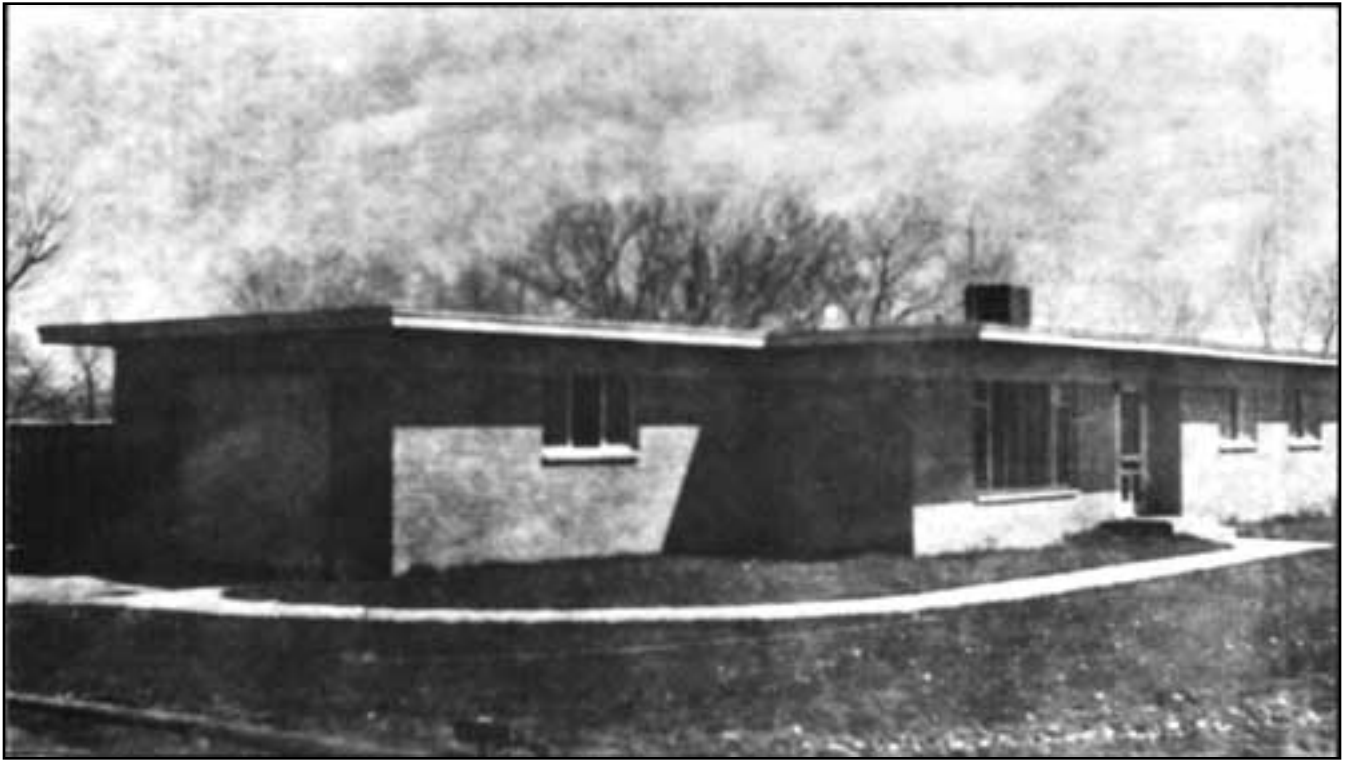
Figure 10.8. Building 9, 1958.

The first of the new houses (building 9), a three-bedroom cement block structure, was completed in 1958 at a cost of \$24,951.34. It was placed to the east of the utility court (see Figure 10.8). This brought to four the number of service and domestic buildings in the southeastern part of the monument. The house was scarcely done before it was realized that a mistake had been made in the selection of its location. The southward slope of the land and natural drainage channels led directly to the house site. Surveyors established the elevation at the northeast corner of the West Ruin at 5,639.5 feet above sea level. At building 8, it was 5,622 feet above sea level, or a drop of 17 1/2 feet from approximately the north boundary of the monument to the south boundary. [64] The high water table and generally unstable bentonite subsoil added to the problems. Because of little drainage, water to a depth of nine to 18 inches rose beneath floors after rains, walls sweated, and the sewer system backed up. Maintenance workers made repeated attempts to pump water from under the new house, to install dry barrels, and to remove sewage from the septic tank. [65] Finally in August 1961, all the residences were connected to

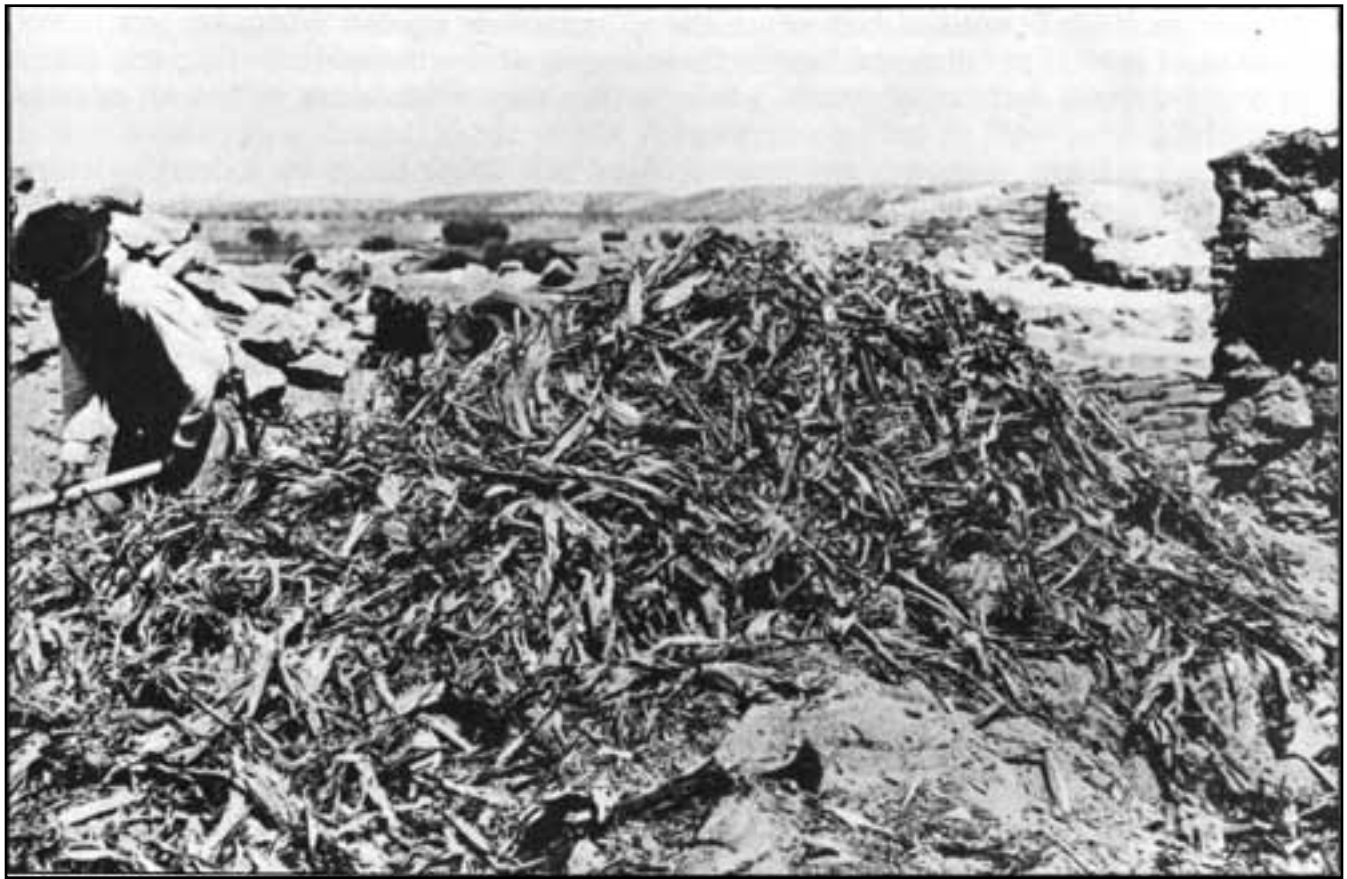
Figure 3.20. A pile of cornhusks found in an unidentified East Wing room.

One of the most significant contributions to a fuller knowledge of Anasazi material culture was an incredible assortment of perishable goods seldom reclaimed from sites situated in the open. Ten to 15 feet of vegetable substance filled some rooms (see Figure 3.20). [45] The collapse of construction rubble and a very dry environment had served to cap and preserve remains of clothing. In this general category were cotton textile fragments of three different weaves, some bearing red bands; leather scraps, thongs, and bags; feather cloth on a yucca cordage base; sandals of two varieties in sizes ranging from those suitable for children to those for adults; and leather moccasins for an infant. Among woven articles also were rush bags and others formed of cornhusks stuffed into a yucca cordage backing; sturdy coiled and plaited baskets and plaques; headbands or tumplines of woven yucca fiber; braided fiber rings of several sizes; twisted and braided cordage; and pot rests of cedar bark, cornhusks, grass, twigs, or plaited yucca. Wooden artifacts included reed arrows, some with wood foreshafts, feather binding, and plaited bands; digging sticks; prayer sticks with the end occasionally flattened into snake heads; hoops for undetermined uses; painted bark; shaped wooden slabs and cylinders; and flower-like ceremonial objects. Grass ropes; rush and willow matting; reed-stem cigarettes; yucca needles; unfired clay plugs used to stopper ceramic jars; macaw feathers and skeletons from tropical Mexico; deer or antelope hoof rattles hung on yucca cord; corn-cob darts; and yucca or grass-stem hair brushes are the general miscellany left from daily life.
