Aztec Ruins National Monument Administrative History of an Archeological Preserve

Robert H. Lister and Florence C. Lister

1990

National Park Service
Division of History
Southwest Cultural Resources Center
Santa Fe, New Mexico
Professional Papers No. 24

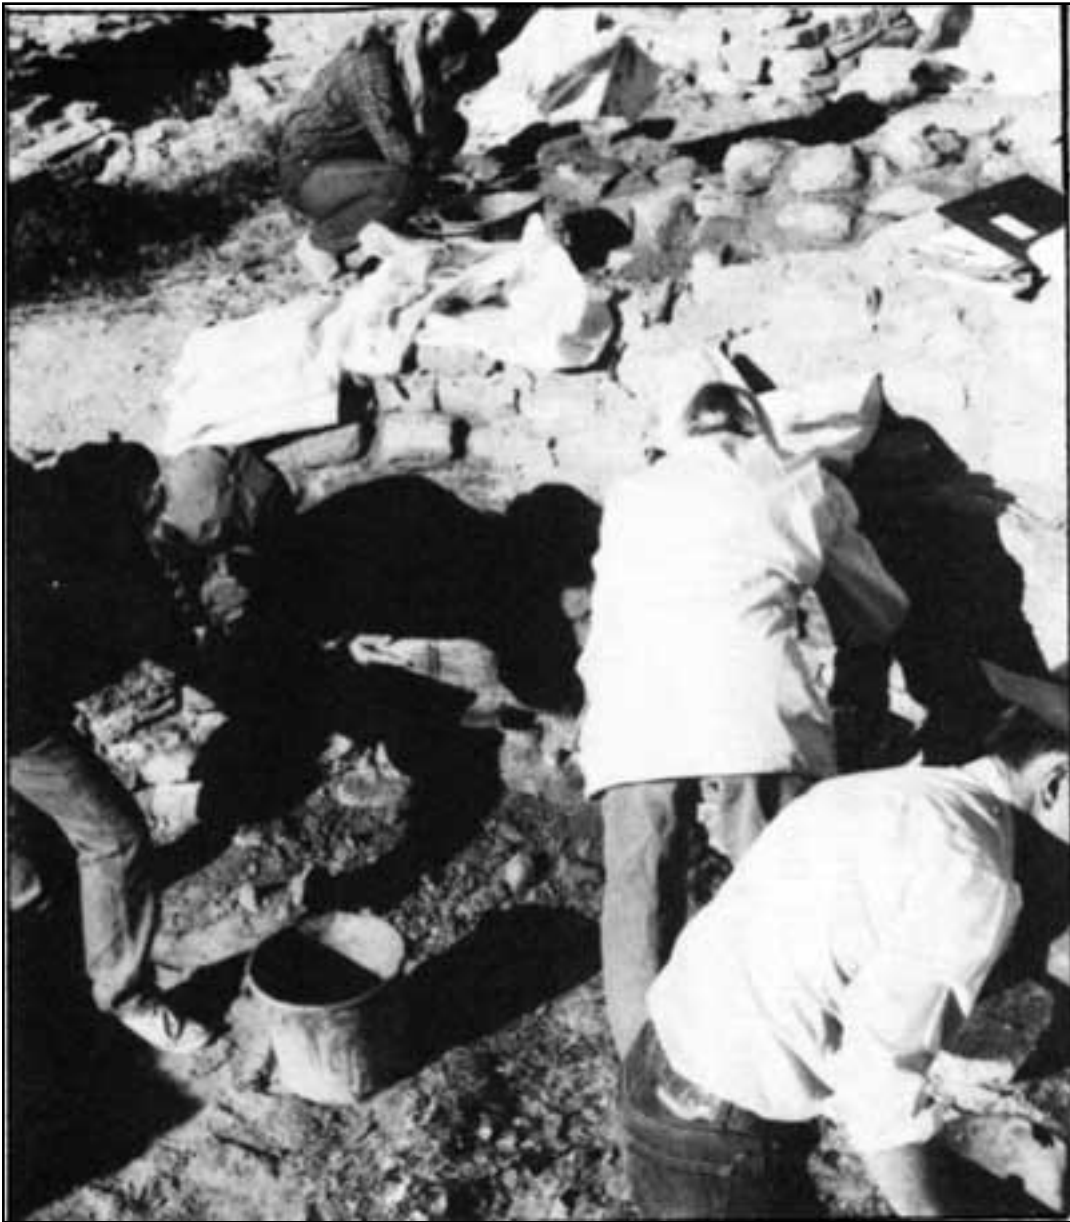
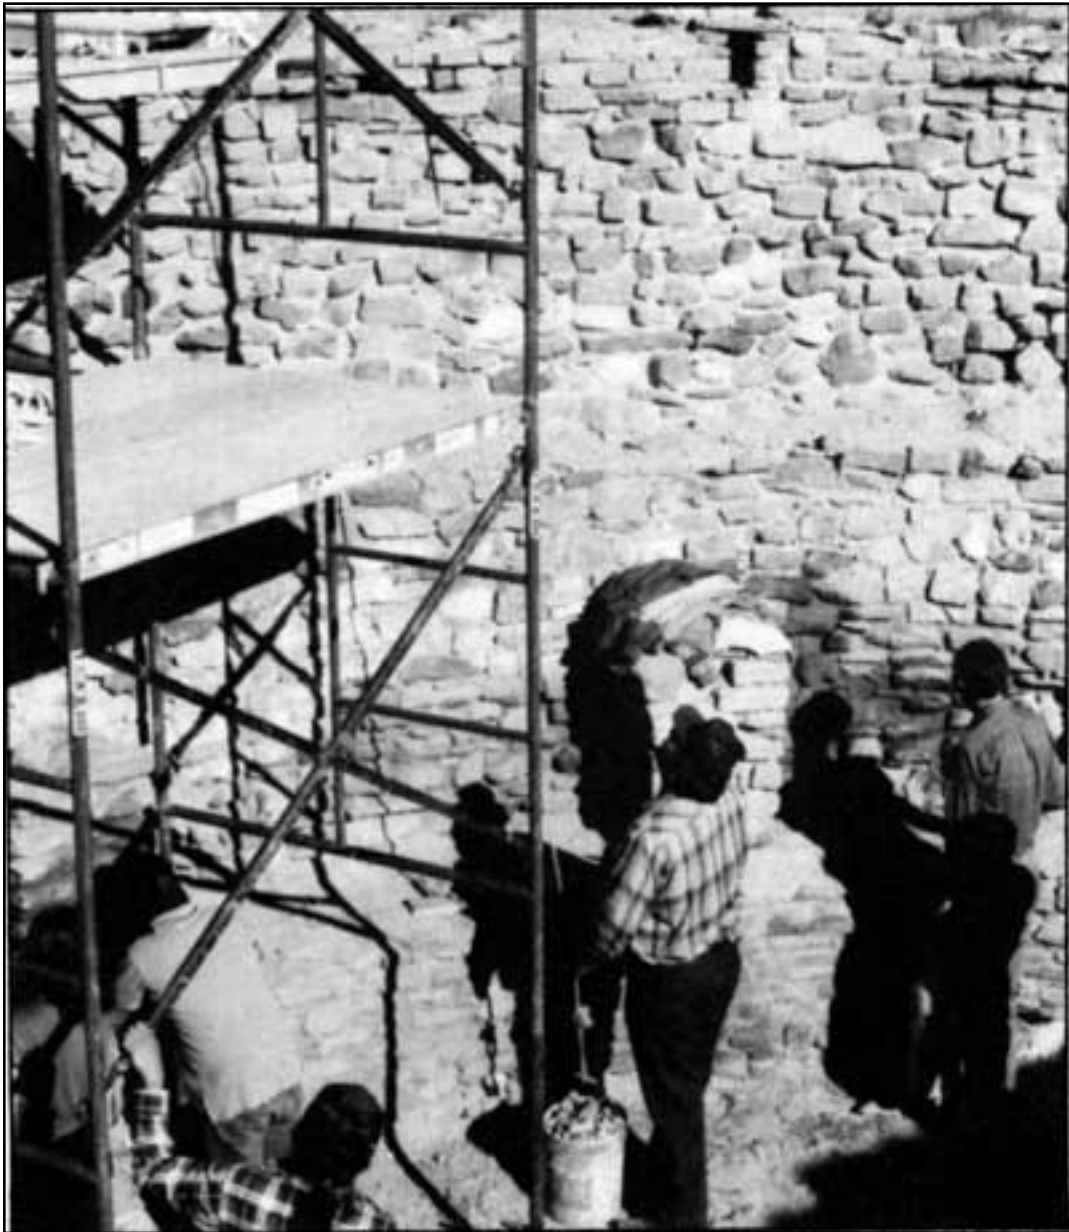
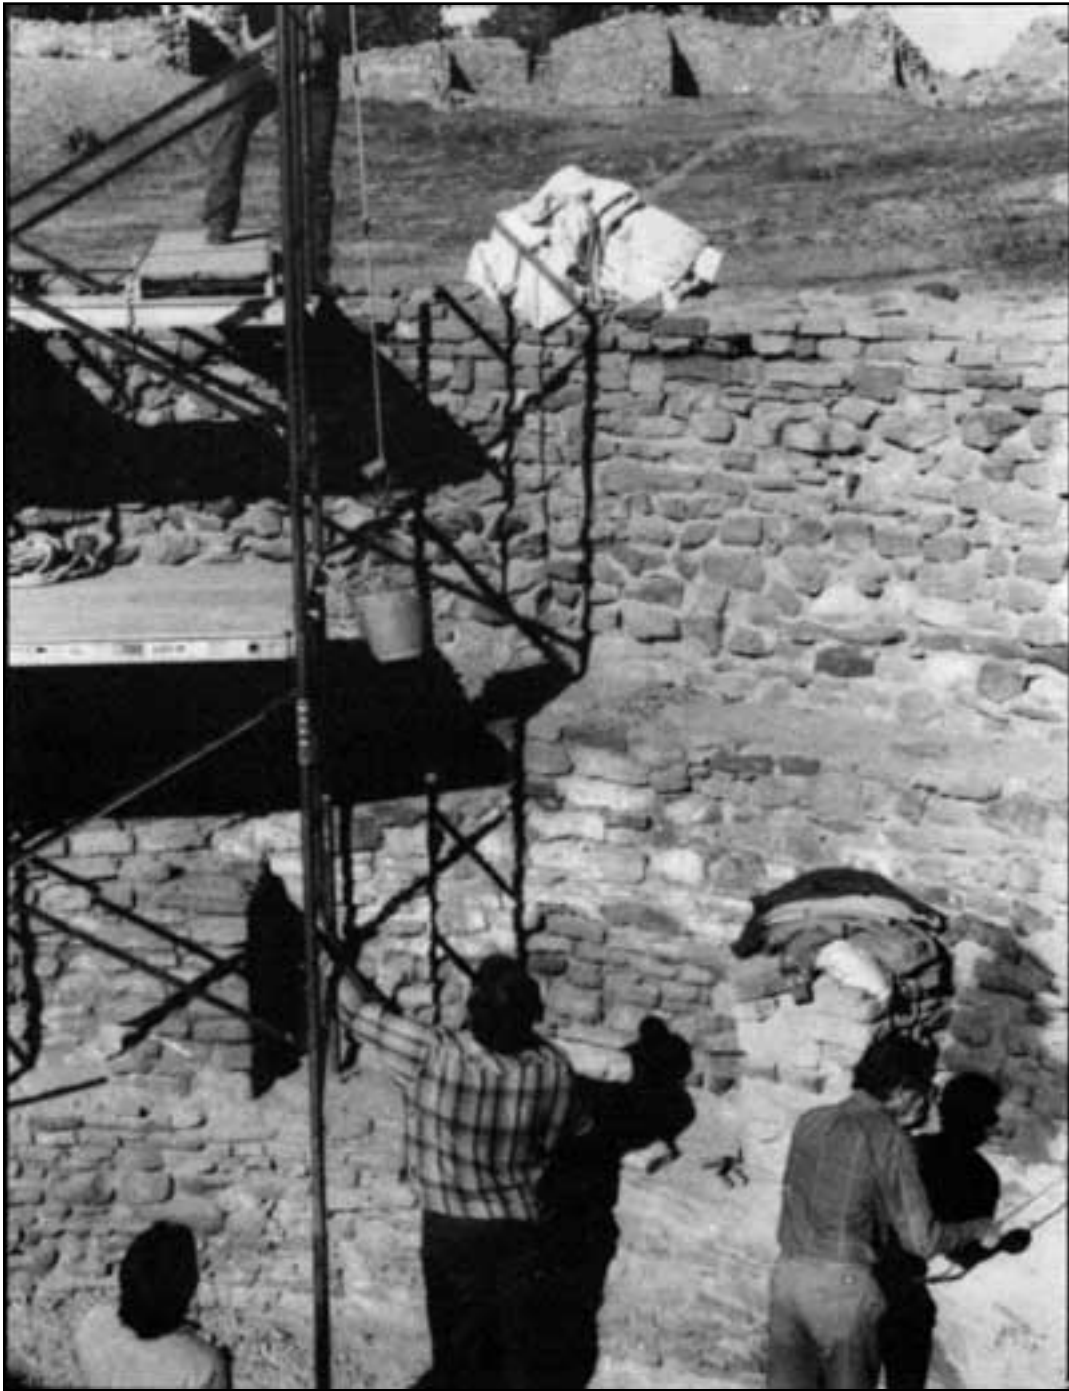
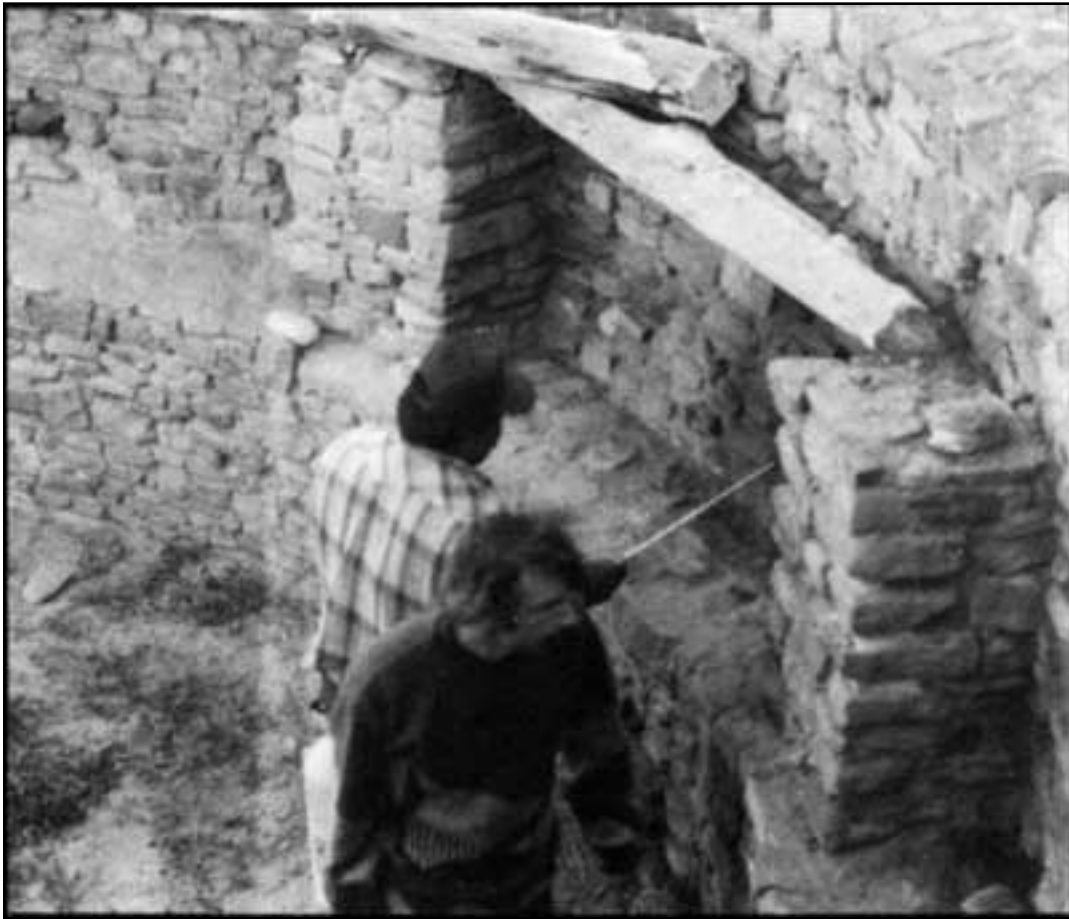
Figure 12.6. Routine maintenance stabilization at Aztec Ruins being done in connection with regional training exercises, May 1989.

Figure 12.7. Routine maintenance stabilization at Aztec Ruins being done in connection with regional training exercises, May 1989.

Figure 12.8. Routine maintenance stabilization at Aztec Ruins being done in connection with regional training exercises, May 1989.

Figure 12.9. Routine maintenance stabilization at Aztec Ruins being done in connection with regional training exercises, May 1989.

Meantime, in 1981, a permanent historic preservation position was added to the Aztec maintenance roster. A trained masonry worker, James D. Brown, was named to supervise the continual upkeep of the monument's Anasazi communities. Stabilization experts, exhibit specialists, and archeologists in the Southwest Cultural Resources Center, continued to monitor and evaluate the work performed at Aztec, to introduce new methods when applicable, and to take care of jobs beyond the capability of the local maintenance force. By 1983, Brown's crews were conducting routine annual maintenance of Aztec's vulnerable archeological remains. Each summer, based on a Scope of Work Plan usually formulated by the Southwest Cultural Resources Center, three to five experienced laborers work for six or seven months on cyclical and emergency stabilization designed to keep the ruins at status quo (see Figures 12.6-12.9). At times, the National Park Service crews are supplemented by young men and women enrolled in summer training programs, such as the Youth Conservation Corps, a federally funded plan, or the Summer Youth Employment Training Program, sponsored by the State of New Mexico.

Brown's tenure at Aztec is marked by still another new additive in preparing soil mortar for grouting, pointing, capping, and plastering original construction or repairing previously stabilized units. This is called Rhoplex, an acrylic polymer solution. Although the formula of sand, soils, water, and Rhoplex has been modified several times in seeking a fortified soil mortar that will meet preservation standards and endure through time, this combination of substances seems to be proving satisfactory. However, past experience shows that it is too soon to know whether Rhoplex will be the mortar additive of the future.

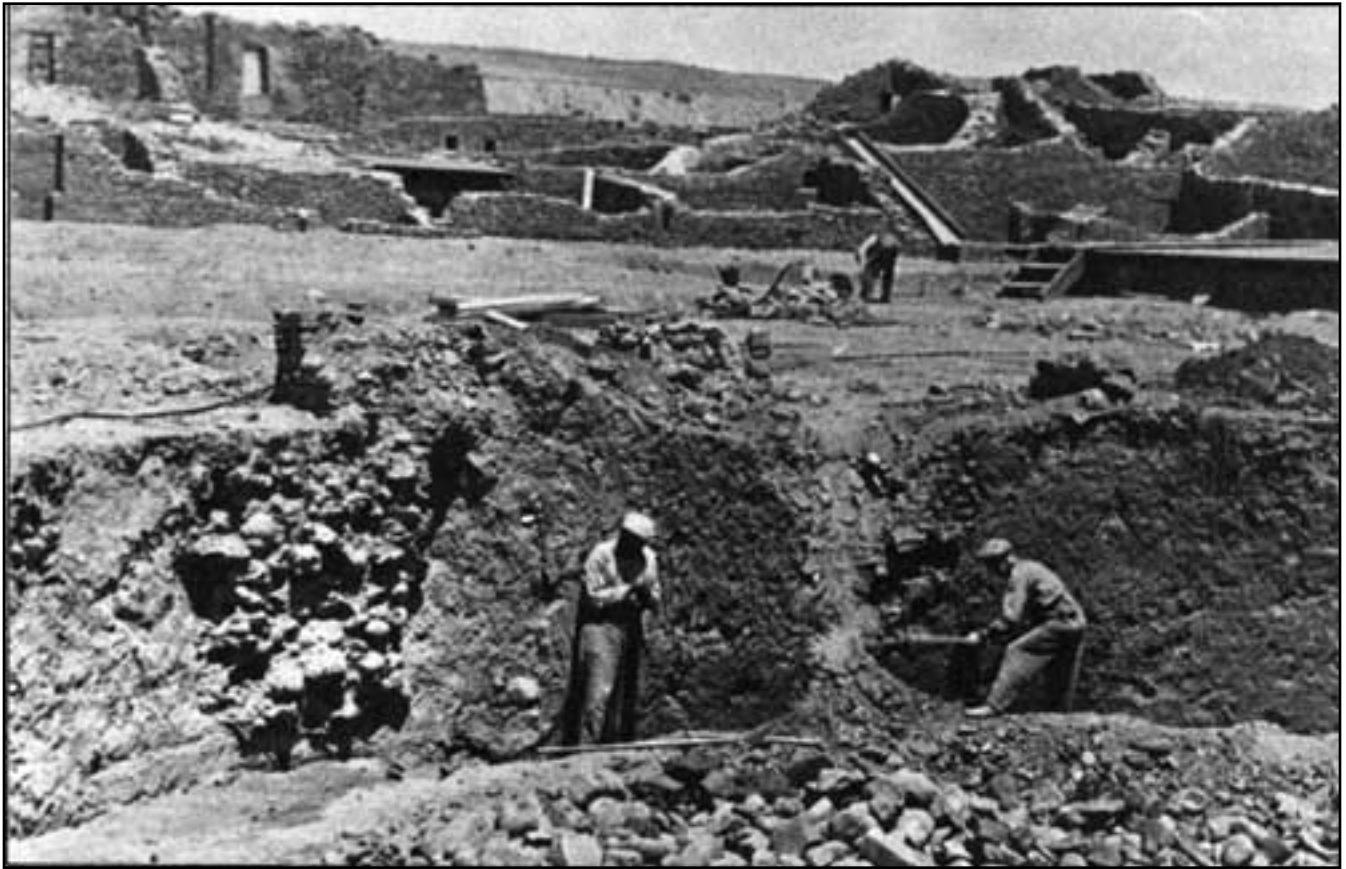
Figure 3.23. Excavation of the Great Kiva, 1921.

As soon as funds were available in February, work commenced on the Great Kiva (see Figure 3.23). Morris figured that excavation and repair of the structure would take \$600 from an annual appropriation of \$4,800. [90] Despite cold weather and partially frozen ground, he pushed his crew so that by the end of the month 10 ground-level rooms of a concentric tier of 15 arc-shaped rooms (Rooms 160 through 173) around the upper limit of the kiva were opened and about three-fourths of the subterranean kiva itself was bared. A month later, job completed, Morris already was at work on his report (see Figure 3.24). It was published that same year. [91] A personal race had been won.

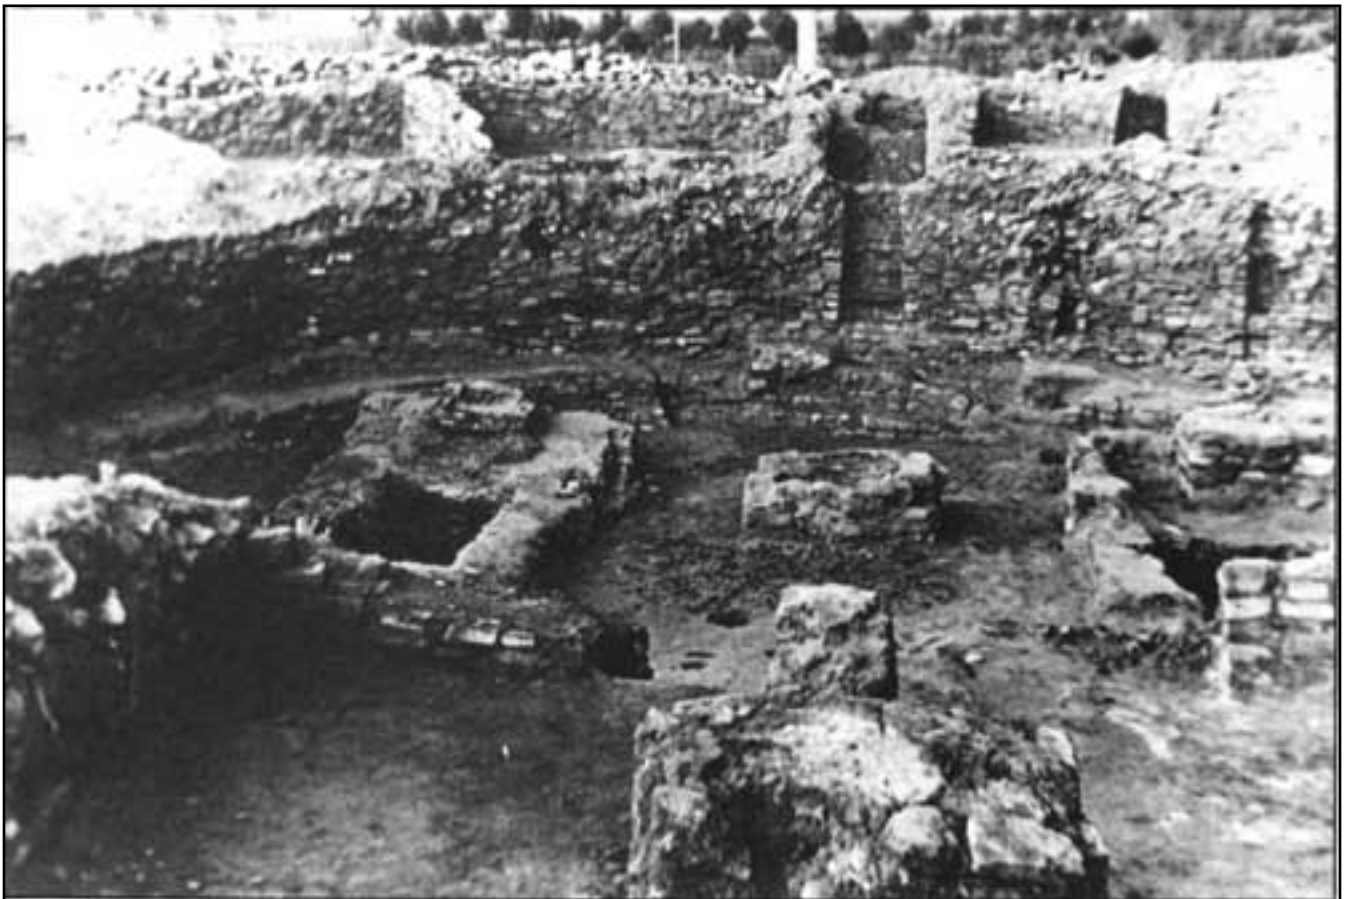
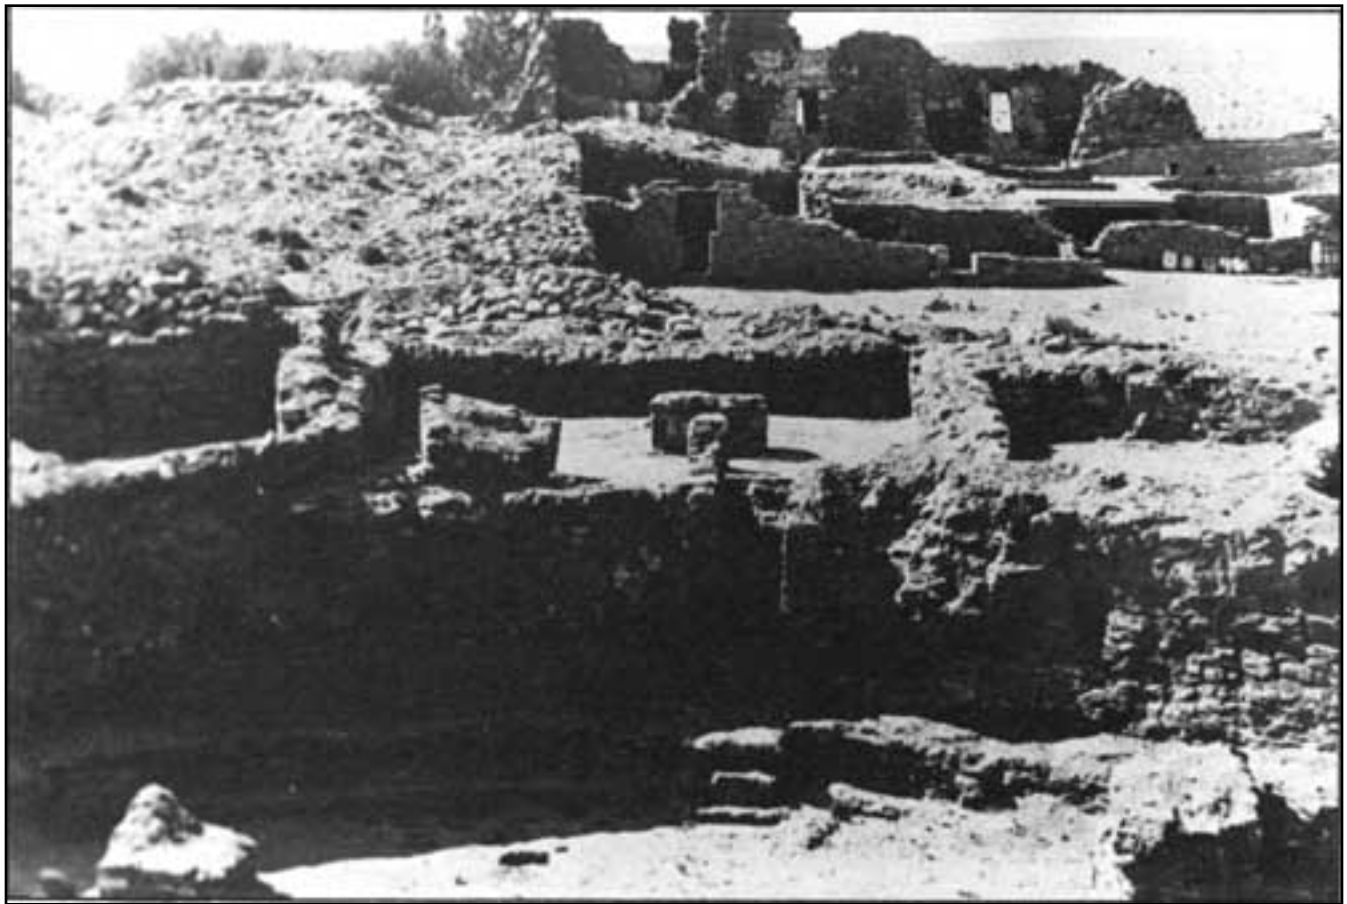
Figure 3.24. Excavated Great Kiva in 1921, showing floor features. Above, view to south; below, view to north.

In addition to the size of the Great Kiva, 48 feet in interior diameter, features that differed from the clan kivas included the 15 encircling surface rooms. All had doorways opening to the courtyard. The largest room on the north axis was enriched with a raised square platform, which Morris called an altar. The rooms were connected to the subterranean chamber by wooden rungs inset vertically into the kiva's masonry wall. A bench wrapped around the lower wall of the kiva. On the floor of the chamber were outlines of two large rectangular vaults that originally might have been covered with planks to make foot drums. Between them was a squared fire hearth. Forming a square at the perimeters of the circular floor space were the stubs of four squared masonry columns, which had supported a log roof over the kiva and its attached rooms. Horizontal layers of small poles were embedded in the columns to reduce their rigidity. During the interval when these features were puzzling the crew because of their unusualness, Morris spent three weeks heading a repair crew at Pueblo Bonito. That gave him the chance to reassure himself that his work at Aztec was correct.

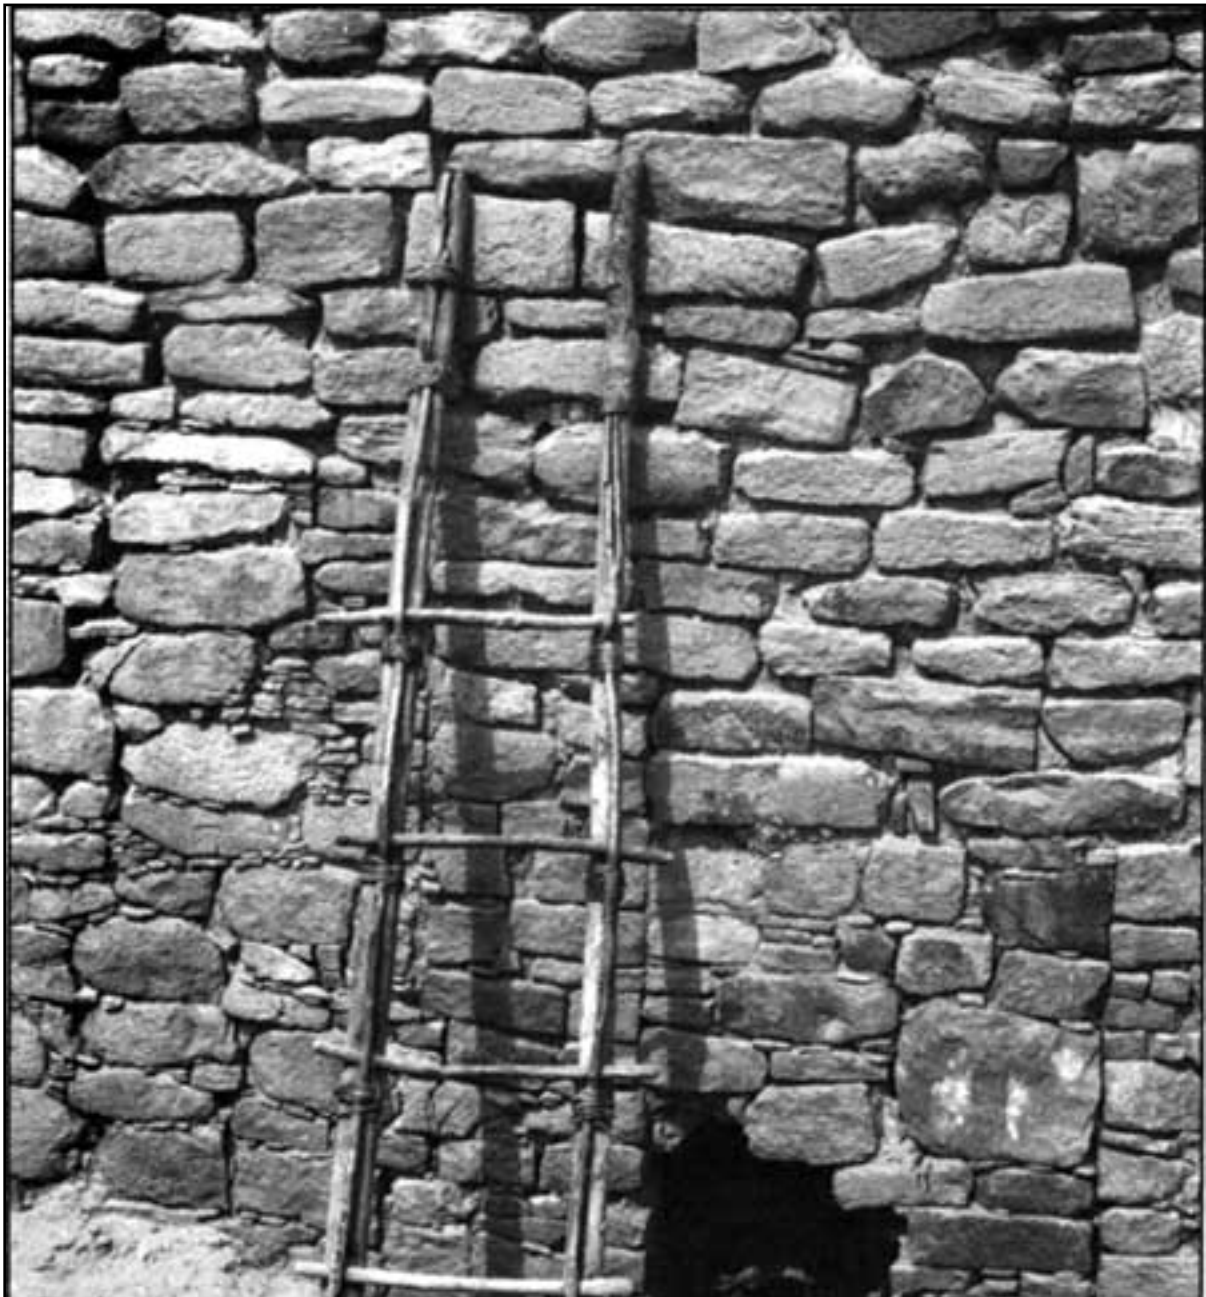
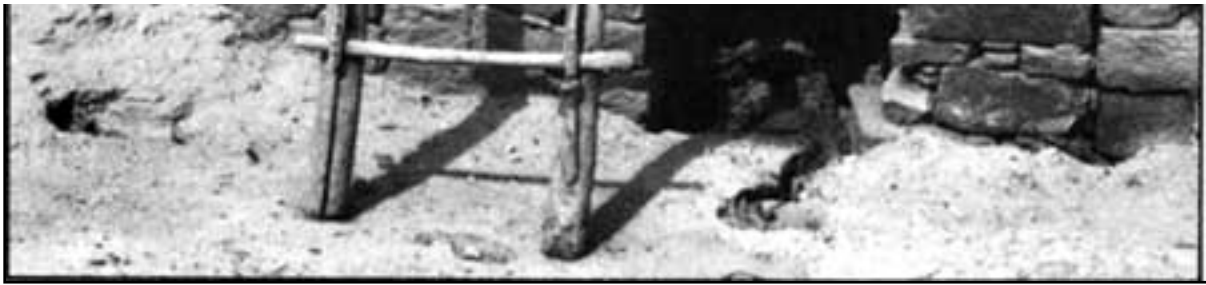
Figure 3.25. Partial poles-and-rungs ladder recovered from a North Wing room.

On one occasion, Morris hired two men for a day to do odd jobs that unexpectedly turned up unusual archeological finds. With their assigned tasks done before quitting time, they started clearing Room 196² in the North Wing. This was a second-story room. Oley Owens and Morris shoveled side by side on the floor level to uncover a coiled basket, a stone axe with wooden handle still attached by bright yucca cord wrappings, and the skeleton of a dog. Owens then struck a long wooden object. He had exposed a few feet of it by time to stop for the day. With the light of a lantern, Morris continued digging around this mysterious specimen, until at 11 o'clock he had before him a remarkable runged ladder (see Figure 3.25). [105] Its transverse poles, lashed in place by sturdy bindings, were well polished by the rub of many feet. As Morris reconstructed events, the ladder had been at least 12 feet long when complete. It had leaned against the edge of the ceiling hatchway but had been pushed over when large masonry blocks tumbled from above. The first ladder of its kind found in the ruin, it now forms part of a prominent display in the visitor center.
