"In the Midst of a Loneliness" The Architectural History of the Salinas Missions

Salinas Pueblo Missions National Monument Historic Structures Report

James E. Ivey

Southwest Cultural Resources Center
Professional Papers No. 15
Southwest Regional Office
National Park Service
Santa Fe, New Mexico

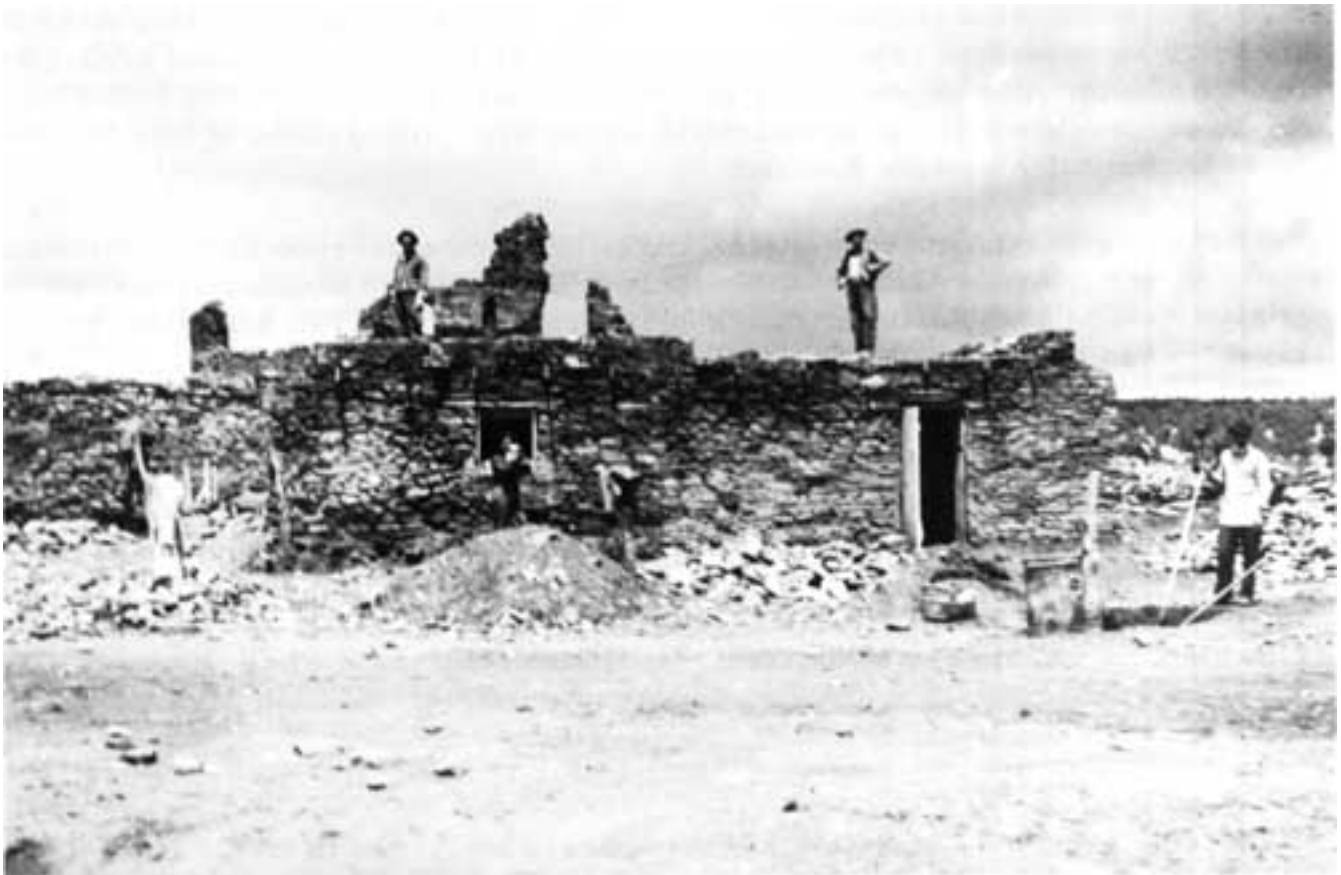
Figure 47. The Marcos Luna house at Abó. It is being converted to a toolshed by workmen under the direction of Joseph Toulouse about June 28 or 29, 1938. The Luna house can be seen in earlier photographs taken at a distance from the church, but only the lower few feet of walls still stood at the time. In 1882 Adolph Bandelier drew its outline on his map of the ruins of the pueblo of Abó, along the east edge of the mounds left by the collapse of the convento. Toulouse raised the walls by about 5 feet and added doors, windows, a roof, and a fireplace. The entire building was removed in late 1939 as part of the final cleanup of the area.

the Marcos Luna house and use it as his toolroom. Work on the reconstruction of the rooms was completed by June 30. Later, in 1939, Toulouse demolished the toolroom and all other traces of the Luna house that he could recognize.

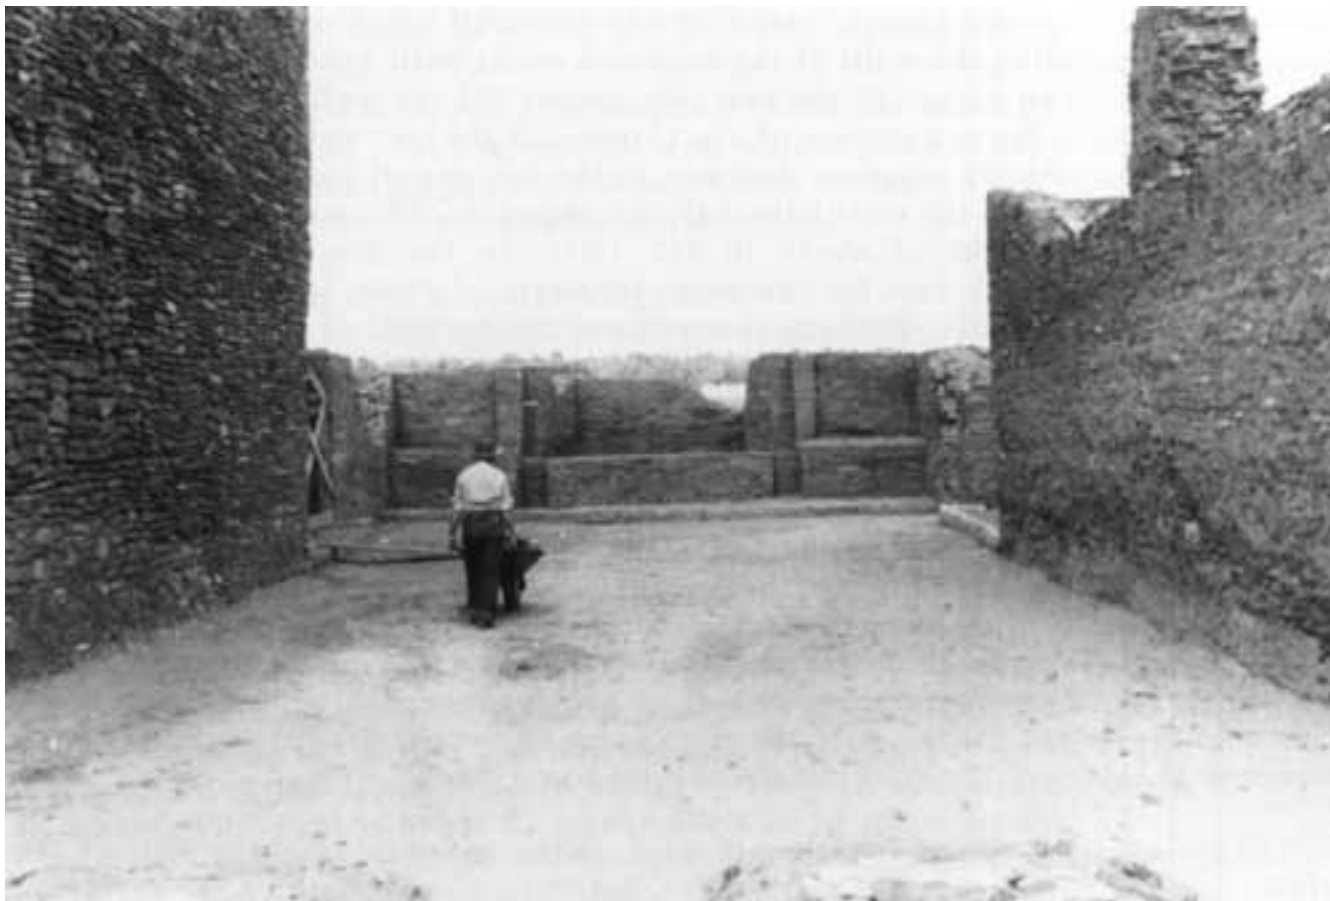
Figure 58. Abó in 1939. The interior of the church in the final stages of cleanup and stabilization. Replacement beams have been cut and set into the floor along the edges of the side chapel altar platforms and in front of the main altars. Stabilization of the side walls of the sanctuary near the side altars has not yet been carried out.

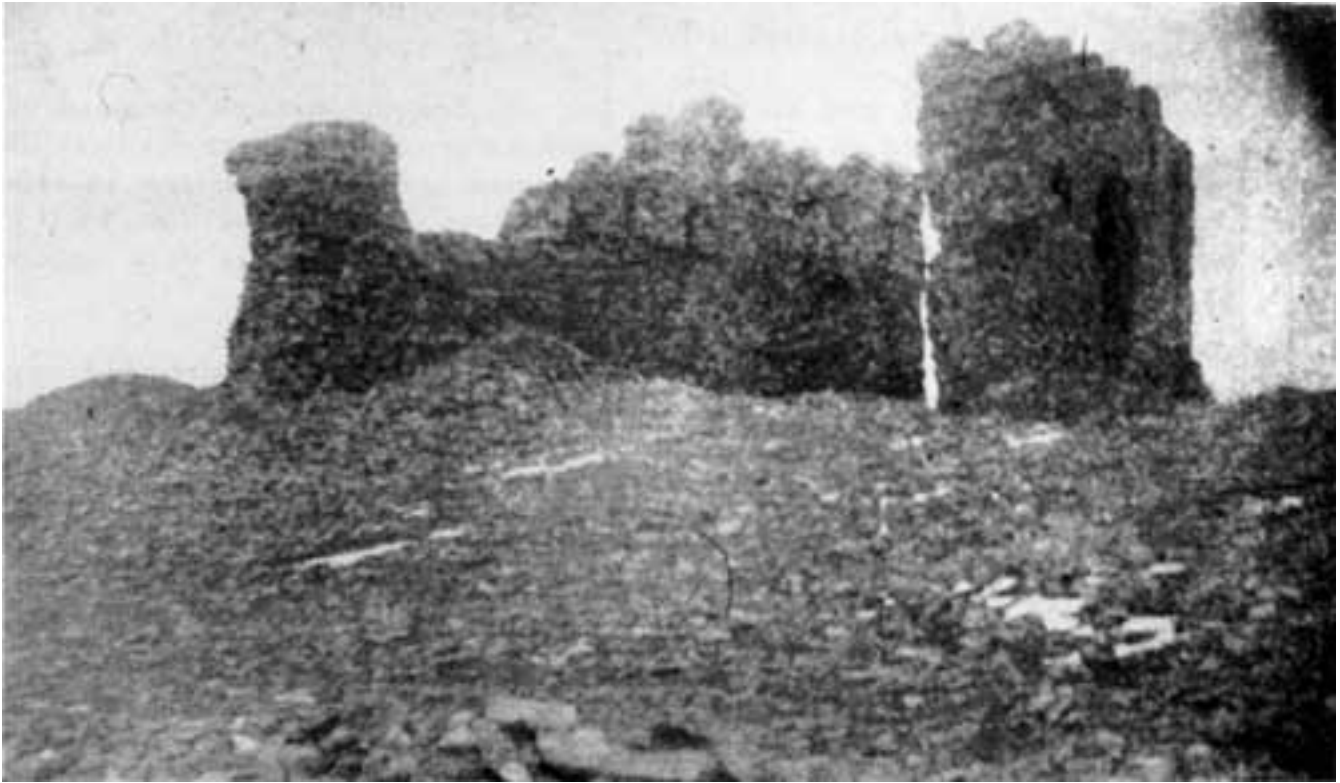
Figure 25. Abó in 1882 as photographed by Bandelier. This picture was taken from almost the same angle as Abert painted his watercolor 36 years before. Since Abert's watercolor, large sections of the walls of the church have fallen. The southwest tower and the south end of the west wall of the nave have fallen, as well as the east wall of the nave from the southeast tower to the east side chapel. The southeast tower itself still stands. At the north end of the church, the entire apse wall of the building has fallen.

The crenelations along the tops of the walls can easily be seen.

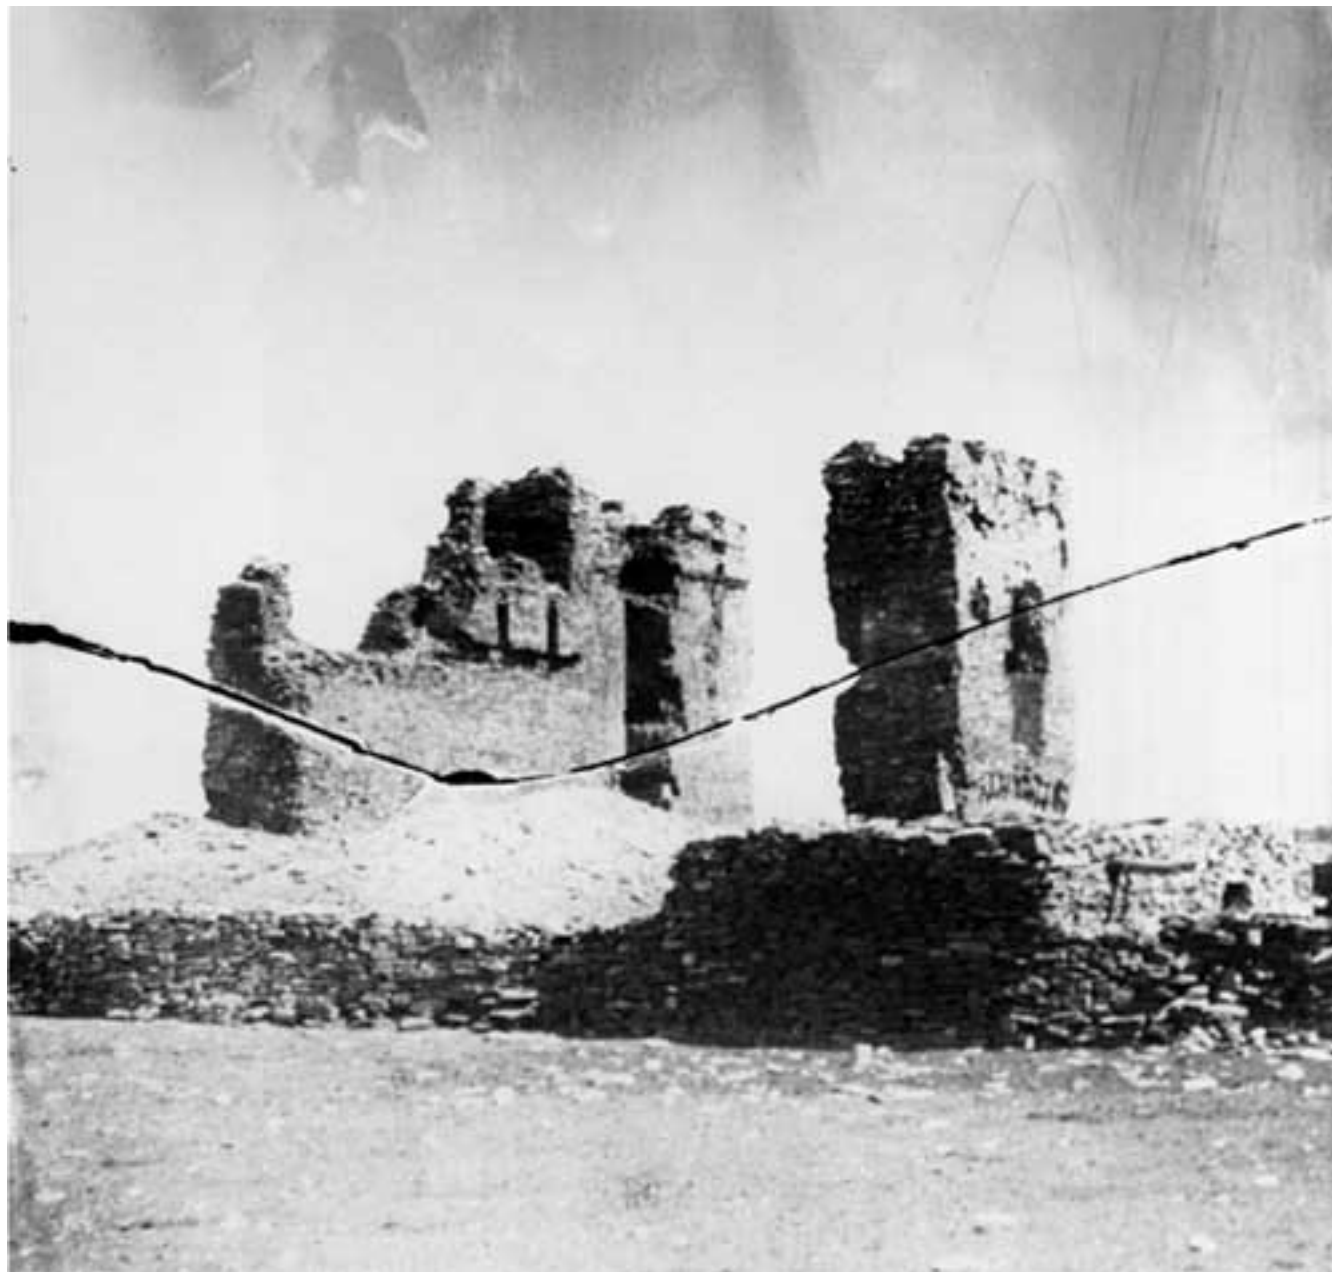
Figure 26. Abó as seen by Charles Lummis in 1890. This picture was made from almost the same angle as the Bandelier photograph 8 years earlier. In the interval the southeast tower had finally collapsed, but few other changes can be seen. In the foreground, walls and structures constructed during the second reoccupation after 1860 are visible.

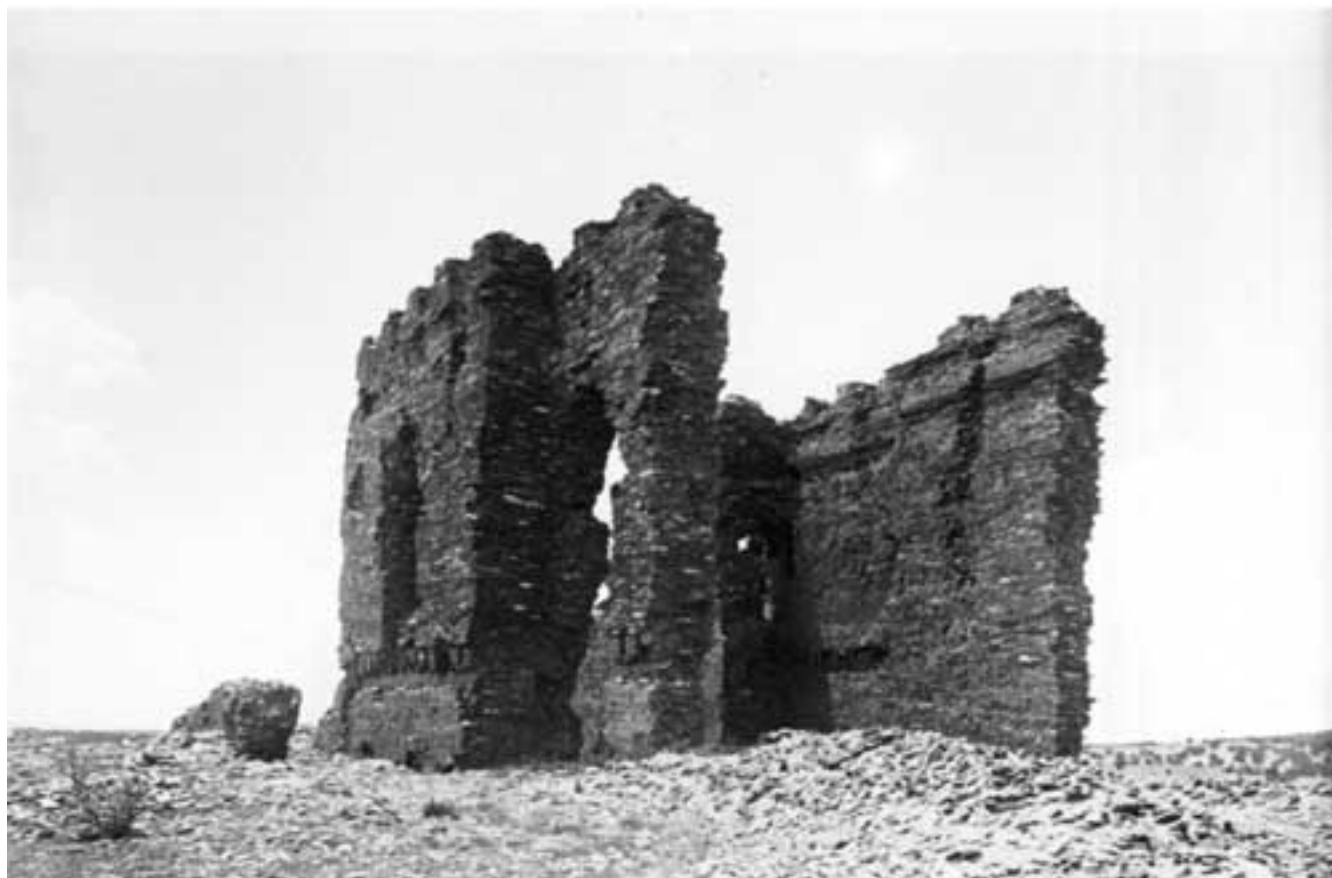
Figure 27. A second view of Abó in 1890. This picture is looking towards the southwest, and the north or sanctuary end of the church is in the foreground. In both this and the previous picture, the crenelations at the top of the building can be seen clearly.

These two Lummis photographs are critical to the analysis of the structure of Abó, because only they record several items of important information. The wall at the right in this picture is the west wall of the sanctuary (or transept in the case of Abó, with its peculiar arrangement of space. At the top of the wall, below the crenelations, can be seen two horizontal bands in the stonework. The upper of these is the scar left by the roofing above the roof vigas themselves, which in this area ran lengthwise down the church, or parallel with this wall. The lower horizontal band marks the sockets of the bond beams creating the box-like structure around the wall tops of the high walls of Abó. The bare wall between the two bands was covered by the westernmost of the roof vigas in this area. The vertical, irregular scar down the face of the wall was produced by a failed roof canal. Instead of draining roof water through the wall, the canal became blocked, the water pooled, the roof seal failed, and water began running down the inner face of the wall, cutting this channel. This indicates that the roof sloped down towards this wall. In this and the previous photograph, three sockets can be seen in the irregular scarring left by the leak. They line up with three sockets a few feet to the south at the corner of the side chapel. The six sockets together are the last traces of the central support for the high roof of the church as well as the catwalk from balcony to balcony. The sockets for the floor of the west balcony are visible below and to the left. On the left, or east, side of the church, the second window into the sanctuary can be seen above the remnants of the sacristy doorway. To the left of the sanctuary window is the large

³⁶ These steps can be seen in two photographs taken by Charles Lummis in 1890, SWM # 24831 and 24867, and MNM # 28794 (ca. 1910). The transept and sanctuary windows can be seen in SWM # 24831 and 24832 (C. F. Lummis, 1890). The window on the east wall of the nave had fallen in by 1846, but the gap left by the collapse was recorded in the watercolor of the church made by Lieutenant J. W. Abert, made in November, 1846; see Abert, Western America in 1846-1847: The Original Travel Diary of Lieutenant J. W. Abert, ed. John Galvin (San Francisco: John Howell Books, 1966), facing p. 52. See figures 24, 26, and 27 in Chapter 9.

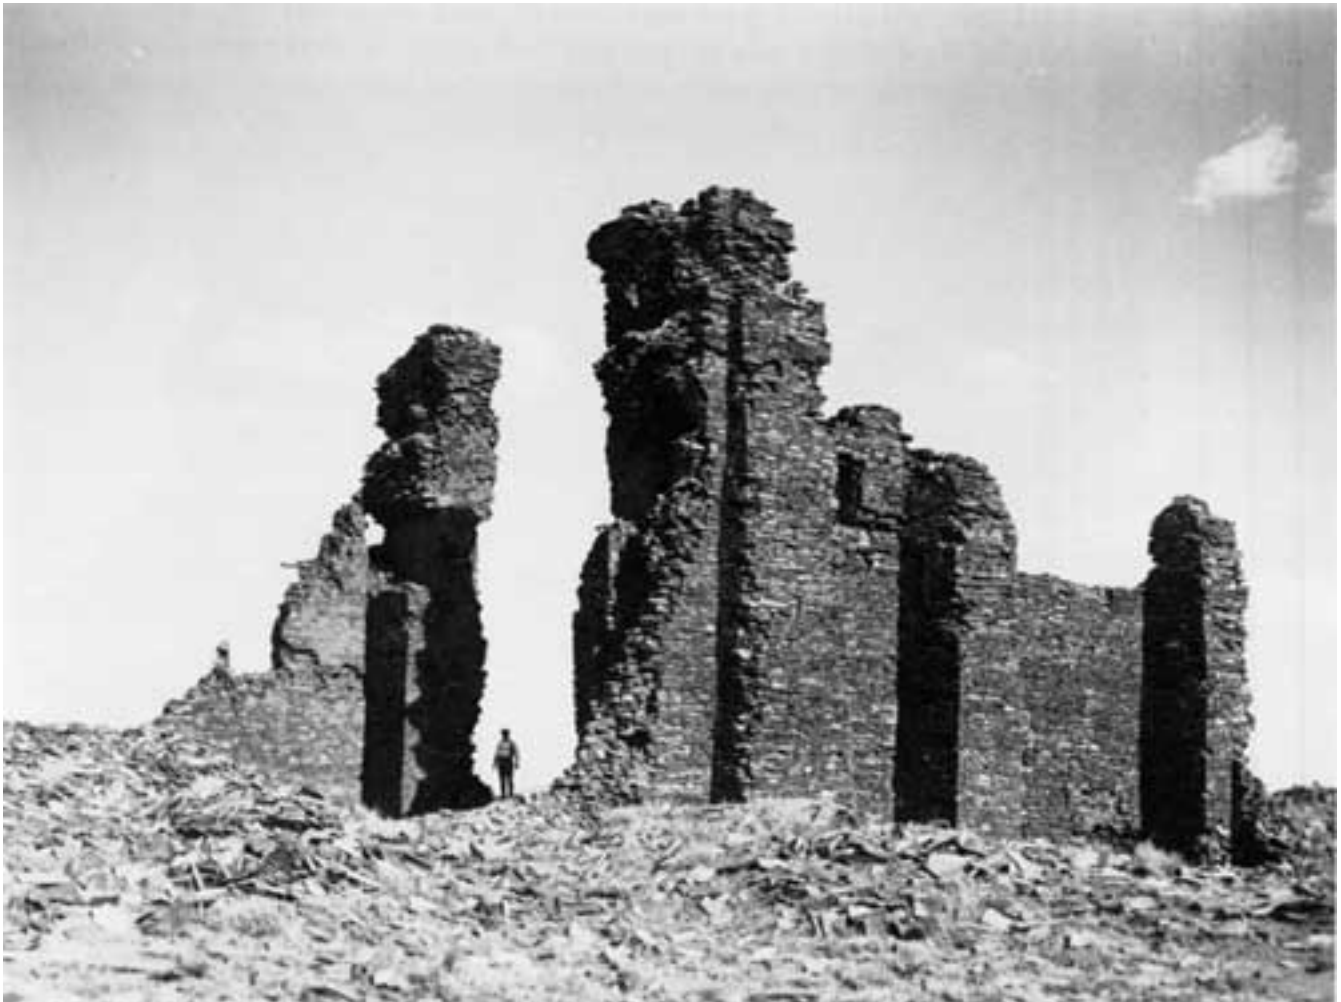
Courtesy Museum of New Mexico, # 12876.

Figure 28. Abó from the northwest in 1916, by Jesse L. Nusbaum. The walls of the sanctuary and side chapels have fallen, except for the buttressed area of the bell tower, and the tower buttress on the east side. The southernmost bottom corner of the balcony doorway is visible just to the right of the figure sitting on the sill of the doorway on the wall. Below the doorway can be seen the irregular traces of the sockets for the eastern balcony. On the shadowed north face of the east tower buttress, the dark patches of the socket for the viga that supported the balcony can be seen, with the sockets of the balcony railing above it. The large depression in the wall above the railing sockets is the socket for the east end of the lower clerestory vigas and corbels; the hole through the wall at this point marks the end of the vigas themselves where they penetrated to within inches of the outer surface of the wall. Several feet above this is the smaller indentation of the upper clerestory viga socket, and in the irregular wall surface above this and below the crenelations are the sockets of the vigas and corbels for the high roof above the clerestory. A similar series of sockets can be seen in the bell tower section of the west wall, closer to the camera.

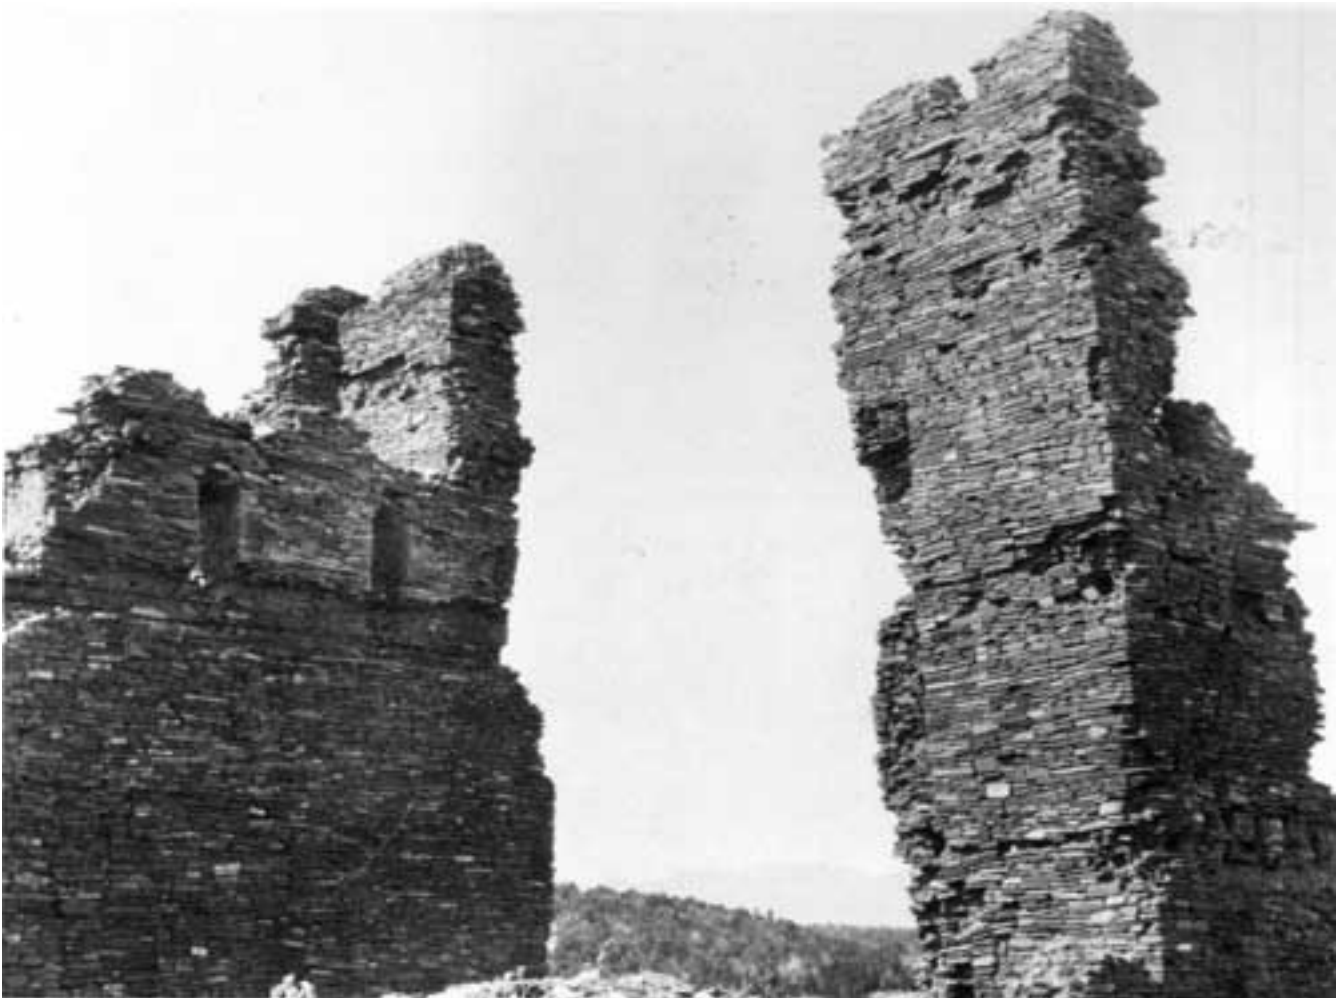
Courtesy Museum of New Mexico, # 58308.

Figure 29. Abó in about 1916. This is a closeup of the southeast corner of the east side chapel and the east face of the west wall of the nave, taken by an unknown photographer. Fine details such as the second level of inset of the crenelations and the imprints of both bond beams on the west wall can be seen. The scar of the east wall of the nave is visible on the east buttress tower, and the corbel sockets, viga sockets, and the scar of the small section of wall that had been at the edge of the doorway from the sacristy to the corridor can all be seen in this view. To the left of the rectangular sockets of the sacristy roof, the smaller round sockets of two corridor roof-beams are visible, and next to them on the south face of the tower, the irregular horizontal shadow line in the stonework marks the upper surface of the roof of room 18.

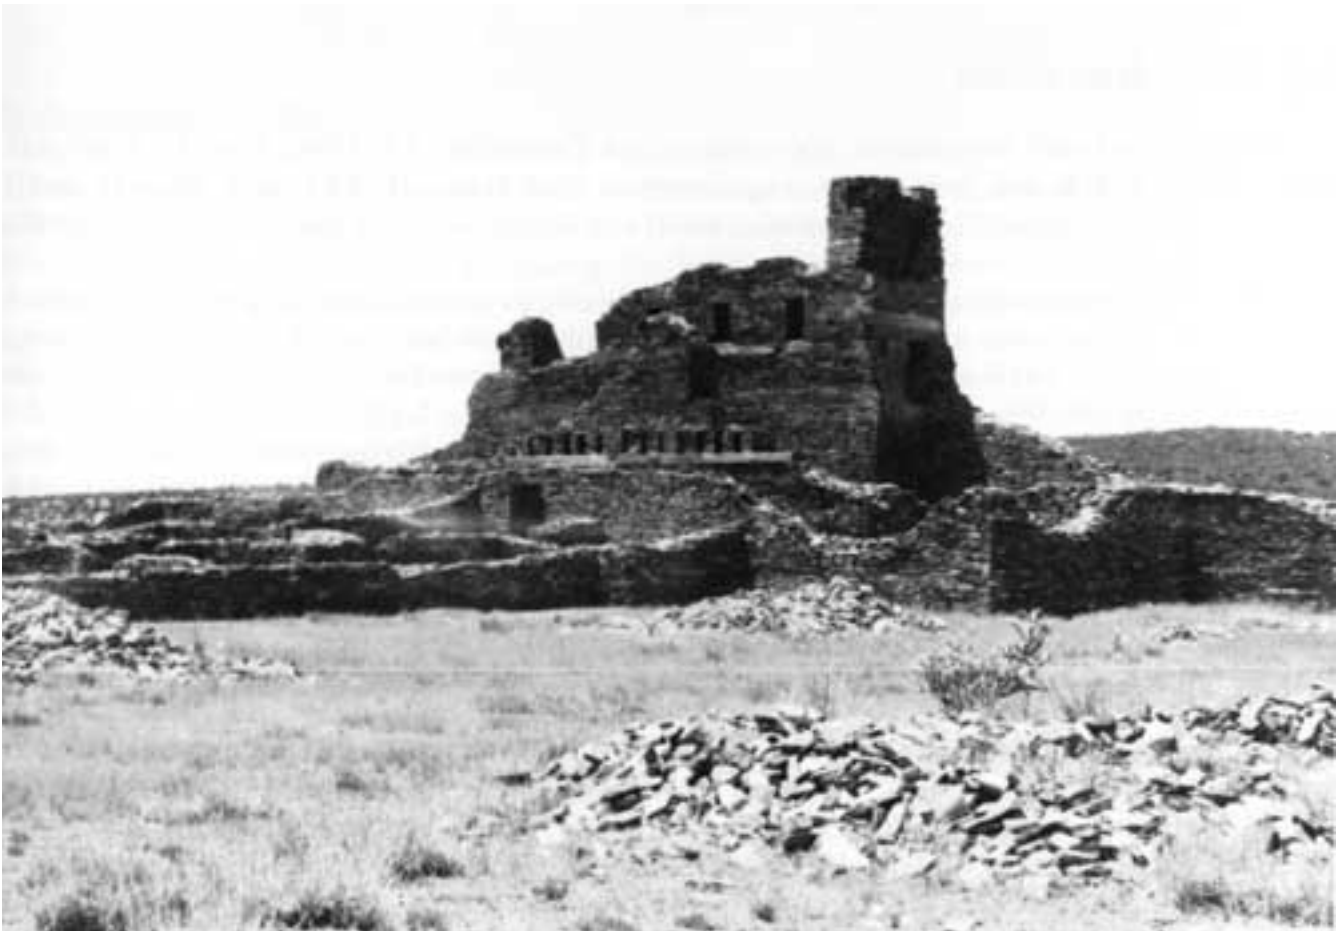
Figure 59. Abó as it appears today. The bell tower area is about 5 feet lower in this picture than in the previous photographs, but its top has been reconstructed to have the same general appearance as it had before the removal of the upper masonry. This demolition and remodelling occurred in 1972. The lower four viga stubs set in the north face of the tower by Toulouse are still in place, as are the viga sections in the east face of the west wall and under the sacristy roofbeam sockets, but the upper pair of viga stubs in the tower are gone, removed in 1958. The wall for the first four feet above the surviving viga stubs is refaced, the result of the work of 1972.

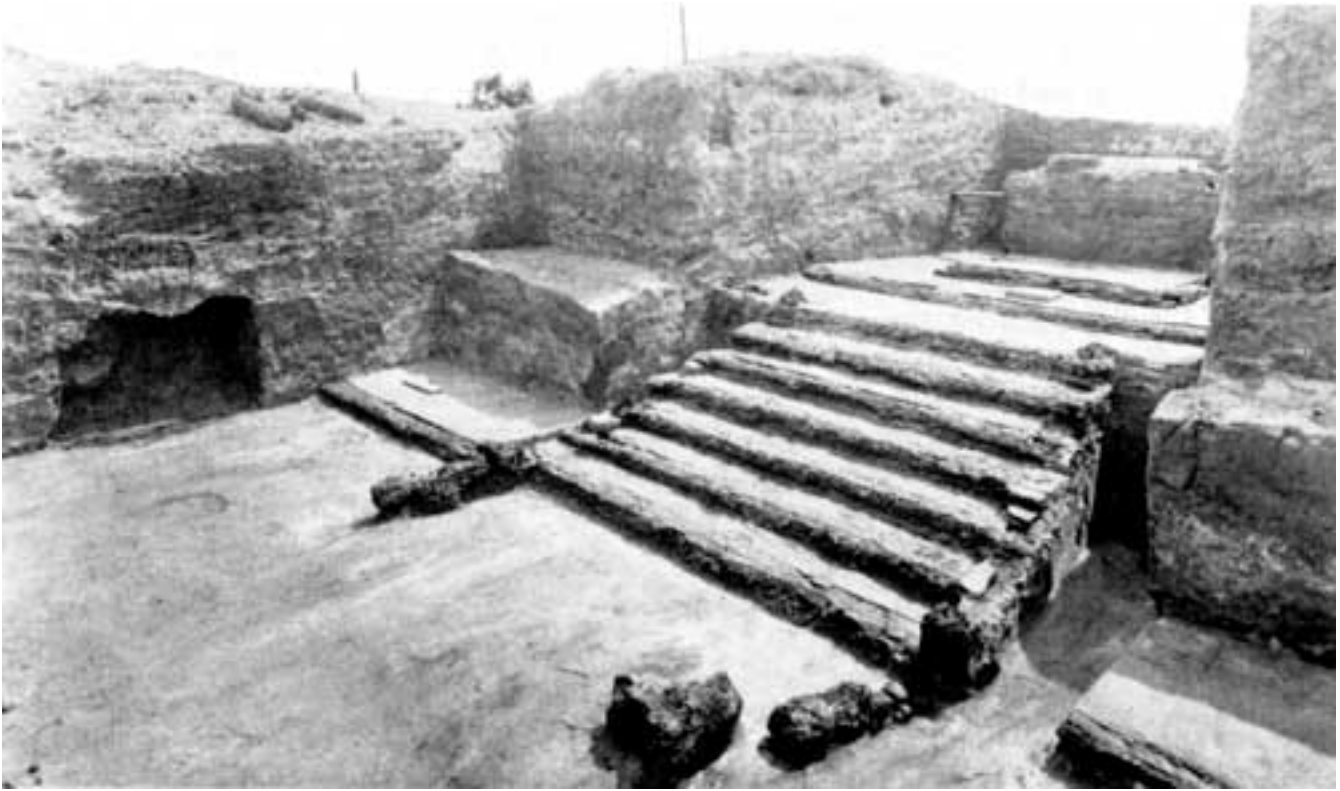
Figure 5. The sanctuary area and altars of the church at Hawikuh, burned out in 1672. The altars of Abó and Quarai probably looked very much like this. At the left edge of the stairs up to the main altar can be seen the large post that supported the bannister for the stairs. The predella platform under the main altar is visible, as are the platforms for the side altars.

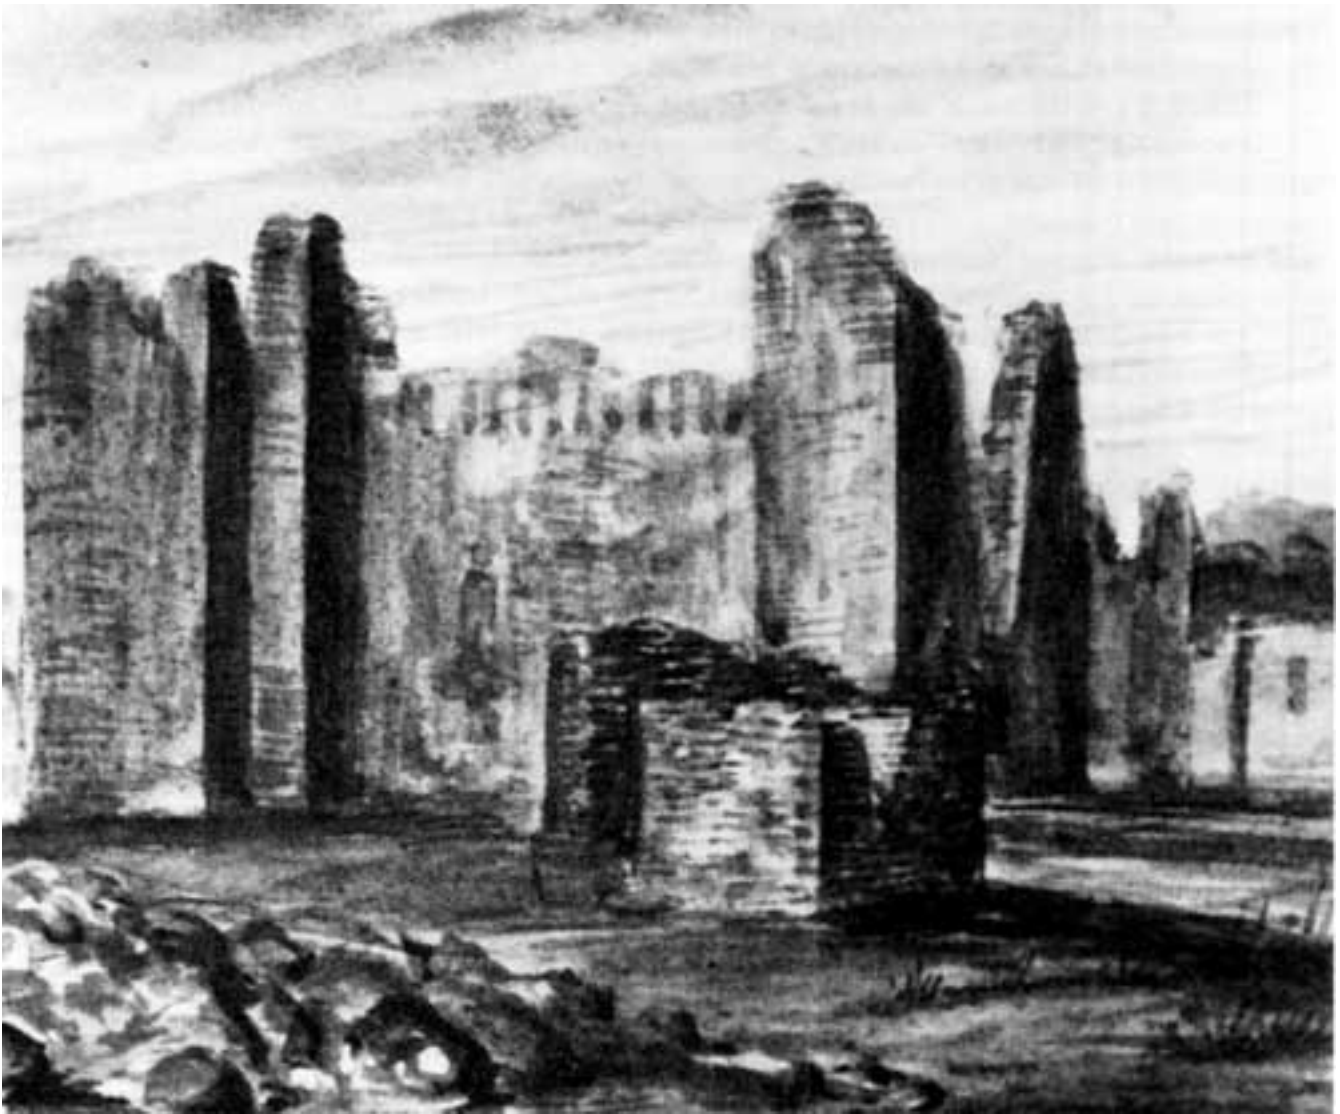
Figure 32. Quarai as painted by James Abert on Wednesday, November 4, 1846. In the foreground is the ruin of Mound J House, with the notch of a collapsed window on the right, or south side. Immediately behind it is the baptistry of the church. Abert indicates that he could see the sockets for the roof vigas of the nave from the outside of the building, meaning that the stonework between the sockets still stood to the height of the tops of the beams in 1846. To the right of the facade of the church, the choir loft stairwell and belltower still stand to the height of the top of the second story window. Just to the right of the belltower rooms is the gap where the portería has fallen in, and then the facade of the convento with a window opening, probably into the east hall. The rooms added on the southeast by the Luceros are out of sight to the right.

- ³⁴ See Chapter 8, n. 56, for a detailed discussion of the evidence for the dating of the destruction of the church and other buildings at Quarai. Abert's watercolor of the ruins shows that not only the church but also the baptistry and Mound J House burned out; see figure 32.

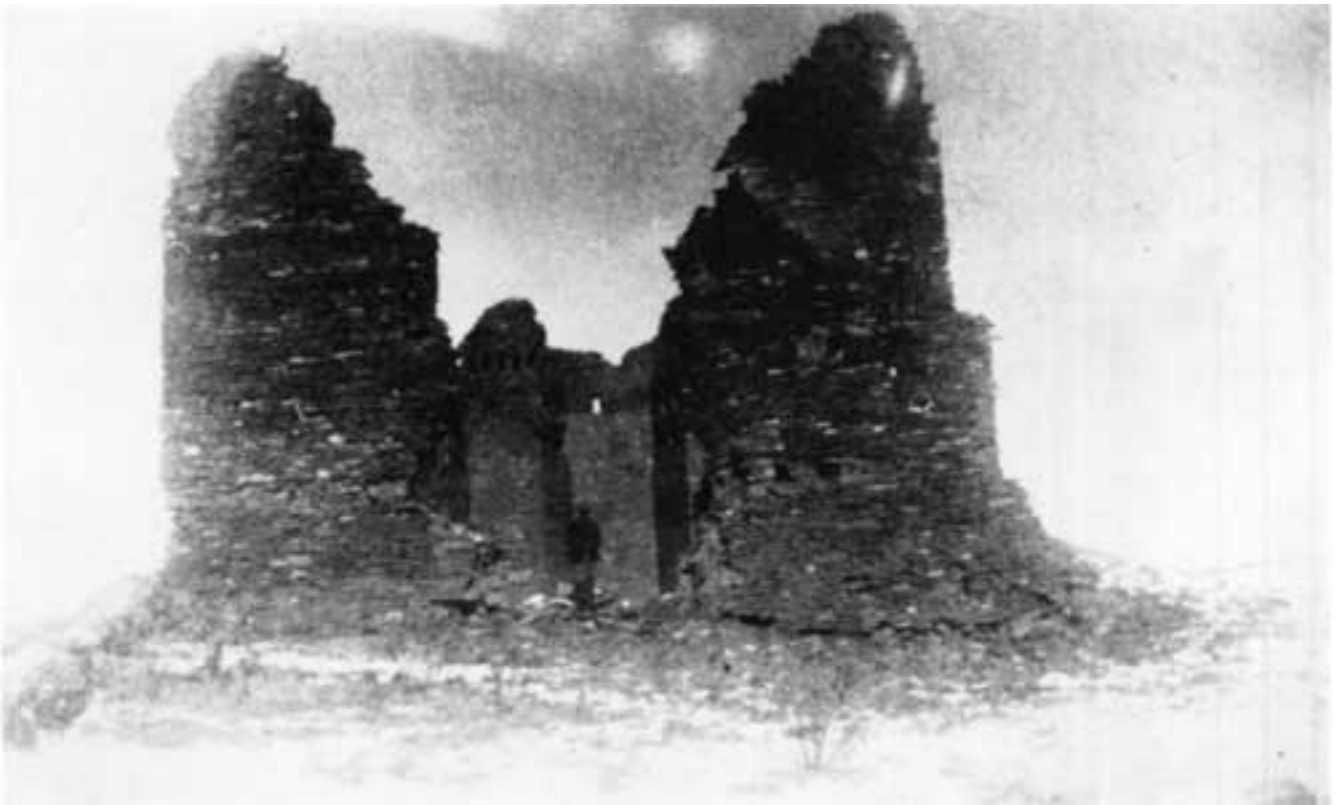
Figure 33. Quarai on December 28, 1882, as photographed by Bandelier. The edge of the window on the second story of the choir stairwell and belltower can be seen at the right edge of the facade of the church. Near its top corner, the stub of one of the lintel beams still survives. This beam has since been sawed off flush with the stonework, but is still in place. The wall beneath it originally extended to the left, or west, edge of the portería, but most of it had collapsed by the time of this photograph. The empty sockets of three vigas for the floor of the choir loft and front balcony are visible to the right of the collapsed entrance doorway. The sockets to the left of the doorway are not visible because the ends of the vigas are still in the sockets. At the left side of the church, the baptistry has fallen to a low mound, and a rubble stone wall extends across the mound to the corner of the church.

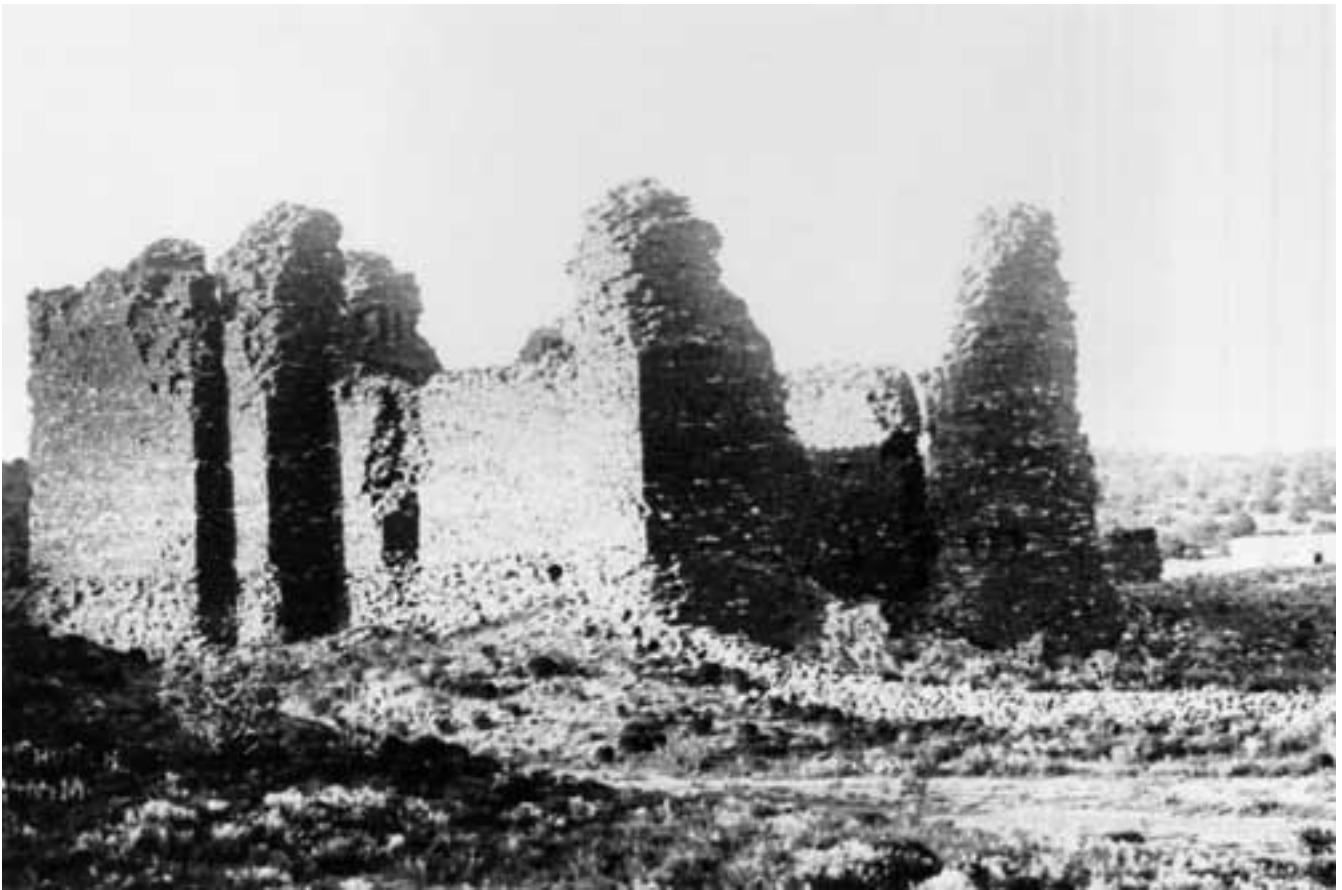
Figure 34. Quarai as photographed by Charles Lummis in 1890. To the right of the church in the distance can be seen the Lucero House, with a covered wagon parked next to it. Below the Lucero house, the ruins of the walls of the south end of the east hall and of room 20 are visible. To the left of the Lucero House, the south wall of room 13 still stands to almost its full height, and three beam sockets can be made out along its top edge. These beams, running north to south, covered the hallway (room 14 from the east hall to the east courtyard). By reconstructing the lines of sight of this scene at Quarai today, it was possible to determine that the top of the wall of room 14 was about 13 feet above the present floor level.

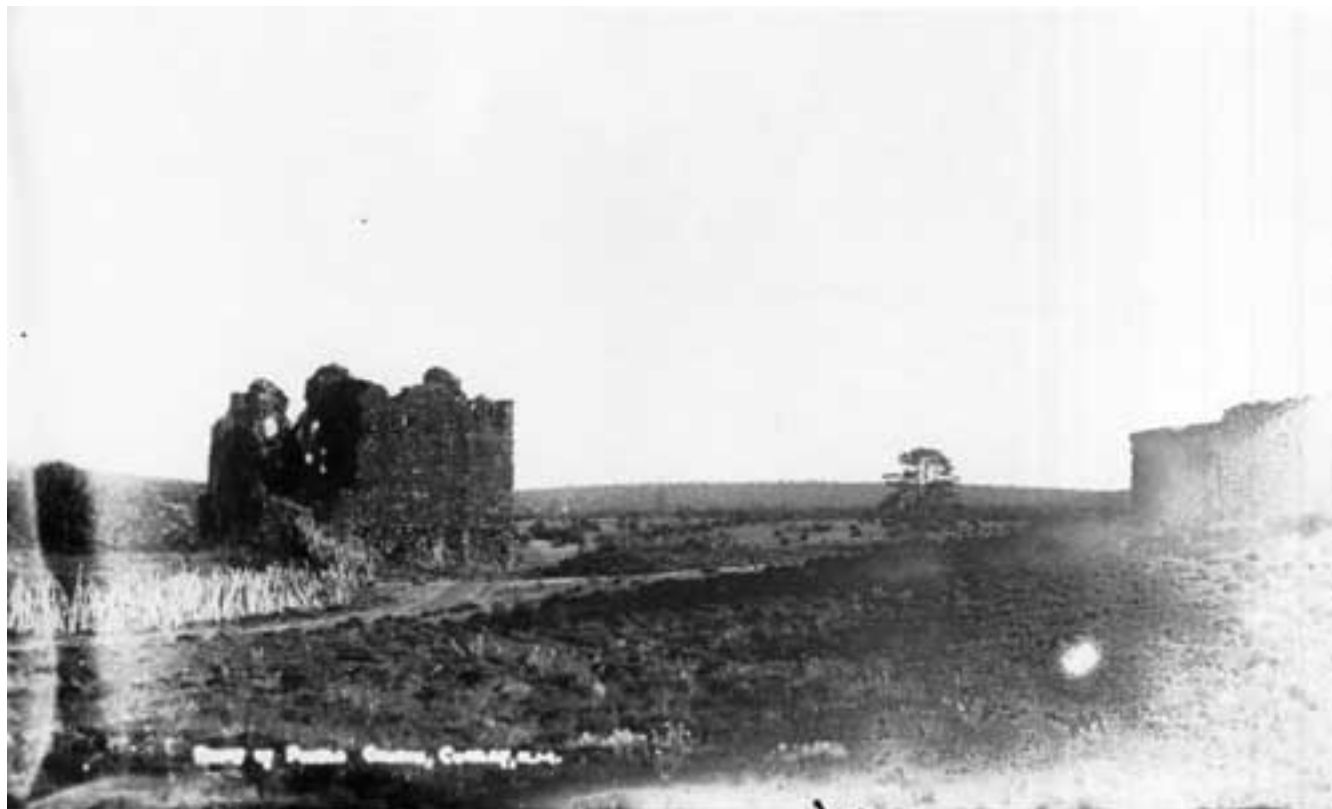
Courtesy Southwest Museum, # 24828.

Figure 35. Quarai from the north in 1890. Lummis was the first photographer to record the details of this side of the church. At the right edge of the picture, the North House still stands to its full height. On the left corner of the church the walls of room 6 still stand to the top of the second story, and one roof viga remains in place against the north wall of the east transept. The notch of a window at the second floor level can be seen in the north wall of the room. At the top of the apse, the ventilation opening can clearly be seen, as well as the notch in the top of the wall where the canal that drained the apse roof had penetrated. The road to Abó from Punta de Agua curves around the church with a jacal fence along its east side. The road and fence were both recorded by Bandelier on his plan of the pueblo and mission made from the notes and sketches of his 1882 visit.

- ³² This description of the North House is based on Charles Lummis photograph SWM # 24828 (1890), figure 34; Quarai Topographic Map, National Park Service, Koogle and Poole Engineering, July 6, 1982; and field measurements by the author.

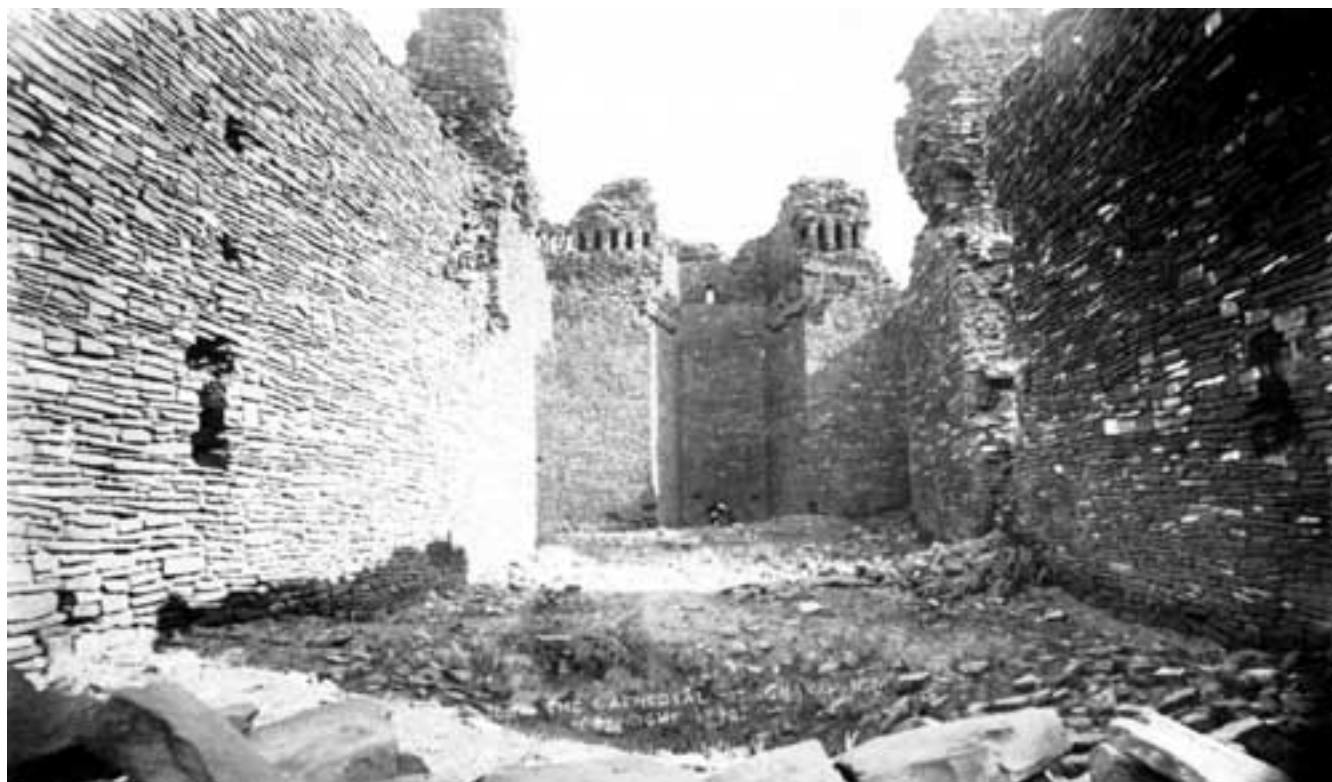
Courtesy Southwest Museum, # 24844.

Figure 36. The interior of the church of Quarai in 1890. This is the earliest detailed view of the interior wall surfaces of the church. A number of important details can be made out. In the north wall of the apse, the hole chopped through the wall by treasure hunters is easily visible. To the left and right of this hole on the apse wall are the sockets for the lower supports for the retablo. At the left and right corners at the mouth of the apse can be seen the sockets for the bannisters of the stairs of the main altar. On the left wall of the nave, the collapsed stonework above the lintel of the west window can be seen, as well as the neat masonry that sealed the window in colonial times. The stonework fell in above the window because the lintel woodwork burned out all the way through the wall during the fire in ca. 1830. Closer to the camera on the left can be seen the multiple sockets of the choir loft. The lowest socket is a three-part outline for the cobel beneath the main viga, the viga itself, and the lower railing of the choir loft bannister above. Above this triple socket, and a few inches north, are the middle and upper sockets of the choir loft bannister. On the right, or east wall, of the nave, an identical set of sockets can be made out. Closer to the transept, the notch of the east window of the nave can be seen. The sill of the window has collapsed almost to the level of the fill within the church. The fill at this time is only about three feet deep. Photograph by Charles Lummis, 1890.

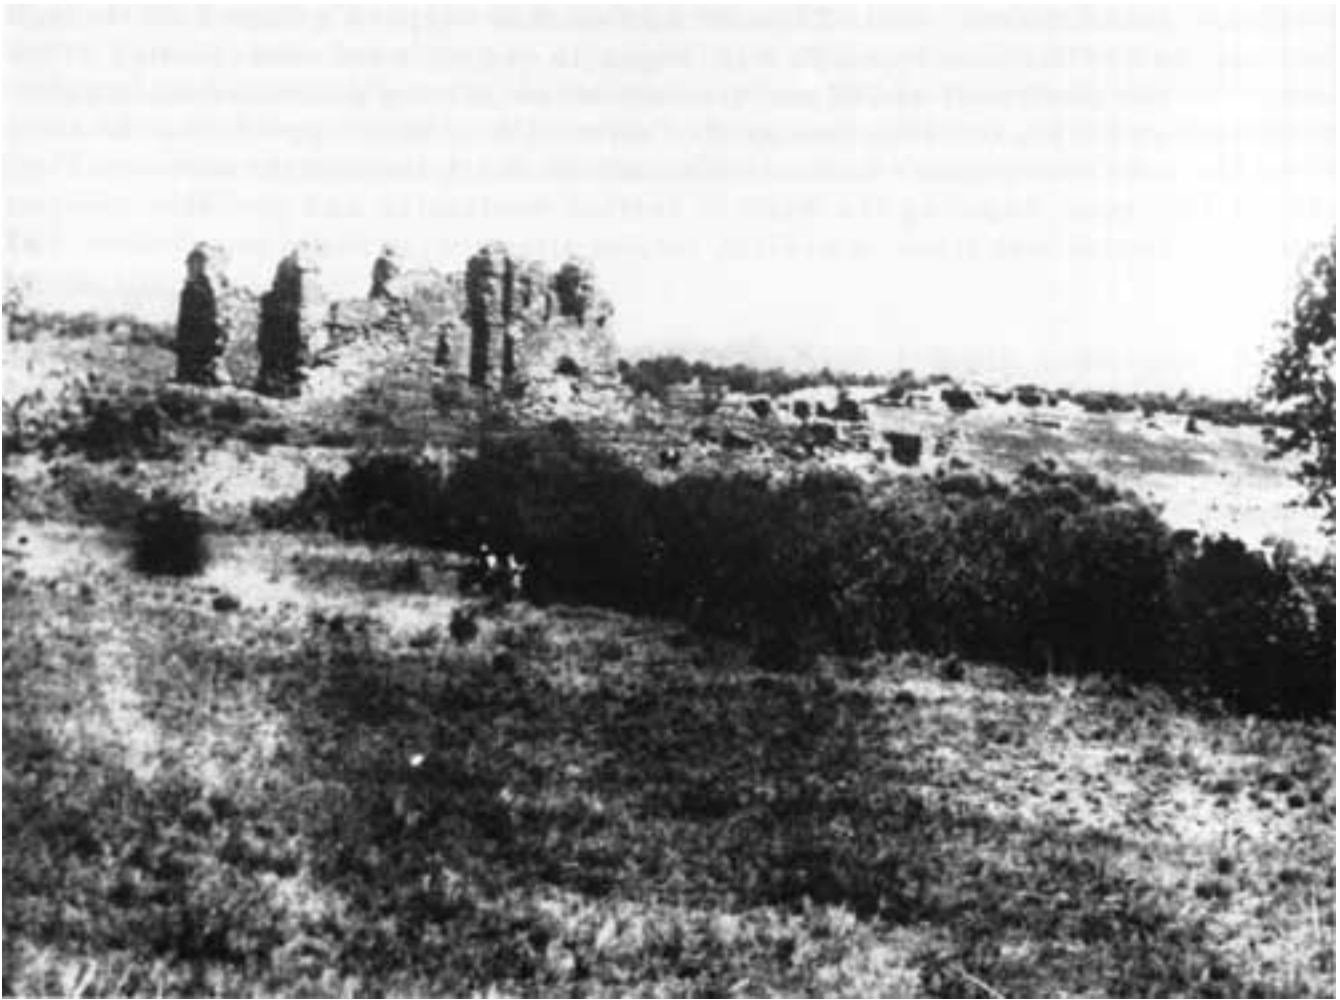
Courtesy National Park Service.

Figure 37. Quarai about 1900 from a photograph found in the files of the National Park Service. This is a print made from a negative made from a slide made of a print of the original negative. With so many generations of duplication, many of the details in the original have been lost, and the source of the photograph is unknown. Careful inspection and comparison with other pictures, however, recovers much useful information from the print. At the right background of the view, the walls of parts of the North House still stand, even though the main east wall visible in the Lummis photograph made in 1890 has fallen. Closer, just above the trees across the center of the photograph, the walls of several rooms of the east courtyard are visible, and just above them the walls in the area of rooms 11, 12, 13, and 29 can be seen. The imprints of most of the walls that adjoined the east wall of the church can be made out by comparison with other photographs.
