"In the Midst of a Loneliness" The Architectural History of the Salinas Missions

Salinas Pueblo Missions National Monument Historic Structures Report

James E. Ivey

Southwest Cultural Resources Center
Professional Papers No. 15
Southwest Regional Office
National Park Service
Santa Fe, New Mexico

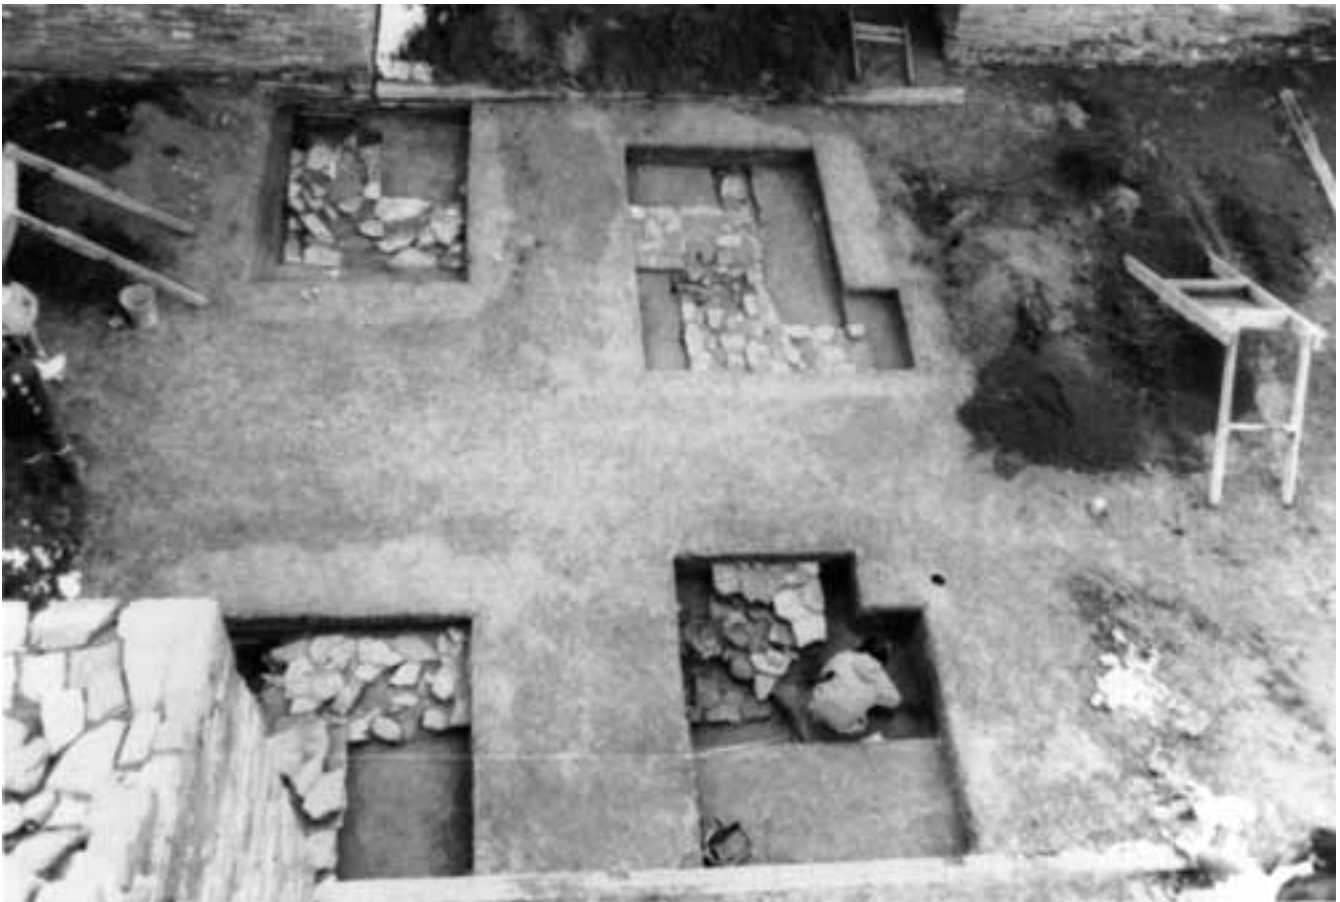
Figure 49. The first church of San Gregorio de Abó. This photograph, taken during excavations in March, 1987, shows the walls outlining the apse of the church.

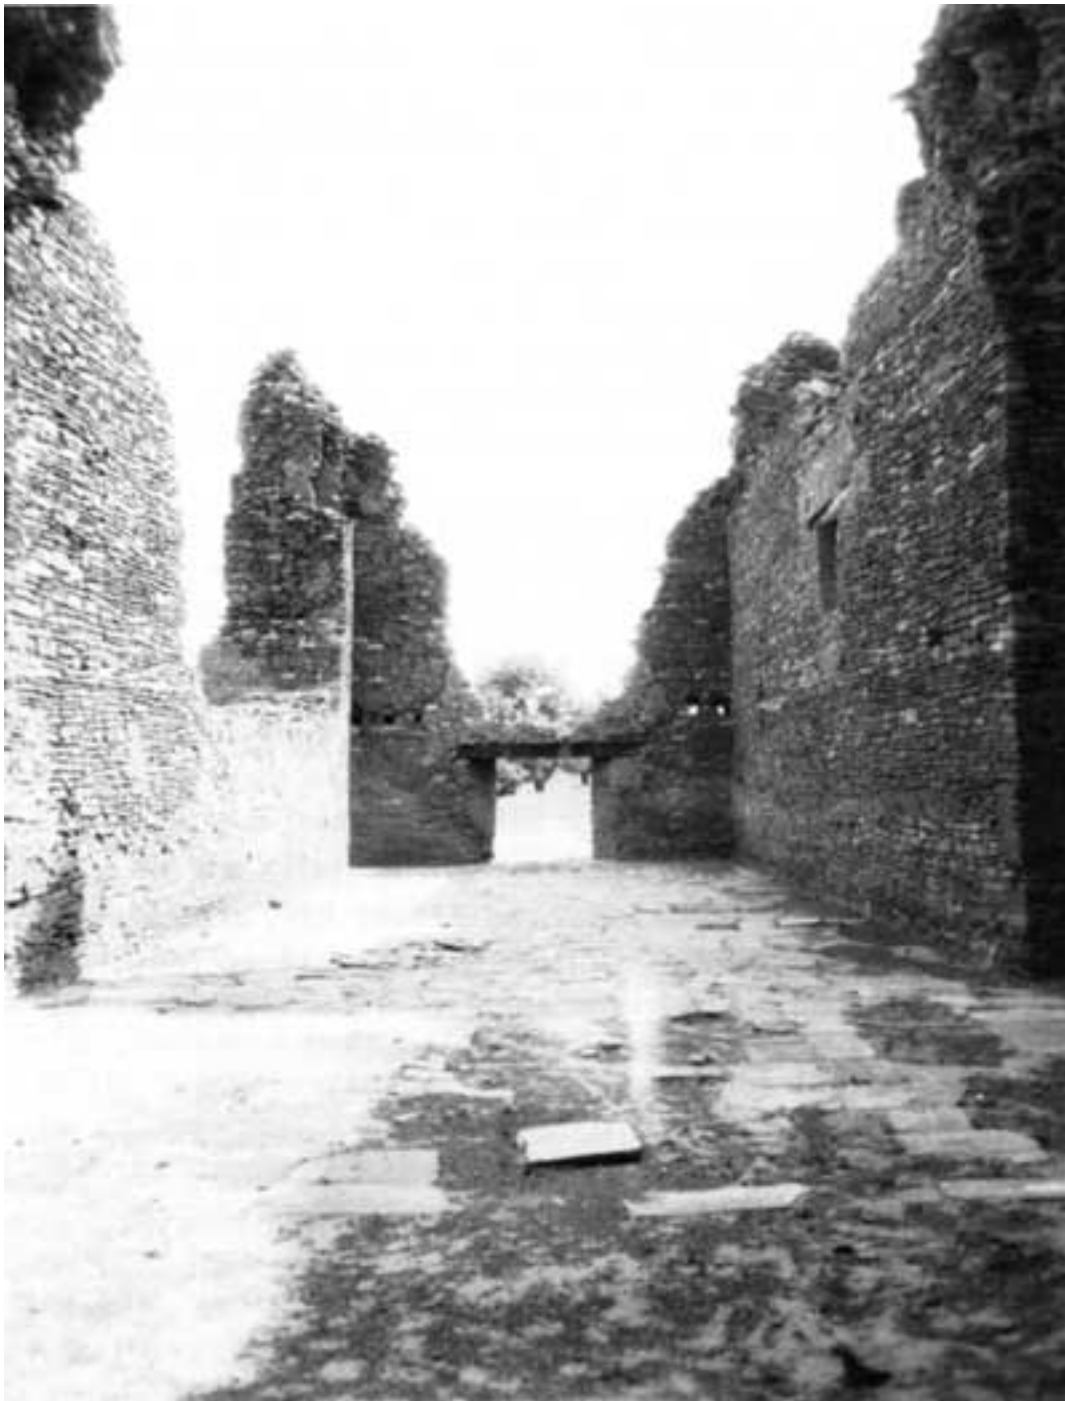
Figure 60. The nave of the church of Quarai in the fall of 1937. The photograph was taken after the completion of the first excavation and stabilization of the building. All of the surviving flagstones of the church floor remain undisturbed.

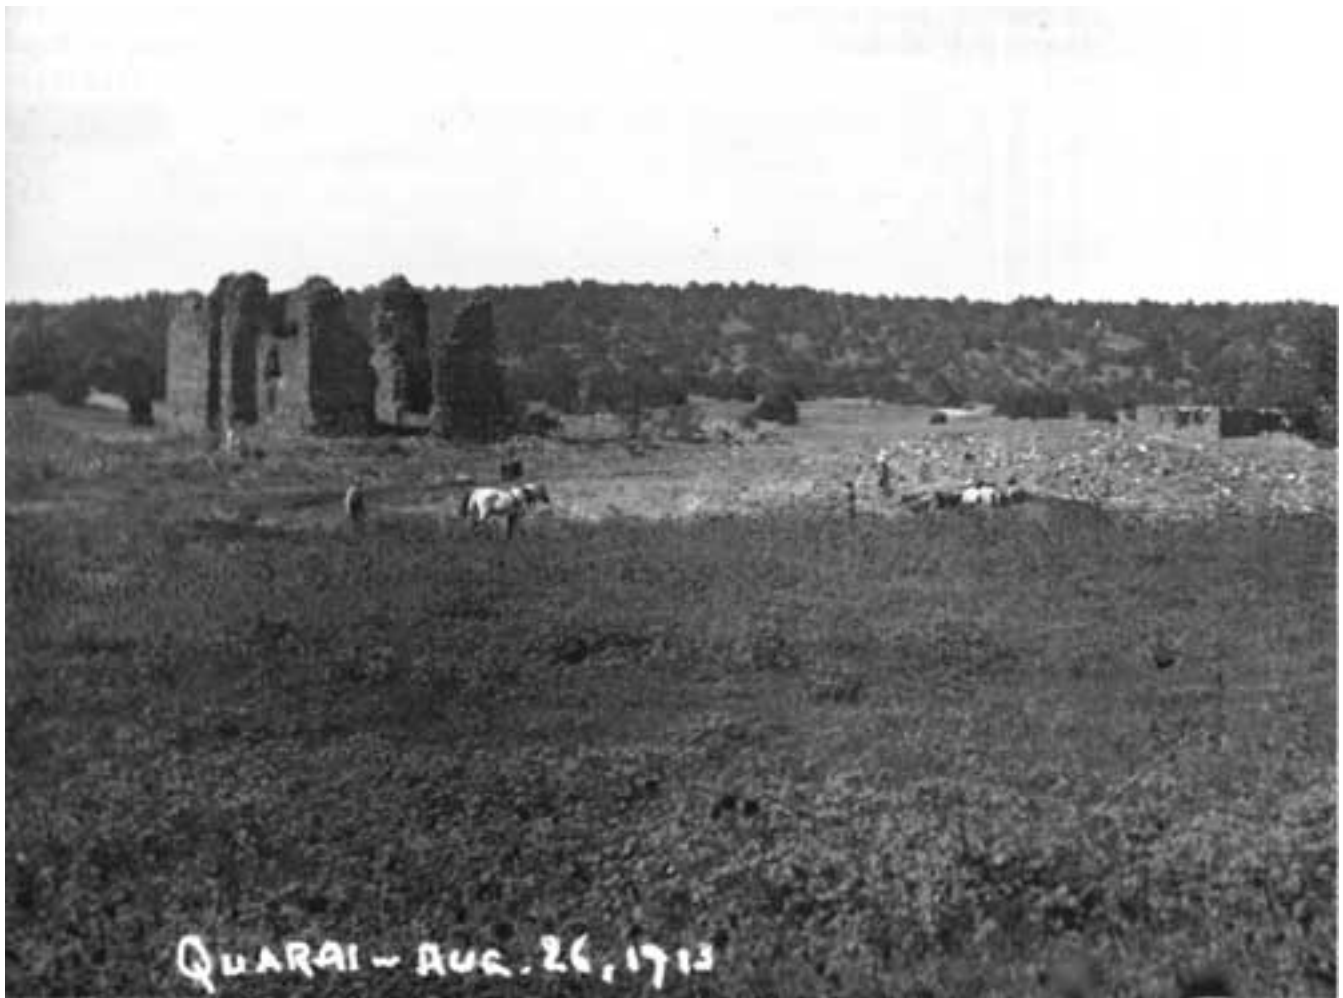
Figure 50. Quarai on August 26, 1913. In the foreground is Mound A, with the School of American Research excavations in progress. Just above the mound is the Lucero House, showing signs of deterioration on the enclosing wall. The house appears to be just behind the mound, but this is an effect produced by Lummis's camera lens. The walls of the convento have all fallen to within a foot or two of the tops of their rubble mounds, and the east wall of the nave has fallen into the church.

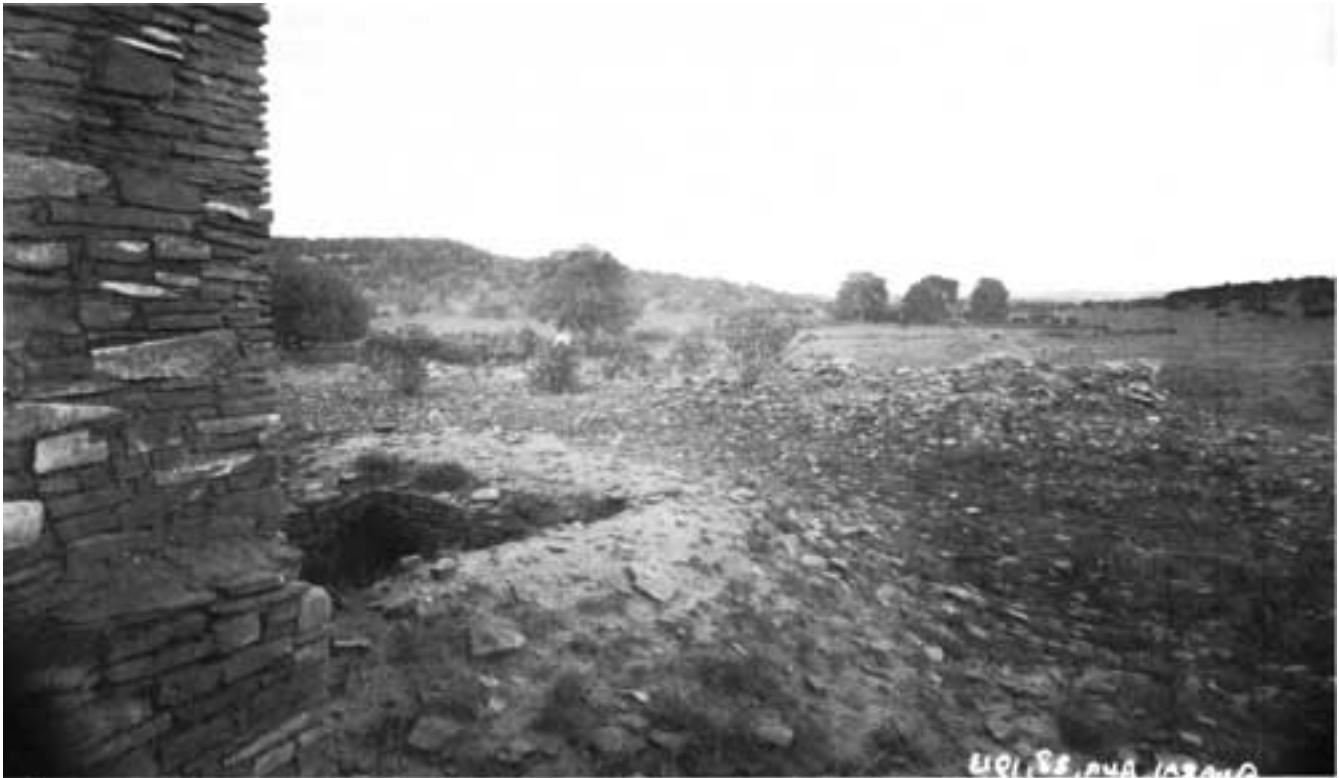
Continued >>>

Figure 51. The area of the sacristy of Quarai in 1913. Lummis stood on top of the stub of the wall of room 6 to take this photograph. Just past the corner of the transept, the hole excavated into the sacristy can be seen. In the middle ground the walls of rooms 11, 12, and 13 have all fallen to heights of about one or two feet on the side toward the camera. On the east side, the walls stand four or five feet above the sloping rubble.

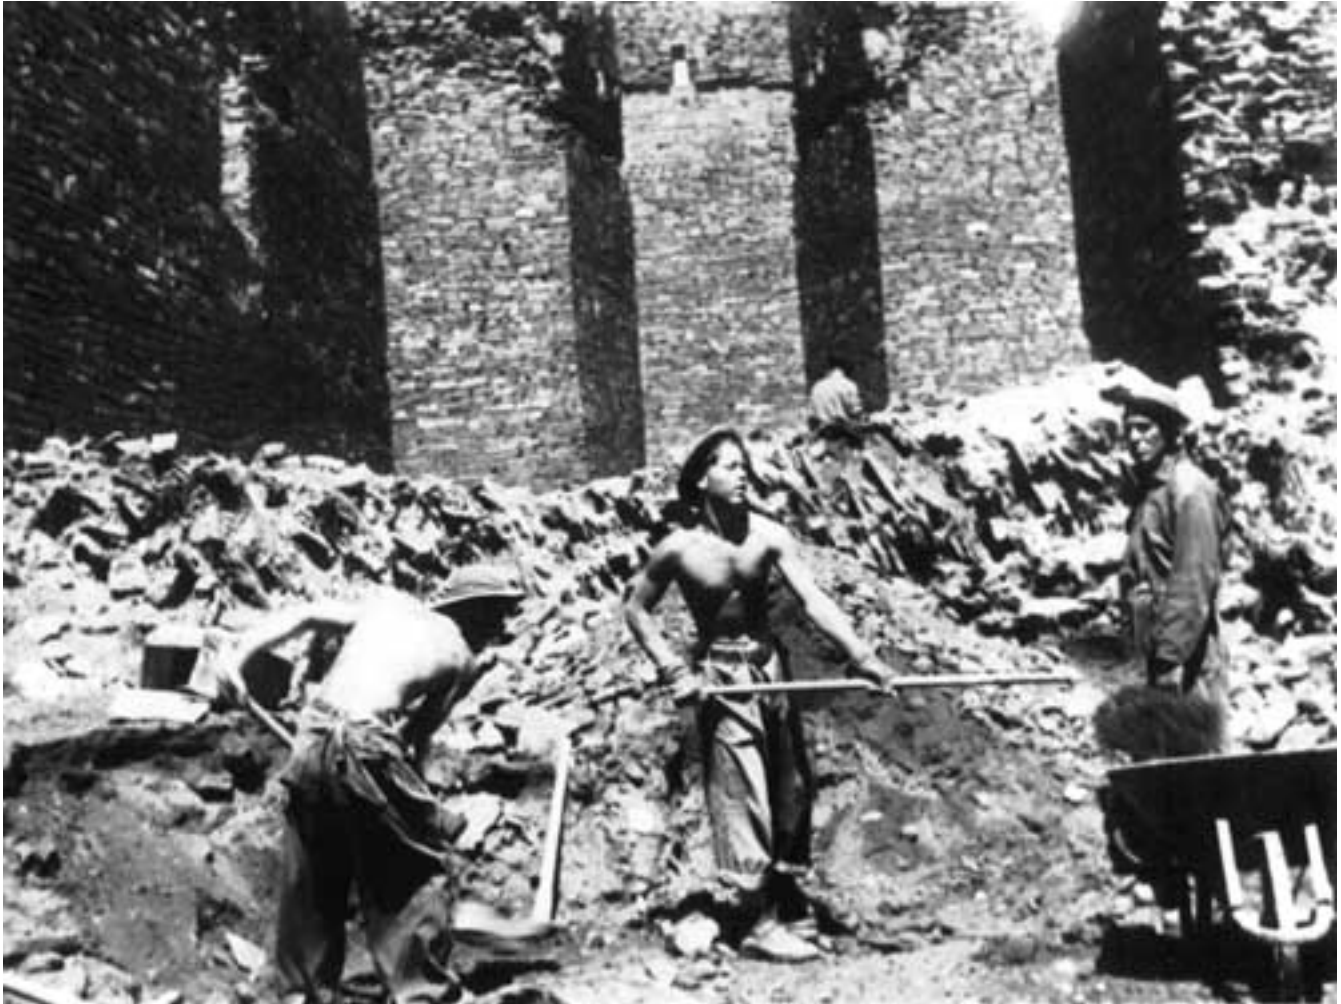
Figure 53. Removing the fill from the nave of Quarai, first week of August, 1934. The fallen east wall of the nave can be seen behind the workmen, with the stones still in approximately their original relationship to each other. The workmen are standing about on the original floor of the church.

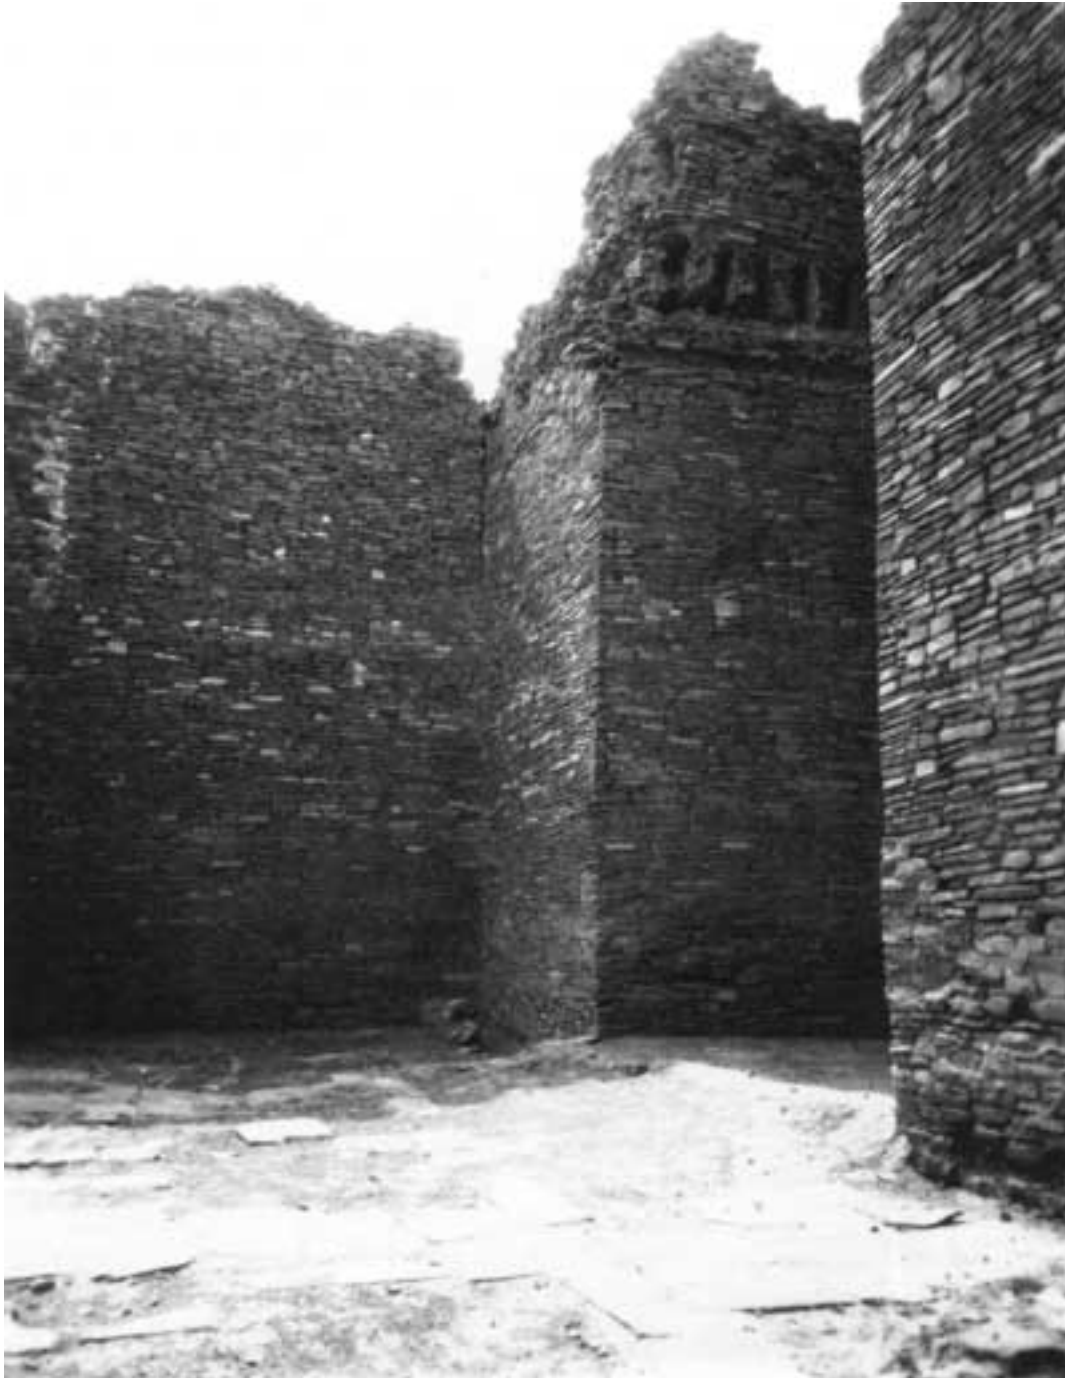
Figure 54. The west transept and apse of the church of Quarai in the fall of 1937. In the northeast corner of the transept the west side altar base still stands, and closer the last traces of the main altar stairs remain at the west side of the apse. The socket for the stair bannister on the corner of the apse has been filled. In the foreground at the lower right corner of the picture, the top of the east side altar base is just visible. The surviving flagstone of the transept can be seen, and the rectangular areas of bare dirt in front of each of the altars. High on the west wall of the transept, patches of white wall plaster can be seen. Some of this patch still survives today. High in the apse the horizontal socket of the retablo support beam runs beneath the sockets of the apse roof vigas. Above these, the severe collapse around the sockets of the transept roof beams is visible. This collapse was caused by the burning out of the main viga that ran across the north face of the transept just under the corbels of the transept vigas. It supported

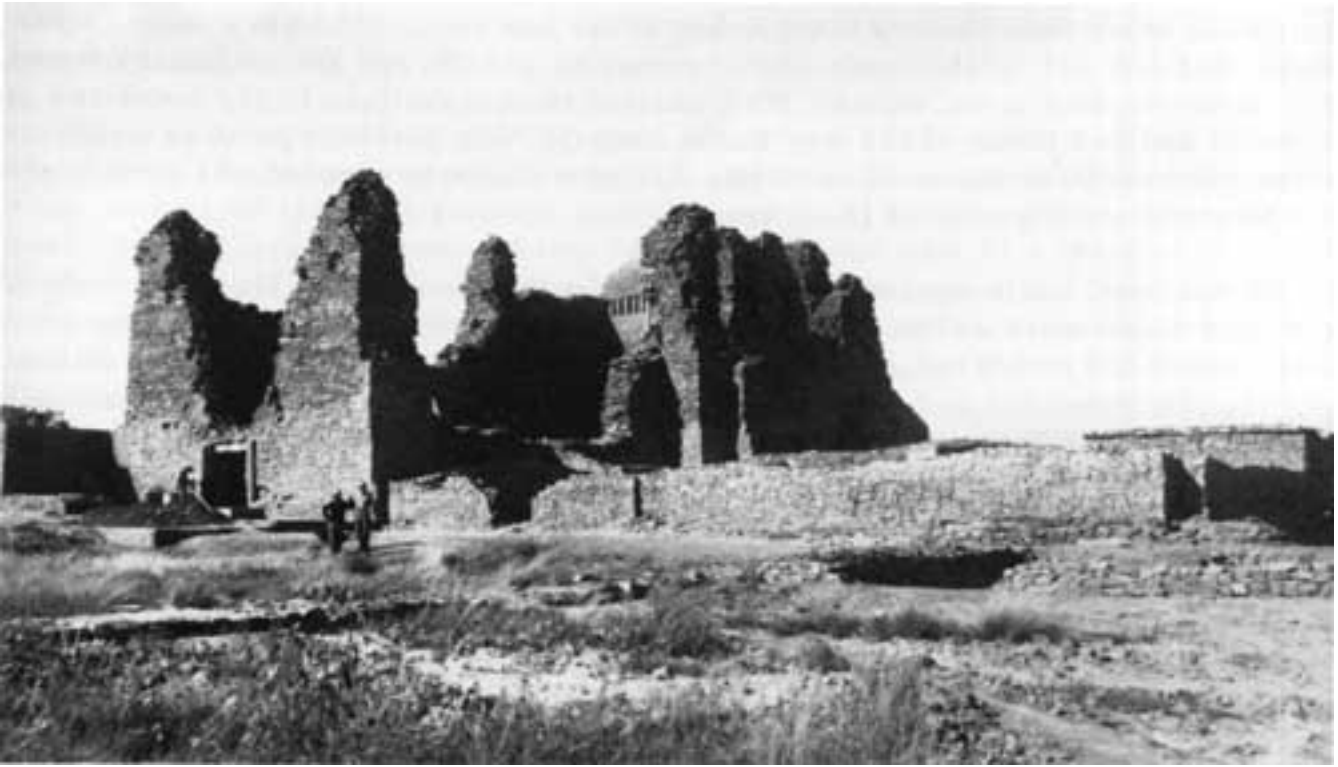
Figure 61. Quarai during the stabilization by Wesley Hurt, October, 1939. At this date the terrace in front of the church had been restored and the north wall of the west transept stabilized and built up to the height of the adjoining tower. The scaffolding has been moved into the apse. One strut of the scaffold is visible at the left edge of the tower at the south side of the east transept.
Courtesy Museum of New Mexico, # 6666.

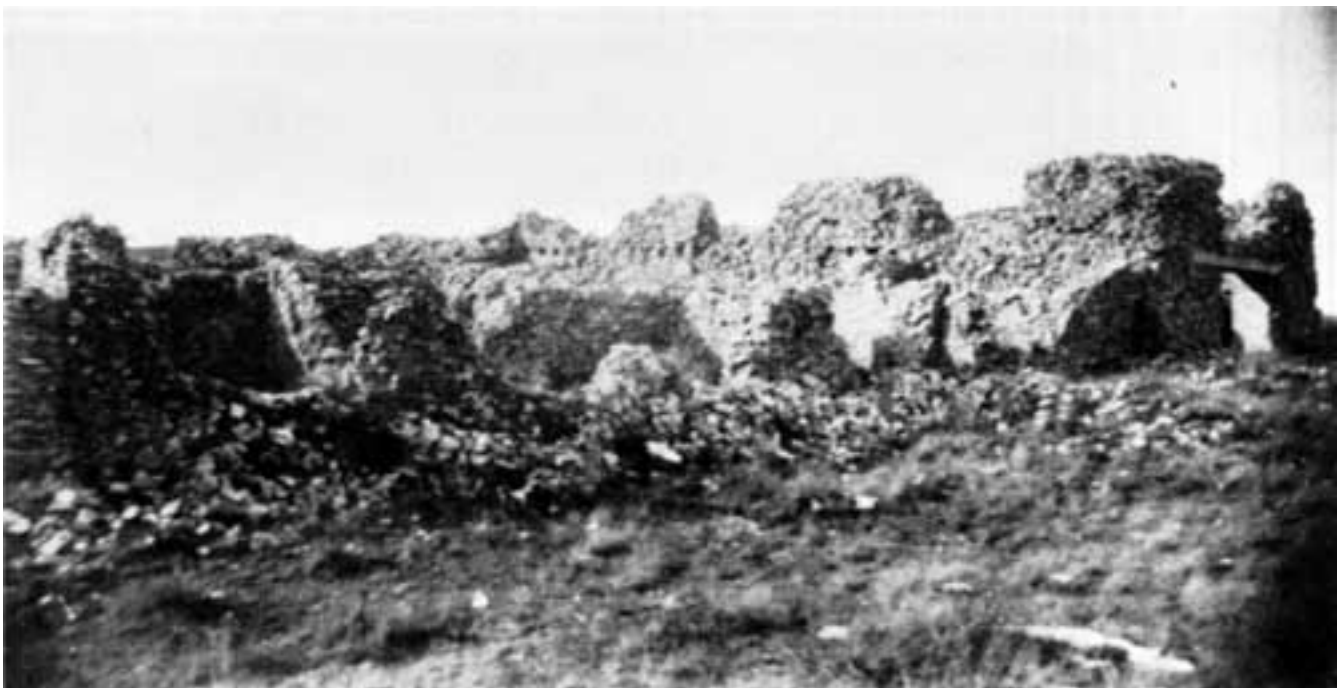
Biblioteca Apostólica Vaticana, Archivo Fotografico, #14116-49, courtesy Charles Lang.

Figure 39. San Buenaventura in 1883, as photographed by Bandelier. The door and

window openings high on the wall of the church are still sharp-edged and the tops of the walls flat, straight lines.

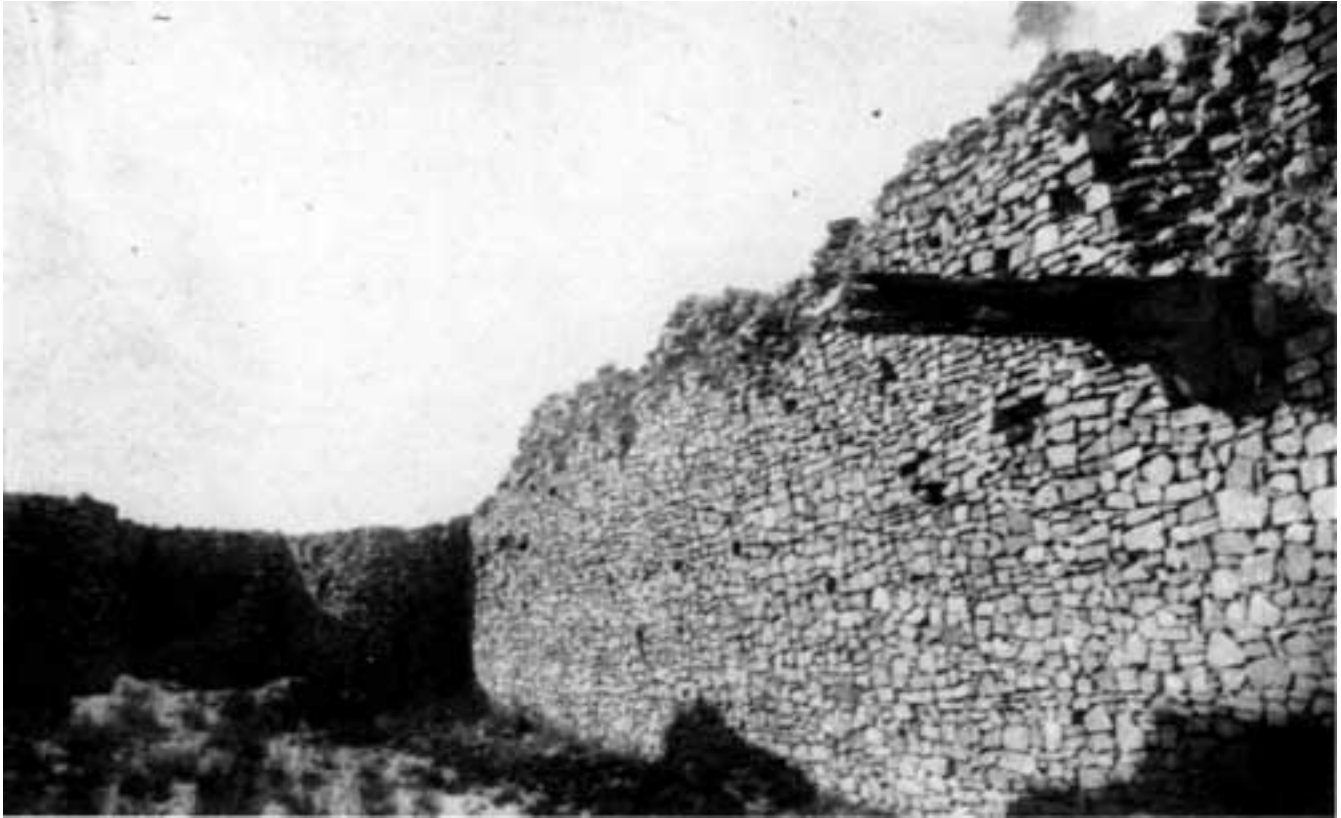
Biblioteca Apostólica Vaticana, Archivo Fotografico, # 485-50, courtesy Charles Lang.

Figure 40. The interior of the church of San Buenaventura as Bandelier saw it in January, 1883. The right stub of the viga that formed the main support for the choir loft, and its corbel, are both still set into the north wall. These are the same corbel and viga sketched by Morrison in 1877. The entablature running from the viga to the front wall of the church, however, has been removed. The rubble fill against the walls in the nave of the church is only 1-1/2 to two feet higher than the present floor surface.

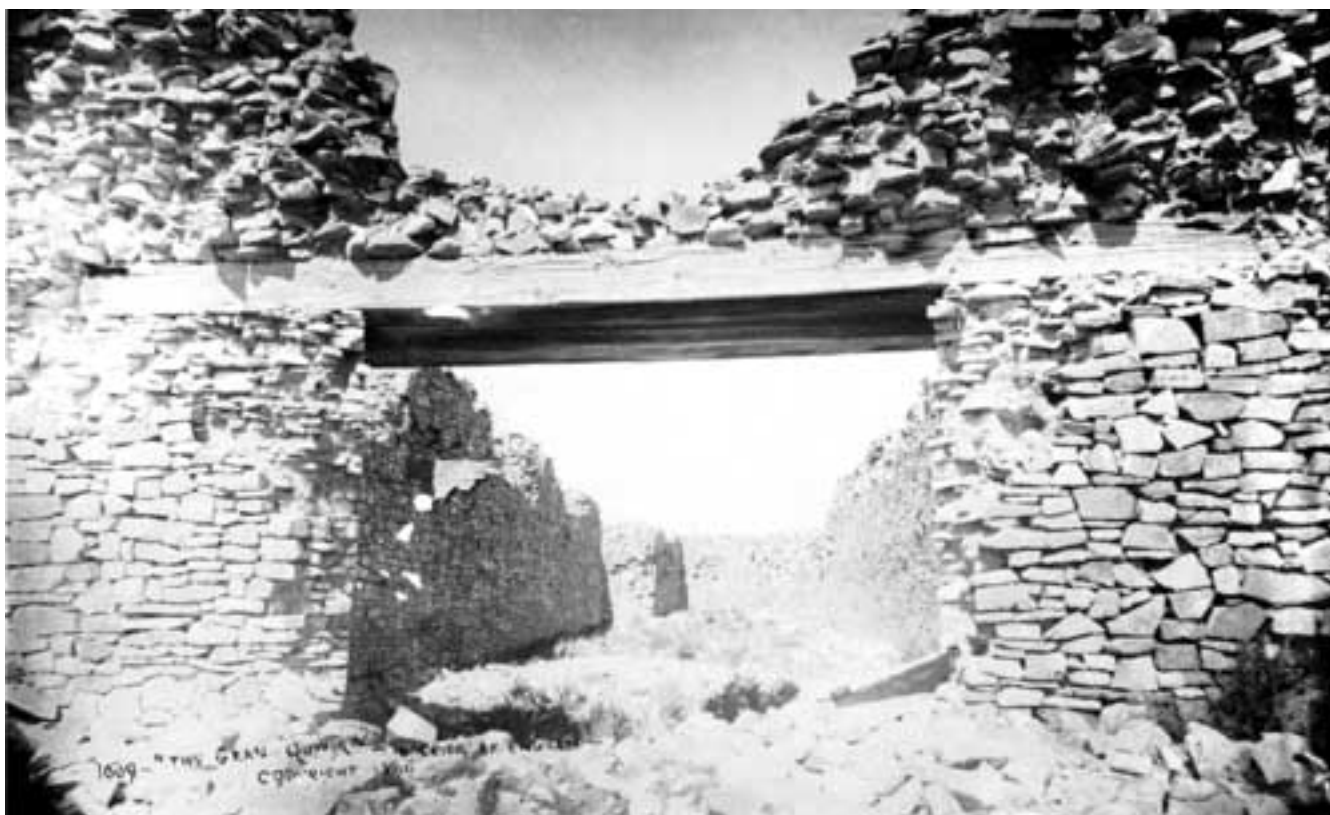
Courtesy Southwest Museum, # 24825.

Figure 42. The interior of the church of San Buenaventura in 1890. Lummis

photographed the south end of the main viga that supported the choir loft, with its corbel, and the outside of the lintel over the front door of the church. It was this photograph that allowed the identification of the beam presently over the door as the beam closest to the camera in the lintel, by the distinctive pattern of knots and cracks.

⁷⁴ See the photograph by Lummis, SWM # 24836, figure 42.

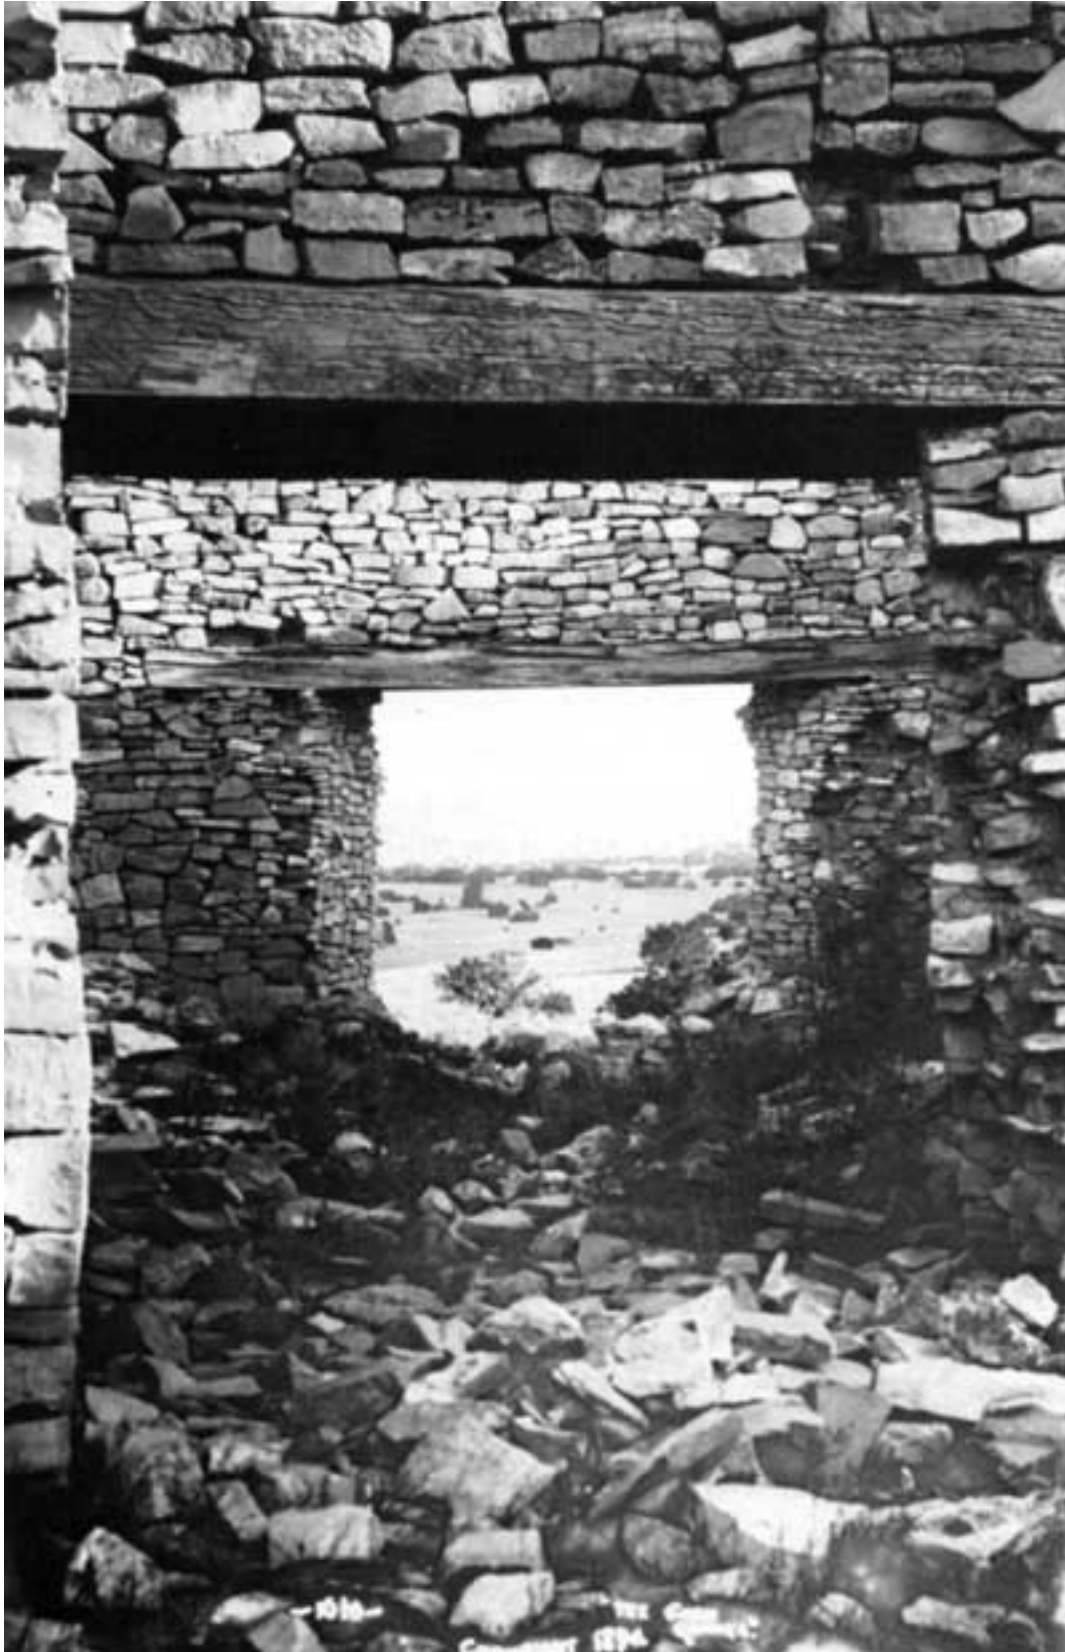
Figure 43. The doorway from the church of San Buenaventura into the sacristy in 1890. This photograph by Lummis shows the decorative carving on the beam over the doorway, and the appearance of the sacristy window.

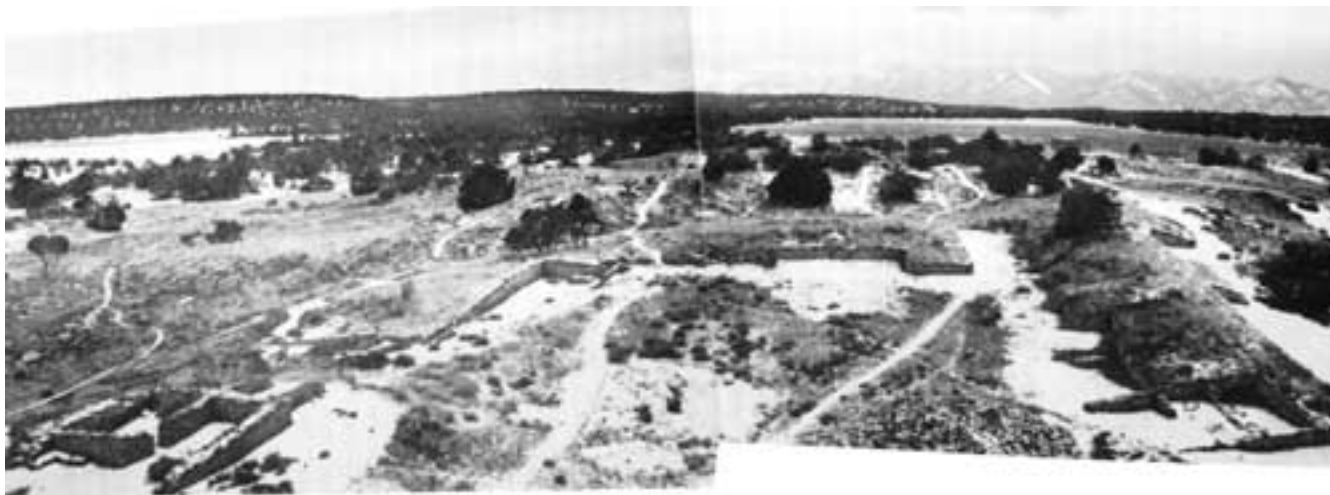
Figure 55. The pueblo of Quarai west of the church. This is the appearance of mounds H, I, and J after Hurt completed the clearing of the rubble from the outlines of the mounds in 1939.

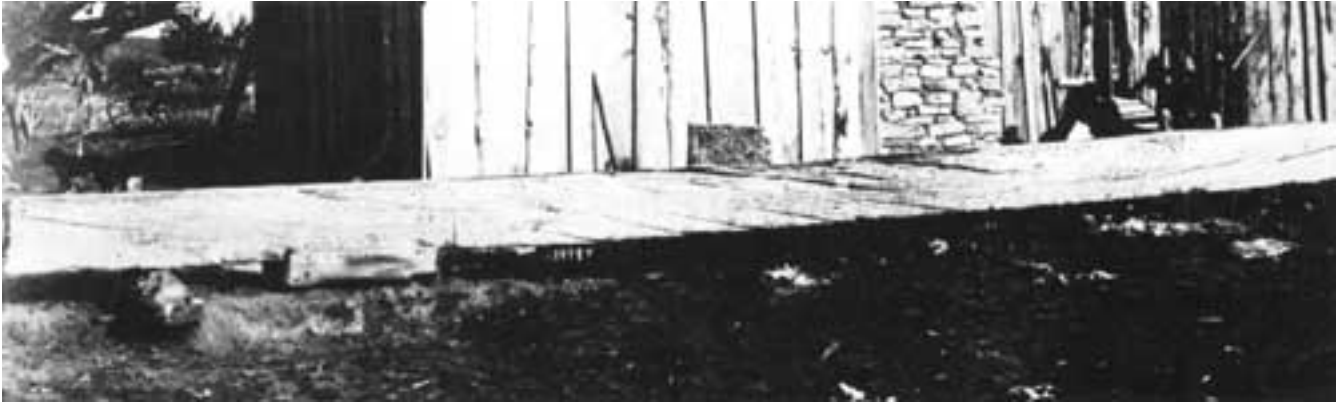
Figure 45. A beam from San Buenaventura. It was photographed in 1896 in front of a shed of the Dow House next to the post office of Gran Quivira. This beam has decorative carving on the middle section of the face towards the camera. The carving, cracks, and weathering all match the details of the beam in the engraving in the previous illustration, making it very likely that this beam had been removed from the inner face of the facade of San Buenaventura between 1890 and 1896.

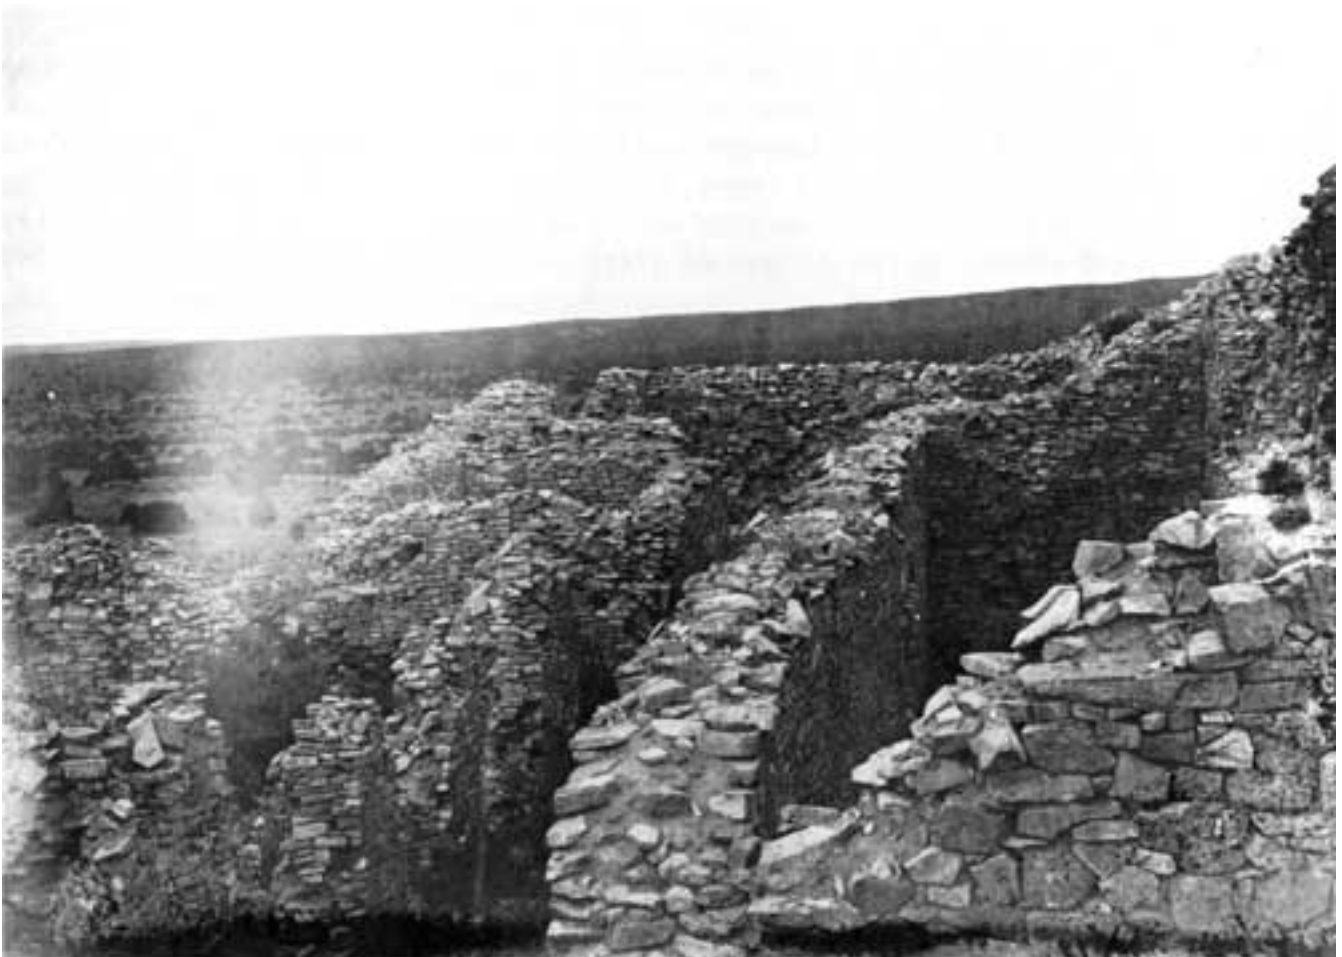
Figure 46. The north portion of the convento of San Buenaventura about 1900. The room at the right is room 16, and the north corridor runs diagonally across the center of

the picture to the sacristy in the background. This photograph is of great importance, because it records the last surviving traces of the roof of the convento. Six beam sockets can be seen in the top of the wall between the sacristy and room 15. The second socket from the left still has the stub of a beam set in it. The sockets and beam stub survive here because the thickness and height of the sacristy wall kept it from collapsing to a level below the beam sockets of the convento, as happened everywhere else in the convento except along the south side of the church. The sockets in room 15 were about 10 feet above the present floor level, three feet lower than the sockets in the south wall of the church in rooms 1 and 16.

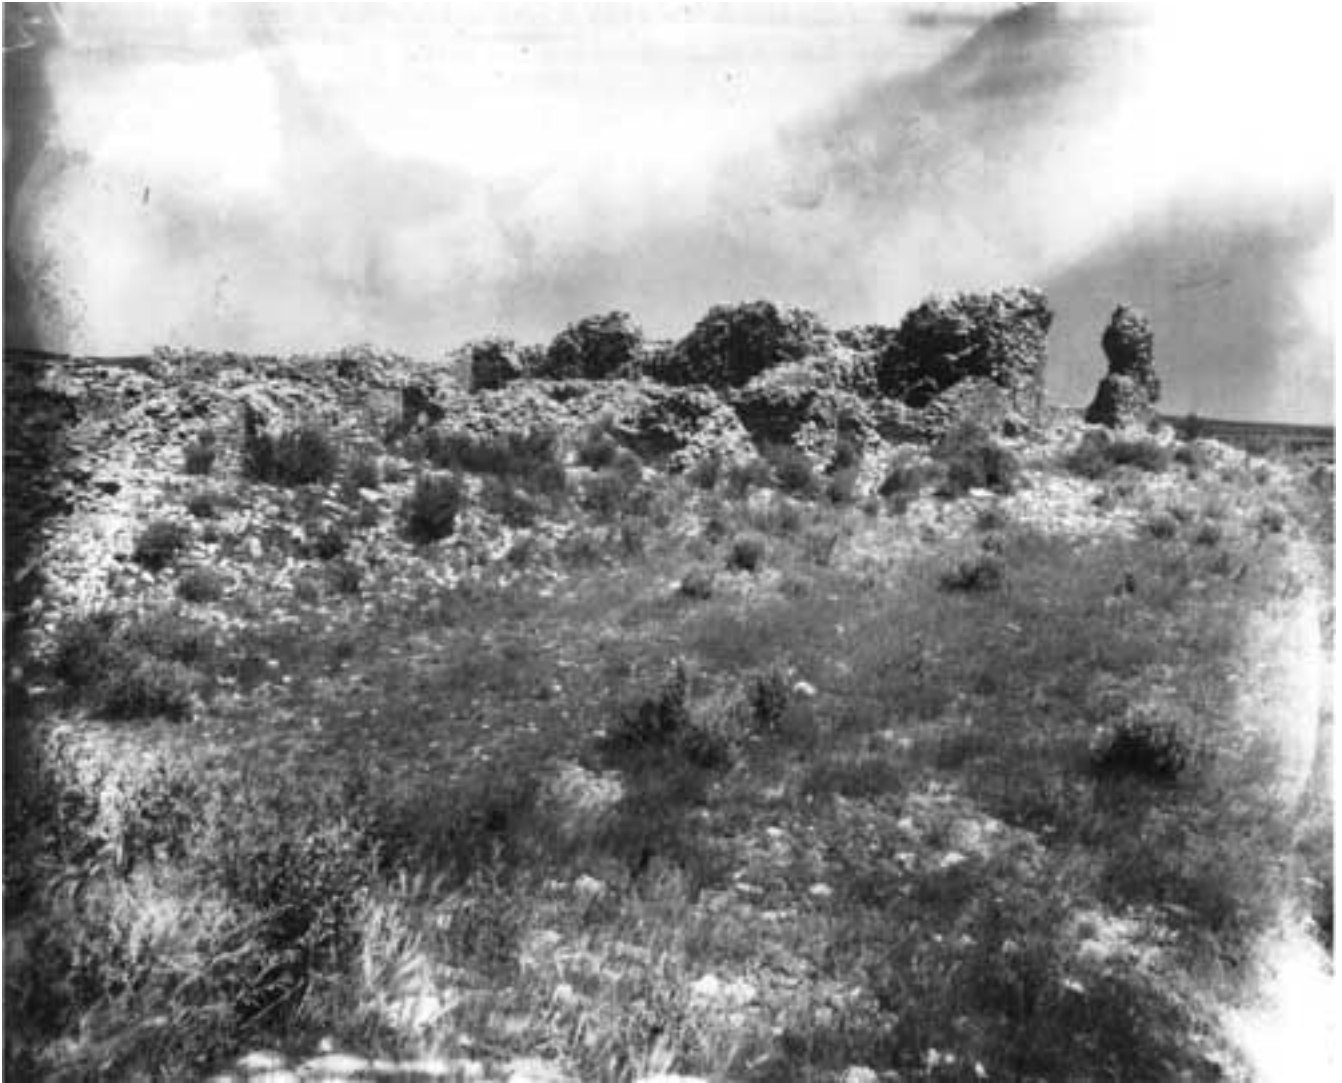
Figure 56. San Buenaventura about 1920, taken from almost the same spot as Bandelier's photograph in 1883. The tremendous loss of wall fabric through the theft or, in a few cases, the decay of lintels, is obvious.

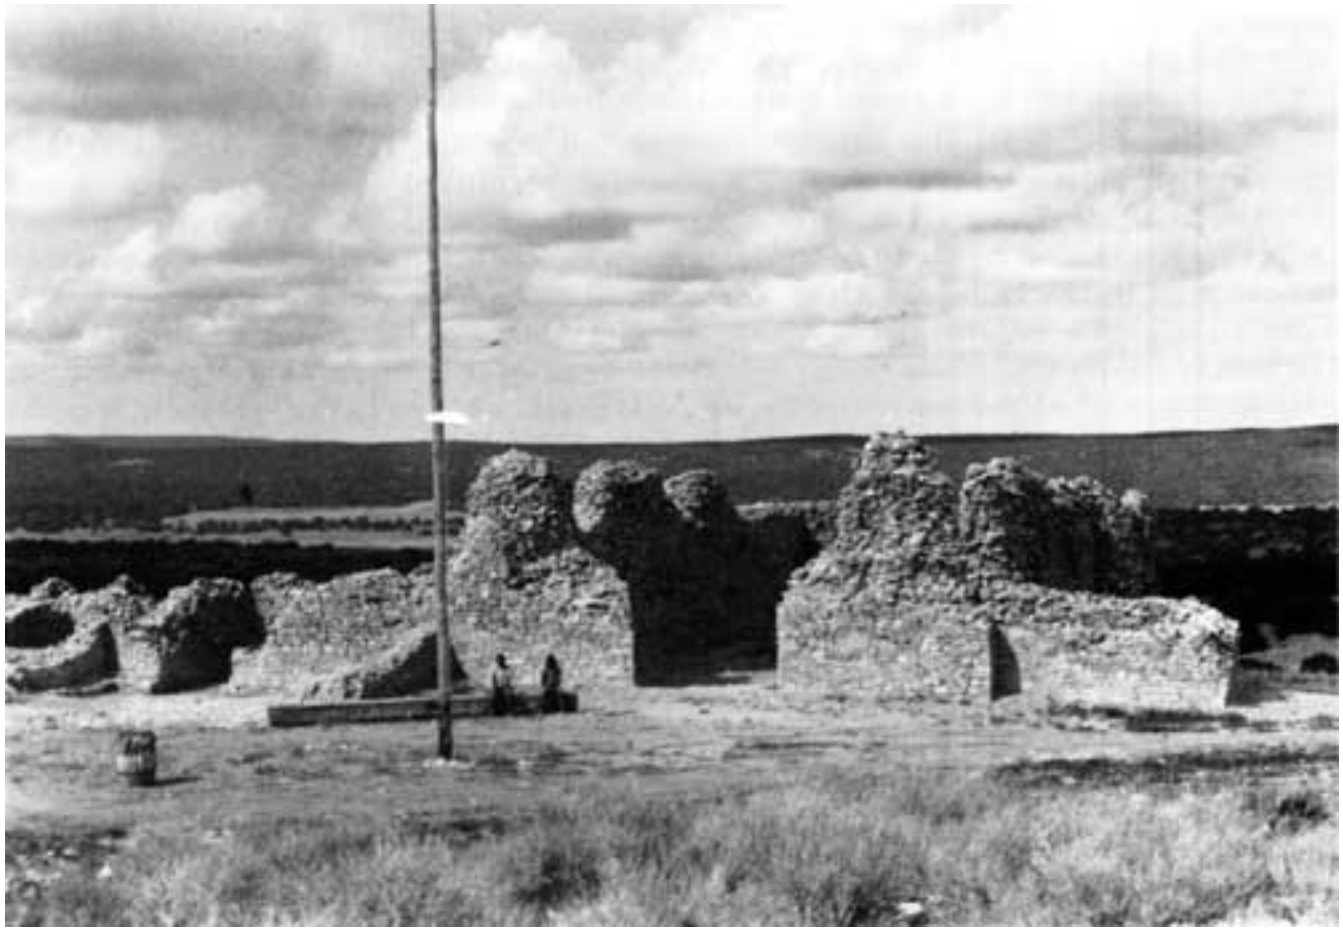
Courtesy National Park Service.

Figure 63. San Buenaventura in the 1940s. The lintel beam has been returned to the site, and is on the ground behind the flagstaff with two people sitting on it.
