Landslide-Induced Wave Hazard Assessment—Tidal Inlet, Glacier Bay National Park, Alaska

Abstract. An unstable landslide perched above the northern shore of Tidal Inlet has the potential from seismic or climatic trigger of rapidly moving into Tidal Inlet and generating large, long period impulse waves. Numerical simulations of landslide-generated waves indicate that near the mouth of Tidal Inlet, wave amplitude would be greatest within approximately 40 minutes of the slide entering water. Significant wave activity would continue in the western arm of Glacier Bay for more than several hours, while wave amplitudes would decrease in deeper waters. Severity of impact to vessels in the region depends on the size and speed of the slide and on which part of the wave ships would encounter.

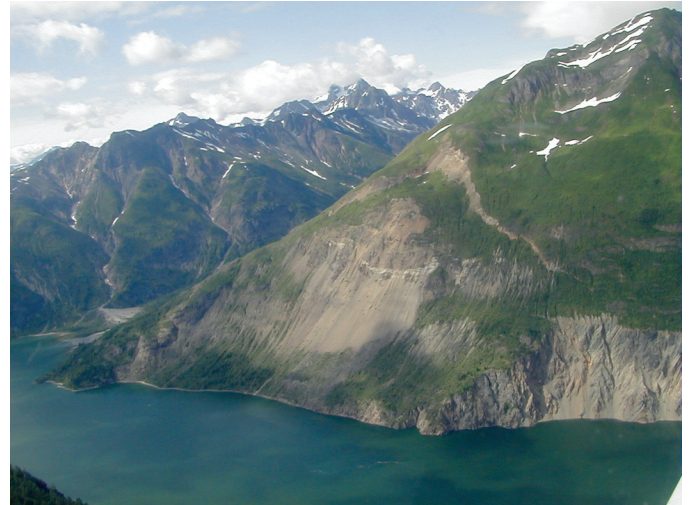
Figure 1. Detached landslide perched above the northern shore of Tidal Inlet, Glacier Bay National Park, Alaska. Photograph taken July 12, 2002.

The main scarp has a fairly uniform range of height, 20–40 m, suggesting that the body of the landslide detached rigidly. Within the main body of the landslide the surface topography is severely disrupted by rotational blocks with

prominent back-facing scarps. In the upper portion of the main body the exposed portions of these blocks are within glacial till, but further downslope bedrock can be seen within the blocks. The thickness of the landslide was estimated to determine the total volume of material that could enter Tidal Inlet. The stability of the landslide was evaluated by examining the features and by measuring movement of established reference points using GPS. However, on the right (west) flank of the landslide, two closely spaced sets of parallel open fissures were found in surficial soils extending downhill from the termination of the main scarp, and pointing downslope towards the toe of the landslide. These fissures appeared relatively fresh within generally weak soils and would not be preserved for more than a year.

The crown of the main scarp is arcuate, but irregular along its length, with the highest part of the crown at an elevation of about 700 m. The estimated distance from the base of the main scarp downslope to the center of the toe of the landslide block is about 500 m and the maximum slide width is about 1,230 m. With an estimated maximum depth of 30 m of the surface rupture, the estimated volume of the Tidal Inlet landslide ranges from 5 to 10 million m³.
