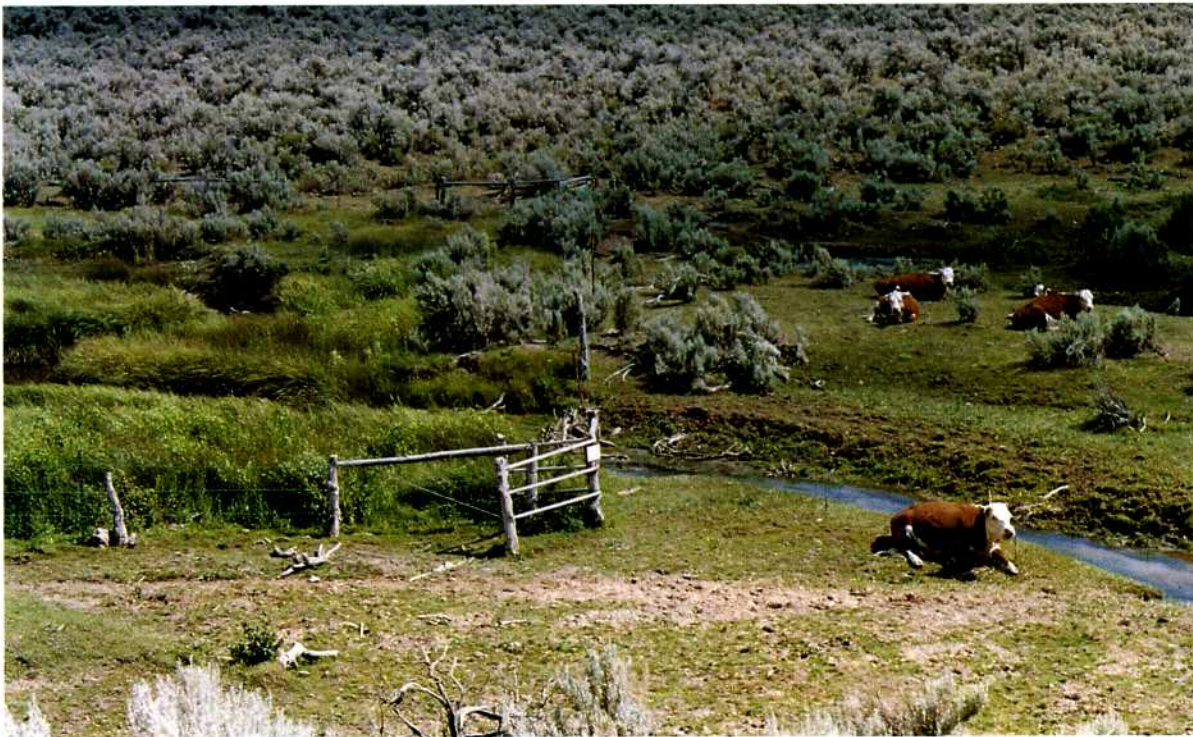
Riparian conditions inside and outside the Big Creek riparian restoration demonstration fence, September 1981.

Streambanks became more stable. The stream narrowed and deepened. The riparian area widened due to the raised water table.

However, fish habitat improvements within the fenced area were counteracted by poor watershed conditions upstream. Instream structures trapped large amounts of sediment from upstream erosion. Instream structures outside the enclosure ceased to function and were washed out because of unstable streambanks caused by poor grazing management.
