Palmerton Zinc Pile

Compost/Biosolids Application to Revegetate Defoliated Areas

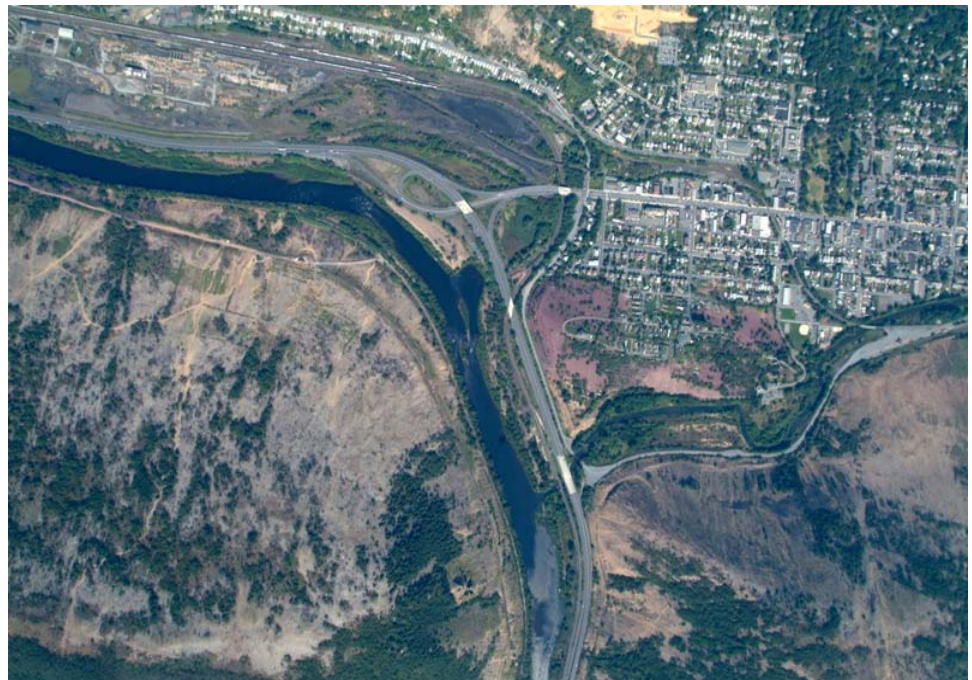
Figure 3: Palmerton Zinc Superfund Site Aerial View
