Simulations Conducted in House in Bethel, Vermont

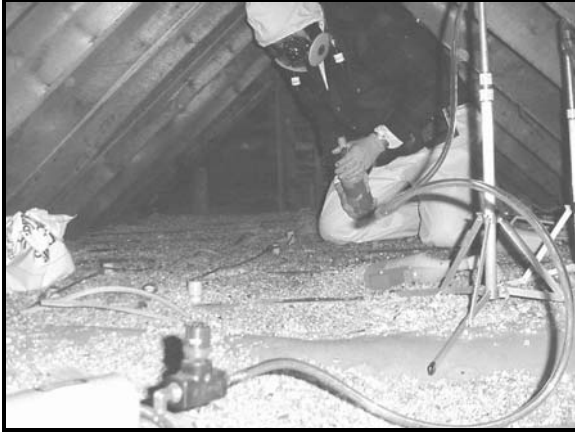
Figure 33: Wet Simulation in Attic of Vermont House - Versar Employee Spraying Water on Attic Insulation During Simulation.

Notes: Portion of stationary ambient air monitoring pump is visible in foreground. Personal air monitoring cassettes can be seen on Versar employee, oriented toward the breathing zone.

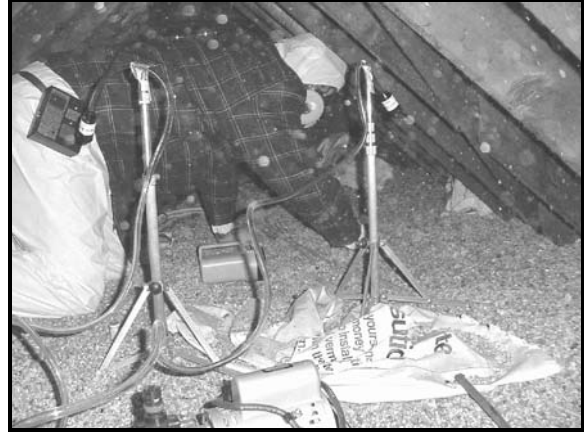
Figure 34: Dry Simulation in Attic of Vermont House - Versar employee manipulating attic insulation during simulation.

Notes: Portion of stationary ambient air monitoring pump is visible in foreground. SKC low volume air pump visible on belt of Versar employee.

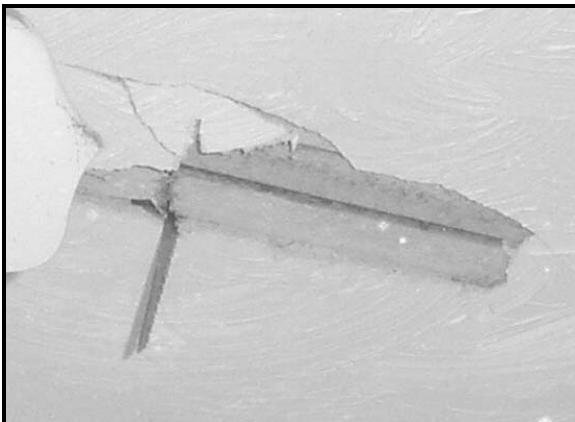
Figure 35: Hole Being Cut in Ceiling of Vermont House - View from living space, hole being cutting from attic side.

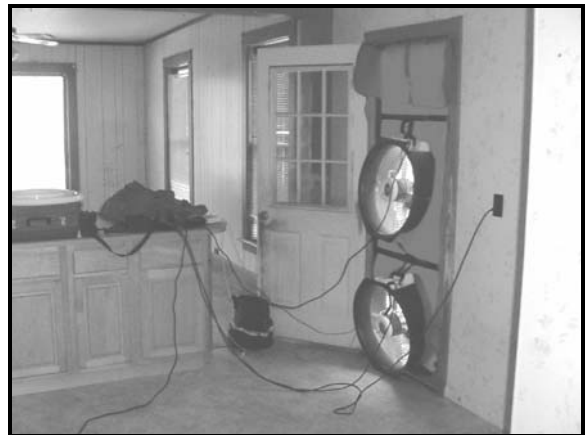
Figure 36: Equipment for Blower Door Test Installed in Door of Vermont House.
