Safety Hazard Alert

Vehicle Tool Compartment Explosion

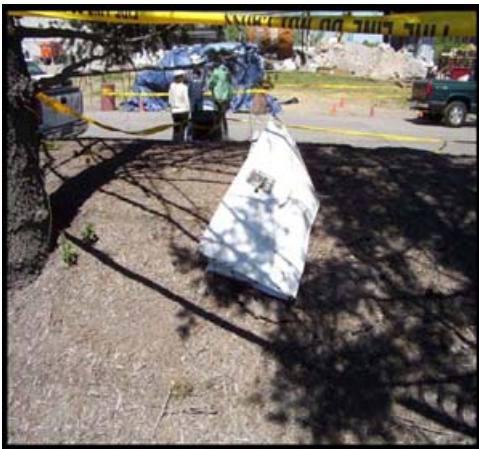
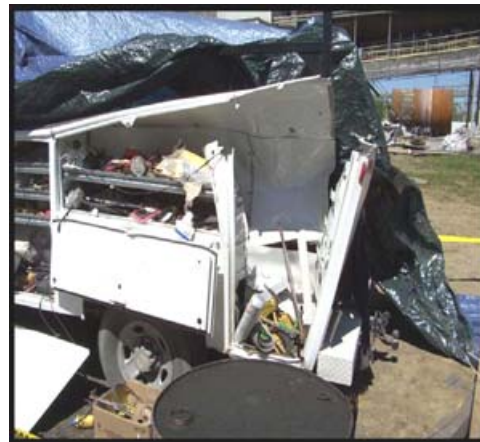
On May 7, 2005, a contractor employee received injuries when an acetylene cylinder exploded at a cement operation. The victim and a co-worker had just parked their utility body service truck and used a 12 volt, wireless remote, key fob to unlock the tool compartments. When the lock mechanism activated, an explosion occurred inside one of the tool compartments propelling the door approximately 40 feet. The employee closest to the truck suffered a broken finger. Fifteen days prior to the accident, a full, 20 pound acetylene cylinder (that did not have a protective cover) had been placed inside the tool compartment. The cylinder was found to be $\frac{3}{4}$ full, after the accident. Tests showed that the valve would leak if slightly bumped. As a result of the accident, the manufacturer of the utility bodies will attach stickers to all utility body doors constructed in the future warning persons against storing flammable materials inside the compartments.

- Ensure that flammable gases or liquids are not stored in any enclosure or vehicle that utilizes wireless, remote door locks.
- Periodically conduct tests to identify leaks on gauges, hoses, and compressed gas cylinders.
- Ensure that compressed gas cylinders are stored in ventilated areas and protective valve covers are installed when the cylinders are transported or stored.
- Train all personnel regarding safe handling, use and storage of flammable liquids and compressed gases.
