Middle North Umpqua Watershed Analysis

Middle North Umpqua/Old Fairview Watershed Analysis

5th Field Watershed and 6th Field Subwatershed

Roseburg District BLM

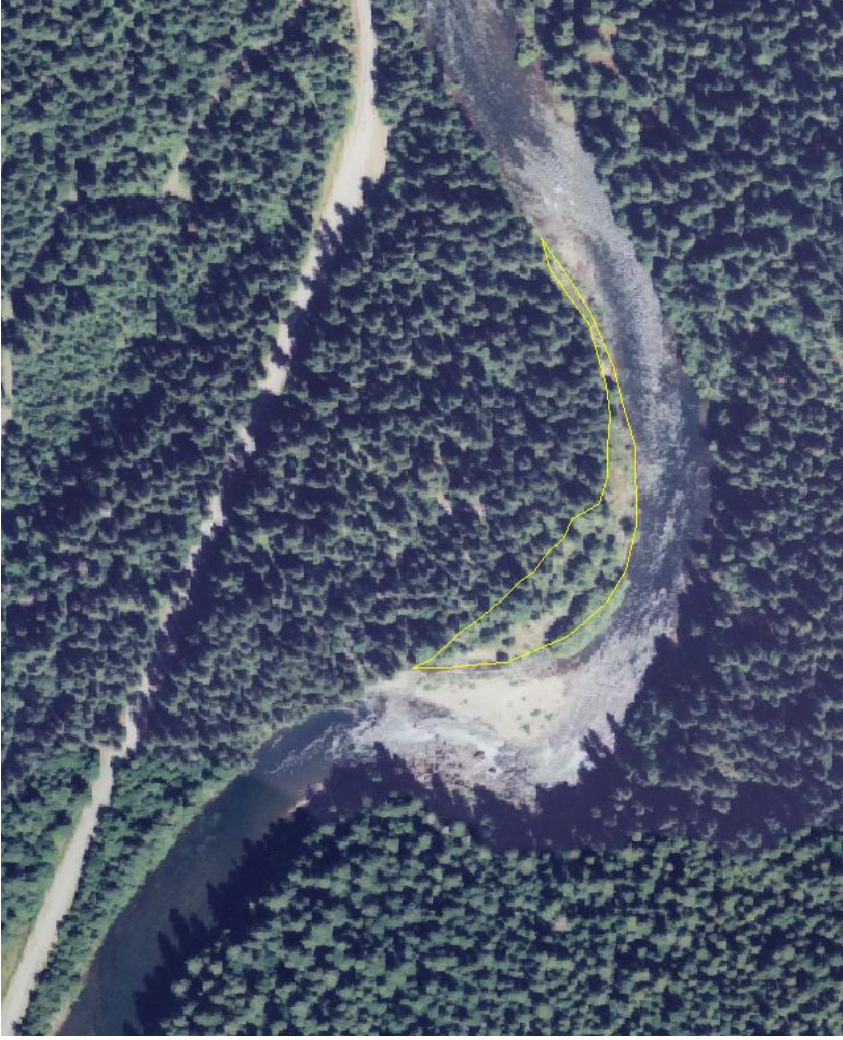
Susan Creek Outlet Island, Side Bar and Secondary Channel

Susan Creek Campground, Island, Side Bar and Secondary Channel: Large side bar, small mid-channel bar and secondary channel. Side bar is dominated by large, dense populations of various non-native plants, particularly Meadow Knapweed, Himalayan Blackberry, Trefoil Birdsfoot, and Everlasting Pea (see area outlined in yellow below). Some French Broom is also present. The mid-channel bar currently appears to be populated primarily by willow.

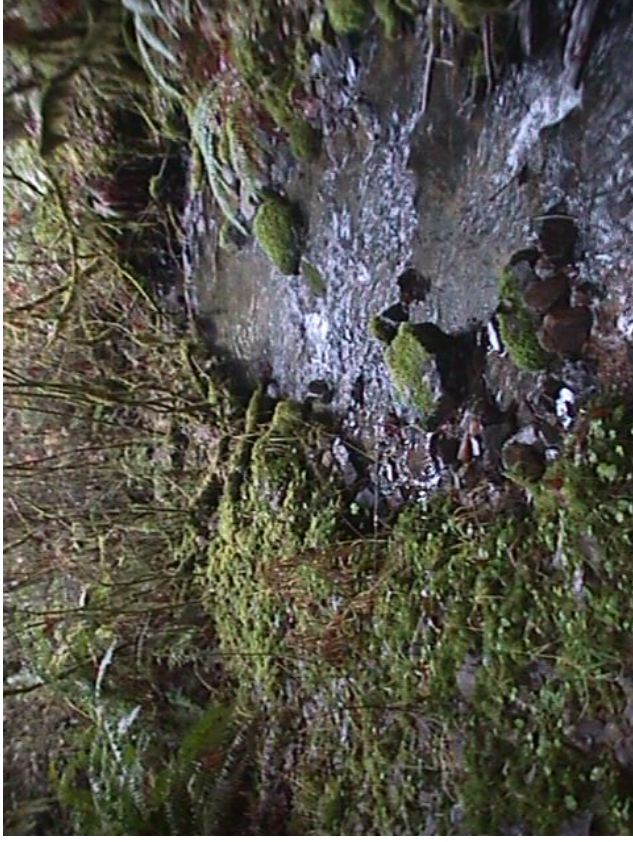
A short, 0.4 mile reach of non-fish bearing, semi-alluvial habitat was identified in Creek A (photo, below). No habitat data are currently available for this reach. The substrate is boulder and cobble dominated.

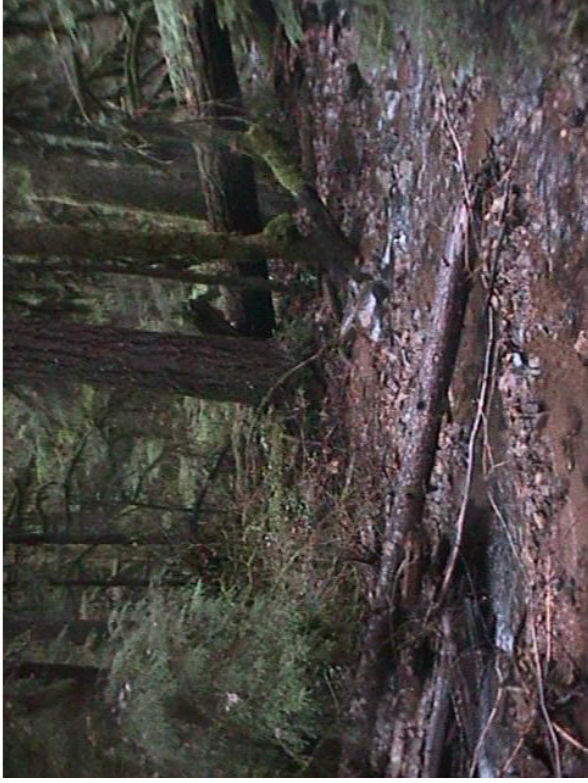
Upper Bob Creek, Middle North Umpqua tributary. Much of this reach (just above BLM road #207) was apparently scoured down to bedrock in the early 1980's, probably as a result of log removal and/or a landslide originating in the harvest unit directly upstream. Although the stream is incised, the channel and floodplain have reconnected in places due to an abundance of large trees, newly recruited LWD, and resulting aggregation of the stream bed.

Within Old Fairview subwatershed, the riparian corridor of Upper Bob Creek (see Figure 6-2) is a unique patch of unharvested riparian habitat. Obligate and facultative wetland flora are generally absent here, however, perhaps because the valley floor is well drained and/or sloped just enough to lower the water table and prevent lower frequency floods from saturating much of the flood prone area and perhaps, in part, because the channel has been disconnected to some extent from its floodplain by previous debris flows. Although much of the reach is incised, pockets of relatively clean gravels and cobbles were observed in January of 2001 (see photographs below). This reach is not fish bearing due to a series of waterfalls farther downstream.

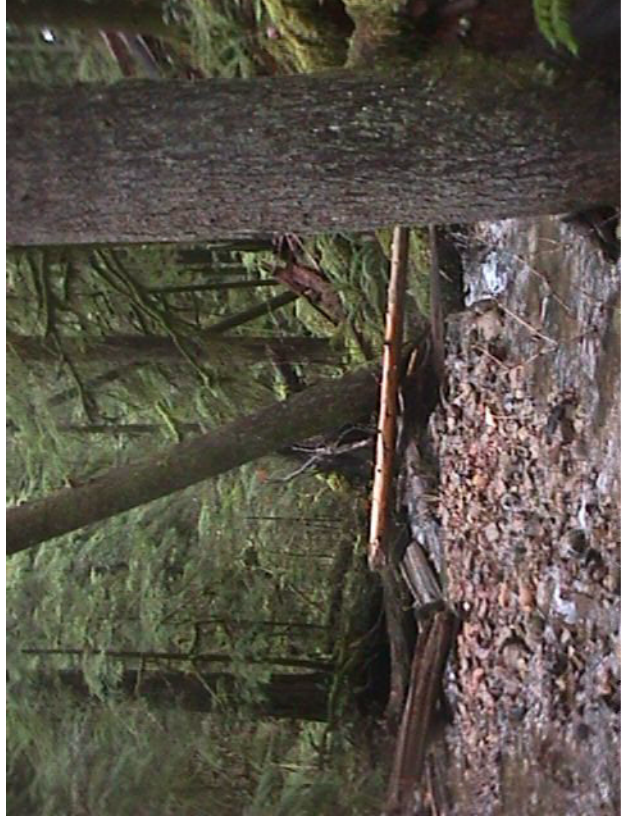
Small debris jam is effectively trapping gravels and cobbles, creating potential habitat for macroinvertebrates and the amphibians that feed on them.

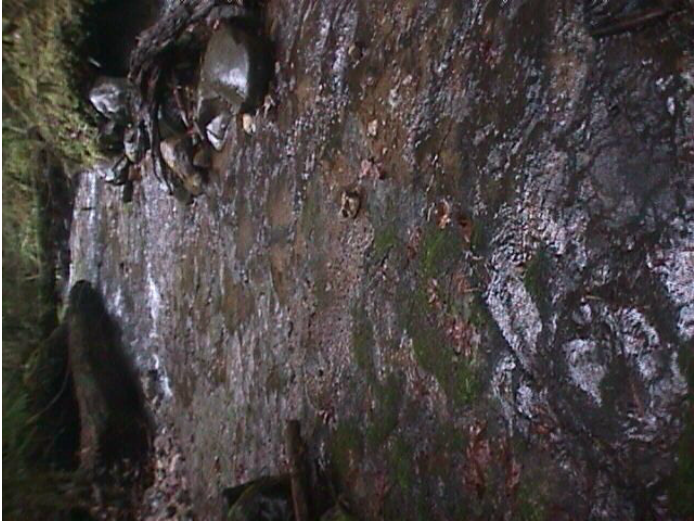
Further downstream, evidence of a debris flow is still apparent where the stream has been scoured down to bedrock. Gravel has failed to accumulate here, probably due to a lack of large wood in this section.

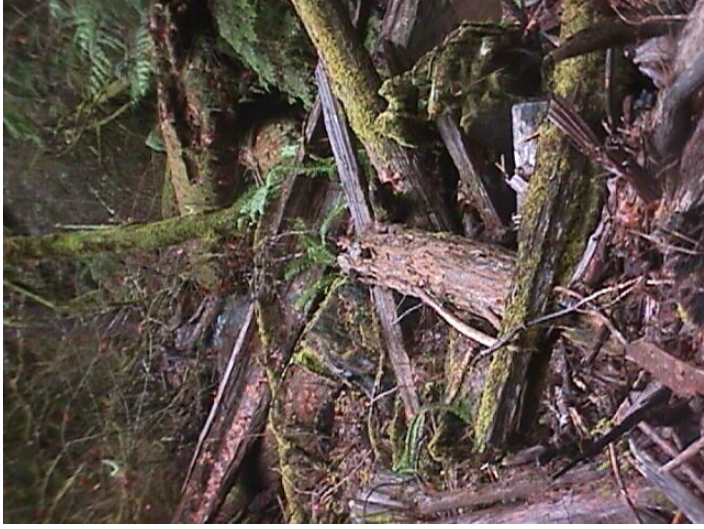
Just below the upper harvest unit, a new logging debris jam has formed.

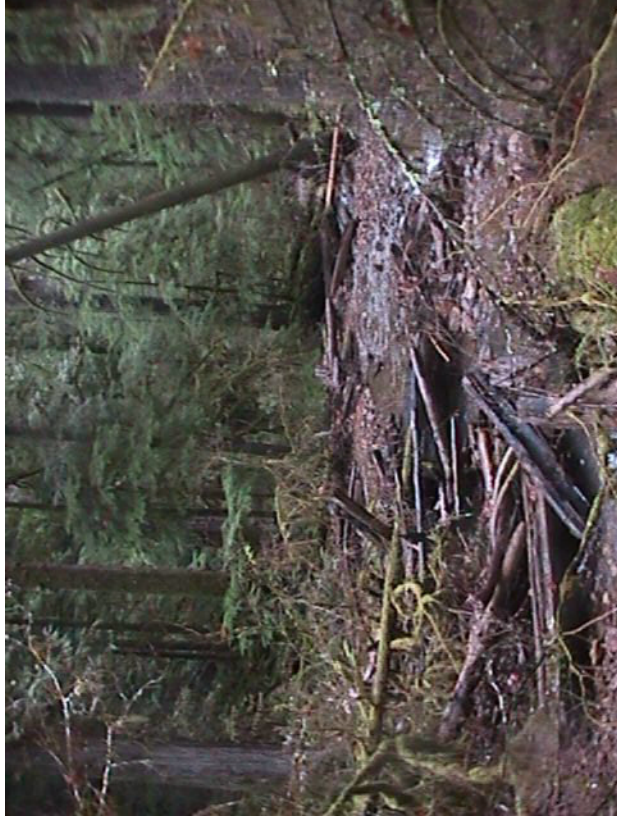
Looking downstream from debris jam. The log jam has trapped a large volume of sediment upstream. A dam break could result in another debris flow.

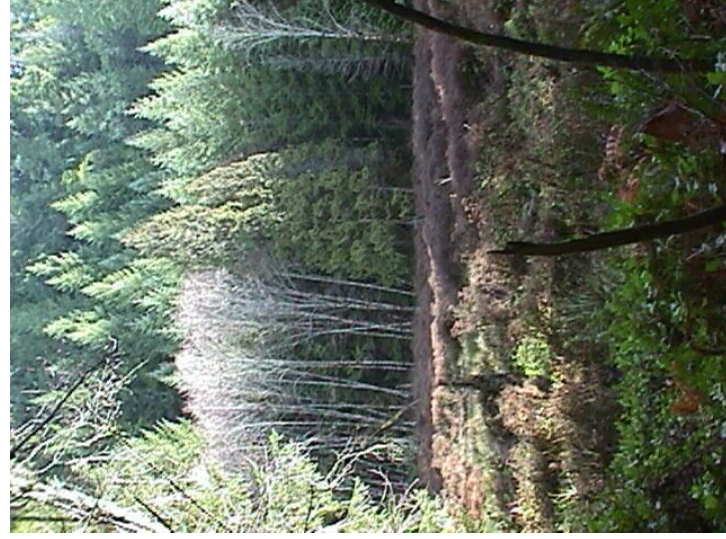
The beaver pond complex near Hill Creek (see photo, below) appears to be a unique habitat type within the Old Fairview. Formed by beaver activity along a small, 2nd order stream, the complex consists of a network of wet meadows composed of a mix of open ponds and areas dominated by various grasses, sedges, rushes and/or shrubs. An abandoned logging road bed encircles the lower part of the complex. No botanical or wildlife surveys have been conducted in this area.
