Watershed Analysis  
North Bank WAU  
(Watershed Analysis Unit)

Roseburg District BLM

January 1997

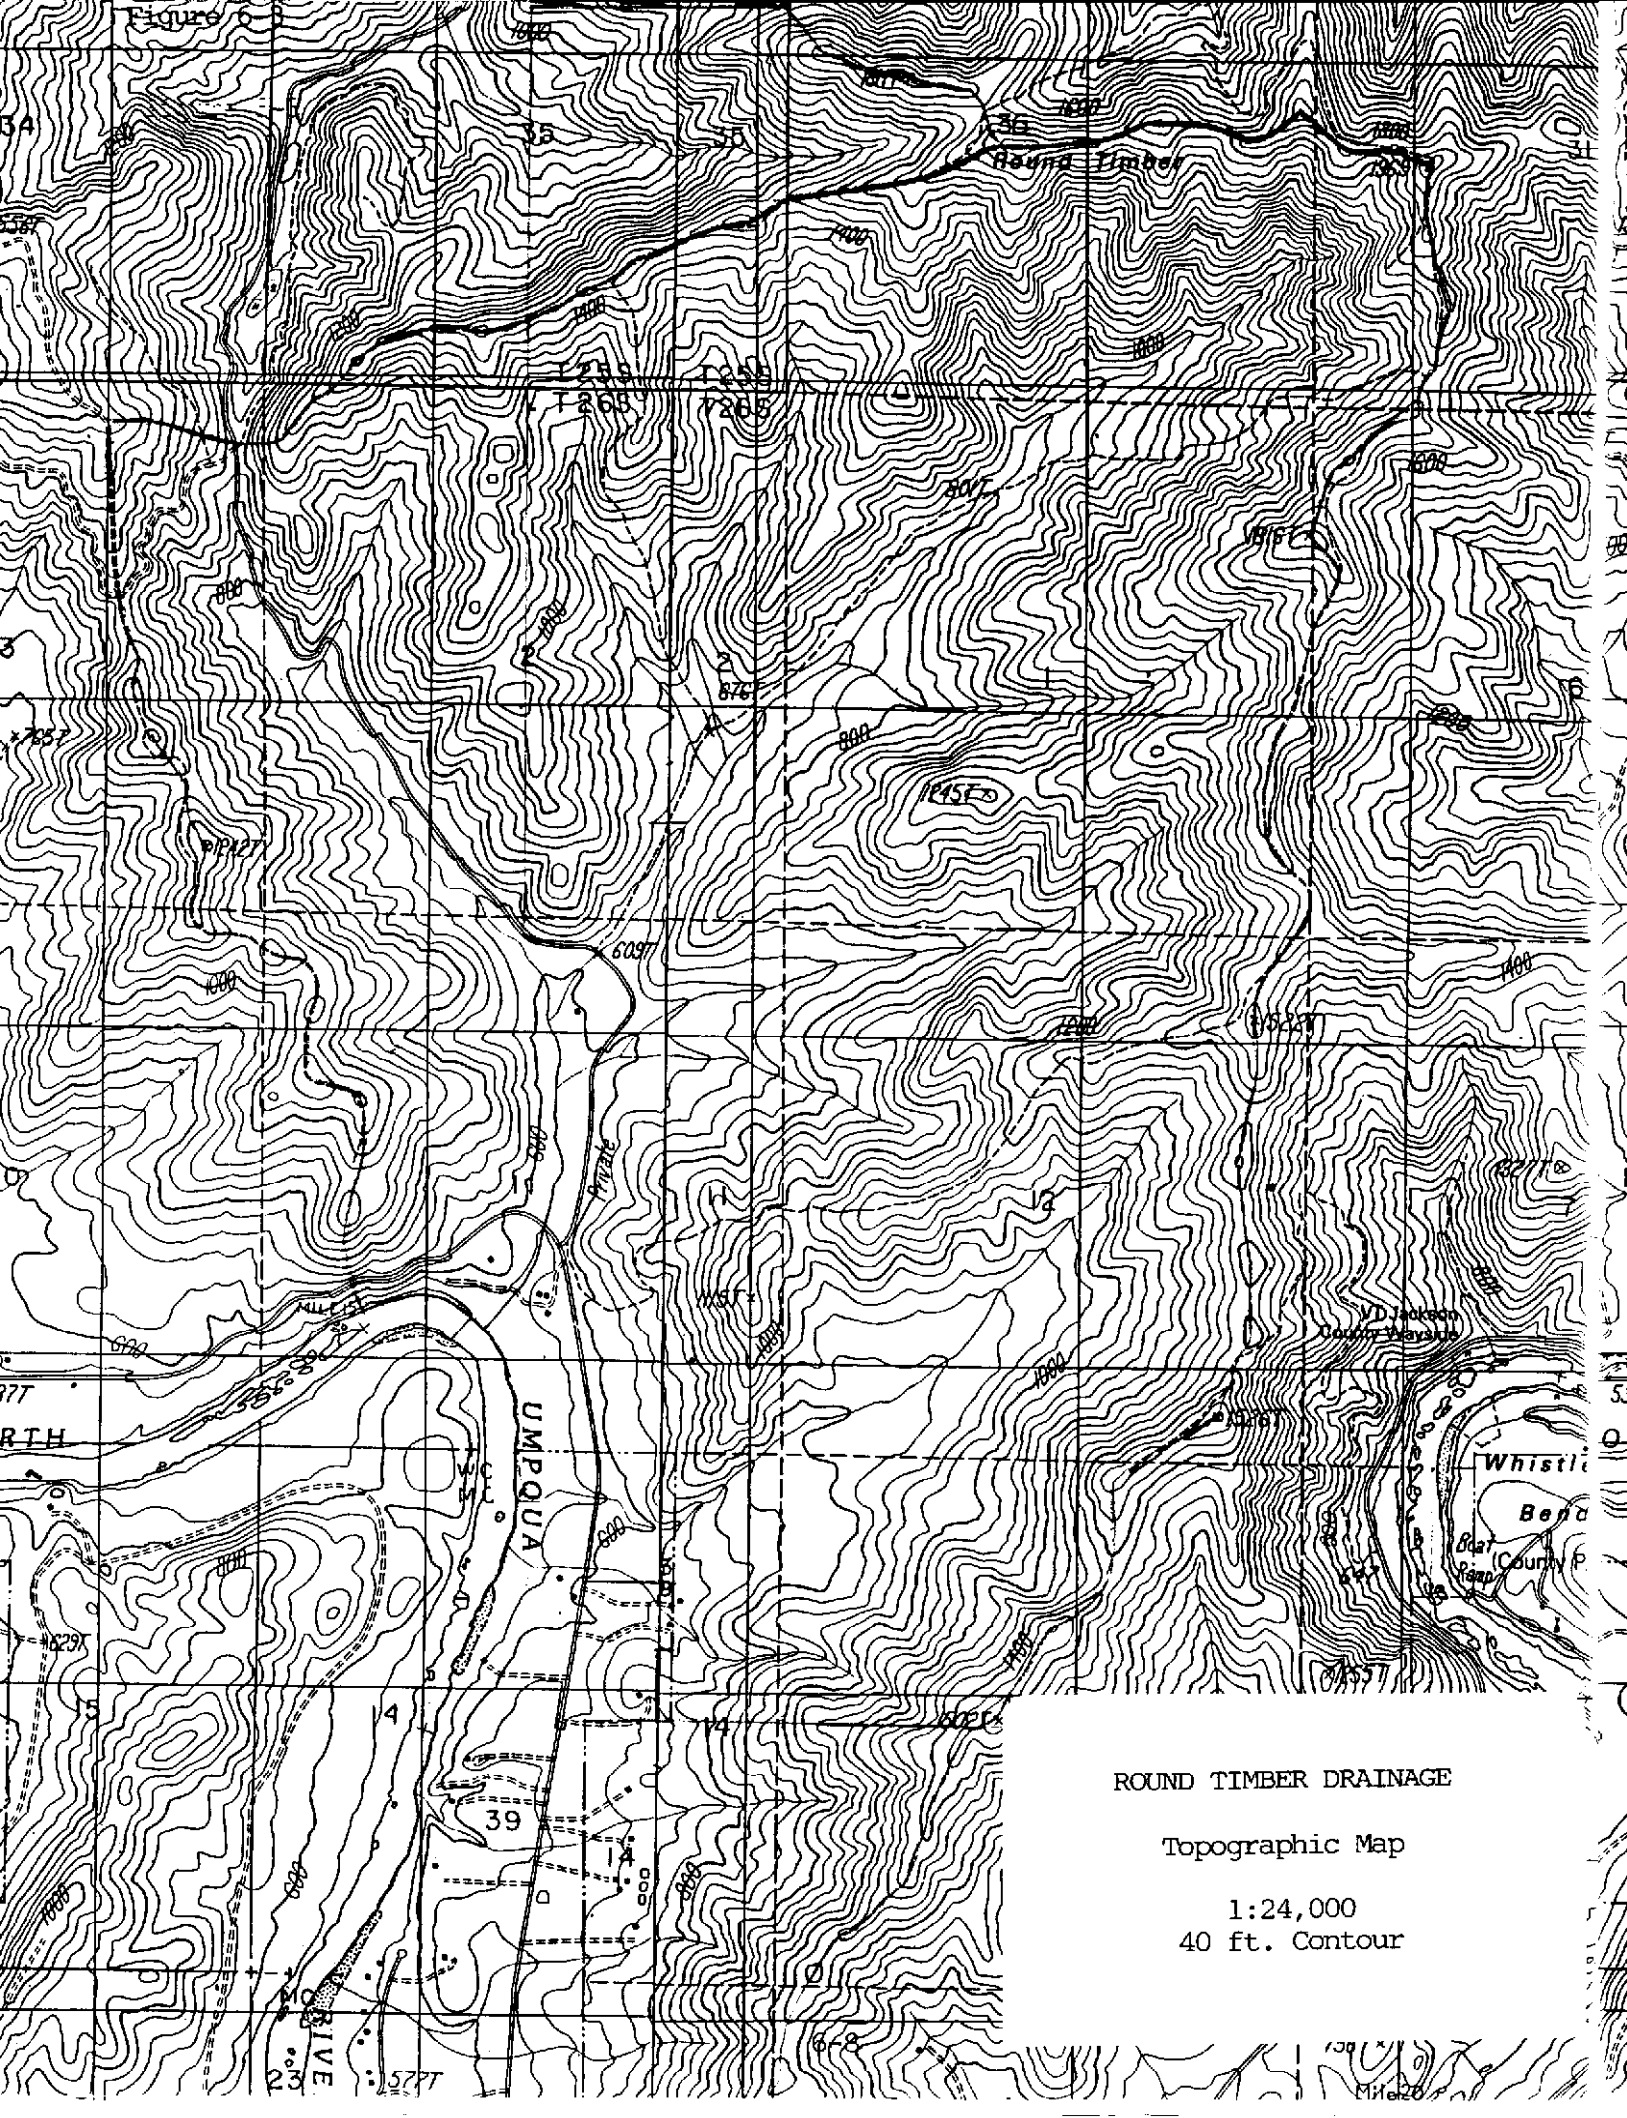
Figure 6

ROUND TIMBER DRAINAGE

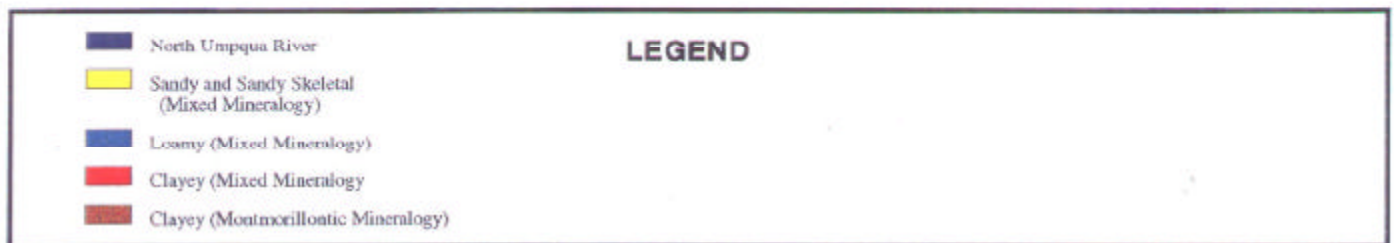
Figure 6-6

# Soil Moisture Regimes and Soil Drainage

The upland soils are typically well drained and have a xeric moisture regime (67 percent of WAU). A large percentage of soils in riparian zones, floodplains, and fans have drainage ranging from moderately well drained to poorly drained where water tables are near or at the surface for lengthy periods of the year (**Figure 6-6**). Poorly drained montmorillonitic soils have been known to support the endangered plant *Plagiobothrys hirtus*.
