Test Case 2

Historic Building/Urban Location

INTRODUCTION

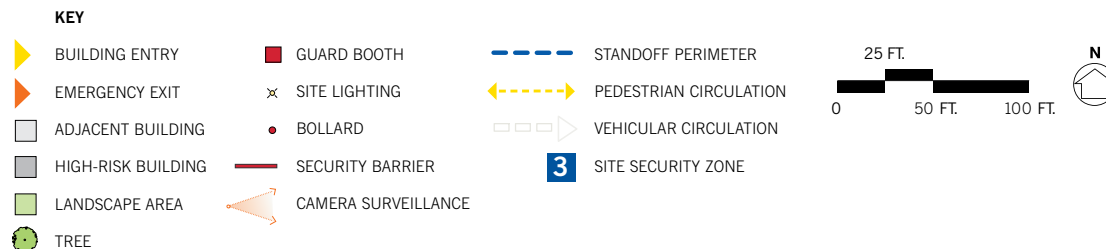
Test Case 2: Existing Conditions/Site Context Plan

Test Case Assumptions

- 1 The historic federal building is located near a light rail transportation stop in a historic district. Key features are the historic light standards and street tree planting.
- 2 The sidewalks along Second Street cannot be widened to increase the standoff distance between the federal building and the adjacent parking structure, which presents a high risk.
- 3 There is a landscaped area between the loading dock and the alley north of the building, which is part of the public right-of-way.
- 4 There are no site amenities, such as outdoor seating or a bus shelter, serving tenants and visitors to the facility.
- 5 The ADA entry at the First Street side of the building is separated from the main building lobby.
- 6 The office of a high-profile occupant is located on the first floor of the northwest corner of the building, on the side of the building where the standoff is most compromised.

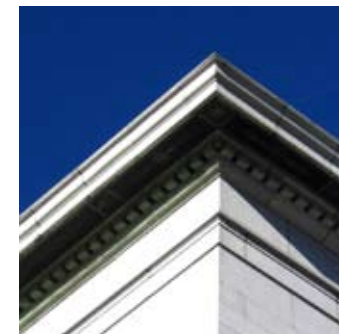
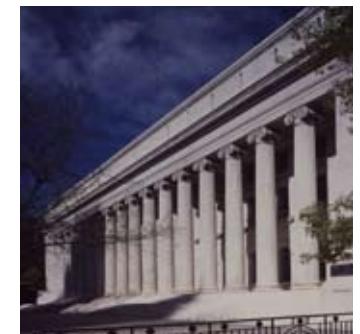
Rich architectural detailing, formal entry, and minimal setback are characteristics common to many urban historic federal buildings.

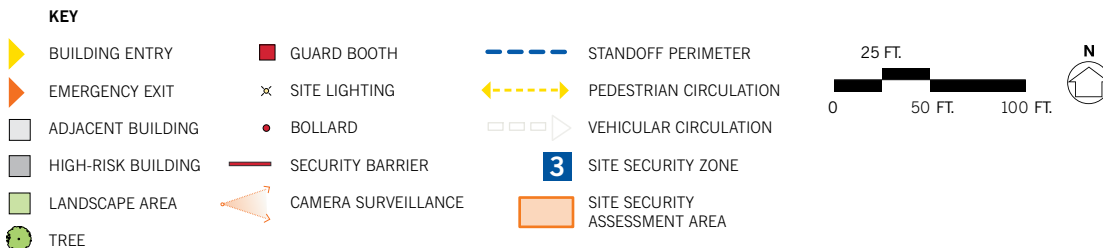
Test Case 2: Site Security Assessment Plan

Security and Site Design Topics

- 1 The proximity of the building to the light rail stop presents an opportunity to develop public space that can integrate the building into the urban fabric of the existing historic district.

- 2 The privately owned parking garage within the 50-foot standoff represents a high risk. The federal building may need additional hardening on the west side to mitigate vulnerability.

- 3 There is insufficient vehicular and pedestrian access control between the alley and the service/loading area. The mature trees and formal hedges in the median were part of the site's original historic landscape design.

- 4 The sidewalk along Main Street is littered with a mix of temporary and permanent barriers that are neither sufficiently anchored nor reinforced to stop a vehicle. They ignore the historic architecture of the building.

- 5 Accessible entries located away from the main entry require additional security screening and may not conform to the intent of accessibility laws or the principles of universal access.

- 6 The office at the northwest corner is highly visible from the street and vulnerable to threat from the adjacent high-risk building, as well as from traffic along Second Street, which falls within the 50-foot standoff zone.

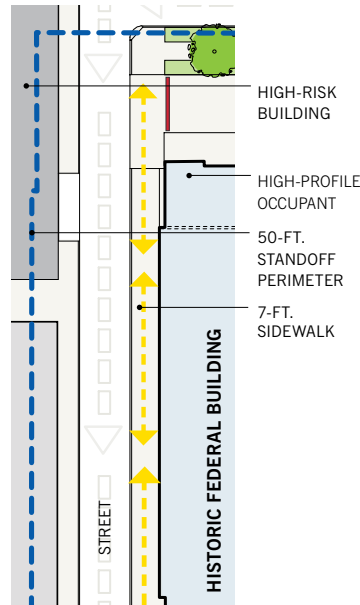
Existing Conditions Plan

Security Design Problem

Current ISC standards for standoff distances can be impossible for a historic building in an urban location. Adjacent buildings within the standoff perimeter should be evaluated for potential security risks. For example, a privately owned parking garage within the 50-ft. standoff represents a higher risk than a retail building or a parking garage outside the standoff. Risk acceptance might be appropriate for a low-risk building, while mitigation measures such as sidewalk widening or the acquisition of adjacent properties might be necessary if the risk is deemed too high. In this case, the sidewalk may not be widened because of local transportation needs, so alternative solutions need to be explored.

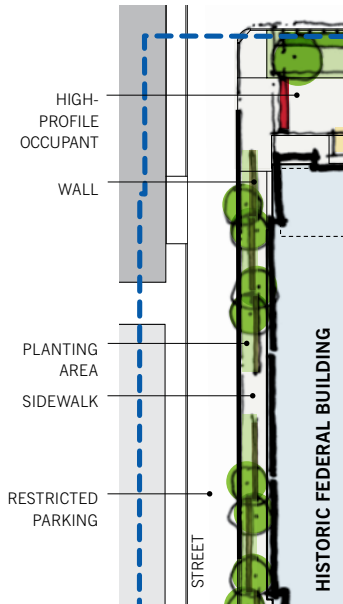
Conceptual Strategy Investigation: Rejected

As a means of providing a hardened perimeter, the team investigates a staggered wall system with integrated seating and planting areas. Due to the spatial constraints of a dense urban site, however, this hardened wall element would provide only marginal protection. Also, given the thick masonry construction of the historic structure, the building itself resists a measurable degree of force.

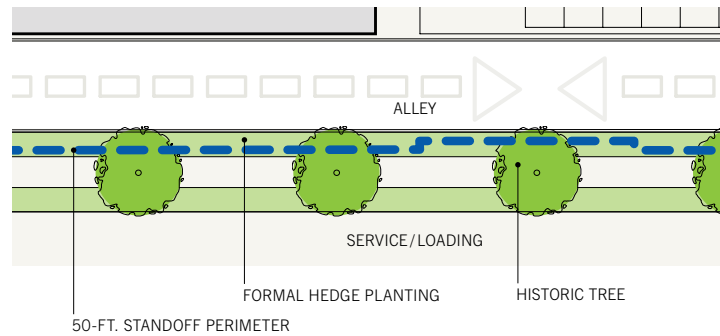
Existing Conditions Plan

Security Design Problem

Alleys and service entries can present security issues with regard to public access. In some cases, an alley must be maintained as part of the public right-of-way. This can present significant risk, especially when the alley is in the required standoff. Both vehicular and pedestrian access to the building site through the public alley should be controlled and carefully monitored. Service entries should have limited access regulated by staffed guard booths, or automated security devices activated by key cards. The historic trees along the median present another issue when considering the implementation of security elements. The footing required to adequately anchor bollards or site walls can disrupt or destroy the root systems of mature trees if not placed properly. Underground conditions should be investigated and documented to understand possible impediments to effective security design.

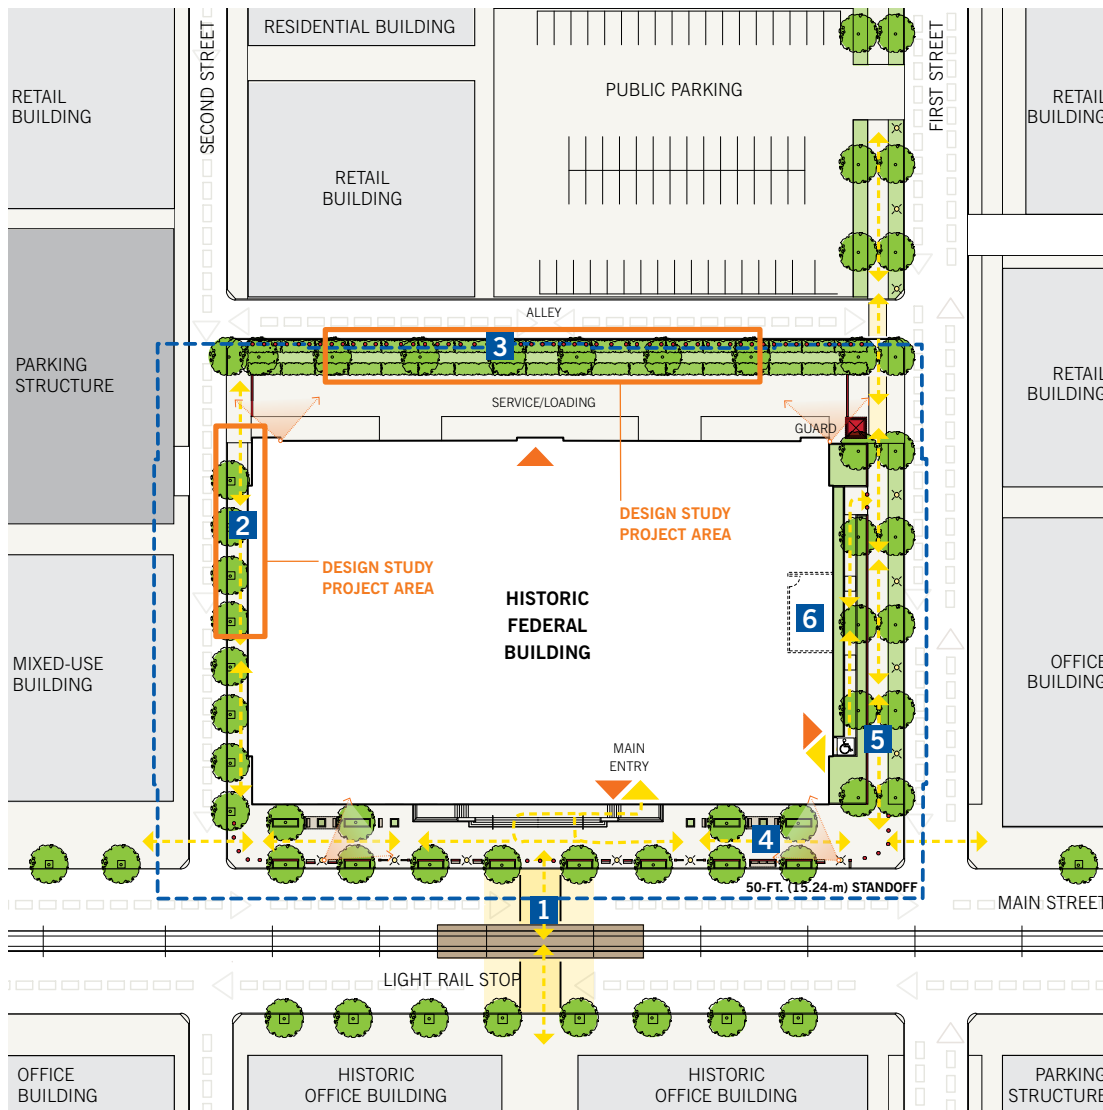
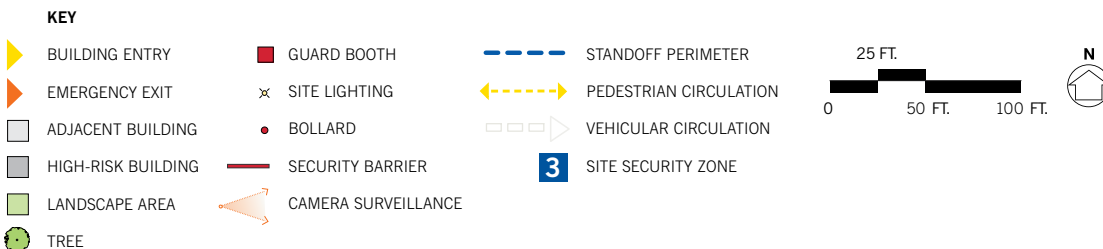
Test Case 2: Final Concept Plan

Security and Site Design Solutions

- 1** An enhanced crosswalk emphasizes the pedestrian connection from the building's main entry to the light rail stop and the historic district beyond. New street amenities, such as benches and bicycle racks, heighten public use.

- 2** After careful study of reasonable options, risk acceptance is a better alternative than investing scarce resources on security measures that would not significantly mitigate risk.

- 3** The median between the alley and the service entry incorporates security measures that prohibit vehicular approach and regulate pedestrian access, while accommodating historic landscape elements.

- 4** A kit-of-parts consistent with the historic character of the building includes security elements that are also site amenities, such as a new bus shelter, lighting standards, and covered seating.

- 5** A new ADA entry near the building's main lobby integrates into the landscape area on the east side of the site.
- 6** The high-profile occupant is relocated to an office on the First Street side, where reinforced site walls and raised planting areas offer better protection.

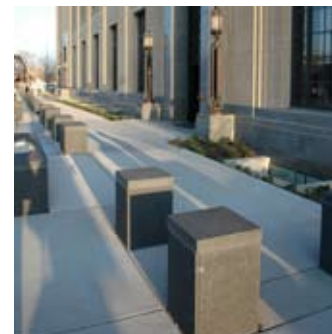
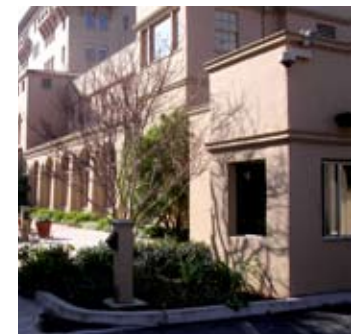
Bollard and guard booth designs are based on material and style cues from existing features.
