**Second Five-Year Review Report
for
Cal West Metals Superfund Site
Lemitar
Socorro County, New Mexico**

September 2005

**Region 6
United States Environmental Protection Agency
Dallas, Texas**

FIVE-YEAR REVIEW

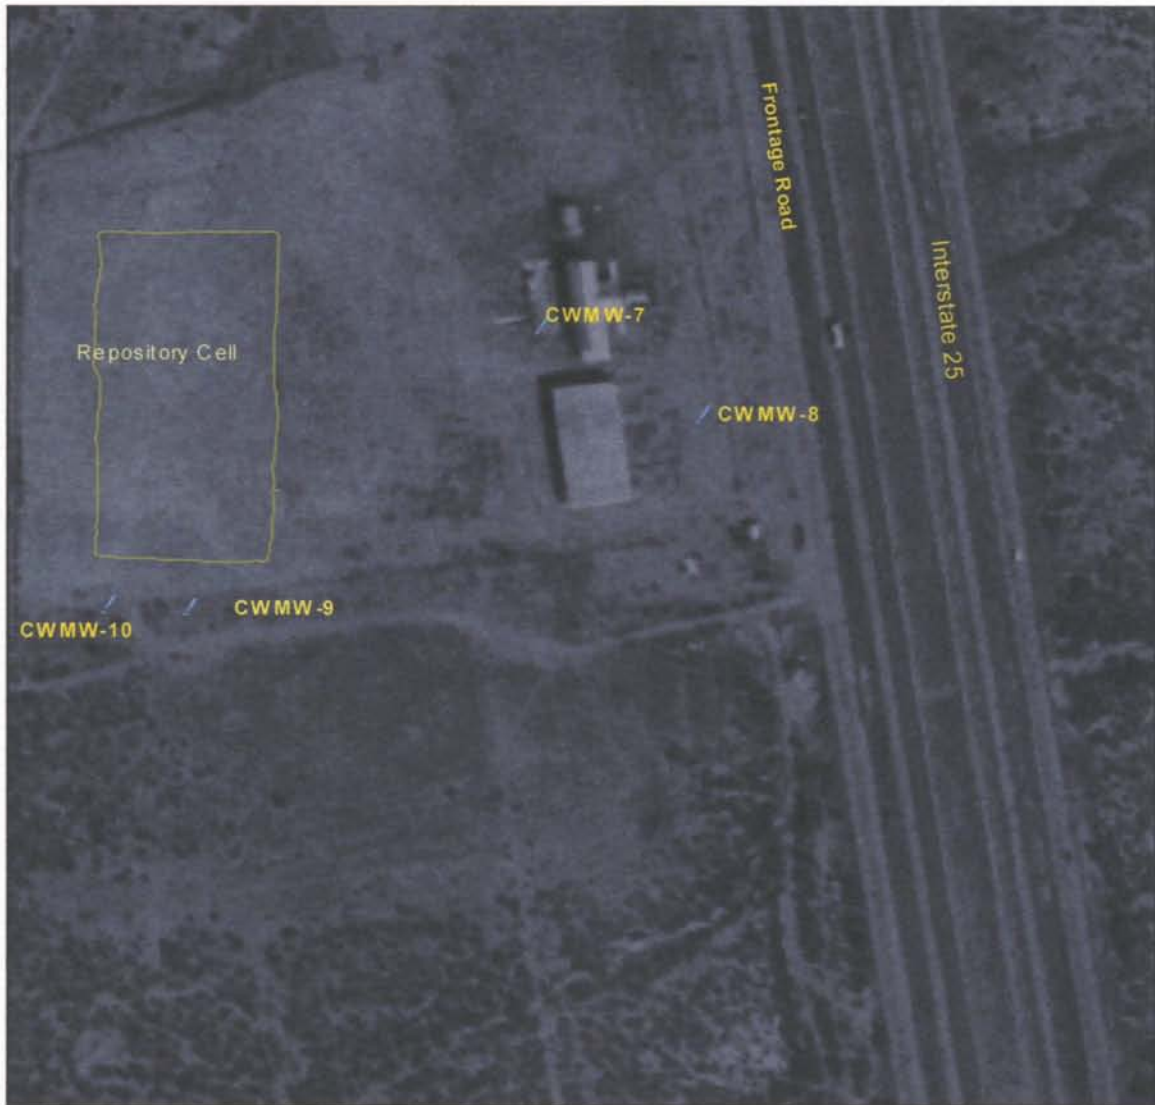
Figure 3: Cal West Metals Repository and Monitoring Well Location

During the site inspection the repository cell and monitoring wells were inspected. The inspection evaluated the integrity of the cell, soil cover, site fencing, access, building condition, and monitoring well condition. Figure 3 shows the location of the repository cell and monitoring well locations. A summary of inspection findings is presented below.

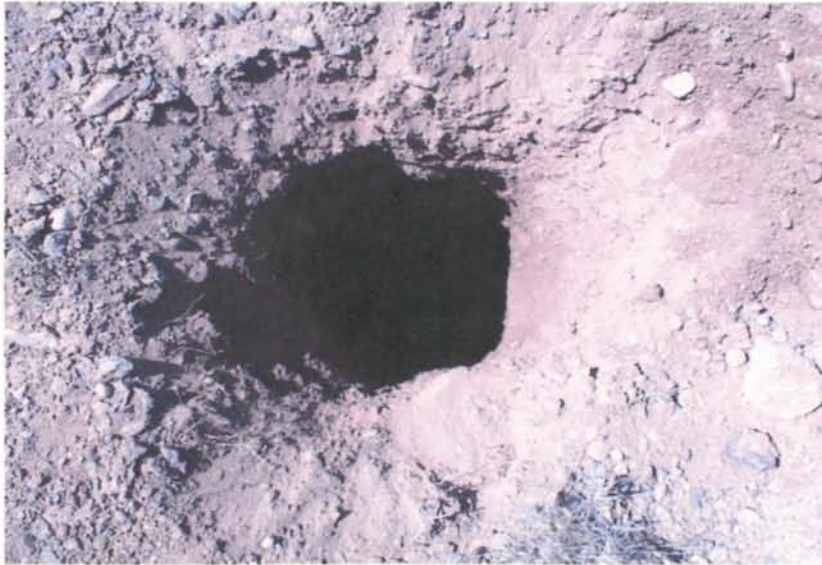
PHOTO 1 - PHOTO OF TEST PIT 1

NMED dug three test pits (1, 2, and 3) to determine the integrity of the repository cell. It was noted that the soil was extremely rocky and compacted. After digging approximately 14 to 18 inches, the cell cover was encountered (Photos 1, 2). NMED noted that the vegetation growing on the repository cell was like the surrounding vegetation. NMED noted approximately eight different species of vegetation. On the southern edge of the repository cell it was noted that an animal attempted to burrow (Photo 3) approximately eight inches into the surface soil of the repository cell. NMED covered the burrow with loose dirt.

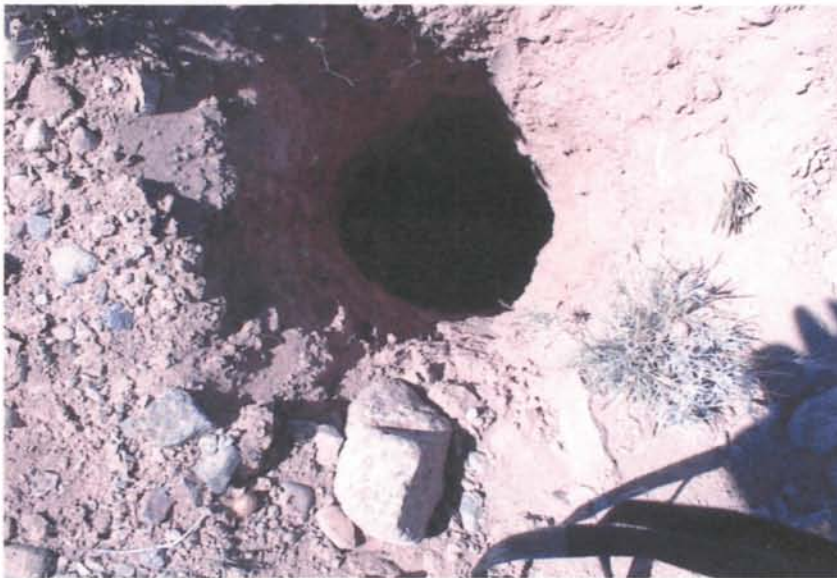
PHOTO 2 - TEST PIT 2 SHOWING SOIL COVER AND TOP OF CEMENT COVER ON REPOSITORY

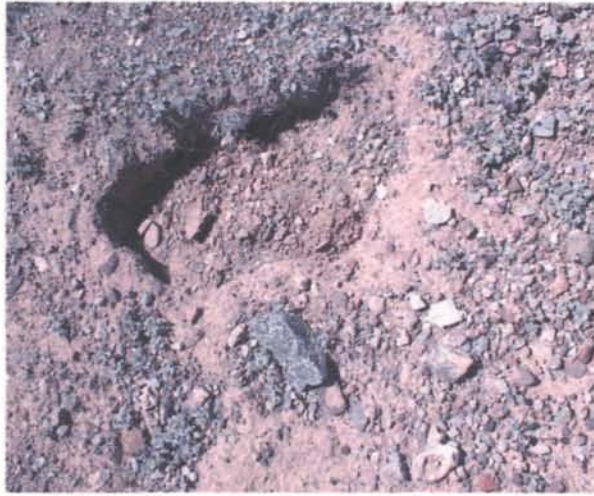
B. Other Site Conditions		
<u>Remarks:</u> It was noted that an animal burrowed 8" on the repository cell soil cover.		
VII. LANDFILL COVERS		
		<input checked="" type="checkbox"/> Applicable <input type="checkbox"/> N/A

PHOTO 3 - PHOTO OF LOCATION WHERE ANIMAL BURROWED ON SURFACE OF REPOSITORY CELL

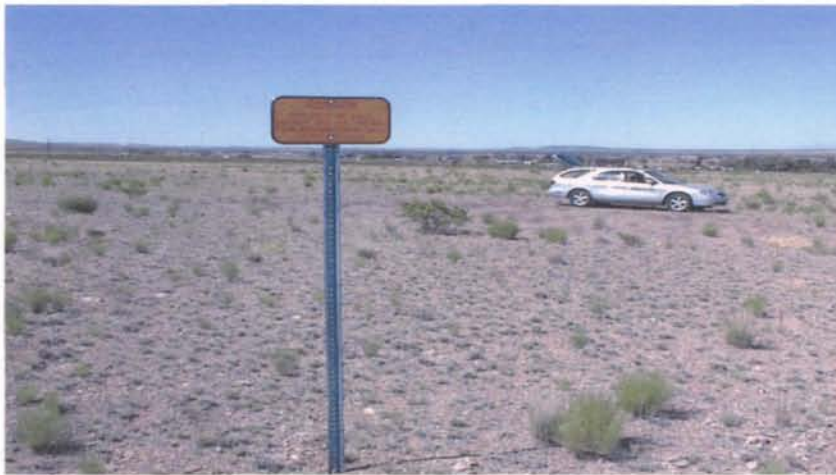
PHOTO 4 - Repository warning sign. Sign states "Repository cell, Do Not Dig or Trench, For Information Call 827-2911"

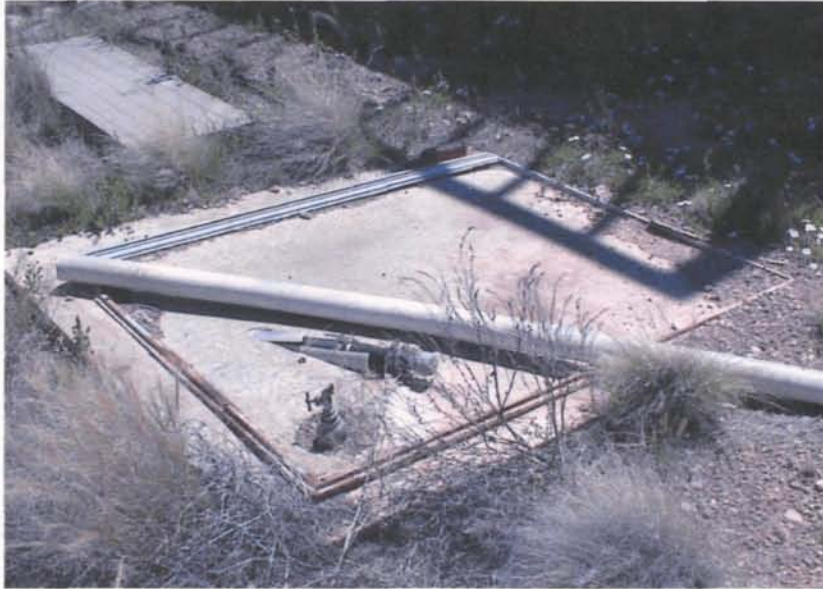
All monitoring wells (CWMW 7-10) were locked and the concrete pads were in good condition. The rope for the dedicated bailers on CWMW 7 through 9 is becoming frayed and will require replacement. CWSW-1 is a former pump house and supply well. The well house has fallen off its foundation and has exposed a concrete slab with a 3-inch PVC pipe, a 2-inch black hose, and a spigot (Photo 5). NMED had previously notified the City of Socorro by correspondence regarding the condition of this well in October 2003. The production well that is located on the southeast corner of the site (CWSW-2) had the pump house removed by the City of Socorro. To protect the well, a steel cover with lock has been installed over the well (Photo 6).

Photo 5 - Supply Well CWSW-1 with exposed two inch black PVC pipe and spigot.

- The NMED Office of General Council is currently reviewing the draft language for the deed notice. NMED will follow-up and with the City of Socorro to implement the deed notice as the institutional control.
- Supply well CWSW-1 has not been plugged and abandoned. NMED will follow-up to determine the time frame when this supply well will be plugged and abandoned.

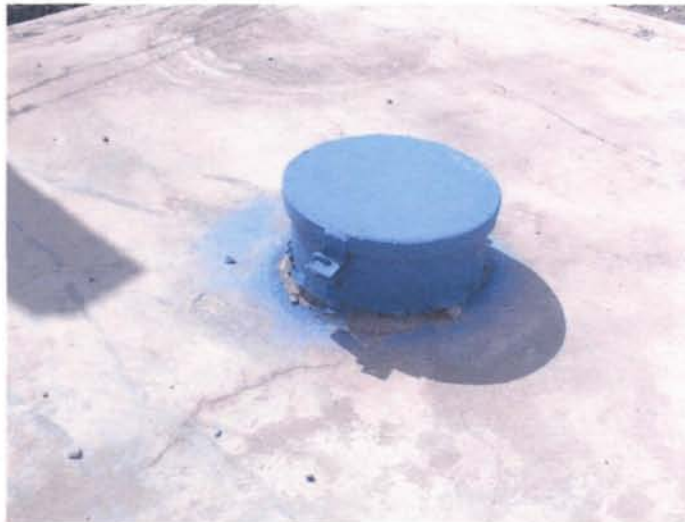
Photo 6 - Supply well CWSW-2 with steel cover and lock installed

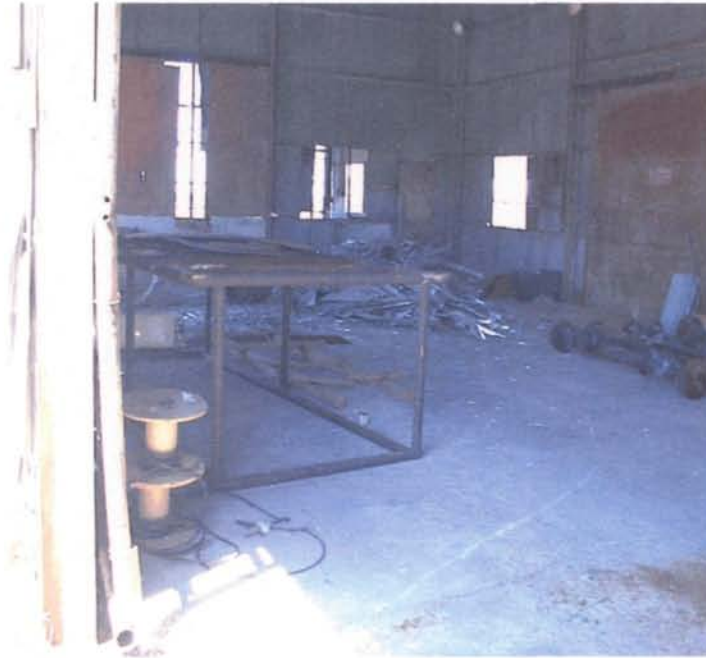
The middle building (Photo 7) is being used for welding operations. NMED noted barrels being stored on the concrete pad. There were four black drums and two blue drums (Photo 8). The black barrels are partially full and it was noted that there is a white residue staining the concrete pad. There is a partially legible label on the black barrels that states "acid." The black barrels were not capped and did not appear to be bulging. The blue drums were empty and are stenciled "motor oil." NMED notified the City of Socorro.

Photo 7 -
Middle building
being used for
welding operations.

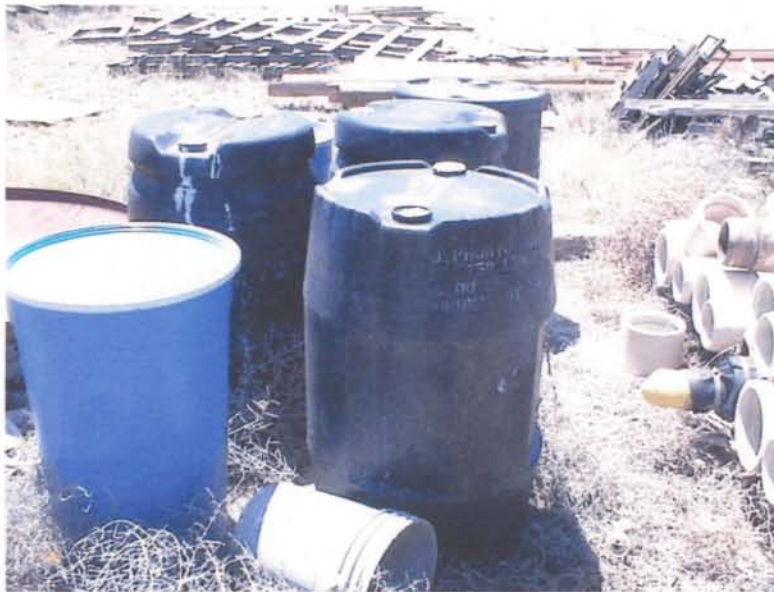
Photo 8 - Four black drums with partially legible label that states "acid". The two blue drums are empty.
