Five-Year Review Report

First Five-Year Review Report for the RSR Corporation Superfund Site Dallas, Dallas County, Texas

September 2005

FIRST FIVE-YEAR REVIEW
RSR Corporation Superfund Site
EPA ID# TXD079348397
Dallas, Dallas County, Texas

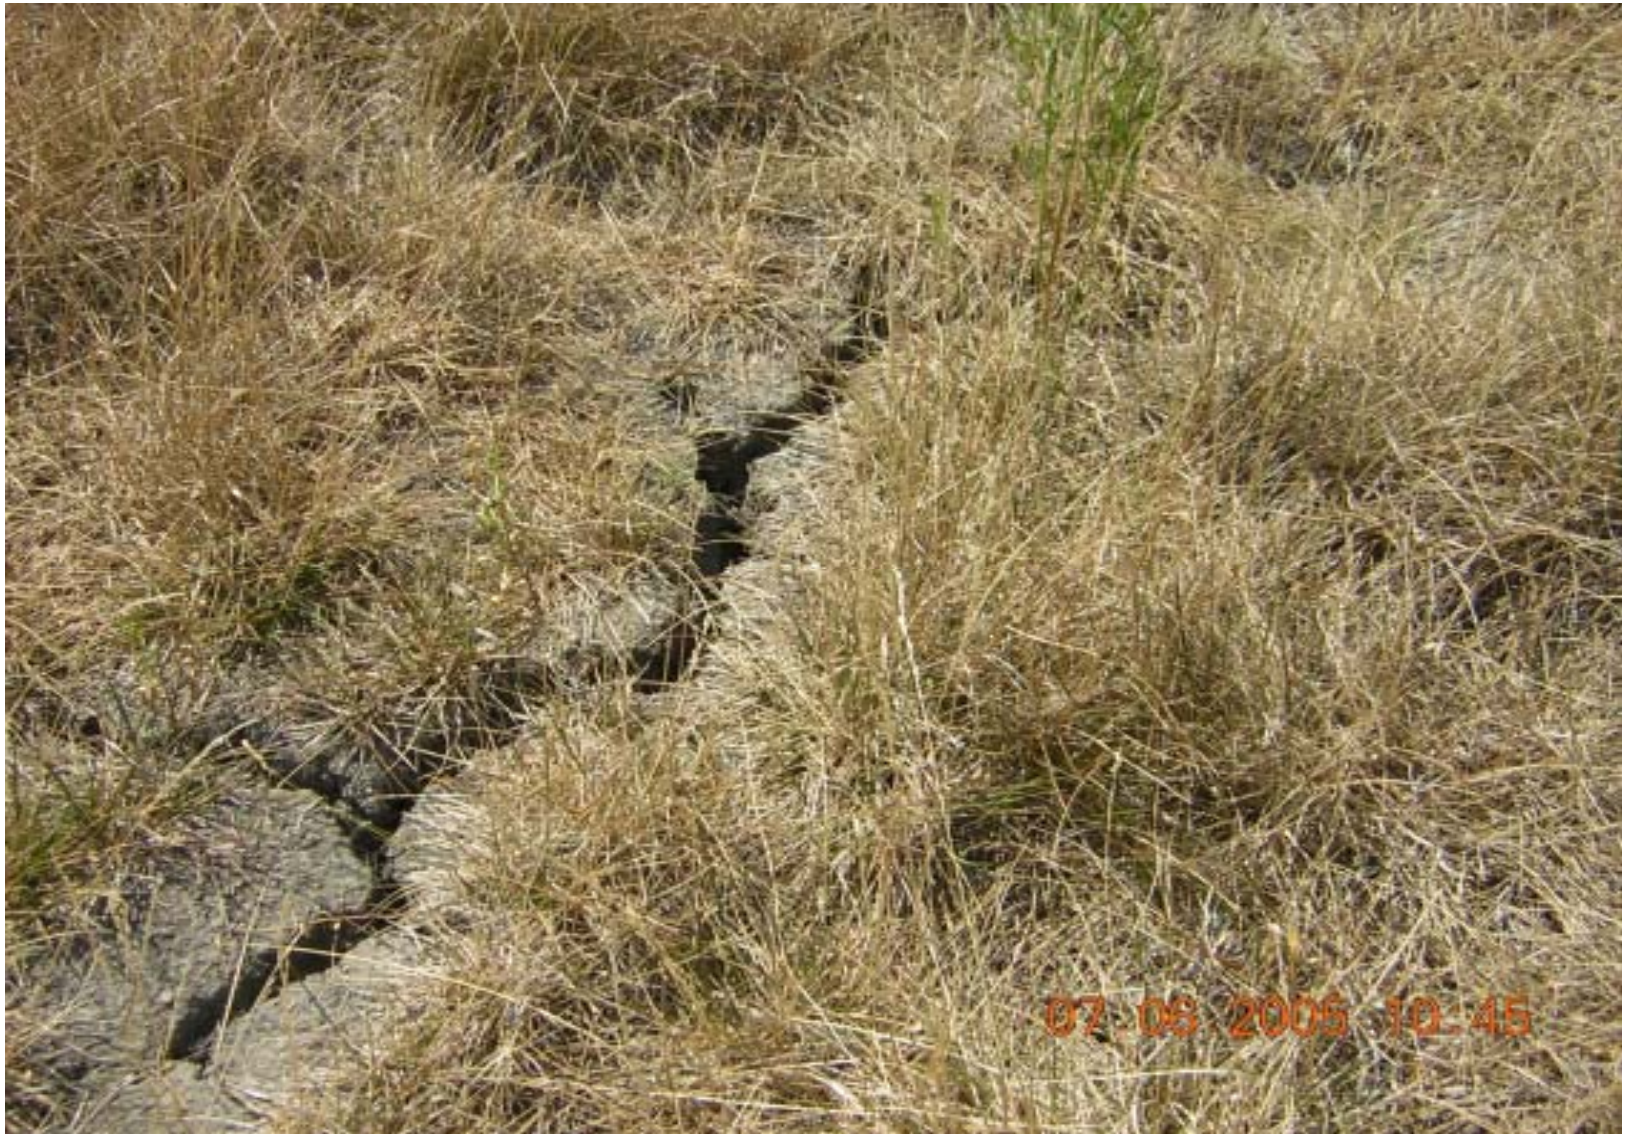
Photo 4: OU5 – Subarea 2 – view of desiccation crack in cover.

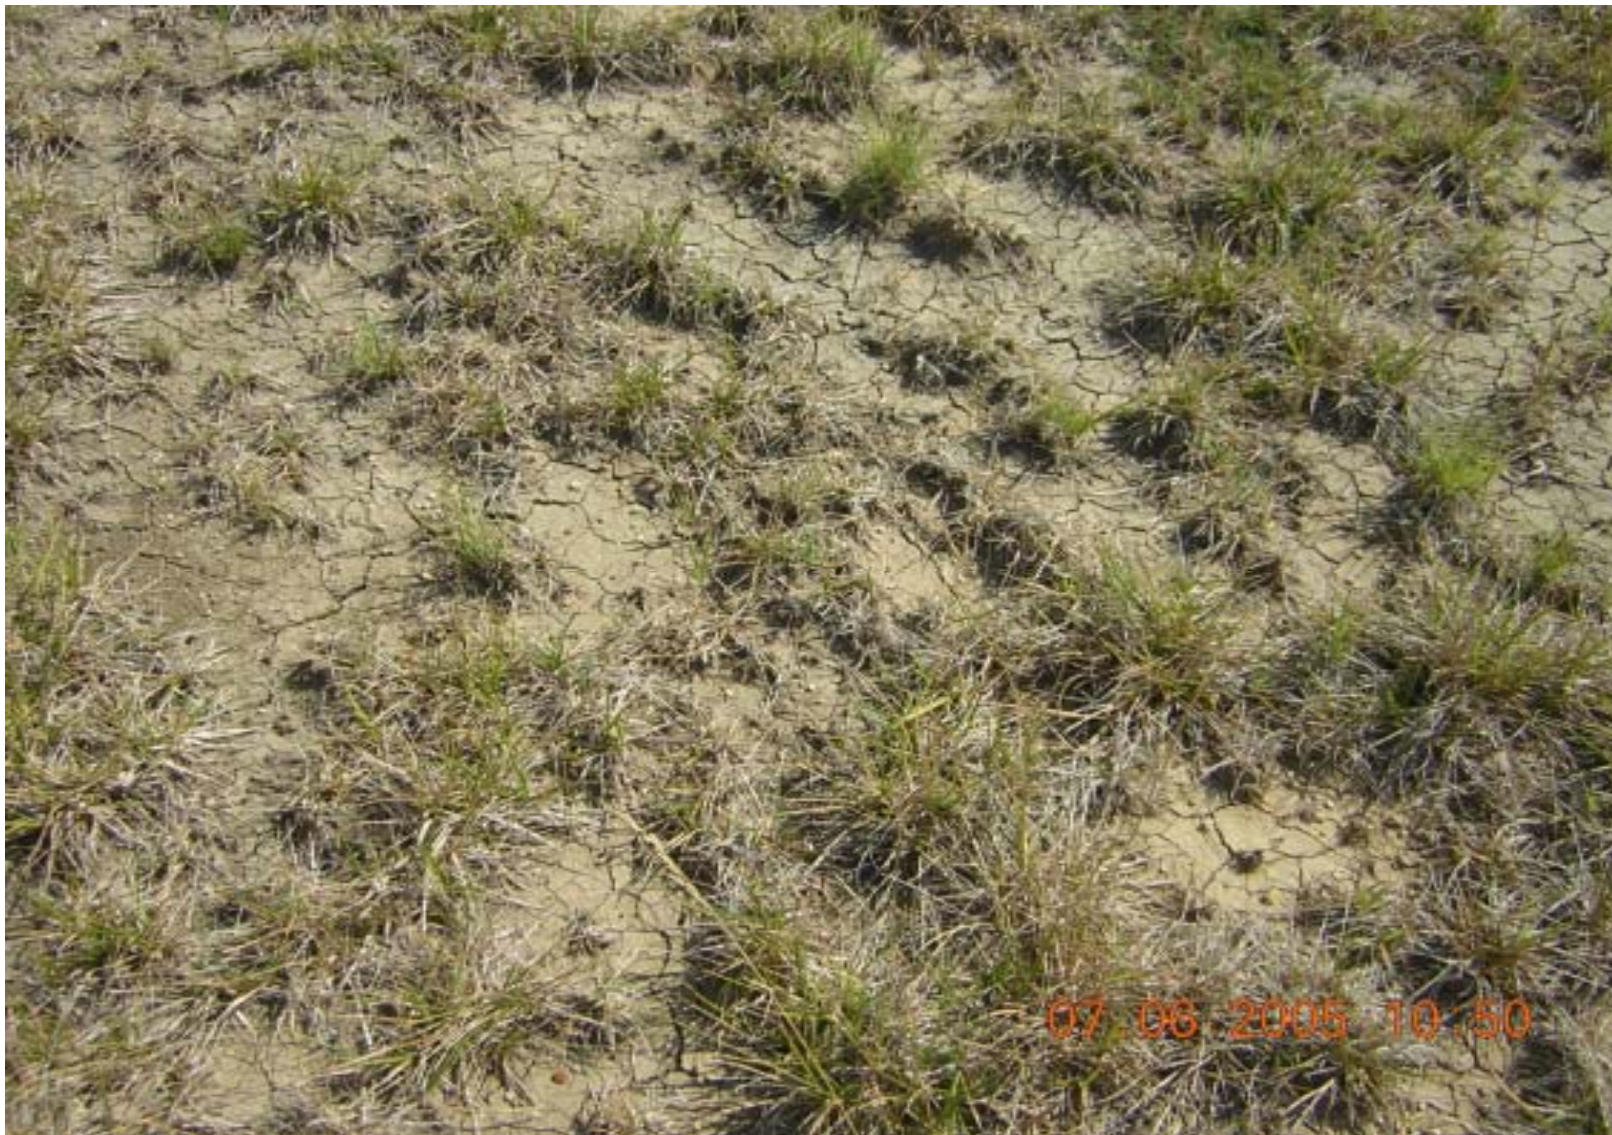
Photo 7: OU5, Subarea 2 – view of sparse vegetation and minor desiccation cracking in cover over former landfill.

- 4. The soil covers at OU3, Sites 3 and 4 and OU5, Subarea 2 should be revegetated.** Sparse vegetation was noted during the site inspection at these sites. New vegetation should be established to reduce the potential for erosion of the soil covers at these sites, thus reducing the potential for the underlying contamination to become exposed.

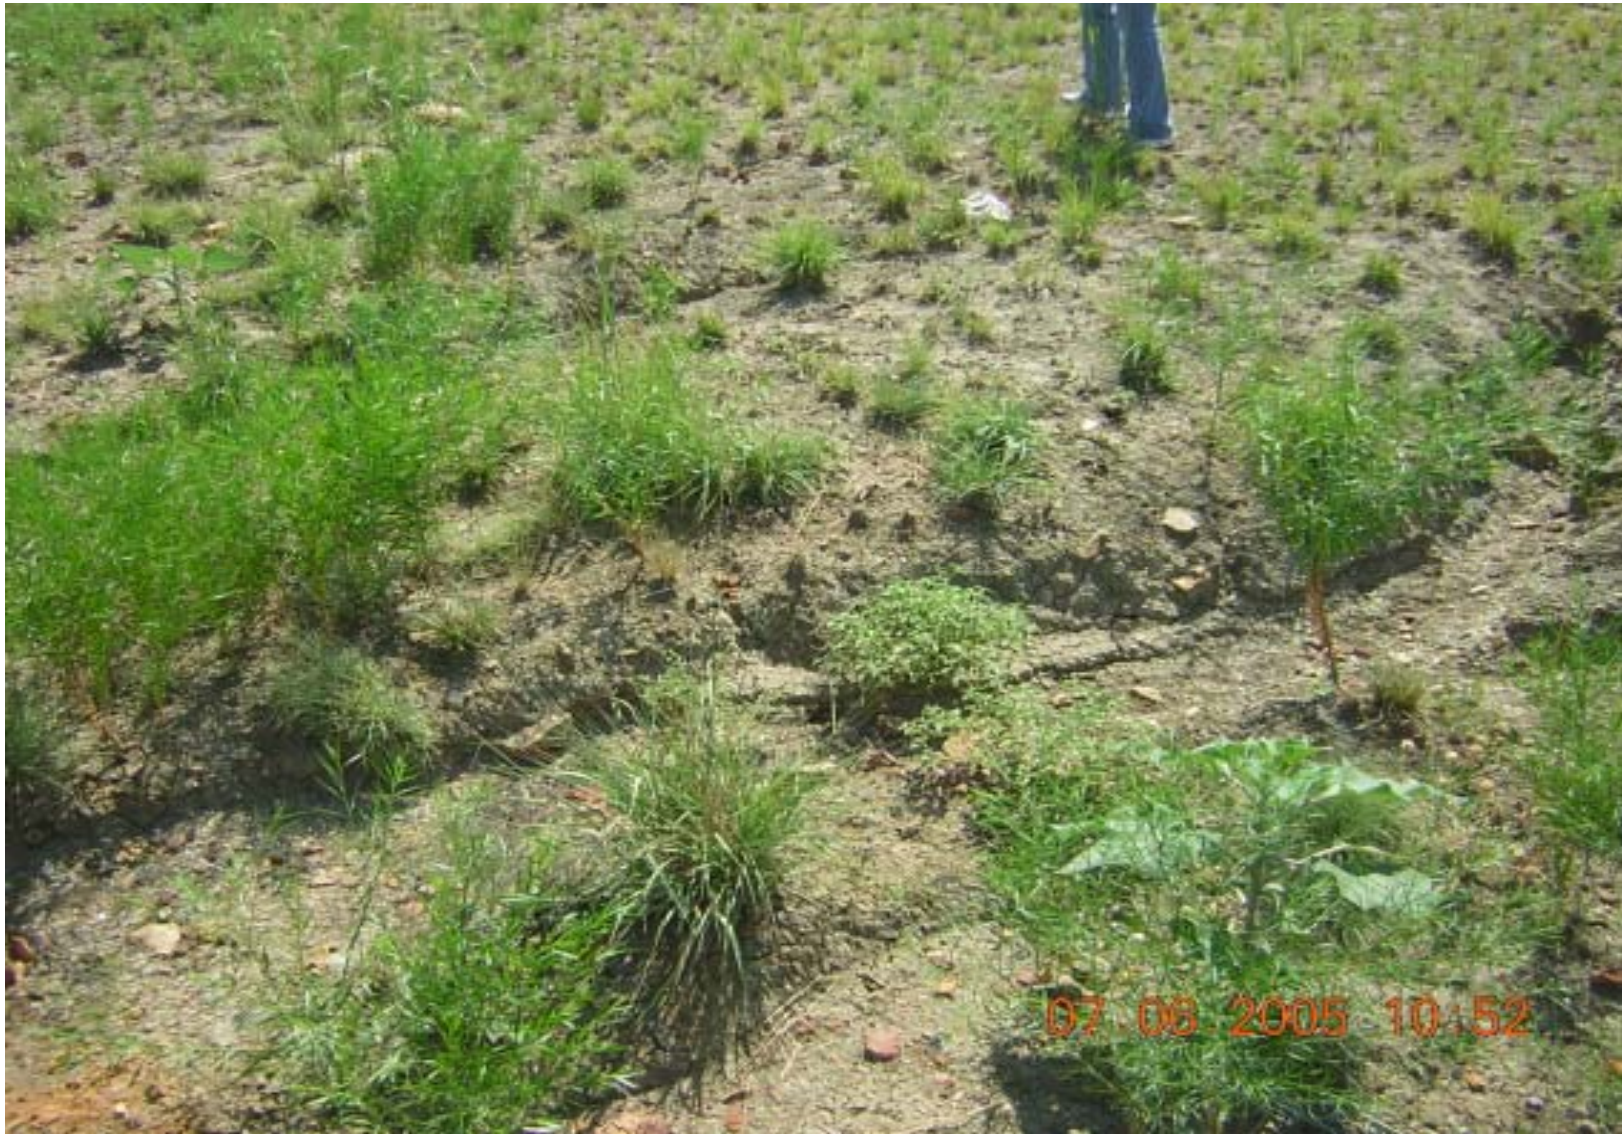
- 2) Erosion gullies are present on the soil covers at OU3, Sites 1 and 3, and near the landfill cover at OU5, Subarea 2. Several large erosion cuts are present on the slope at OU3, Site 1. Rock armor was placed at the top of each gully to reduce erosion. Should these gullies continue to grow, they could result in slope instability problems and expose underlying contamination. Small erosion gullies are present in the clay cover at OU3, Site 3. These gullies could potentially grow and expose the underlying contamination. Also, a neighboring property owner has run several discharge pipes over the soil cover at Site 3. Discharges from this piping have resulted in one of the erosion gullies in the clay cover. Large erosion gullies are present near the clay cover at OU5, Subarea 2. These gullies could potentially grow and expose the landfilled materials and contamination. Although the erosion does not currently affect the protectiveness of the remedies, if left unaddressed, the erosion gullies will continue to grow.

Photo 8: OU5 Subarea 2 – view of erosion channel near former landfill cover.

- 2. Repair the erosion gullies present at OU3, Sites 1 and 3, and at OU5, Subarea 2.** The erosion features should be filled in; rock armor placed where appropriate; and new vegetation established to prevent further erosion. This action is necessary to provide the necessary to protect the soil covers over the contamination left in place at each site.

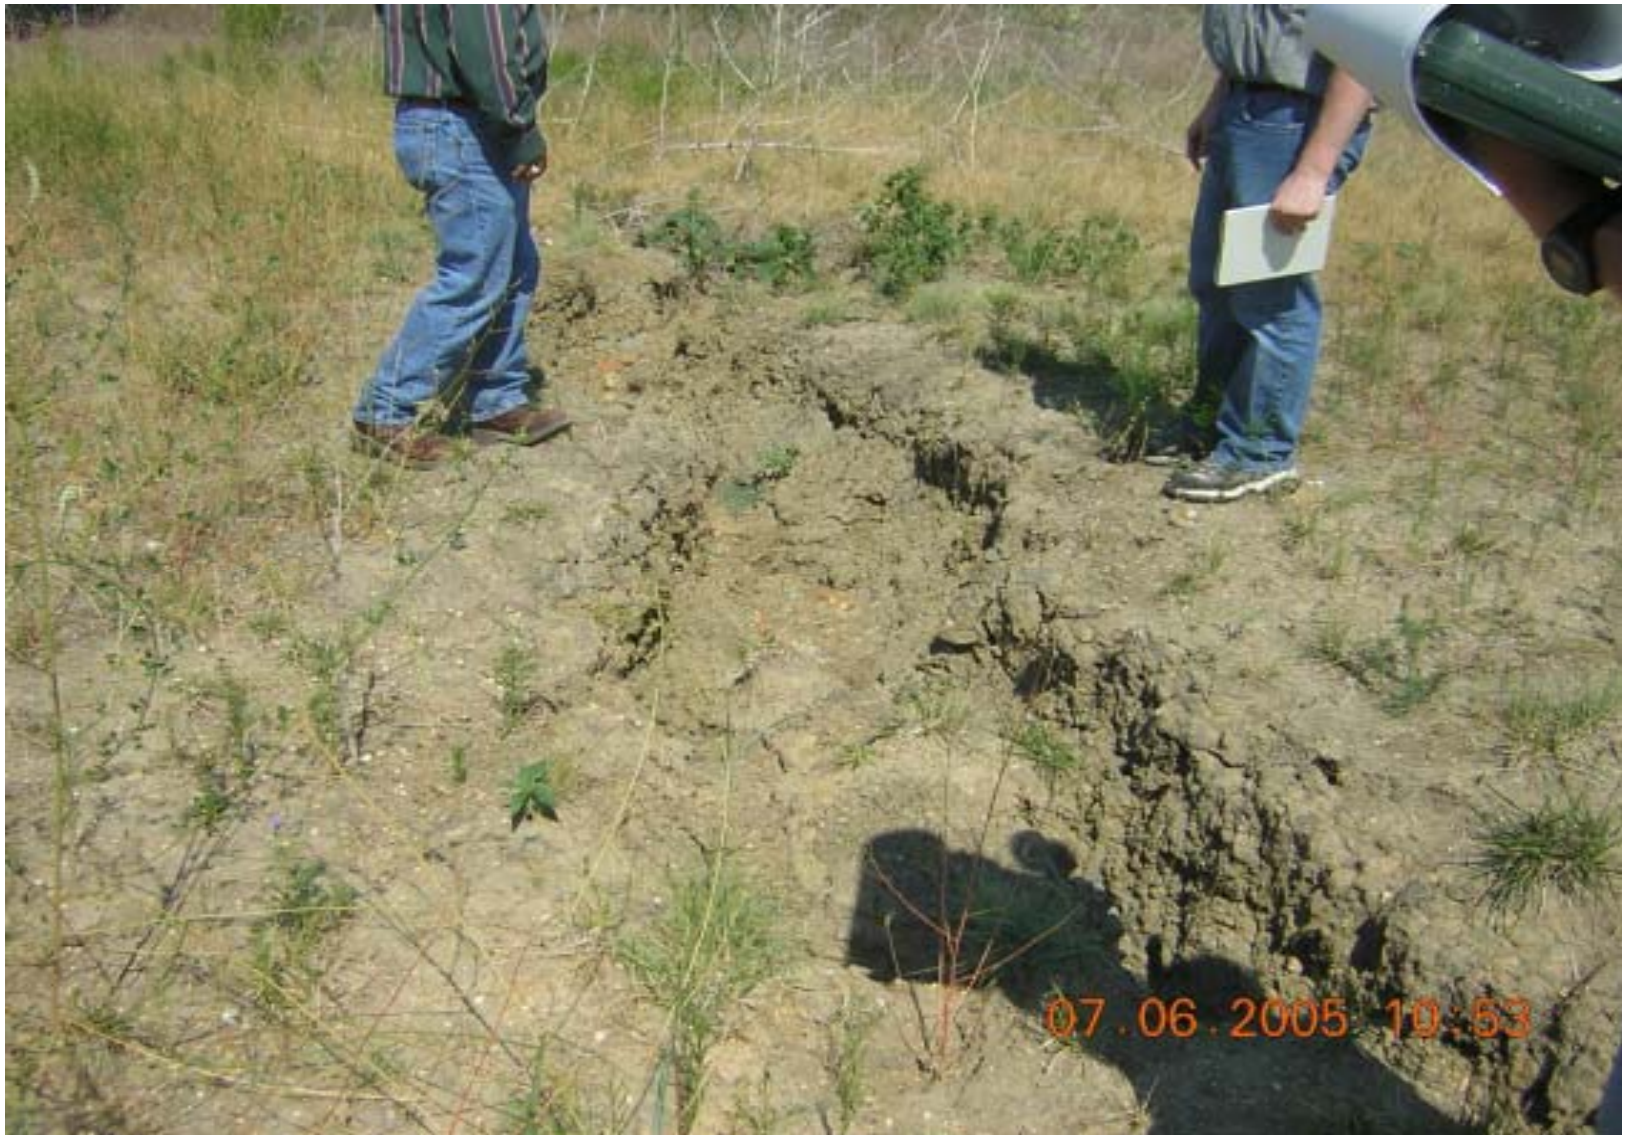
Photo 9: OU5, Subarea 2 – View of large erosion channel west of cover over former landfill.

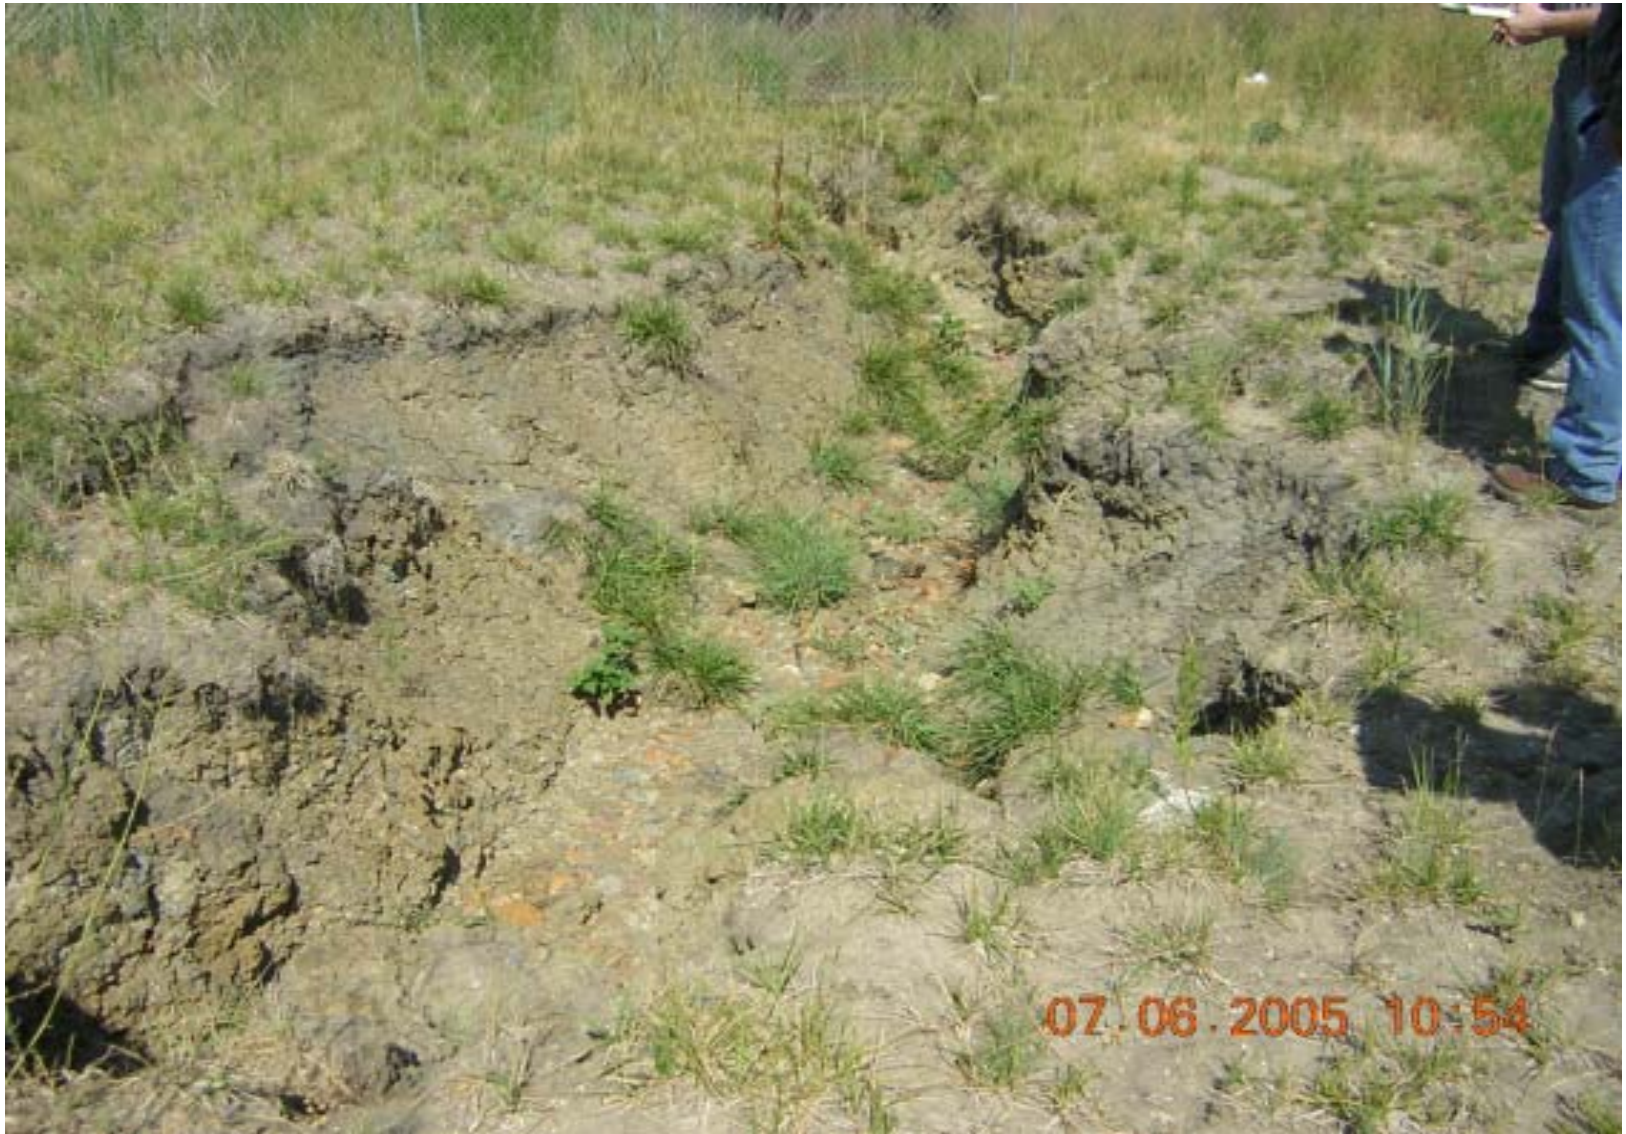
Photo 10: OU5, Subarea 2 – view of large erosion channel near fence just west of cover over former landfill.

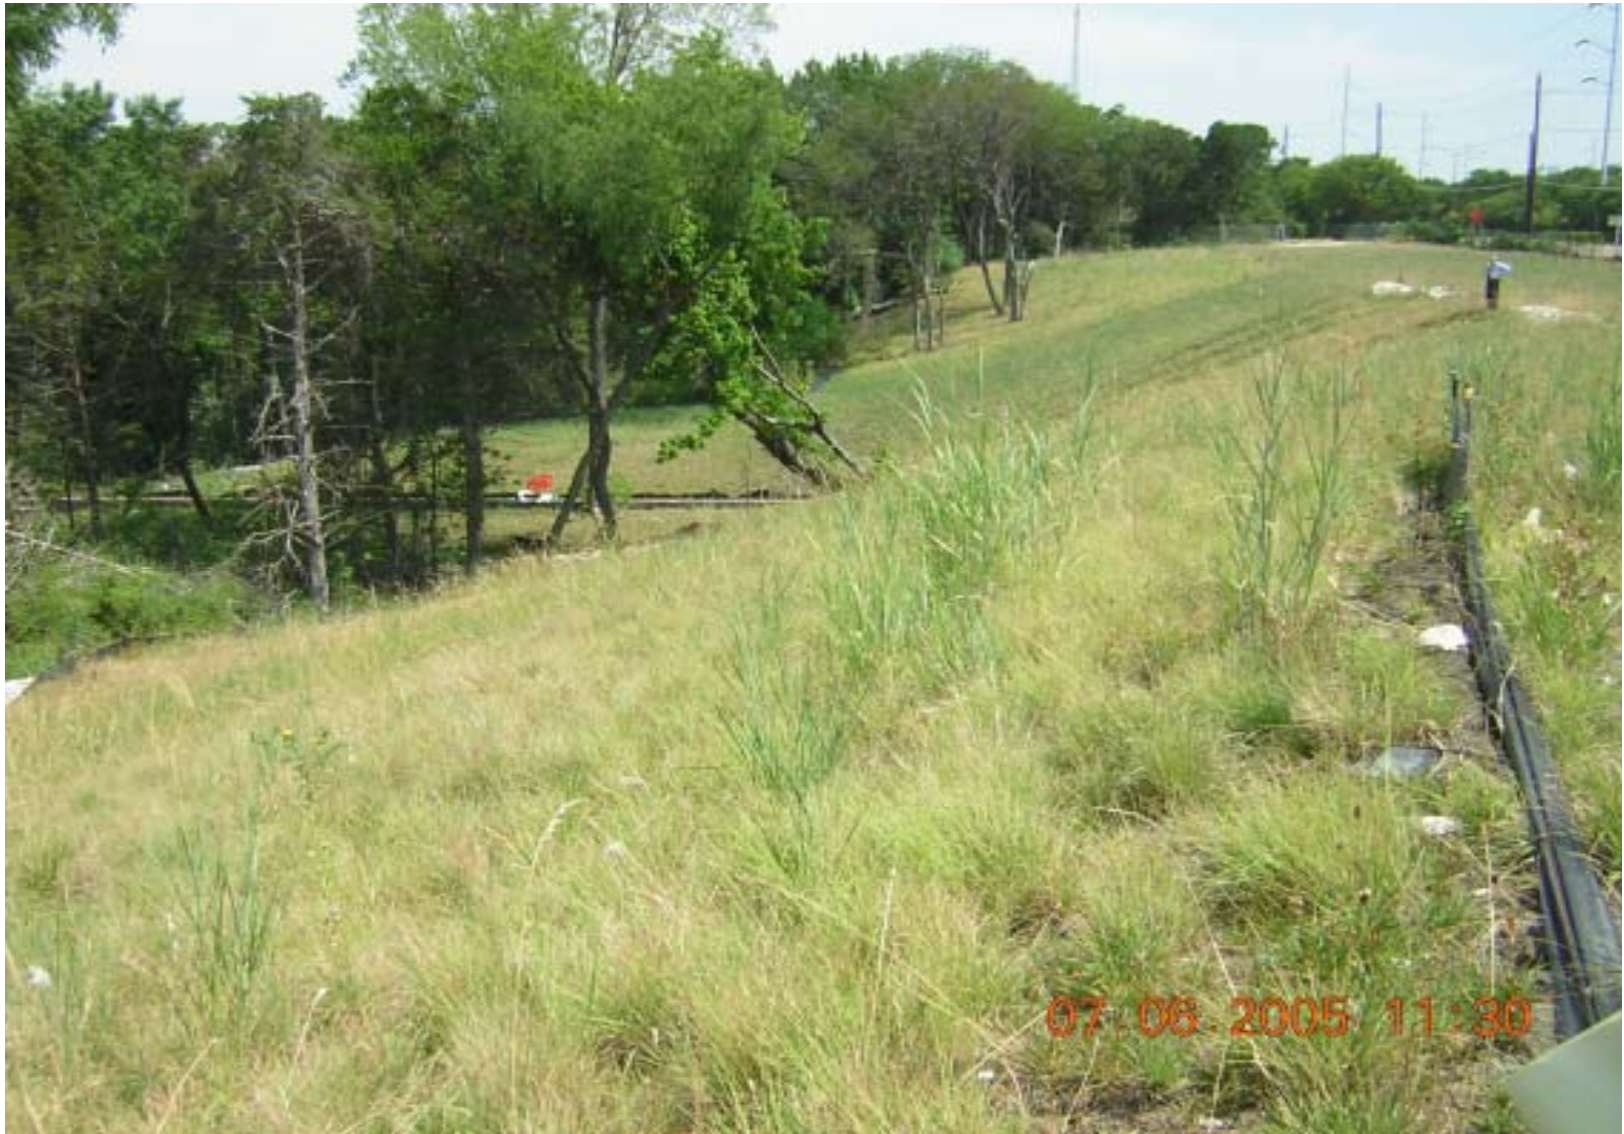
Photo 13: OU3, Site 1 – View of slope in middle of site. Erosion channels are visible in middle of slope. Rock material was placed on top of slope. View is facing north.

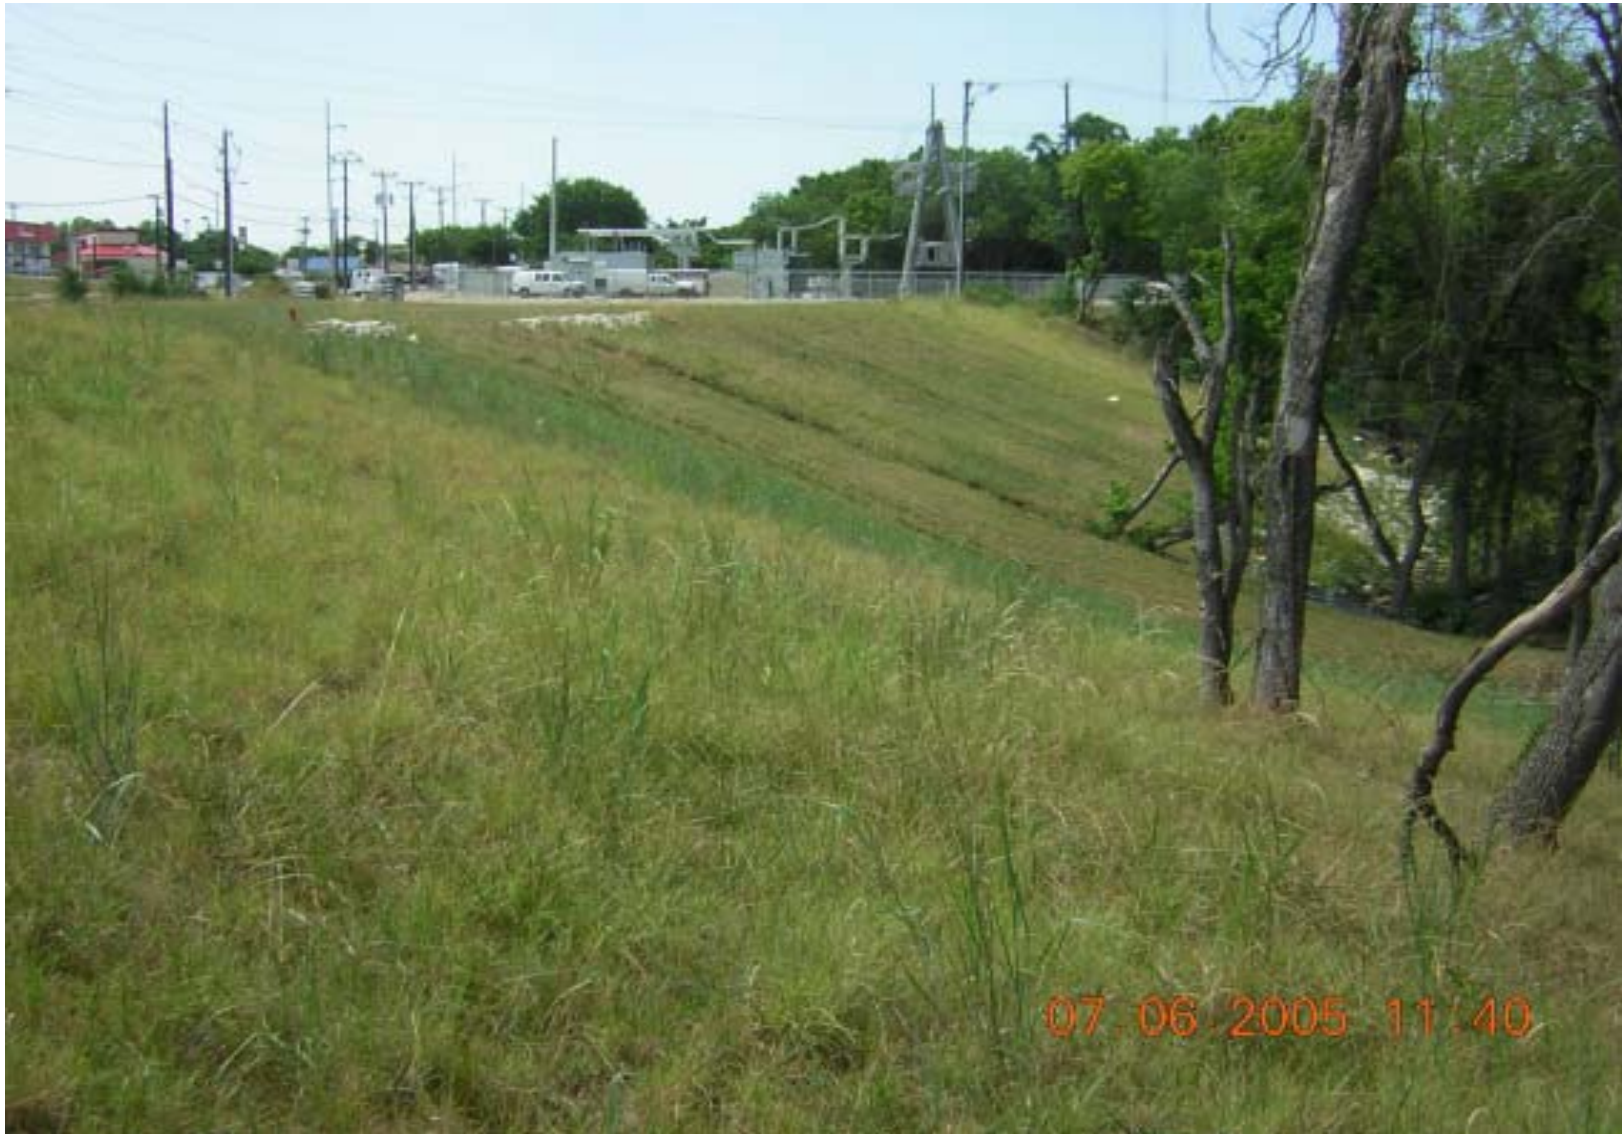
Photo 14: OU3, Site 1 – View of slope in middle of site. Erosion channels are visible in middle of slope. Rock material was placed on top of slope. View is facing south.

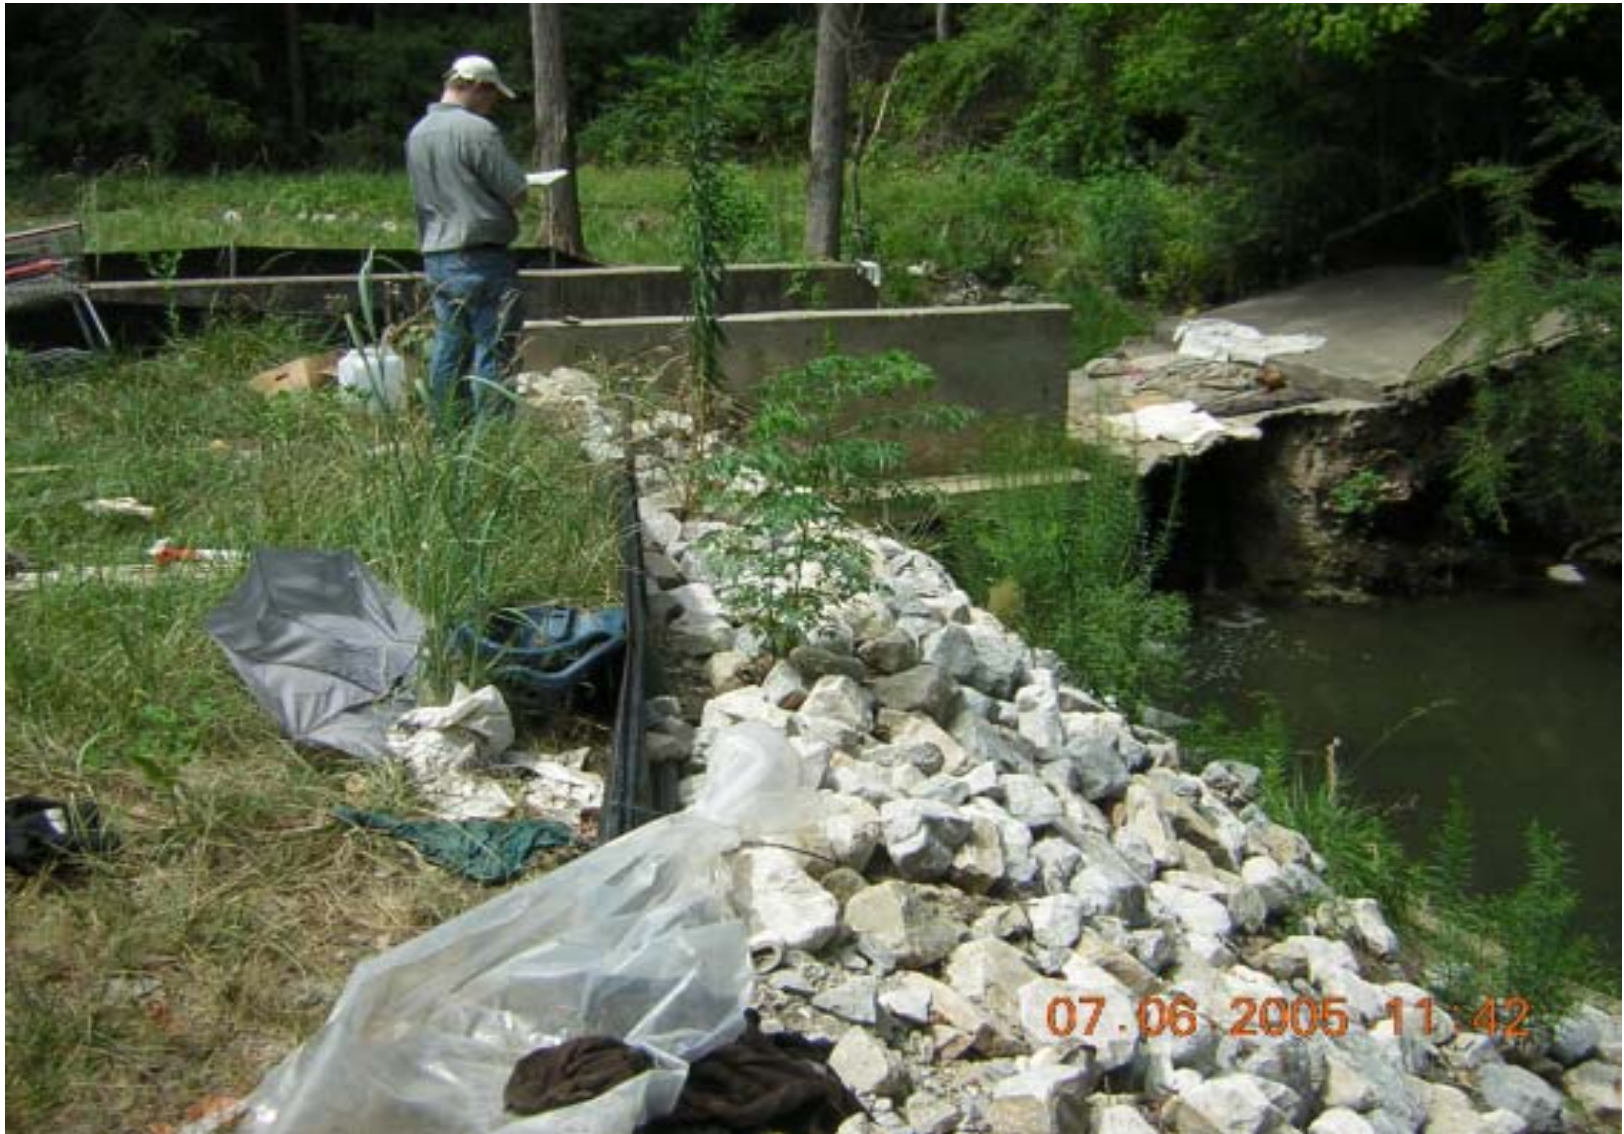
Photo 15: OU3, Site 1 – View of creek at base of slope. Garbage and debris in area is evidence that people have been using the site.

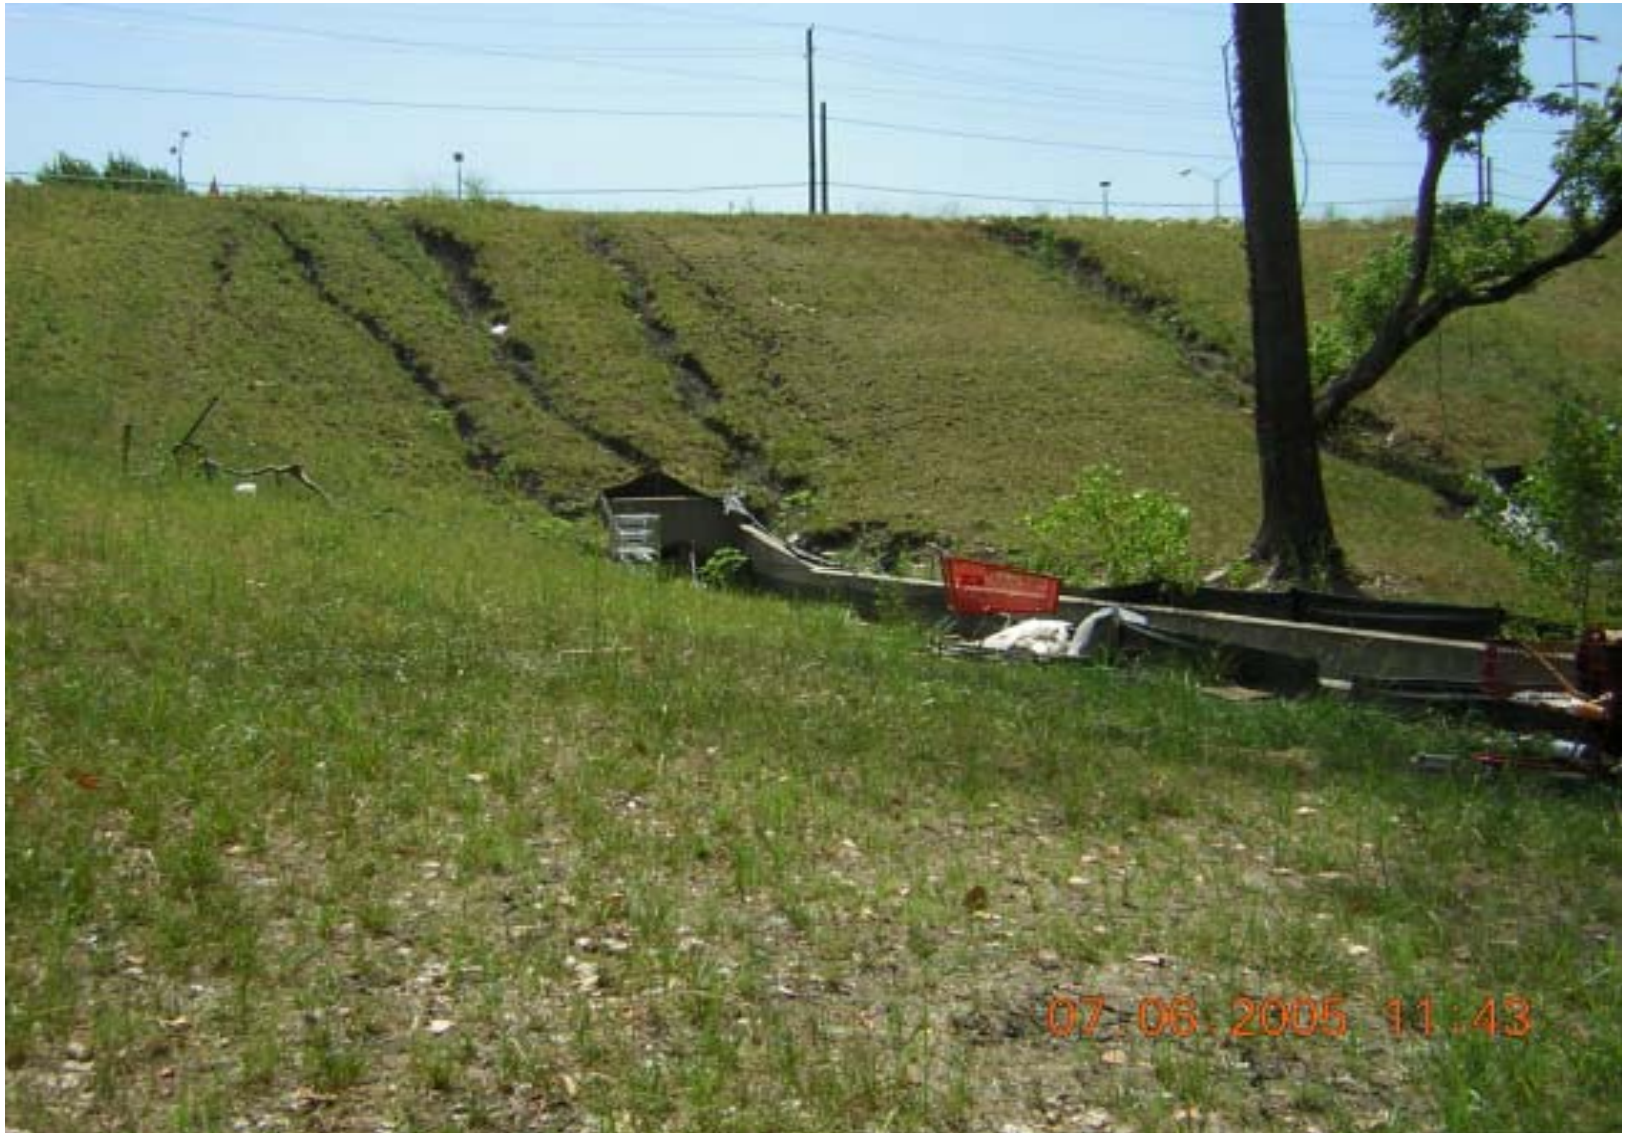
Photo 16: OU3, Site 1 – View up the slope of the erosion channels in the slope. View is facing to the east.

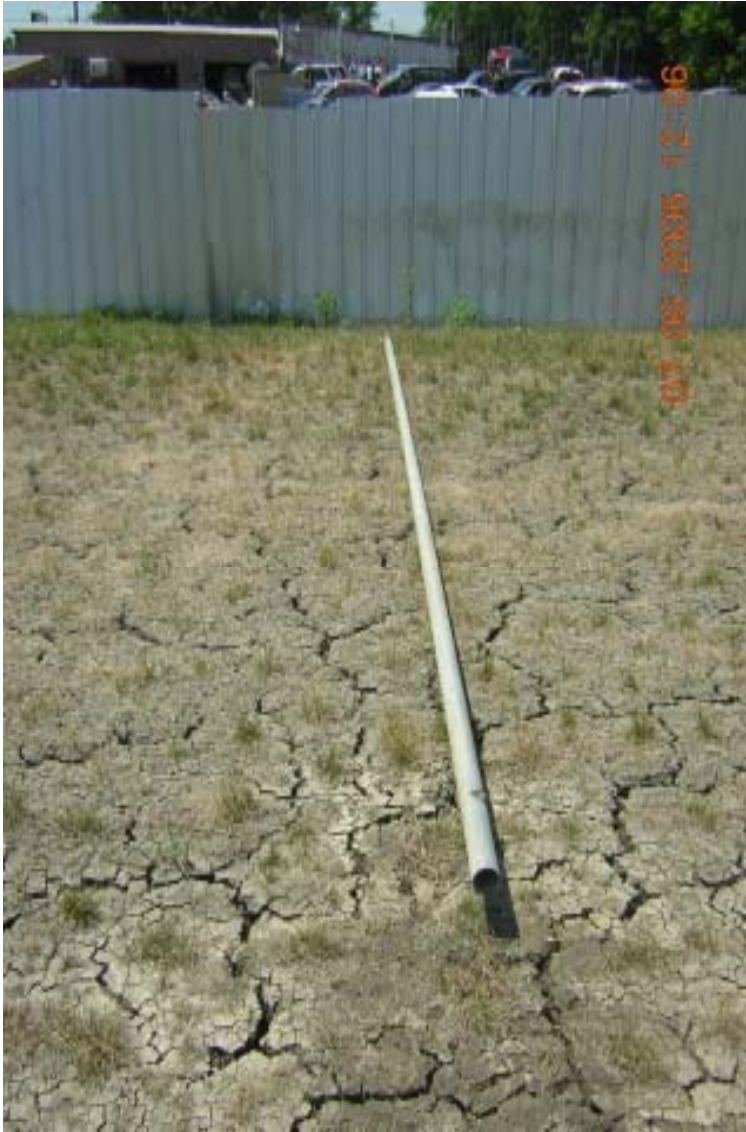
Photo 17: OU3, Site 3 – View of one of the discharge pipes placed by adjacent property owner on the cover at the southern portion of the Site. Also, desiccation cracks are present on the cap.

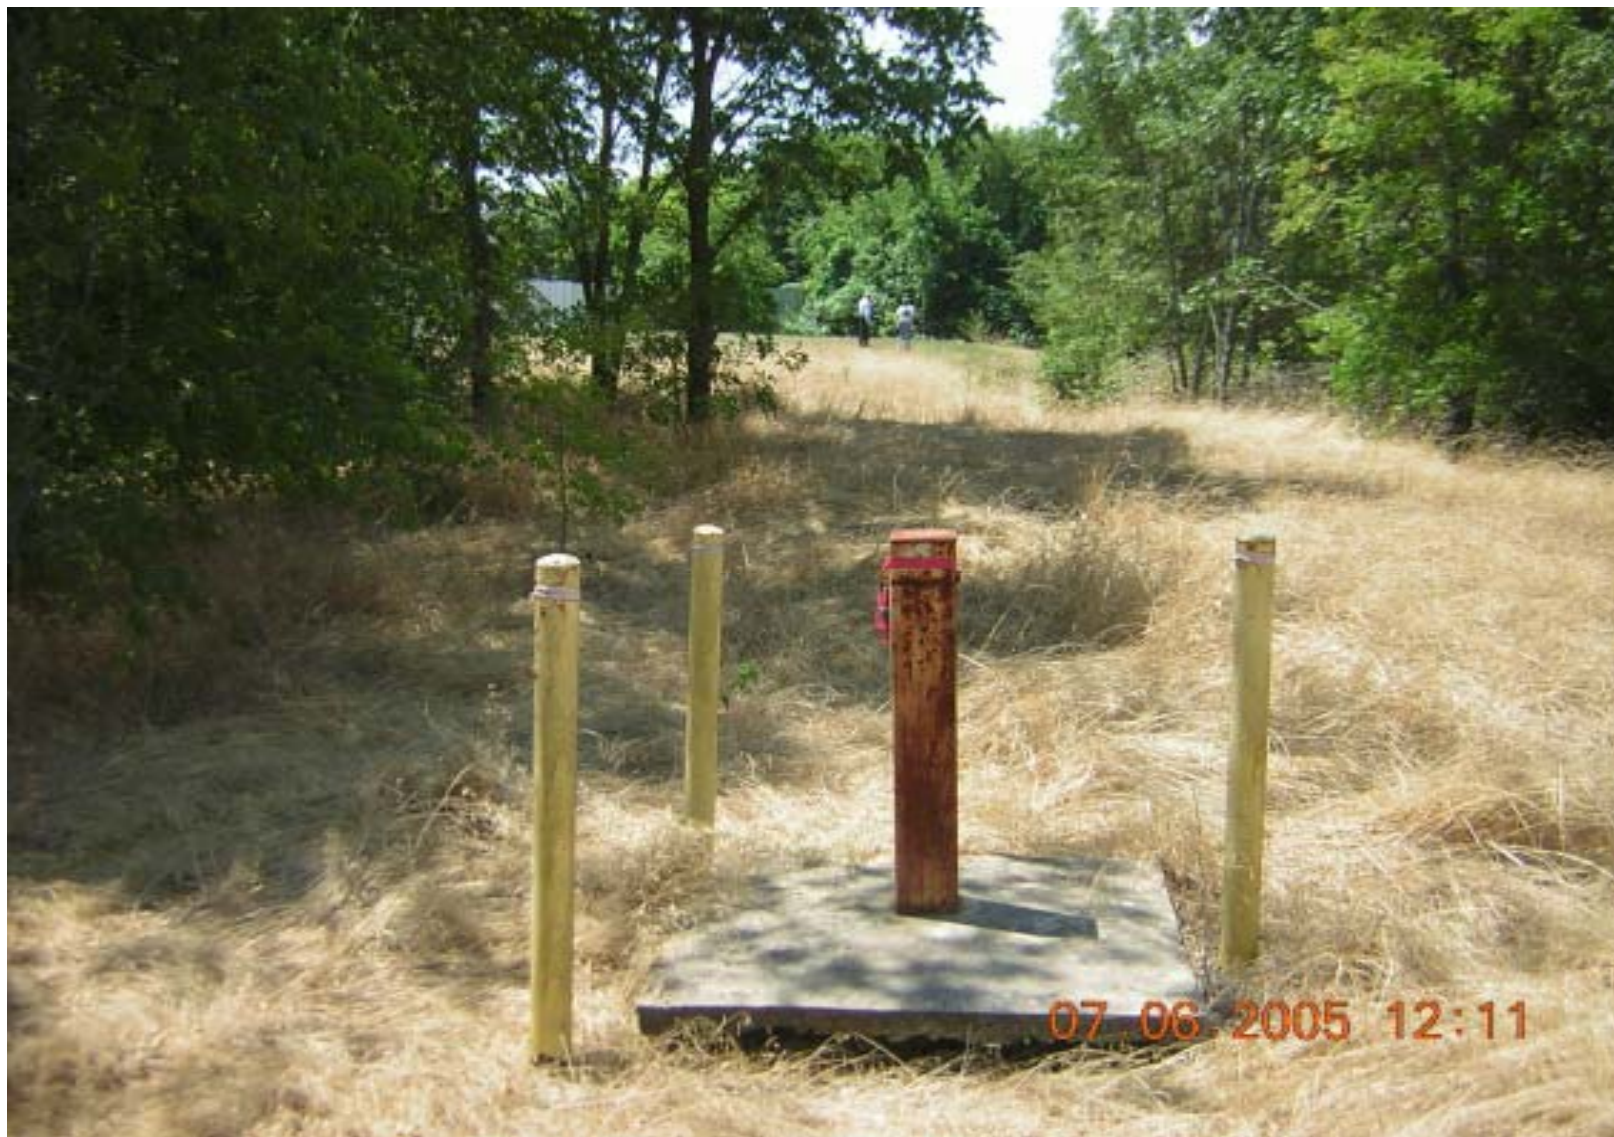
- 3. Unused monitor wells are present at OU3, Sites 3 and 4.** The original intent was to temporarily monitor ground water at these sites after completion of the RA, but this monitoring was not found to be necessary. Although the monitor wells are currently locked and secured, they do provide an open conduit to the subsurface. If the integrity of the monitor wells was compromised in the future, they would provide a potential pathway for the migration of contamination to the subsurface in the future.

Photo 19: OU3, Site 3 – View of monitor well. Settlement can be observed at the base of the well's concrete pad.

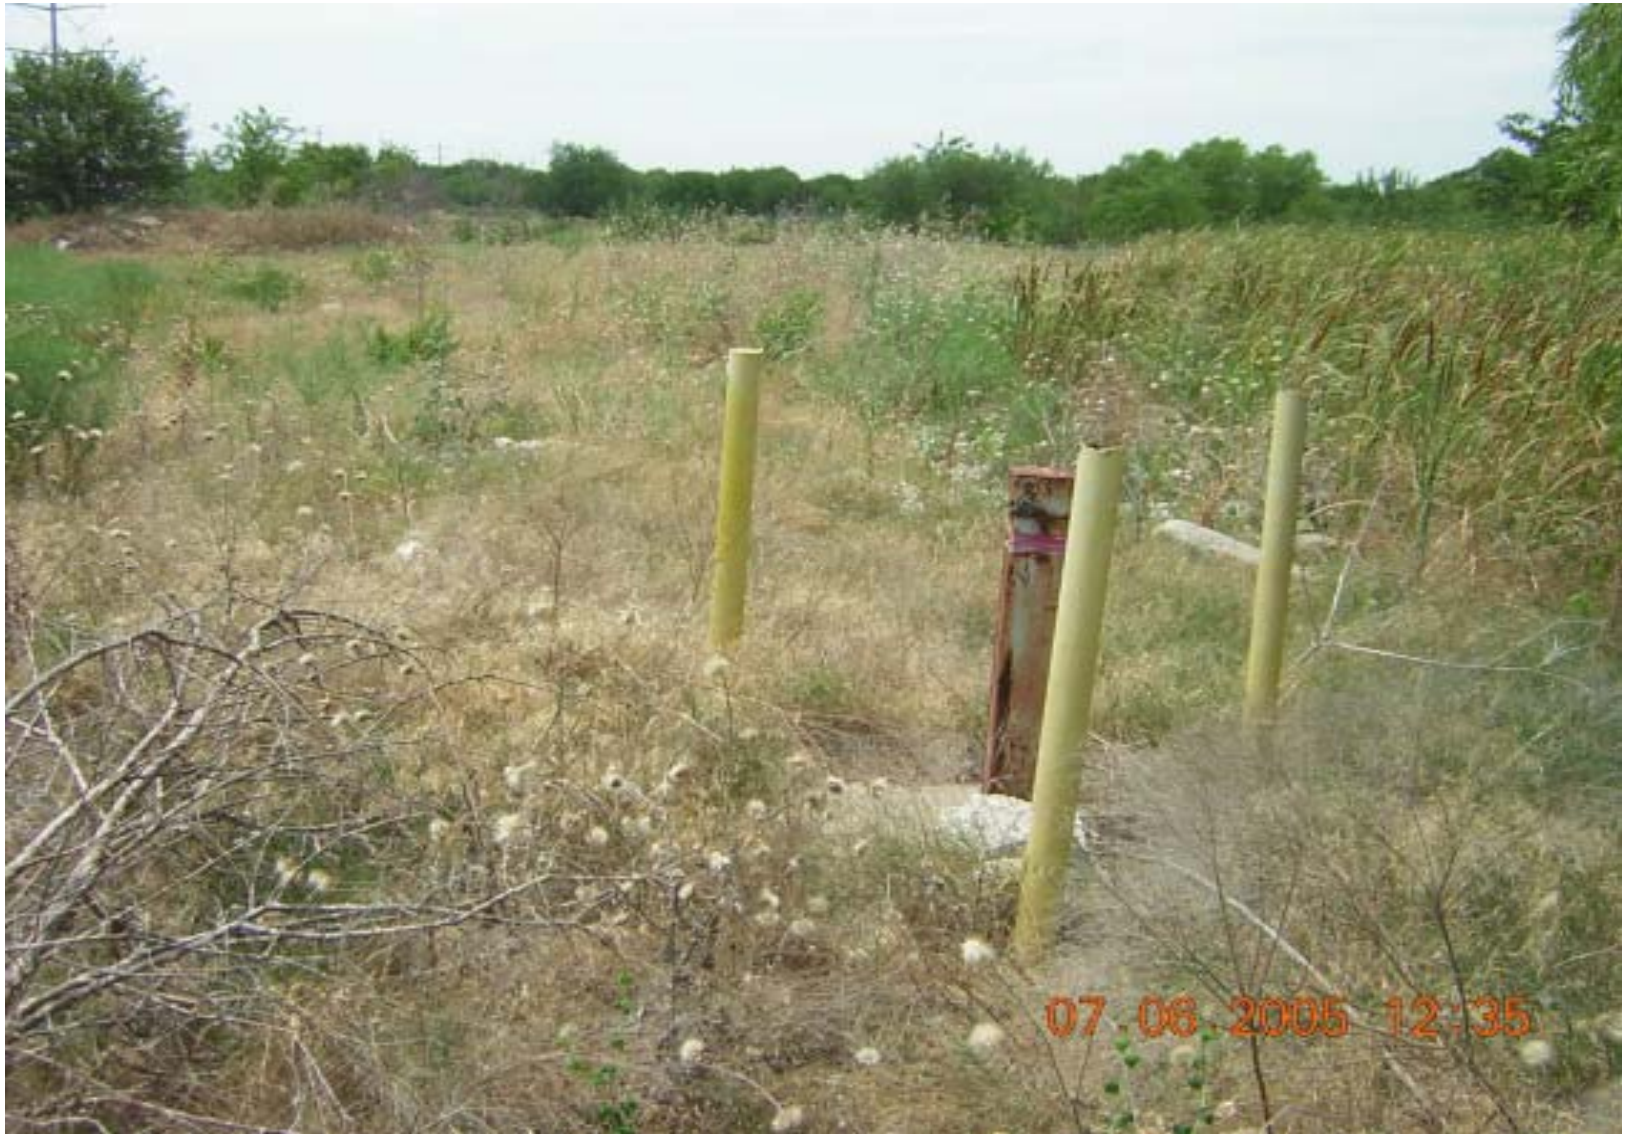
Photo 20: OU3, Site 3 – View of a monitor well installed at the north end of the site.
