Five-Year Review Report

First Five-Year Review Report for the RSR Corporation Superfund Site Dallas, Dallas County, Texas

September 2005

FIRST FIVE-YEAR REVIEW
RSR Corporation Superfund Site
EPA ID# TXD079348397
Dallas, Dallas County, Texas

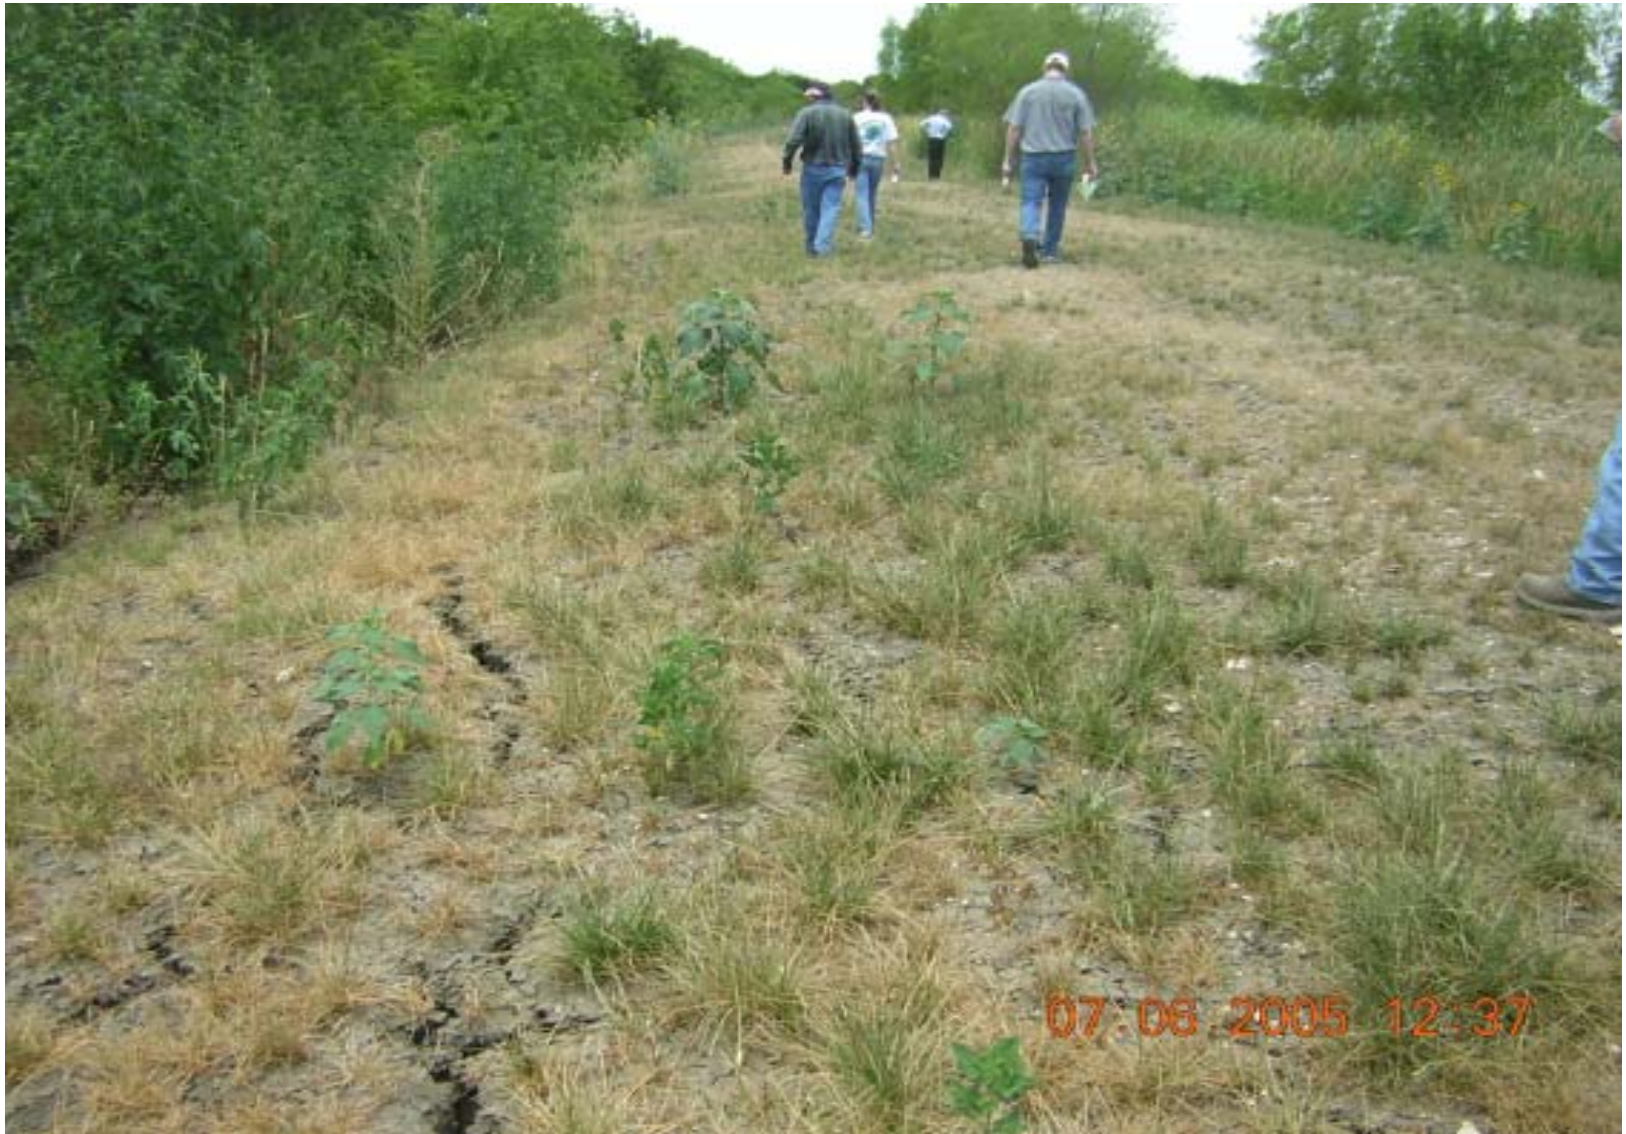
Photo 21: OU3, Site 3 – View of the soil cover in the northern portion of the site. The vegetation is sparse and large desiccation cracks are observed in this photo. View is facing west.

- 4. The soil covers at OU3, Sites 3 and 4 and OU5, Subarea 2 should be revegetated.** Sparse vegetation was noted during the site inspection at these sites. New vegetation should be established to reduce the potential for erosion of the soil covers at these sites, thus reducing the potential for the underlying contamination to become exposed.

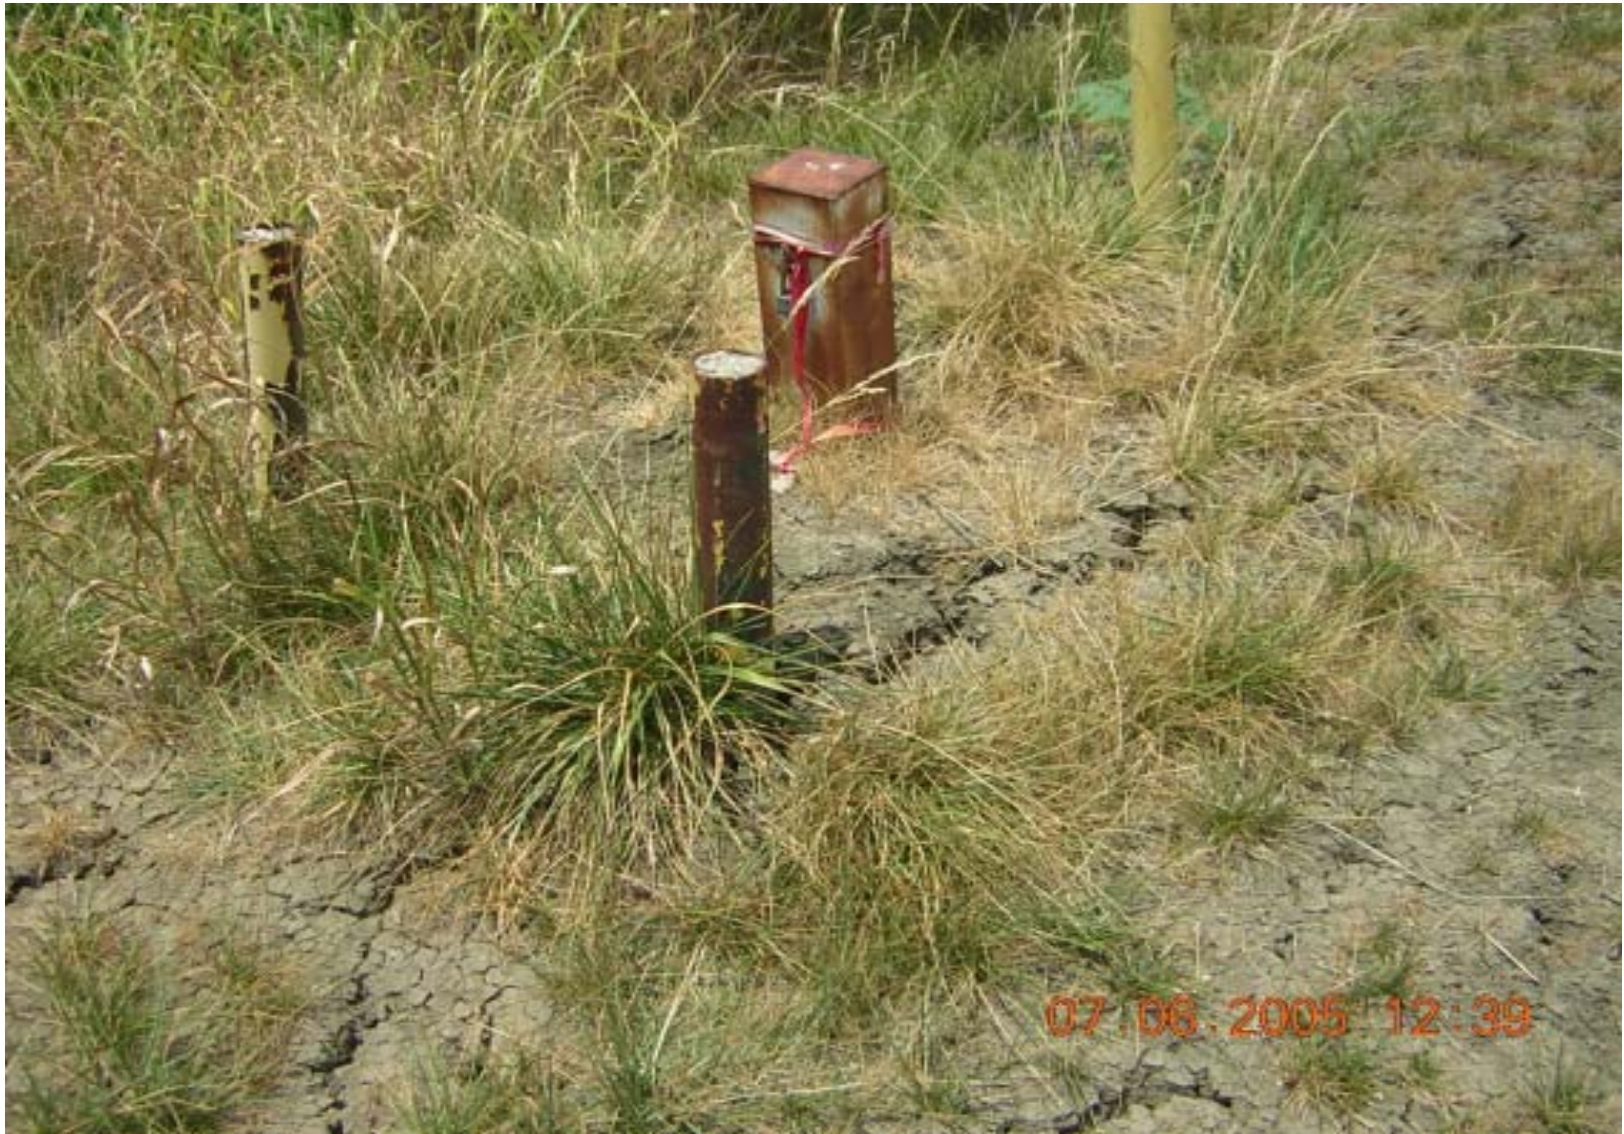
- 3. Unused monitor wells are present at OU3, Sites 3 and 4.** The original intent was to temporarily monitor ground water at these sites after completion of the RA, but this monitoring was not found to be necessary. Although the monitor wells are currently locked and secured, they do provide an open conduit to the subsurface. If the integrity of the monitor wells was compromised in the future, they would provide a potential pathway for the migration of contamination to the subsurface in the future.

Photo 22: OU3, Site 3 – View of monitor well near soil cover in northern area of site. Monitor well lacks a well pad.

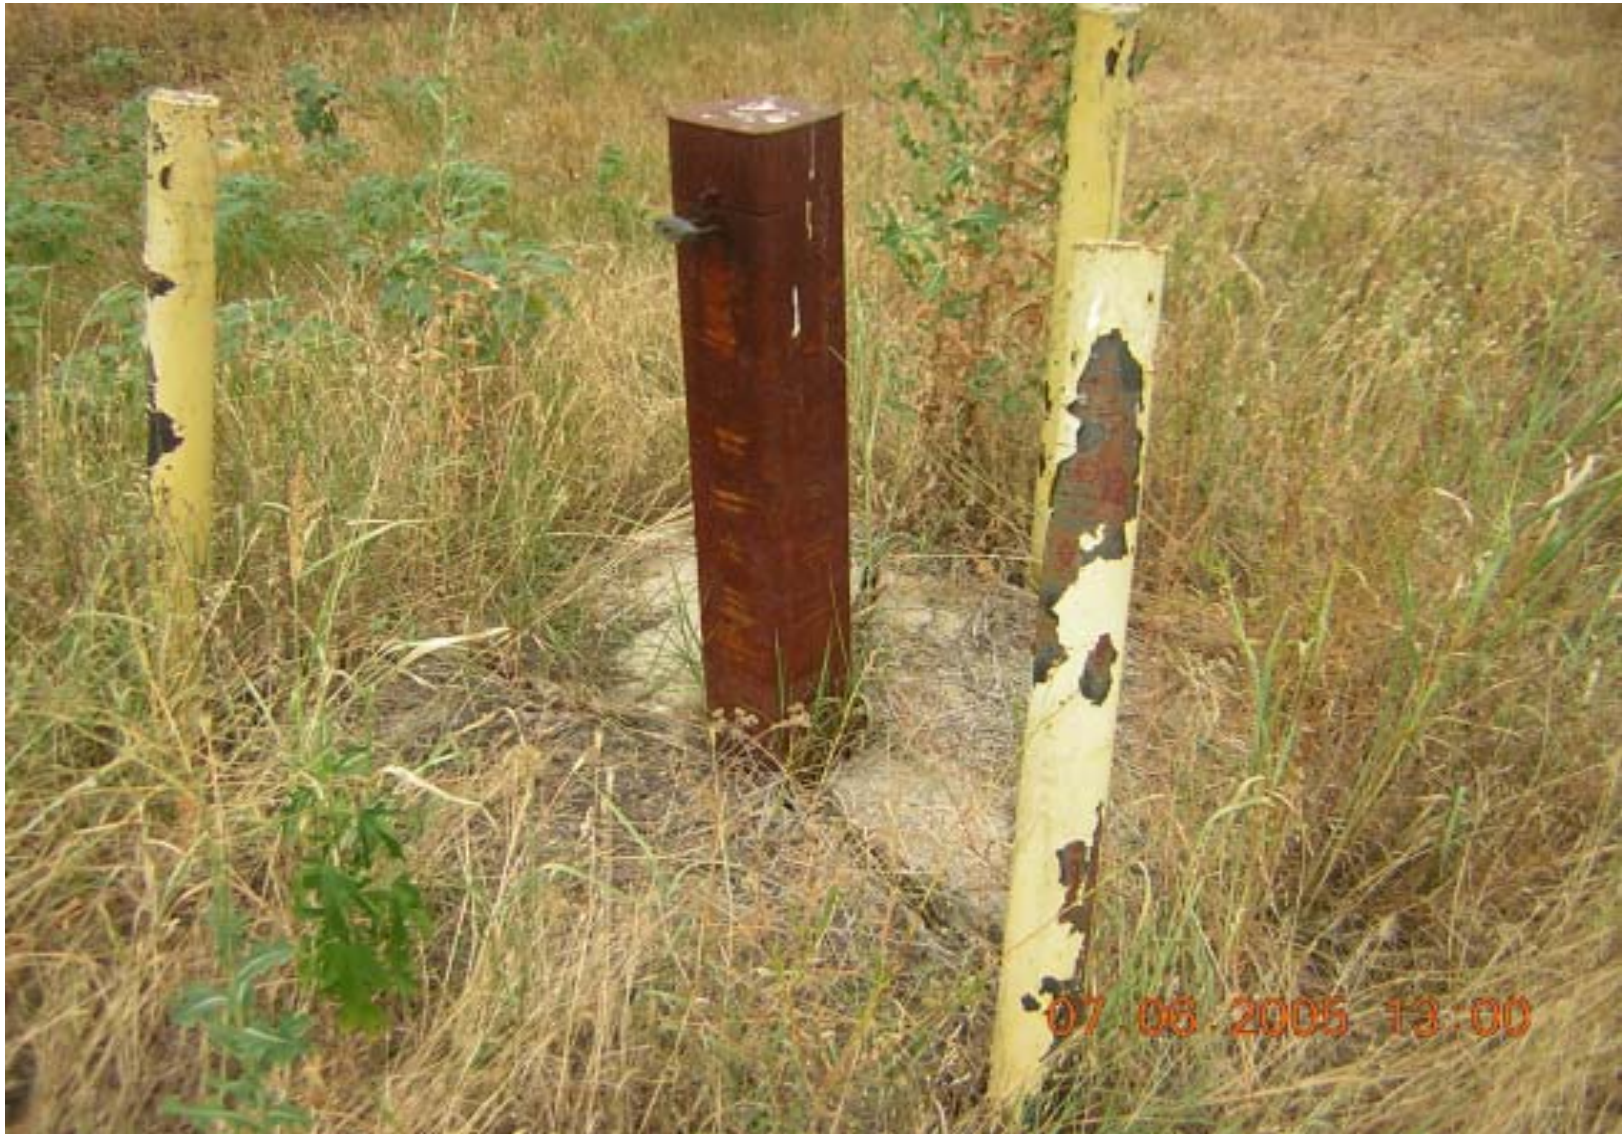
Photo 24: OU3, Site 4 – View of monitor well at site.

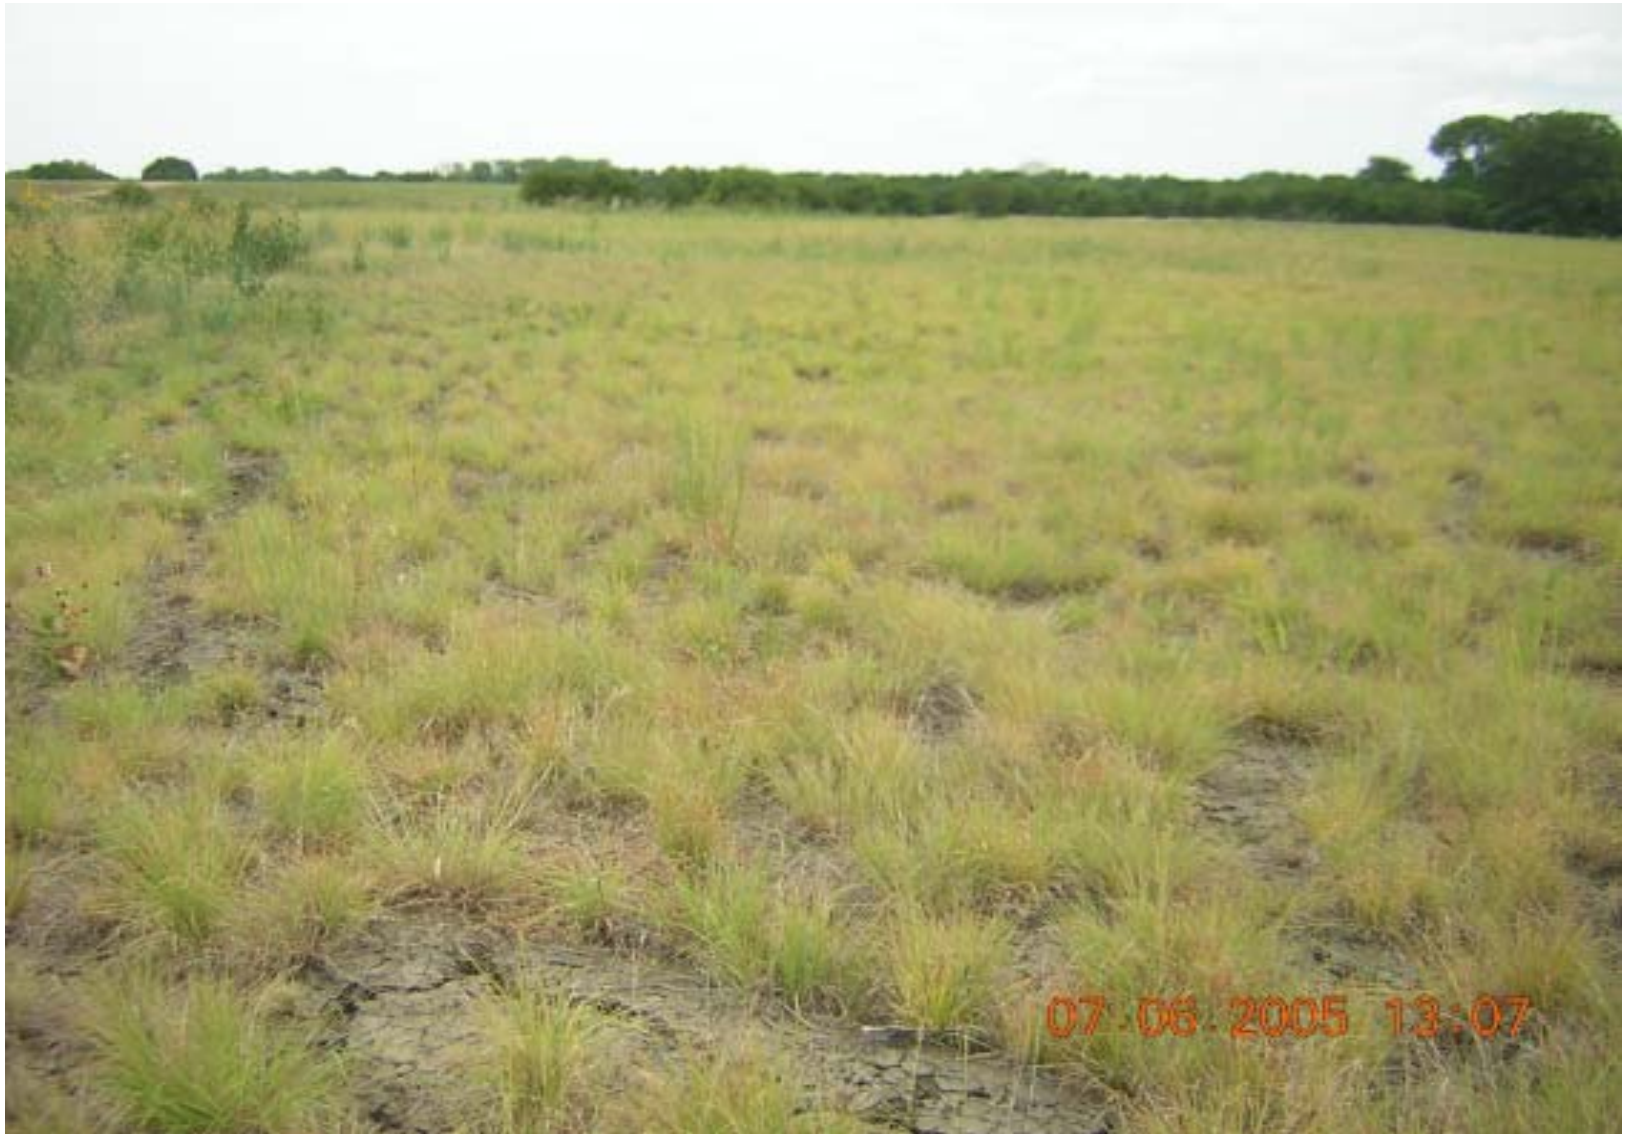
Photo 25: OU3, Site 4 – view of soil cover at site, facing west. There are numerous desiccation cracks in the surface of the soil cover and the vegetation is sparse.

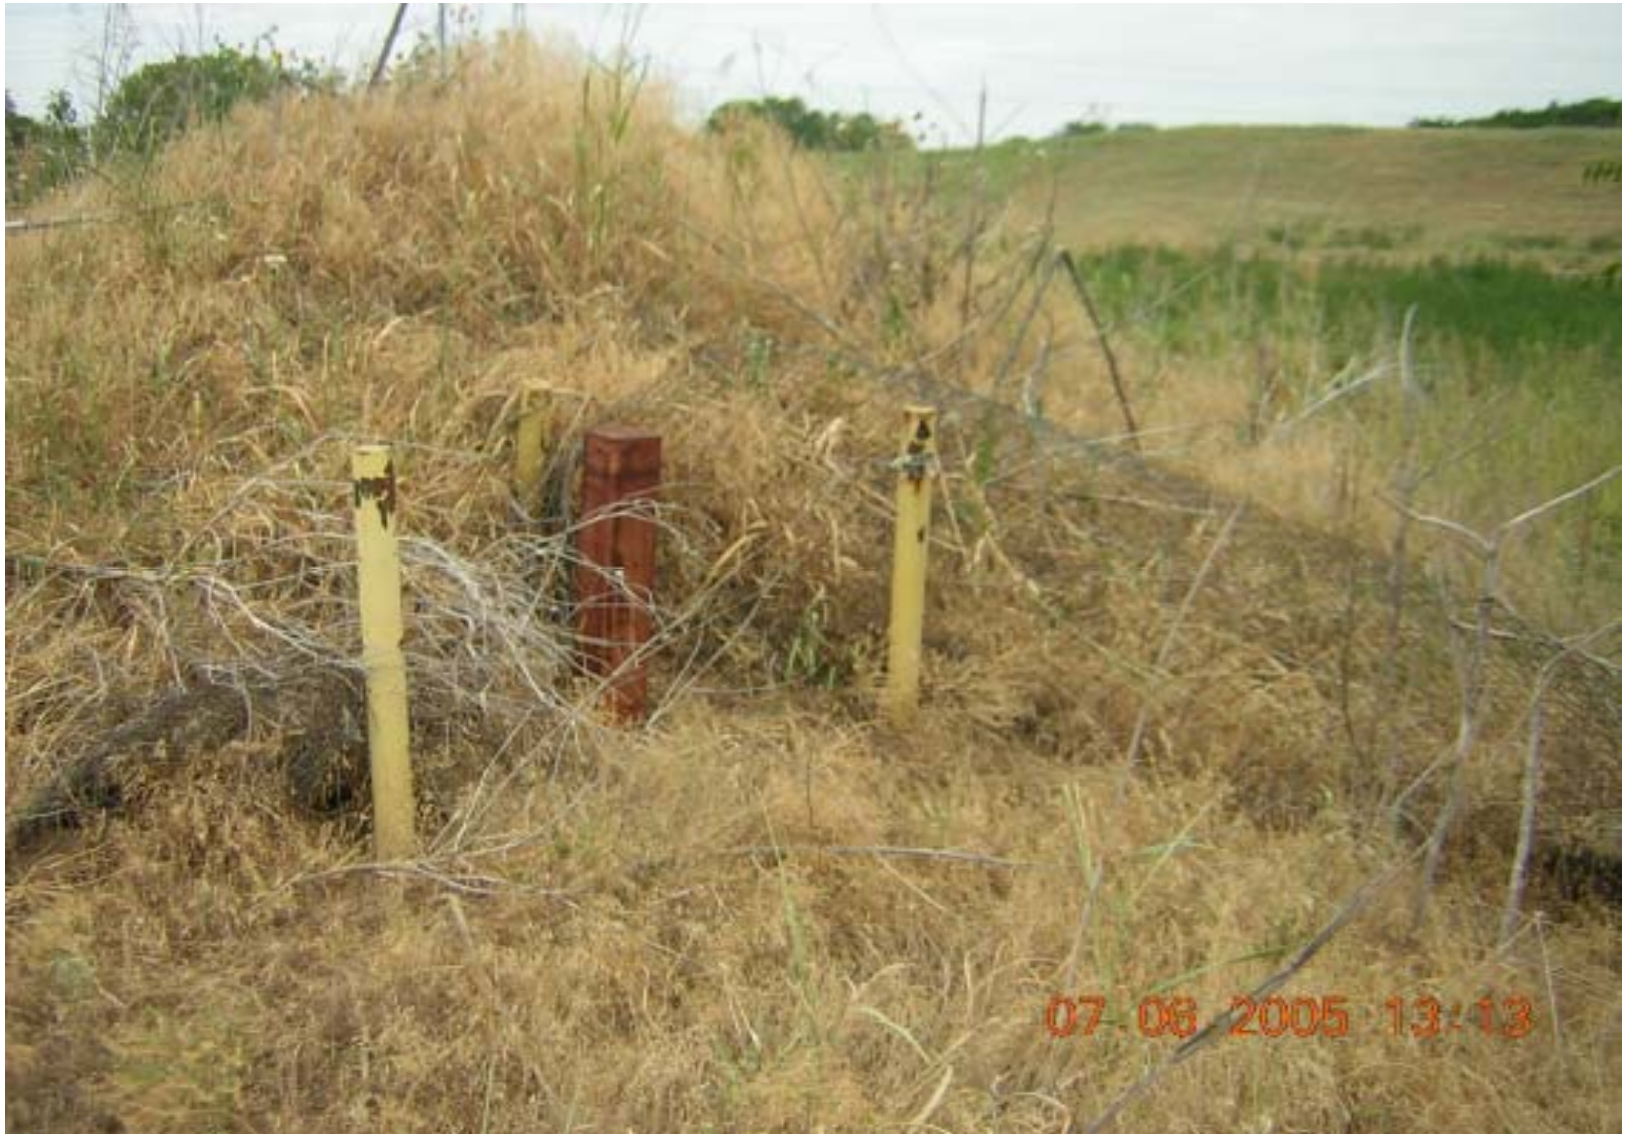
Photo 26: OU3, Site 4 – View of monitor well at site. The well is almost covered by vegetation.

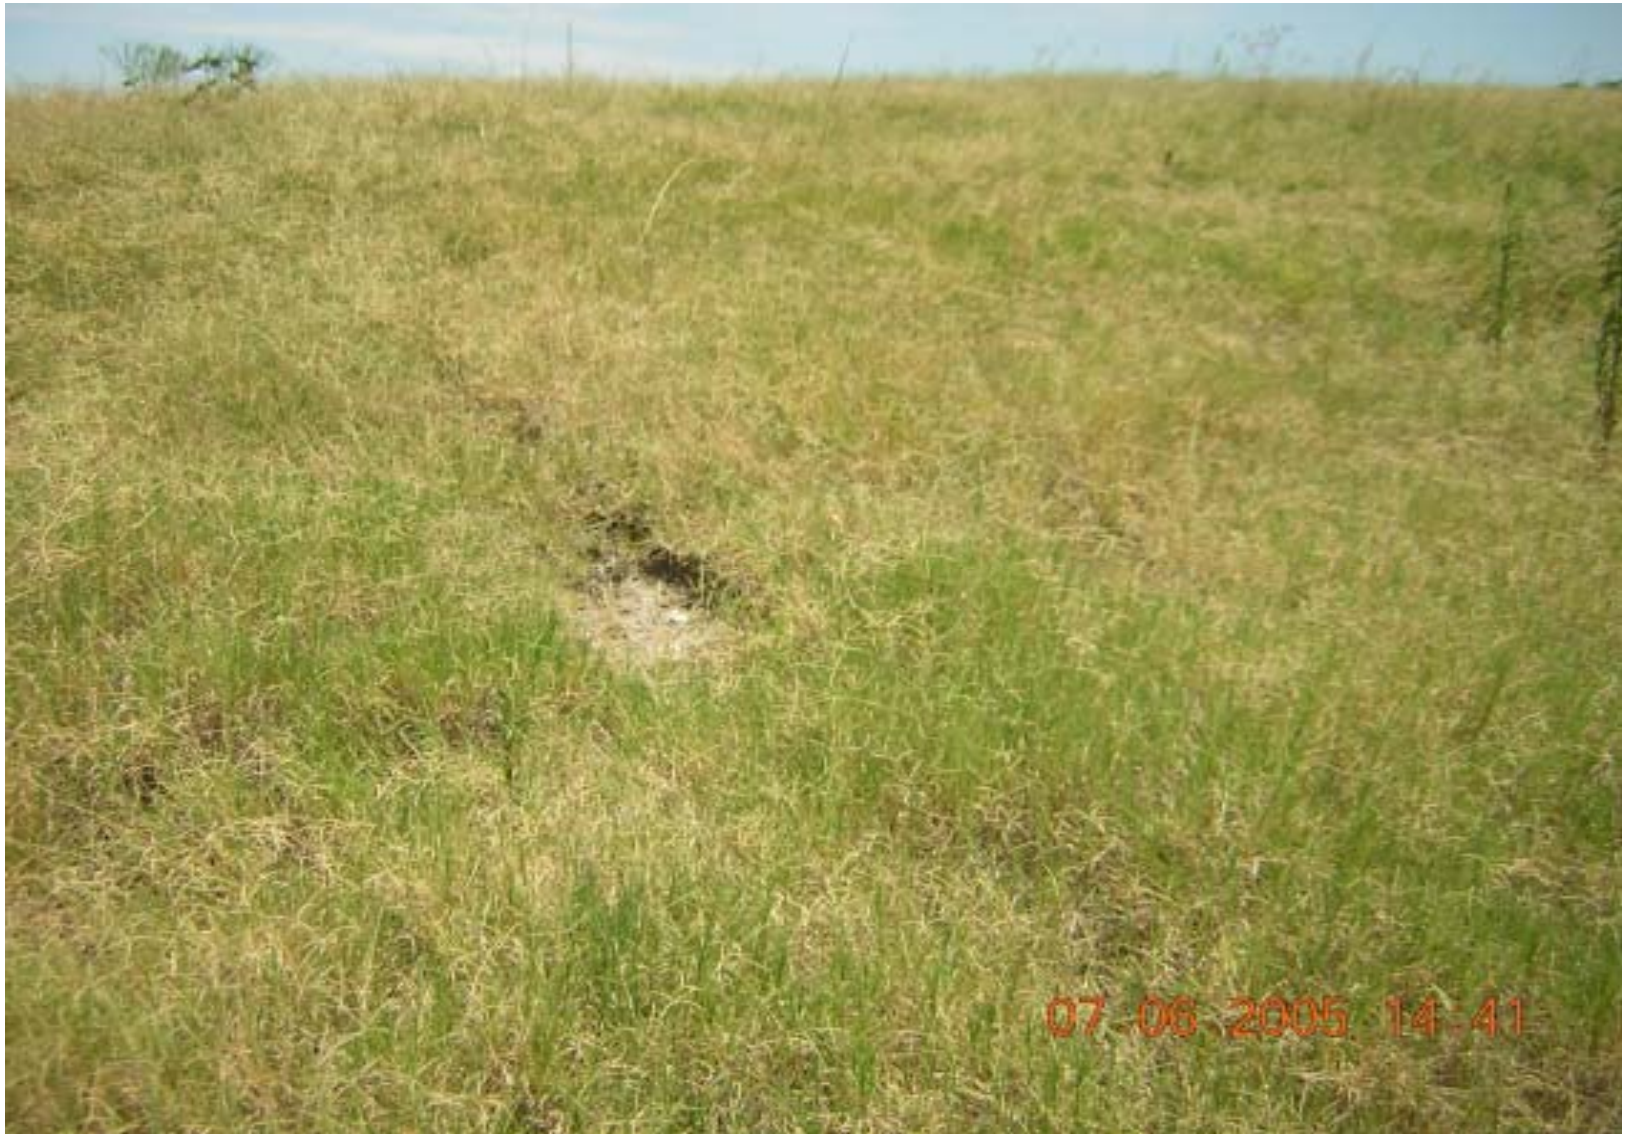
Photo 32: OU5, Subarea 1 – View of bare spot on cover at the former surface impoundment.

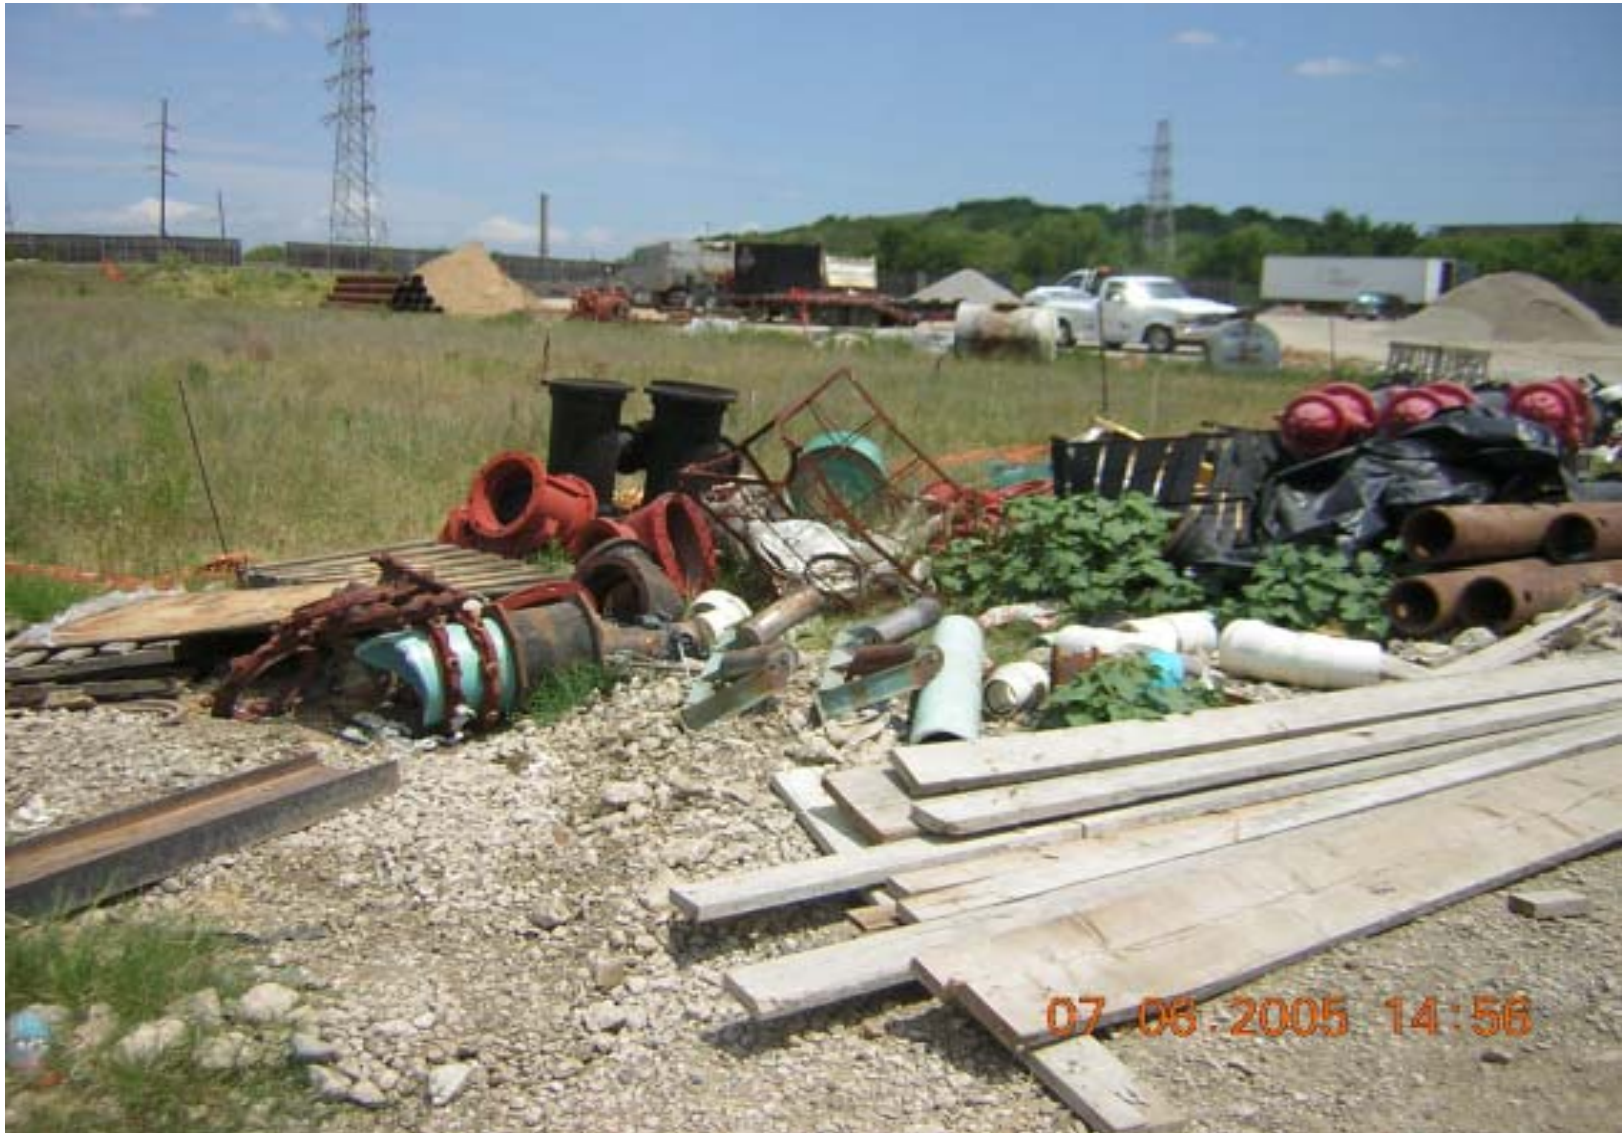
Photo 35: OU4 – View of site. Construction company has stored equipment and materials on the site.

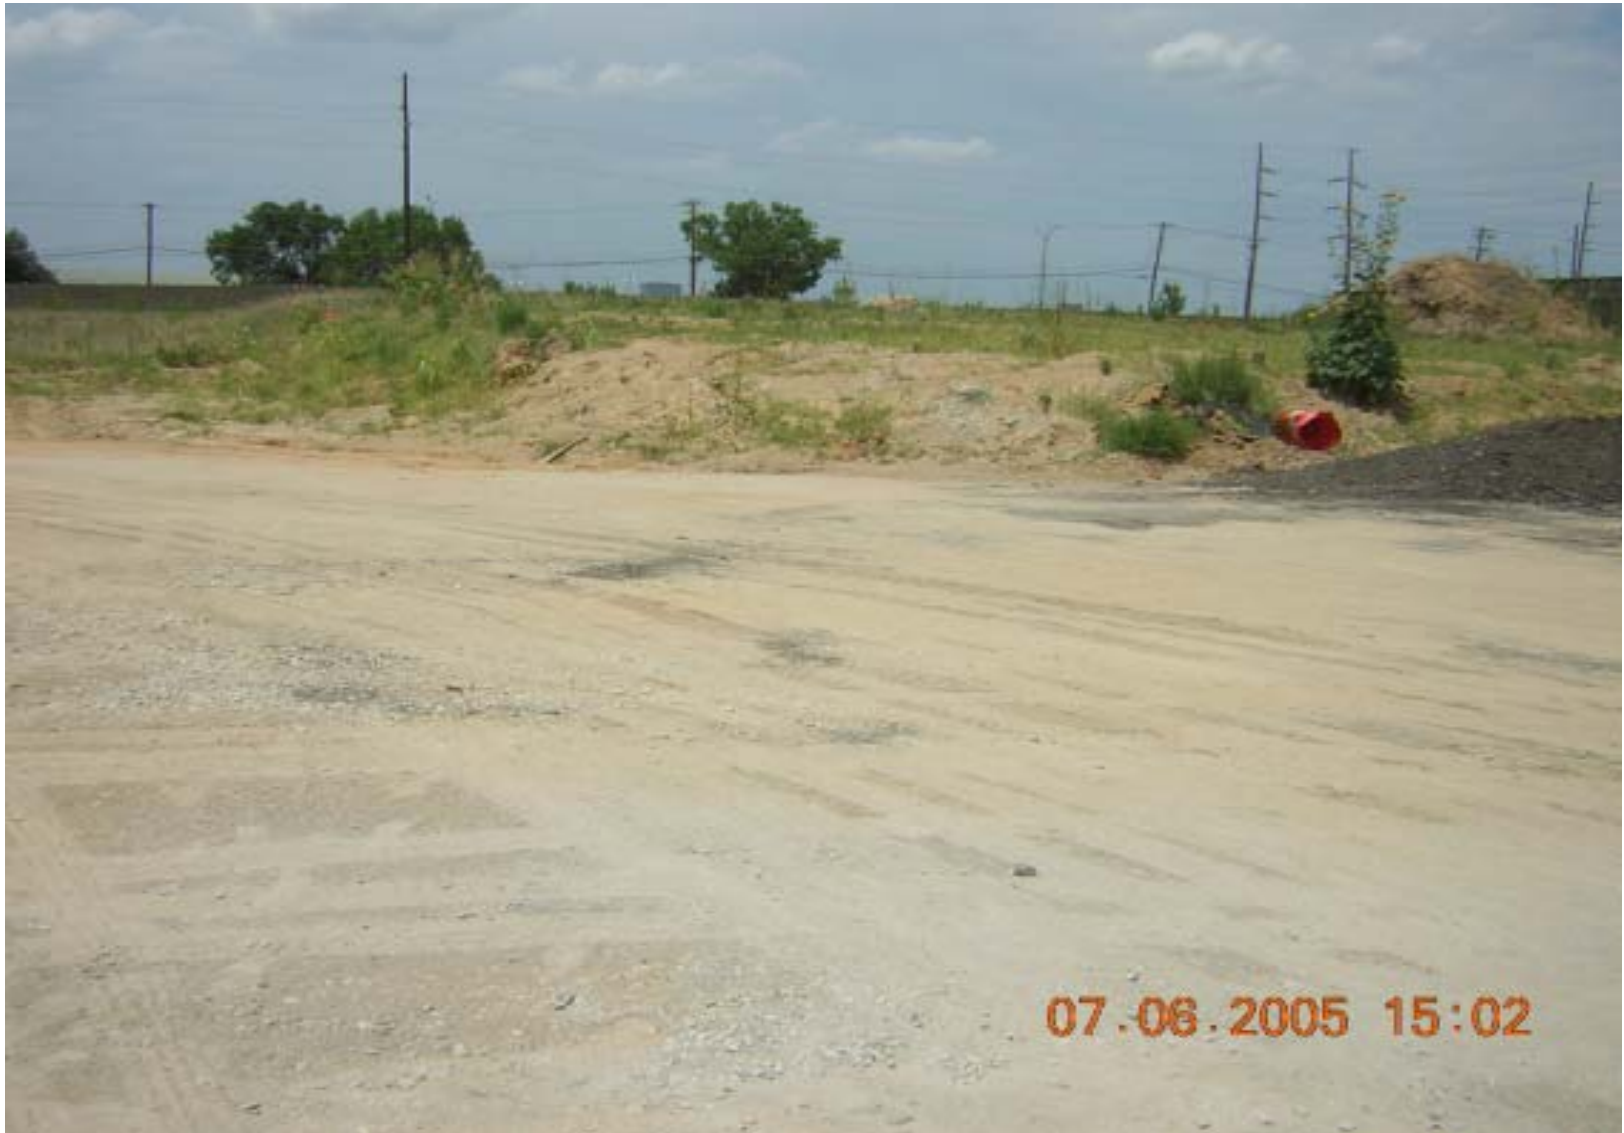
Photo 36: OU4 – View of road surface and stockpiled dirt placed on site by construction company that is leasing the property.
