**GULF COAST VACUUM SERVICES SUPERFUND SITE**  
Vermilion Parish, Louisiana

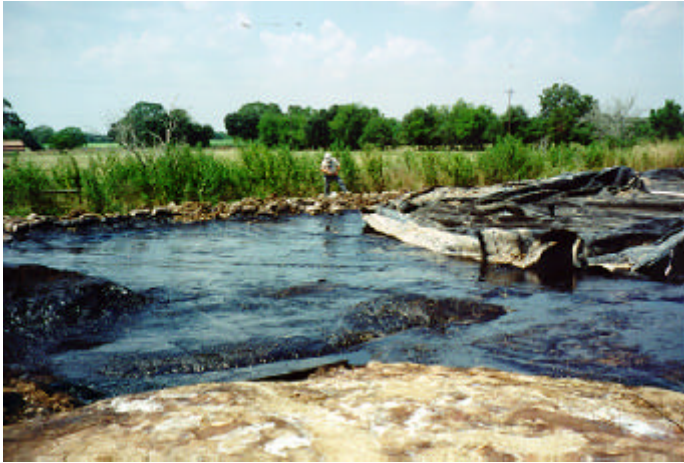
*BEFORE*

Organic-contaminated sludge in West Pit prior to treatment, after cover removal (right side of picture shows cover used to keep contaminated rainwater from accumulating and overflowing into nearby pasture)

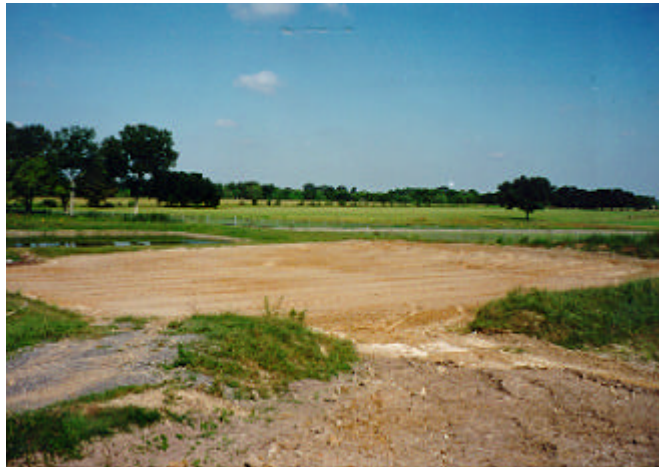
*AFTER*

One of the on-site landfarms where the sludge is taken for biological treatment (note color change from above by end of treatment)

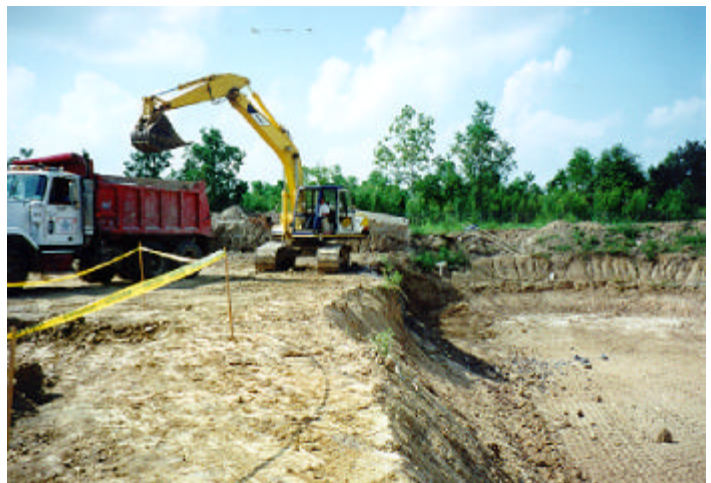
On-site pit where biological treatment residuals and stabilized metal-contaminated material are placed (pit will be capped at end of project)
