EVALUATION OF CAB CAR CRASHWORTHINESS DESIGN MODIFICATIONS

ABSTRACT

A study was conducted to evaluate the effectiveness of structural modifications to rail cab cars for increased crashworthiness protection in train collisions. The crashworthiness benefits were calculated based on a particular design's ability to preserve the space occupied by the operators and the passengers during a collision. The influences of the modifications on vehicle weight and cost to manufacture were also estimated. The focus of the study was a collision scenario in which a cab car-led consist traversing a switch onto mainline track obliquely collides with a locomotive-led consist traveling in the opposing direction on the mainline track.

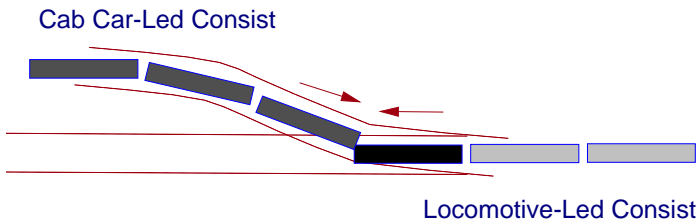
In February of 1996, two unrelated passenger train collisions occurred. In each collision, a cab car and a locomotive were the impacting cars. The initial impact occurred while one of the lead cars was traversing a switch, resulting in an angle between the cars, as well as a lateral misalignment. In both collisions, there was substantial crushing of occupant volume in the cab cars. The main load-bearing structural members of the cab cars (collision posts, draft sill, center sill) were not directly loaded during the collisions. Rather, weaker end members (end beam, side sill) were loaded directly, and failed. Figure 1 schematically depicts the initial conditions of an oblique collision.

Figure 1: Schematic of an Oblique, Cab Car-to-Locomotive Collision.

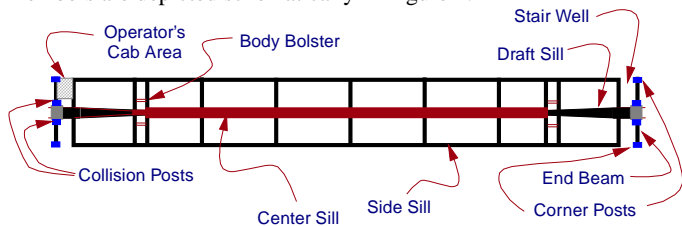
The typical North American passenger cab car structure consists of an underframe, an end structure and a body shell. The underframe consists of four longitudinal members: the center sill, draft sill and two side sills, and two body bolsters, which laterally connect the center sill, draft sill, and two side sills. The end structure consists of an end beam (or buffer wing), two vertical collision posts and two vertical corner posts. The structural members with the largest cross-sectional areas are the center sill, the draft sill, and the body bolster. The main cab car structural members are depicted schematically in Figure 2.

Figure 2: Schematic of Typical Cab Car Structural Members, Top View.

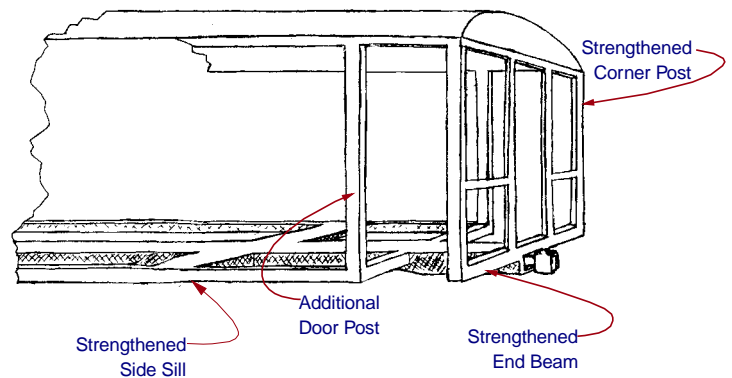
shell acts to stabilize the end structure and underframe members during a collision. Figure 3 illustrates the structural modifications considered.

Figure 3: Sketch of Cab Car Structural Modifications.

Increased strength over existing member design was achieved principally by increased cross-sectional area. Modifications were generally made to the various components by replacing them with similar sections or rectangular tubes whose section moduli and/or cross-sectional area were greater than that of the existing component. In general, closed sections whose outer dimensions required little additional space over the existing component designs were selected. In some cases, higher component strength was accomplished by increasing only wall thickness. Table 1 lists the modifications considered. Two potential modifications were considered for both the door post and the side sill to better estimate the relationship between increases in strength, cost and weight.

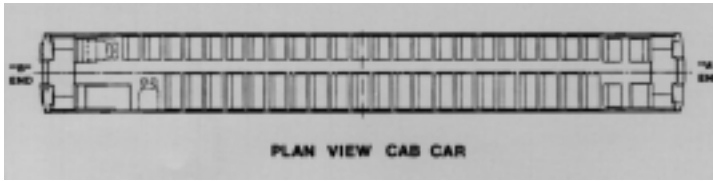
The principal geometric constraint in modifying the cab car structure to improve crashworthiness is the location of the stair well immediately behind the end beam, which limits the locations for structural members. In addition, the floor plan of a typical cab car is almost entirely taken up by passenger and operator seating, leaving little unoccupied area to be designated as a crush zone. A typical cab car floor plan is shown in Figure 4.

Figure 4: Typical Cab Car Floor Layout.

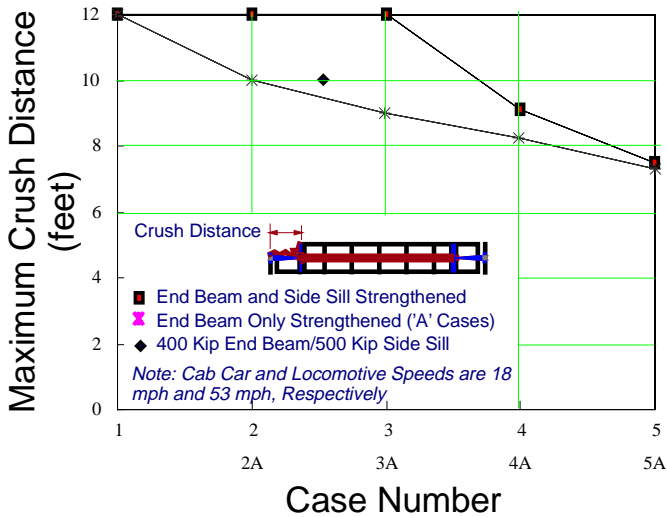
Figure 6 shows a plot of crush distance as a function of end structure strength, with the cab car initially traveling 18 mph and the locomotive initially traveling 53 mph in the opposite direction. The crush distance is the reduction in length along the impacted side of the cab car.

Figure 6: Influence of Cab Car Strength on Cab Car Crush.

The results in Figure 6 for the cases in which only the end beam is strengthened indicate that increasing the force required to crush the end beam increases the deflection of the vehicles out of each other's way. This deflection acts to reduce the crush of the cab car. In contrast, the increased side sill strength tends to increase the engagement of the vehicles, thus maintaining the 12 feet of cab car crush, until the end beam is strengthened by a factor greater than 3.

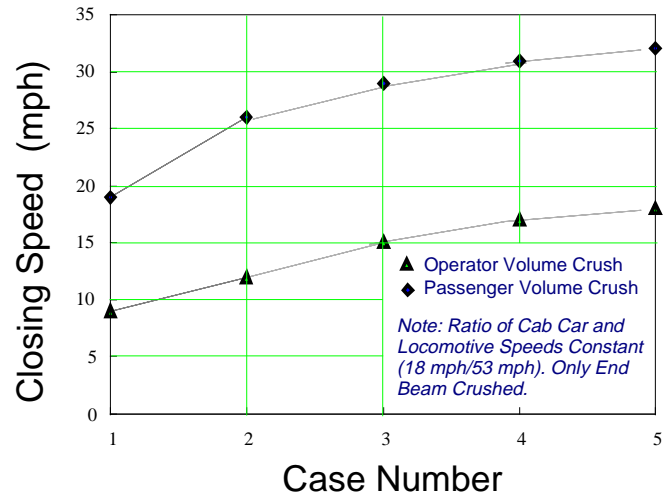
Figure 7 plots the maximum safe closing speed for operators and passengers, assuming that crush greater than 1 foot would reduce the operator's cab volume beyond the survivable limit, and that crush greater than 3 feet would begin reducing the passenger volume beyond the survivable limit for passengers seated near the operator's cab. The maximum closing speed in which the operator may be expected to survive is approximately 17 mph for Cases 5 and 5A and 9 mph for the baseline design (Case 1). The maximum closing speed in which all passengers may be expected to survive is approximately 32 mph for Cases 5 and 5A, with the end beam strengthened by a factor of five greater than the baseline, and 19 mph for the baseline case. Side sill strength does not influence the results depicted in Figure 7, as the side sill is not loaded for these closing speeds.

Figure 7: Influence of Closing Speed on Maximum Cab Car Crush.

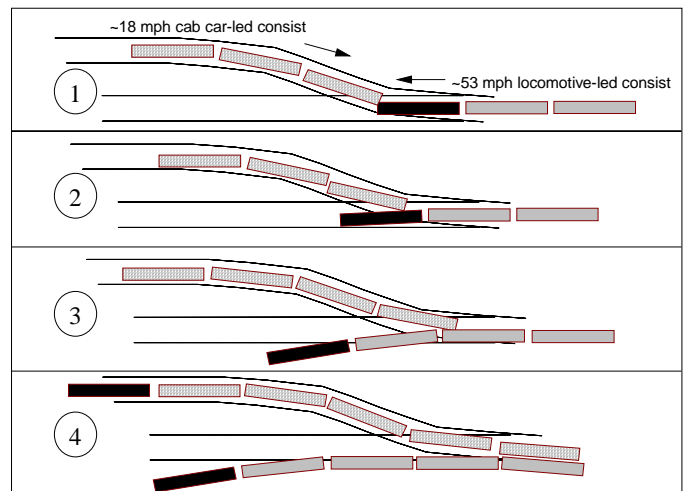
Figure 10 illustrates the sequence of events during the collision, based on conversations with FRA and NTSB officials. It appears that the collision progressed as follows:

1.) The cab car was traveling at approximately 18 mph when it struck the front, right corner of the locomotive, which was traveling at approximately 53 mph in the opposite direction. Based on the track geometry, the angle between the two vehicles at the instant of impact was approximately 7°. The corner post on the right side of the cab car struck the right side of the locomotive. Both collision posts on the cab car remained in place, though the right post incurred some structural damage. The right corner post was torn away from the cab car. The roof plate from the right side of the cab car broke away and penetrated the window of the locomotive.

2.) The cab car raked down the side of the locomotive. The left rail (field side) under the locomotive rolled over and the locomotive derailed.

3.) The derailed locomotive pulled the trailing cars off the track. The cab car continued to rake the cars trailing the locomotive, damaging stair wells and radius rods as it went.

4.) Most cars in the locomotive-led consist derailed (the last car may have stayed on the track). Only the cab car derailed in the cab car-led consist. The cab car-led consist was stopped by the collision at the switch. The locomotive-led consist slid to a stop on the ties and ballast.

Figure 10: Schematic of February 9, 1996, Secaucus, New Jersey, Cab Car/Locomotive Collision

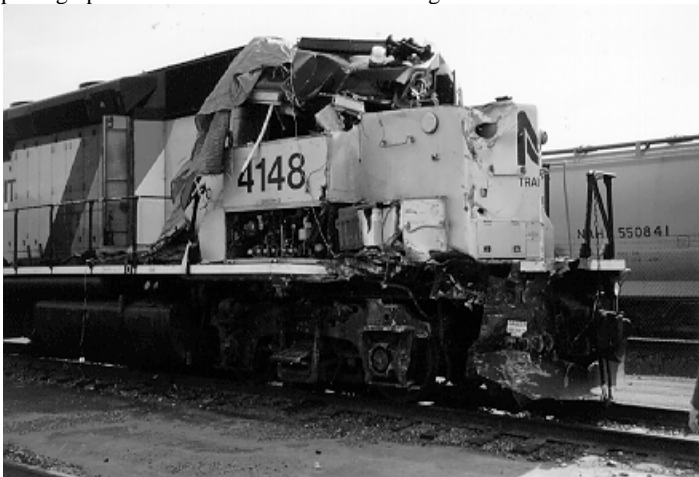
The roof plate of the cab car penetrated the operator's window of the locomotive. Damage to the hood of the locomotive appeared to be due to the roof plate riding up on the hood and through the window. Some superstructure damage to the front of the locomotive, approximately halfway between the coupler and the side of the locomotive, appeared to have been caused by the front of the cab car. The center sill and main structure of the locomotive remained essentially intact. A post-collision photograph of the locomotive is shown in Figure 11.

Figure 11: Lead Locomotive, NJT Train.

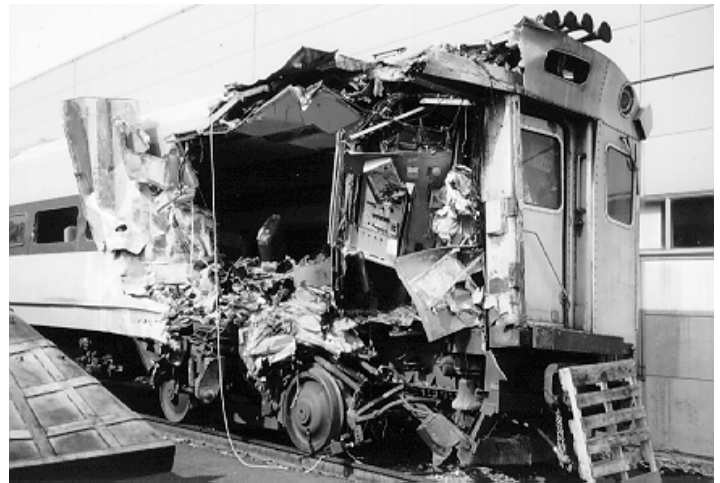
Damage to the lead cab car includes crushing of the right, front corner of the car from the end of the car to the body bolster. This area includes the operator's compartment and approximately five rows of seats. The right (track-side) collision post incurred substantial damage: there are several large cracks in and around the attachment point. This damage may have occurred when the end of the transverse floor member was torn off in the initial collision with the locomotive. The collision post itself may not have been loaded directly. The corner post and a portion of the roof plate were separated from the cab car. A post-collision photograph of the cab car is shown in Figure 12.

Figure 12: Lead Cab Car, NJT Commuter Train.

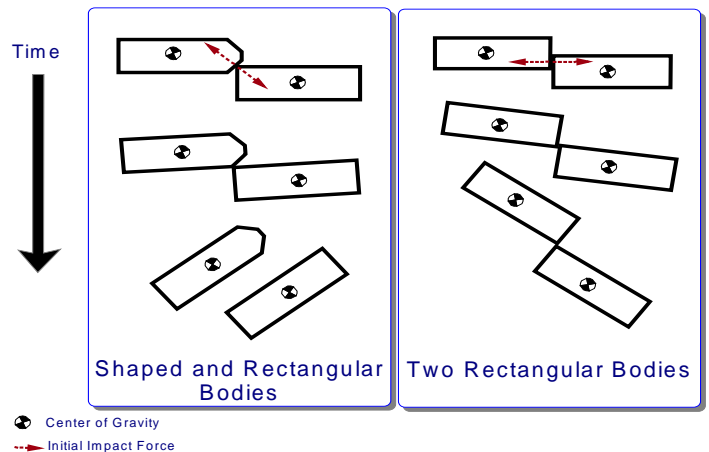
Figure 13: Time-History Schematic of Oblique Collision of Two Rigid Bodies.

The undeformed and deformed geometries of the carbody structures influence the direction of the forces, including the magnitude of the lateral force component, consequently influencing the gross motions of the colliding cars during a collision. Figure 13 illustrates the influence

of geometry on the results of an offset collision between two rigid bodies. For rectangular rigid bodies, the impact force causes both bodies to turn into each other (both bodies turn clockwise in the illustration). In a collision between a shaped body and a rectangular body, the bodies turn away from each other.

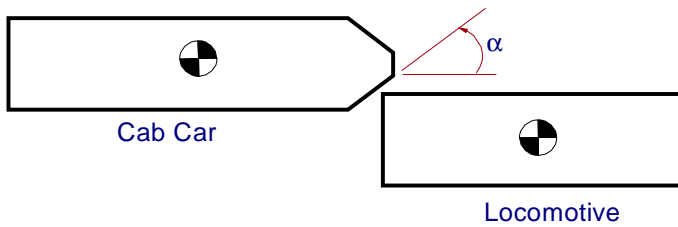
Figure 14 is a schematic of a shaped body (cab car) colliding with a rectangular body. The general plane motions of these bodies can be determined from rigid body mechanics, assuming a perfectly plastic collision and conservation of momentum. Table 6 lists the parameters of the rigid body model.

Figure 14: Model of Oblique Collision of Two Rigid Bodies.

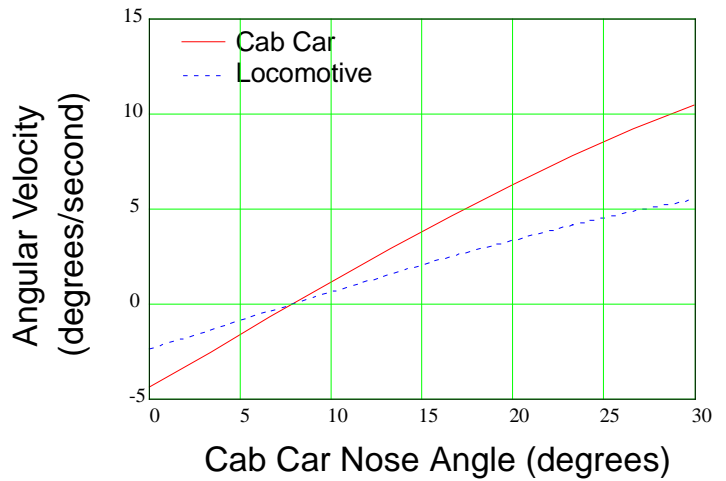
Figure 15 shows the influence of the cab car end structure geometry angle α for a collision in which the locomotive is initially standing and the cab car is moving with a longitudinal velocity of 30 mph. The centers of gravity of the two cars are offset laterally by 10 feet. For cab car end structure angles less than approximately 8 degrees, the cars turn into each other, i.e., both cars turn clockwise, while for cab car end structure angles greater than 8 degrees, the cars turn away from each other, i.e., counterclockwise.

Figure 15: Influence of Cab Car Nose Angle on Cab Car and Locomotive Yaw Velocity, Rigid Body Model.

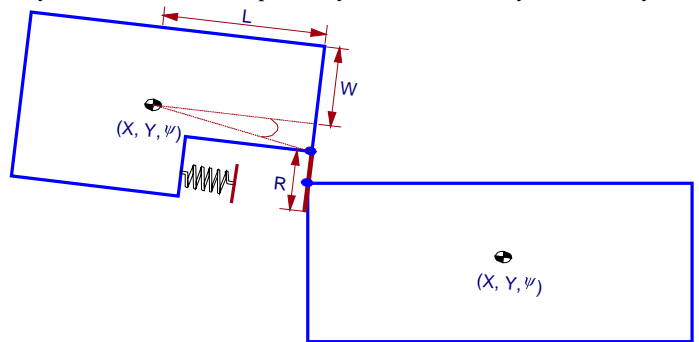
Figure 16 is a schematic of the oblique collision dynamics model. The model allows for the general plane motion of the cab car and the locomotive. The forces acting on the cars include the track forces and the forces due to crushing of the cab car end structure. The locomotive is assumed to be rigid relative to the cab car. Coupler forces are neglected. Due to the location and nature of the draft gear, the coupler cannot develop a significant yaw moment about the center of gravity of the car, and consequently does not significantly influence the gross motions of the impacting cars. In addition, there was minimal, if any, damage to the trailing draft gears of the locomotive or cab car and their associated coupled cars in the Secaucus collision. The lack of damage indicates that the coupler force levels were relatively low.

Figure 16: Schematic of Oblique Collision Dynamics Model.

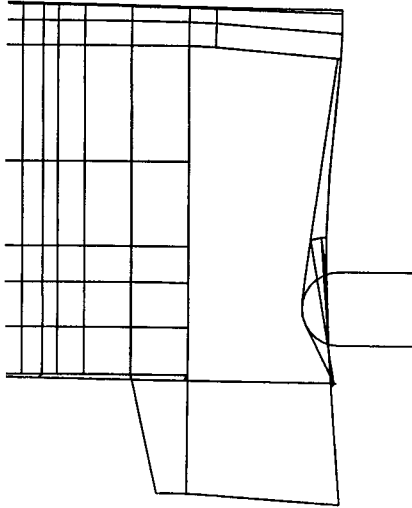
Force/crush characteristics for the end beam and the side sill were developed using a finite element mesh of the entire vehicle length, with the longitudinal midplane treated as a plane of symmetry (Mayville, et al, 1996). This means that the model of a collision or corner post load was a simulation of loading both collision or corner posts. The mesh

was constrained from displacement only at the bolster locations. The load was applied quasi-statically to the components through a simulated rigid, cylindrical body as illustrated in Figure 17. In the figure, the load shown is being applied to the corner post 18 inches above floor level, ahead of the end side door.

Figure 17: FEA Mesh with Load Applicator.

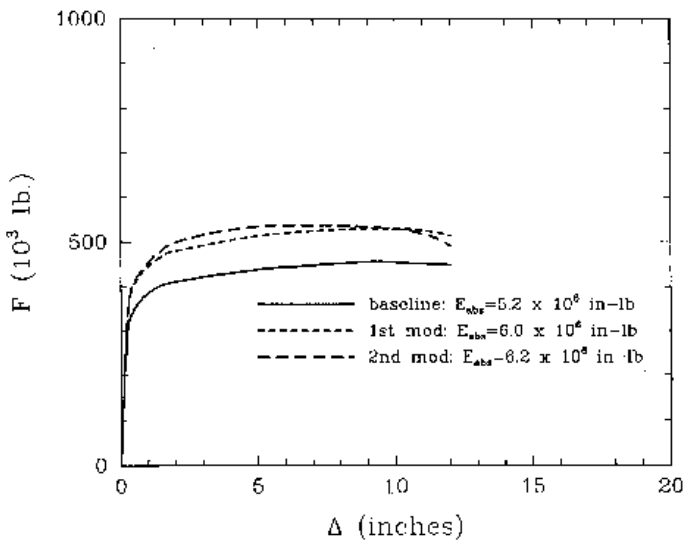
The force/crush characteristics for the side sill aft of the end door for the baseline and modified designs is shown in Figure 18. The side sill is loaded longitudinally, initially just aft of the end side door at floor level. For the baseline side sill, the yield strength calculated is approximately 240 kips, and the ultimate strength calculated is approximately 400 kips. For the modified designs, the yield strength is 300 kips and the ultimate strength is 500 kips. The nature of the force/crush characteristic is essentially the same for the baseline and modified side sill designs.

Figure 18: Modified and Baseline Side Sill Force-Crush Characteristics at Base of Door Post.

Current analysis results show that a load of approximately 400 kips is required to significantly crush the side sill (see Figure 18) ahead of the body bolster. The side sill cross-section is the same ahead and behind the body bolster, and consequently it is likely that it will crush at the same load aft of the body bolster as it does ahead of the body bolster. Aft of the body bolster, this load is principally carried by the center sill and two side sills, as shown in the free body diagram for the load applied at the draft stops in Figure 20. When a load of 800 kips is applied to the body bolster at the side wall of the car, the side sills and center sill are carrying loads near those required to cause significant crush.

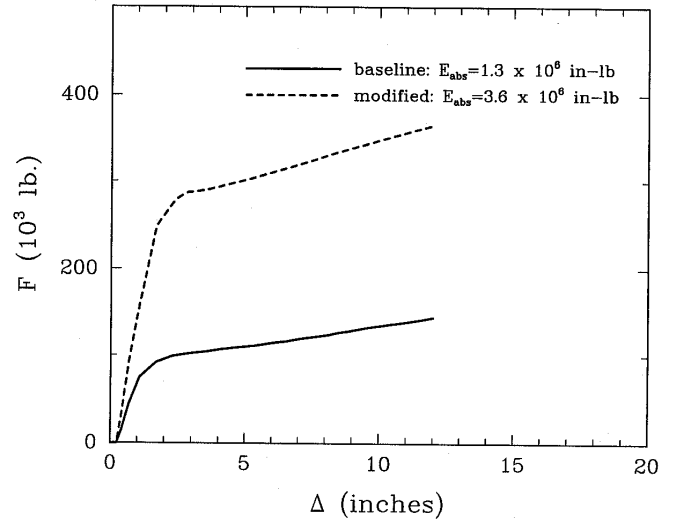
Figure 19 shows the force/crush characteristic for the end beam when loaded at its outboard edge, near the sidewall just ahead of the end side

door. For the baseline end beam design, the yield strength is approximately 110 kips, and the ultimate strength is approximately 150 kips. For the modified design, the yield strength is 300 kips, and the ultimate strength is 400 kips.

Figure 19: Modified and Baseline End Beam Force-Crush Characteristics at Base of Corner Post.

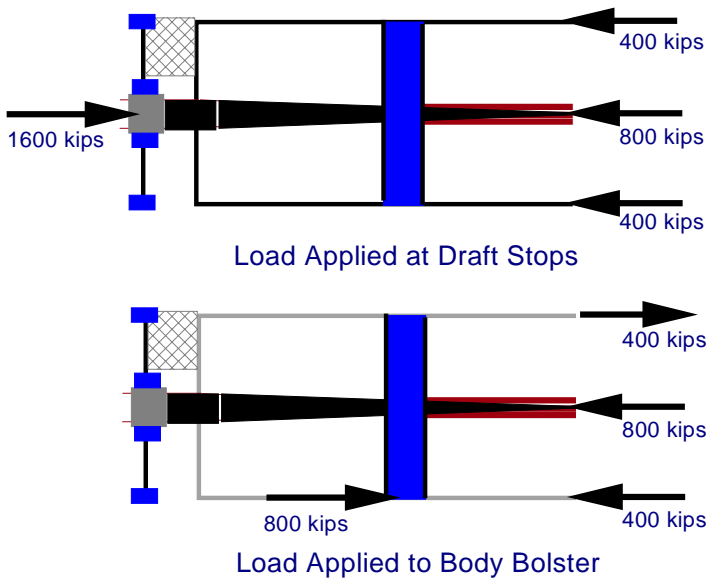
Figure 20: Car Structure Free-Body Diagrams, Load Applied at Draft Stops and Load Applied at Body Bolster Near Car Sidewall.

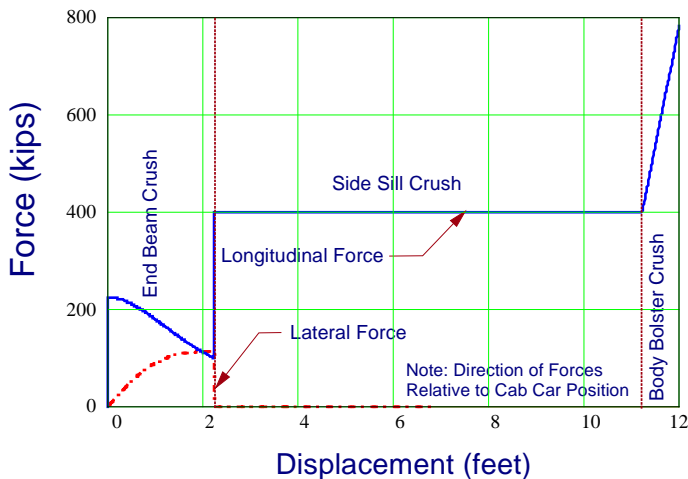
In the train collision mechanics model, the end beam, side sill, and body bolster are loaded sequentially. The end beam is assumed to behave like a rigid beam with the force/crush characteristic shown in Figure 19. A greater load, resulting in the same moment about the connection of the end beam to the draft sill, is required when the load is applied inboard from the sidewall of the car. The load transverse to the end beam is assumed to be small compared with the load normal to the beam. The load applied to the side sill and body bolster is assumed to act in the longitudinal direction of the car, i.e., the transverse loads supported by these members are assumed to be small compared with the longitudinal loads. Loads applied to the body bolster are assumed to increase linearly to 800 kips in 6 inches from the location of collapse of the side sill. The force crush characteristic for the baseline vehicle for a load applied near the sidewall of the car is shown in Figure 21.

Figure 21: Baseline Cab Car End Structure Force

Displacement Characteristic.

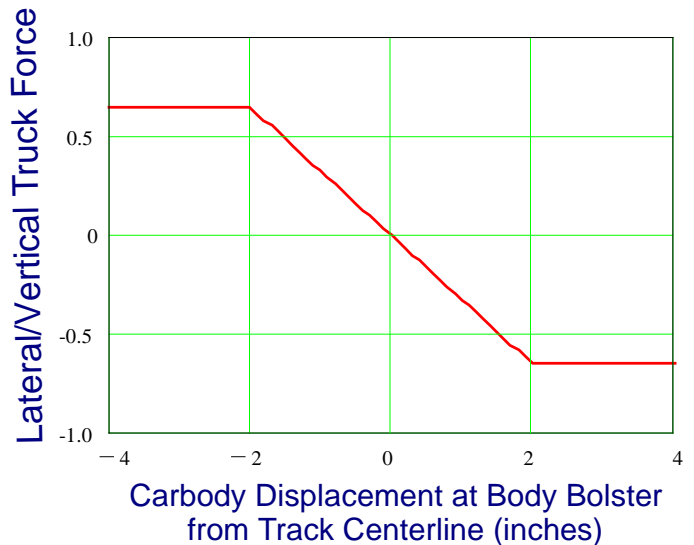
Figure 22 shows the lateral force acting on the carbody at body bolster as a function of body bolster displacement from track centerline. Such a force acts on both body bolsters. This force is assumed to be proportional to displacement, until the displacement has become sufficient to indicate derailment. Derailment is taken to occur at an L/V ratio of 0.6. Subsequent to derailment, the flanges of the wheels are presumed to plow the ballast. The L/V ratio is assumed to be 0.6 for the wheels laterally plowing the ballast.

Figure 22: Lateral Force Acting on Carbody at Body Bolster.

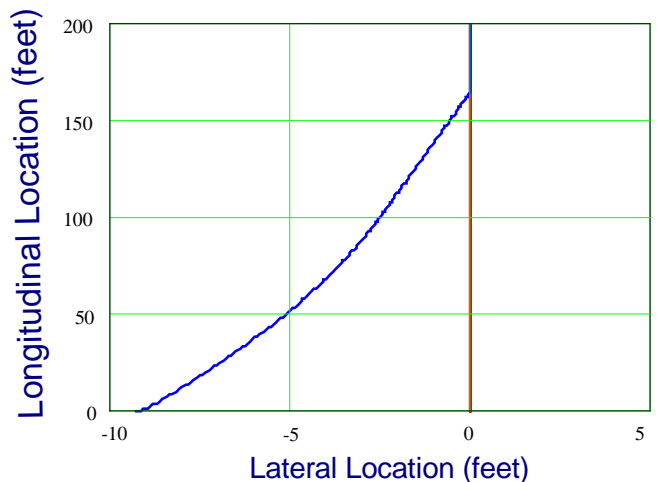
The track layout approximates an AREA No. 15 Turnout (Manual for Railway Engineering, 1972). This layout geometry is illustrated in Figure 23. The locomotive is positioned on the tangent track, while the cab car is positioned on the curved track.

Figure 23: Track Layout Geometry.
