## VEHICLE POSTMORTEM AND DATA ANALYSIS OF A PASSENGER RAIL CAR COLLISION TEST

Robert A. MacNeill and Steven W. Kirkpatrick  
Applied Research Associates, Inc.  
2672 Bayshore Parkway, Suite 1035  
Mountain View, CA 94043

### ABSTRACT

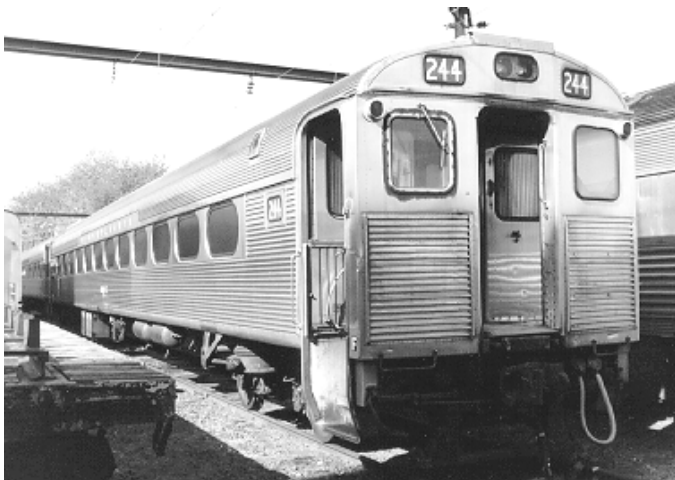
Figure 2. Pretest Budd Pioneer Passenger Coach Car

The objective of the equipment postmortem was to document the deformation modes of the principal structural members. The test vehicle, shown in Figure 2, was a Budd Pioneer passenger coach car. The Pioneer cars, intended to be a low-cost, lightweight passenger car, were designed in the late 1950s and built through the 1960s.

The car body structures of the vehicle prior to the test were intact with the exception of the original seats and some auxiliary equipment removed from the vehicle. A few prototype seats and crash dummies were added to the vehicle interior to study occupant protection strategies [3]. In order to account for the weight difference of the removed equipment, approximately 10,000 lbs of concrete was added to the test vehicle as ballast to increase the test weight.

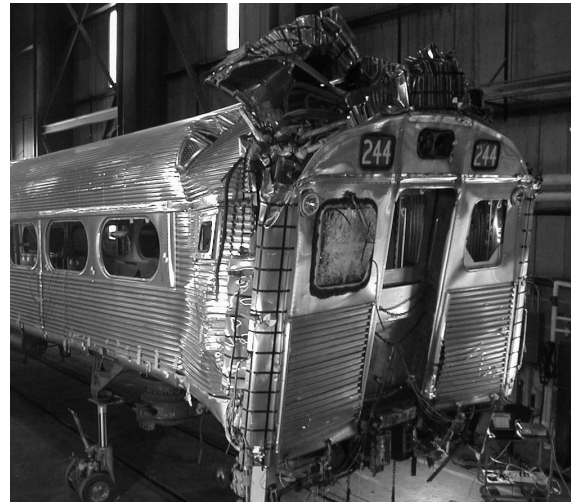
Figure 3. Front and Right Side Car Body Crash Deformations

The impact speed of the test vehicle was measured at 35.1 mph. The overall crash deformation of the car body is shown in Figure 3. The observed crash response features a complete collapse of the car end structures in the vestibule and

deformations that extend into the occupant compartment behind the vestibule bulkhead wall. The overall reduction in the car body length from the crush deformations measured after the test was approximately 54 inches (reduction in length between the A-end body bolster and buffer beam). The upper portion of the superstructure in the vestibule had nearly completely failed as shown in Figure 3. As a result, the car body end wall was primarily attached to the remainder of the car body by the deformed under frame components.

An inspection of the vehicle interior at the impact end found that virtually all of the survivable space within the vestibule was eliminated. In addition, the floor immediately aft of the vestibule bulkhead wall was buckled upward and the bulkhead intruded into the first row of seats. The upper plate section of the draft sill was torn away from the draft sill and pushed upward through the floor in this section.

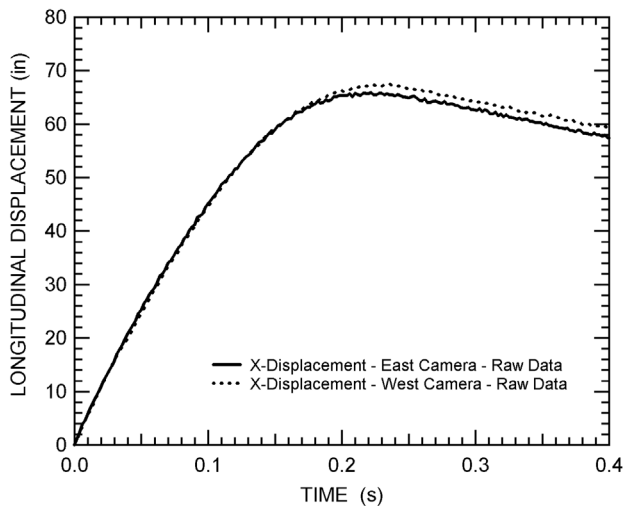
Figure 8. Longitudinal Displacement from High-Speed Film

The longitudinal displacements obtained from the east (left side) and west (right side) high-speed cameras are shown in Figure 8. The film data indicates a maximum crush distance of 65.8 inches on the left side and 67.2 inches on the right side of the vehicle at approximately 0.23 seconds.

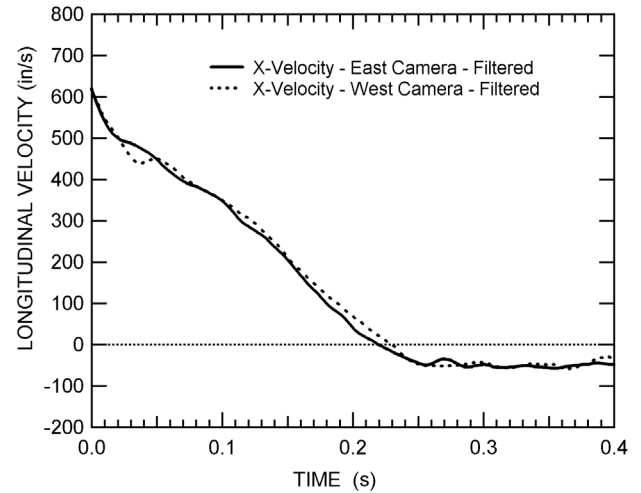
Figure 9. Longitudinal Velocity from High-Speed Film

the film. The longitudinal velocities obtained from the east and west cameras are shown in Figure 9. This velocity data was smoothed using a low-pass phaseless 4<sup>th</sup>-order Butterworth filter with a cutoff frequency of 23 Hz.

An examination of the longitudinal velocity data shows an approximately linear deceleration from the initial velocity of 618 in/s (35 mph) to a final rebound velocity of approximately -50 in/s (3 mph). The duration of the crash response was approximately 0.25 seconds beyond which the vehicle has rebounded from the wall.

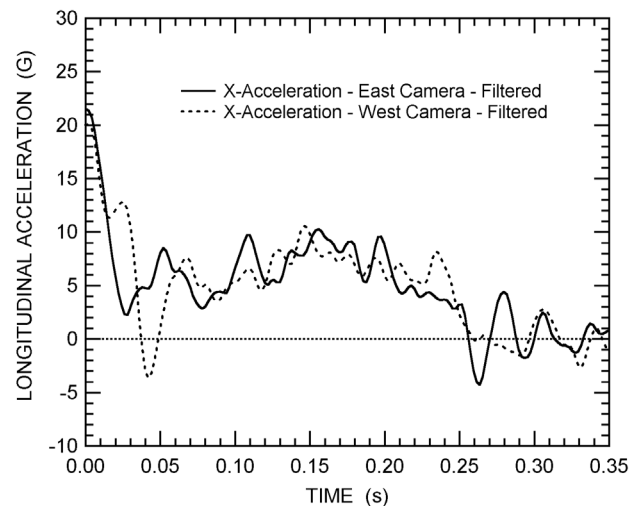
Figure 10. Longitudinal Acceleration from High-Speed Film

If we again differentiate the filtered longitudinal velocity curves, we can obtain the longitudinal crash deceleration pulse from the high-speed film as shown in Figure 10. The vehicle crash deceleration pulse shows an initial spike as the vehicle hits the wall. The subsequent crash pulse duration is approximately 0.25 seconds and has an average amplitude of about 7-g.

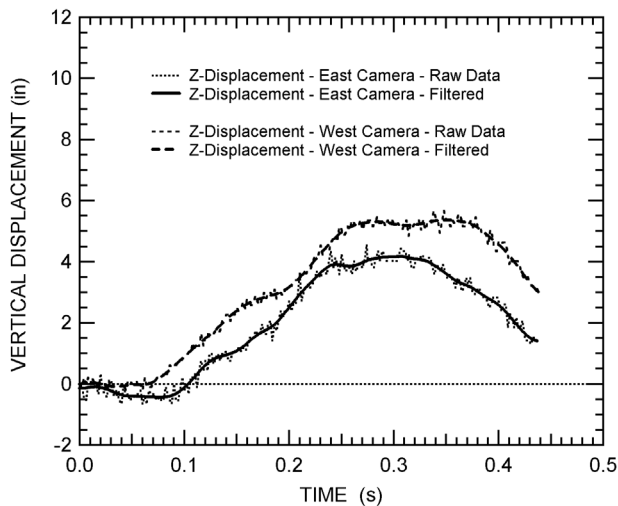
Figure 11. Vertical Displacement from High-Speed Film

The vertical displacements obtained from the high-speed cameras are shown in Figure 11. This graph shows a frame-by-frame variation on the order of  $\pm 0.5$  inches giving an estimate of the maximum resolution error on the film displacement measurement. The film data indicates a maximum vertical lift of 4.2 inches on the left side and 5.3 inches on the right side of the vehicle at a time of between 0.25 and 0.40 seconds. The majority of the vertical lifting motion occurs between 0.1 and 0.25 seconds.

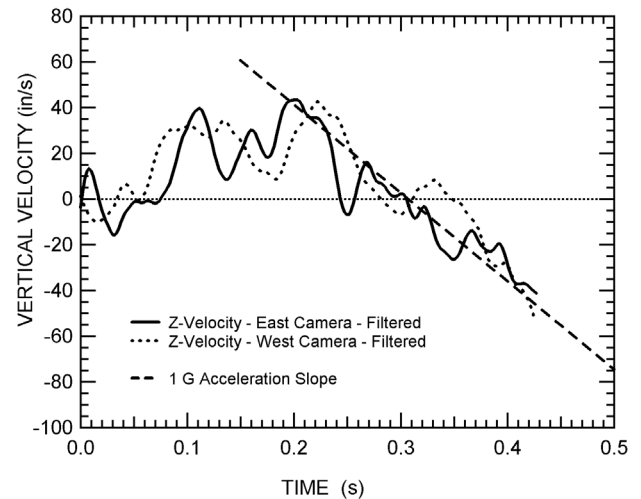
Figure 12. Filtered Vertical Velocity from High-Speed Film

The filtered vertical velocities obtained from differentiating the high-speed camera displacement data are shown in Figure 12. The figure shows that the vertical velocity magnitudes vary in the range between approximately 10 to 40 in/s during the crash response from approximately 0.1 to 0.25 seconds. The subsequent velocity history shows that the vertical velocities dropped at an average rate equal to a 1-g deceleration. This behavior is consistent with a gravitational free fall of the front end of the vehicle after the impact face rebounded from the wall (0.25-0.42 seconds). Therefore, the vertical velocity histories obtained from analysis of the high-speed film are consistent with the observed crash response.

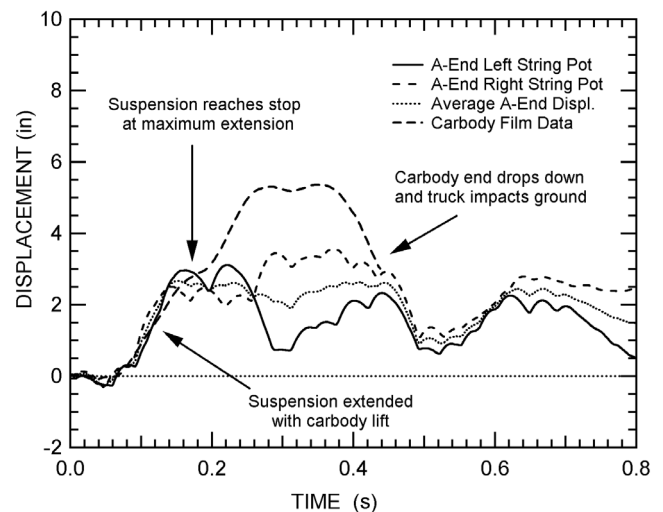
Figure 13. Suspension and Vertical Car Body Motion Data Comparison

An analysis of the A-end string potentiometer data is shown in Figure 13. Included in the figure is an average of the measurements from the right and left sides and the vertical car body displacements as measured from the west side high-speed camera. The comparison shows that the early time vertical motions of the car body, up to a time of approximately 0.16 seconds, is facilitated by extension of the secondary suspension (the vertical car body motion is equal to the string potentiometer extension).

The measured potentiometer data shows that the secondary suspension reaches its extension limit between 0.16 to 0.46

seconds. This is indicated by the relatively uniform extension of the average potentiometer displacement at approximately 2.5 inches. The difference between the extensometer displacement and the car body displacement during this time interval is equal to the vertical lift of the trucks relative to the track. Thus the measurements indicate a vertical lift of the front truck of approximately 3 inches between 0.26 and 0.38 seconds.

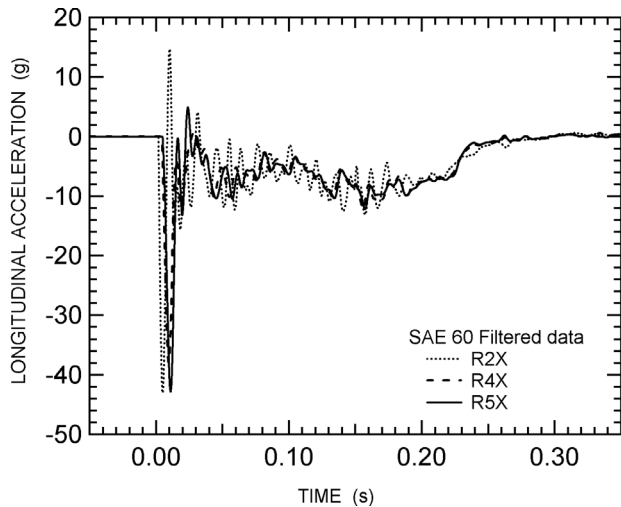
Figure 15. Right Side Sill Longitudinal Accelerations

The longitudinal accelerations measured at positions along the right side sill are shown in Figure 15. These records have been filtered using an SAE 60 Hz filter and are typical of the measurements on the vehicle under frame. Comparing the records shows differences in the details of the pulse shapes and peak magnitudes. However, on average, the records have a similar character with an early time peak acceleration followed by a rapid drop to low accelerations and a subsequent average deceleration magnitude of approximately 7-g.

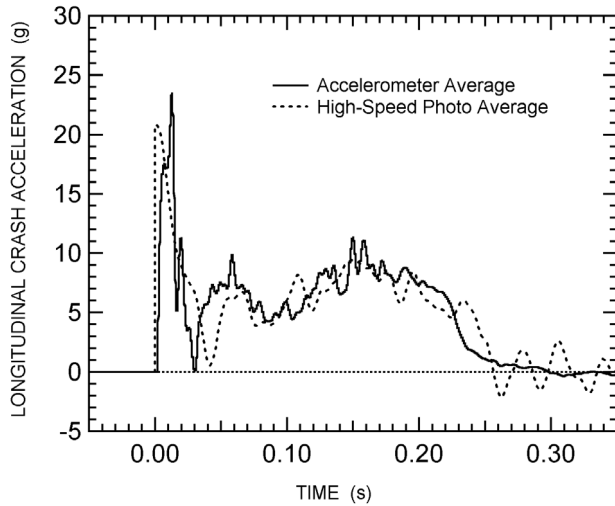
Figure 16. Accelerometer and High-Speed Film Comparison

A corresponding average deceleration pulse for the longitudinal accelerometer records is given in Figure 16. This average acceleration record clearly indicates the form of the characteristic longitudinal crash pulse shape. As a consistency check, we can compare the longitudinal accelerations obtained from analysis of the high-speed film with the accelerometer data. The average of the east and west side high-speed film acceleration, shown previously in Figure 10, is compared to the average accelerometer longitudinal crash pulse in Figure 16. The comparison shows good agreement in both the shape and magnitude of the longitudinal crash pulse.

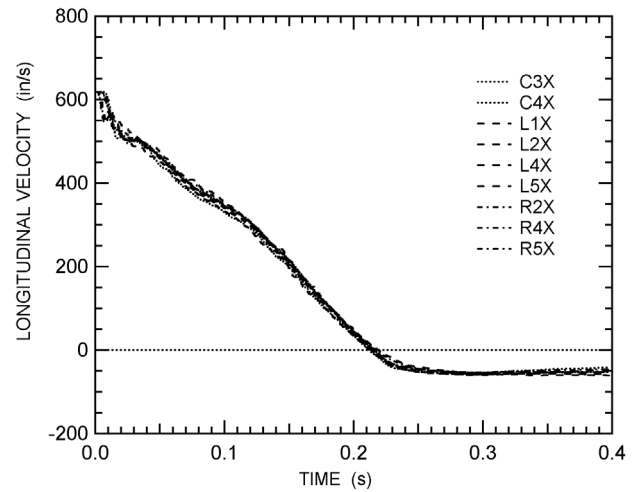
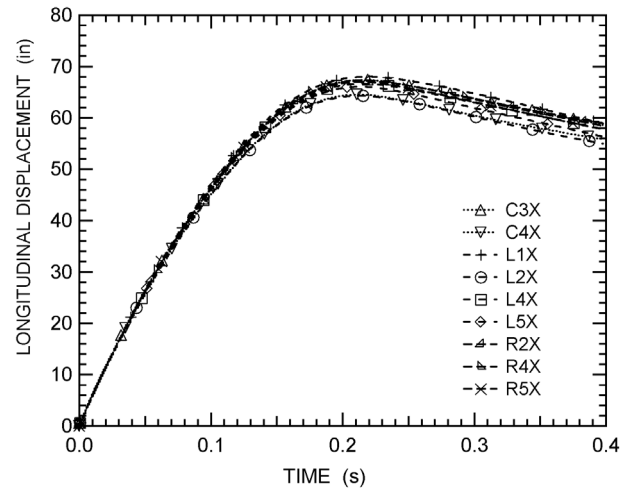
The integrated longitudinal velocities and displacements obtained from the corrected acceleration records are shown in Figure 17 and Figure 18, respectively. After correction, the peak displacements range from 64 to 68 inches. These agree well with the maximum longitudinal displacement obtained from the film analysis of approximately 66 to 67 inches.

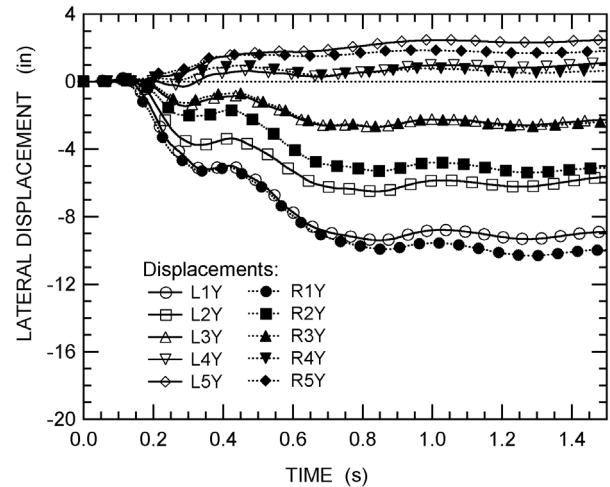
Figure 20. Lateral Displacements Obtained from Analysis of Accelerometer Data

The data correction procedure performed for the lateral accelerations was identical to that used for the vertical accelerations. The displacements obtained by double integration of both the left and right side corrected lateral acceleration histories are shown Figure 20. The first observation about the displacements is the good agreement between the left and right side displacements. Agreement between the right and left sides is expected because of the small lateral deformations across the car body under frame between the corresponding left and right side accelerometer positions. This agreement between independent corrections of the left and right side data provides a level of confidence in the data reduction process.
