David Tyrell
Senior Engineer
Volpe Center
US Department of Transportation
Cambridge, Massachusetts

N. Thomas Tsai
Program Manager
Federal Railroad Administration
U.S. Department of Transportation
Washington, District of Columbia

An Overview of Passenger Equipment Full-scale Impact Tests: Results to Date

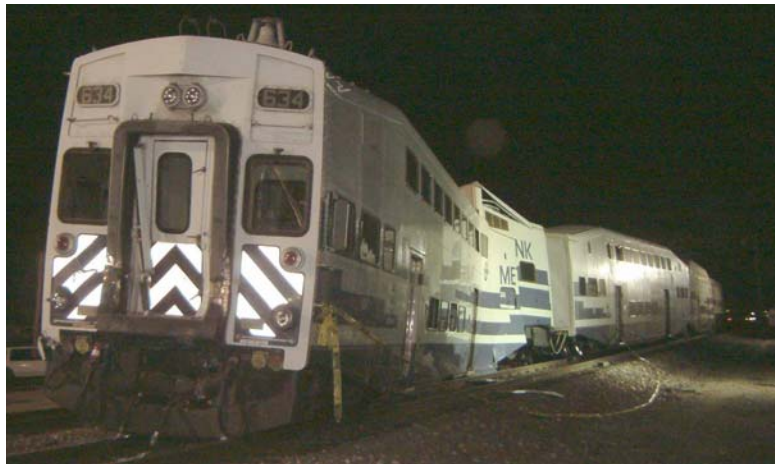
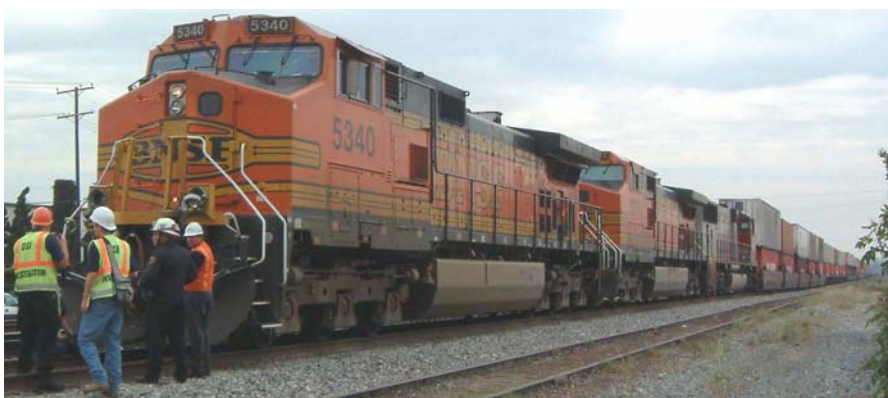
Figure 1. Post-accident photographs, lead cab car and lead locomotive, Placentia, California collision

In Placentia, California on April 23, 2002, a westbound commuter train came to a complete stop at the Atwood control point. Meanwhile, an eastbound freight train approached on the same track. At approximately 8:10 a.m., a freight train, though in full emergency braking at the time, collided head-on with the passenger train at approximately 22 mph. The passenger train had been traveling in a cab car leading arrangement; where the cab car was the westernmost car in the passenger consist. Consequently, the lead locomotive in the freight consist collided with the cab car in the passenger consist. Out of approximately 265 passengers and crew initially on the passenger train, 161 were transported to local hospitals, and two of the passengers received fatal injuries. The two freight locomotive cab occupants received minor injuries. Figure 1 shows the arrangement of each train after the accident.

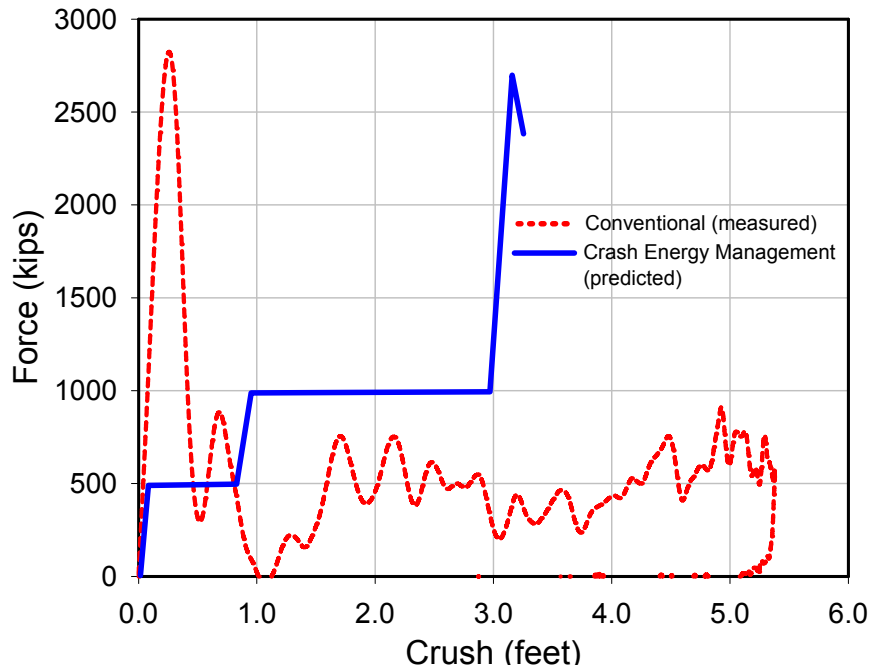
Figure 5. Force/crush curves, typical U.S. passenger equipment

Figure 5 shows the force/crush characteristics developed from measurements made during impact tests of a single passenger car [17]. This curve has high initial peak loads followed by significantly lower loads, which are approximately constant, for continued crush. Figure 5 also shows the force/crush characteristic predicted for CEM equipment. An increasing force is predicted for just over 3 feet of crush. Crush, as shown in Figure 5, starts with the longitudinal displacement of the coupler into the car immediately after the coupler touches the wall, for both the conventional and CEM curves.

One implication of the force/crush characteristic for conventional equipment, shown in Figure 5, is that the crush will be focused on the colliding cars. Once the impacting car has been crushed by 100 mm (4 inches), the most force it can exert is significantly less than the peak force, while any cars behind can apply up to the peak force. The shape of the characteristic is why, in the test of two coupled cars with a fixed barrier, the lead car sustained significant structural damage while the front end of the trailing car sustained only minor scarring due to the direct contact with the trailing end of the lead car. The implication of the force/crush characteristic shown for CEM equipment in Figure 5 is that the crush will be distributed among the cars of the train. When the impacting car has reached the plateau in the curve where it takes 1000 kips to crush the front of the car, sufficient force can be supported on the trailing end for it to start to its crush at 500 kips.

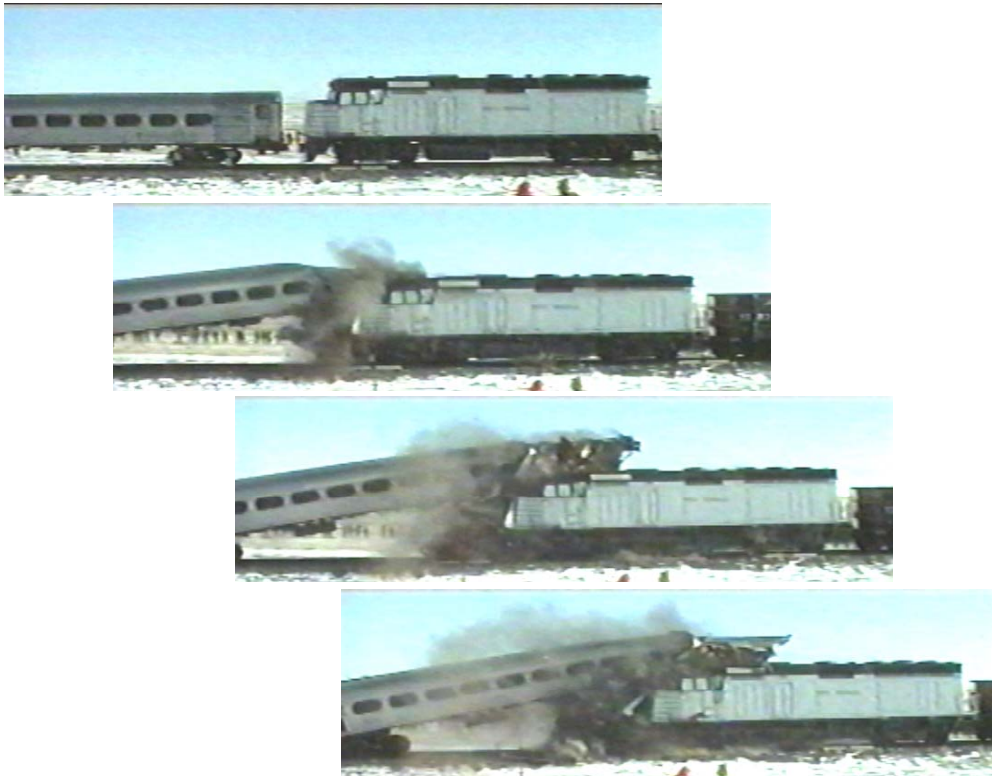
Figure 7. Sequential photos of the in-line train-to-train test

During the train-to-train test, the cab car overrode the locomotive; the underframe of the cab car sustained approximately 22 feet of crush and the first three coupled connections sawtooth buckled [21]. The short hood of the locomotive remained essentially intact, while there was approximately 12 inches of crush of the windshield center post. There was nearly no damage to the other equipment used in the test. Nearly all of the damage was focused on the cab car, with relatively modest damage to the locomotive. There was substantial loss of occupant volume during the test. Figure 7 shows a series of still photographs taken from a high-speed movies of the test.

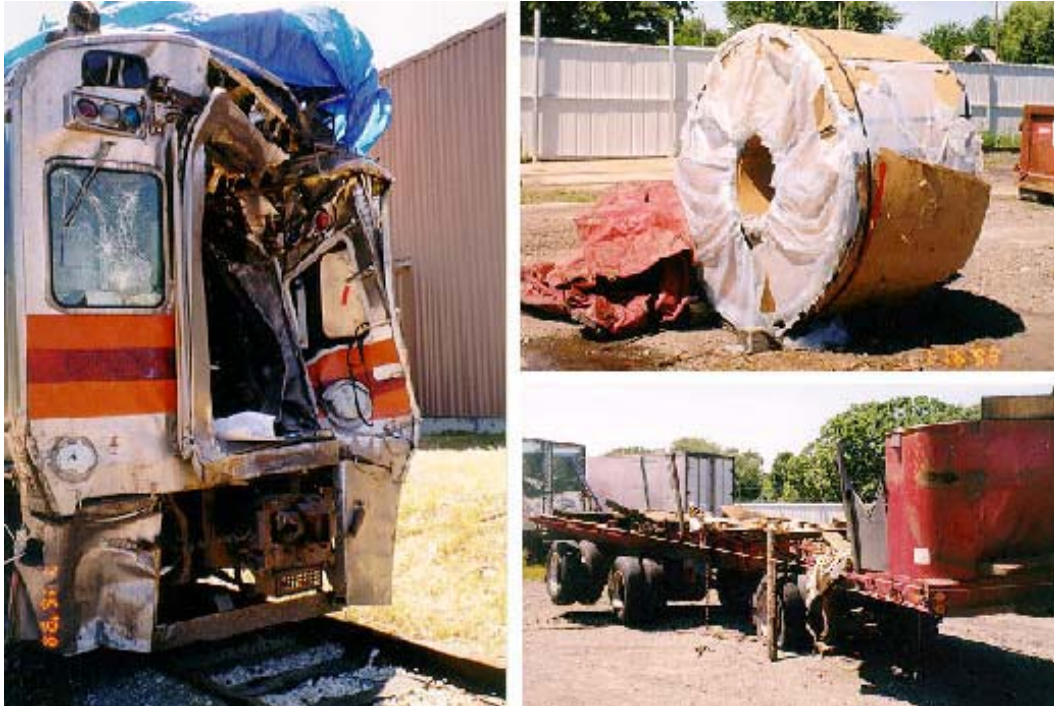
Figure 9. Photos of the steel coil used in the grade crossing test, and the crush of the cab car after the collision

loaded with steel coils weighing 20 tons each. As the vehicles collided, the cables restraining the coils severed and an impacting coil broke through the end structure and bulkhead of the cab car and proceeded to crush through the passenger compartment. This collision resulted in five minor injuries and three fatalities. Figure 9 shows the cab car, the highway trailer, and the coil of steel after the accident.

Two similar tests took place involving a cab car traveling on tangent tracks colliding obliquely into a 41,300 lb steel coil raised about four feet above the top of the rail on a frangible support – the base of the coil located two inches above the substructure [30, 31]. In the event of a grade-crossing collision with a freight truck, heavy objects may potentially challenge the strength of individual posts. These vertical beams are the primary guard against intrusion into the passenger compartment.

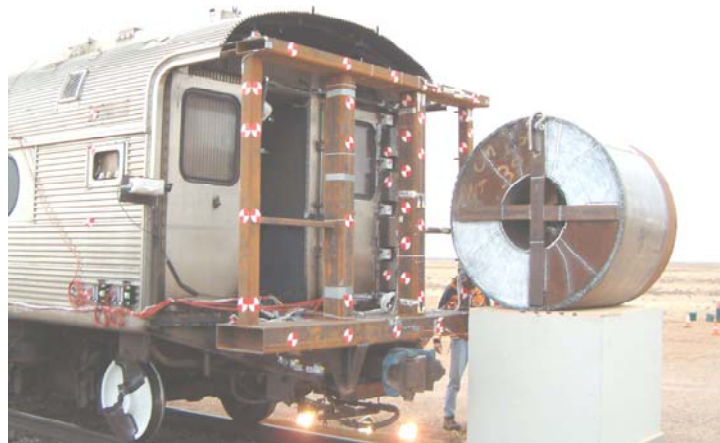
Figure 11. Setup of 1990's design test

Figure 11 shows a photograph of the test setup for the 1990's design. The car was instrumented to measure the accelerations of the carbody, the displacements of the suspension, the displacements of the corner posts, and the strains in the selected structural members. In both tests, the cab car was pushed by a locomotive to a speed of 14 mph, then released and impacted the coil.

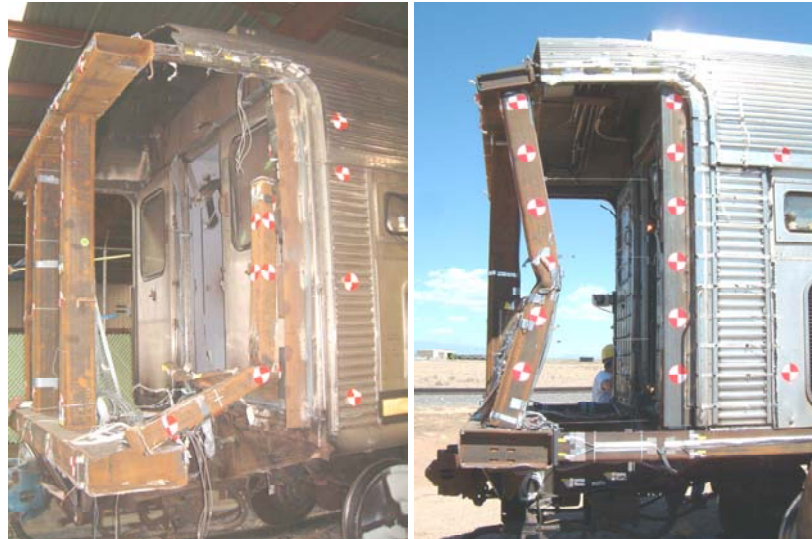
Figure 12. Post-test photographs, 1990's and SOA end frames

Figure 12 shows the final deformed shapes taken from the tests of the 1990's design and the SOA design. During the test of the 1990's design, the corner post pulled out of its attachment at the top. The results of the test show that this corner post design is not sufficient to preserve the operator's volume in such an impact. During the SOA design test, the corner post remained attached. The maximum rearward deformation measured was approximately 8 ½ inches. The results of this test show that the SOA design is sufficient to prevent the operator from being crushed in such an impact.

Tests have been developed to measure the crashworthiness performance of rail passenger equipment in in-line train-to-train and grade-crossing impacts. For grade-crossing impacts, a test was developed for evaluating the crashworthiness of the corner structure of cab cars. This test has been applied to conventional and improved crashworthiness equipment. The results of these two tests show that the SOA design cab car is substantially more crashworthy than the 1990's design cab car. For in-line impacts, a sequence of three tests has been developed to measure the crush behavior of an individual car, the interaction of coupled cars, and the interaction of colliding equipment. These three tests have been applied to conventional U.S. rail passenger equipment. The results show that all the structural damage is focused on the impacting equipment, and that coupled equipment tends to buckle out laterally during impacts.
