Review of Severe Deformation Recommended Practice Through Analyses – Comparison of Two Cab Car End Frame Designs

Volpe National Transportation Systems Center

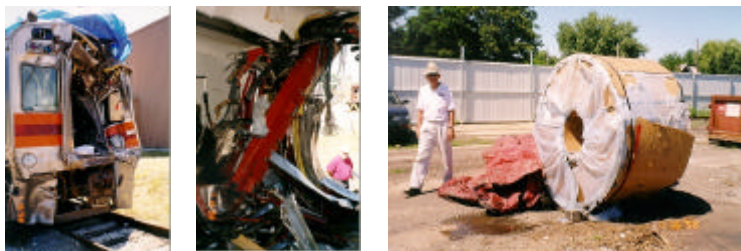
Figure 1. Grade Crossing Accident in Portage, IN, 1998

The roof attachment and the post itself apparently failed with very little deformation of the post. Additional examples of incidents where the end frame was engaged and a loss of operator survivable volume ensued are: the 1975 Yardley, Pennsylvania collision between a cab-car-led commuter train and a tractor semi-trailer carrying coils of steel [7], the 1996 Secaucus, New Jersey collision between a cab car led consist with a locomotive led consist at a switch [8], the 1996 Silver Spring, Maryland collision between a cab car led consist with a locomotive led consist at a switch [9], and the recent 2004 Metro North collision of a cab car led consist with a crane fouling right-of-way.

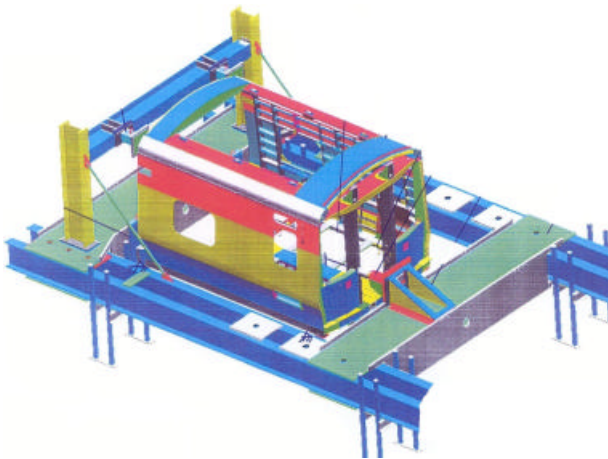
Figure 2. Schematic of Testing Set-up for the M7 Cab Car Collision Post Load Case

The mock-up test article was installed in the testing bay and supported vertically in 4 locations along the side sills. The supports were located at the rear of the mock-up and 70 inches behind the end sill. The longitudinal supports were located at the rear of the mock-up at the side sills and the roof rails. In addition the mock-up was restrained laterally at each corner for stability reasons against the jig longerons. Figure 2 is a schematic of the test set-up used.

Four 500,000 lbf load cells were situated at the rear longitudinal support positions to measure the loads. A 400,000 lbf hydraulic jack was used to input the longitudinal load into the collision post over a bearing plate that helped to distribute the load. The bearing plate dimensions were 10 inches wide by 4.75 inches high by 1.5 inches thick. The increased width of the bearing plate was to prevent a bearing failure of the collision post outermost flange.

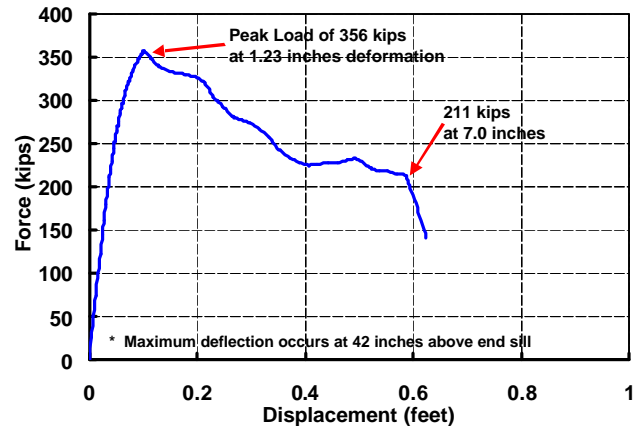
Figure 3. Force Deflection of M7 Cab Car Collision Post Loaded 30 inches Above the End Sill

The results from the ultimate plastic load application at 30 inches above the end sill are shown in Figure 3. This is a plot of force deflection where the maximum load of 365,150 lbf is reached at a deflection of 1.23 inches. The force level subsequently softens and the load was removed from the structure at 7.0 inches of crush with the load at 211,000 lbf. The same deflection gauges were used for the linear elastic test and the maximum deflection, 8.5 inches, occurred at the 42-inch height on the post. The load deflection is shown in Figure 3.

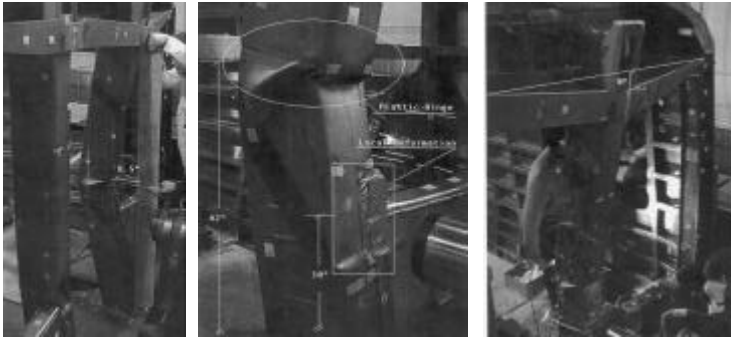
Figure 4. Post-Test Deformed Shape of M7 Cab Car Collision Post Loaded 30 inches Above the End Sill

The post-test inspection did show some material failure occurring in various components. Some failure occurred in the collision post at 42 inches above the end sill in the tension flanges and the compression flanges experienced significant plastic flow. This is where the central hinge forms under this loading condition. Additionally there were plastic deformations at the load application area. Progressive fracture occurred at the base of the collision post during later stages of deformation, which resulted in the termination of the test for safety reasons.

The structural shelf broke at its connection with the collision post. The decision was made to reinforce the

connection for production end frames, to reduce the likelihood of the connection failing under such load conditions. The bulkhead sheet pulled out the end sill top plate. In addition the end sill bottom flange buckled between the collision post and the end sill end plate. Finally, the anti-telescoping plate was pulled down 3 inches. Figure 4 shows several views of the final deformed shape of the collision post.

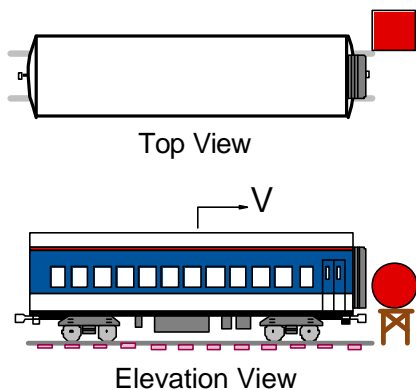
Figure 5. Schematic of Grade Crossing Collision Test

The full-scale grade crossing impact tests were conducted as part of a series of crashworthiness tests of passenger rail equipment. The overall objective of this series of tests is to evaluate incremental improvements in the crashworthiness performance of modern corner post designs when compared against the performance of older designs [10, 11, 12]. The grade crossing tests were designed to address the concern of operator vulnerability to bulk crushing resulting from offset/oblique collisions where the primary load resisting structure is the end frame design. Two grade crossing tests were conducted in June 2002 and in both tests a single cab car retrofitted with an end frame design impacted a steel coil resting on a frangible table at a nominal speed of 14 mph [13, 15]. The 40,000 lbf steel coil was situated such that the coil impacted the corner post of the cab car above the end sill. Figure 5 is a schematic of the grade crossing test.

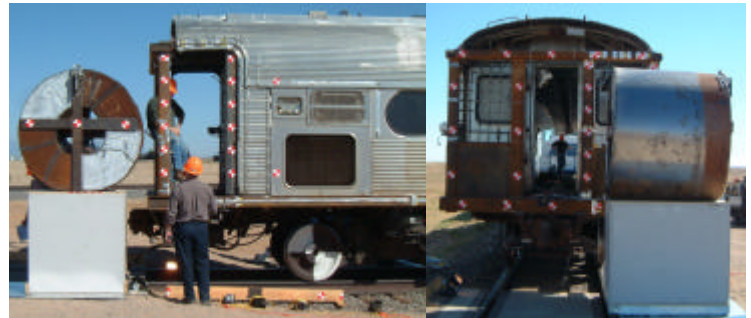
Figure 6. Grade Crossing Scenario Dynamic Impact Test Set-Up for SOA End Frame Design

Figure 6 shows a photograph of the test setup for the developed prototype SOA end frame design. The car was instrumented to measure the accelerations of the carbody, the

displacements of the suspensions, the displacement of the corner post, and the strains in selected structural members. The coil was instrumented to measure the three dimensional accelerations including the yaw, pitch, and roll. On-board and wayside high-speed film and video cameras were used to record the impact. Details of the instrumentation requirements for the test are in [13]. A locomotive was used to push the cab car up to speed and then released; the cab car subsequently struck the steel coil.

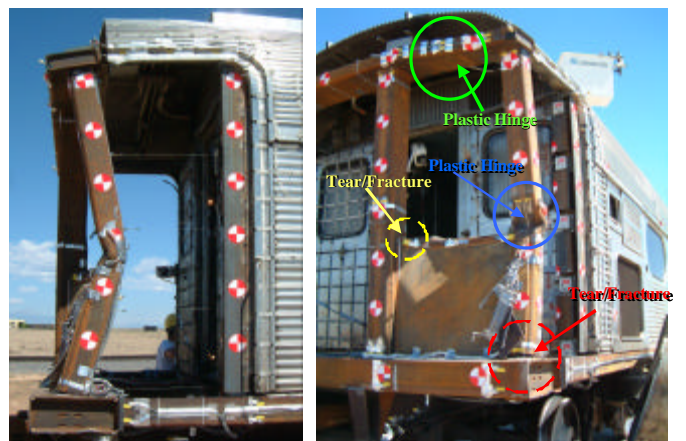
Figure 7. Post-Test Deformed Shape of Prototype SOA End Frame Design

The results from the prototype SOA end frame testing is that the crush was restricted to less than 12 inches of inward deformation thereby preserving space for the operator to safely ride out the collision. The incremental increase in safe closing speed as compared to the minimum FRA design also tested is from 11 mph to 15 mph. A post-test photograph of the SOA cab car is shown in Figure 7. Although there is some material failure present, no connections have fully failed for a crush distance just less than 9 inches.

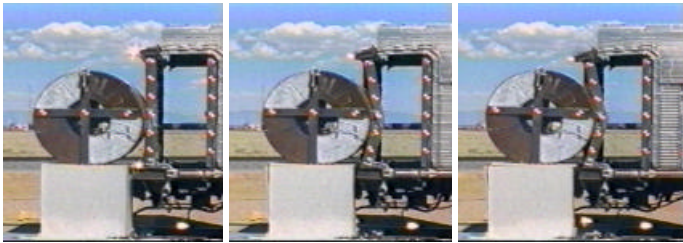
Figure 8. Deformation Sequence Experienced by Prototype SOA End Frame Design

Figure 8 shows three still photographs taken from a high-speed film of the test of the SOA design. The first frame shows the coil and corner post at the instant of impact, the second frame shows the coil and the cab car after approximately 0.03 seconds and 5.25 inches of rearward displacement of the corner post. The third frame shows the coil and the cab car after approximately 0.08 seconds and 9 inches of displacement of the

corner post. In the test, the corner post acted largely as a fixed-pinned beam that is overloaded. A plastic hinge formed early in the test near the center of impact. As the test progressed, the corner post bent into a 'V,' which put a significant tension load on the corner post. Both the upper and lower attachment of the corner post had to support the shear load from the coil and the tension load due to the bending of the beam. The end beam did not visibly plastically deform, and so the floor attachment acted as a fixed connection. The anti-telescoping plate and the cant rail did deform downward, and consequently the roof connection of the corner post acted as a pinned connection.

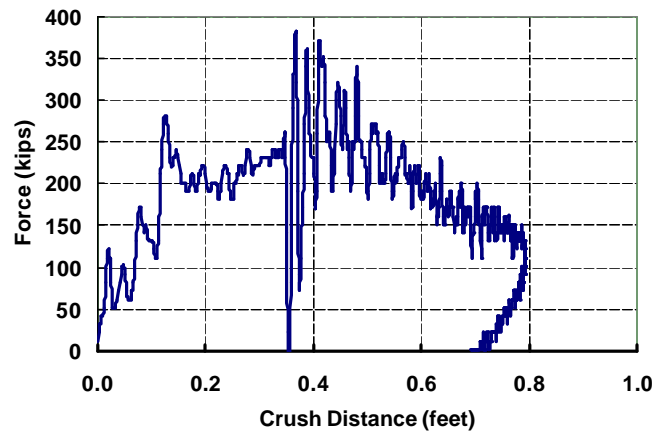
Figure 9. Measured Dynamic Force Crush Characteristic for the Prototype SOA End Frame Design

The unfiltered force crush characteristic determined for the corner post response is depicted in Figure 9. The force was obtained by using the resultant acceleration obtained using the 9 accelerometer array on the steel coil and multiplying this value by the mass of the coil. The required load level at 18 inches above the end sill is 100,000 lbf without permanent deformation. The bending moment generated by the steel coil load is much higher and occurred in the plastic domain. The peak load resisted is approximately 275,000 lbf. This load level occurred at 6 inches of inward deformation. The greatest crush distance measured was 9.5 inches, but the final crush distance measured was 8.5 inches. The corner post experienced some elastic recovery upon rebound of the coil.

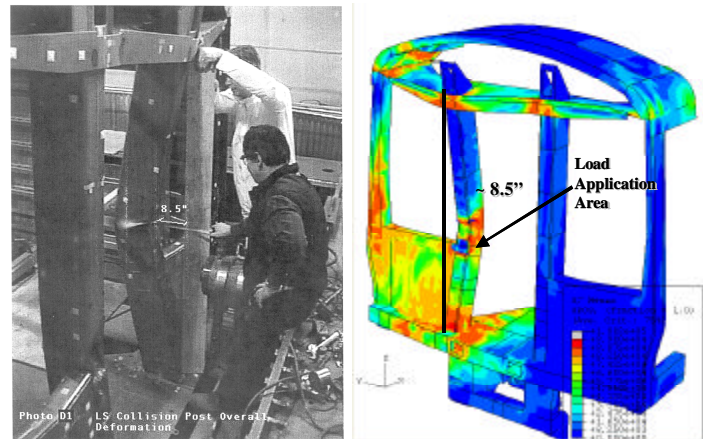
Figure 10. Comparison of Observed Quasi-Static M7 Cab Car Collision Post Deformation with Predicted FEA Model Results

The results from the quasi-static large deformation plastic load application of the collision post of the M7 cab car are in good agreement with the deformed shape observed during the test. The model captures the deformation modes of the key structural elements that make up the integrated end frame very well. The model is also capable of predicting those areas where it is expected that material failure will occur. Figure 10 and 11 show comparative test photographs with model results.

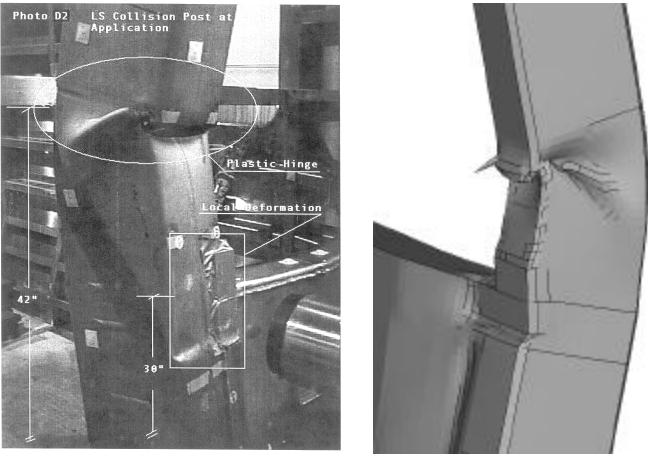
Figure 11. Close-Up Comparison of Load Application Area and Central Plastic Hinge

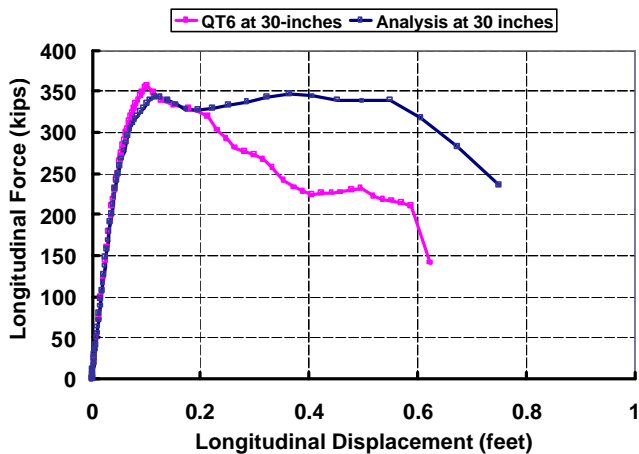
Figure 12. Comparison of Force Crush Characteristics for Collision Post Loading 30 inches Above the End Sill

Using nominal material properties for the end frame components resulted in under estimation of the test results. The nominal properties were increased by ten percent to better capture the peak force at the appropriate crush distance and the overall force crush trend for the full crush distance. There is good agreement with the force crush characteristic prior to post-buckling softening. For larger crush distances, the model tends to over predict the force levels exhibited by the structure, but the trend is maintained. The force crush characteristic is depicted in Figure 12. It has been shown that the variation in the peak force derived from test measurements can be as much as 140 percent for ostensibly identical structures crushed under similar test conditions; it also has been shown that the variations in average force computed from test data can be approximately 20 percent [14]. The results obtained from the finite element model were considered sufficient to now use the same developed model for running the offset grade crossing collision scenarios.

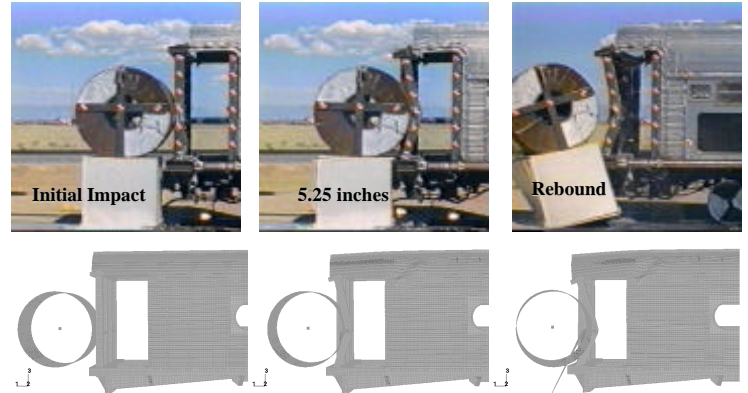
Figure 13. Comparison of Pre-Test Model Deformation Sequence with Observations from Full-Scale Grade Crossing Corner Post Impact Test

The same pre-test model was used for the prototype SOA design that is discussed in more detail in [15]. Figure 13 depicts a comparison of the deformation sequence observed in the full-scale grade crossing test with the predictions using the pre-test finite element model. The pre-test model had excellent agreement both with the force crush characteristics measured but also with the modes of deformation and failure. Figure 14 depicts the comparison of the force crush characteristics measured and predicted. This model was considered sufficiently validated that it can now be used directly in running the offset grade crossing collision scenarios.

As is apparent from both the deformation sequences shown in Figures 13 and 15. The collision post is 7.75 inches deep while the corner post is 6.625 inches deep. The displacement of full failure of the either post respectively at the connection with the buffer/end beam is 11.5 inches and 11.1 inches respectively. These distances are the reported distance the steel coil displaces inward after initial contact with the end frame.

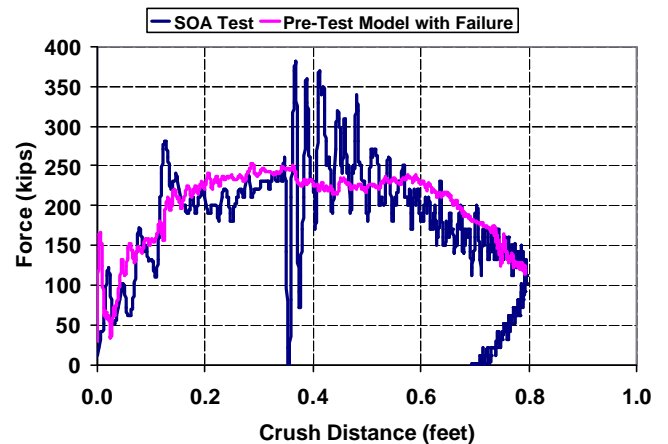
Figure 14. Comparison of Pre-Test Model Predictions and Measured Force Crush from the Full-Scale Grade Crossing Corner Post Impact Test

Having established the fidelity of the two models to a certain level, the dynamic performance of the two designs is now compared. The purpose of these calculations are to understand the modes of deformation of the individual components loaded and the reaction of the load through the attachments, predict where material failure initiation should occur, and compare the force crush characteristics.

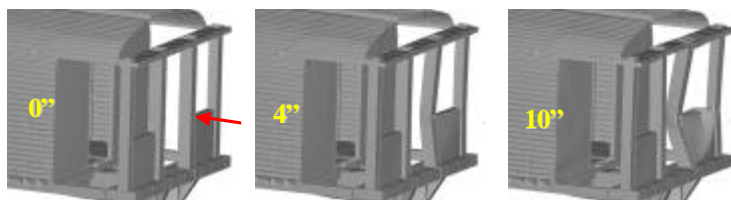
Figure 15. Predicted Deformation Sequence of the Prototype SOA End Frame Under the Dynamic Offset Collision Post Loading

The results from the collision post loading are that prior to complete failure of the connection with the buffer/end beam the collision post deforms 11.5 inches. There is still residual capacity of the structure due to the degree to which it is integrated with the rest of the end frame. The bulkhead sheet continues to shed load to the corner post and into the buffer/end beam. The calculation was stopped after 12 inches of crush, which was the maximum allowed crush distance. Figure 15 depicts the deformation sequence for the collision post loading condition of the prototype SOA end frame design.

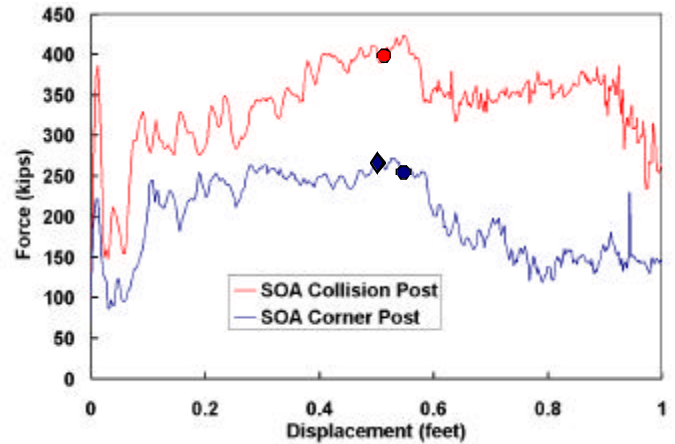
Figure 16. Comparison of the SOA Collision and Corner Post Force Crush Under the Dynamic Loading Condition

Comparisons of the force crush characteristics for both prototype SOA end frame design collision and corner posts are shown in Figure 16. The force crush characteristics were determined by cross-plotting the longitudinal displacement after initial contact of the steel coil against the acceleration multiplied by the mass of the steel coil. The shape of the two curves is very similar for the 12 inches of crush shown. However, the collision post characteristic is elevated in comparison with the corner post. This is due to two important factors: the collision post is larger than the corner post and the anti-telescoping plate connection to the adjacent collision post helps to distribute significant load into the rest of the end frame. The blue diamond figure on the plot demarcates the location where failure of the shelf/lateral member experiences complete failure. The two octagon figures on the plot demarcate the crush distance at which failure at the connection with the buffer/end beam initiates.

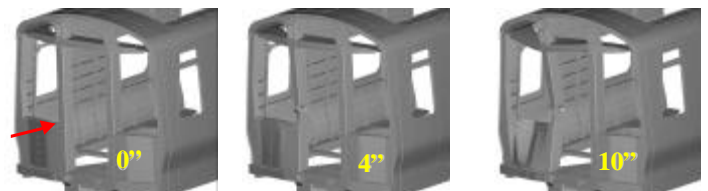
Figure 17. Predicted Deformation Sequence of the M7 End Frame Under the Dynamic Offset Collision Post Loading

The results from the M7 cab car collision post analysis is that complete failure of the connection of the collision post with the end sill does not occur until 13.1 inches of deformation. Similar to the SOA design there is some additional capacity due to the presence of the bulkhead sheet and the connection through the anti-telescoping plate. The results are only plotted out to 12 inches of crush, which corresponds to the allowable degree of inward deformation to maintain occupied volume. The deformation sequence for this analysis case is shown in Figure 17. The three stages shown are initial impact, 4 inches of crush, and 10 inches of crush. The red arrow demarcates where the coil is initially impacted. The deformation pattern is similar as that predicted and observed from the quasi-static tests. The position of greatest inward deformation occurs at roughly 42 inches above the end sill where the shear reinforcement ends. Additionally the shelf/lateral member connection failed. There is a similar lateral torsional deformation of the anti-telescoping plate as well.

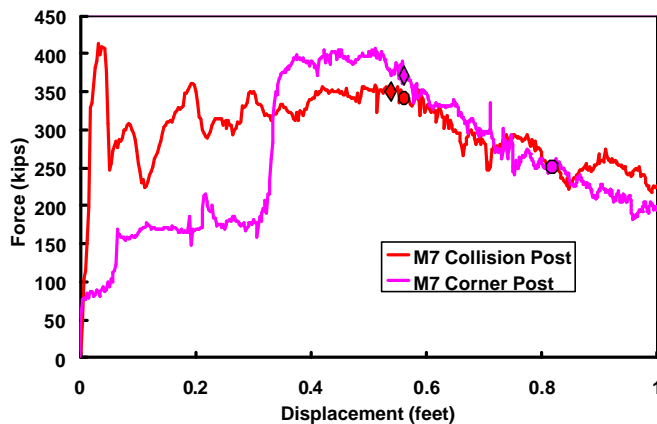
Figure 19. Comparison of the M7 Collision and Corner Post Force Crush Under the Dynamic Loading Condition

Figure 19 is a plot of the force crush characteristics predicted from the two M7 loading conditions discussed. The pink and red diamond figures on the plot demarcate the crush distances for each loading condition where the shelf/lateral member starts to fail. The collision post was pushed inwards 6.7 inches and the corner post was pushed inwards 7.0 inches. The octagon figures demarcate the crush distances that failure at the base of the post initiates. The crush distances for the collision and corner post at complete failure are 13.1 inches and 11.9 inches of inwards deformation respectively. Testing is considered to further validate these results.

Both designs have an intermediate shelf/lateral member of similar strength just below the forward facing windows. In addition both designs make use of a bulkhead sheet that is integrally tied to the buffer/end beam, the collision post, the corner post, and the shelf/lateral member. This bulkhead sheet is present to help prevent intrusion of foreign objects and serves as a spall shield. The M7 corner post is reinforced with the outer wall sheathing and longitudinal wall stiffeners from the end sill to the cant rail whereas the SOA design is without such lateral reinforcement. This has a significant effect on the performance of the M7 design. The lateral support that the wall provides enhances the crush resistance of the corner post as visible in the later stages of crush in Figure 19.

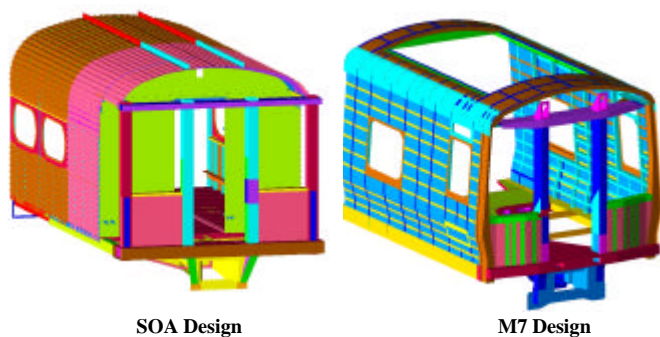
Figure 20. Models Developed of Prototype SOA and M7 End Frame Designs

Two detailed finite element models were developed to investigate both the quasi-static large deformation behavior and dynamic behavior of the prototype SOA end frame design retrofitted onto a Budd Pioneer passenger car and an M7 cab car end frame design. The SOA model incorporated the first twenty feet of the car structure. The M7 model incorporated the first fifteen feet of the car. The cars were modeled using 4 node reduced integration shell elements in ABAQUS EXPLICIT [16]. The characteristic element length in the coarse regions of the two models was approximately 2 inches while in the fine regions it was approximately between 0.25 and 0.5 inches. The SOA model was constructed from 160,005 elements while the M7 model used 123,470 elements. Both models were fully fixed at the rear of the structure. Non-structural components were not included in these models. Figure 20 depicts the two models developed. Stresses, strains, and displacements of key components were outputted.

The steel coil was modeled as a rigid object using rigid shell elements. The rigid coil was constructed from 17,940 elements. The diameter of the steel coil is 62.5 inches and the length of the coil is 52 inches. The coil was assigned a weight of 41,300 lbf. The coil is assigned a longitudinal velocity and is then free to translate and rotate freely during the simulated impact. The three dimensional accelerations, velocities and displacements were outputted.
