**IMECE2006-13597**

## **A Train-to-Train Impact Test of Crash Energy Management Passenger Rail Equipment: Structural Results**

**David Tyrell  
Karina Jacobsen  
Eloy Martinez**

Volpe National Transportation Systems Center  
US Department of Transportation  
Cambridge, MA 02142 USA

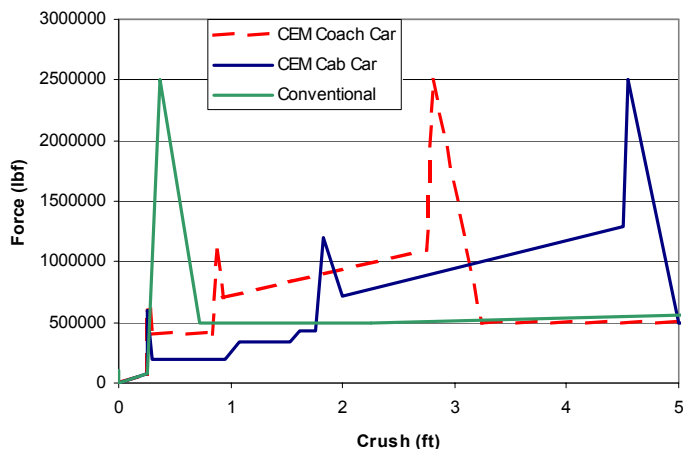
**Figure 2. Idealized CEM Force/Crush Characteristics**

When a cab car, MU locomotive, or conventional coach car is loaded longitudinally, the structure of the vehicle's body is initially very stiff. As the load is increased, deflections of the vehicle body remain relatively small until a critical load is reached, and the body begins to crumple. Once crumpled, its ability to further support a longitudinal load is compromised. As a result, a much lower load is required to deform the vehicle body longitudinally, and the deflections of the vehicle body increase significantly. This behavior is shown schematically as the conventional force/crush characteristic in Figure 2. Because the longitudinal force develops in the impacting cars first, once the peak force is attained and the vehicle body crumples, the colliding vehicle of a train will lose the ability to transmit significant longitudinal forces rearward to the trailing cars. In a collision, a colliding vehicle that performs in this manner will singularly absorb much of the collision energy as the occupied volume crushes. If the collision is extreme, this situation can result in the colliding vehicle being destroyed.

Passenger rail equipment crashworthiness can be significantly increased if the force/crush behavior is engineered

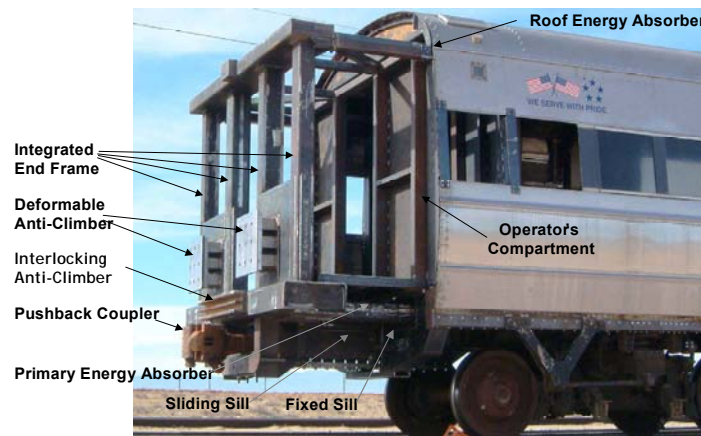
**Figure 4. Cab End Crush Zone**

Figure 4 shows the FRA prototype cab end crush zone design that was developed as part of the research. The cab end crush zone includes four key elements:

1. A deformable anti-climber arrangement
2. A pushback coupler mechanism
3. An integrated end frame, which incorporates an operator compartment
4. Roof and primary energy absorbing elements

The activation of the pushback coupler initiates the crush zone and provides a mechanism that allows each component to operate in sequence. When the coupler triggers and pushes back, an energy-absorbing element crushes. The travel of the shear-back mechanism accommodates the coupler of the

As the anti-climber begins to deform, it accommodates the geometry of the locomotive and distributes the load over as large an area on the integrated end frame as can be reasonably achieved. As a goal, the collision posts should carry 60 percent of the crushable anti-climber loads and the corner posts 40 percent. The anti-climber is designed to crush in a controlled manner and must avoid forming a ramp or a catapult by limiting the potential for material failure. The anti-climber must sustain off-center impact loads and be able to transmit longitudinal loads into the end frame.

When the integrated end frame is subject to a high-energy impact load, the cab end crush zone deforms in a controlled manner, activating the roof and primary energy absorbers. The energy absorbers are able to properly function while accommodating deflections of the integrated end frame. These devices can absorb more than 2 million foot-pounds of energy.

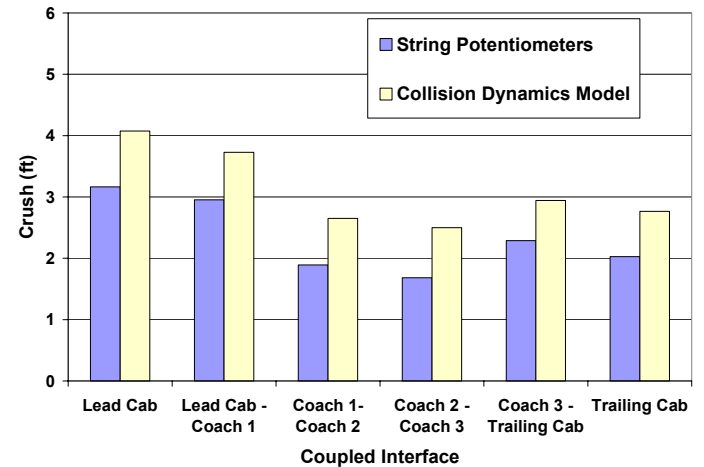
**Figure 6. Train-to-Train Test Crush Distribution (Summed at Coupled Interfaces)**

Figure 6 shows the crush distribution for the cars in the CEM consist. Crush is shown at the lead end of the cab car and summed at each successive coupled interface. The test data represent the measurements of the string potentiometers for total stroke of a crush zone (i.e., the stroke of the pushback coupler and the carbody energy absorbers). The plot in Figure 6 compares these measurements with the pre-test collision dynamics model results.

The crush distribution plot in Figure 6 shows how the crush was shared between the crush zones of the CEM consist. At the 30.8 mph impact speed, the crush zone of the lead cab car is crushed the most; crush is passed back to the following crush zones. Each car in the CEM system is characterized by an increasing, stepped force/crush behavior. When the force level on the first crush zone reaches the second step, and the primary energy absorbers crush, force levels also begin to be passed to the successive cars, causing those crush zones to trigger. Because the pushback couplers trigger at a lower load than the primary energy absorbers, crush is distributed to additional crush zones before the third peak load level is exceeded at the lead crush zone.

The pre-test collision dynamics model captures the trend of crush distribution, but it consistently overestimates the total crush at each interface. This difference is attributed to the material properties assumed for the primary energy absorbers. The crush zones manufactured for the single-car and two-car tests of CEM equipment were a batch of steel different from the 10 crush zones manufactured for the train-to-train test. When a sample was tested, the material properties were found to be about 10 percent higher than the material specification. Accordingly, the average crush load of the primary energy absorbers would be higher than estimated by the idealized force/crush curves developed from the previous full-scale testing. Correspondingly, the amount of crush of the energy absorbers required to absorb a set amount of energy decreases with an increased average crush load.

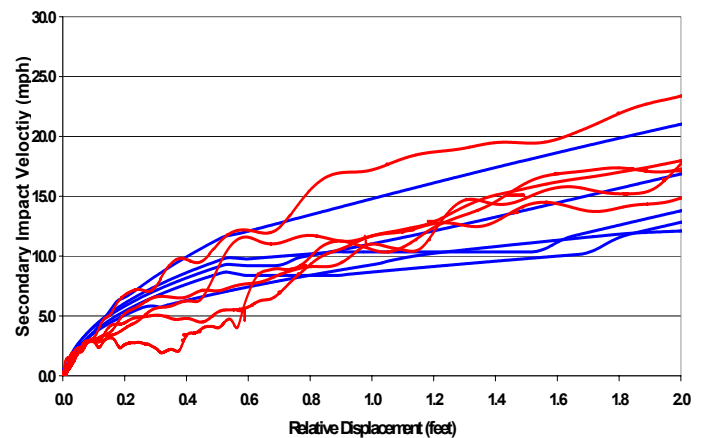
Figure 8. SIV Comparisons

Figure 8 shows a plot of the secondary impact velocities (SIVs) in the passenger train. Secondary impact refers to the impact between the occupant and some part of the interior,

In Figure 8, the red traces show the data processed from the accelerometers, and the blue traces indicate the corresponding model results. The test data is computed from the same accelerometers as used for the velocity-time histories in Figure 7. The model results fall within the expected ranges predicted for the cab car and following passenger cars. The secondary impact plot is shown out to 2 feet of travel distance. During a collision, typical commuter seats allow a free-flight distance of 2 feet.

Figure 7 shows that upon impact with the standing consist, the cab car decelerates at the highest rate in the passenger consist. The SIV in Figure 8 verifies that the cab car experiences a more severe occupant environment than the successive cars. A more detailed evaluation of the interior environment and the occupant experiments conducted during the CEM train-to-train test is presented in a complementary paper [19]. This paper discusses strategies for mitigating the more severe occupant environment of the CEM cab car.

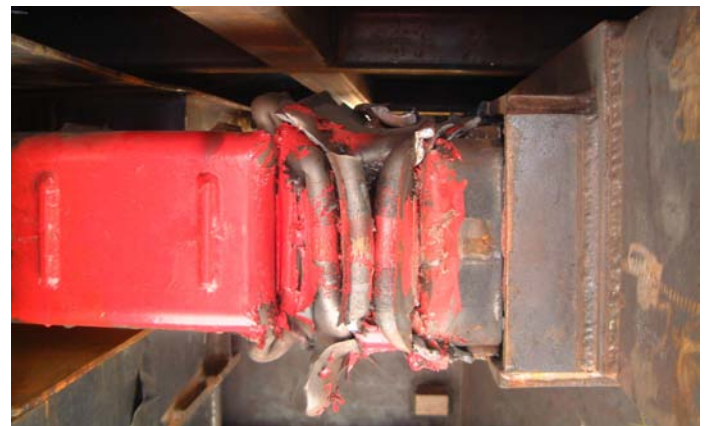
**Figure 12. Primary Energy Absorber, Post-Test Photograph Showing Material Failure**

As shown in Figure 12, the primary energy absorbers exhibited material failure as a result of the test. This material failure did not influence the function of the energy absorbers during the test—they absorbed energy as intended. However, material failure is difficult to simulate with fidelity, and does increase the uncertainty in analytic predictions of the mode of deformation and the force/crush characteristic of the energy absorber design. For the test equipment, this uncertainty was reduced by prior component, single-car, and two-car tests. A similar level of confidence in the force/crush characteristic of alternative designs may be achieved with fewer tests if material failure is not expected for such designs.

The design development and performance of the deformable anti-climber suggests that material failure in the primary energy absorbers can be greatly reduced and potentially eliminated. The deformable anti-climber also performed as designed, and, as shown in Figure 13, deformed as intended without any material failure. The deformable anti-climber was required to be able to support vertical and lateral loads that might arise from the interaction with the colliding locomotive. Consequently, the deformable anti-climber was required to deform without material failure in order to maintain the load path for any vertical and lateral loads. Key differences with the primary energy absorber include thinner, more ductile material, and annealing of the deformable components to relieve residual stresses from forming. Developing primary energy absorbers that incorporate these features would likely result in a design that is not as prone to material failure.
