Public Education and Enforcement Research Study

Safety of Highway-Rail Grade Crossings

DOT/FRA/ORD-06/27

December 2006
Final Report

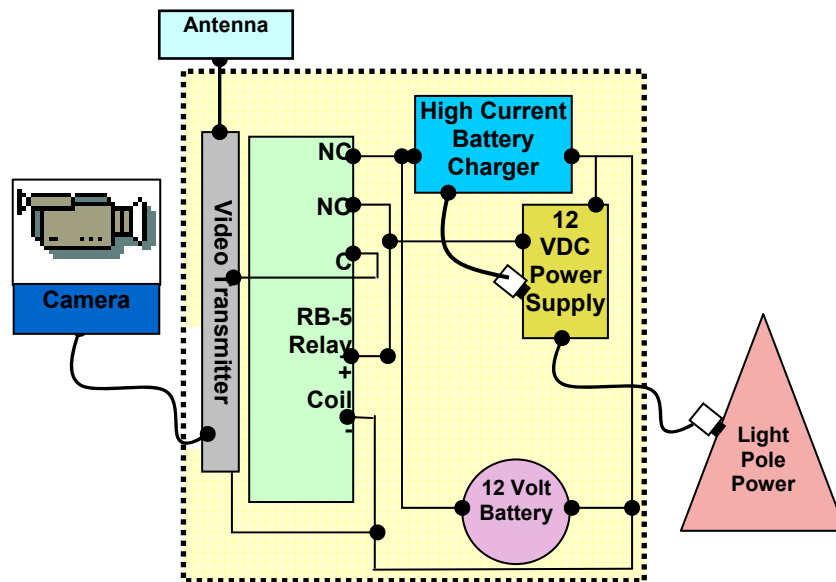
Figure 4. PEERS Light Pole Power System Schematic

The Volpe Center evaluation team developed the PEERS light pole power system, which contained an AC power outlet, high current battery charger, RB30 relay, video transceiver, and a 12 volt 12 AH battery. This system was necessary in order to provide sufficient power for some of the study cameras. At specific locations, the only available power was from the street lighting system. This system only received power during the nighttime hours of operation. During the night by use of the Volpe light pole power system, the batteries would be charged. Then, at dawn and throughout the day, the cameras and transmitters would operate only on battery power. Figure 4 shows a camera and pole schematic.

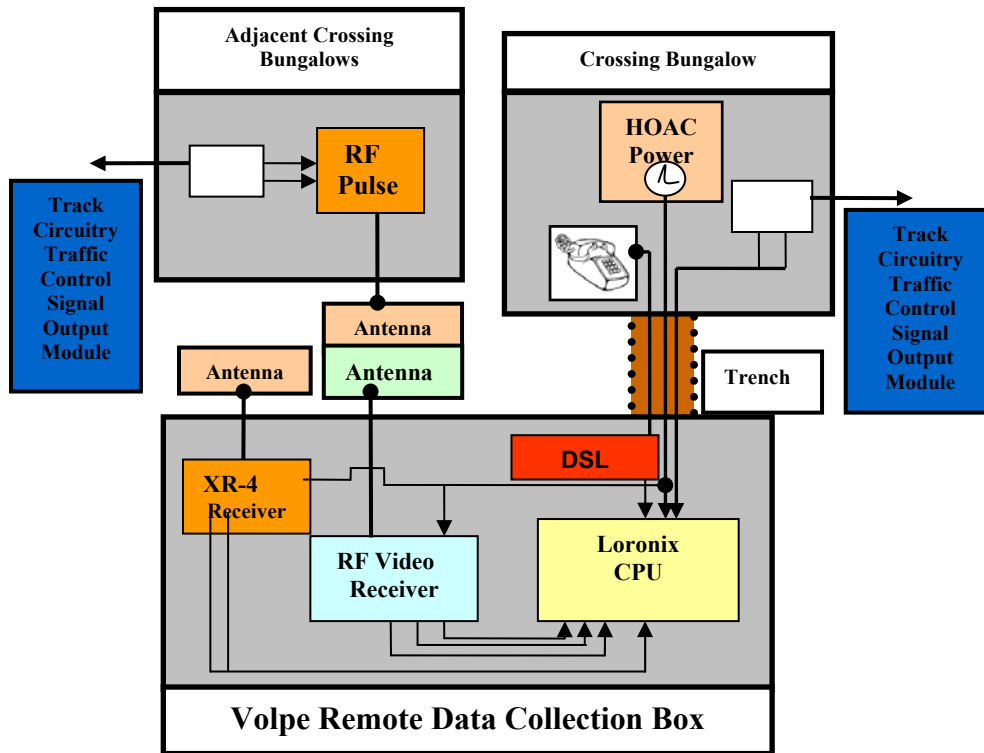
Figure 5. Field System Schematic

The PEERS Volpe remote data collection box system stored the receiver, the radio frequency video receiver, the computer processor unit, and the digital subscriber line modem (DSL). Figure 5 shows a diagram of the field system.

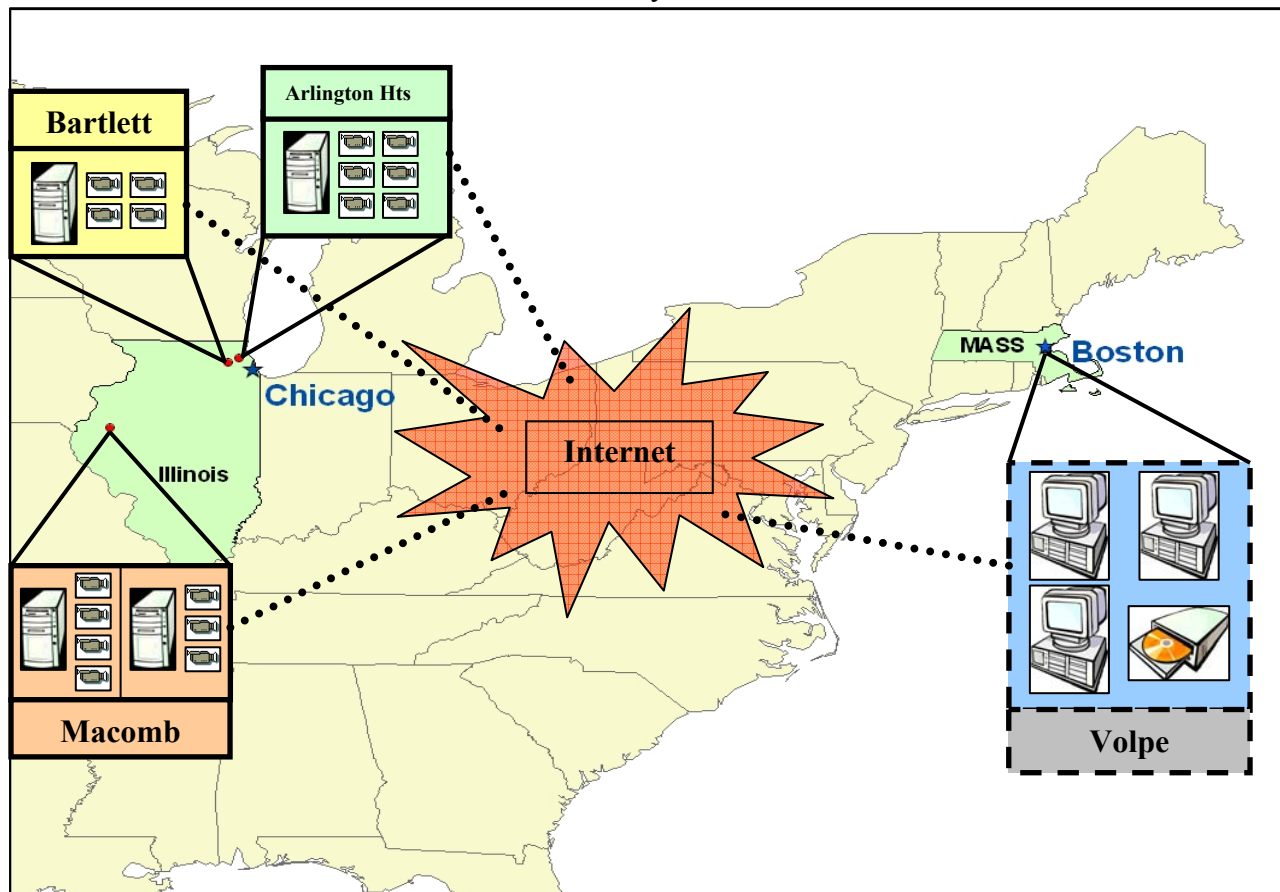
Figure 6. Remote Data Collection Schematic

Video data was collected and stored onsite in each community and then transmitted to the Volpe Center via the Internet. Each camera captured, digitized, and catalogued alarm video on the remote stations. Three computers with an in-house Internet connection were used to download the site data to the Volpe Center. One workstation per community was designated for study participation. Based on the large volume of data collected, a backup hard drive was necessary as additional storage for data that would be accessed later for analysis. All video images collected were transferred to DVD media for viewing and archiving. The Volpe Center workstations used a local client to access the remote database. By using structured query language (SQL) calls, the Volpe Center could call up the appropriate alarm data and pull the video and associated information off the remote systems and upload them to the Volpe Center workstations. Figure 6 shows a schematic of this remote data collection system.

The crossings were monitored by six cameras (two at each crossing, facing the railroad tracks from opposing directions). Both cameras were continuously recording data, and alarm events triggered by warning device activations were tagged and saved for a minimum of 60 days. These events recorded activity starting 10 seconds before warning device activation and continued 30 seconds after the warning devices were deactivated. Only one camera per crossing was analyzed for violation activity, and the other cameras were used as a backup or if a closer unobstructed view was needed from the opposite direction. The video data files were divided into alarm files and non-alarm files. The files of interest to this project were the alarm files, which contained footage of the activated crossing warning devices. Non-alarm video files were deleted first from the computer memory to preserve alarm video files. Data was downloaded to the Volpe Center workstation via the Internet and backed up on DVD media for processing and archiving purposes.

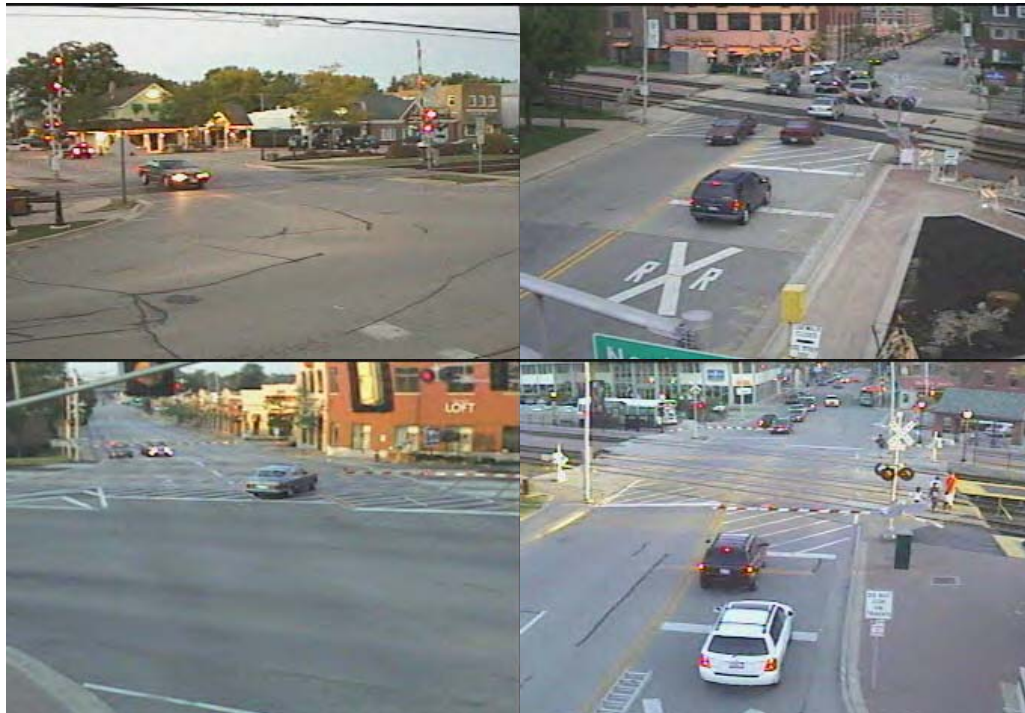
Figure 7. (Clockwise) Type I Violation, Type II Violation, Pedestrian Type III Violation, Motorist Type III Violation

- A type I violation occurs when a violator traverses the crossing while the lights are flashing, the bells are ringing, but before gate descent.
- A type II violation occurs when a violator traverses the crossing during gate descent or ascent with audible devices sounding.
- A type III violation occurs when a violator traverses the grade crossing after the gates finish their descent and are fully deployed in a horizontal position.

Type III violations are the most risky and type I the least. The type I violation occurs at the first warning that a train is on approach to the crossing. Type II violations occur both before and after the train arrival at the crossing. This type of violation is of particular concern during second train coming events, as the first train departs and the second train is arriving. During a type III violation, the gate is in the horizontal position, and a motorist or pedestrian would have to go around, or through, the downed gate. Figure 7 shows examples of each violation.

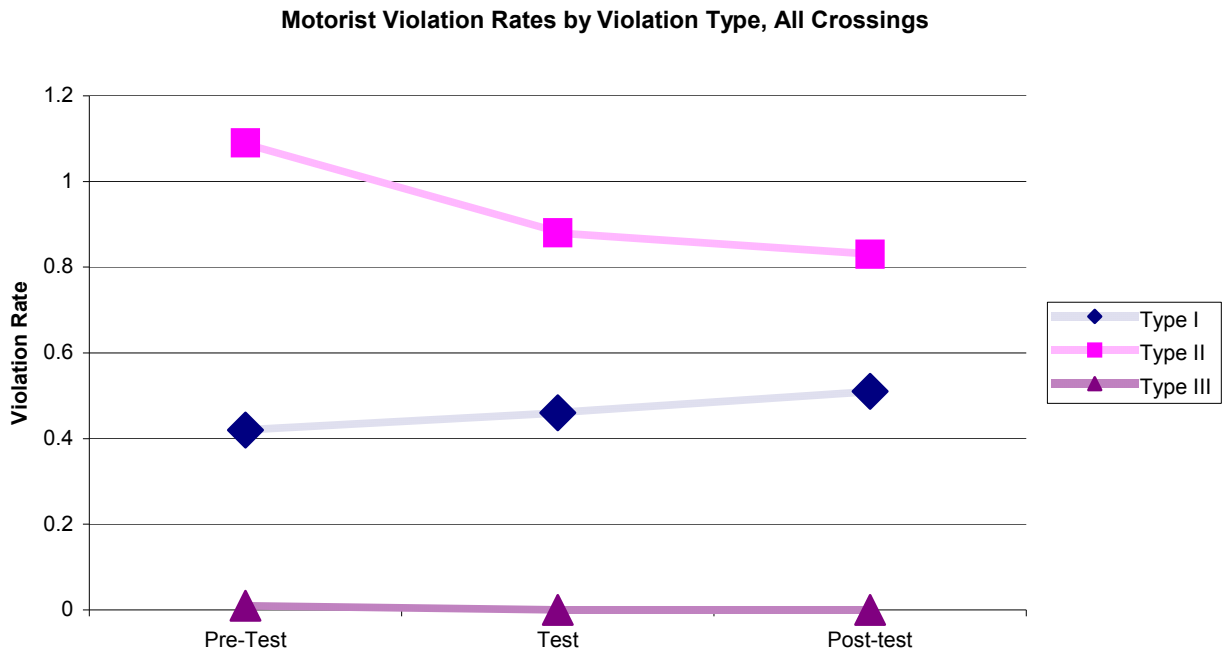
Figure 15. Motorist Violation Rates by Violation Type, All Crossings

<i>Motorist Violation Rates by Violation Type for All Crossings</i>			
<i>Violation</i>	<i>Pre-Test</i>	<i>Test</i>	<i>Post-Test</i>
Type I	.42	.46	.51
Type II	1.09	.88	.83
Type III	.01	.00	.00

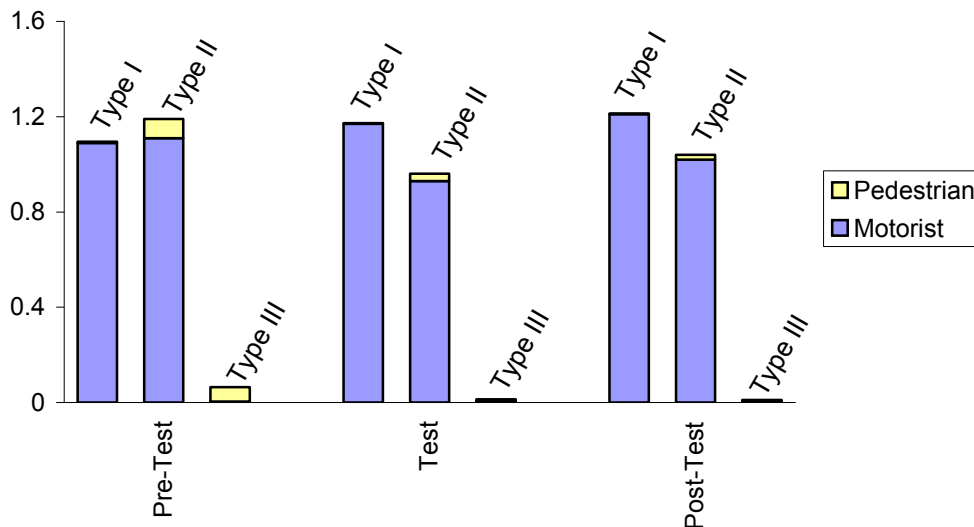
Figure 17. Motorist and Pedestrian Violation Rates, Arlington Heights Road

<i>Arlington Heights Road Motorist and Pedestrian Violation Rates by Violation Type/Period</i>				
<i>Violation Type</i>	<i>Mode</i>	<i>Pre-Test</i>	<i>Test</i>	<i>Post-Test</i>
<i>Type I</i>	M	1.09	1.17	1.21
	P	0.005	0.003	0.003
<i>Type II</i>	M	1.11	0.93	1.02
	P	0.08	0.03	0.02
<i>Type III</i>	M	0.004	0.004	0.001
	P	0.06	0.01	0.01

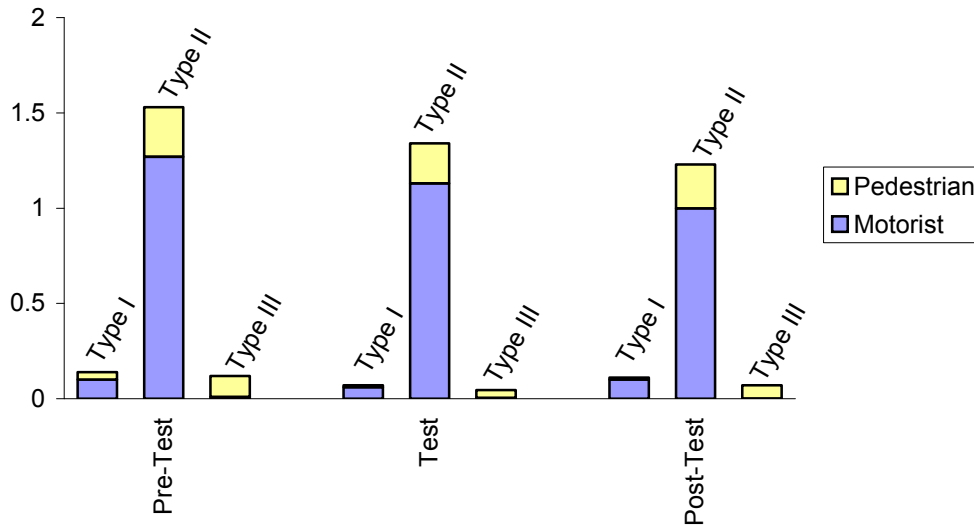
Figure 18. Motorist and Pedestrian Violation Rates, Evergreen Avenue

<i>Evergreen Avenue Motorist and Pedestrian Violation Rates by Violation Type/Period</i>				
<i>Violation Type</i>	<i>Mode</i>	<i>Pre-Test</i>	<i>Test</i>	<i>Post-Test</i>
<i>Type I</i>	M	0.10	0.06	0.10
	P	0.04	0.01	0.01
<i>Type II</i>	M	1.27	1.13	1.00
	P	0.26	0.21	0.23
<i>Type III</i>	M	0.01	0.005	0.001
	P	0.11	0.04	0.07

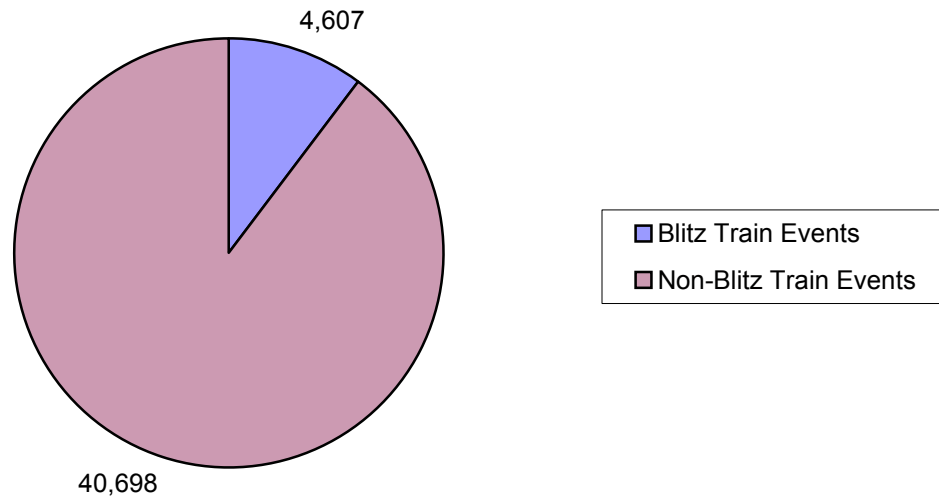
Figure 20. Count of Train Events on Blitz and Non-Blitz Days

Only 29 of the 337 days of data collected in the test period experienced some blitz activity. Figure 20 is a pie chart of the number of train events observed during the test period and whether they occurred on a blitz day or not.

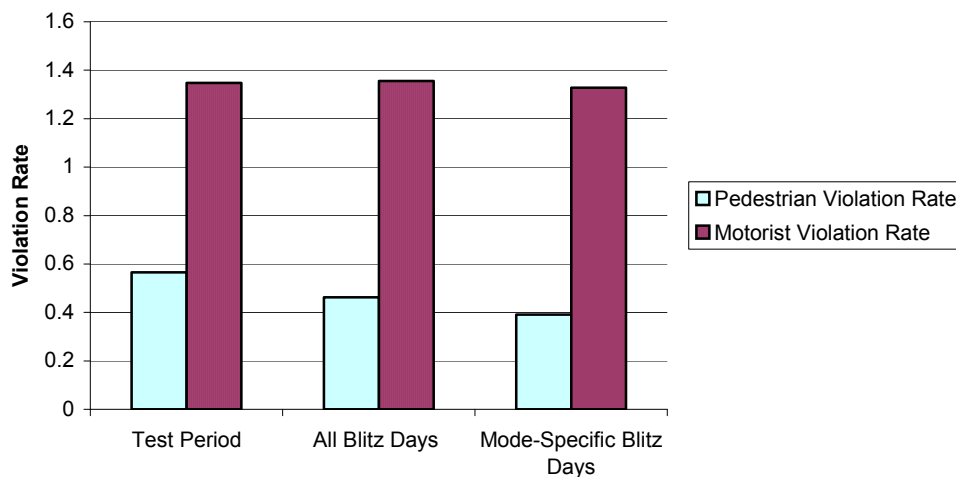
Figure 21. Test Period Violation Rates versus All and Mode-Specific Blitz Days Violation Rates by Mode of Transportation

<i>Test Period Violation Rates versus All and Mode-Specific Blitz Days Violation Rates</i>			
	Test Period	All Blitz Days	Mode-Specific Blitz Days
Motorist	1.347	1.356	1.328
Pedestrian	0.565	0.463	0.391
