# Environmental Effects of Historical Mining in the Animas River Watershed, Southwestern Colorado

*The U.S. Geological Survey has completed an extensive environmental study of the effects of historical mining on water and sediment quality and aquatic and riparian habitat in the Animas River watershed upstream from Silverton, Colorado. Results from this study are being used by Federal and State agencies and by the local watershed stakeholders group to implement remediation and cleanup activities.*

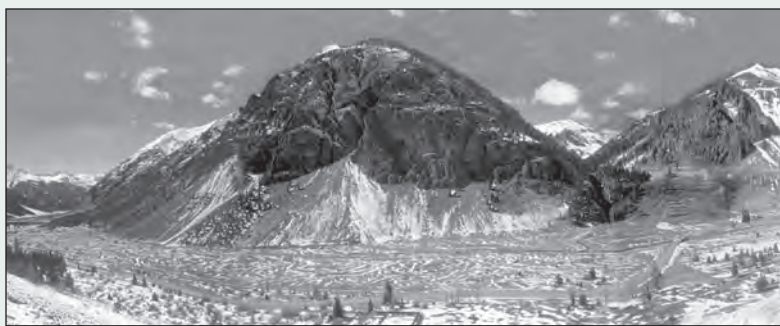
**Figure 2.** Animas River valley at Eureka. Foundation of Sunnyside Eureka Mill is on hill at far left above road. Riparian zone downstream from the mill site was completely obliterated by discharge and storage of mill tailings during the mill's operation (1917–1930). About 1 meter of sediment accumulated on the flood plain as a result of disposal of mill tailings in the Animas River. The site was remediated by Sunnyside Gold, Inc., in 1996. Photograph by Kirk Vincent (1999).

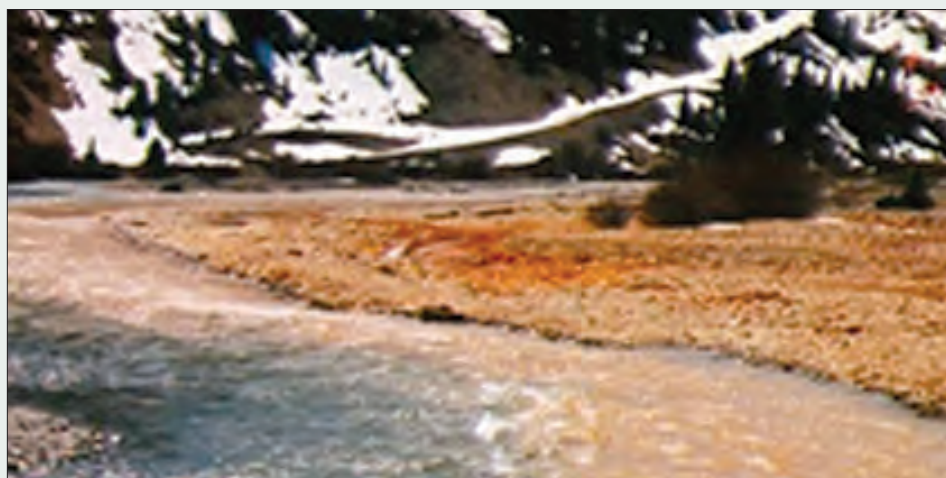
**Figure 3.** View looking downstream (southwest) from confluence of Cement Creek (right) with Animas River (left). Iron colloids precipitate from more acidic surface water in Cement Creek ( $\text{pH} \approx 3.5$ ) upon mixing with more neutral water of Animas River. Some of the iron and much of the toxic metal load in Cement Creek are the result of historical mining in the Cement Creek basin.

Historical mining occurred during a time when environmental effects of mining were poorly understood and of little understanding or concern to much of society. Effects of mining are noticeable throughout the watershed (fig. 3). In many stream reaches, elevated trace-element concentrations are the direct result of historical mining exemplified by zinc (fig. 4). Other potentially toxic trace elements (Al, Cd, Cu, Pb, and Mn) in both water and sediment resulting from historical mining activity show the same general distribution patterns. The presence of Paleozoic carbonate rocks as well as the carbonate in propylitic hydrothermal alteration in the upper Animas River basin resulted in good near-neutral water in the Animas River and many of its west-flowing tributaries (fig. 5). Tracer studies conducted in the watershed indicate that the Animas River upstream from Cement Creek contributes the largest portion of the manganese. In contrast, water from Mineral Creek contributes

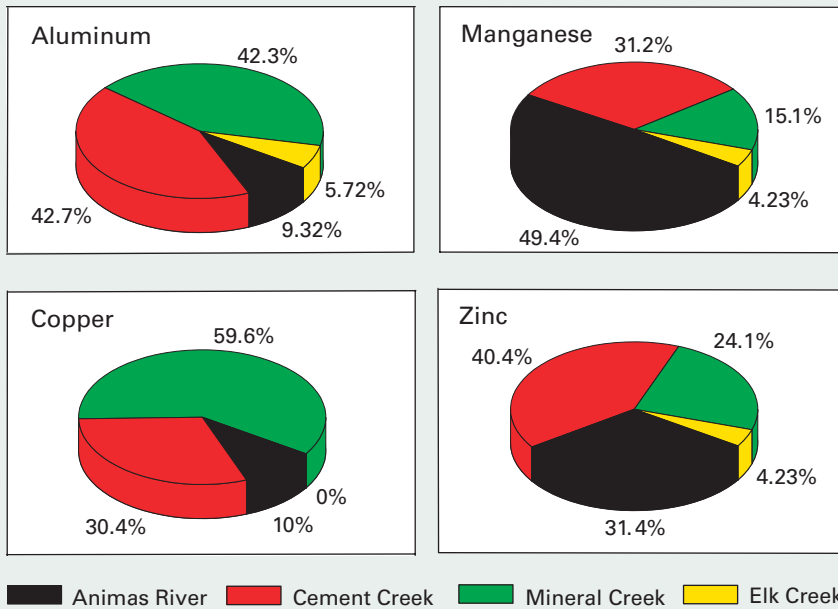
**Figure 6.** Percent of the total dissolved load of Al, Mn, Cu, and Zn calculated from tracer data, Animas River, Cement Creek, Mineral Creek, and Elk Creek.

the largest portion of the copper load and Cement Creek the largest portion of the zinc and aluminum loads (fig. 6).
