# **Landslides Triggered by the October 8, 2005, Pakistan Earthquake and Associated Landslide-Dammed Reservoirs**

**Open-File Report 2006–1052**

**U.S. Department of the Interior  
U.S. Geological Survey**

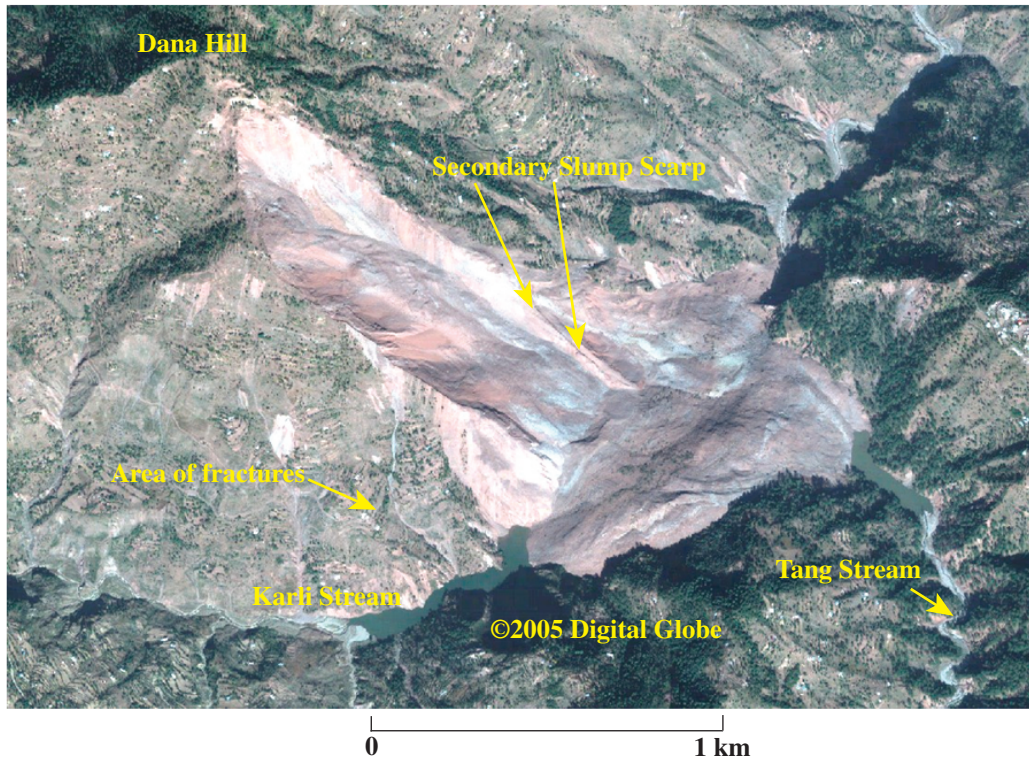
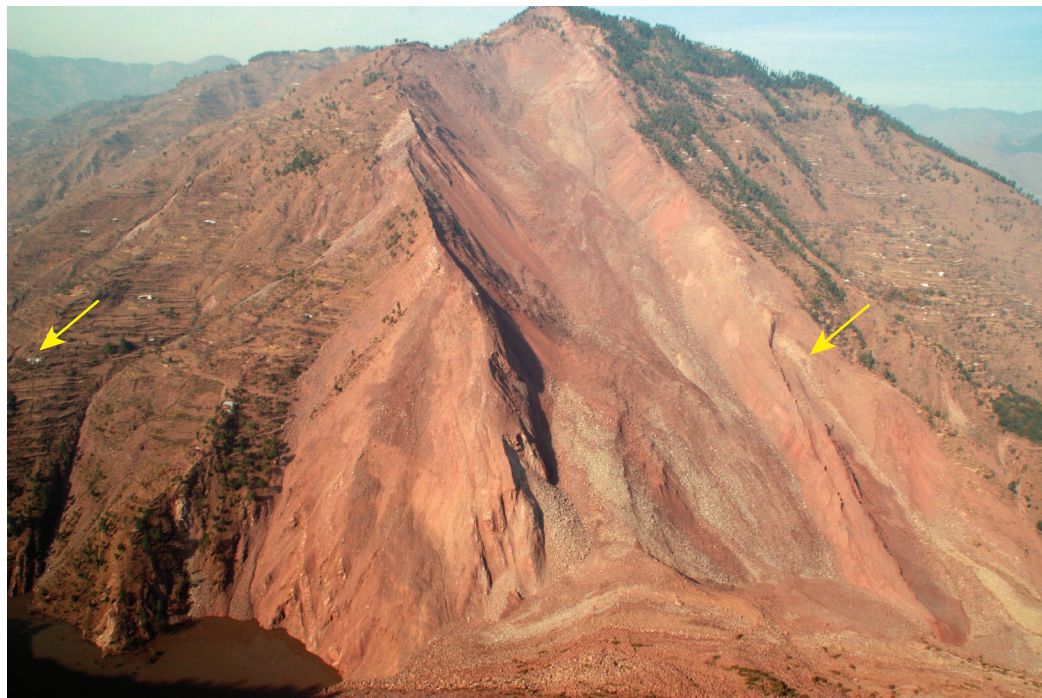
Figure 2. Views of the Hattian Bala debris avalanche. (A) Near-vertical view of the Hattian Bala debris avalanche and the two lakes impounded by the landslide debris in the Karli and Tang valleys. (Photograph from DigitalGlobe Quickbird II Natural Color, October 27, 2005). Debris traveled approximately 1.5 kilometers from the crest of Dana Hill to Karli Valley. Secondary slump is indicated by arrows. Area of concentrated fractures is noted in lower left of the photograph. (B) Oblique aerial view of the Hattian Bala debris avalanche showing the avalanche scarp, travel path and debris, the lake in the Karli drainage, a secondary slump at the right side of the photograph (arrow), and area of fractures shown in figure 5 (arrow at left of photograph).

Several other slumps and rock slides are present along the margins of the avalanche. At its lower left shear surface (looking downslope), a secondary slump has formed in the ridge forming the left margin of the slide (fig. 2B). Roughly triangular in shape, this slump is about 300 m from crown to toe with a headscarp approximately 15 m high. Several secondary rock slides issue from the steep right margin of the avalanche (fig. 2B).

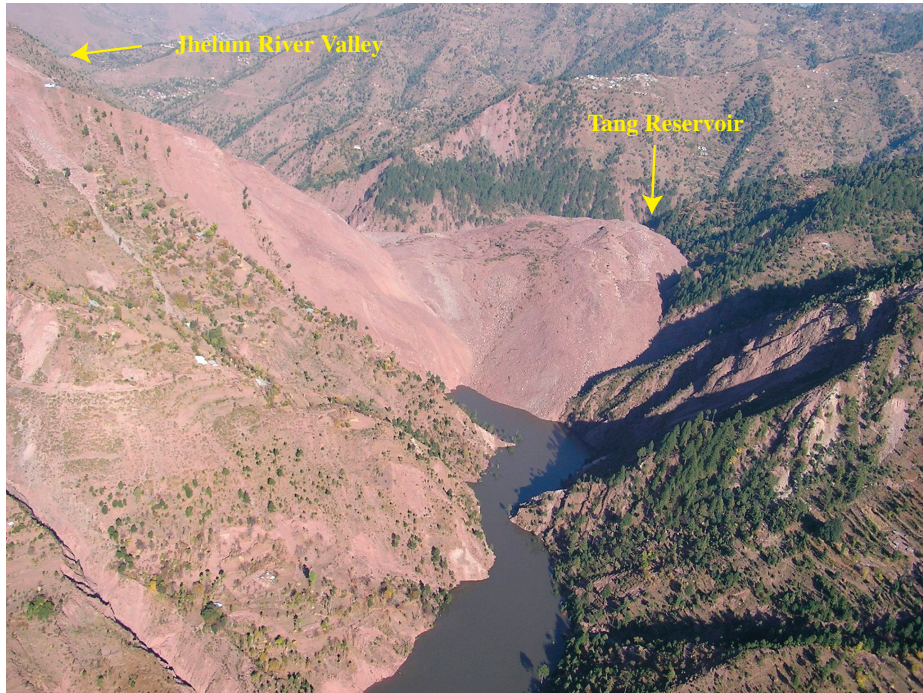
Figure 3. Oblique aerial view of the debris impounding the lake in the Karli stream drainage (Photograph courtesy of USAID).

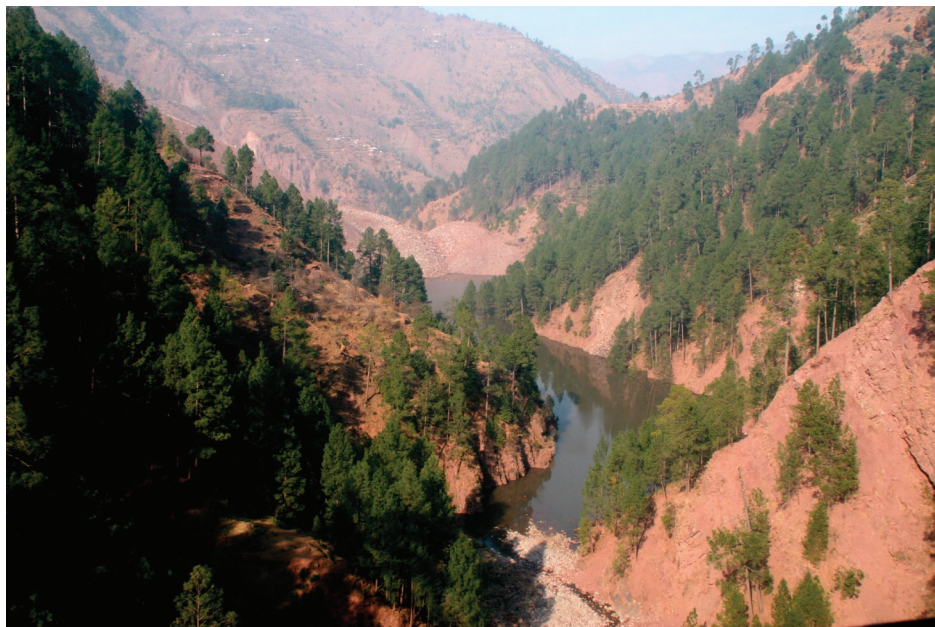
Figure 4. Lake impounded by the debris in the Tang stream drainage.

Eighty million cubic meters of rock and soil dislodged from a mountainside in the Kashmir Range by the earthquake traveled approximately 1.5 km downslope as a debris avalanche (landslide nomenclature according to Varnes, 1978) damming two tributaries of the Jhelum River. The Hattian Bala avalanche, located approximately 32 km southeast of Muzafarrabad (figs. 1A and 1B), filled the valley of the Karli stream for 1.3 km and also blocked the drainage of the Tang stream valley at its intersection with the Karli stream. The avalanche debris filled the Karli drainage to a depth of about 130 m above the valley axis (figs. 2A and 2B). Two reservoirs have been impounded upstream from the landslide dam. The larger reservoir is in the Karli stream drainage and is about 20 m deep and 800 m long as of December 19, 2005 (fig. 3). Its water level as of this date is at 1,267.55-m elevation with slightly more than 100 m to rise before it will overtop the landslide debris (established by recent survey by Pakistan Military Engineers completed December 18, 2005). The smaller reservoir in the Tang stream drainage was approximately 10 m deep and 400 m long as of December 19, 2005 (fig. 4). This reservoir had only 22 m to rise before it overtopped the landslide debris blocking its path.

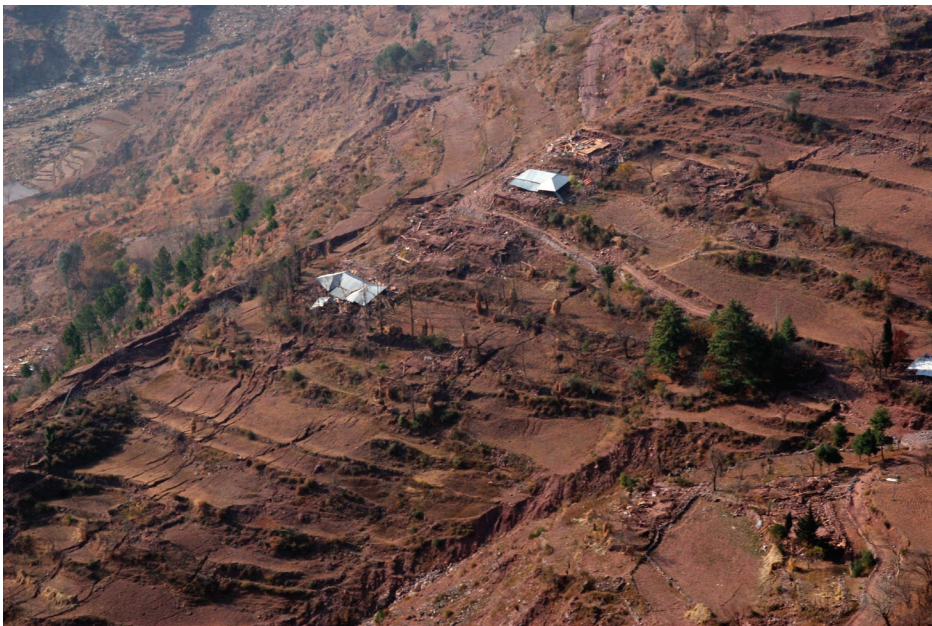
Numerous fractures occur in bedrock at the avalanche margins. Fractures bounding incipient slumps are present along both lateral margins of the landslide path as well as at the headscarp area. Many fractures are present immediately to the southwest of the avalanche path. This area just above the reservoir to the top of the mountainside is laced with fractures that may be part of an incipient slump mass and (or) a network of fractures generated from the shaking alone (fig. 5). Most of these fractures seem to be parallel to the strike of the bedding.

Figure 5. Oblique aerial view of slopes above the reservoir in the Karli stream drainage with numerous fractures (lower left in photograph) extending through the terrain parallel to the slope direction and to the strike of bedding.

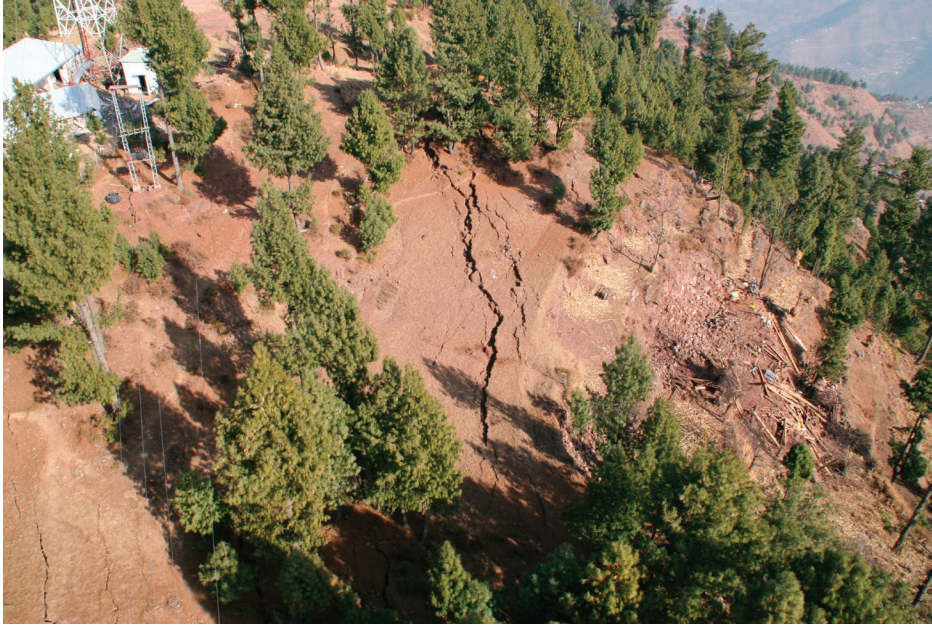
The top of the mountain on which the avalanche occurred and several ridges near the top also are covered with fractures that are concentrated at the ridge crests and the summit (fig. 6). These fractures probably are associated with increased levels of shaking due to topographic amplification of the ground shaking.

Figure 6. Fractures on ridgetop (Dana Hill) above debris avalanche.

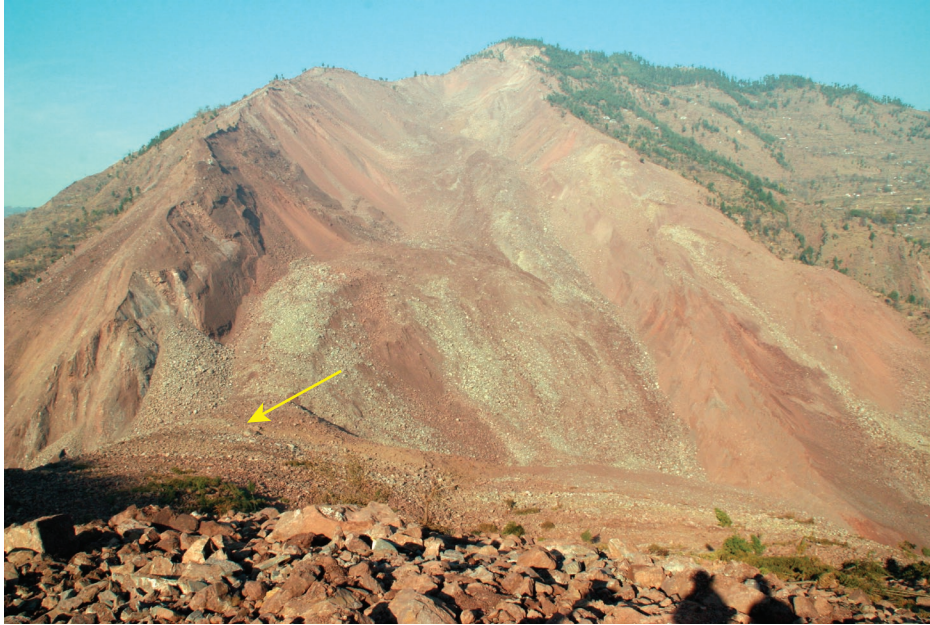
Figure 7. Ground view of debris avalanche and Karli stream debris dam with arrow pointing to low point at the crest where a spillway is to be excavated.

The engineers concluded that enough width exists at the low-elevation saddle in the debris blocking the Karli drainage to excavate a spillway 30 m deep (fig. 7). A spillway 100 m deep, sufficient to reach the current lake level, is not possible because the excavated slopes would have to be too steep to be stable. The saddle where the spillway will be excavated is approximately 200 m wide with gentle slopes. The mixture of fine-grained and boulder-sized debris indicates that some blasting of large rocks will be necessary in the excavation process. The westernmost part of the saddle is less than 100 m wide parallel to the stream drainage with moderately steep slopes in the debris to the north where much of the excavated debris could be sidecast (fig. 8).

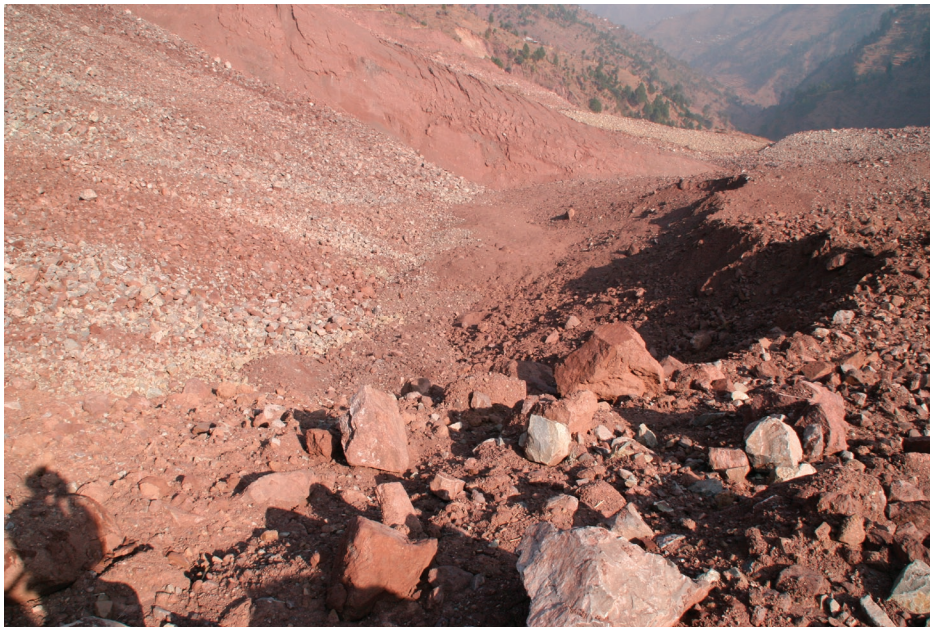
Figure 8. View northeast downvalley from crest of the Karli stream landslide dam where Pakistan military engineers plan to construct a spillway in the debris. Note the depression in the foreground where some of the excavated debris may be deposited.

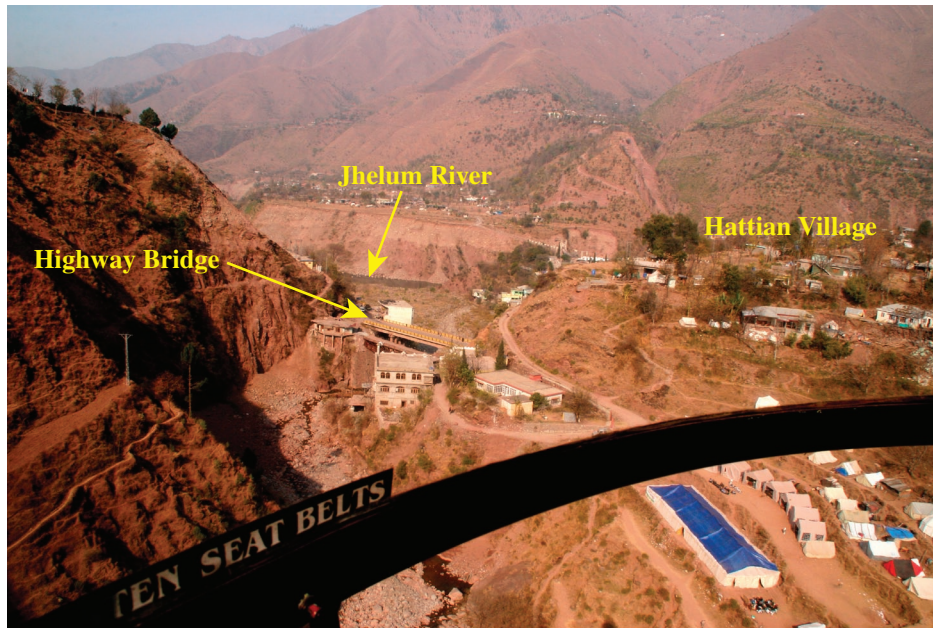
The nearest settlement downstream from the landslide dam is the village of Hattian, which is 2.8 km distant and is at the junction of the Jhelum River and the Karli tributary dammed by the landslide. The stream course downstream from the landslide dam is a steep, narrow canyon with numerous tight meanders and associated narrow ridges that bisect the inside curves of these meanders. Dwellings near the stream course are high on the slopes above the stream except near the outskirts of Hattian. Here, within one kilometer of the village, there are a few dwellings located near the stream and not far above it. As the stream course reaches Hattian, it curves to the left in a tight meander with the main body of Hattian on the right. At this point, numerous permanent and temporary shelters are located near the stream and only slightly above it. A bridge over the stream, part of the highway along the Jhelum River that leads to India, is just beyond this meander (fig. 9).

Figure 9. Northward aerial view of village of Hattian showing bridge on main highway to India and other permanent and temporary dwellings near stream level of the landslide-dammed Karli tributary to the Jhelum River.

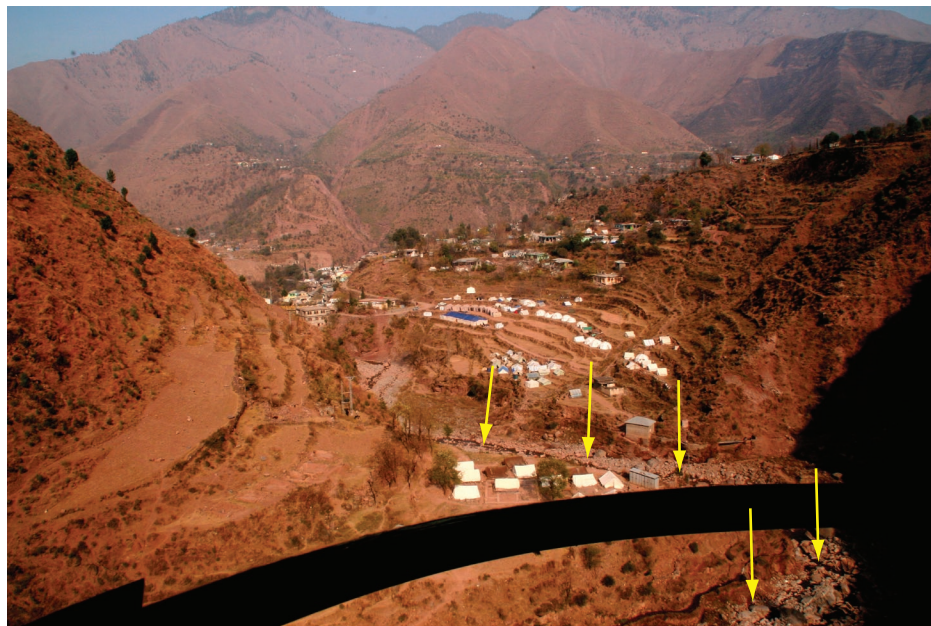
If the dam blocking the Karli stream drainage breaches catastrophically, floodwaters and mixed sediment traveling downstream from the breach will superelevate at the junction with the Jhelum River and will tend to be carried by centrifugal force toward the center of Hattian village. The village is located on an uplifted river terrace that slopes down to the tributary stream where it joins the Jhelum River. This slope forms a smooth ramp that will enhance the runup on the outside of the meander in the direction of the main portion of the village (fig. 10). Downstream from Hattian, along the Jhelum River, dwellings are mainly located on river terraces of varying heights

Figure 10. Aerial view of tributary stream drainage near Hattian. Location of tent camp in middle ground is on a smooth ramp just above the tributary stream (arrows) whose channel is curving to the left. This area is likely to be subject to severe runoff, or superelevation, of floodflow immediately following a potential breach of the Karli stream landslide dam.

above the river. To adequately evacuate these populations prior to the breach of the Hattian Bala landslide dam by the Karli stream, flood-routing models appropriate to the conditions of the landslide deposits with an excavated spillway have been run to estimate the extent of evacuation necessary. This information is currently being evaluated by the Pakistan military.
