This map is one of seven showing areas in Nicaragua impacted by debris flows and other landslides triggered in response to the torrential rainfall that accompanied Hurricane Mitch in October of 1998. The maps provide a record of landslide activity over areas of diverse geology, geomorphology, microclimates, and vegetation. When combined with information on the physical properties of hillslope-mantling materials, hillslope form and gradient, and rainfall characteristics, the inventories provide a foundation for evaluating the susceptibility of other similar areas to landsliding.

**MAP OF LANDSLIDES AND RELATED DOWNCHANNEL EFFECTS TRIGGERED BY HURRICANE MITCH IN PARTS OF JINOTEGA (2955 II) AND SAN RAFAEL DEL NORTE (2955 I) QUADRANGLES, NICARAGUA**

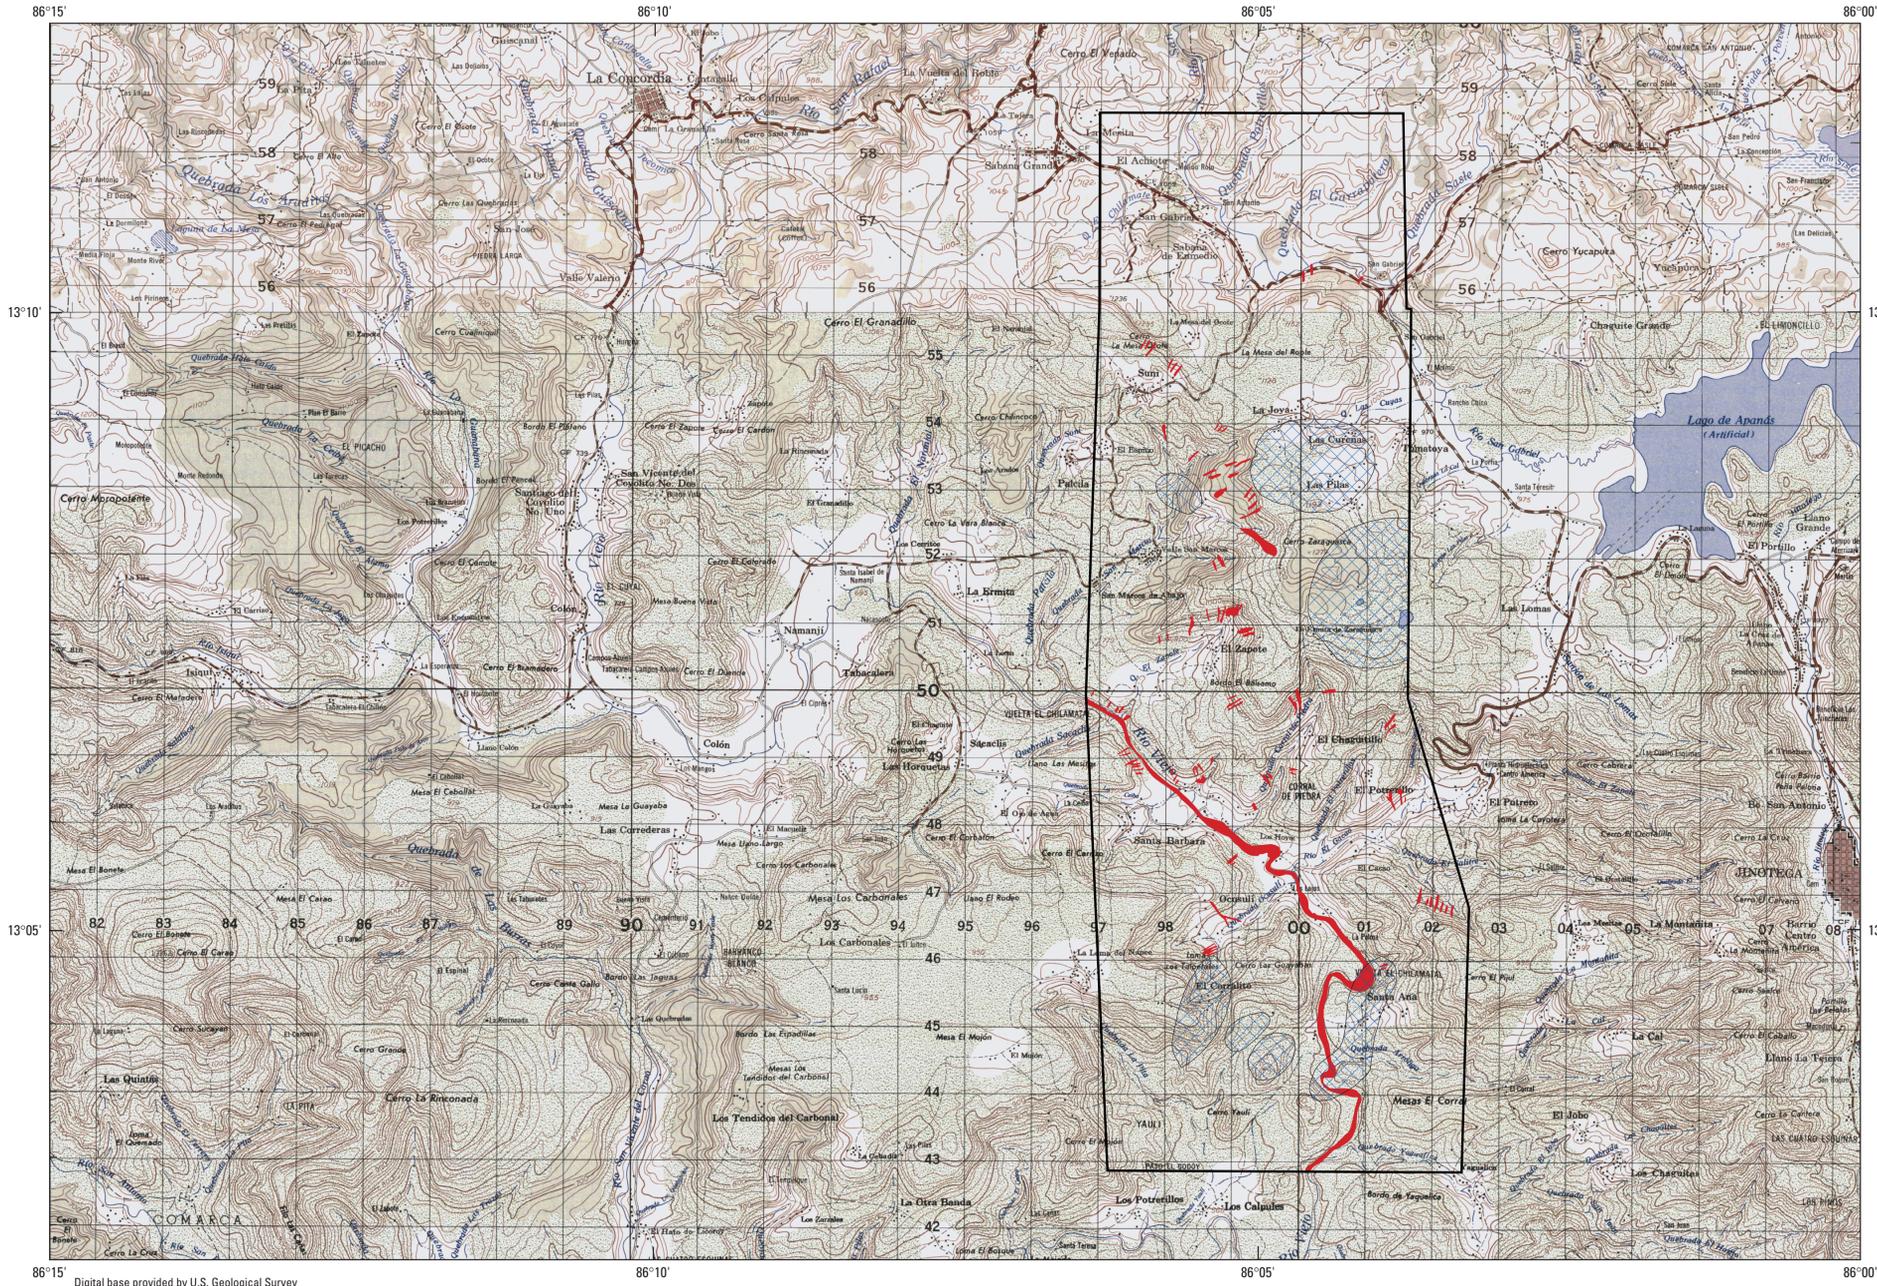
Area impacted by landslides and related downslope effects mapped from aerial photography. Effects include deposition and erosion in downslope channels and on alluvial fans

- Extent of aerial photography coverage
- Area not mapped due to cloud cover

Aerial photographs taken between 4 and 19 December 1998 were used to map the landslides shown on this plate. The aerial photographs were taken under the Open Skies program of the Defense Threat Reduction Agency (<http://mitchnts1.cr.usgs.gov/data/aerial.html>). Photographs at 1:60,000 scale were available for all seven study areas, and 1:30,000-scale photographs were also available for portions of the Matagalpa and the Jinotega/San Rafael del Norte study areas. Digital Raster Graphics (DRG) scanned images of 1:50,000-scale quadrangles projected to Transverse Mercator were used as base maps for mapping the landslides. Landslides and related effects in and adjacent to downstream drainages were mapped by first identifying them on the aerial photographs using a mirror stereoscope. The area visible on the aerial photographs impacted by the landslides was manually plotted by inspection onto the base maps. In some cases, the base maps were enlarged to 1:25,000 scale to facilitate mapping. Locations of landslides mapped using this procedure are estimated to be accurate to within 200 m.

Following field verification, the area impacted by the landslides was digitized manually, and the data were then digitally registered to the DRG base map in Arc/Info. The initiation location of each landslide was also digitized. Final maps are presented at 1:50,000 scale.

The small scale of the aerial photographs precludes identification of locations of transitions between debris-flow source areas and debris-flow paths, and transitions between debris-flow and streamflow processes. For this reason, we mapped debris flows as extending from the source areas to the farthest point down channel that appeared to have been affected by flow processes, whether streamflow or debris flow. Also, because of the small scale of the aerial photographs used for this mapping, it is possible to discern between debris flows and slow-moving earth flows, but not between different types of landslides that mobilized into debris flows. In addition, the maps show areas where cloud cover obscured the ground in the aerial photographs. Although landslide features may be present in these areas, it was not possible to map them. If a landslide feature was only partially obscured by trees, shadows, or cloud cover we mapped only what was visible. Finally, the area impacted by each landslide was mapped by filling in a colored polygon that best represented its shape and size. Because each feature is represented by a line at least the width of one pencil lead, the size of very small features may be somewhat exaggerated.

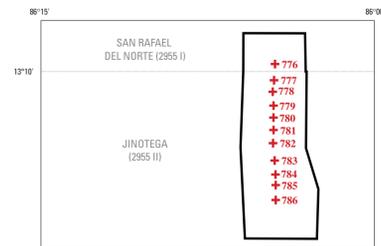
Index to aerial photography and base-map coverage. Topographic base map and reference number from Series E751. Crosses and respective frame numbers represent location of photo centers used in mapping the landslides. Aerial photographs from Open Skies Mission 4 (red).
