### MISCELLANEOUS FIELD STUDIES MAP MF-2346 Version 1.0

# MAP SHOWING RECENT AND HISTORIC LANDSLIDE ACTIVITY ON COASTAL BLUFFS OF PUGET SOUND BETWEEN SHILSHOLE BAY AND EVERETT, WASHINGTON

## By Rex L. Baum,<sup>1</sup> Edwin L. Harp,<sup>1</sup> and William A. Hultman<sup>2</sup>

### 2000

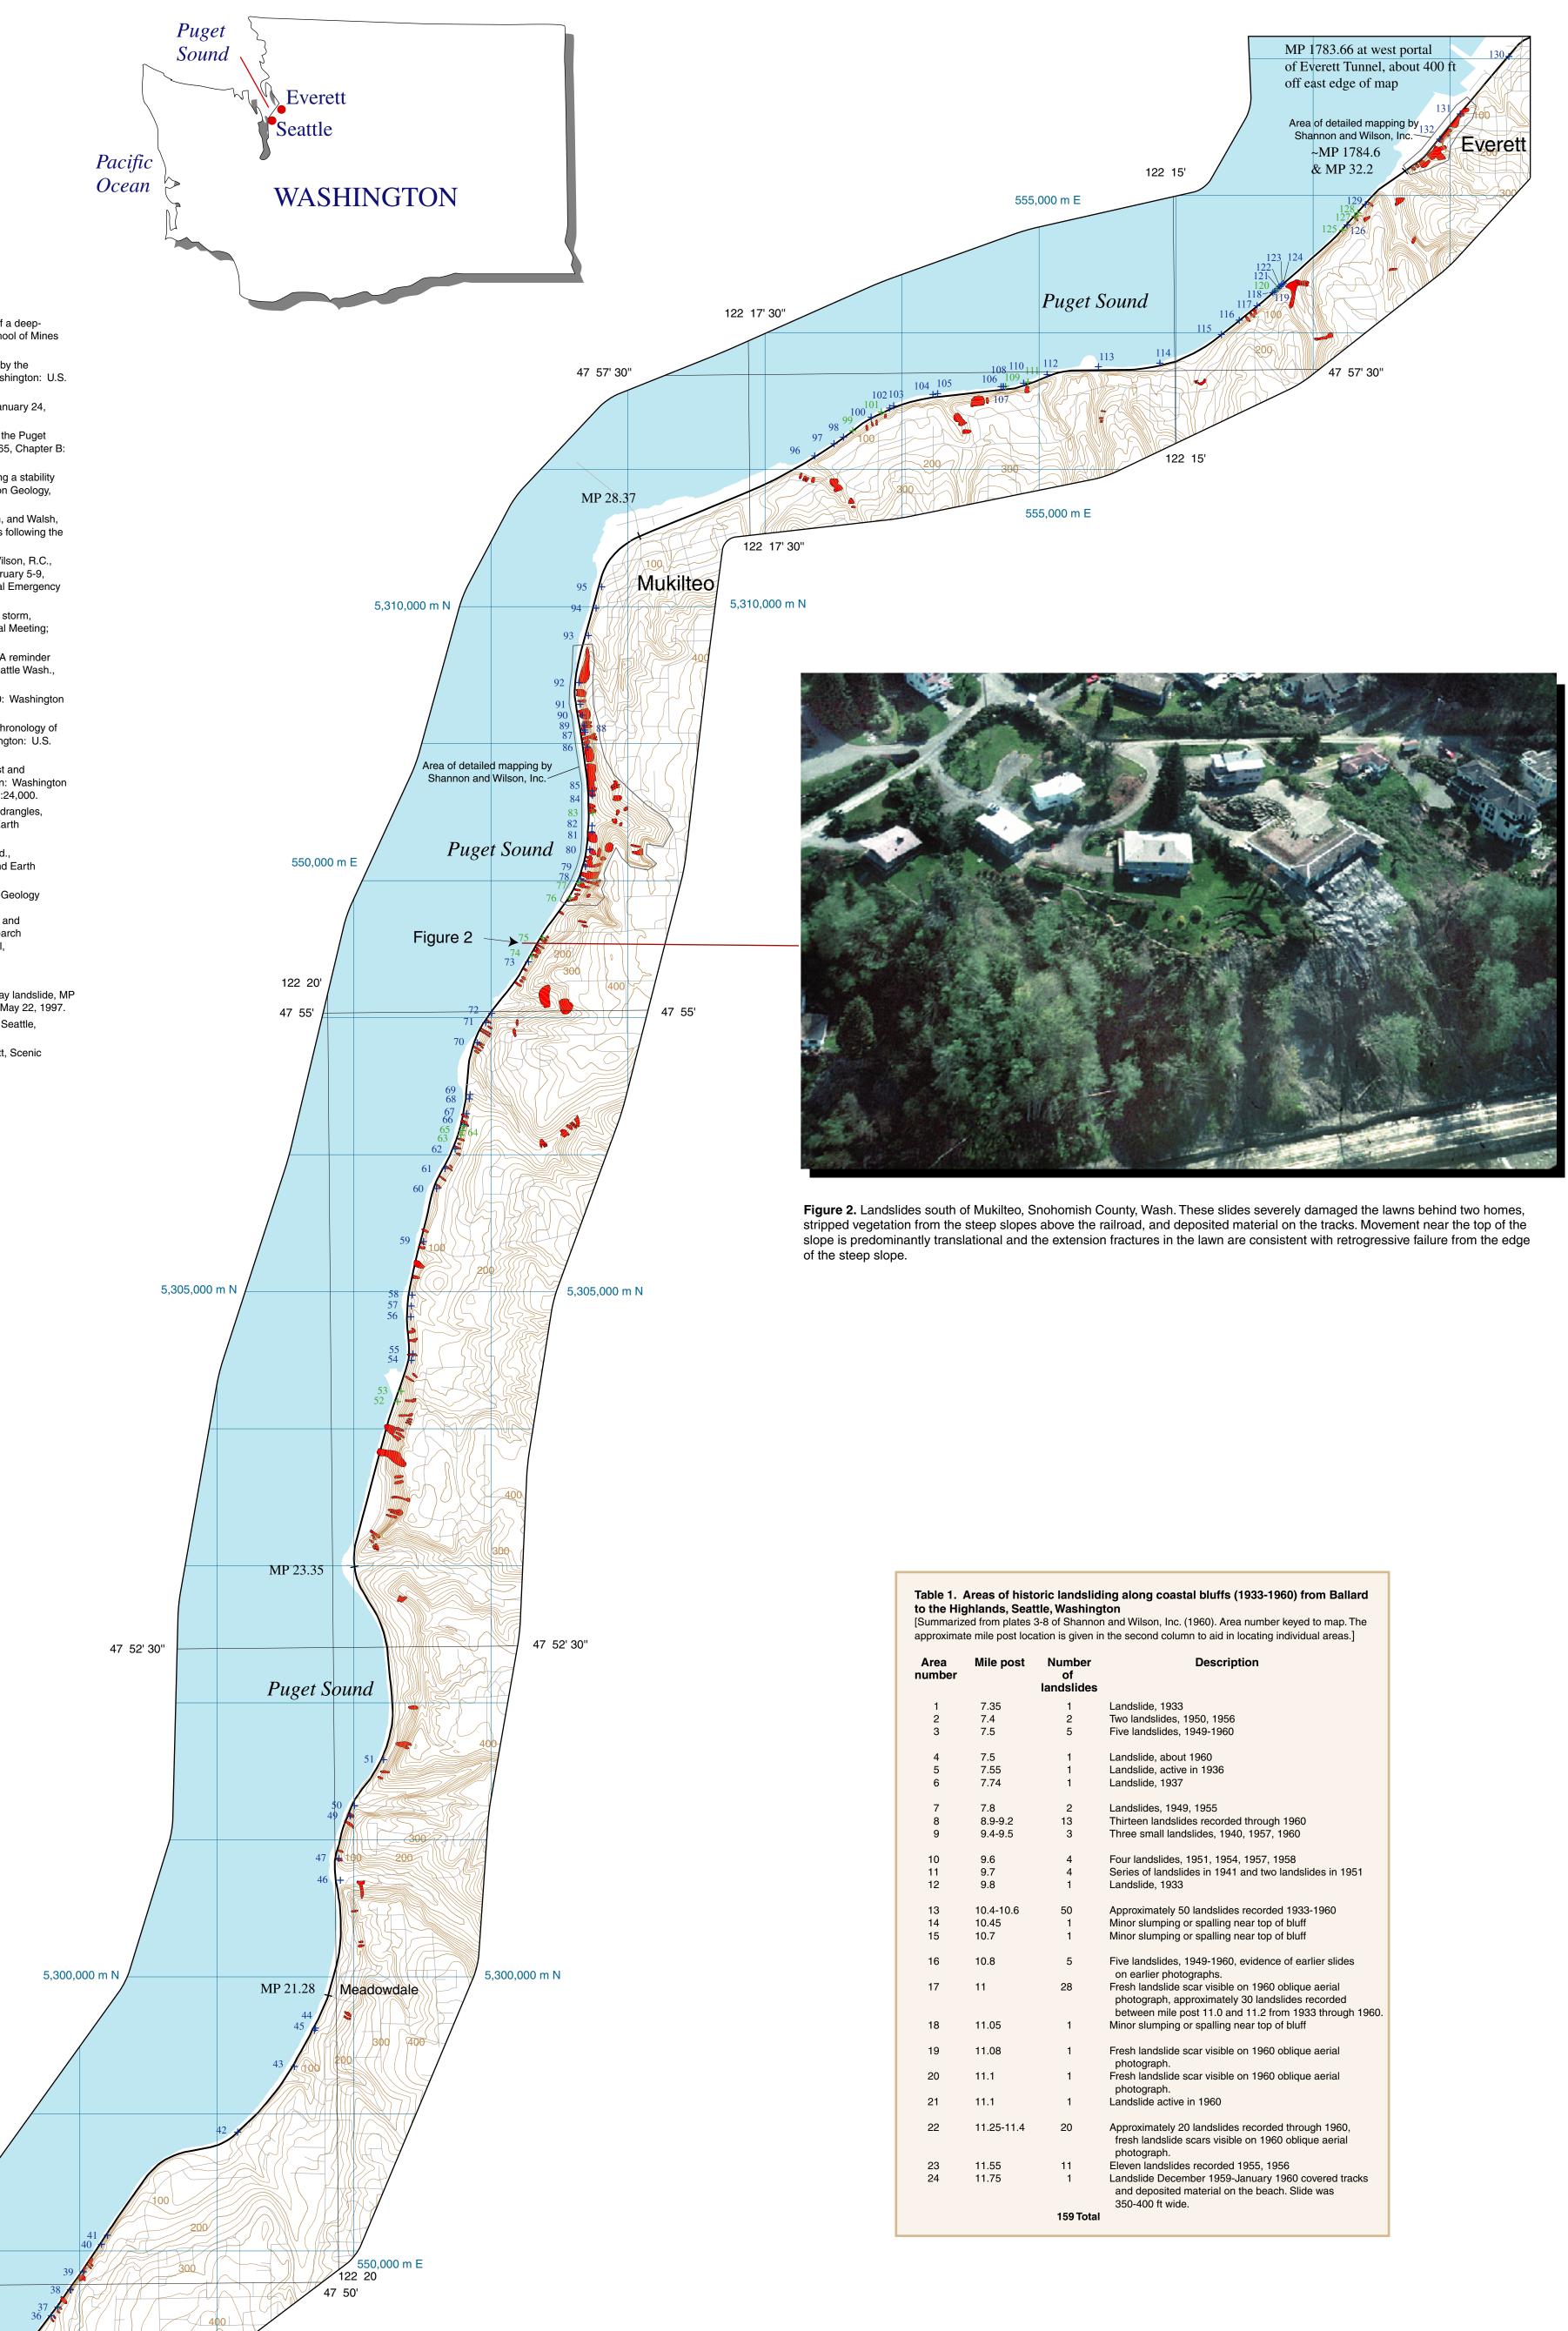
The map shows three kinds of data: (1) outlines of landslides that resulted from the winter storms of 1995-96 and 1996-97, (2) point locations where landslides affected the railroad in 1995-96 and 1996-97, and (3) areas of historic (pre-1960) landsliding in the southern part of the map area. We compiled the landslide inventory from a combination of USGS data and BNSF data on file at the office of its consultant, Shannon and Wilson, Inc. The railroad data are included by permission of BNSF. Most of the original data were in foot-pound units and most potential end users of this report are likely to use foot-pound units, therefore we have used foot-pound units rather than SI (metric) units in this report.

We mapped the outlines of landslide scars and deposits on 1:24,000-scale USGS topographic maps primarily by interpretation of 1:12,000-scale color aerial photography acquired by the USGS through a private contractor on May 7, 1997. We performed ground reconnaissance of several areas between Seattle and Mukilteo in the winter and spring of 1997 to observe locations and characteristics of reported landslides (Baum and others, 1998). Harp, assisted by W.Z. Savage, performed aerial reconnaissance of landslides along the bluffs in April 1997. We checked this inventory against 1:6,000-scale color aerial photography acquired earlier in 1997 for use by Shannon and Wilson, Inc. under contract to BNSF. This check resulted in several additions or modifications to the inventory mapping in a few places. The 1:6,000-scale photographs had a low sun angle, which made many of the landslide scars and deposits more difficult to see than on the 1:12,000scale photographs; however, the larger scale enabled us to see a few details locally that were not readily visible on the 1:12,000-scale photographs. We also added landslides that Shannon and Wilson, Inc. (1997b) had mapped in the field under contract to BNSF for detailed studies of three areas where landsliding was particularly severe in 1996 and 1997 (see map).

Point locations, referenced by railroad milepost, show approximately where landslides impacted or came near the railroad. These point locations were derived from a table prepared by Shannon and Wilson, Inc. (1997c<sup>4</sup>) on the basis of their field investigations. Generally, this table included only landslides that were close to the railroad or threatened it. A table of landslide data referenced to these locations appears in Appendix A. This table contains landslide classification, dimensions, slope angle, geologic materials, seepage, and related information compiled by Shannon and Wilson, Inc. from their field investigations. We have reinterpreted the landslide classifications to make them consistent with the nomenclature of Varnes (1978). These include earth slides, debris flows, rapid earth flows, and rotational earth slides (slumps) or combinations thereof. Our reinterpretation is based on Shannon and Wilson's descriptions of individual landslides and our field reconnaissance of the area. We could determine the map locations of a few railroad mileposts from the railroad's track chart; milepost locations between the known locations were interpolated linearly along the track. Consequently, some of the point locations do not correspond exactly with the locations of mapped landslides. In most instances we do not know which mapped locations correspond to the point locations.

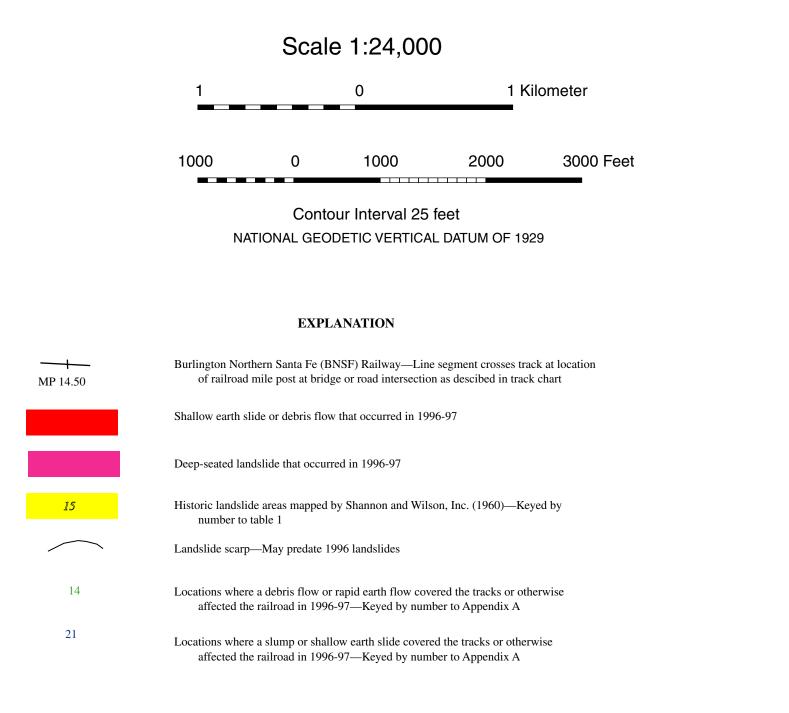
Figure 1. Shallow landslides north of Carkeek Park, Seattle, Wash. Much of the material in these slides originated at the edge of the midbluff bench. Slow-moving, deep-seated landslides occupy the bench, and material calves off the toes of these slides during or after severe rainstorms.

The few available observations of the speed or duration of these landslides coupled with local experience indicate that most landslides were rapid and lasted less than a minute. Some landslides consisted of several separate pulses that occurred several hours apart, but each pulse lasted a less than a minute. Circumstances surrounding the main pulse of the Woodway landslide are consistent with duration of less than 20-30 seconds. The main pulse of the Woodway landslide struck the train as it was passing and pushed several cars into Puget Sound. Three engines and one other car had pushed through thin debris on the track before the slide struck. A secondary pulse that occurred several hours later lasted about 15-20 seconds according to eyewitnesses (Shannon and Wilson, Inc 1997a). Accounts of other recent landslides around Puget Sound similarly indicate duration of a few seconds or tens of seconds (Bjorhus and Tu, 1997); however a few large, persistent, slow-moving slides also exist in the area (for example, large slow translational landslides occur on a mid-bluff bench north of Carkeek Park). Shallow earth slides and debris flows that covered the tracks originated at the toes of some of these slow-moving slides (fig. 1).
