REPORT NO. DOT-TSC-UMTA-72-3

NOISE LEVEL MEASUREMENTS ON THE UMTA MARK I DIAGNOSTIC CAR (R42 MODEL)

OCTOBER 1971
TECHNICAL REPORT

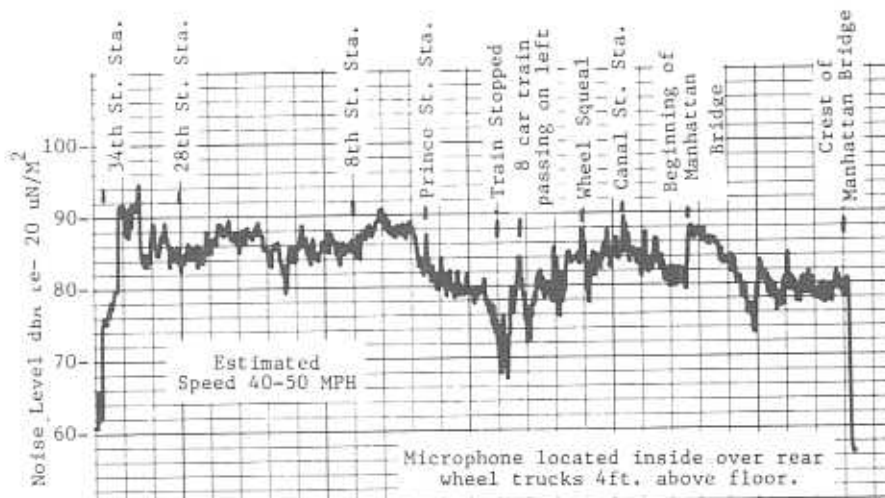
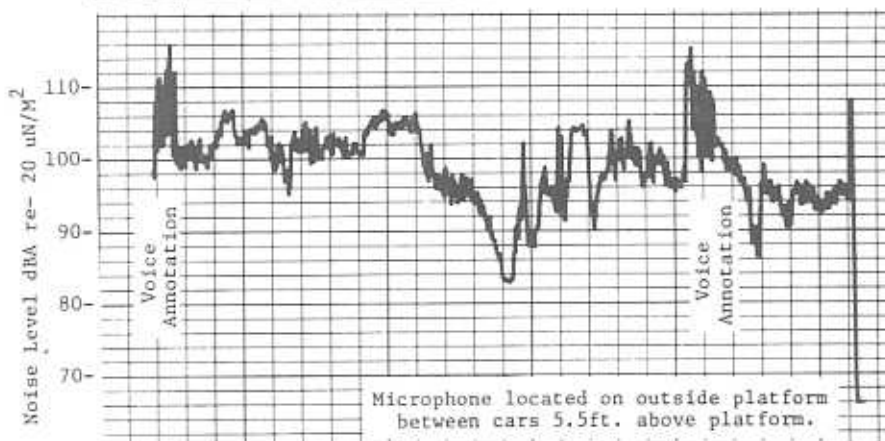
Figure B-1 Coincident Time Histories of Noise Levels Measured at Three Locations. Express Run from 34th. St. Station to Crest of Manhattan Bridge. "N" Line NYC Transit System. - May 6, 1971 See Figure F-1 for Microphone Locations. (No Speed Information Available)

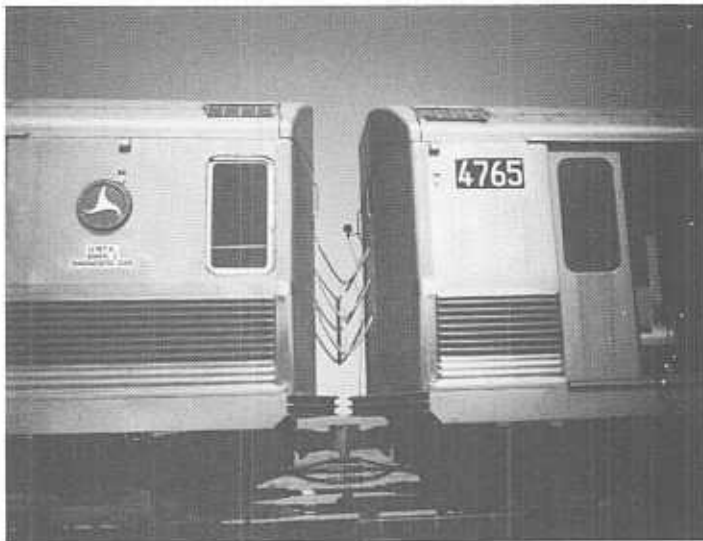
Figure F-2b. Microphone Located on Outside Platform Between Cars.

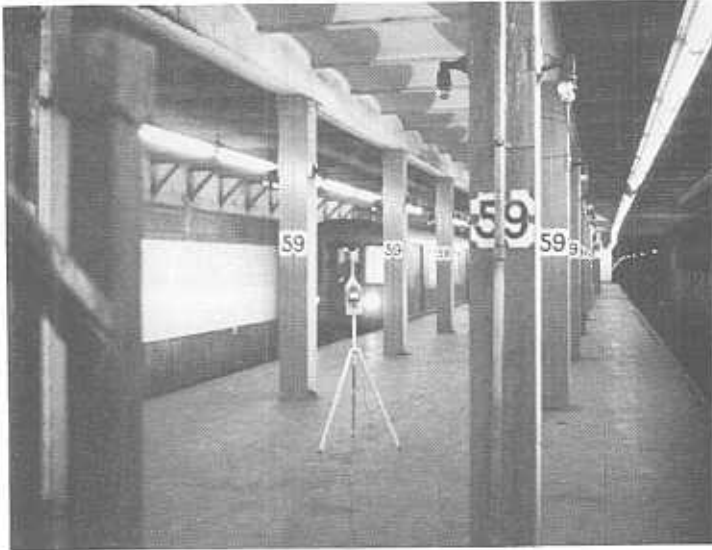
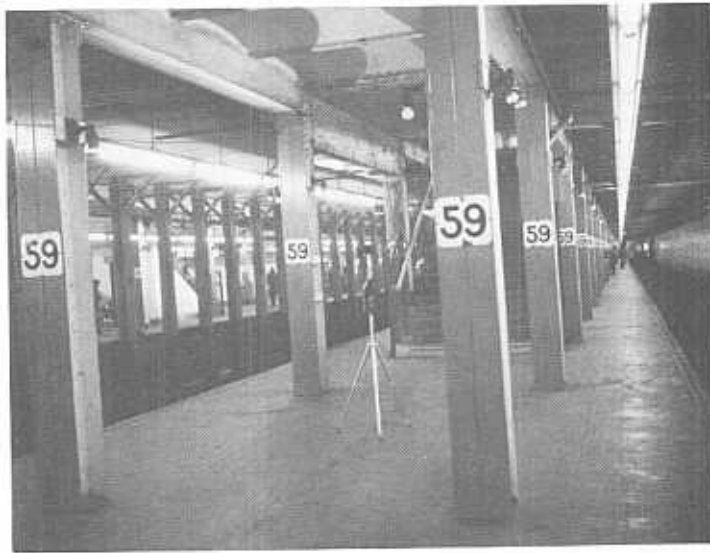
Figure F-4: Two Views of Microphone Located on Passenger Platform in 59th. St. Subway Station, NY City Transit System.

Figures F-3 and F-4 depict the location of the microphone set up at a height of 5.5 feet in the 59th Street Subway Station of the "N" line on the New York City Transit System. The four tracks have been numbered 1 through 4 for convenience.
