1. Report No. DOT-TSC-OST-73-46		2. Government Accession No.		3. Recipient's Catalog No.	
4. Title and Subtitle NOISE LEVEL MEASUREMENTS OF RAILROADS: FREIGHT YARDS AND WAYSIDE				5. Report Date May 1974

14. Sponsoring Agency Code	
15. Supplementary Notes					
16. Abstract Noise from railroad operations were measured. Noise level data from freight yard operations were measured at the Argentine Freight Yard of the Santa Fe Railroad in Kansas City, Kansas and on a smaller scale in three facilities of the Boston and Maine Railroad in Boston Massachusetts. In addition, wayside noise data from passenger and line-haul operations were measured on the Penn Central Railroad in New Jersey and Massachusetts, and on the Sante Fe Railroad in Kansas. This report contains statistical temporal noise data, graphical time history level recordings, and one-third octave frequency spectra of selected data.

Measurements were made of noise emissions emanating from railroad freight yards and at the wayside from passenger and line-haul operations.

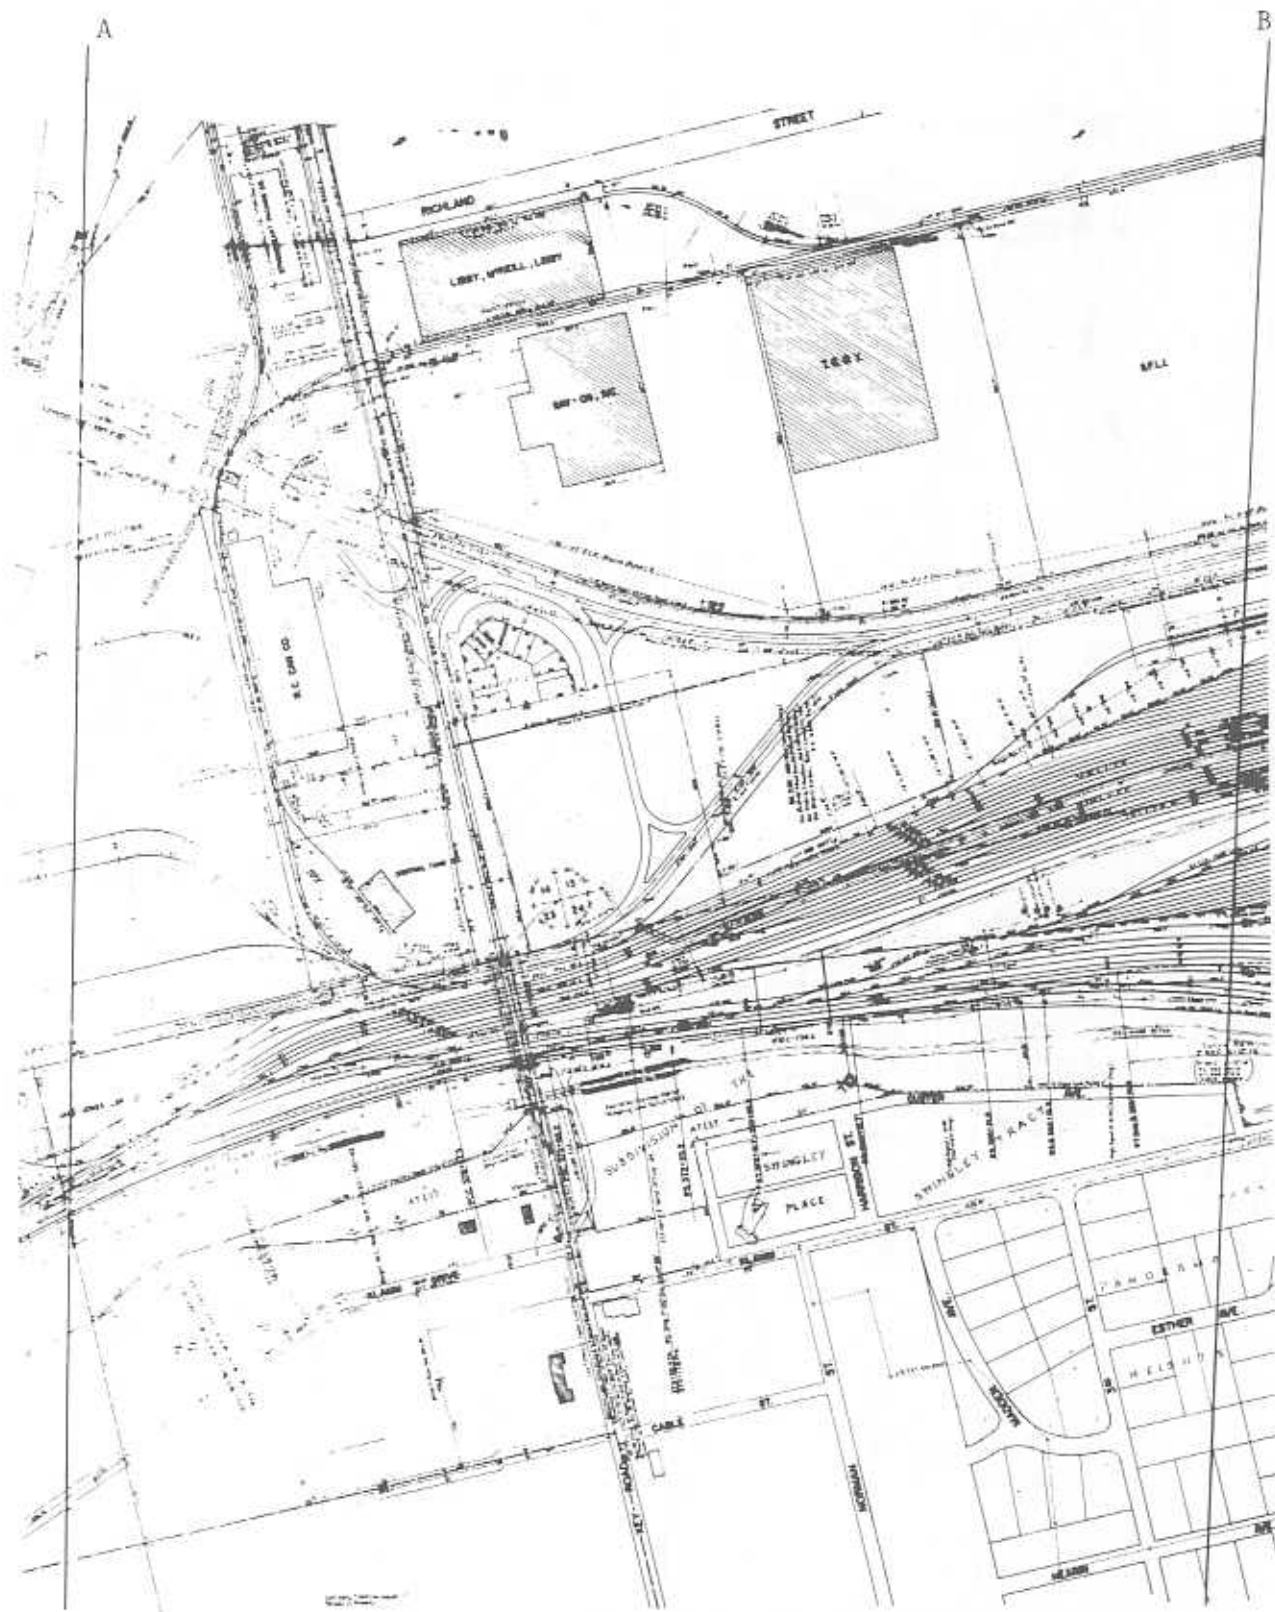
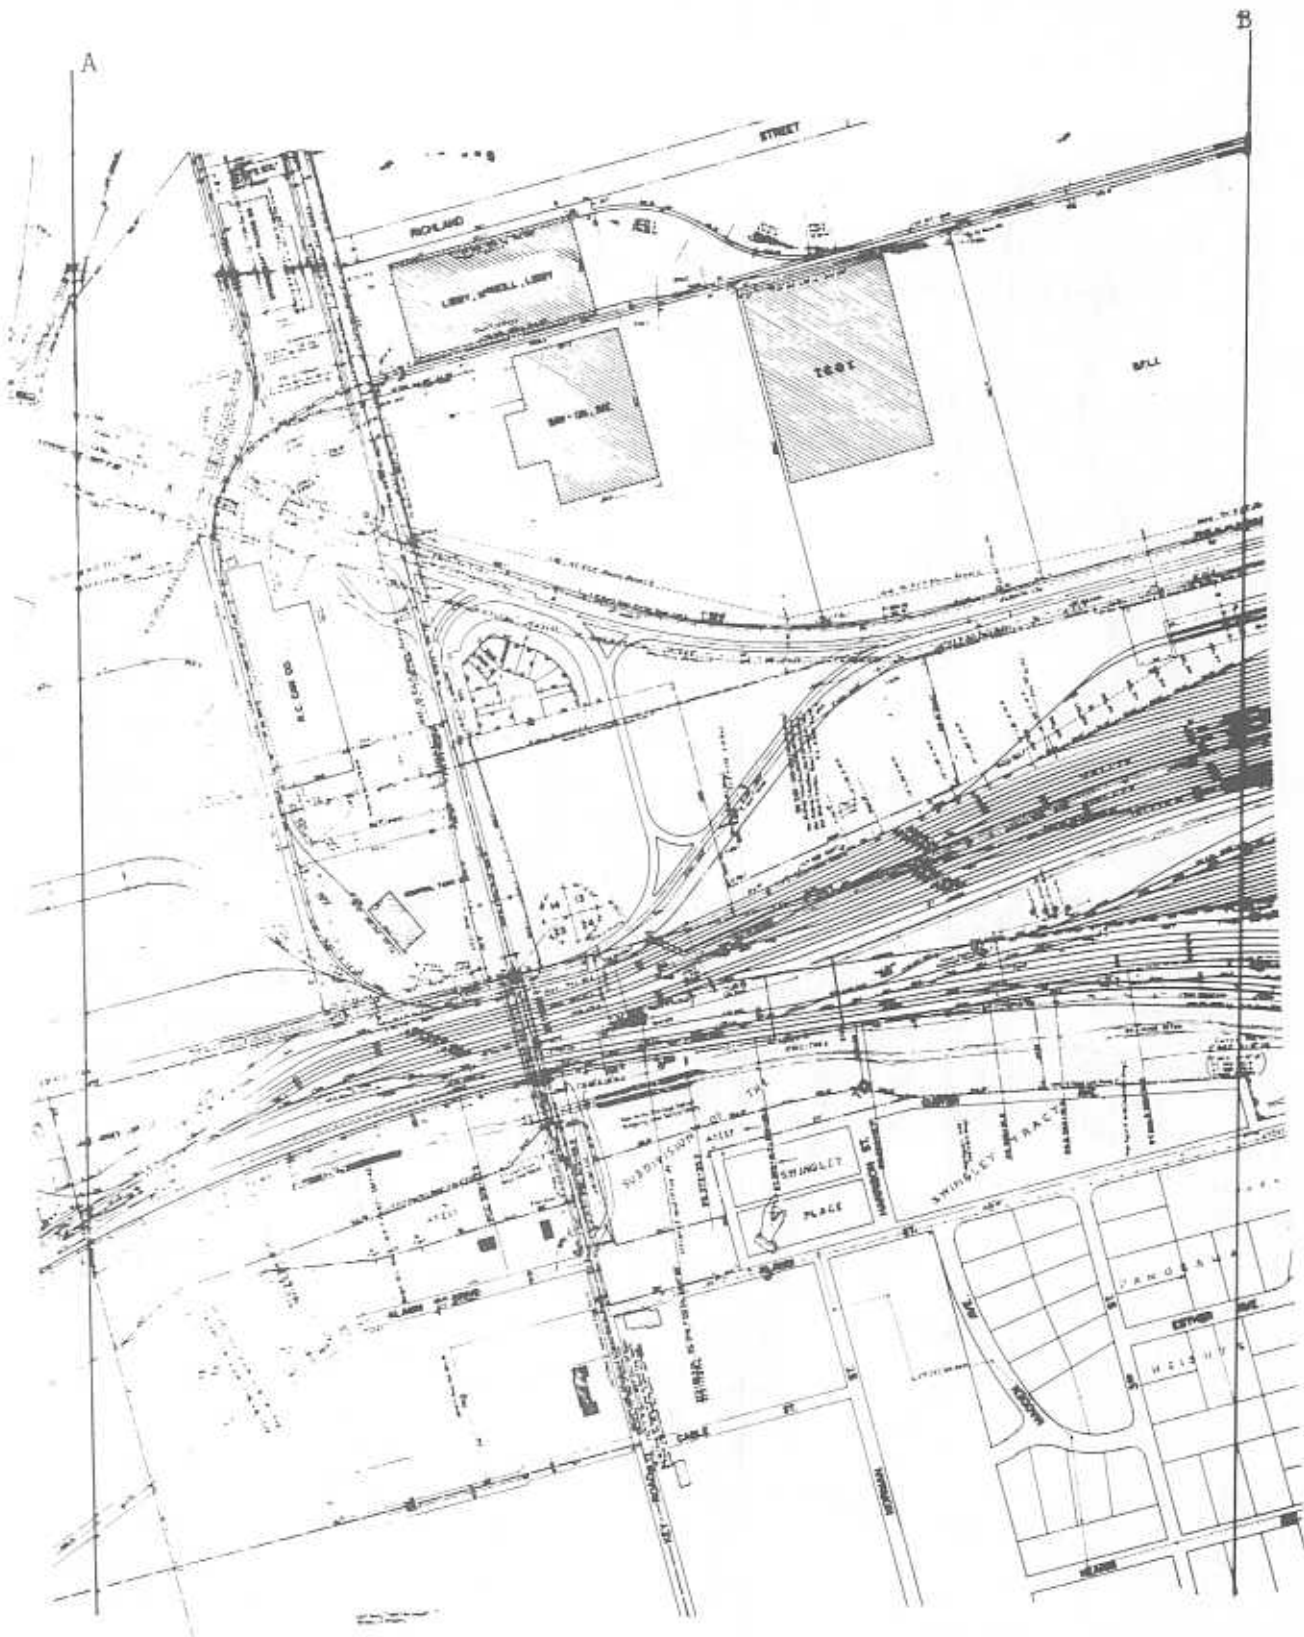
Figure E-2. Freight Yard Map, Argentine Freight Yard, Santa Fe RR
 Kansas City KS

Also shown in figures E-1 and E-2 is a 10-million bushel grain elevator and various other smaller car repair facilities.

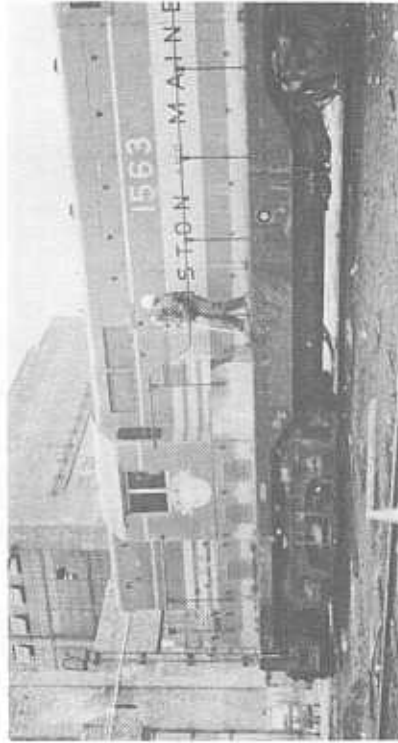
c) Moveable Microphone on Catwalk Platform

Figure E-25. Photographs of Measurement Site, Static-Locomotive Measurements, B&MRR, Locomotive-Repair Facility, Iron Horse Park, Billerica MA
