Rock-Fall Hazard Assessment of Little Mill Campground, American Fork Canyon, Uinta National Forest, Utah

By Jeffrey A. Coe, Edwin L. Harp, Arthur C. Tarr, and John A. Michael

U.S. Geological Survey Open-File Report 2005–1229

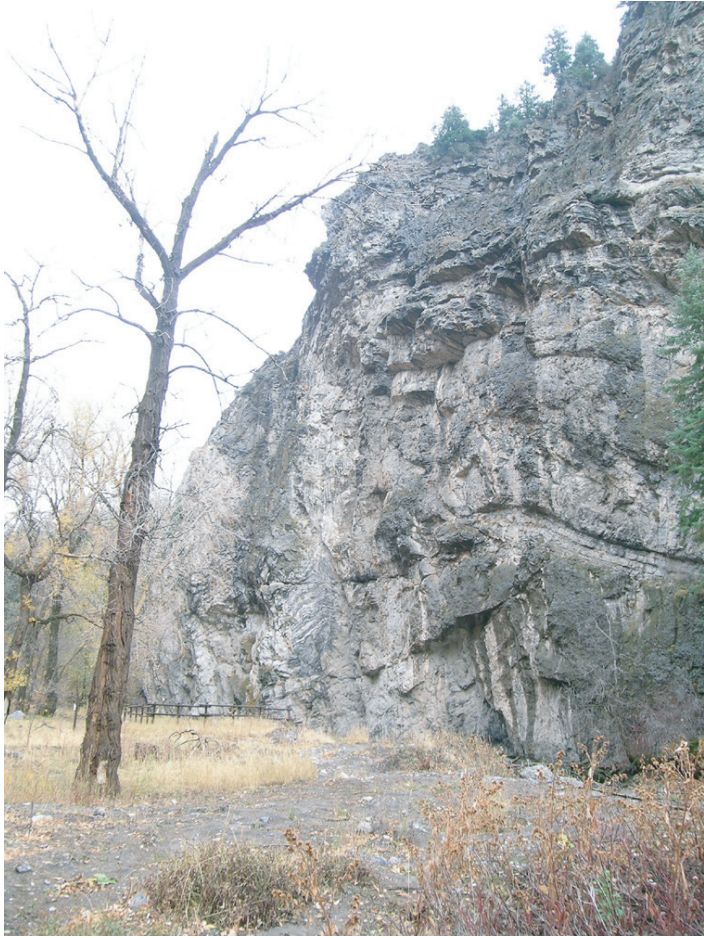
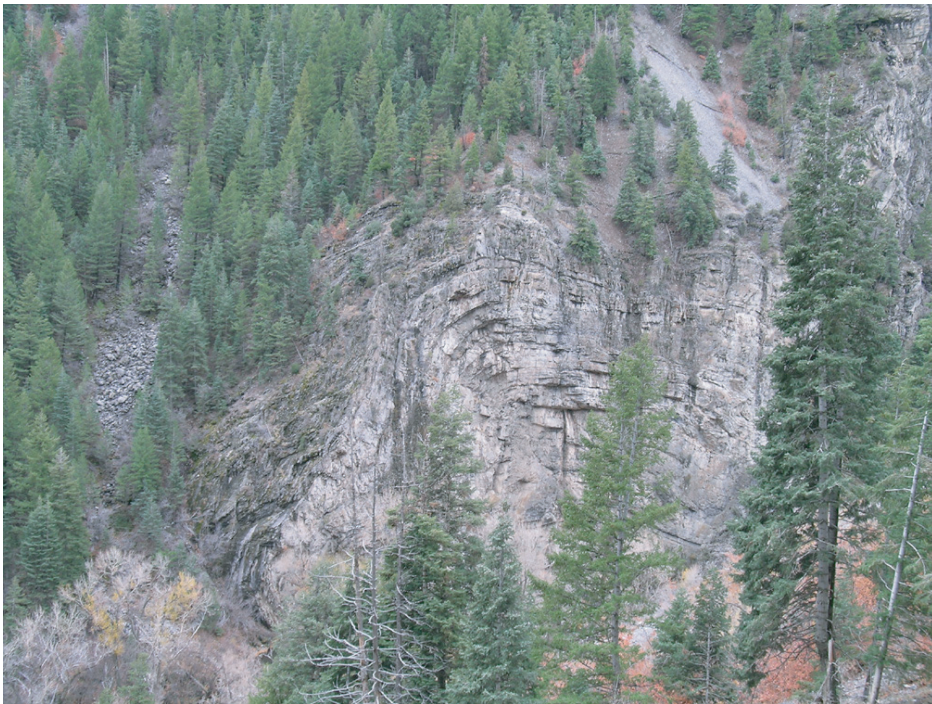
Figure 2. Limestone cliff at the now abandoned Hanging Rock picnic area. See Figure 1B for location. (A) View from the ground. Photograph taken on October 24, 2004. (B) View of the upper part of the limestone cliff from the opposite (north) side of the canyon. Photograph taken on October 26, 2004.

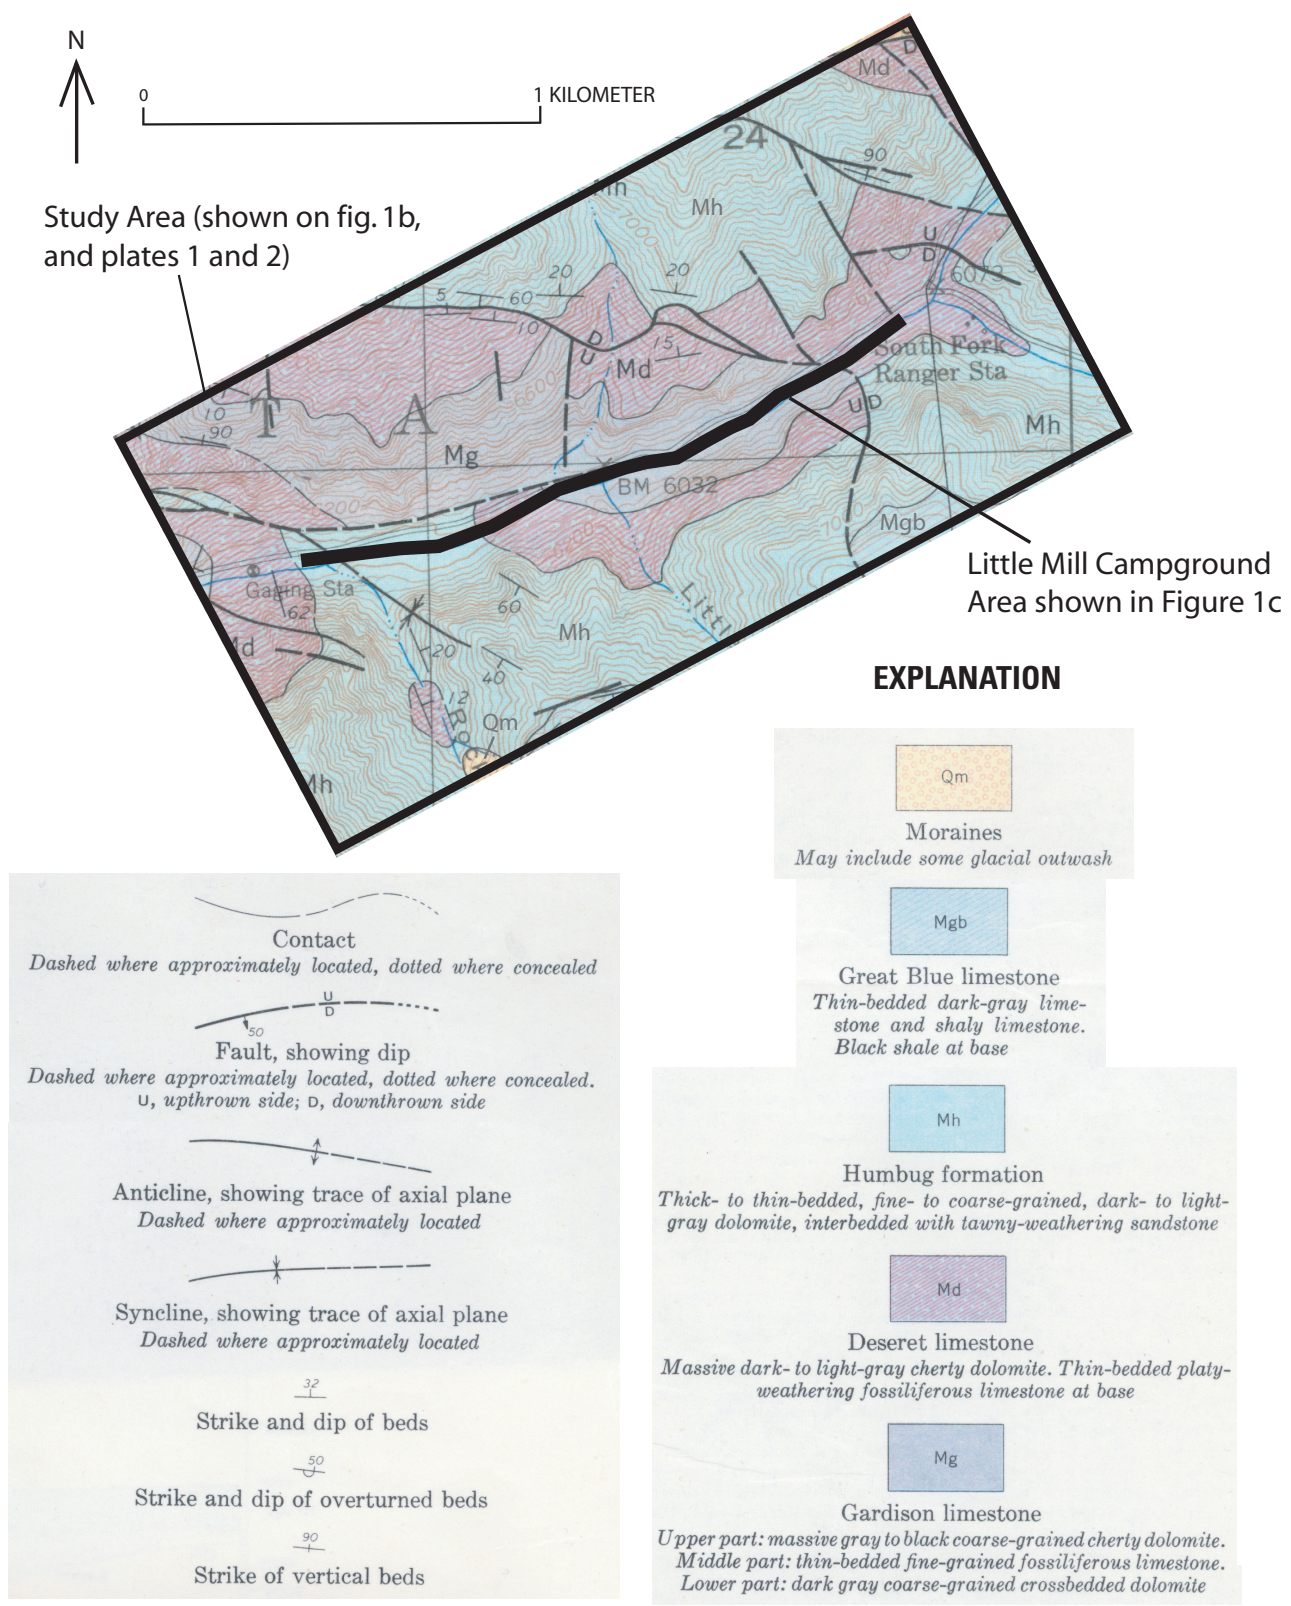
Figure 3. Geologic map of the area surrounding Little Mill campground. Modified from Baker and Crittenden (1961).

Older faults and folds within the Wasatch range are exposed in American Fork Canyon. Several of these older features are present in the vicinity of Little Mill campground (fig. 3). The most prominent of these features are a series of folds with axes that are acute to perpendicular to the direction of the canyon. In general, these folds have steeply dipping limbs near the west end of the campground (fig. 4) and shallow to moderately dipping limbs near the center and east end of the campground (fig. 5). The folds deform a thick sequence of limestones of Mississippian age (fig. 3). These limestones are divided into four formations (Baker and Crittenden, 1961), the Gardison Limestone, Deseret Limestone, Humbug Formation, and the Great Blue limestone (listed from oldest to youngest). The Gardison is a series of interbedded, fine- to coarse-grained limestones and dolomites. The Deseret primarily is a massive dolomite with a thin-bedded limestone near the base. The Humbug is composed of an alternating series of limey sandstones and thin-to thick-bedded limestones and dolomites. The Great Blue limestone is a thinly-bedded limestone and shaly limestone with black shale near the base of the unit. Most rocks immediately adjacent to Little Mill are in the Gardison, Deseret, and Humbug Formations (fig. 3).

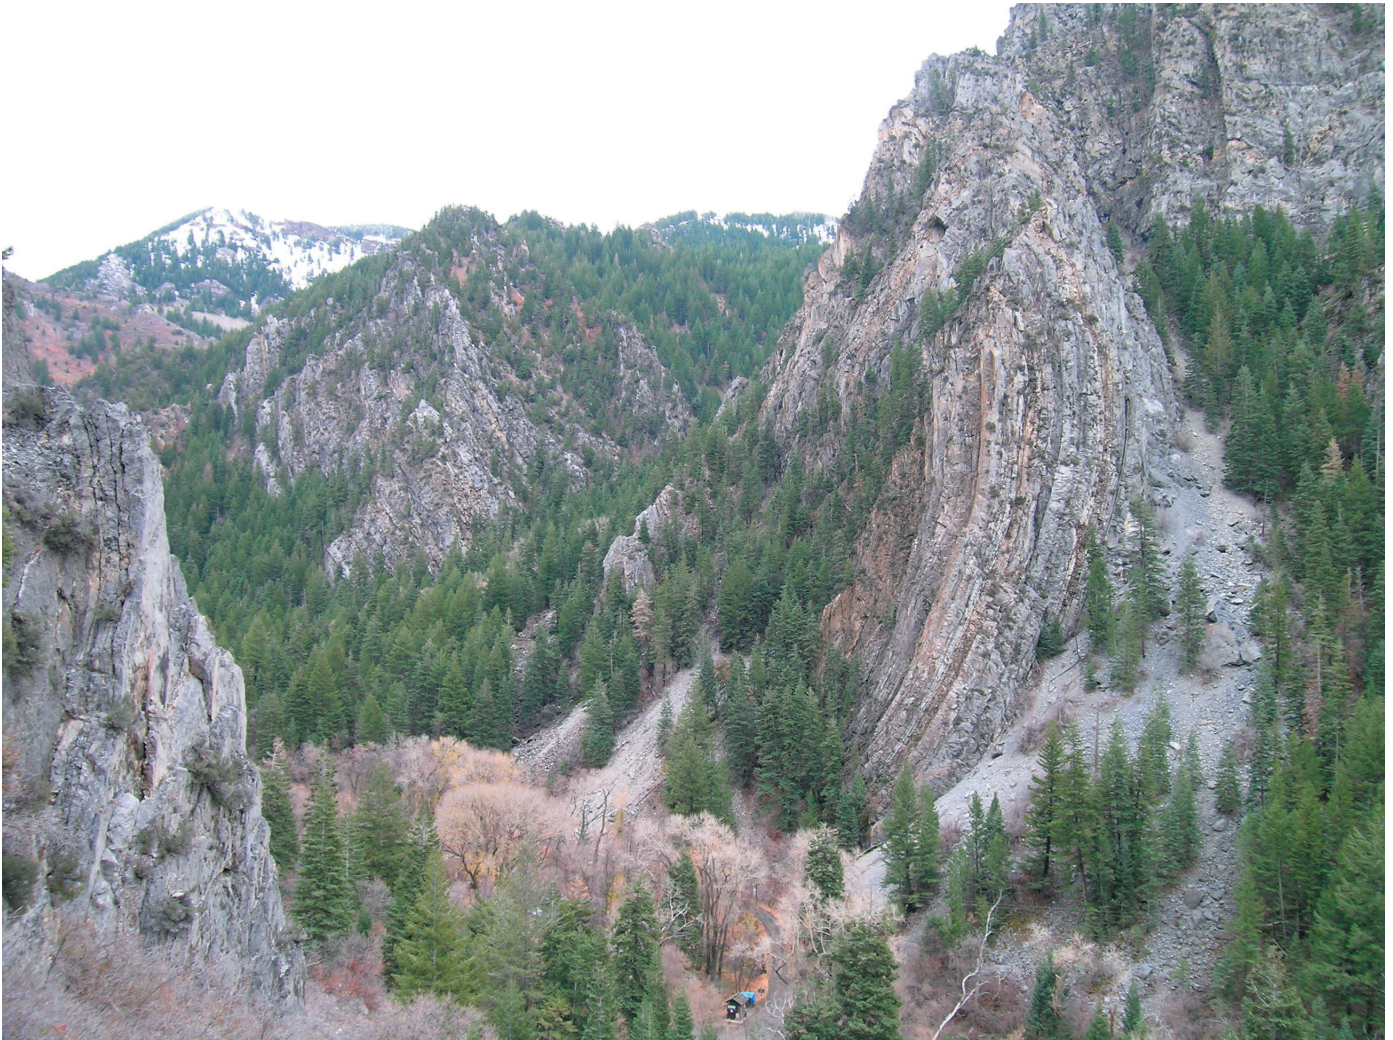
Figure 4. U-shaped fold (a syncline) with steeply dipping limbs above the west end (entrance) of the campground. Campground entrance station is visible at the bottom center of the photograph. Photograph taken on October 26, 2004. View is to the southeast.

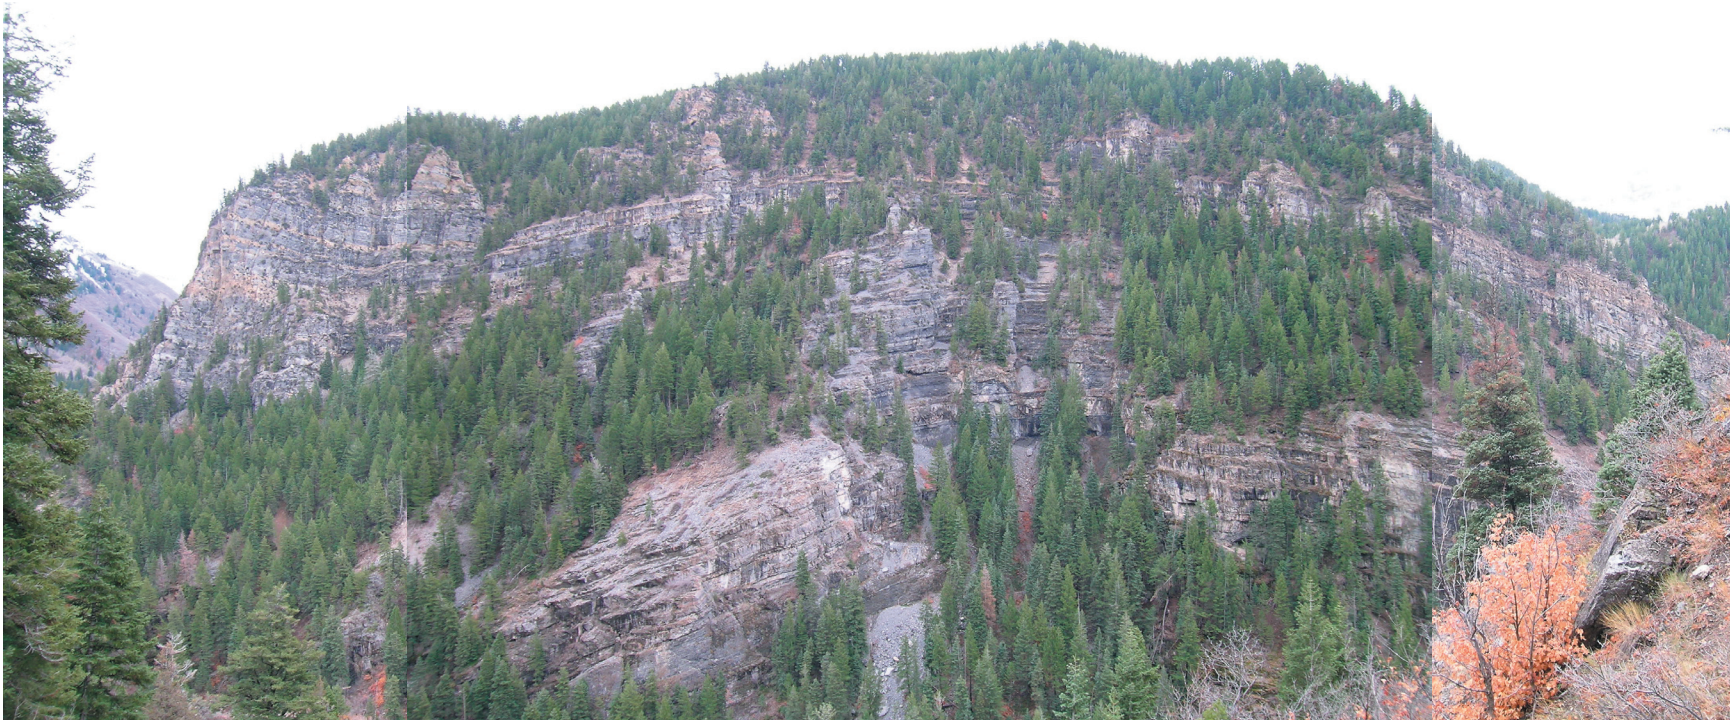
Figure 5. Photograph composite showing broadly folded rocks with shallow-dipping limbs above the central and eastern parts of the campground. Photograph taken on October 26, 2004.

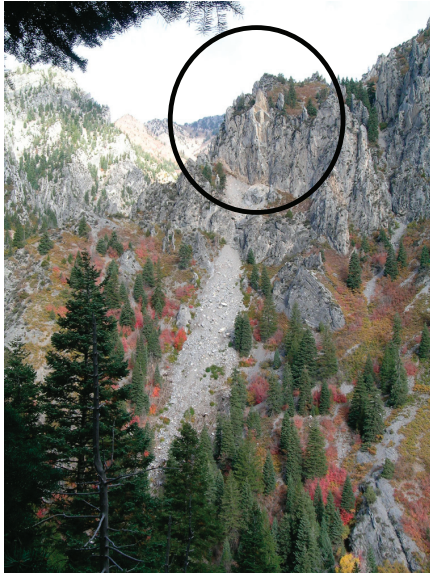
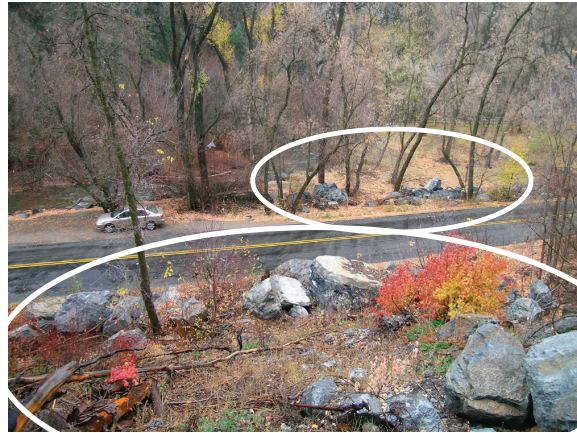
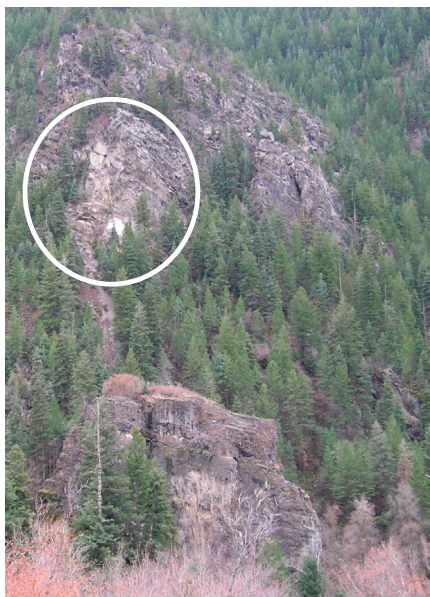
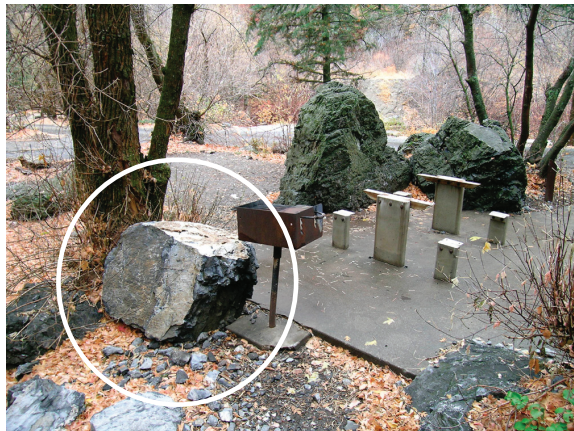
Figure 7. Pairs of photographs showing source areas (circled at left) and rocks (circled at right) from recent rock fall events described in table 3. (A, B) Rock fall 12, about 150 m west of campground entrance. (C, D) Rock fall 13 above campsite 68. (E, F) Rock fall 7 above campsite 33.

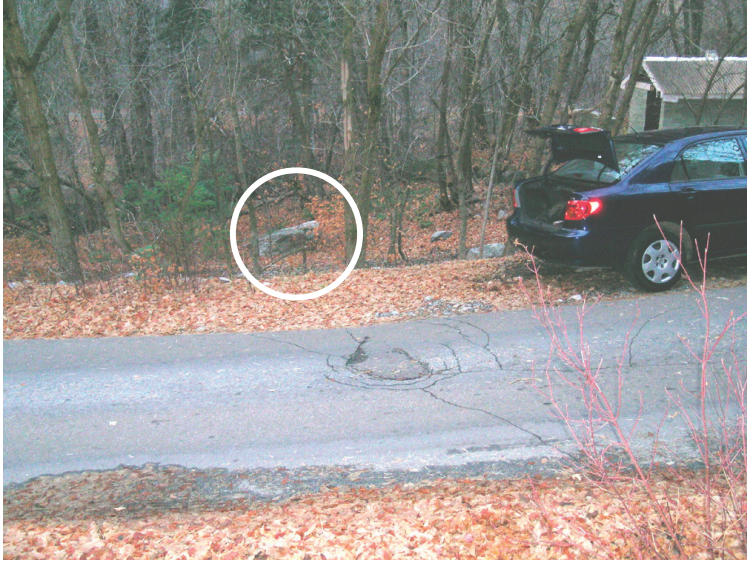
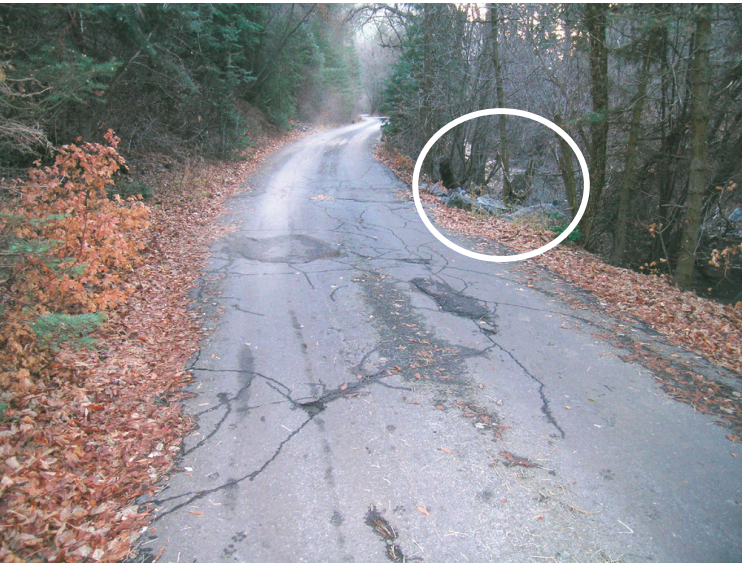
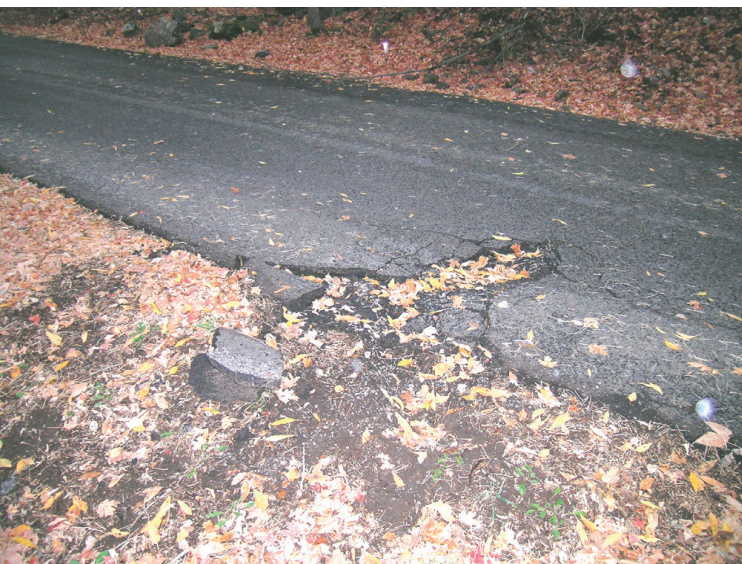
Figure 8. Scars in pavement from recent rock-falls (see table 3). (A) Scar (in campground road) and rock (circled) between campsite 7 and comfort station 1 (rock fall 1, table 3). (B) Scars (in campground road) and rocks (circled) near campsite 68 (rock fall 13). (C) Scar in campground road between campsites 77 and 79 (rock fall 15).

Rock-fall number	Location	Time and date of rock fall	Trigger	Comments	Source(s) of Information
11	Near Little Mill campground	~12:45 pm, October 15, 2000	Unknown	Utah woman hiking near Little Mill campground struck in head by basketball-sized falling rock, found unconscious, treated and released from hospital	Deseret News, 2000
12	About 150 m west of the entrance to Little Mill campground	December 17 or 18, 2000	Unknown	Massive rock fall including many large boulders from north slope cross and close Highway 92 (see figs 7a and 7b).	Personal communication with USFS employees John Hendrix and Dean Larsen, field observations by authors
13	Little Mill Campsite 68	Winter of 2000-2001	Unknown	Falling rocks from south slope land on campsite and on campground road near the campsite (fig. 7c), the largest rock is the size of a small car (fig. 7d), falls have previously affected this area as evidenced by patches in road (fig. 8b), campsite has been removed	2001 USFS safety committee report

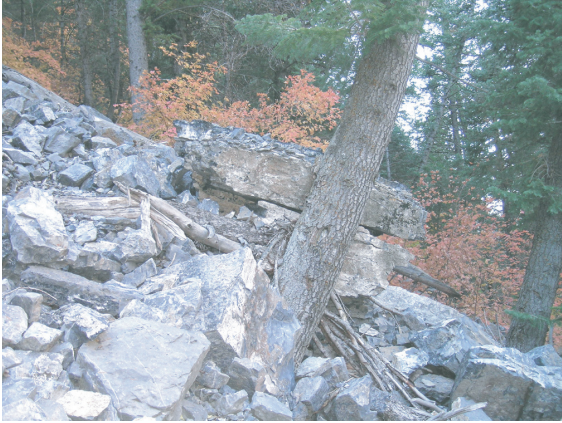
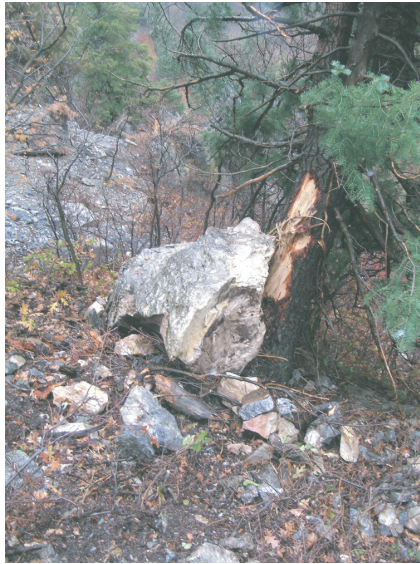
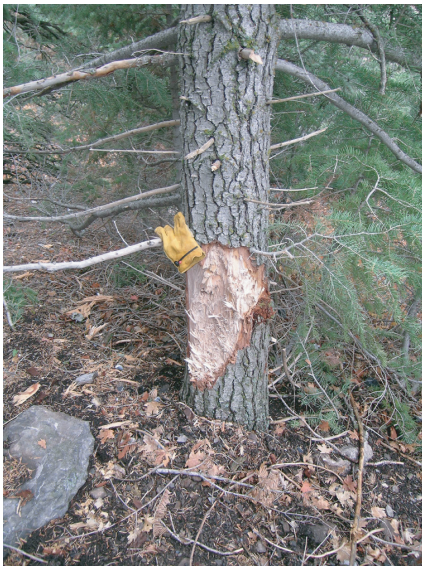
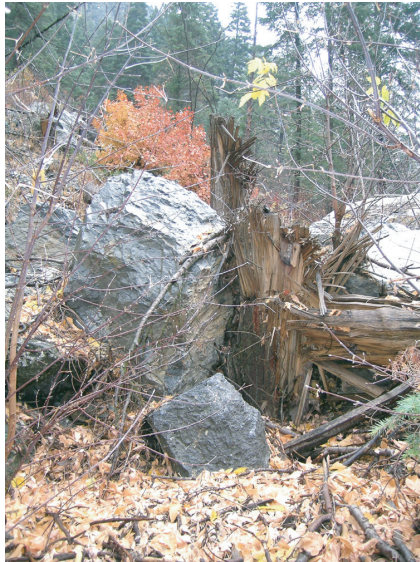
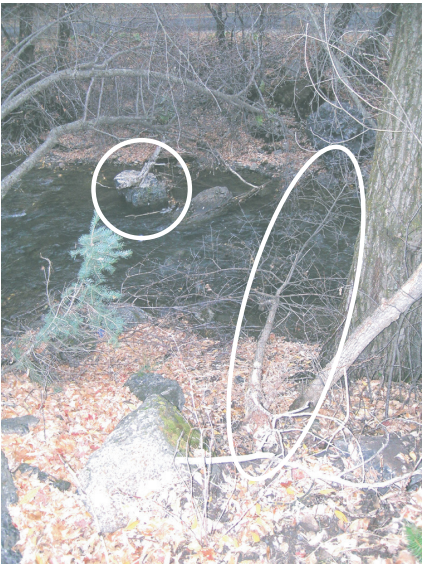
Figure 9. Tree scars from rock falls in and near Little Mill campground. (A) Upslope from campsite 68. Photograph taken on October 6, 2004. (B) Downslope from measurement site Q41. Photograph taken October 25, 2004. (C) Between measurement sites Q57 and Q58. Photograph taken on October 26, 2004. (D) On north side of Highway 92, about 150 m east of campground entrance (rock fall 12 in table 3). Photograph taken on October 25, 2004. (E) North of campground road between campsites 77 and 79 (rock fall 15, table 3). Tree and rock are circled. Photograph taken October 27, 2004.

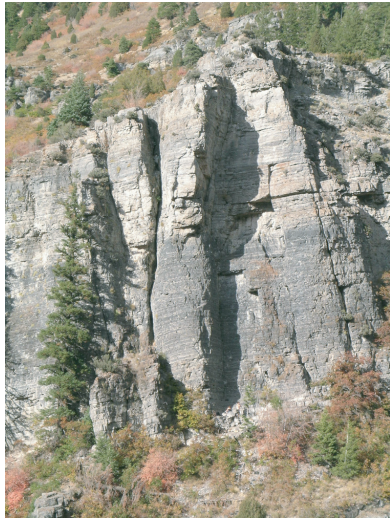
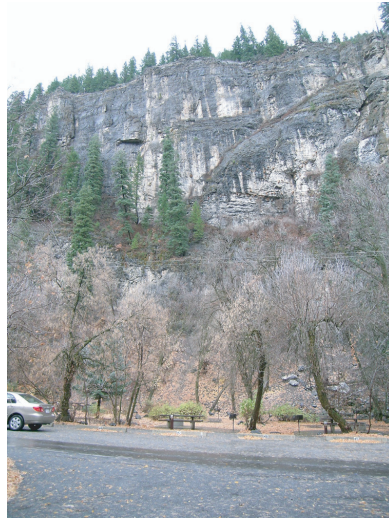
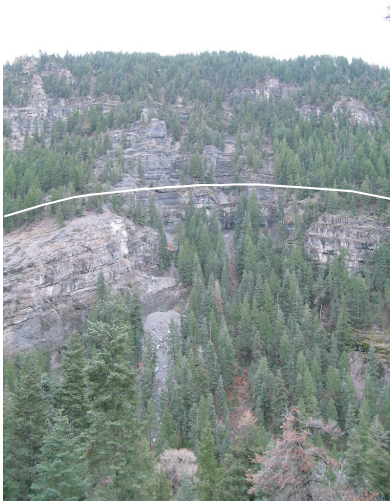
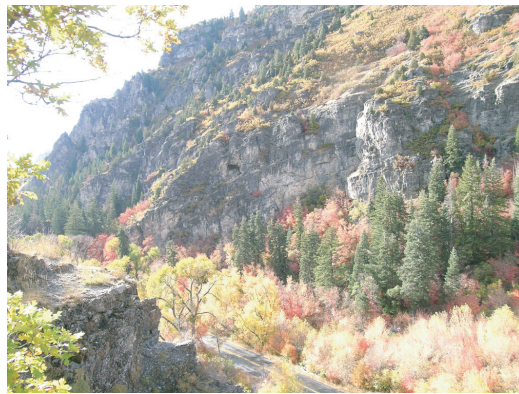
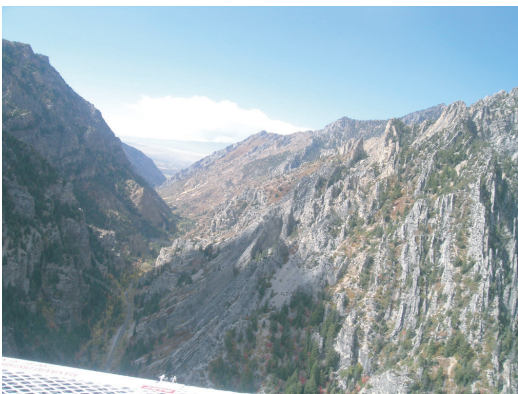
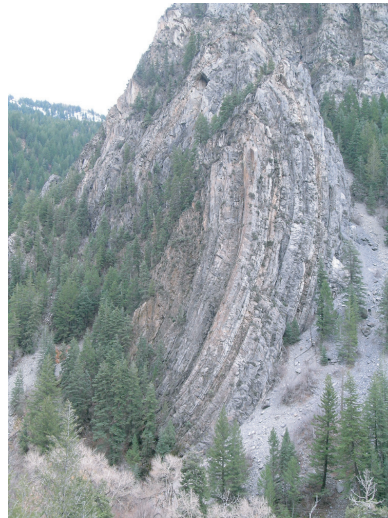
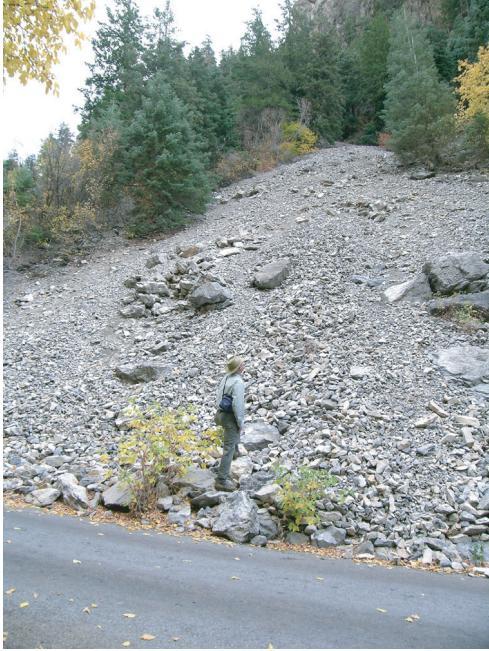
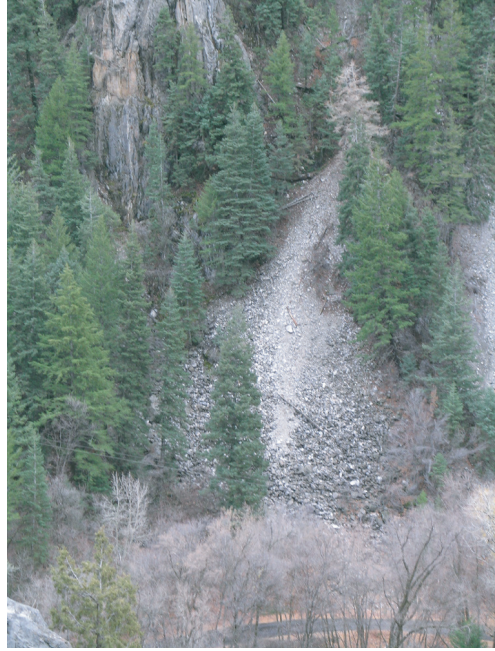
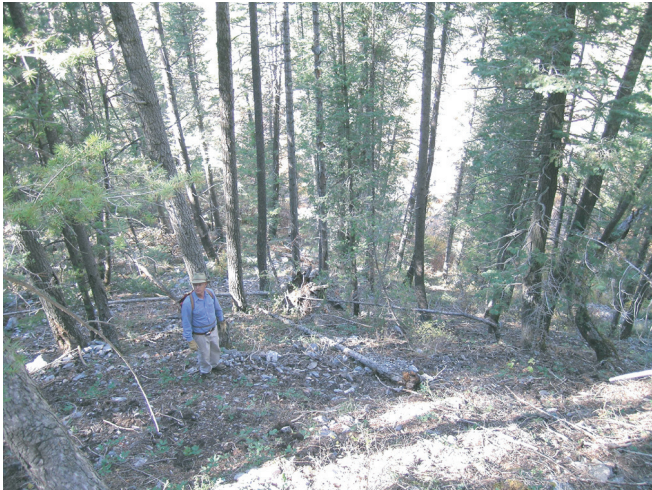
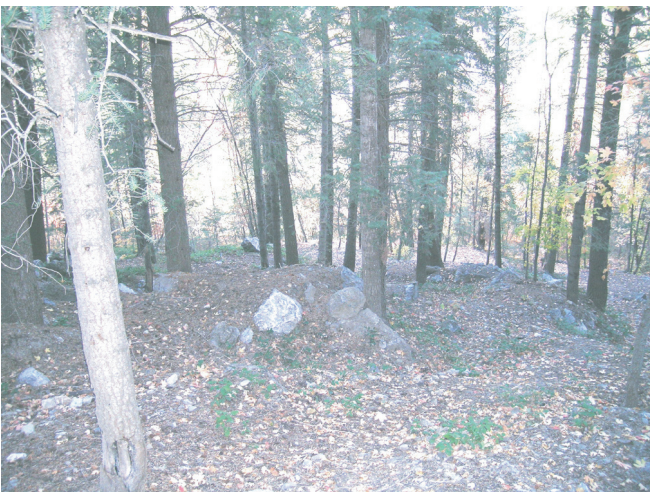
Figure 10. Examples of geologic units mapped in and near Little Mill. (A) Shallow-dipping limestone near Grey Cliffs picnic area. (B) Shallow-dipping limestone above campsites 34–67. (C) Axial fold zone above campsites 68 and 69. Dip of bedding is shown by solid line. (D) Moderately-dipping limestone at Grey Cliffs picnic area (middle part of photograph). (E) Steeply dipping bedrock in American Fork Canyon near the campground entrance and further west. View to the west. (F) Steeply dipping limestone above campsites 5 and 6. (G) Young talus upslope from campsites 5–7. (H) Young talus upslope from campsite 7. (I) Older talus, colluvium, and soil upslope from campsites 78 and 79. (J) Aerial view of axial fold zone, young talus, and older talus at measurement sites Q53 and Q54. (K) Debris-flow deposits on debris fan at the mouth of Little Mill Canyon. (L) Alluvium along the American Fork River.

Young talus deposits—steeply sloping, loose accumulations of fragmented, angular rocks ranging in size from pebbles to boulders. Talus deposits are located between bedrock cliffs and the footslope. These deposits are differentiated from older talus deposits by a general lack or sparseness of vegetation and the presence of extensive, freshly exposed surfaces on rock fragments. See figures 10G and 10H for examples.

Debris fans—fan-shaped deposits at the mouths of ephemeral tributary drainages to the American Fork River that primarily were deposited by debris flows and water-dominated flows. Fans usually are covered by widespread, mature vegetation. See figure 10k for an example.

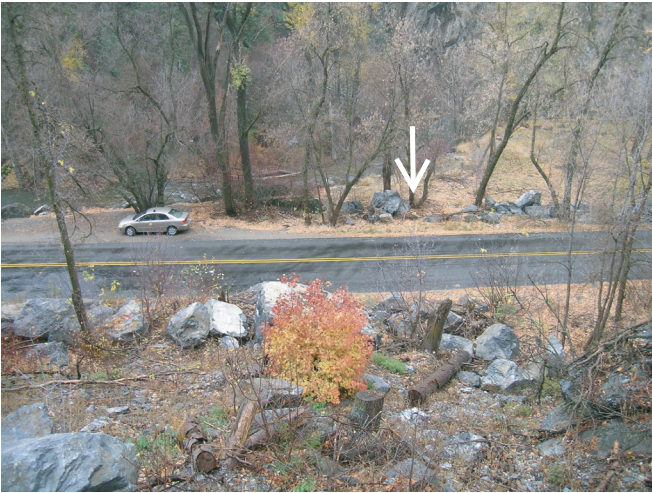
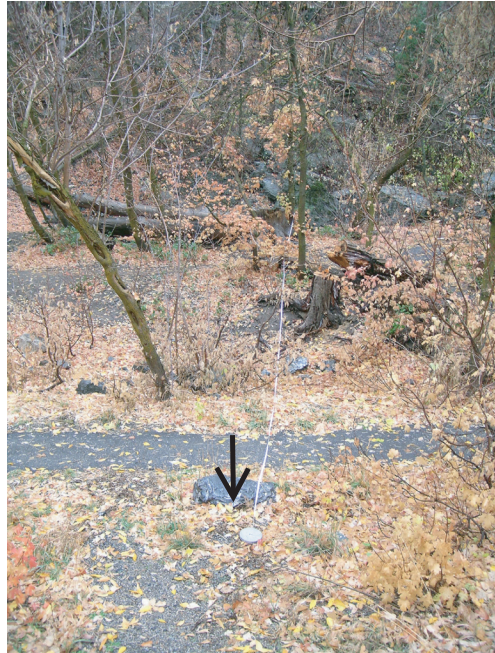
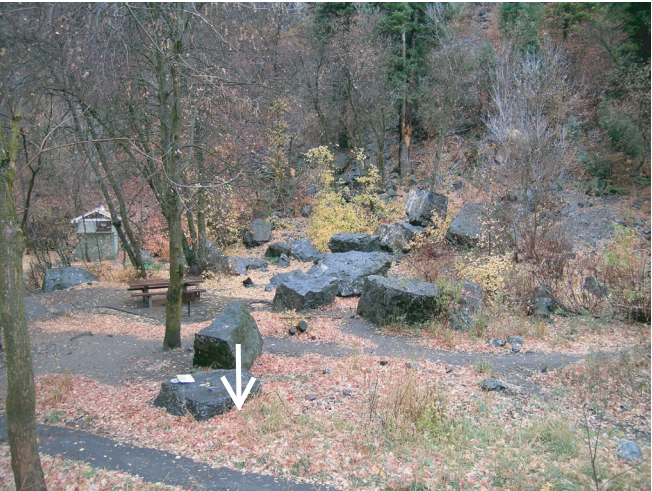
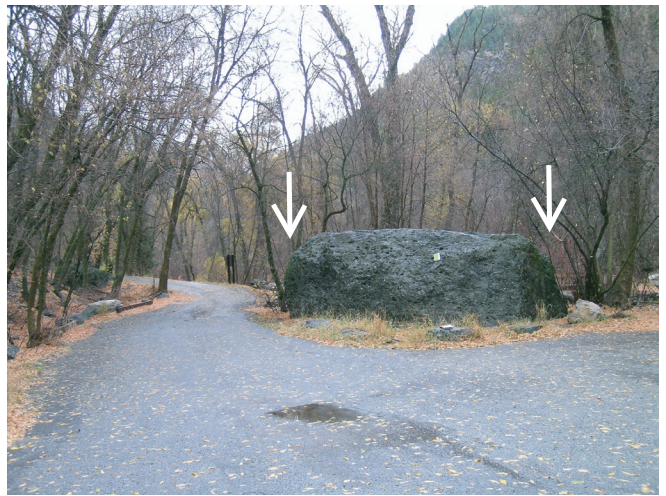
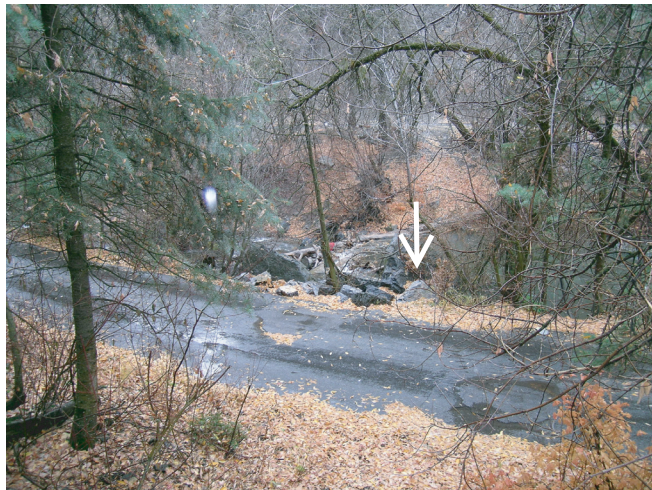
Figure 11. Examples of Extreme Runout (ER) measurement sites. Locations measured are shown with an arrow. (A) Site ER9. Photograph taken October 28, 2004. (B) Site ER11. Footslope is in the upper part of the photograph. Photograph taken October 25, 2004. (C) Site ER13. Photograph taken October 25, 2004. (D) Site ER15. Distance measured from north and south footslopes. Photograph taken October 25, 2004. (E) Site ER 25. Photograph taken October 28, 2004.

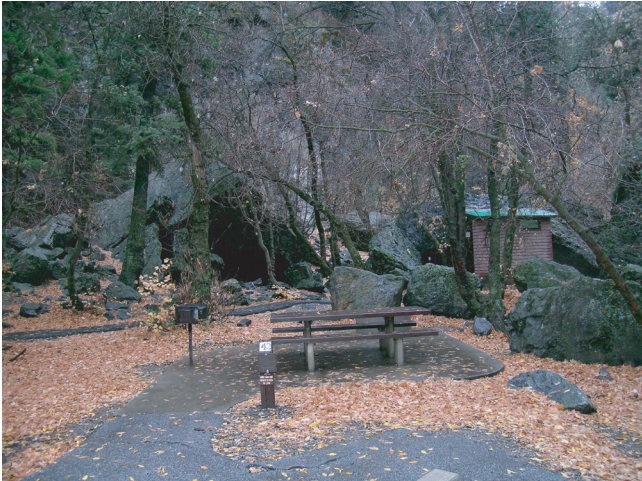
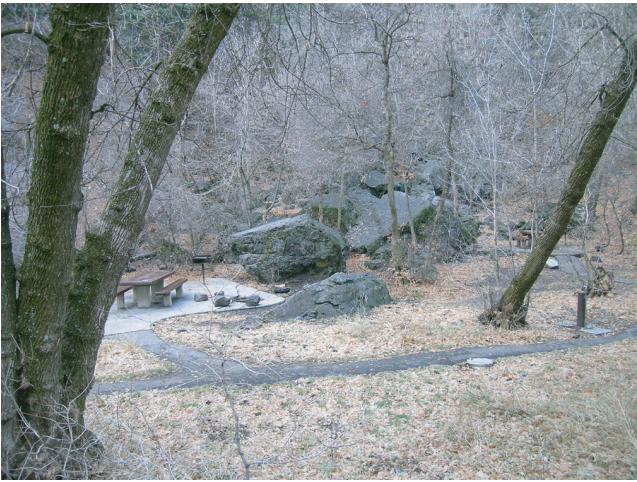
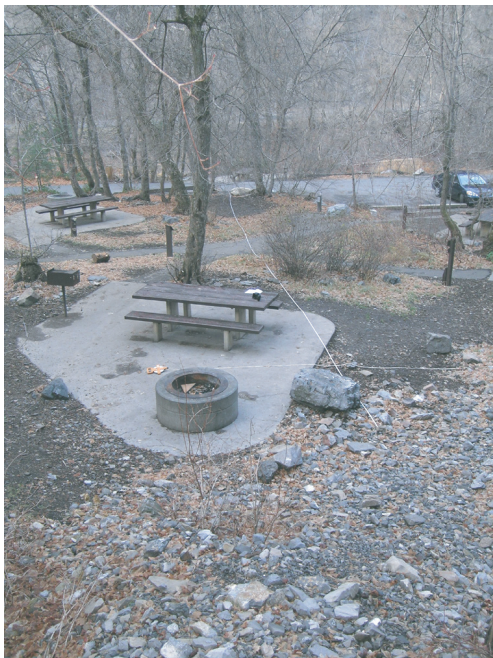
Figure 12. Examples of the sites where the distribution of rock-fall runout (DR) was measured. (A) Site DR1 at campsite 42. Photograph taken October 25, 2004. (B) Site DR3 in Grey Cliffs picnic area. Photograph taken November 14, 2004. (C) Site DR5 at campsite 35. Photograph taken November 14, 2004.

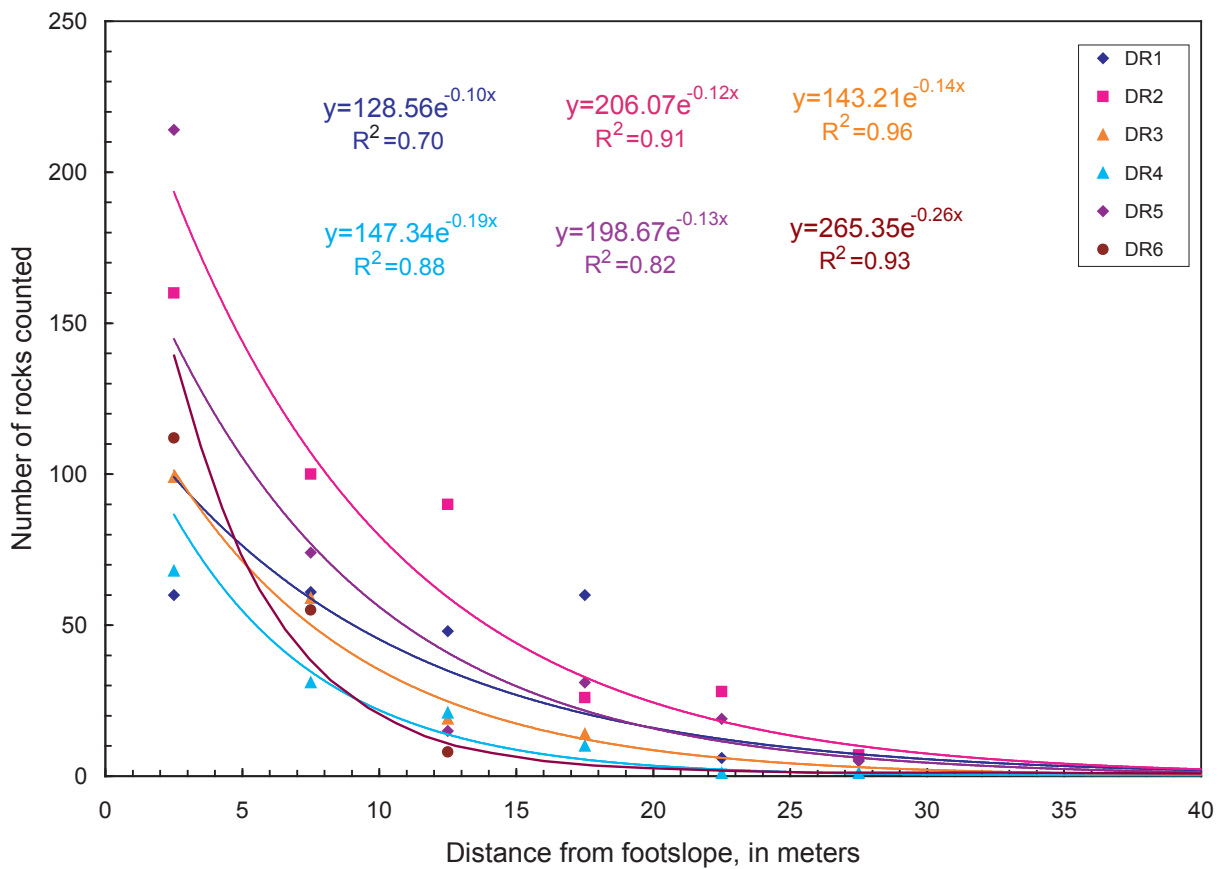
Figure 13. Diagram showing numbers of rocks counted with respect to distances from the footslope at DR locations (see pl. 1). At locations far from the footslope where rocks could not be counted, counts were estimated using the regression equations shown (see table 7 and text for additional explanation).

Results from the distribution of distances at clusters of rocks (DR, pl. 1) are given in table 7. The number of rocks counted in 5 m intervals at each site are shown graphically in figure 13. Because rocks became difficult, and sometimes impossible, to count in some areas far from the footslope, the number of rocks in these areas were estimated by finding a best fit line to the available data using a least squares regression analysis. The equations for the best-fit lines at each site are given in figure 13. The number of rocks estimated using these equations are shown in bold, italicized type in table 7. Once the number of rocks were available for all distance intervals, they were converted to percentages of the total of rocks at each site (fig. 14). Figure 14 shows a negative correlation between distance from the footslope and the percent of rocks. Said another way, as the distance from the footslope increases, the number of rocks decreases. Furthermore, this relation is exponential, with more than 89 percent of rocks located within 20 m of the footslope. The number of rocks that traveled past 20 m ranged from about 1 percent at site DR6 to about 11 percent at site DR2 (fig. 14). These percentages can be used to estimate the number of rocks expected at various distances from future rock falls. For example, taking a conservative approach (from a hazard perspective) and by using the highest percentage of rocks at each distance, indicates that for rocks that travel beyond the footslope, about 76 percent will travel beyond 5 m, 52 percent will travel beyond 10 m, 33 percent will travel beyond 15 m, 11 percent will travel beyond 20 m, 7 percent beyond 25 m, and 4 percent will travel beyond 30 m. These percentages could be used in a risk assessment based on distance from the footslope.

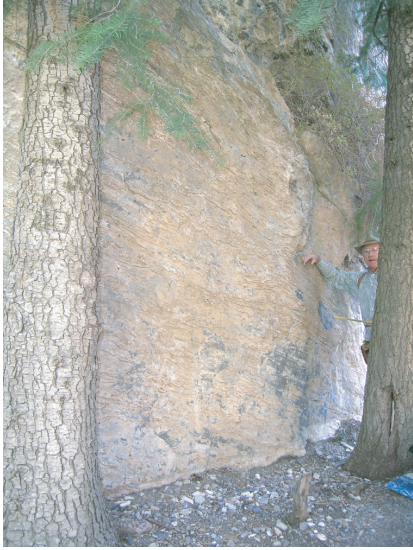
Q17, Q=16.96

Appendix B. Rock Mass Quality (Q) measurement locations. Photographs are individually labeled.

Estimates of relative block sizes (the relative length of a block edge) range from 0.16 (Q43, Appendix A) to 14.13 (Q17, Appendix A). These values indicate that location Q17 has block sizes that are about 88 times larger than blocks at site Q43. Relative block sizes vary systematically according to bedrock map unit (table 5). Shallow-dipping bedrock has the largest average relative block size (2.2, table 5), and steeply dipping bedrock has the smallest average block size (1.3, table 5). These data indicate that, on average, blocks from shallow-dipping bedrock are roughly two times larger than blocks in steeply dipping bedrock.
