Landslide Hazards at La Conchita, California

By Randall W. Jibson

Open-File Report 2005-1067

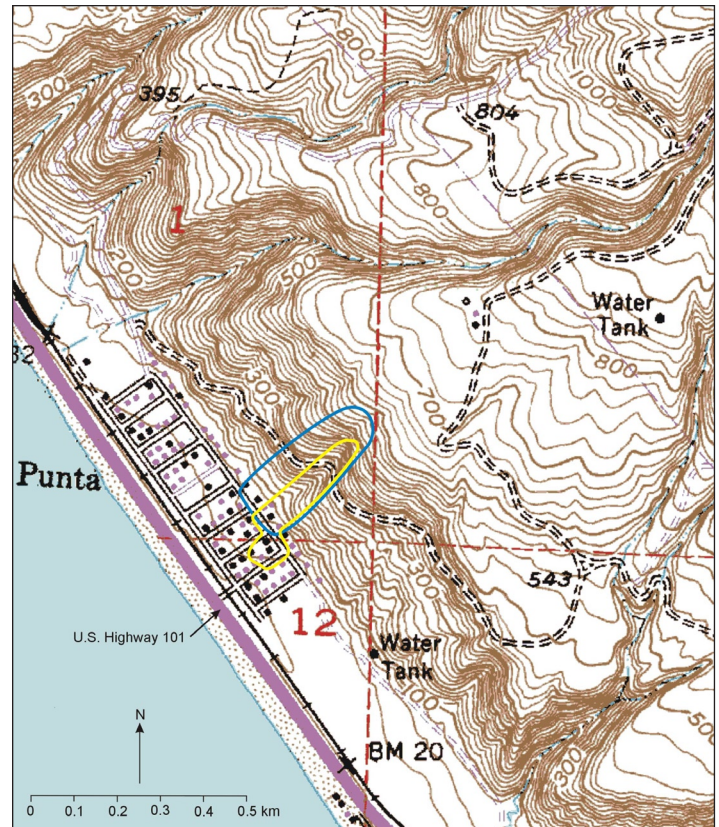
Figure 2. Topographic map showing the La Conchita area. Approximate outlines of 1995 (blue) and 2005 (yellow) landslides are shown. Base from U.S. Geological Survey Pitas Point 7.5' quadrangle, contour interval 20 ft (6.1 m), datum mean sea level; map center is at UTM 11 275256E 3805431N.

La Conchita is located on the southern California coastline midway between Ventura and Santa Barbara (fig. 1). The 11-ha (28-acre) community was first established in 1924 when subdivision created about 200 lots that mostly contain single-family residences. La Conchita lies on a narrow coastal strip about 250 m (800 ft) wide between the shoreline and a 180-m (600-ft) high bluff having a slope of about 35°; above the top of the bluff is a gently rising terrace surface covered by avocado and citrus orchards (fig. 2).

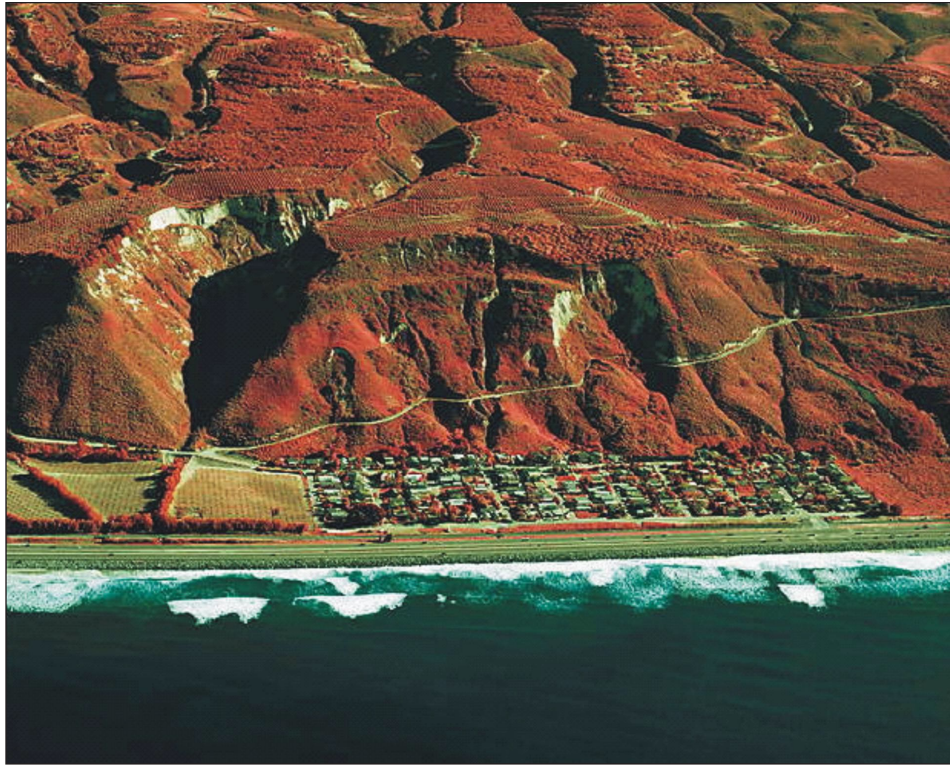
A

Figure 3a. Oblique false-color infrared photograph of La Conchita taken in 2002. The arcuate bench near the top of the bluff in the center of the photograph is the main scarp of an ancient landslide that involved the entire bluff. The 1995 landslide is visible in the right center of the photograph. Other landslides of various ages and sizes are visible on the slopes. Photograph courtesy of Robert Larson, GeoArchives Photography.

The bluff above La Conchita has produced a variety of landslides over an extended period of time. Figure 3 shows LIDAR and false-color infrared images of the bluff above La Conchita and the surrounding area, and several sizes, types, and ages of landslides are visible. The arcuate bench at the top of the bluff is the head of a very large prehistoric landslide that affected the entire bluff. Several smaller, more recent slumps and earth flows also are visible, as is the 1995 slump–earth flow

additional houses in the northwestern part of La Conchita. The main mass that failed is on the southeastern margin of the larger ancient landslide that encompasses the entire front of the bluff (see fig. 3). The 1995 slide was 120 m (400 ft) wide, 330 m (1100 ft) long, and covered approximately 4 ha (10 acres). The depth was estimated at greater than 30 m (100 ft), and the volume was estimated at 1.3 million m³ (1.7 million yd³).

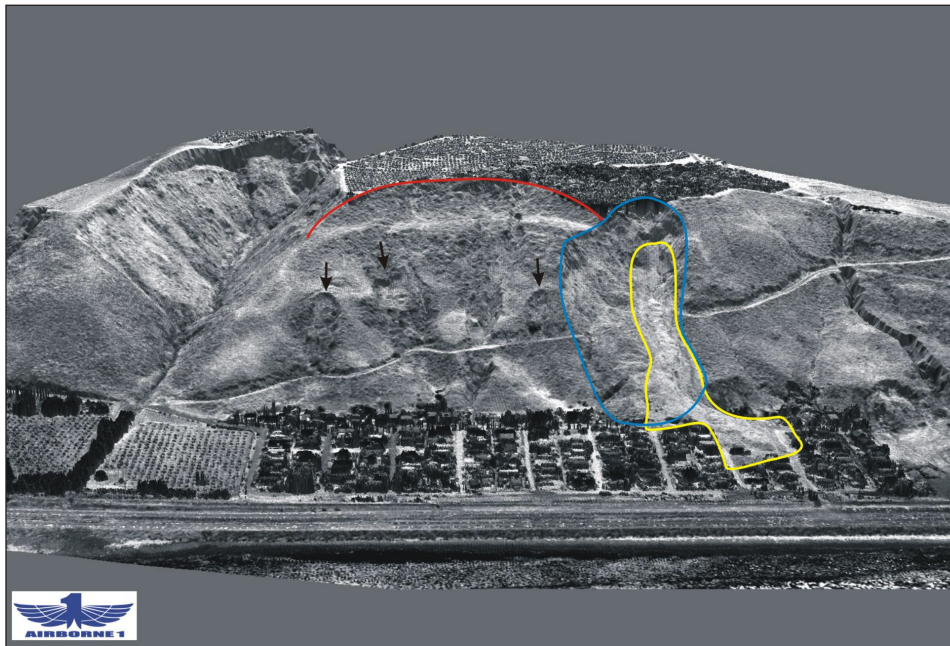
B

Figure 3b. Oblique LIDAR image of La Conchita after the 2005 landslide. Outline of 1995 (blue) and 2005 (yellow) landslides shown; arrows show examples of other landslides in the area; red line outlines main scarp of an ancient landslide that involved the entire bluff. The deep canyon on the left produced major debris flows in both 1995 and 2005. Image courtesy of Airborne 1 Corporation, El Segundo, Calif.

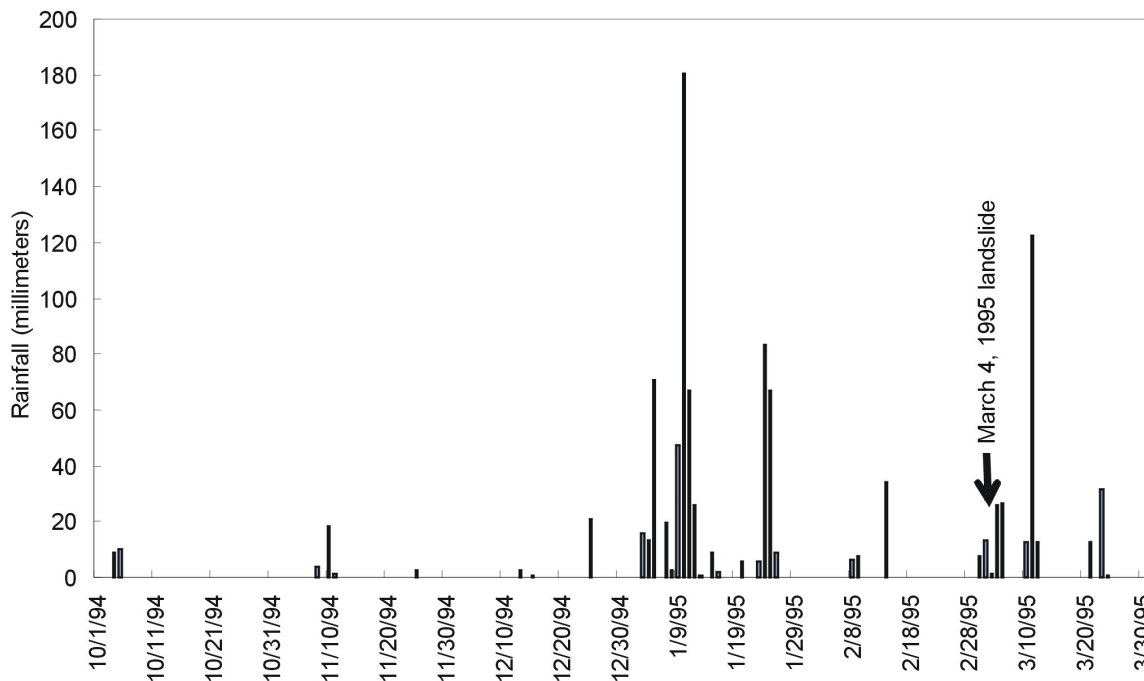
Ojai Daily Rainfall

Figure 4. Daily rainfall at Ojai (20 km [12 mi] northeast of La Conchita) from October 1, 1994, through March 31, 1995 (data from National Oceanic and Atmospheric Administration, 1994b, 1995b). The 1995 landslide occurred more than 1 month after the heaviest rainfall of the season.

The 1995 landslide apparently occurred as a result of an extraordinarily wet year. Mean seasonal rainfall at Ojai (20 km [12 mi] northeast of La Conchita) from October 1 through March 3 (the day before the landslide occurred) is 390 mm (15.37 in) (National Oceanic and Atmospheric Administration, 1994a, 1995a). In 1994–95, about twice as much rain—761 mm (29.96 in)—fell during that period (National Oceanic and Atmospheric Administration, 1994b, 1995b). Figure 4 shows the rainfall

distribution during the 1994–1995 rainy season. Most of the excess rain fell in January, which had 623 mm (24.53 in) as compared to a normal rainfall of 108 mm (4.26 in). February 1995 produced only about one-third of the normal rainfall, but a modest storm on March 2–3 produced 21 mm (0.81 in) of rain. The La Conchita landslide then occurred on March 4.

The timing of the two landslides with respect to the triggering storms is of primary interest. In 1995, after a very wet January, the landslide did not move until more than a month later, during which time very little rain fell (fig. 4). The deep mode of failure in 1995 is consistent with this delay: deeper landslides commonly are triggered by deep infiltration of rainfall, which can take weeks or months to occur (for example, Morton and Campbell, 1989). The 2005 landslide occurred at the culmination of an extremely wet 2-week period (fig. 7). This also is consistent with the shallower, fluid mode of failure: shallow, rapid debris flows most commonly occur during periods of prolonged, intense rainfall with little or no lag time (Campbell, 1975; Keefer and others, 1987; Jibson, 1989).

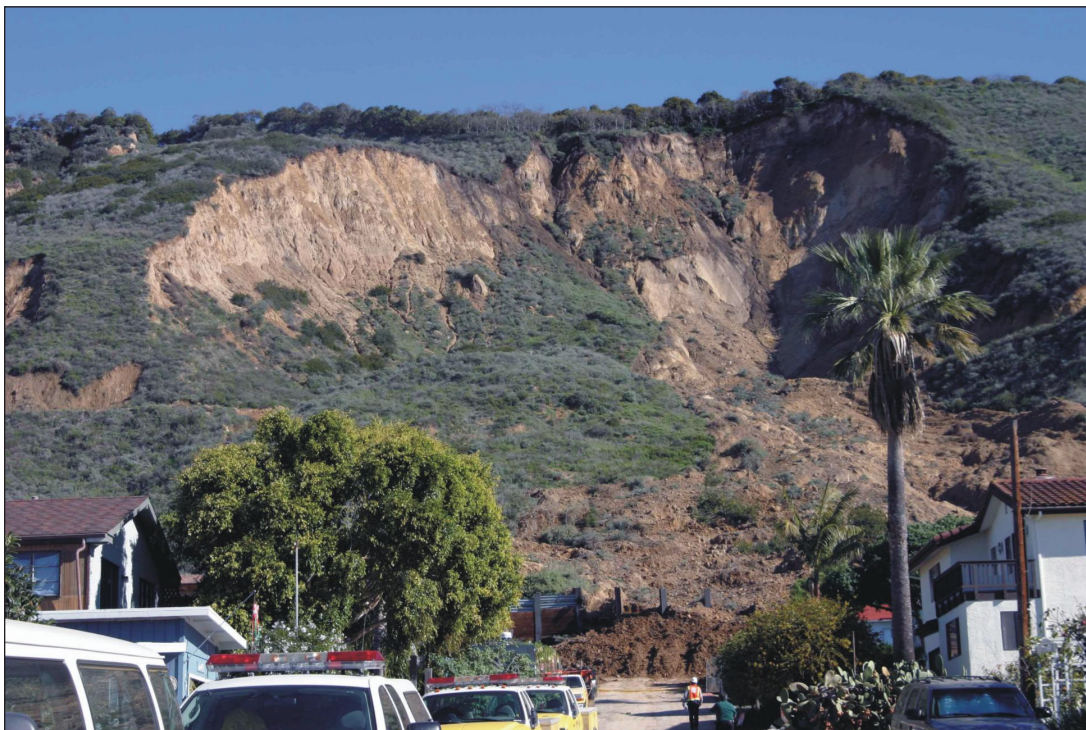
Figure 5. View of the La Conchita landslide taken January 14, 2005. The light-colored, exposed rock in the upper part of the photograph is the main scarp of the 1995 slide. The southeast part of the 1995 deposit (right side of photograph) remobilized in 2005. At the bottom center of photograph, a wall built after the 1995 slide is visible; the 2005 slide overtopped and tilted parts of the wall forward.

wide. The landslide entered the La Conchita neighborhood destroying 13 houses and severely damaging 23 others (figs. 5 and 6). There were 10 confirmed fatalities.

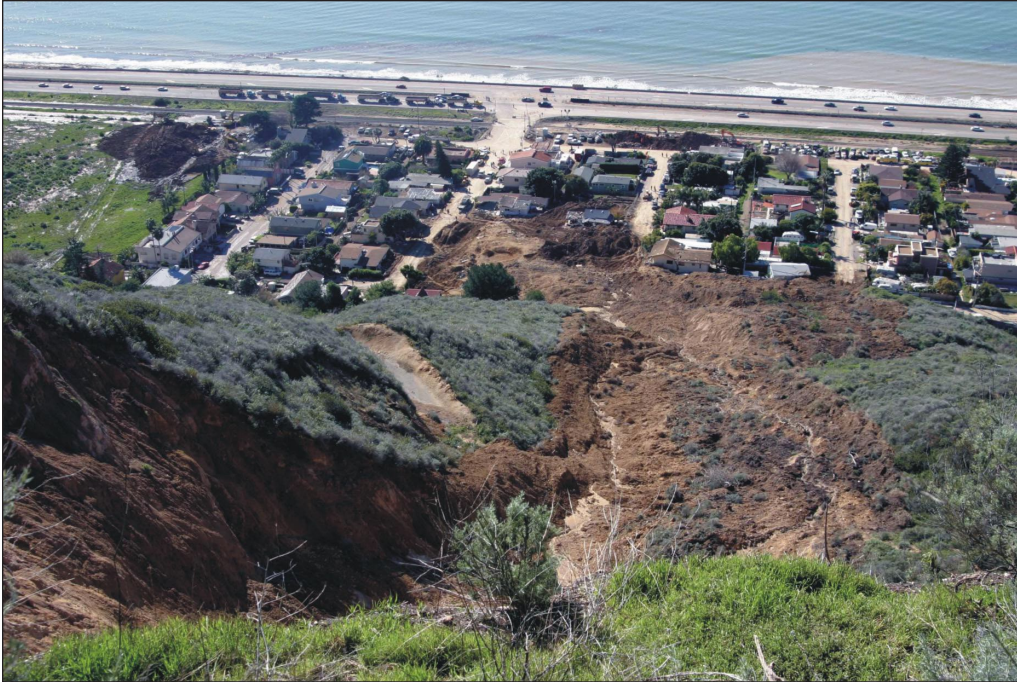
Figure 6. View from the main scarp down the length of the 2005 La Conchita landslide. Water visible in the center of the photograph was issuing from the base of the main scarp when the photograph was taken (January 14, 2005). The 2005 landslide remobilized about 15 percent of the 1995 deposit and followed the left margin (looking downslope) of the 1995 slide. The vegetated ridge in the left part of the photograph is intact material that did not fail in 1995 or 2005; the material in the right part of the photograph is 1995 deposit that is still in place.

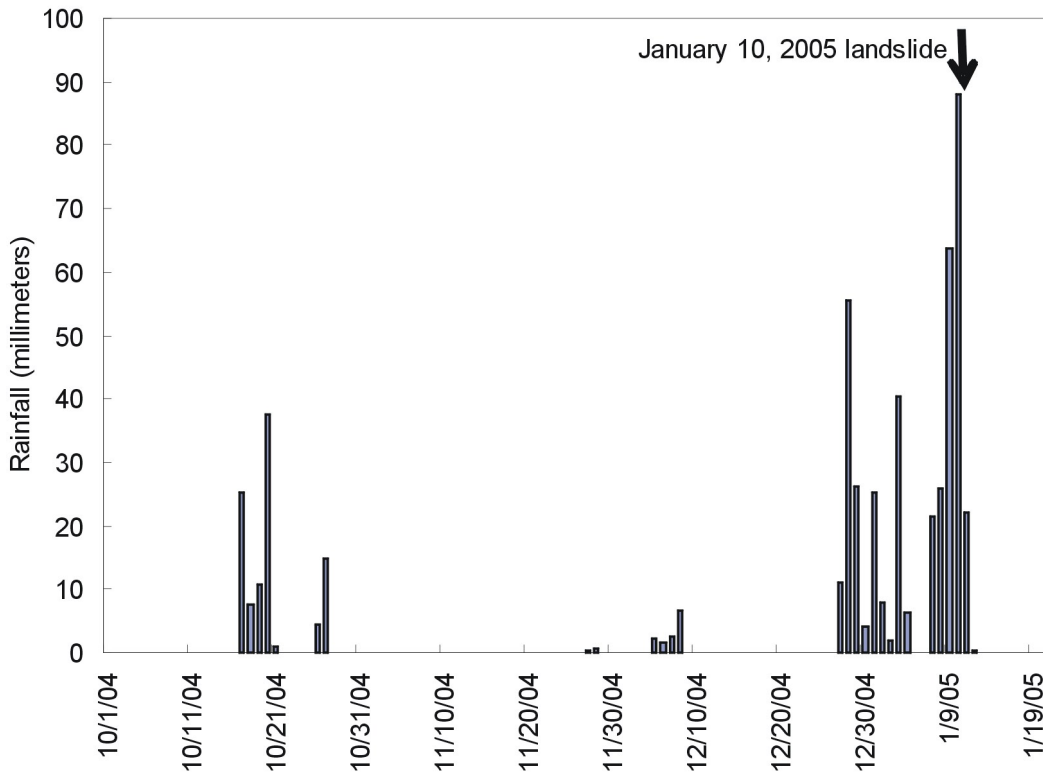
Ventura Daily Rainfall

Figure 7. Daily rainfall at Ventura (20 km [12 mi] southeast of La Conchita) from October 1, 2004 through January 20, 2005 (data from Wofford, 2005). The 2005 landslide occurred at the culmination of the heaviest rainfall of the season.

The 2005 landslide occurred at the end of a 15-day period that produced record and near-record amounts of rainfall in many areas of southern California. At Ventura (20 km [12 mi] southeast of La Conchita) seasonal antecedent rainfall from October 1, 2004 through January 10, 2005 totaled 493 mm (19.4 in) as compared to the mean value of 122 mm (4.8 in). From December 27, 2004 through January 10, 2005, Ventura received 378 mm (14.9 in) of rainfall, only slightly less than its mean annual total of 390 mm (15.4 in) (Wofford, 2005; National Oceanic and Atmospheric Administration, 1994a, 1995a). Although rainfall intensities were not extreme, moderate- to high-intensity rainfall persisted for more than 2 weeks, and the landslide occurred at the culmination of this 15-day high-rainfall period (fig. 7).

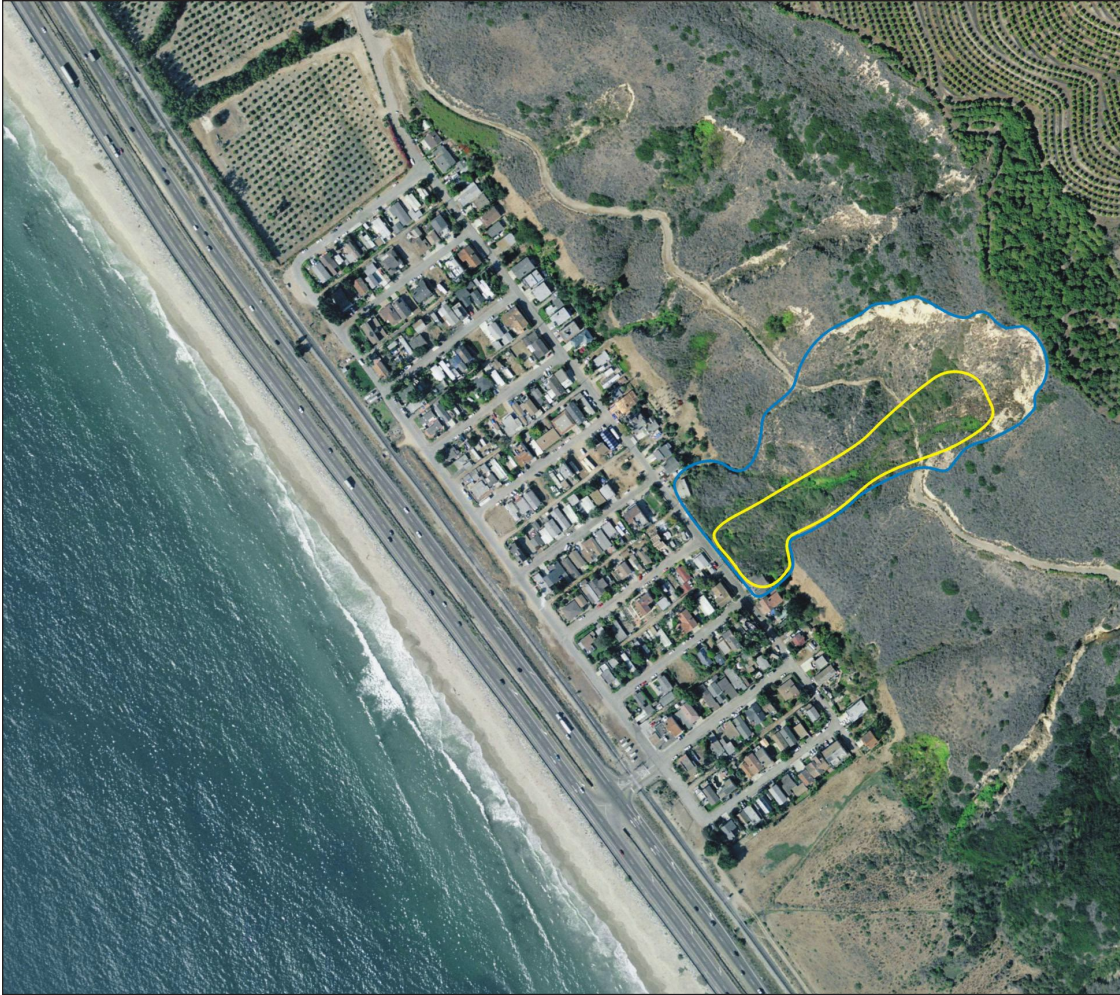
Figure 8. Orthorectified airphotograph of La Conchita taken in September 2004. The 1995 landslide is outlined in blue; the area that remobilized in 2005 is outlined in yellow. Note the concentration of lush, green vegetation in the area that remobilized in 2005, which indicates concentration of surface and subsurface drainage into this area. Image from orthophotography provided courtesy of AirPhoto USA and County of Ventura.

Such a failure scenario, involving a significant amount of dry material that fully mobilized on a saturated layer, indicates that most of the rain that fell on the surface of the 1995 deposit did not infiltrate but drained off the surface. The rising ground-water level within the 1995 deposit would thus have resulted from deeper recharge from rainfall infiltration upslope. Figure 8 shows an aerial photograph of La Conchita taken in September 2004. The lush, green vegetation visible in the southeastern (lower right in photograph) part of the 1995 deposit clearly indicates that drainage on and within the 1995 landslide deposit concentrated water in the part of the mass that failed in 2005. At the time of our visit (January 14, 2005) water was still issuing from the base of the main landslide scarp and was ponding at several locations on the 2005 deposit (fig. 9).

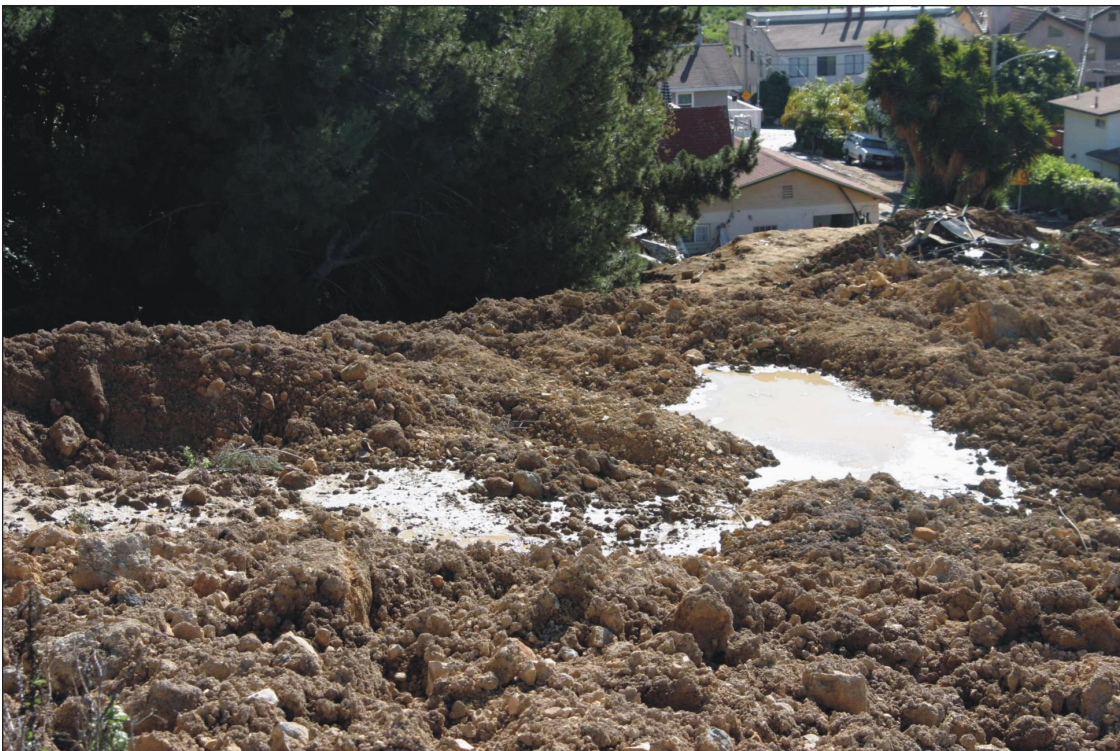
Figure 9. Water was issuing from the base of the main scarp at the time of our visit (January 14, 2005). The water ponded at several locations on the 2005 deposit.

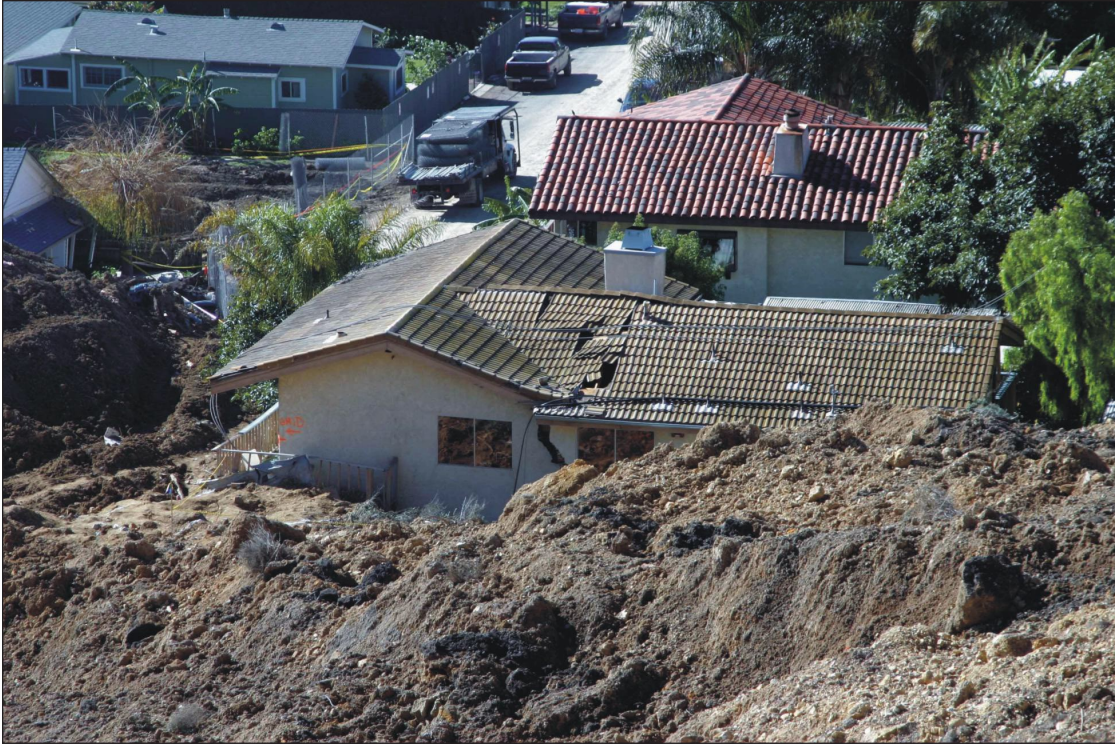
Figure 10. The 2005 landslide moved as a rapid debris flow, but it was quite viscous and pushed houses in its path rather than flowing around or through them. The left part of the house was detached from the right part and was pulled by the landslide several decimeters toward the upper left of the photograph.

The 2005 landslide pushed many of the houses off their foundations and into each other at the toe of the landslide (figs. 10 and 11). A wall built after the 1995 landslide to keep minor landslide debris off the road was tilted forward and(or) overtopped in places by debris from the 2005 landslide (fig. 12). This indicates that the landslide material, although it flowed rapidly, was quite viscous and pushed structures in front of it rather than flowing around them or filling them with mud, as sometimes occurs with fully saturated debris and mud flows. This apparently resulted from a highly hazardous situation involving a two-phased landslide mechanism: (1) a saturated, highly fluid layer at depth on which the landslide mobilized that (2) carried a thick layer of drier, much more viscous material that effectively acted as a battering ram.

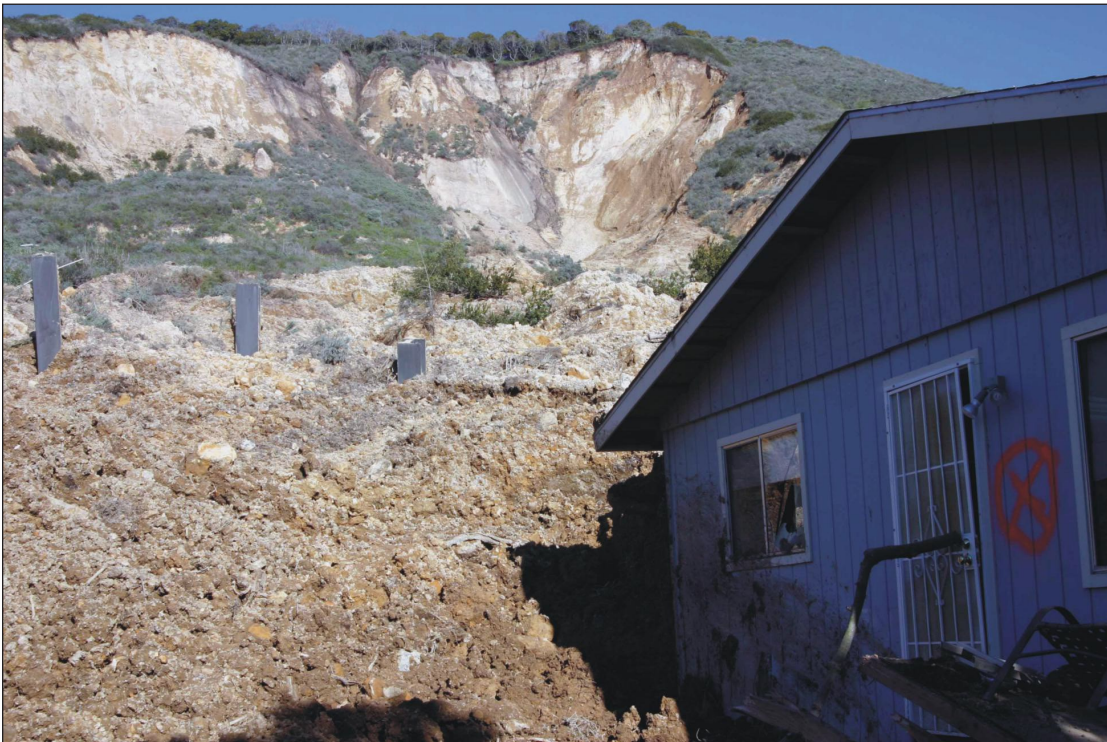
Figure 11. This house was pushed about 3.5 m (12 ft) off its foundation toward the right in the photograph when the 2005 landslide topped a wall. The tops of the H-beams of the wall are visible in the left part of the photograph.

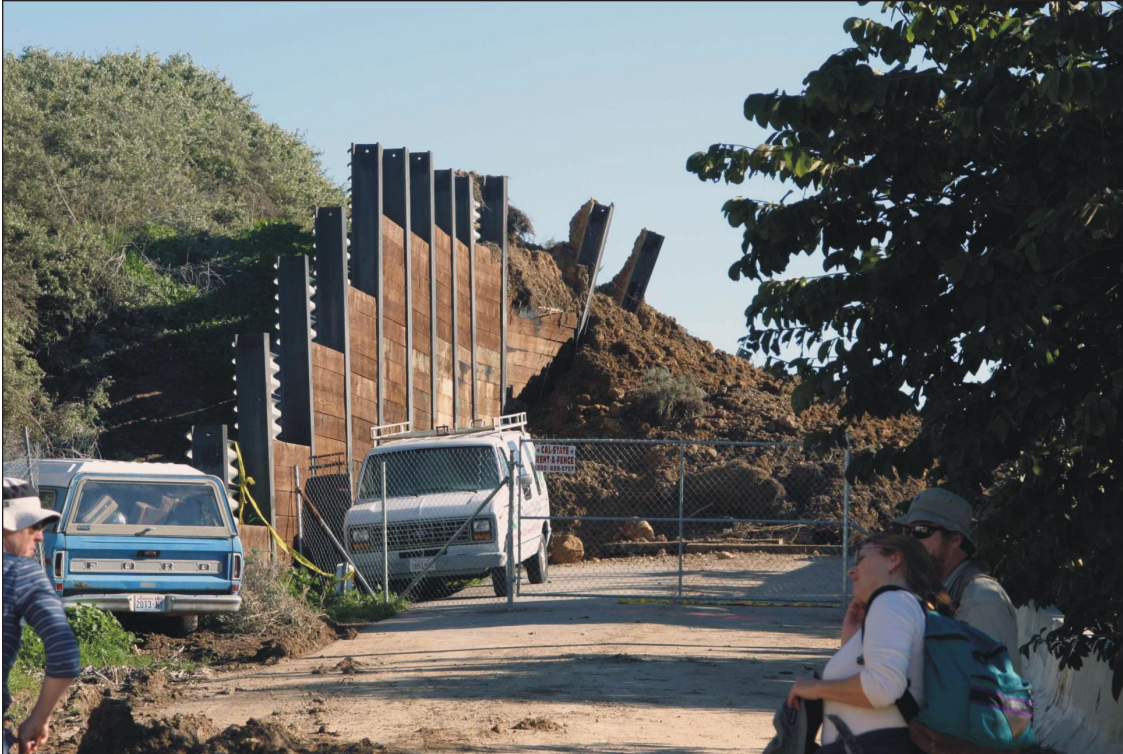
Figure 12. Steel-and-timber wall built after the 1995 landslide was overtopped and tilted forward in places by the 2005 landslide.
