Intersection Road Safety Audit

Pemberton Borough Burlington County

INTERSECTION ROAD SAFETY AUDIT – HANOVER STREET, PEMBERTON BOROUGH

ABSTRACT: This is a documentation of the process and findings of the Hanover Street (CR 616) Intersection Road Safety Audit (RSA) undertaken by Delaware Valley Regional Planning Commission (DVRPC). The goal of the audit is to generate improvement recommendations and countermeasures for intersections demonstrating a history of, or potential for a high incidence of motor vehicle crashes. The emphasis is placed on identifying low cost, quick turnaround safety projects to address the issues where possible. This project represents a step towards implementation of the Delaware Valley Regional Planning Commission (DVRPC) Regional Safety Action Plan. Improving the design and operation of intersections is a priority area for both engineering and enforcement discipline as documented in the Plan. Improvement strategies may be eligible for Local Federal Safety Funds for implementation. The report details safety issues identified by the audit team at the study location and remedial strategies to address them.

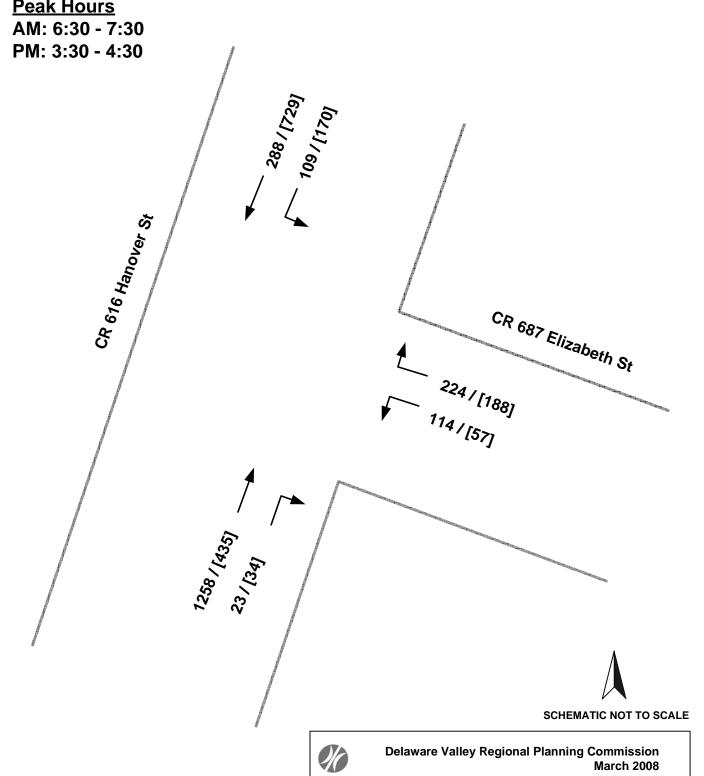
Pemberton Borough CR 616 Hanover Street and CR 687 Elizabeth Street Intersection

Peak Hour Turning Movement Counts AM & [PM]

Peak Hours
