CULTURAL LANDSCAPE REPORT FOR FORT MCHENRY NATIONAL MONUMENT AND HISTORIC SHRINE

SITE HISTORY, EXISTING CONDITIONS AND ANALYSIS

FORT MCHENRY NATIONAL MONUMENT AND
HISTORIC SHRINE

August 2004

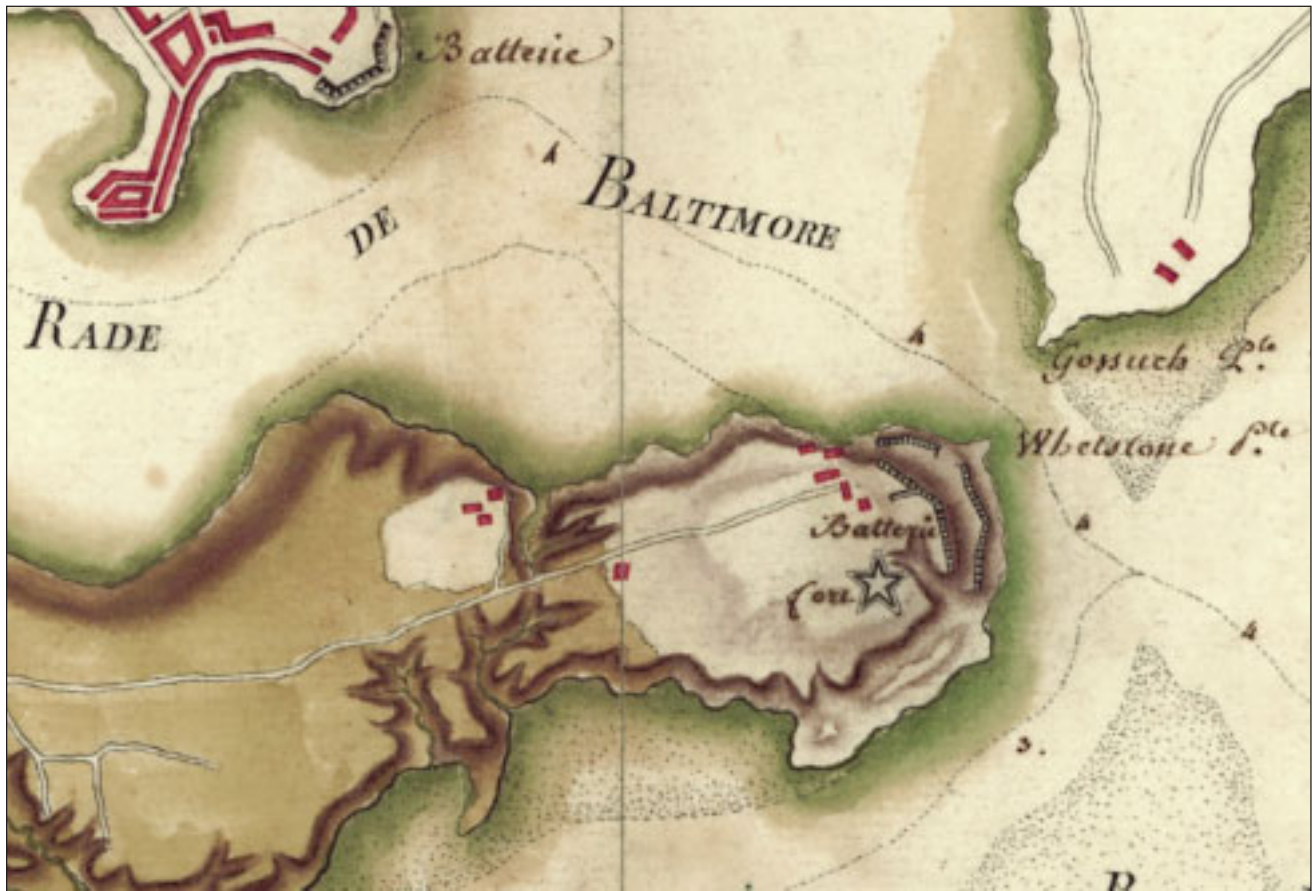
Figure 1.1. Portion of a 1781 plan by Berthier showing Whetstone Point and surrounding environs. Berthier, Louis-Alexandre, "Ville, port, et rade de Baltimore dans le Maryland," c. 1781, Library of Congress, Rochambeau Collection, call number G3844.B2A1 1781 .B4.

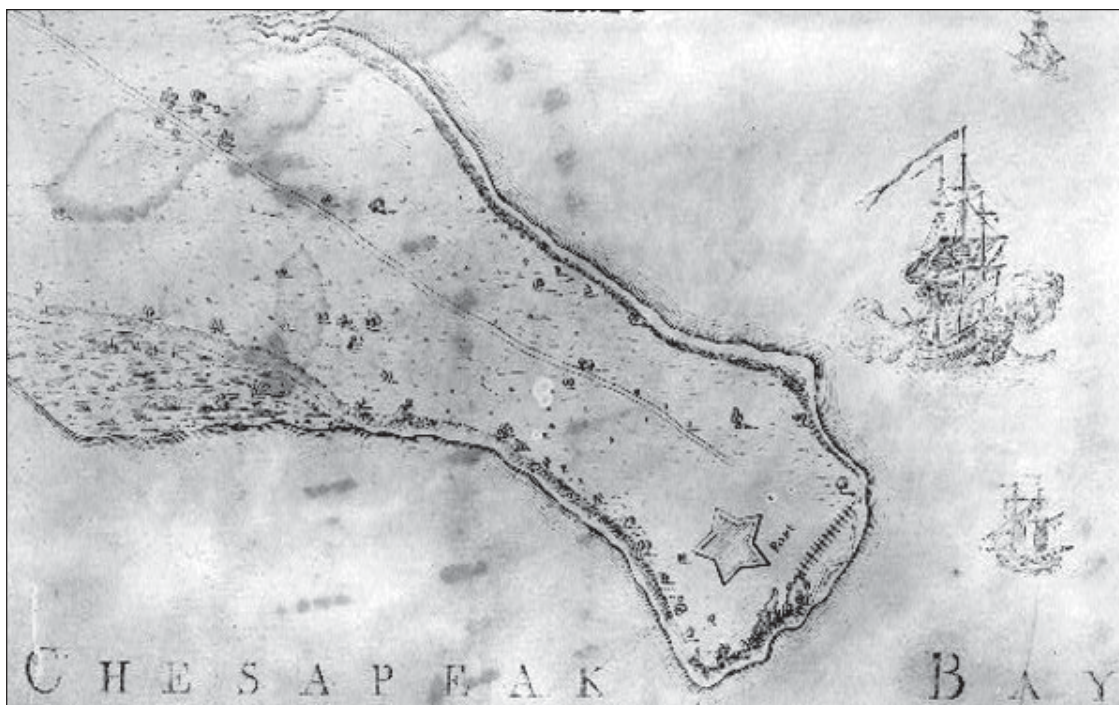
Figure 1.3. Detail of 1792 plan by A. P. Folie, entitled "Plan of the Town of Baltimore and its Environs," showing Fort Whetstone including Star Fort and shoreline batteries. Library of Congress.

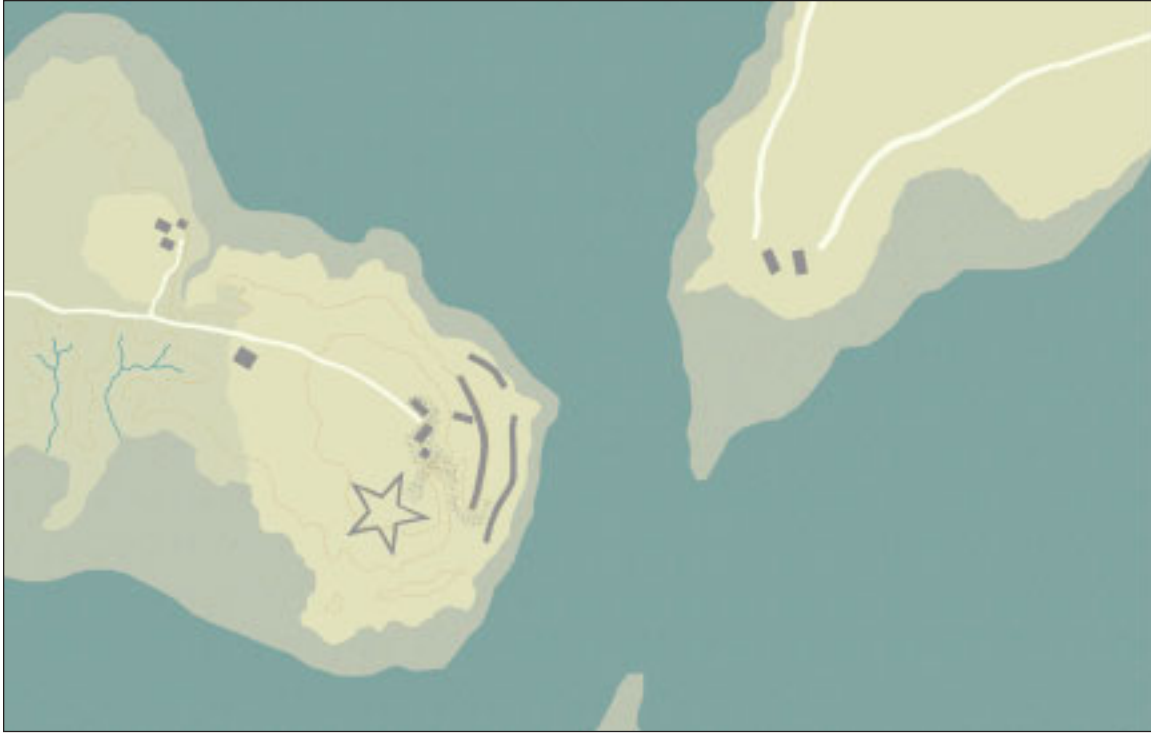
Figure 1.5. Diagram depicting 1793 Fort Whetstone landscape. Graphic prepared by the Olmsted Center for Landscape Preservation (OCLP).

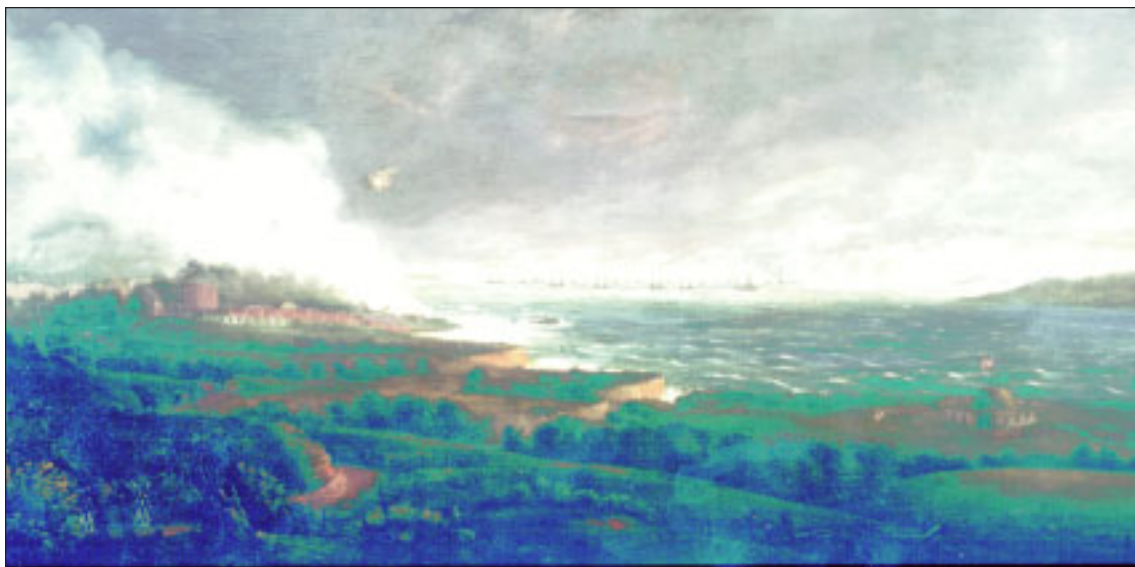
Figure 1.7. “The Bombardment of Fort McHenry, September 13-14, 1814,” by Alfred Jacob Miller (1810-1874). This image, painted c. 1829, depicts Lombardy poplar trees on the fort terreplein, in front of the Star Fort buildings, and lining the approach road. Maryland Historical Society, Baltimore, MD.

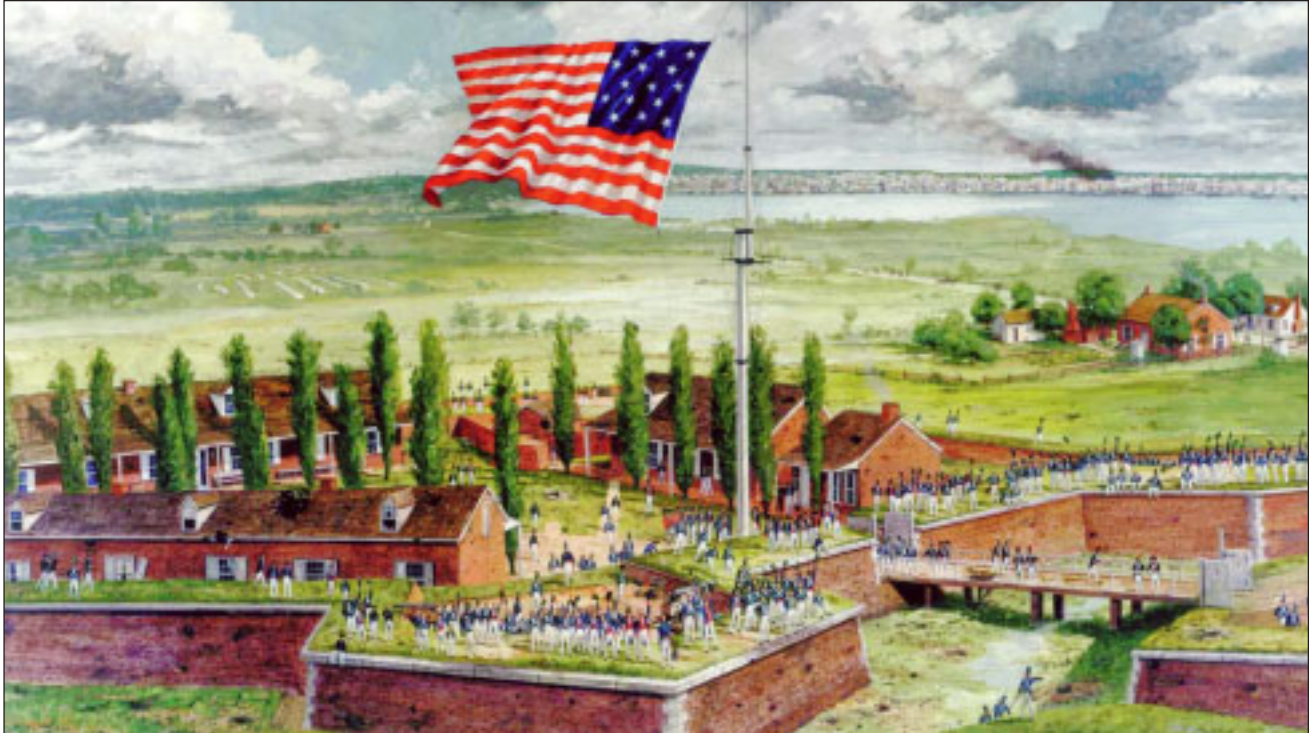
Figure 1.9. “The Flag is Full of Stars,” by Dale Gallon, 1989. This modern interpretive painting depicts Fort McHenry in 1814, showing Lombardy poplars along the terreplein wall and in front of the fort’s interior buildings. Dale Gallon Historical Art, Gettysburg, PA.

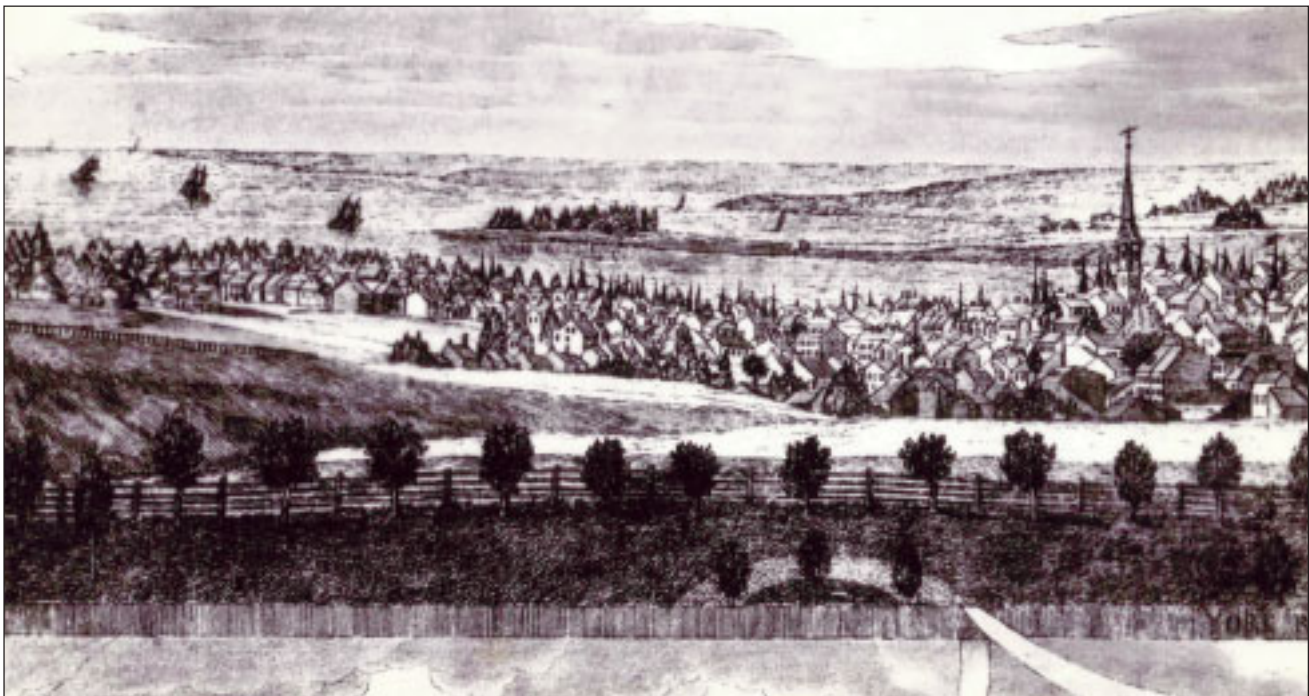
Figure 1.10. View of Fort McHenry and Whetstone Point from Baltimore’s Hampstead Hill, c. 1810. This rendering indicates numerous trees inside and around the Star Fort. New York Historical Society.

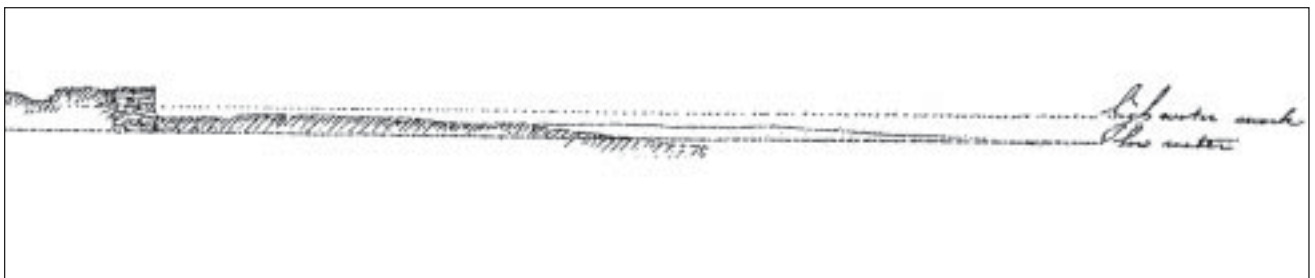
Figure 2.2. Detail of 1819 plan by Captain William Tell Poussin entitled "Reconnoitering of Chesapeake Bay, State of Maryland; Plan and Profiles of Fort McHenry," showing profile of seawall and mudflats at low and high tide marks. National Archives II, College Park MD. Record Group 77.

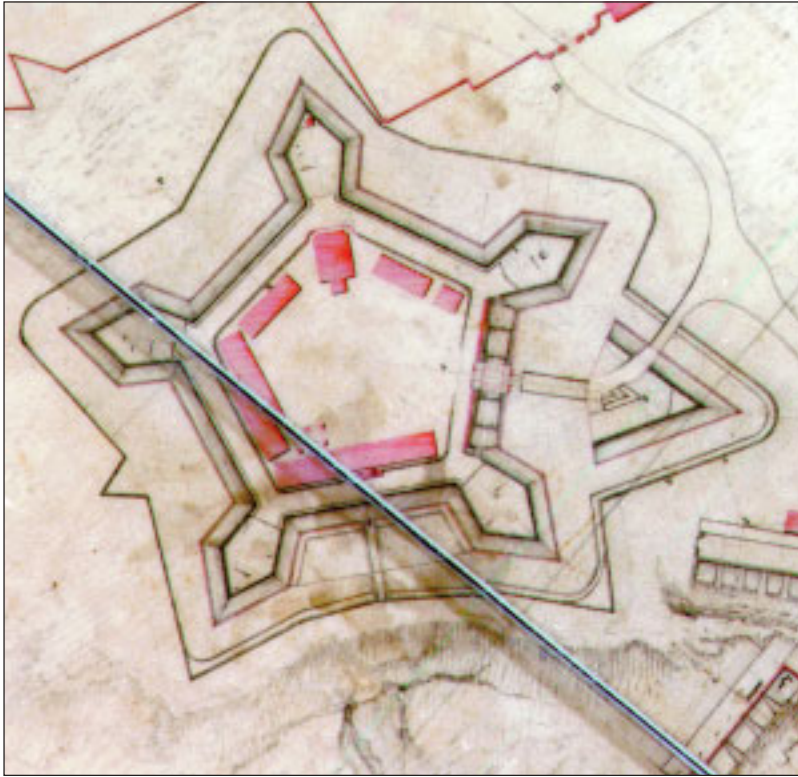
Figure 2.3. Detail of 1819 plan by Captain William Tell Poussin entitled "Reconnoitering of Chesapeake Bay, State of Maryland; Plan and Profiles of Fort McHenry," showing configuration of Star Fort. National Archives II, College Park, MD. Record Group 77..

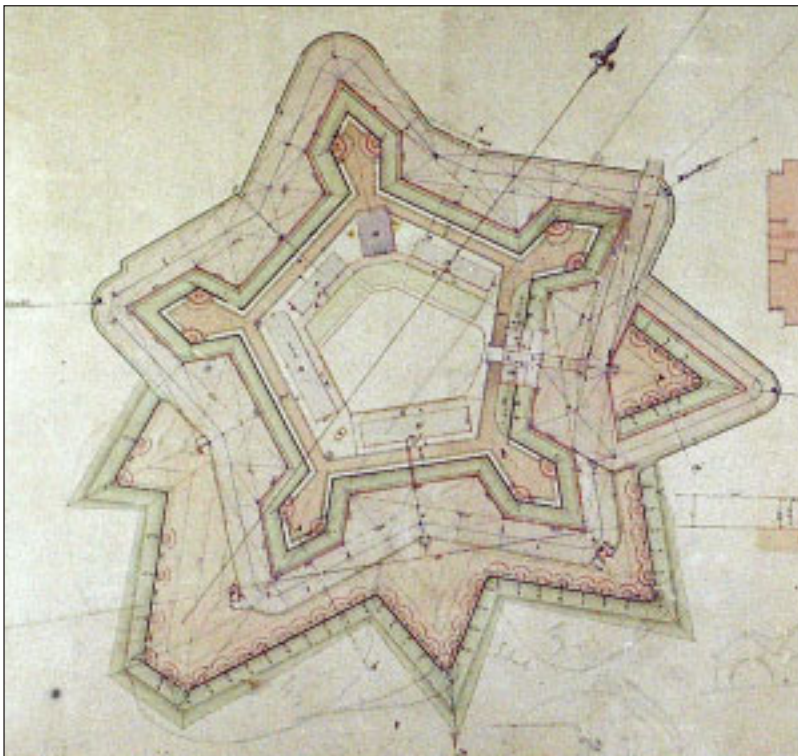
Figure 2.4. Detail of 1840 plan by Capt. Fred A. Smith entitled "[Plan of] Fort McHenry, Baltimore, from dimensions furnished by Capt. Henry A. Thompson," showing alterations to the Star Fort including the new water battery and the remodeled entrance to the sally port. National Archives II, College Park MD. Record Group 77.

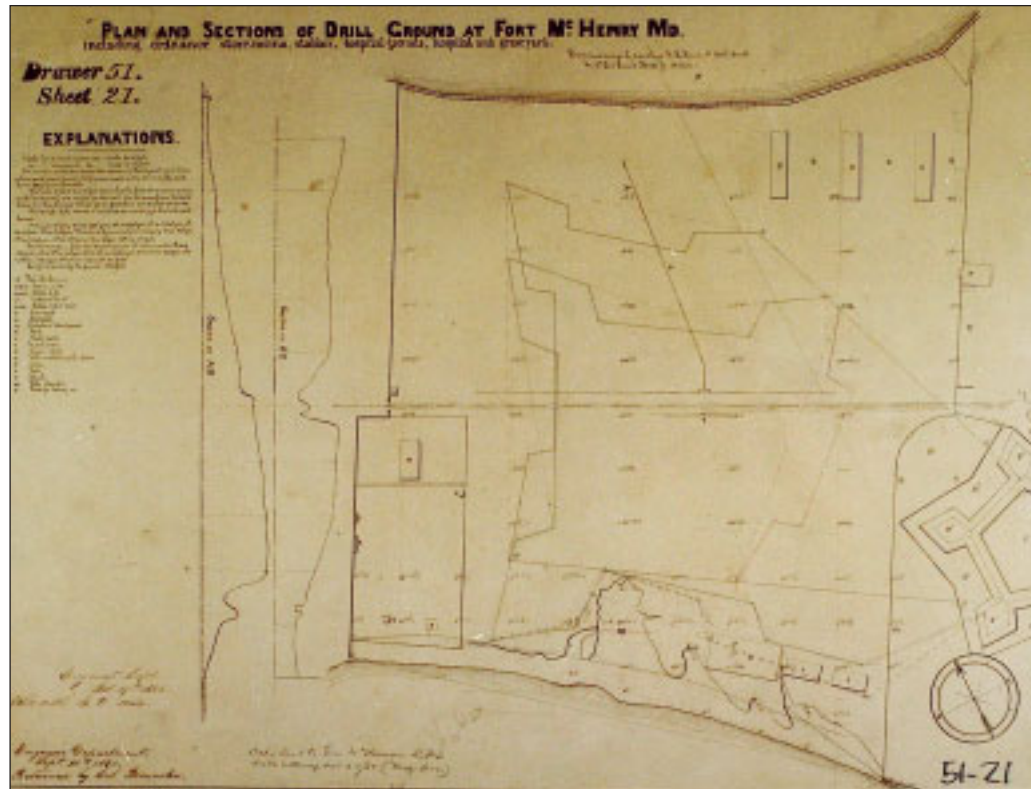
Figure 2.5. Detail of 1858 plan by Lieutenant Samuel Brick entitled “Plan and Sections of Drill Ground at Fort McHenry,” showing the 1837 land purchase by the War Department and includes the new structures constructed by the Army prior to the Civil War. National Archives II, College Park MD. Record Group 77.

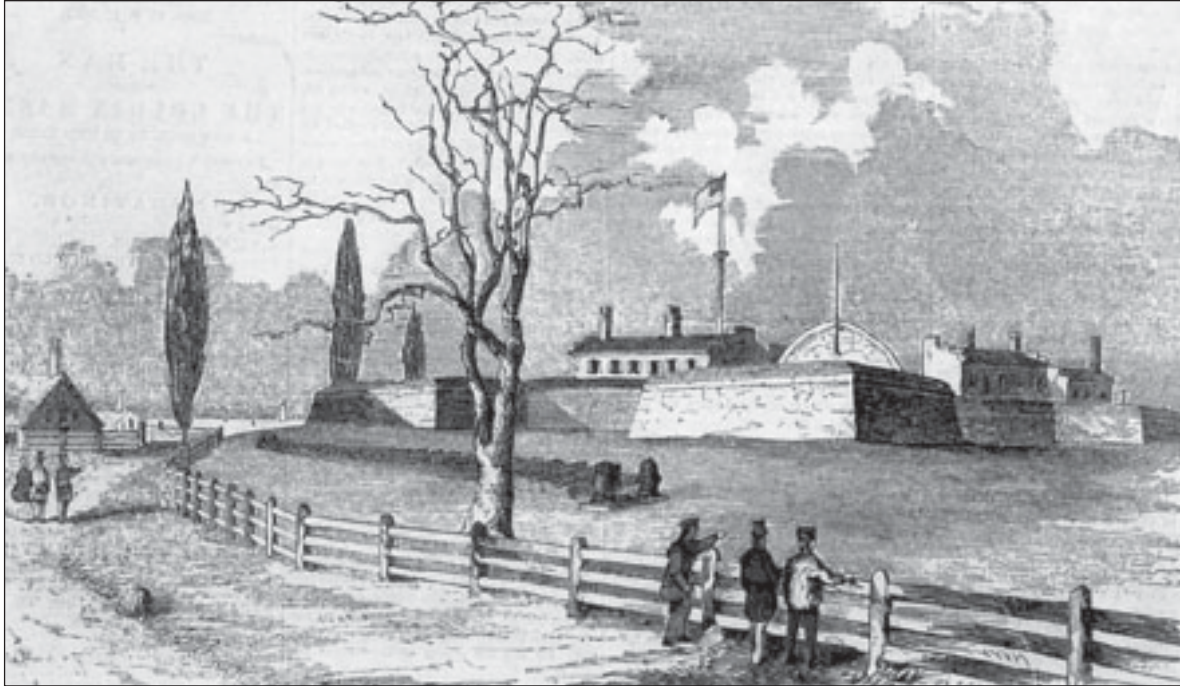
Figure 2.7. “Fort McHenry, Baltimore.” This engraving published in the 22 December 1855 edition of Ballou’s Pictorial depicts conditions along the approach road to Fort McHenry, including three surviving Lombardy poplars. Other items in view include the specimen deciduous tree in foreground, the dressed dimensional lumber of the 1839 rail fencing, and various unmounted ordnance. At the left of the engraving, the 1807 ordnance shed is in view. The military reservation was often used as a strolling place and pleasure ground by the public. Ecoch Pratt Free Library, Baltimore, MD. Cator Print Collection No.28.

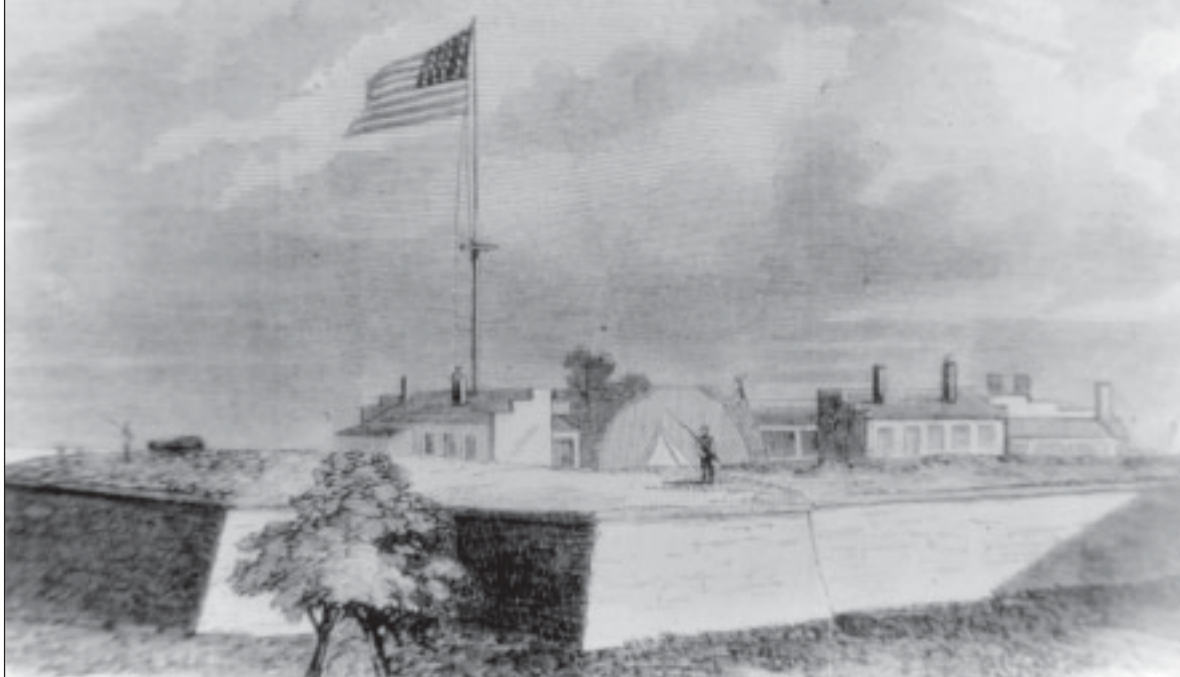
Figure 2.8. This c 1861 engraving from Ballou’s Pictorial depicts a sentinel posted on Bastion II, Columbiads next to star fort, point to Washington Monument and the City of Baltimore. Note the specimen deciduous tree in foreground, and the Columbiad mounted on Bastion I. Fort McHenry Library Special Collection.

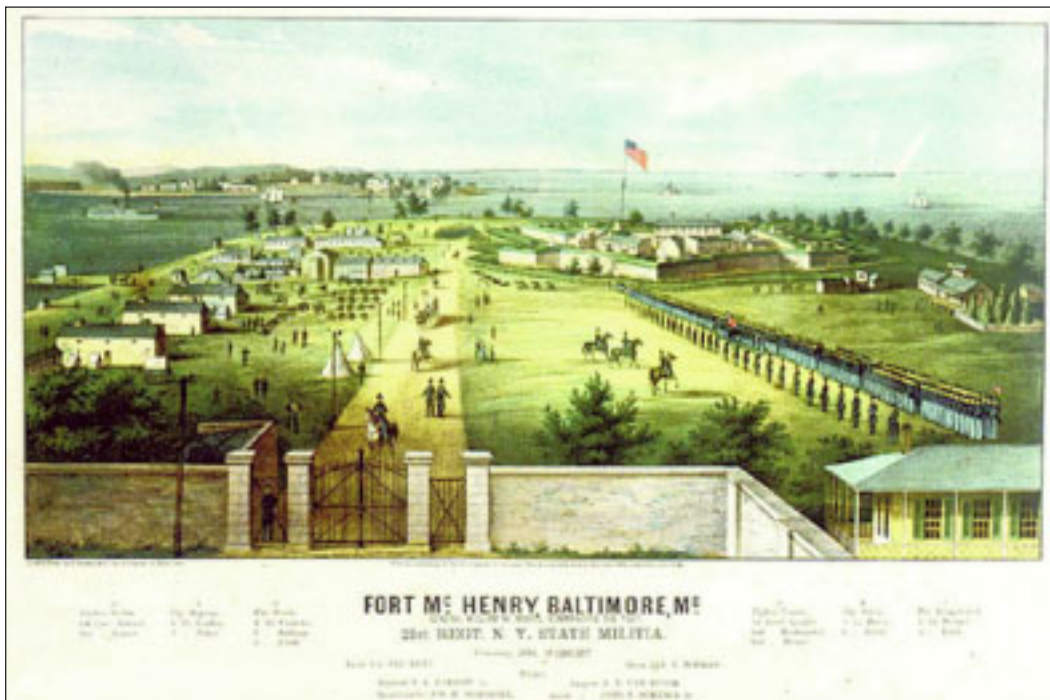
Figure 2.10. “Fort McHenry, Baltimore, MD.” This 1861 color lithograph by E. Sachse depicts the general configuration of the Fort McHenry landscape during the first months of the Civil War. Note the telegraph line on the north side of the entrance drive as well as the diagonal path leading to the barracks buildings. Enoch Pratt Free Library, Baltimore, MD. Cator Print Collection. No. 166.

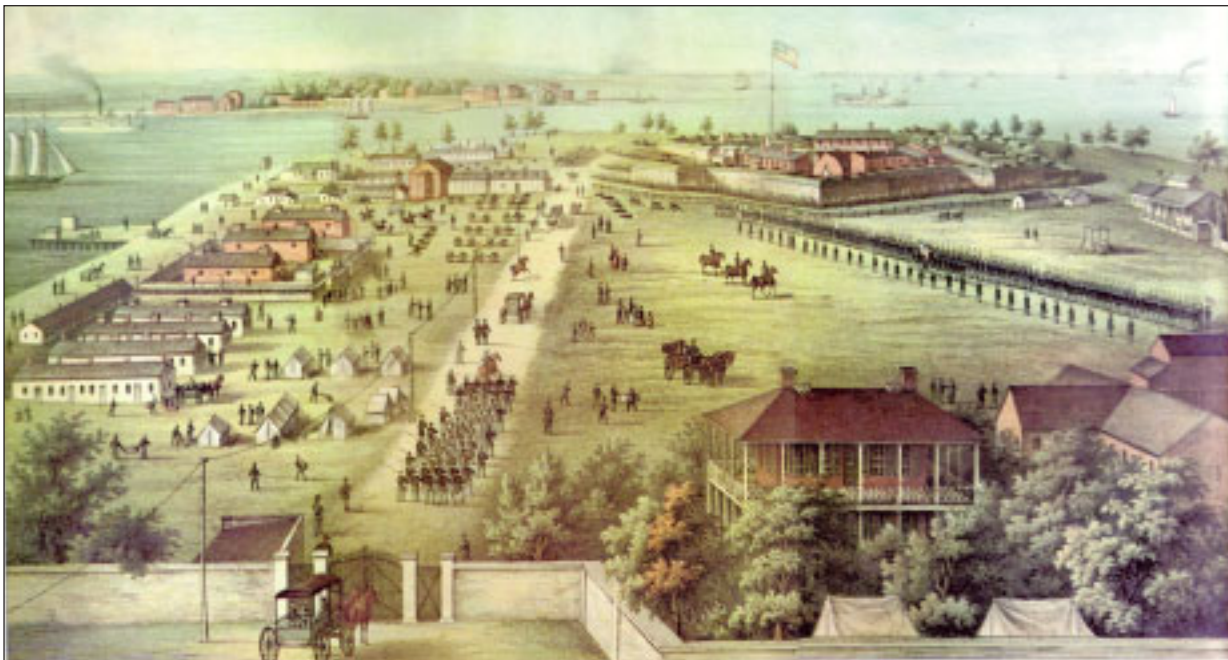
Figure 2.12. 1865 color lithograph by E. Sachse of Fort McHenry showing landscape conditions during the final months of the Civil War. Note the conversion of the three 1843 stables to house Confederate prisoners, employing the use of surrounding stockade fence and guard towers. The post cemetery and gallows is also prominently in view. Following the end of the war, the prison buildings were converted into enlisted men's barracks and remained on site until 1926. Enoch Pratt Free Library, Baltimore, MD. Cator Collection No. 166.

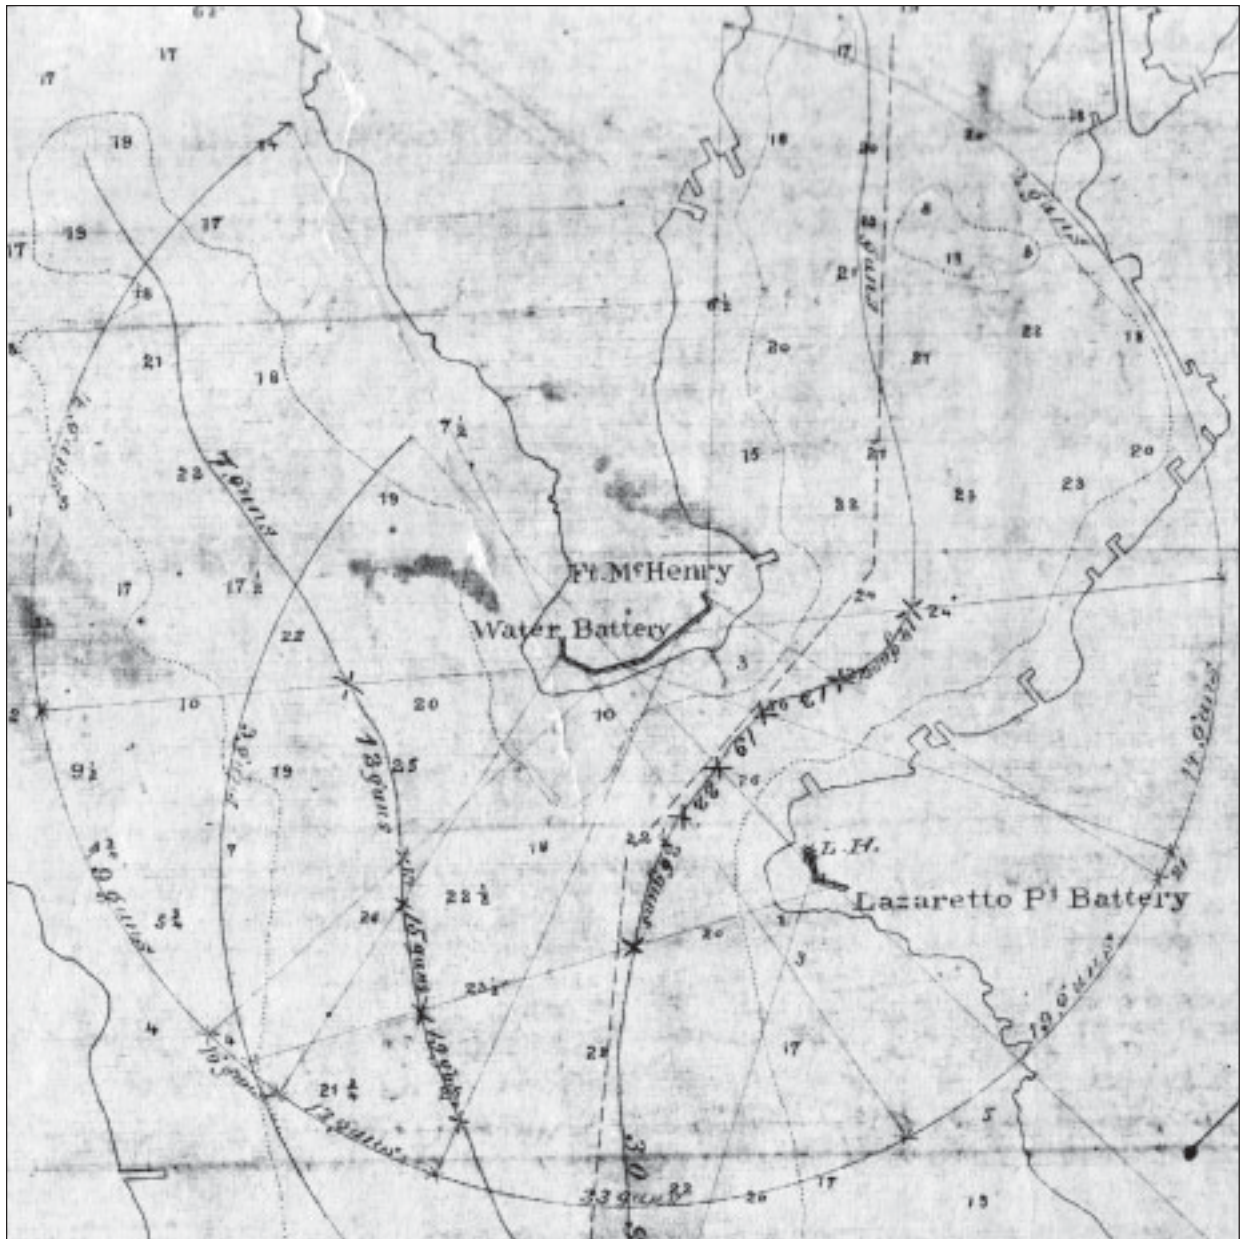
Figure 3.5. Detail of field of fire diagram showing proposed exterior water battery at Fort McHenry and Lazaretto Point Battery. c. 1870. National Archives II, College Park, MD. RG 77.

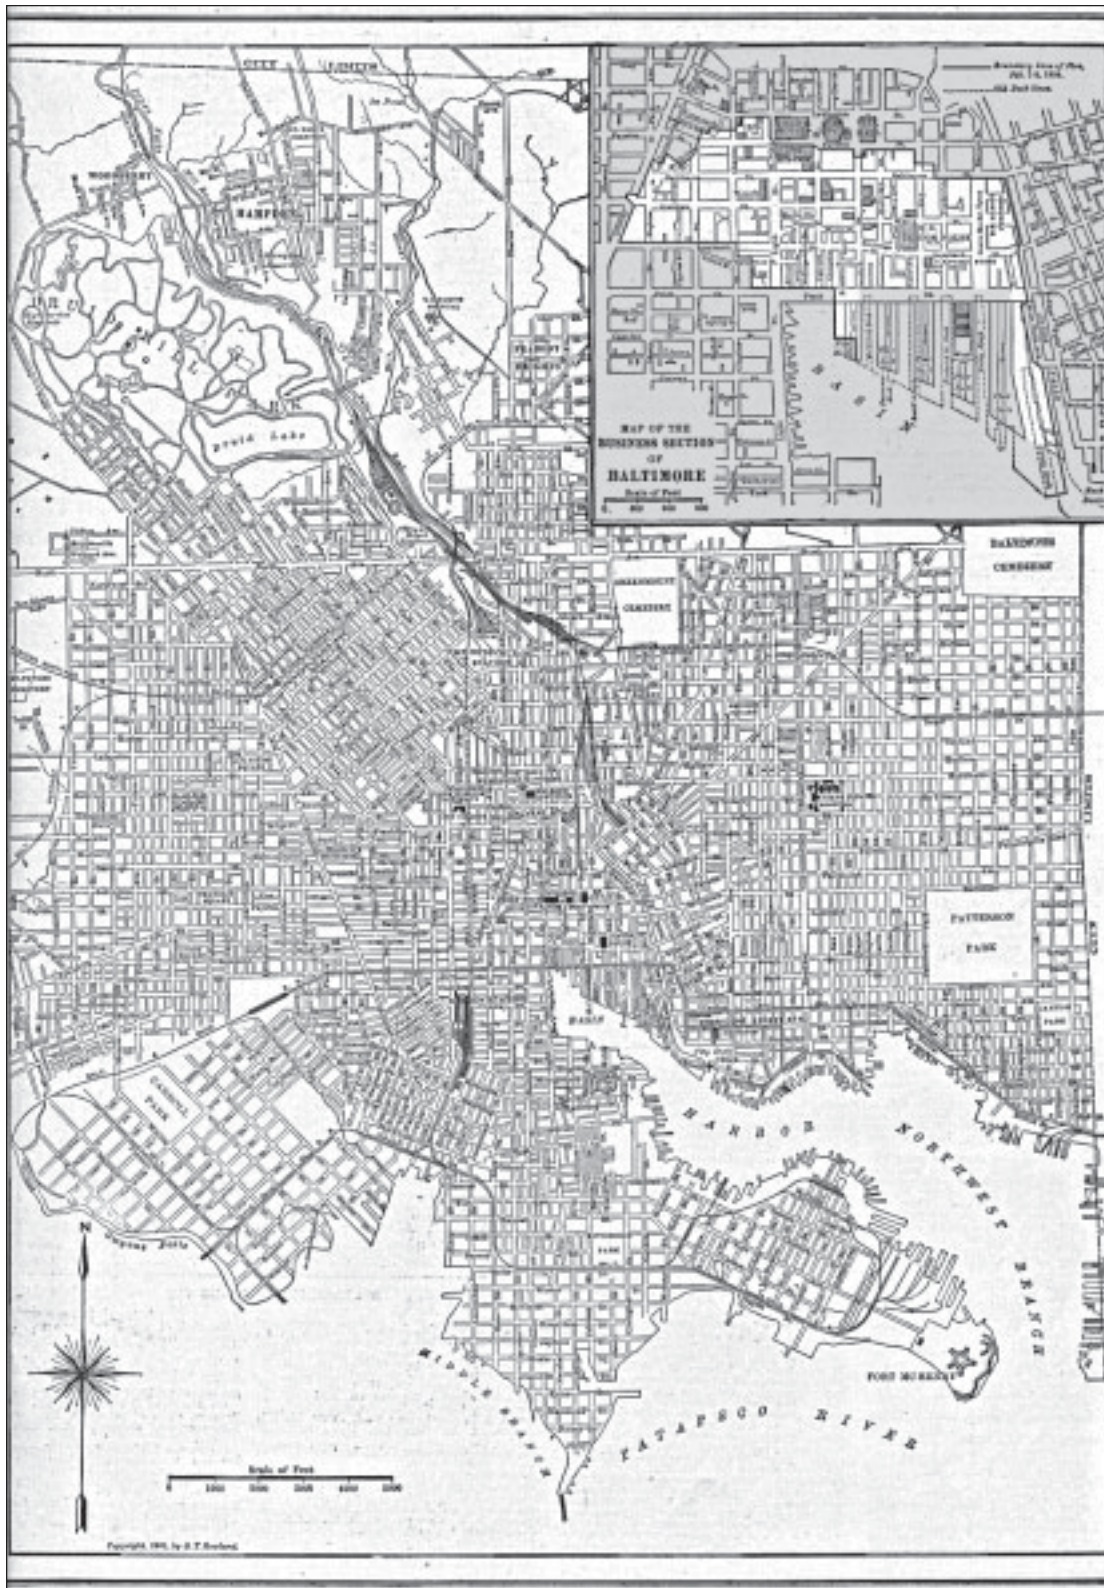
Figure 3.20. Map of Baltimore, 1905, by G. T. Rowland. Map inset shows area burned by the fire of 1904. Fort McHenry Library Special Collections.

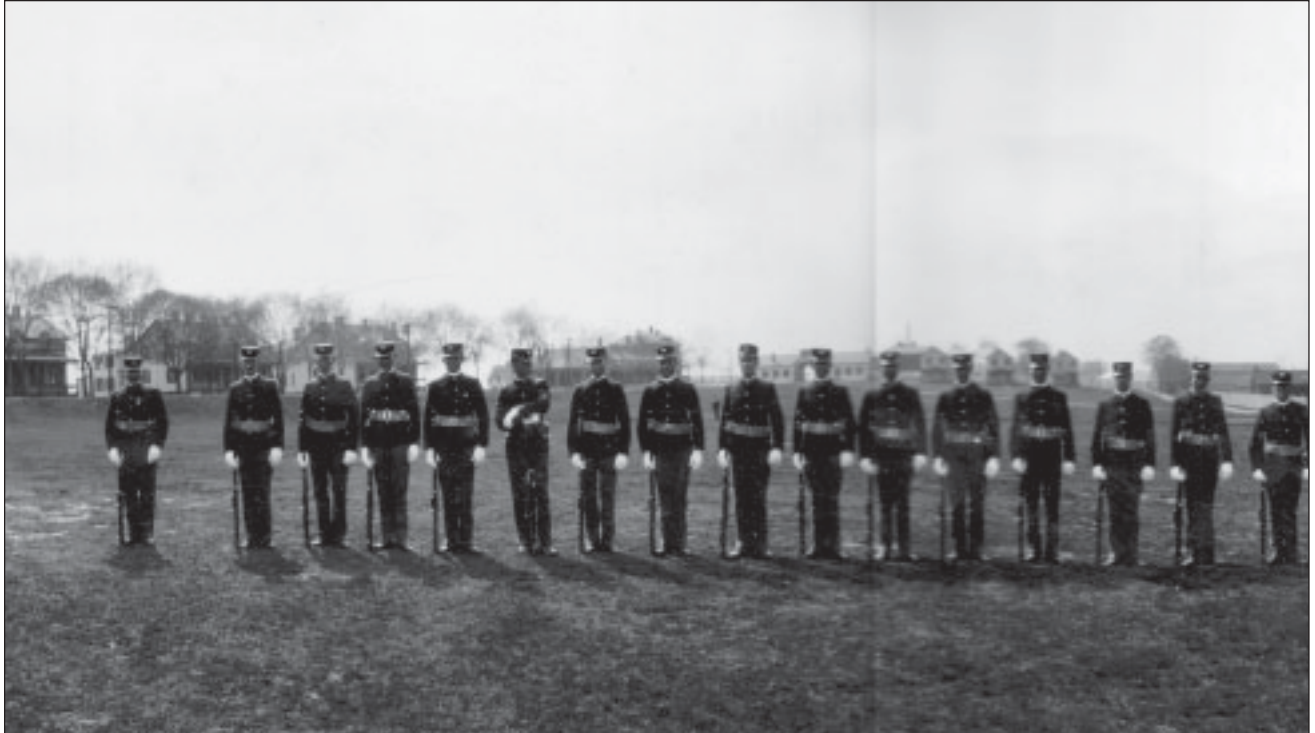
Figure 3.22. Fort McHenry c 1907. This image is paired with Figure 3.21 to the left, depicting landscape conditions at Fort McHenry a few years before the departure of its active military force. Fred W. Mueller, photographer. Fort McHenry Library Special Collections, FOMC 2388.

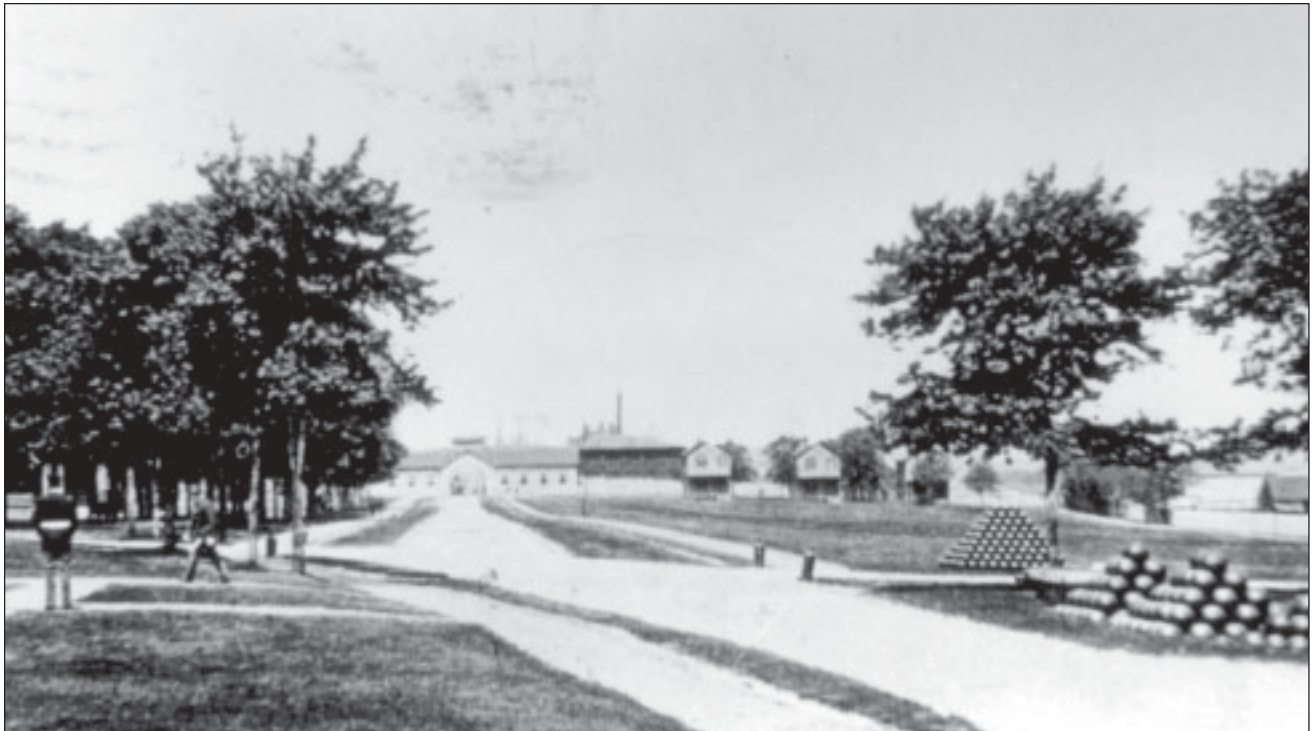
Figure 3.24. Historic postcard of Fort McHenry c 1907. Note displays of military items and generally well-kept character of the landscape. Fort McHenry Library Special Collections, Postcards, FOMC 3899.

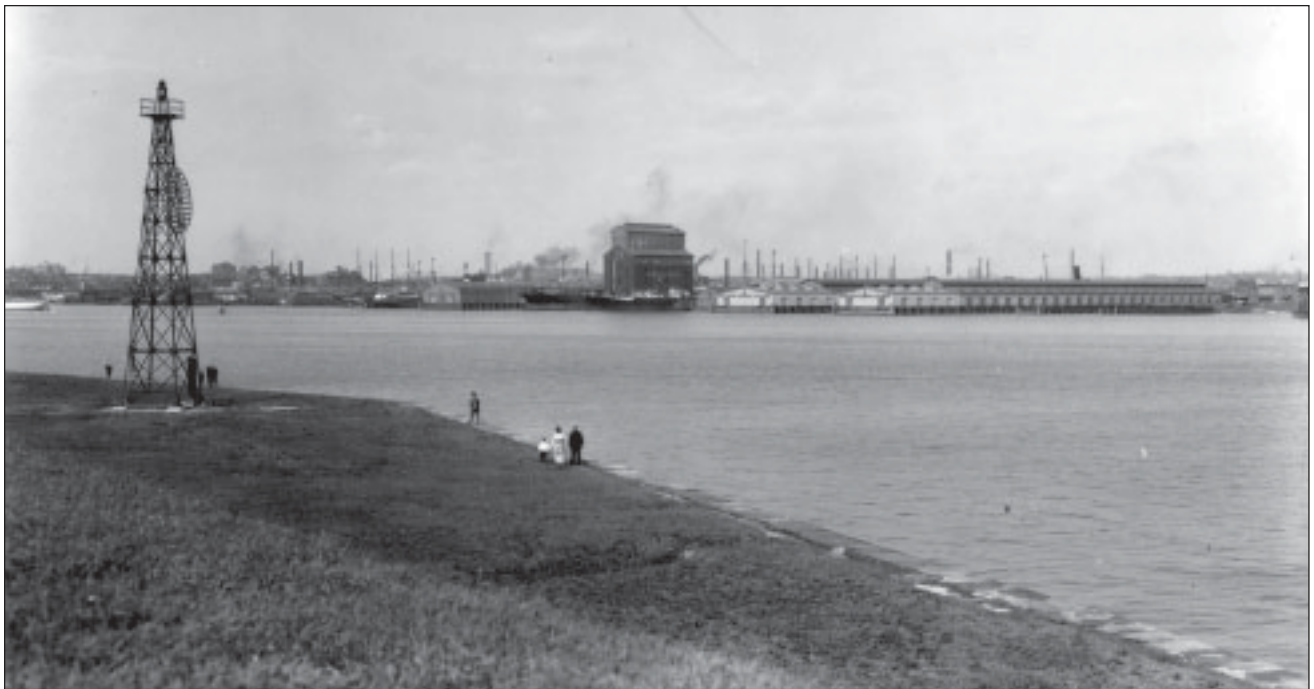
Figure 4.2. The public promenade around the perimeter of the riverfront made use of the wide coping stones of the seawall. Fort McHenry Library Special Collections, FOMC #8996F.

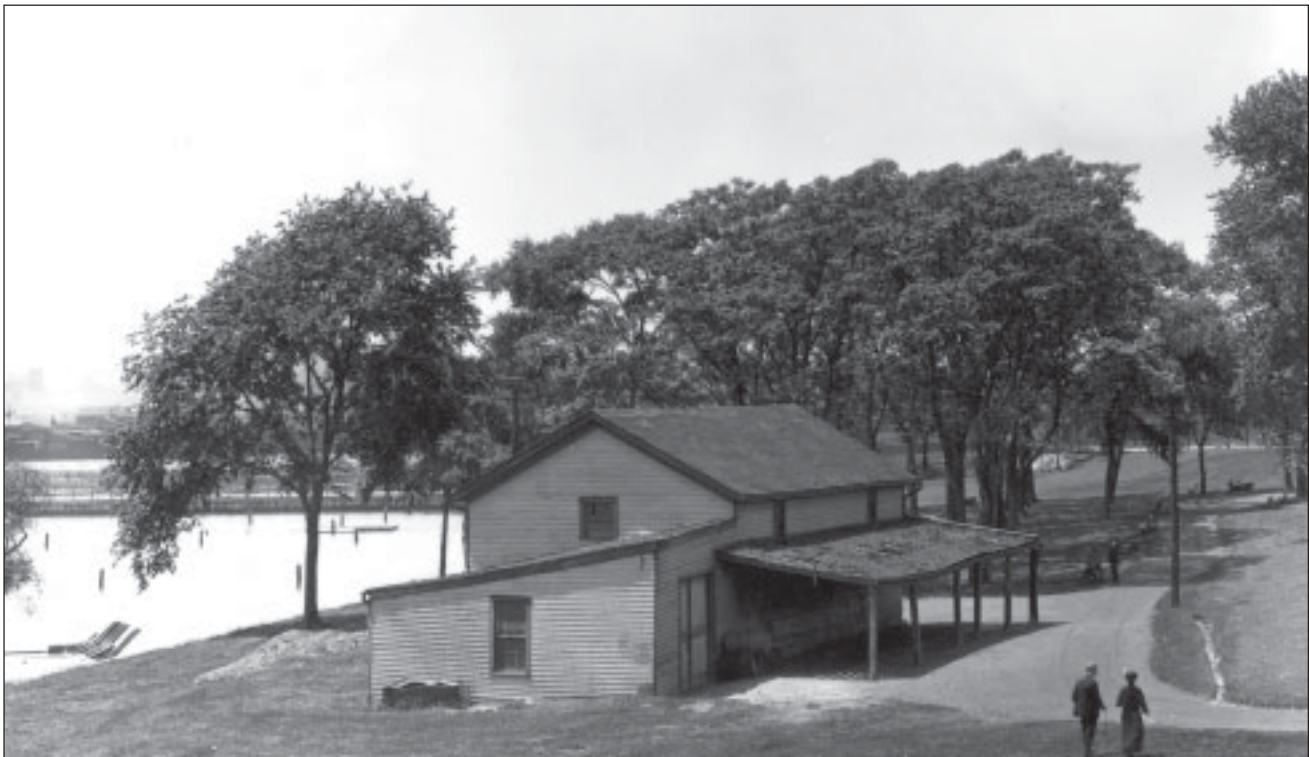
Figure 4.5. Fort McHenry c. 1914-1915. This image is paired with Figure 4.6 to the right, depicting landscape conditions southwest and west of the Star Fort. Note failing porch roof of former Quartermaster's Stables. Fort McHenry Library Special Collections, FOMC #8996M.

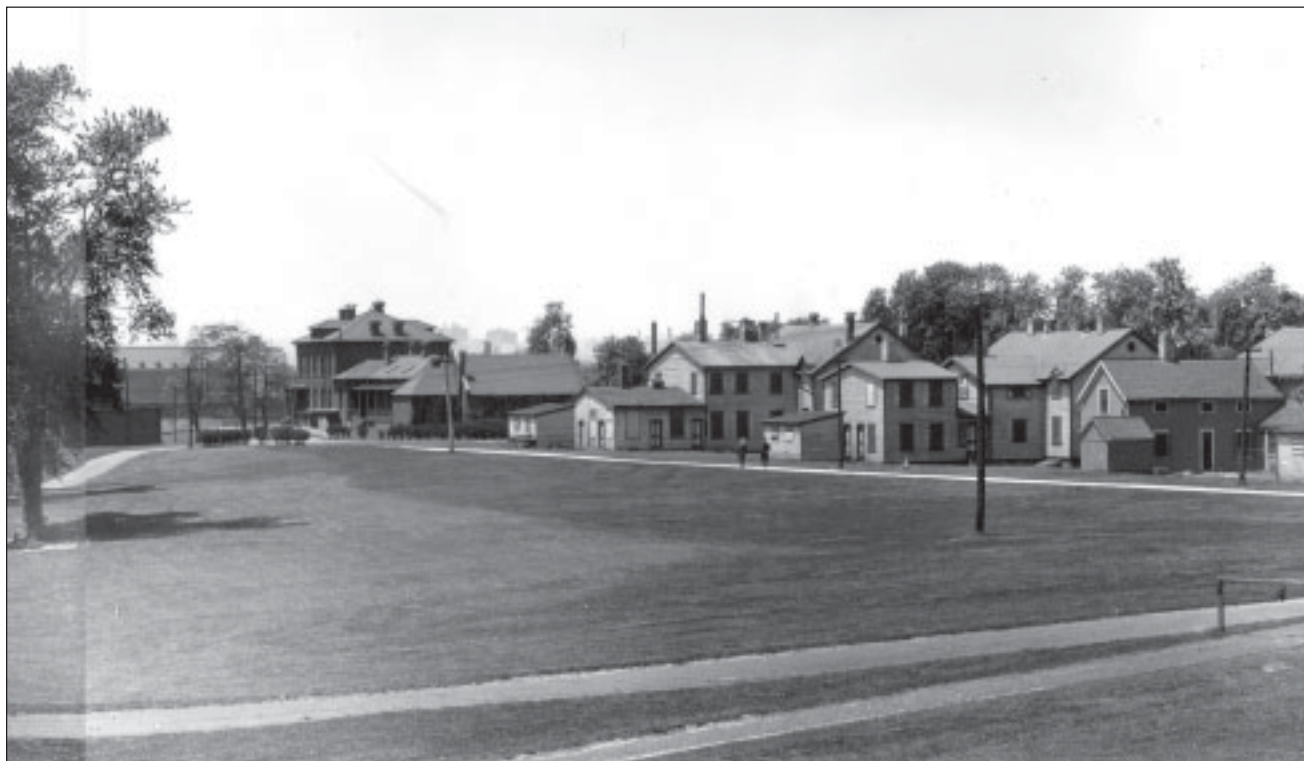
Figure 4.6. Fort McHenry c. 1914-1915. This image is paired with Figure 4.5 to the left, depicting landscape conditions southwest and west of the Star Fort. Note the peeling paint of the south (rear) facades of the row of officers' quarters. Also note 1895 hospital, adjacent to main gate. Fort McHenry Library Special Collections, FOMC # 8996CC.

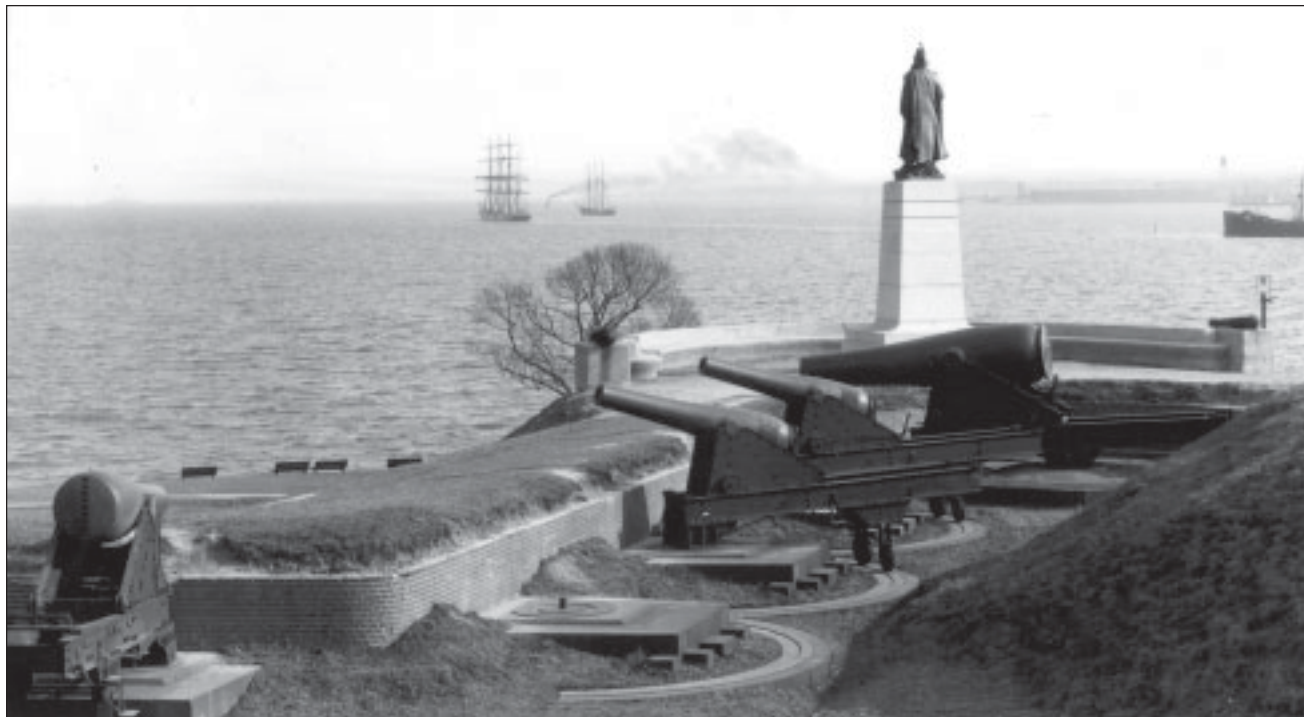
Figure 4.10. The statue memorializing Armistead was installed during the summer of 1914 and dedicated in September. The Olmsted landscape architectural firm lost the argument that the statue should occupy the emplacement of the large Rodman gun. Due to an apparent lack of funds to move the large gun, the statue was placed as shown, “clinging insecurely on the very edge of the embankment.” Fort McHenry Library Special Collections, FOMC #8996W.

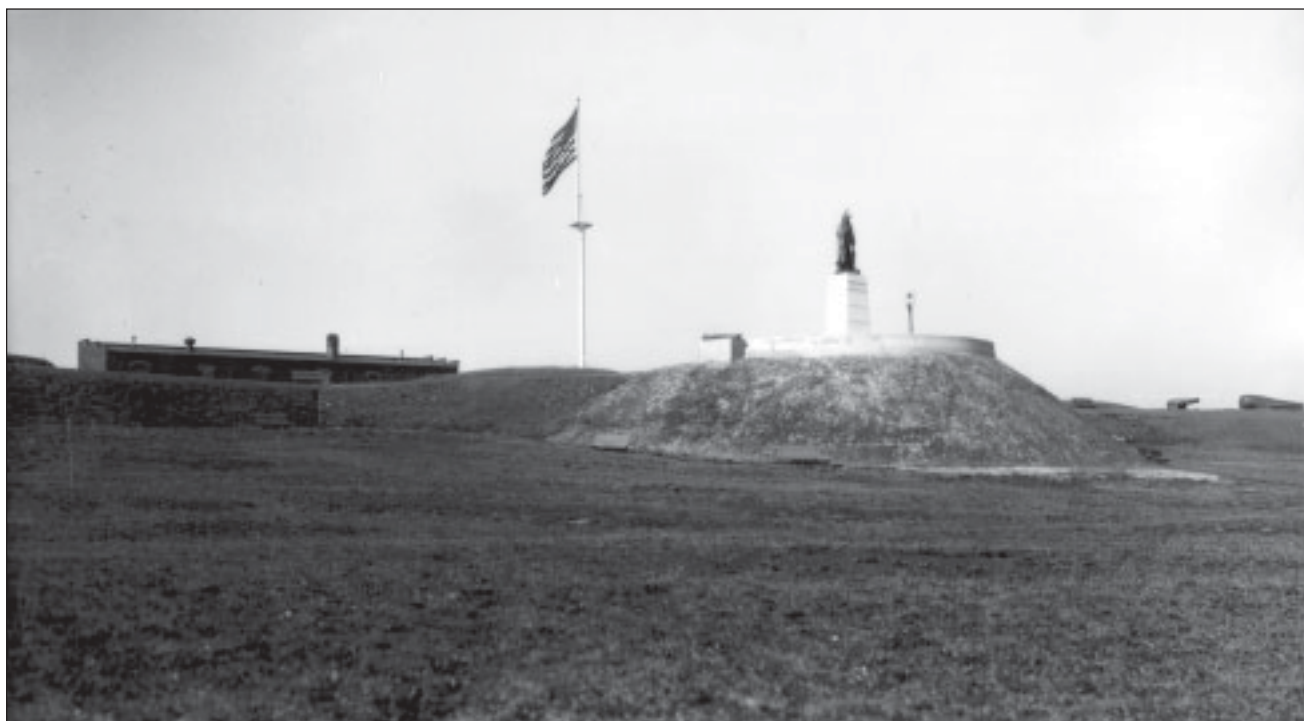
Figure 4.11. Armistead monument, c. 1915. The placement of the Armistead statue required that a large quantity of new fill be placed at the east facing bastion of the exterior battery. The seat-wall exedra accompanying the statue was short lived, and was removed by 1918. Note street light and park benches. Fort McHenry Library Special Collections, FOMC #8996R.
