CULTURAL LANDSCAPE REPORT FOR FORT MCHENRY NATIONAL MONUMENT AND HISTORIC SHRINE

SITE HISTORY, EXISTING CONDITIONS AND ANALYSIS

FORT MCHENRY NATIONAL MONUMENT AND
HISTORIC SHRINE

August 2004

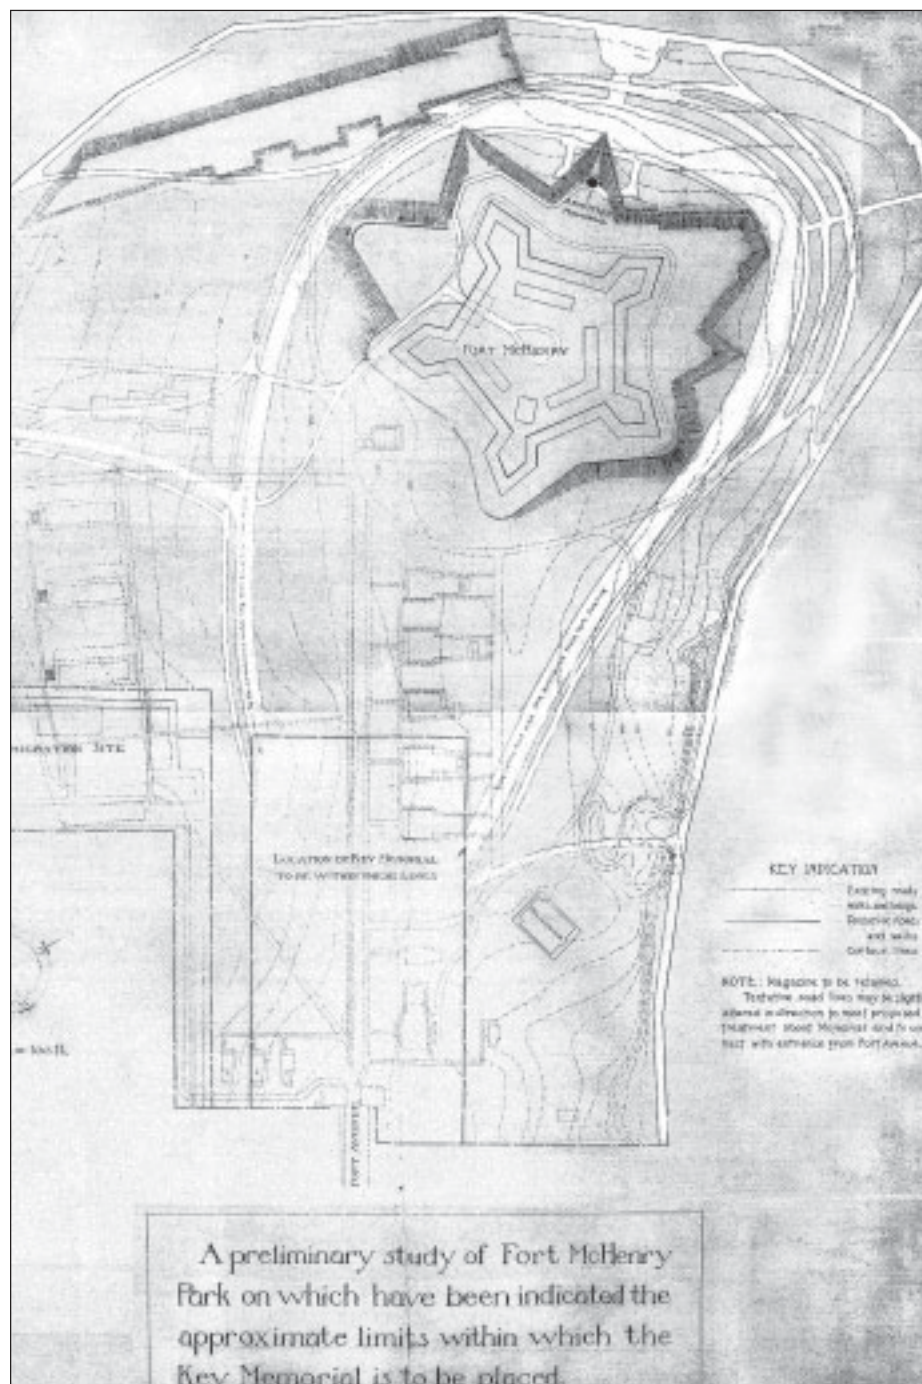
Figure 4.13. Illustration from, "Programme of Competition for a Memorial to be Erected at Fort McHenry Park, Baltimore Maryland, in Memory of Francis Scott Key and Others." War Department, Washington, 20 August 1915. This illustration indicates that the proposed memorial was intended to interface with the circuit drive proposed by the Olmsted landscape architectural firm. Library of Congress, Olmsted Associates, Microfilm Reel #93.

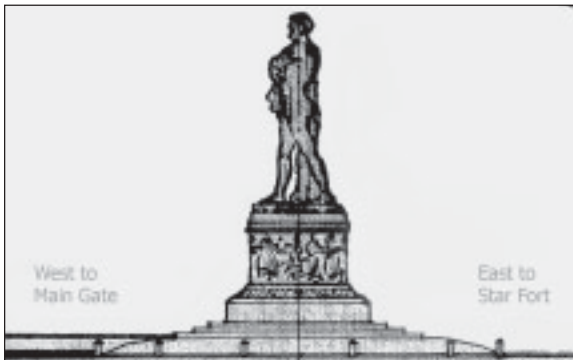
Figure 4.15. Unlike the statue honoring Armistead, which was intended to face the water, Niehaus’s Orpheus was oriented to present its more modest side to visitors entering the park from Fort Avenue. Detail from “Drawing Showing Entrance of Monument and Park Entrance,” Chas. H. Niehaus, Sculptor, Edw. V. Warren, Architect, 1917. Courtesy Frederick Law Olmsted National Historic Site, Job Number, 02437, drawing 15.

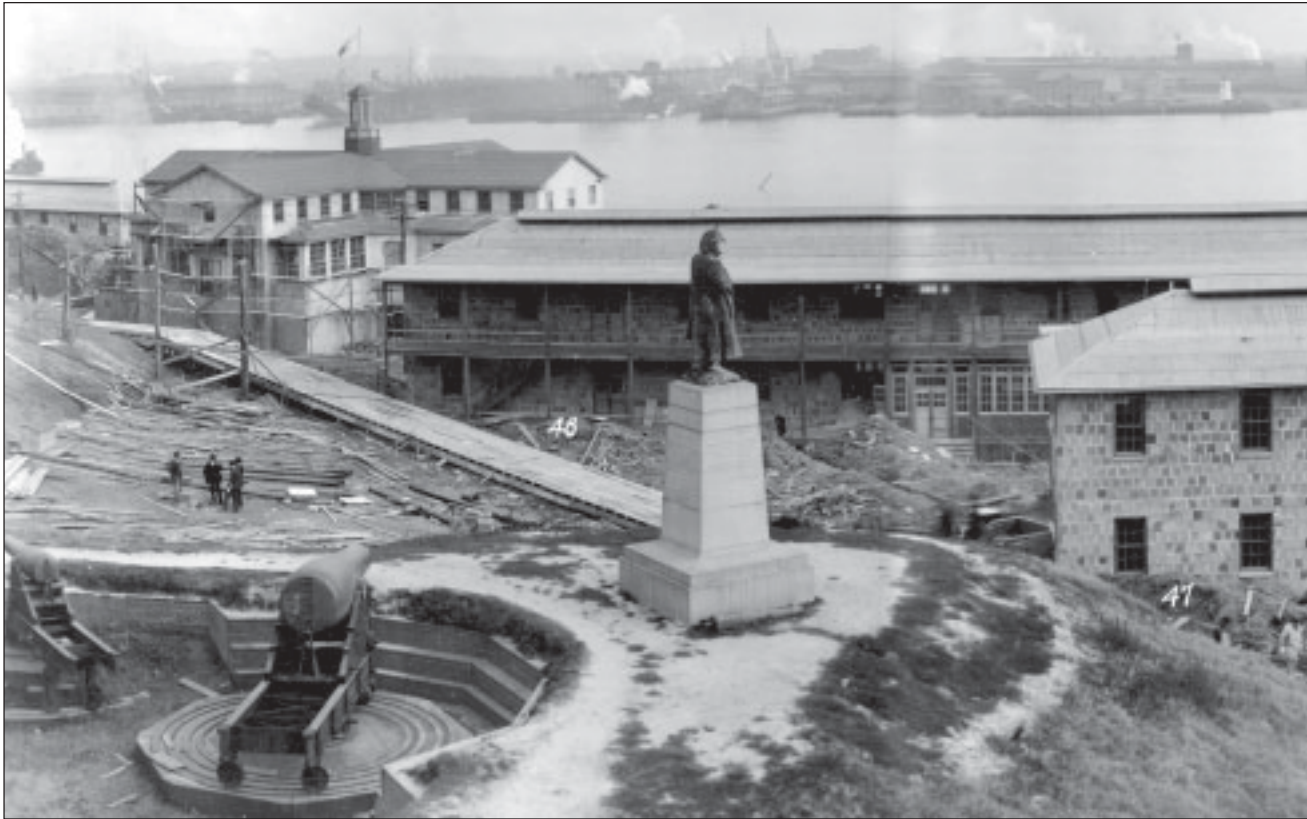
Figure 4.17. Panoramic photograph. This image is paired with Figure 4.18 to the right, depicting conditions during construction of General Hospital #2. Note absence of seat-wall exedra at Armistead statue. General Hospital #2, Fort McHenry, Balto., MD. J. Henry Miller, Inc. Contractor, 1918. Fort McHenry Library Special Collections, FOMC #2368.

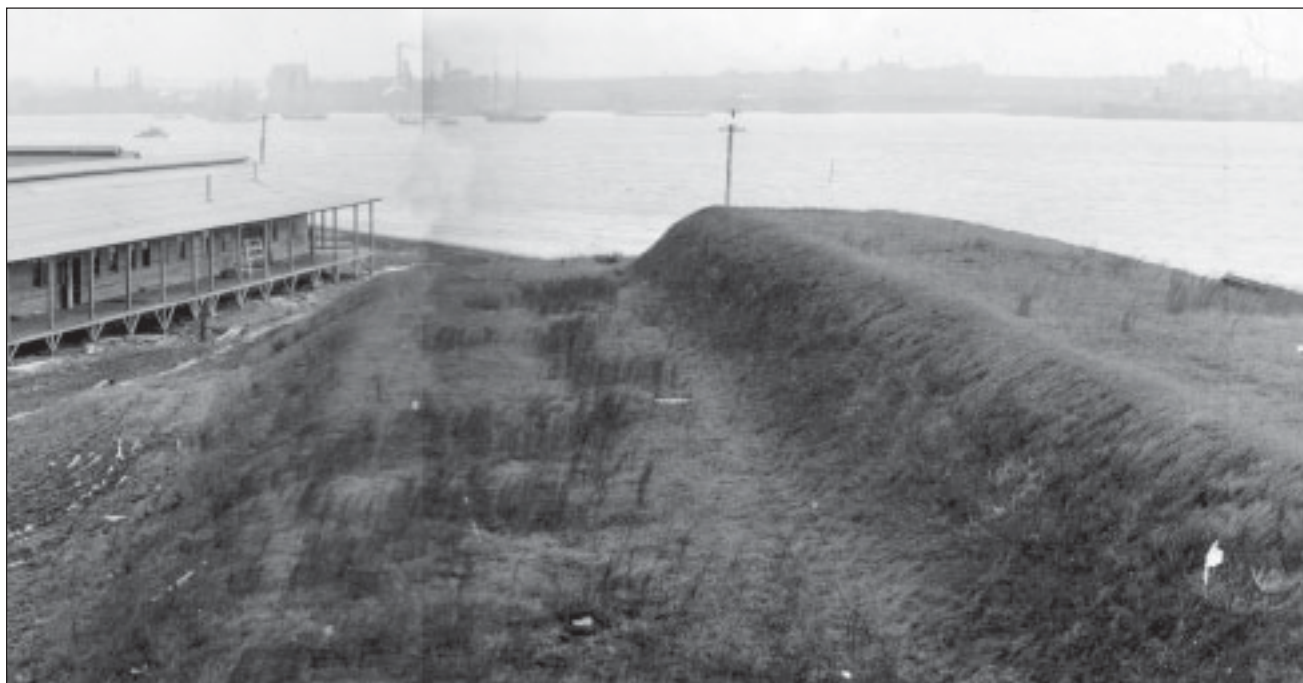
Figure 4.20. Panoramic photograph. This image is paired with Figure 4.19 to the left, depicting conditions during construction of General Hospital #2. Note unfinished water battery begun during the 1870s. General Hospital #2, Fort McHenry, Balto., MD. J. Henry Miller, Inc. Contractor, #57 15 March 1918. Fort McHenry Library Special Collections FOMC #2348.

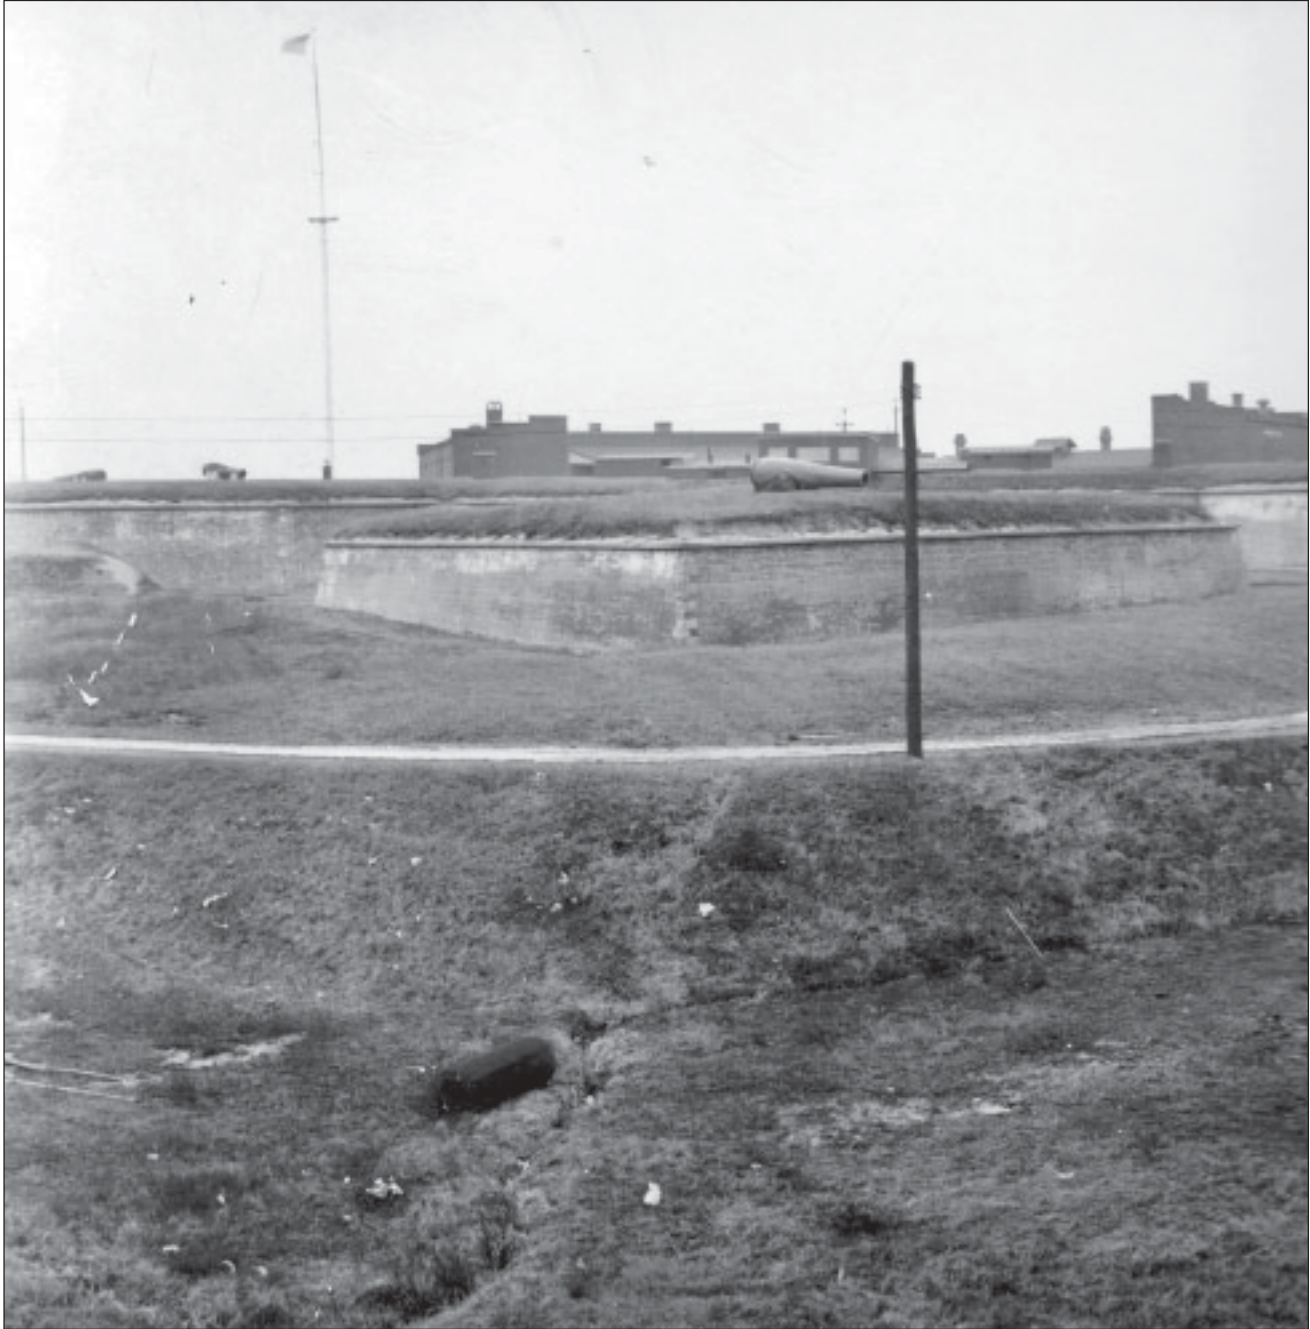
Figure 4.21. Panoramic photograph. This image is paired with Figure 4.22 to the right, depicting landscape conditions during construction of General Hospital #2. Note depth of the dry ditch, still intact in front of the Ravelin. This was removed by the NPS in 1962 during regrading work part of the removal of the War Department's 1930 parking lot. General Hospital #2, Fort McHenry, Balto., MD. J. Henry Miller, Inc. Contractor, 1918. Fort McHenry Library Special Collections, FOMC #2347.

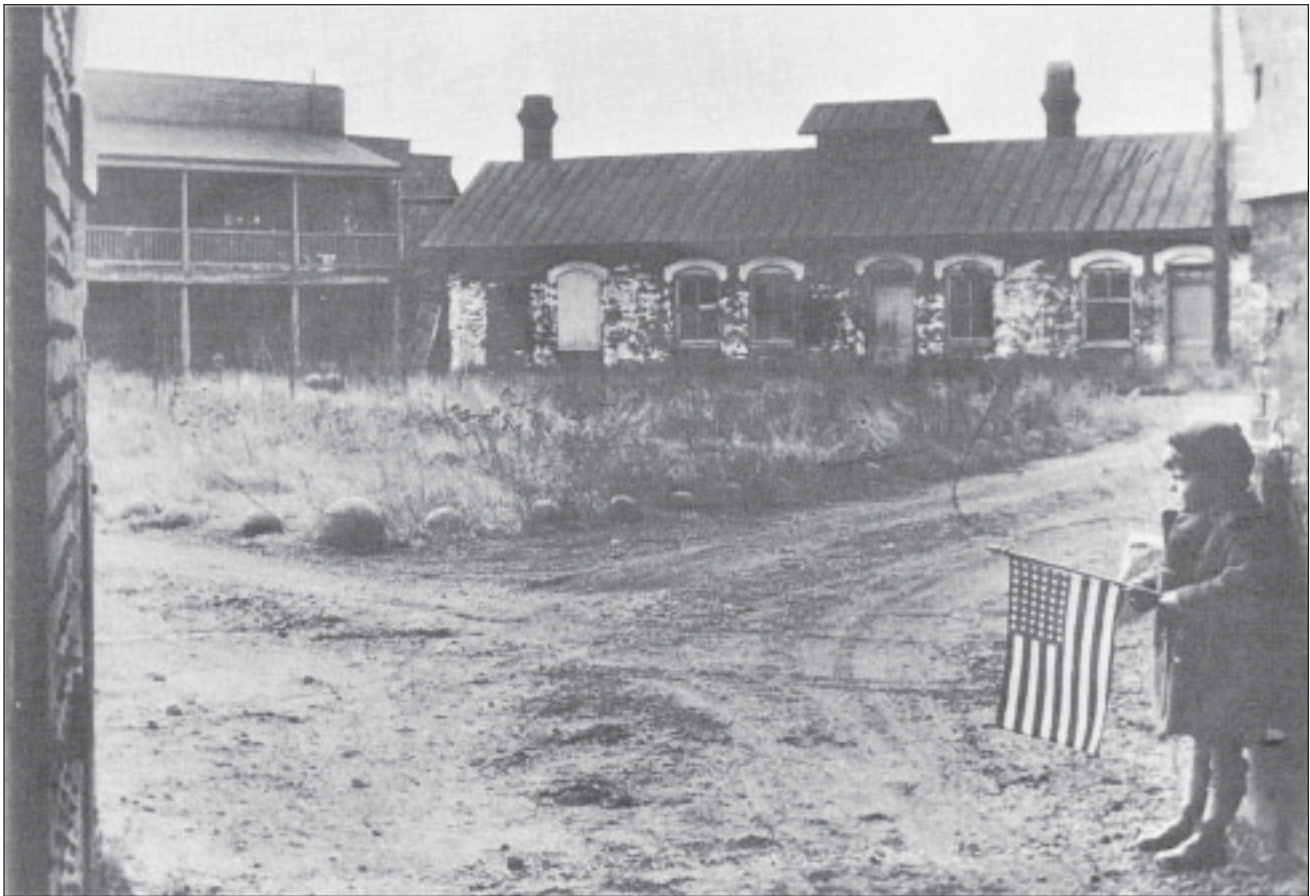
Figure 4.28. This photograph published during 1925 in The [Baltimore] Sun newspaper shows the poor condition of the landscape inside Fort McHenry's Star Fort. Fort McHenry Library Special Collections.

Figure 4.28. This photograph published during 1925 in The [Baltimore] Sun newspaper shows the poor condition of the landscape inside Fort McHenry's Star Fort. Fort McHenry Library Special Collections.

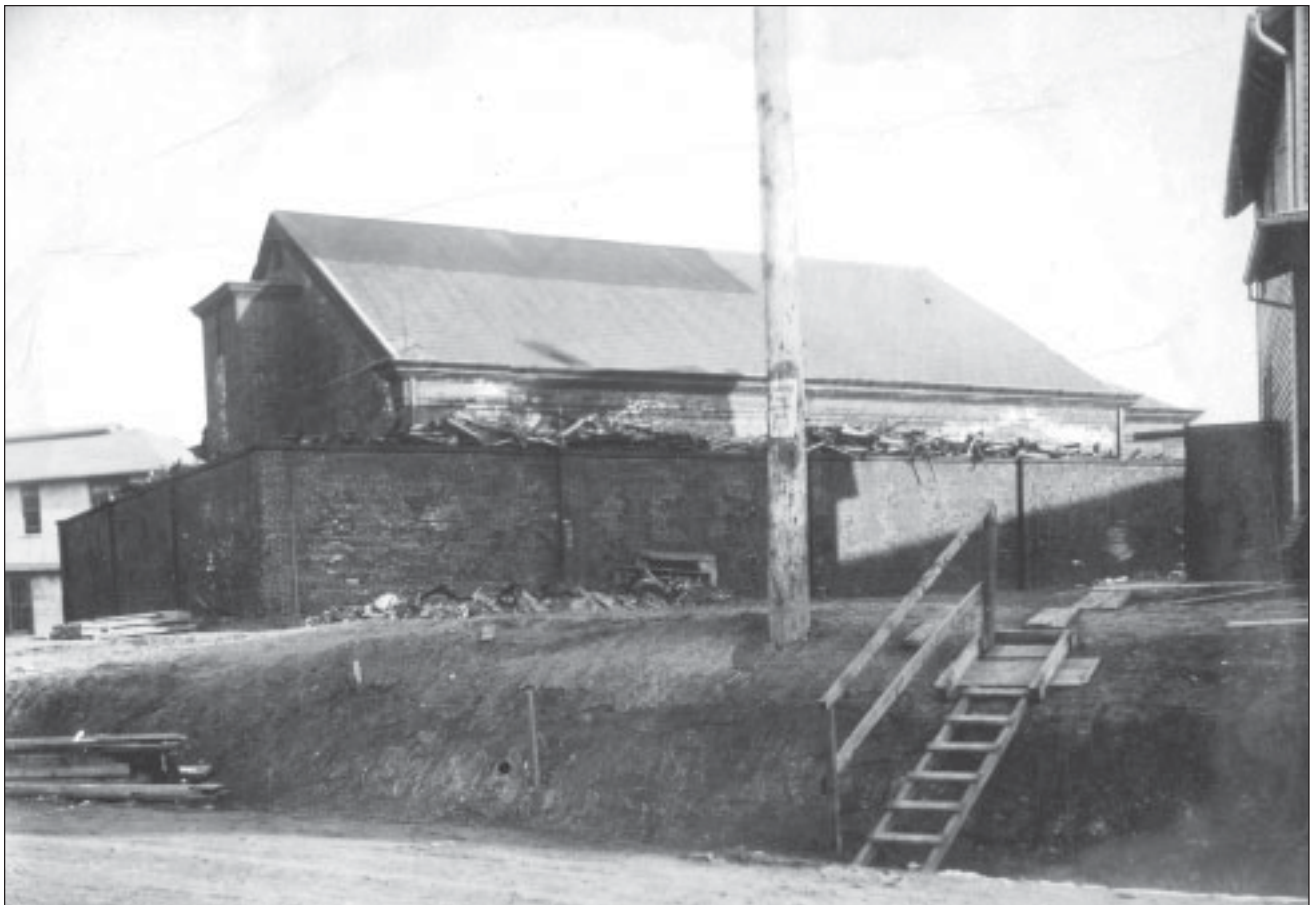
Figure 4.29. Photograph of southwest portion of Fort McHenry c. 1924. The handbill posted on the utility pole reads, "Labor Will Win the War." Note accumulation of refuse within outer Magazine perimeter wall. Fort McHenry Library Special Collections, FOMC 5468.

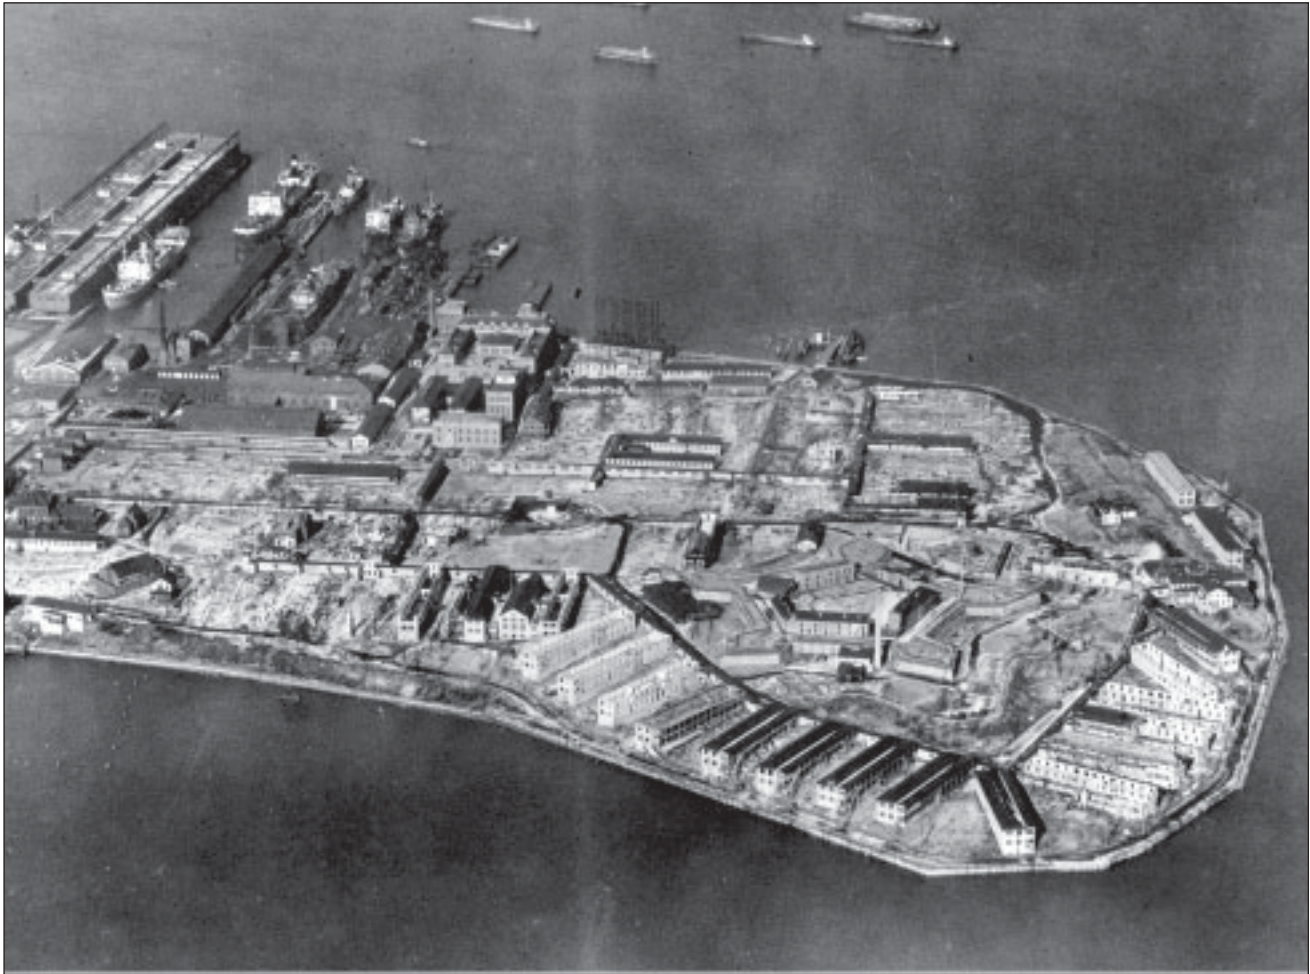
Figure 4.30. This 1926 oblique aerial photograph captures Fort McHenry during the process of demolishing unused hospital buildings. Fort McHenry Library, Special Collections.

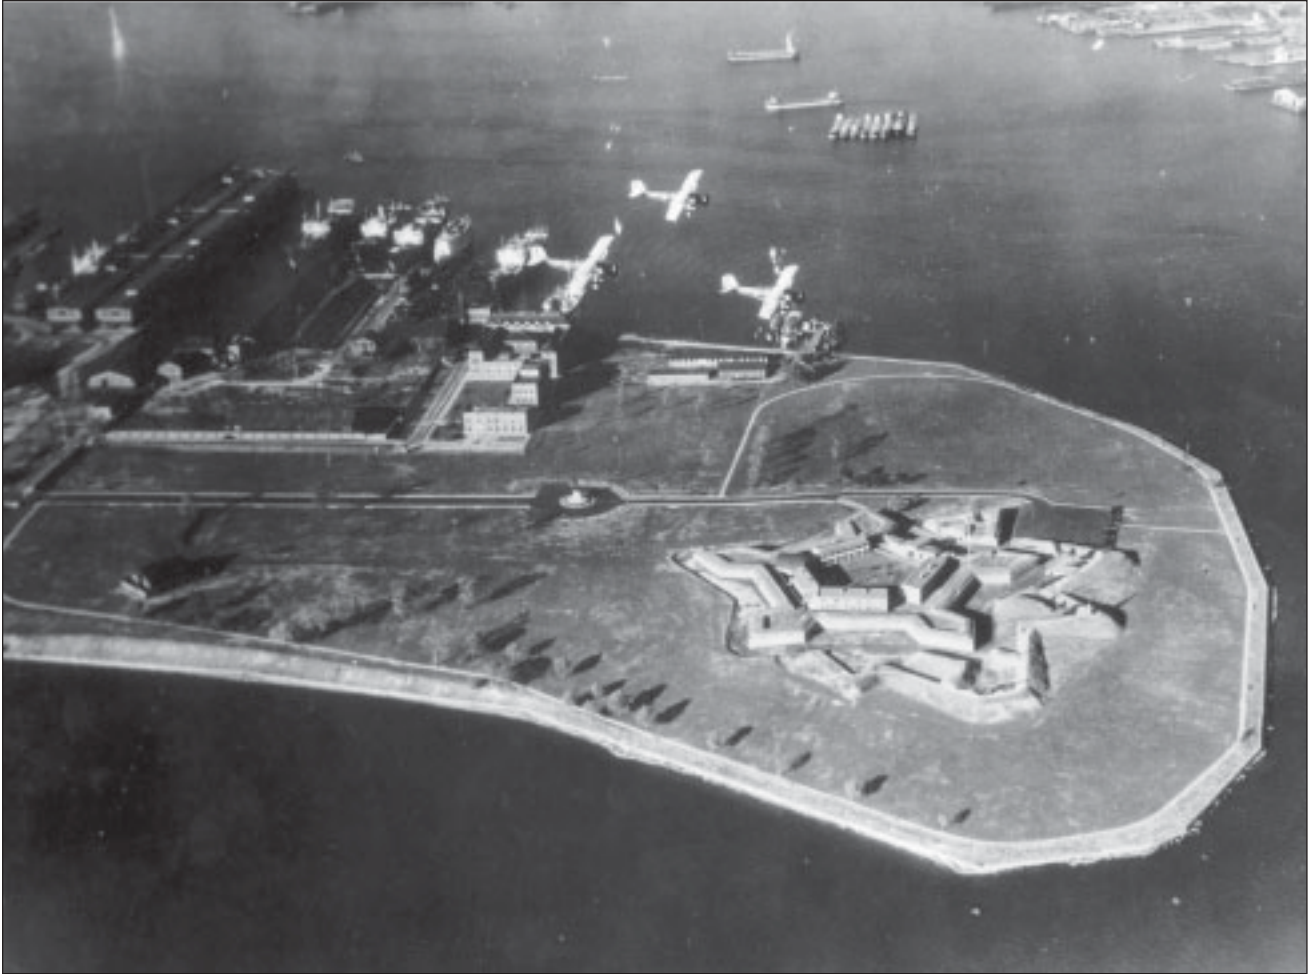
Figure 4.31. This c. 1930 oblique aerial photograph shows Fort McHenry near the completion of the U.S. Army's site restoration and park development program. The overall character of the site would remain essentially as shown here until the National Park Service MISSION-66 development program of 1962. Fort McHenry Library, Special Collections.

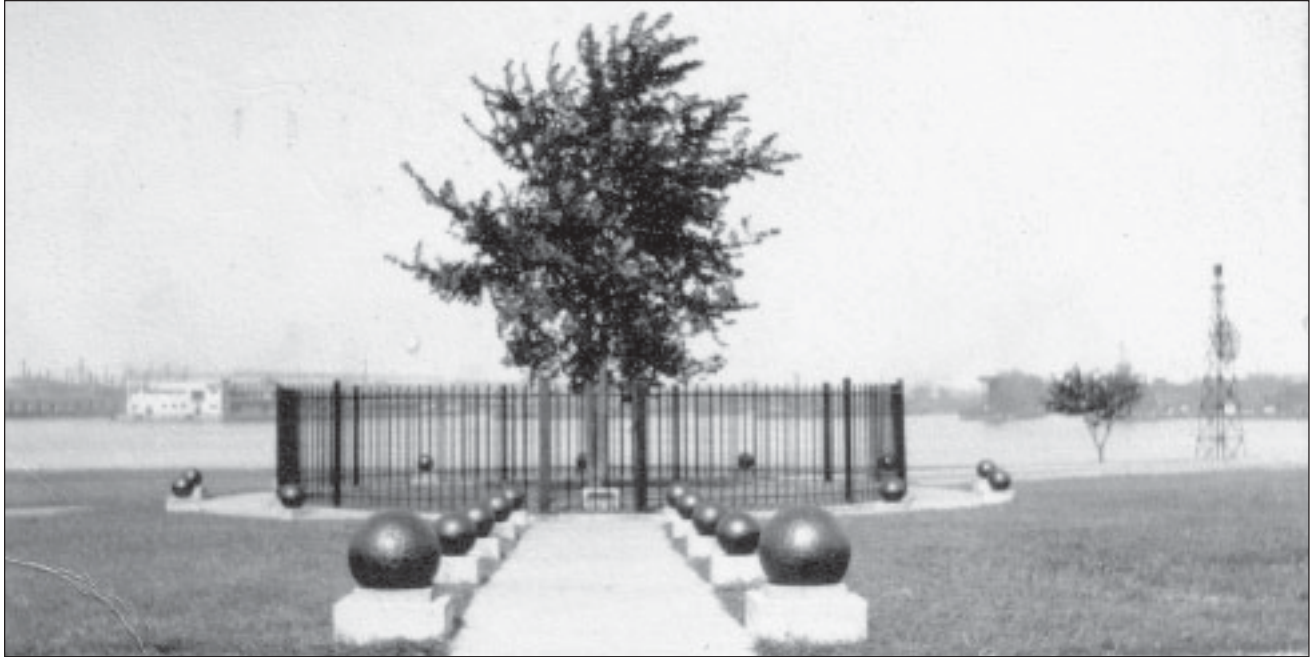
Figure 4.33. An American elm, grown from a cutting taken from the tree in Cambridge, Massachusetts where General Washington took command of Revolutionary forces was planted at Fort McHenry, the Army caretakers cooperating with interested local parties on landscape matters. The tree survived until 1995. Image c. 1933. Fort McHenry Library Special Collections, FOMC #4039.

One month after President Herbert Hoover signed legislation designating Francis Scott Key's *Star-Spangled Banner* as the National Anthem, an American Elm was planted that had been propagated from a cutting taken from a tree on the Cambridge, Massachusetts commons (*Figure 4.33*). It was under the tree in Cambridge that George Washington assumed command of revolutionary forces then fighting against Great Britain.¹⁴¹

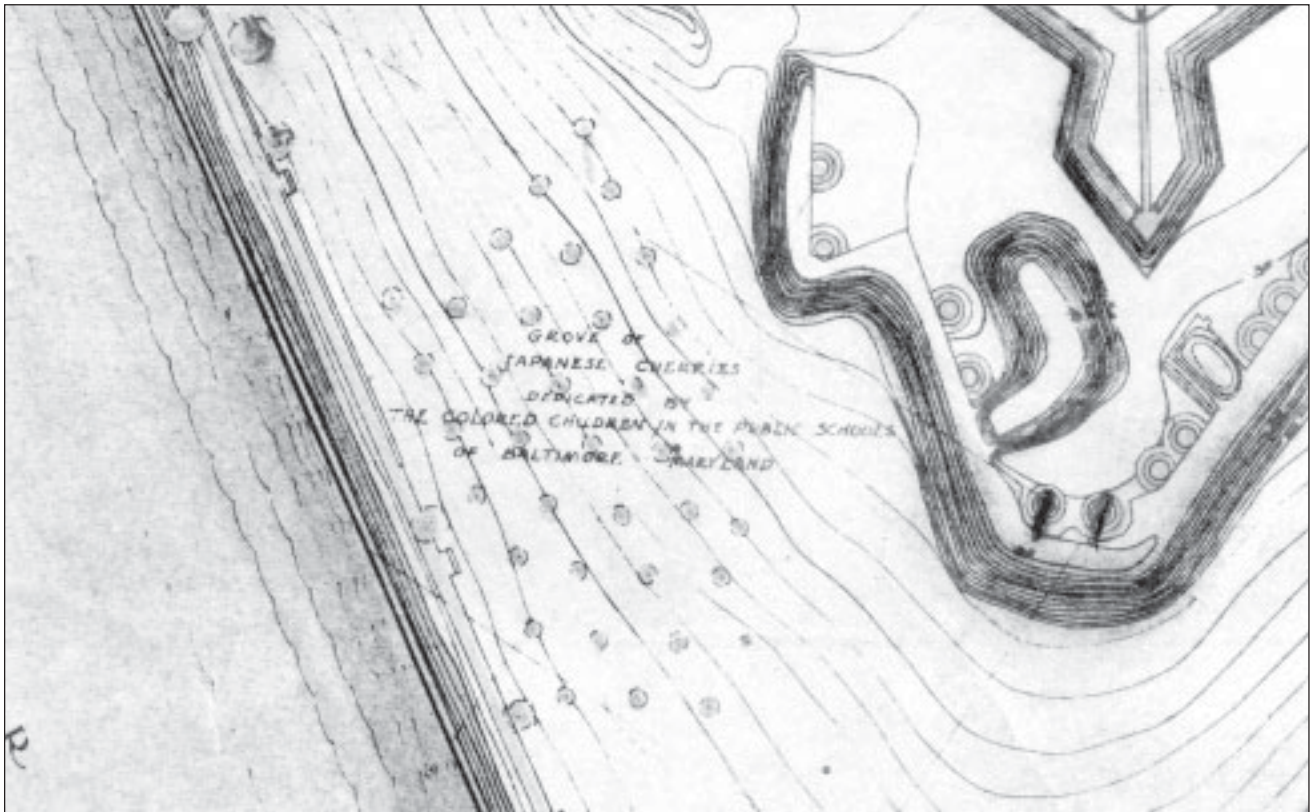
Figure 4.34. Detail from 1939 Existing Conditions Plan of Fort McHenry, part of the NPS Master Plan. Prior to transfer to the National Park Service, during ceremonies commemorating the bicentennial of George Washington's birth, on 24 October 1931, two groves of cherry trees were planted at Fort McHenry. The prevailing racial doctrine of "Separate but Equal" was reflected on site in that one tree was provided for each public school, yet the trees were planted in two separate groves on either side of the historic Star Fort. Fort McHenry Library, Special Collections.

Figure 4.34. Detail from 1939 Existing Conditions Plan of Fort McHenry, part of the NPS Master Plan. Fort McHenry Library, Special Collections.

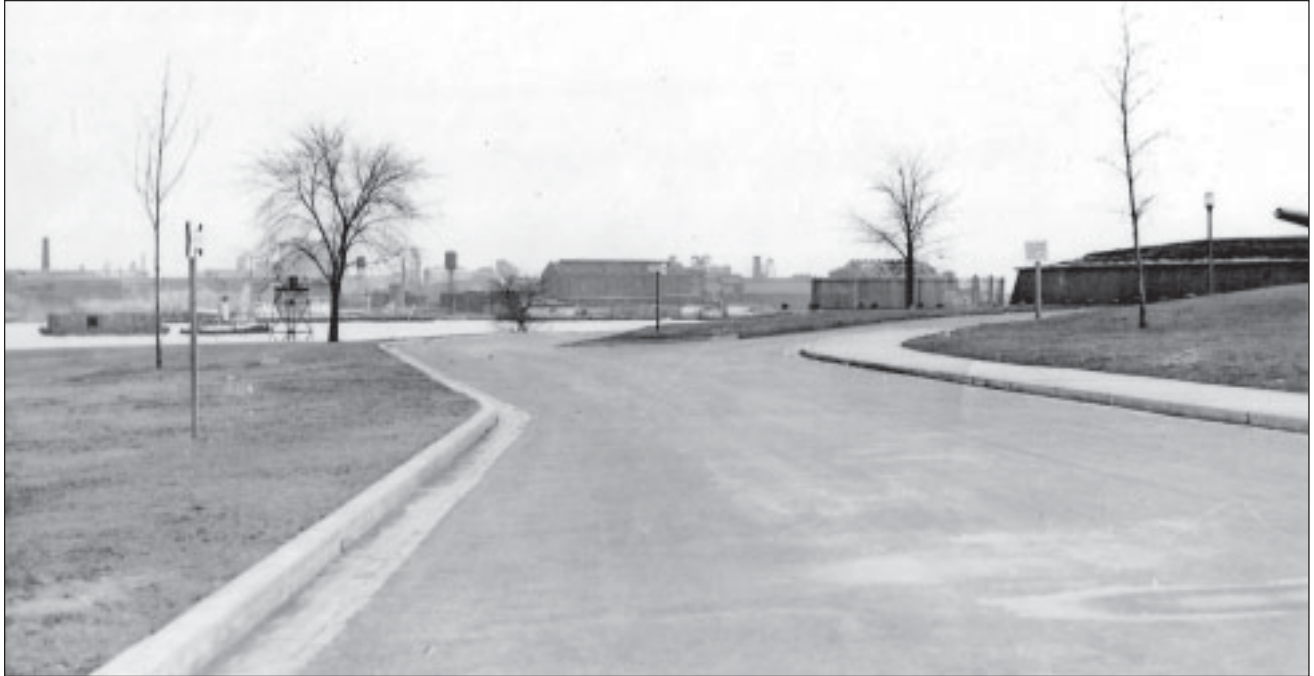
Figure 5.1. Photograph of entrance drive leading to parking lot c. 1934. Note concrete curbing with brick gutter, arrow shaped directional signage and cast iron street light fixtures. Also note Washington Elm and protective iron fencing. Fort McHenry Library Special Collections.

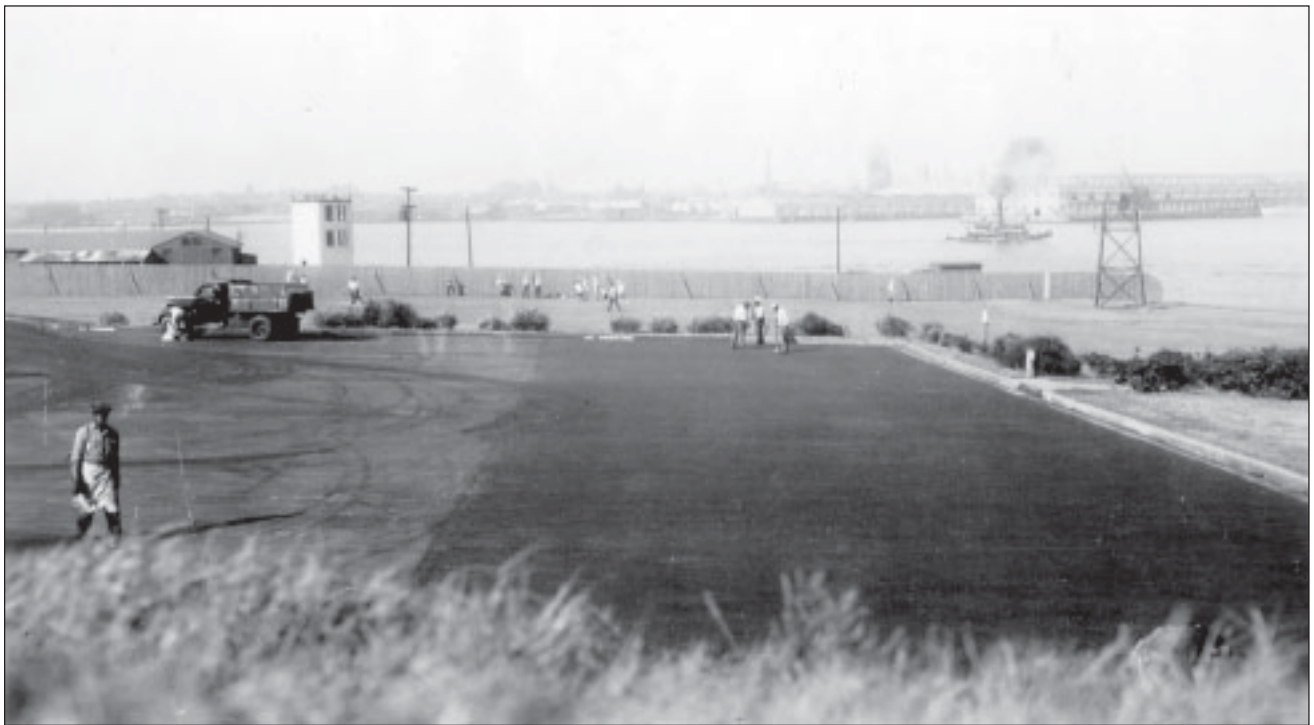
Figure 5.2. Photograph of fifty-car parking lot being resealed c. 1934. Note board fencing surrounding Dept. of Engineers parcel. Fort McHenry Library Special Collections.

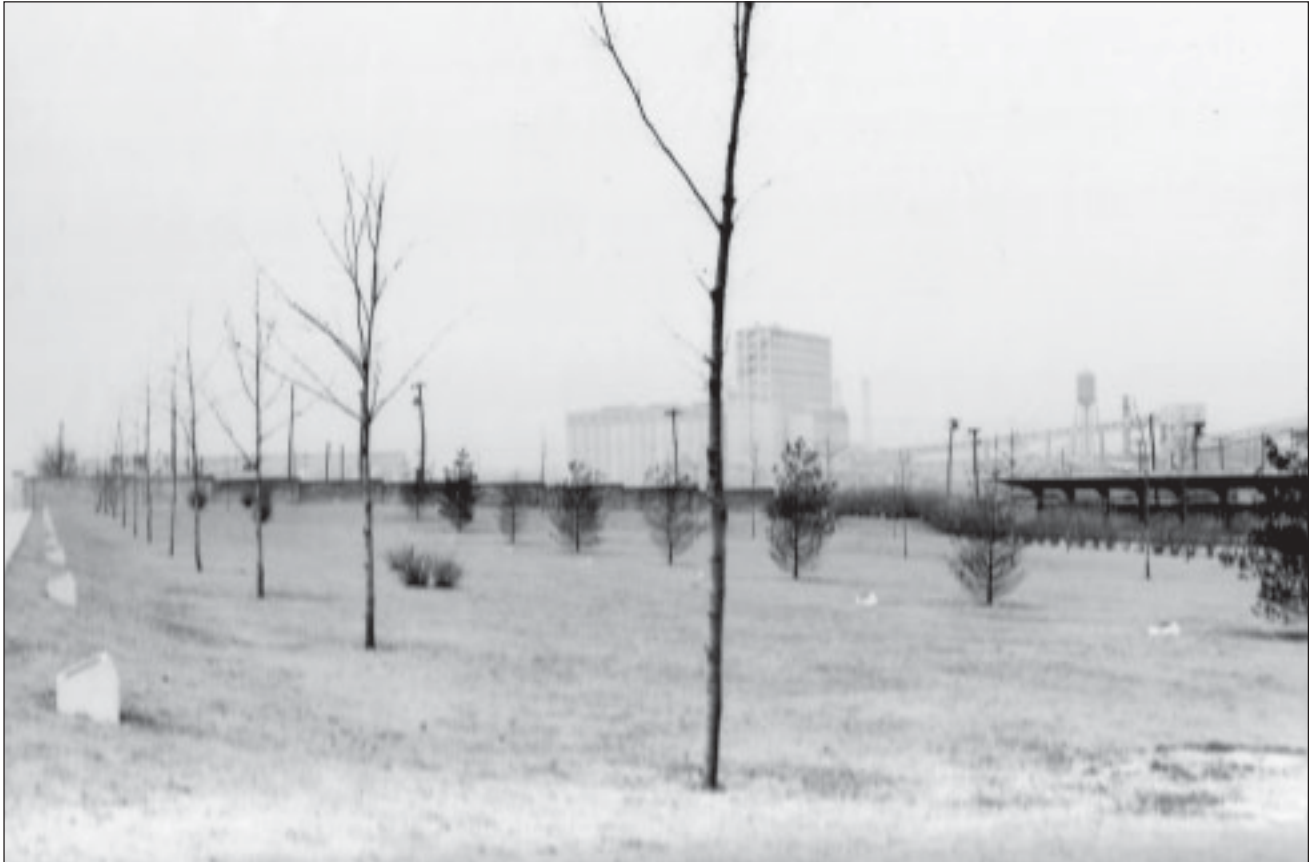
Figure 5.3. Photograph looking northwest from Key Memorial c.1934. Note young tree plantings accompanied by concrete mounted memorial plaques. Trees lining driveway were red oaks, further north, white pines were chosen both to screen off-site development and to highlight the Star Fort when seen from the river. Fort McHenry Library Special Collections.

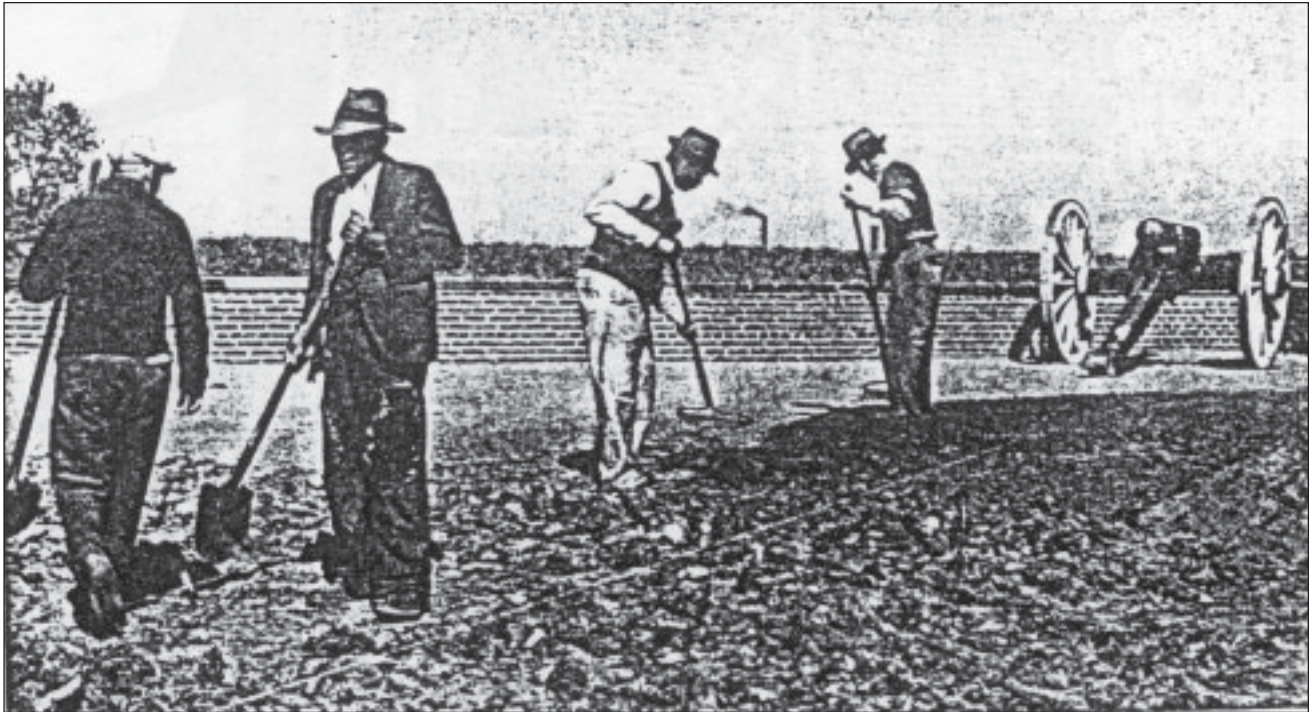
Figure 5.5. Most of the relief labor directed to Fort McHenry as part of President Roosevelt’s “New Deal” was concentrated at the historic Star Fort and areas east of the 1814 reservation boundary. Work performed was predominantly unskilled or semi-skilled, such as grading, painting, pointing mortar joints in brick walls, and assorted landscape related tasks utilizing laborers hired through local WPA agencies. Skilled trades were obtained under contract, such as the construction of public restrooms inside a historic barracks building. Superintendent’s Monthly Narrative Report for July 1938. Fort McHenry Library Special Collections.

federal economic relief funds. Over \$150,000 in WPA funding for relief labor was directed toward Fort McHenry during 1938 alone (*Figure 5.5 and 5.6*).

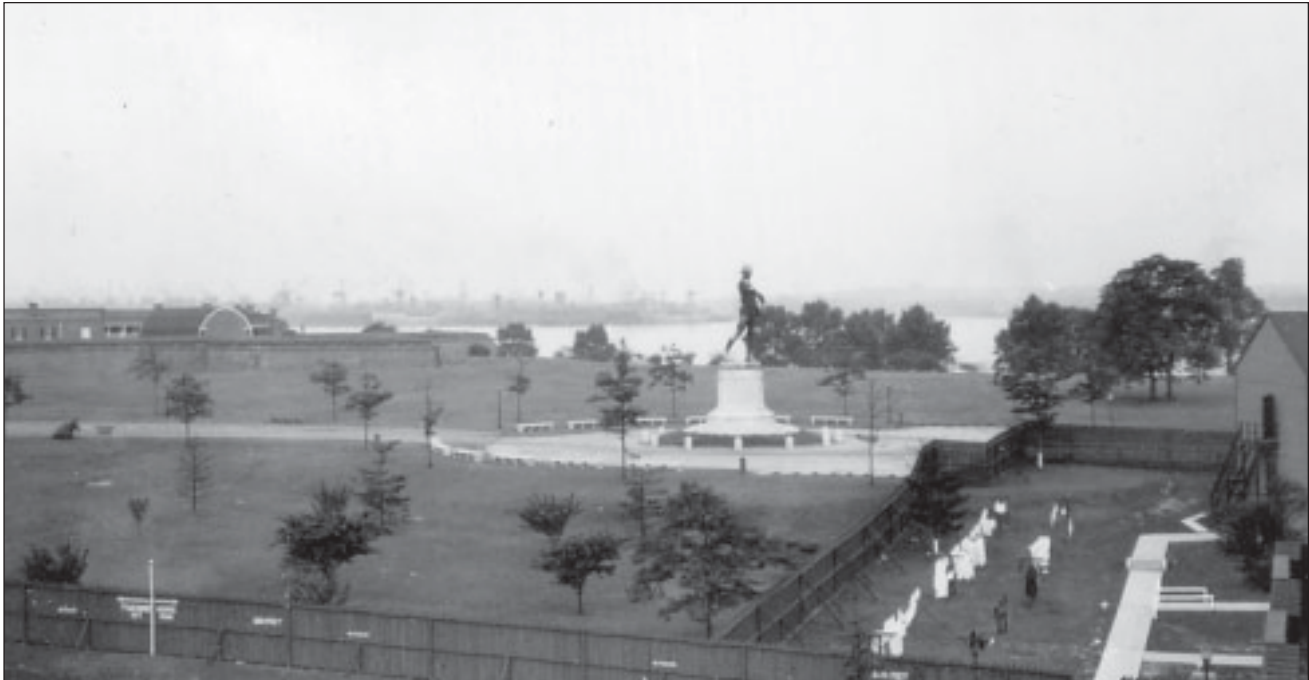
Figure 5.10. Looking southeast from Coast Guard Training Station, November 1944. Late in the war, the area north of the central driveway was occupied with a compound constructed by the Navy Department. The buildings were former CCC barracks in West Virginia, dismantled and transported to Fort McHenry. Fort McHenry Library Special Collection No. 46, U.S. Coast Guard.

On 6 July 1944, one month following the Allied invasion of Normandy, Rader's brief annual report documents an additional use permit granted to the Navy Department. This was for an additional four acres of Fort McHenry real estate, "adjacent to the Main Entrance gate." The Navy's development of this area was completed in February of 1944, creating the "Fort McHenry Navy Receiving Station," with the capacity to accommodate around 300 new recruits at a time (*Figure 5.10 and 5.11*).¹⁵⁹ The buildings were former CCC barracks moved from a closed camp in West Virginia.

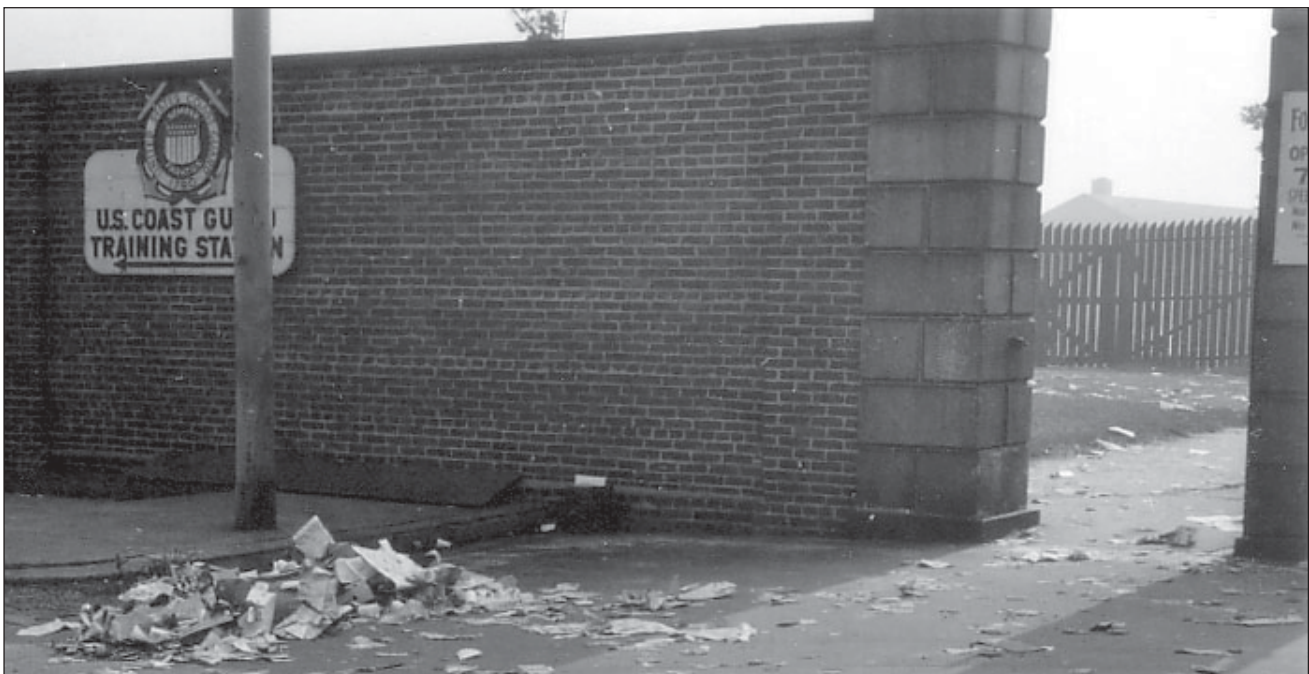
Figure 5.11. Boundary wall and gate at Fort Avenue, November 1944. This image indicates access to the Coast Guard Training Station via the access drive and right-of-way formerly serving the Treasury Department. The fence enclosure north of the main driveway is also visible through the gateway. This view was taken following a large public gathering at the park. Fort McHenry Library Special Collection No. 46, U.S. Coast Guard.

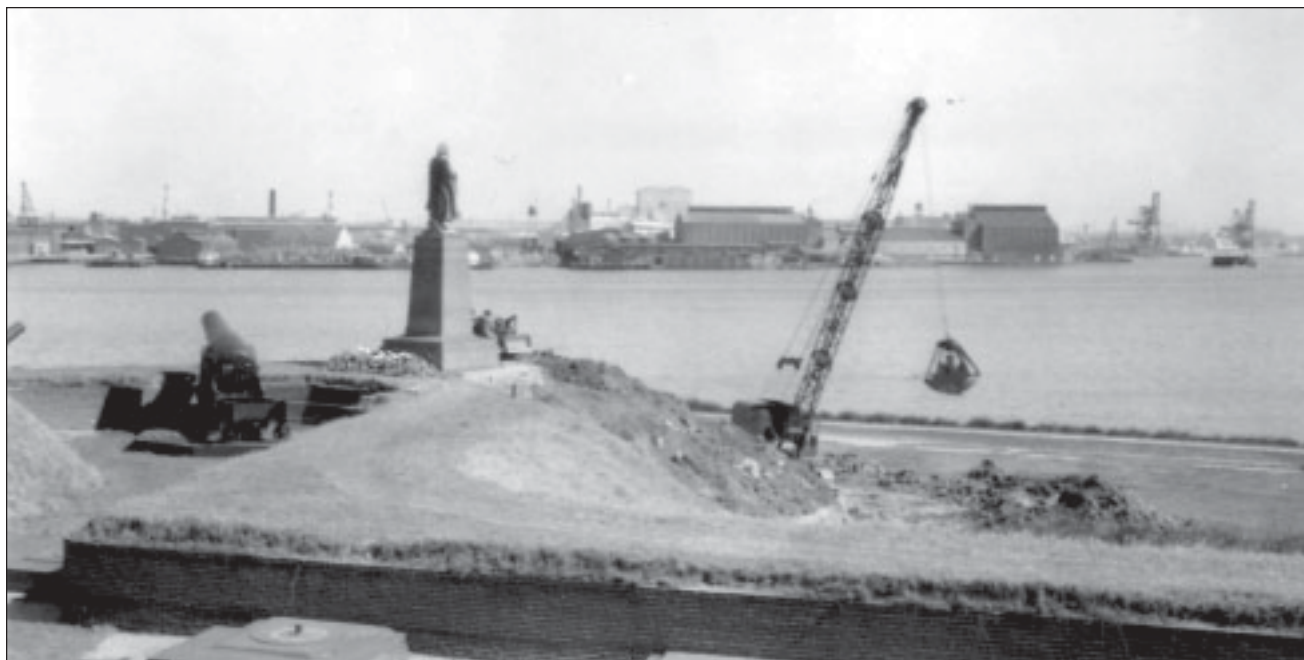
Figure 5.12. View of repairs underway to slope of exterior battery, April 1950. From, "Final Report on Repairing Slides in the Outer Ramparts..." 9 May 1950. Fort McHenry Library Special Collections.

Figure 5.12. View of repairs underway to slope of exterior battery, April 1950. From, "Final Report on Repairing Slides in the Outer Ramparts..." 9 May 1950. Fort McHenry Library Special Collections.

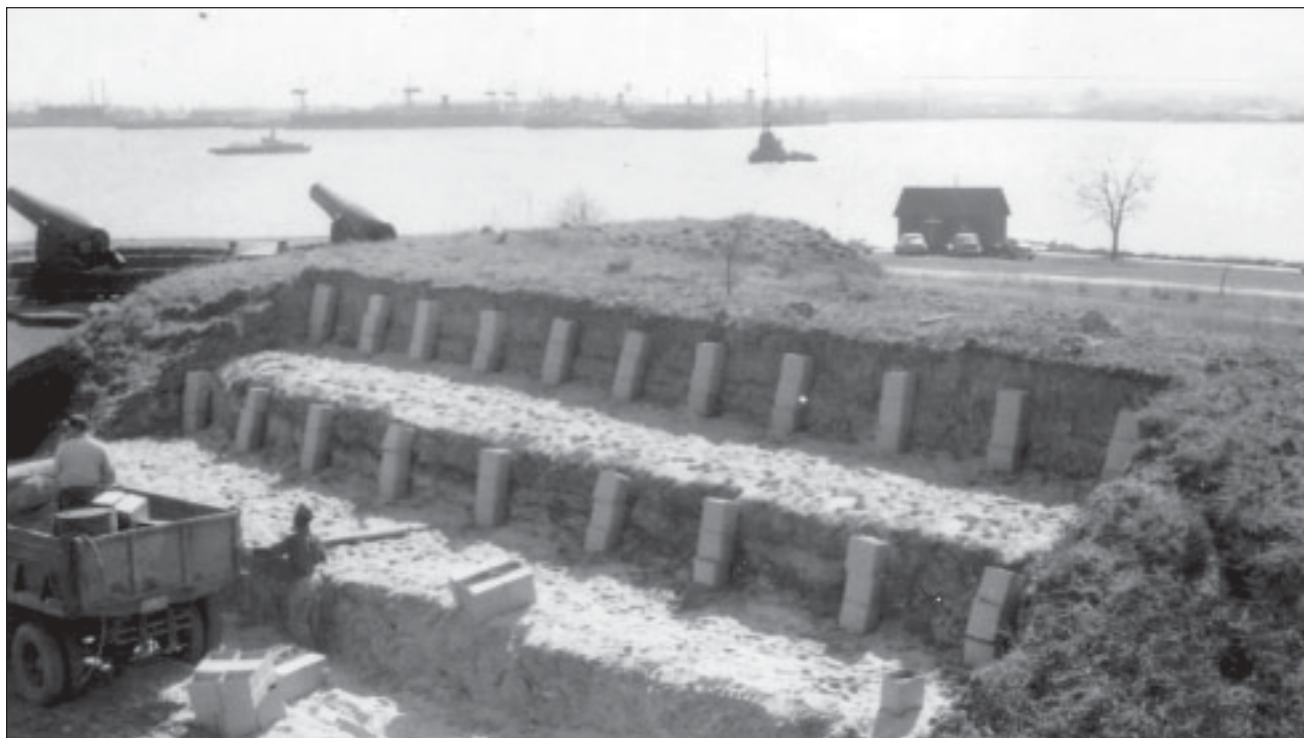
Figure 5.13. View of repairs and drainage improvements to fill covering Magazine 3, April 1950. This image shows the installation of interior drainage structures intended to reduce soil moisture. Small building at upper right is thought to be a temporary construction office. From, "Final Report on Repairing Slides in the Outer Ramparts..." 9 May 1950. Fort McHenry Library Special Collections.

Figure 5.13. View of repairs and drainage improvements to fill covering Magazine 3, April 1950. From, "Final Report on Repairing Slides in the Outer Ramparts..." 9 May 1950. Fort McHenry Library Special Collections.
