CULTURAL LANDSCAPE REPORT FOR FORT MCHENRY NATIONAL MONUMENT AND HISTORIC SHRINE

SITE HISTORY, EXISTING CONDITIONS AND ANALYSIS

FORT MCHENRY NATIONAL MONUMENT AND
HISTORIC SHRINE

August 2004

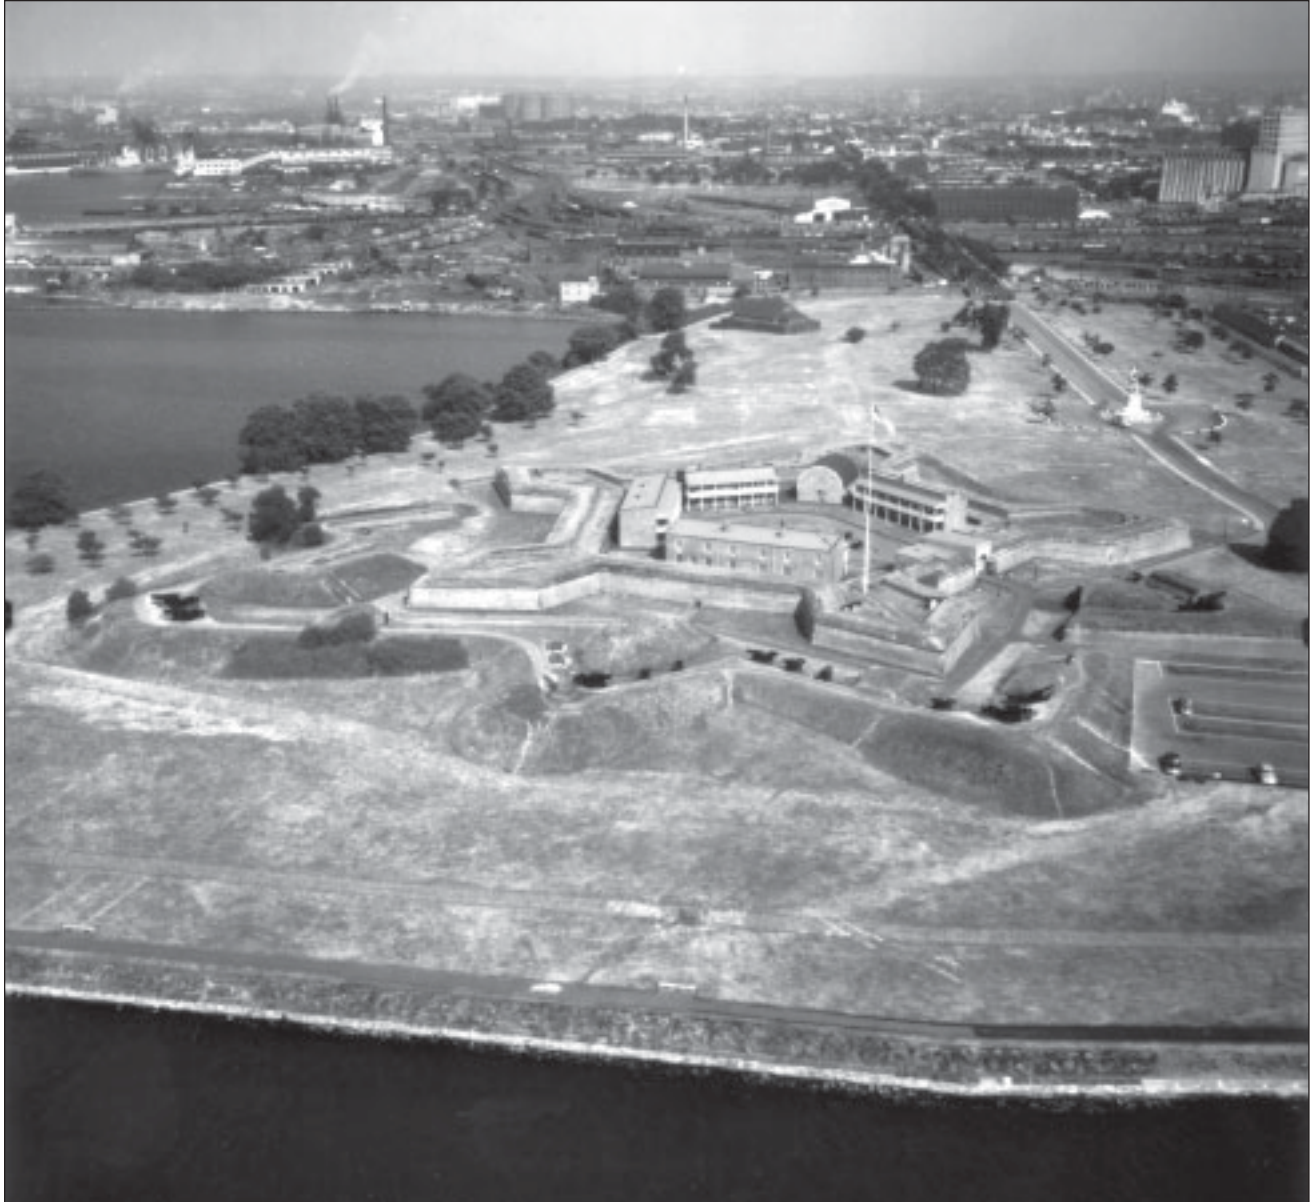
Figure 5.16. Aerial view of Fort McHenry and historic Star Fort, 26 July 1954. Outlines of former hospital buildings, post roadways and other features become visible during periods of dry weather. Shortly following the date of this photograph, the park would begin a new planning effort leading to park development under the MISSION-66 program. Fort McHenry Library Special Collections.

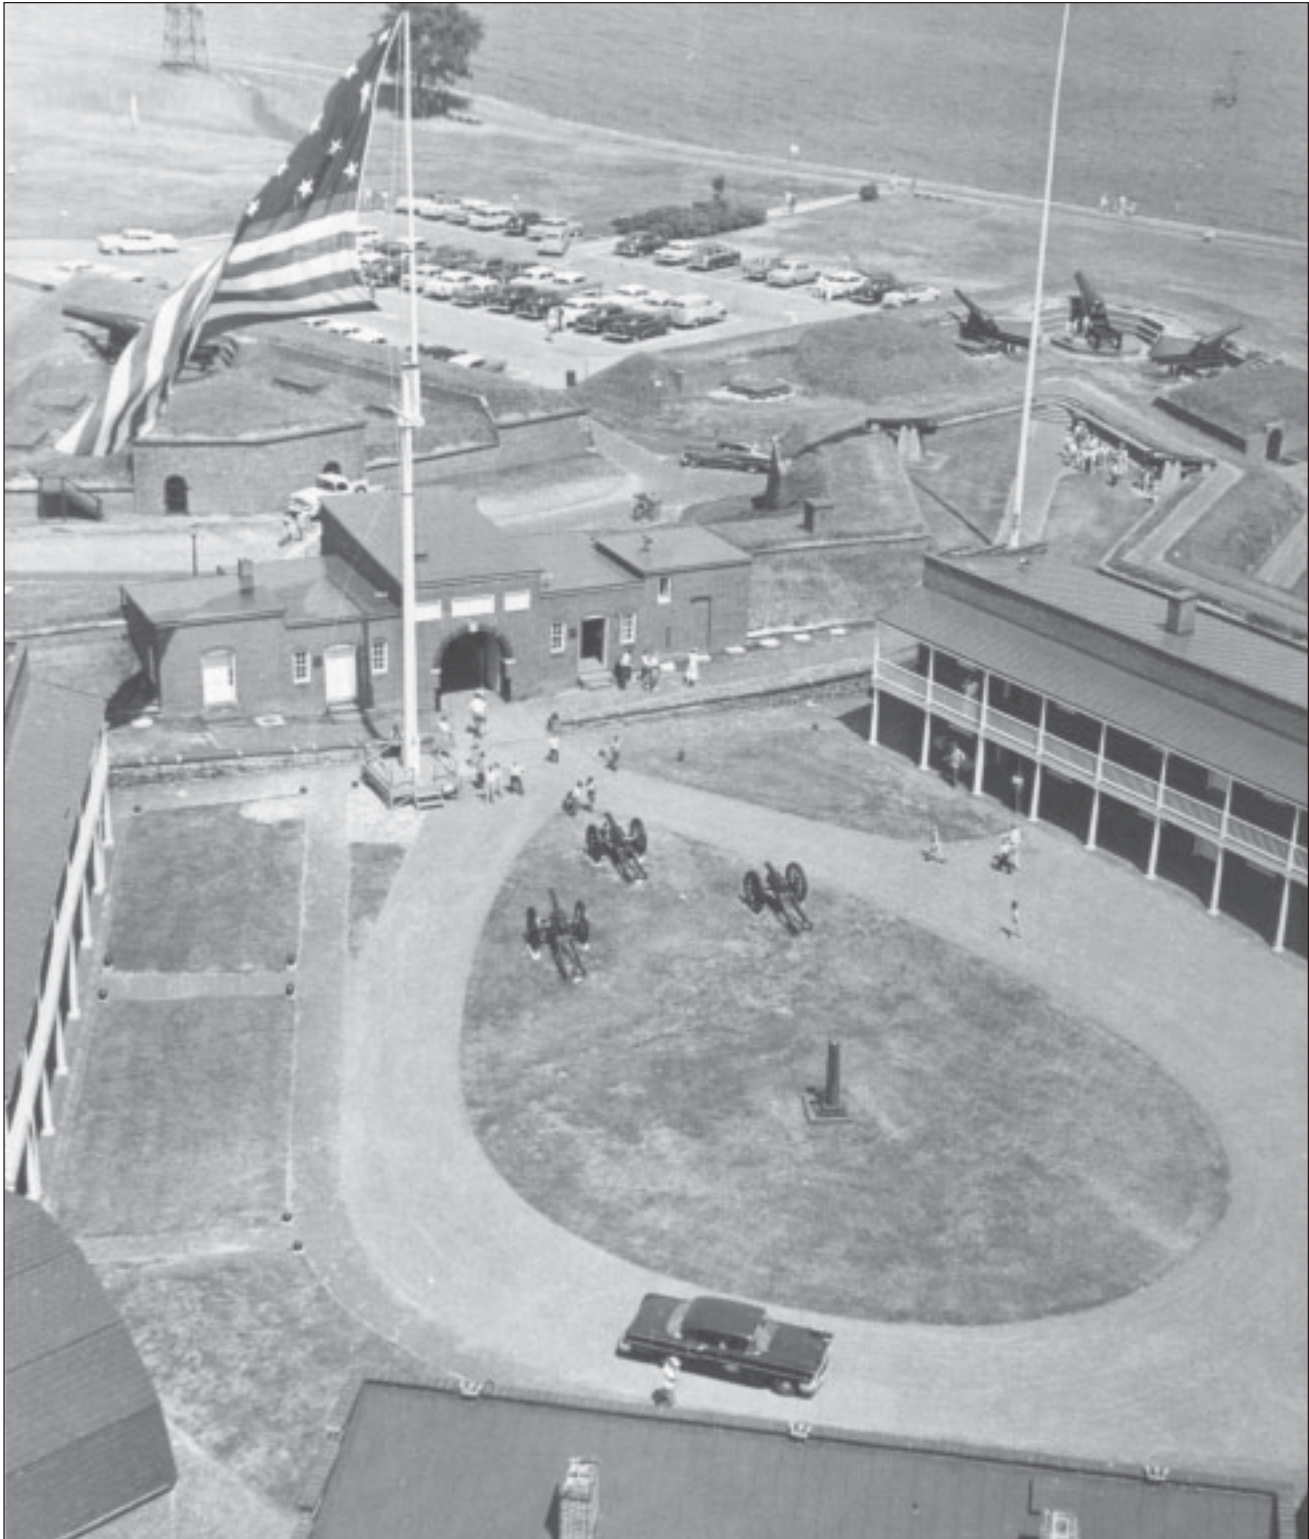
Figure 5.17. Photograph of Star Fort in 1959, shortly after the reconstruction of the flagstaff identified on the 1803 plan and verified through archeological investigation. Flagstaff at northeast bastion had yet to be removed by the date of this photograph. Photographer, Murray E. Ward. Fort McHenry Library Special Collections.

Excited by the location of the 1803 flagstaff base as reported in the prospectus, a justification was soon made for its restoration through the analysis of a watercolor painting of the period and other documents, claiming that this was the location of the flagstaff during the 1814 bombardment. Drawings were prepared and bids were solicited for the reconstruction and restoration of the flagstaff on 20 April 1959 (*Figure 5.17*). Following Alaska's achievement of statehood that January, a ceremony raising the very first 49-star United States flag atop the reconstructed flagstaff was held on 4 July 1959.

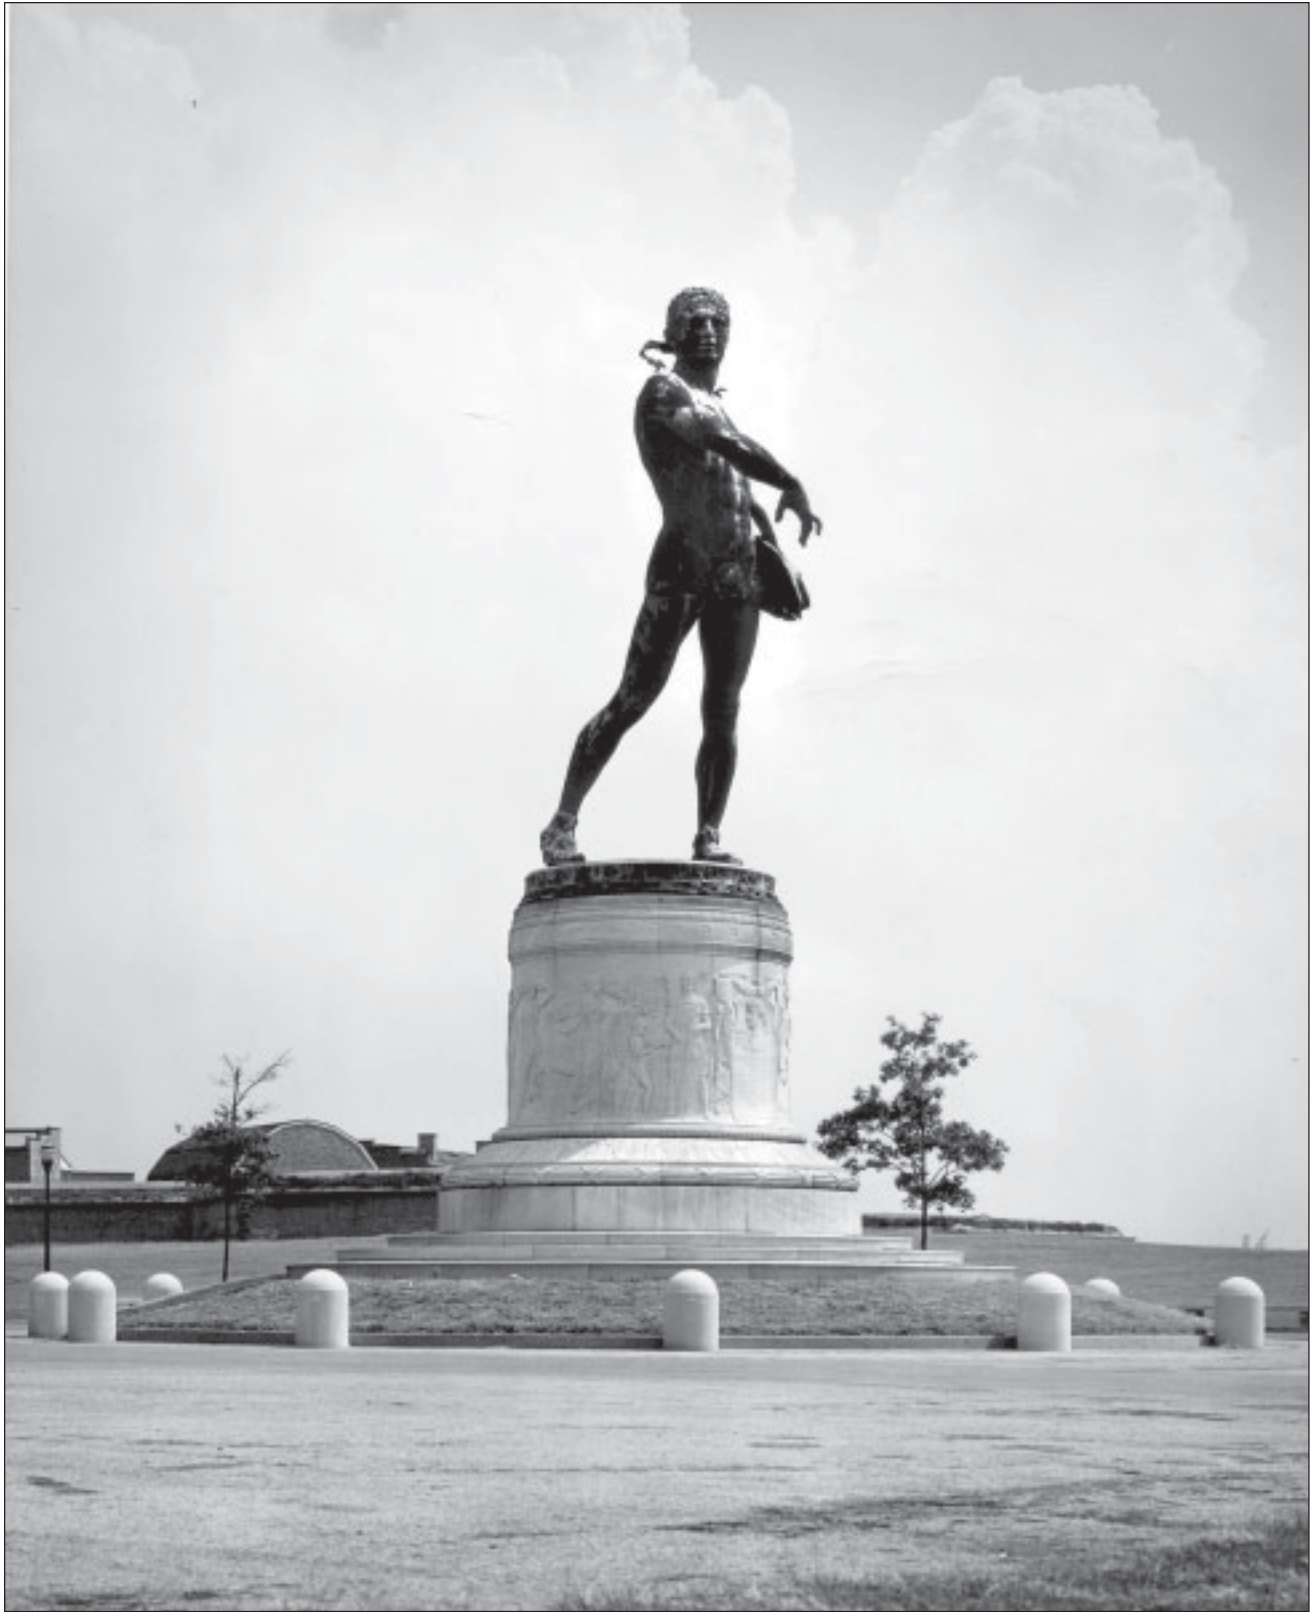
Figure 5.19. Late 1950s image of the Key Memorial prior to its relocation and reorientation as part of Fort McHenry's MISSION-66 park development program. Note the dome shaped earthen pedestal and twelve stone bollards; these elements would not be reproduced in the memorial's new location. Fort McHenry Library Special Collections.

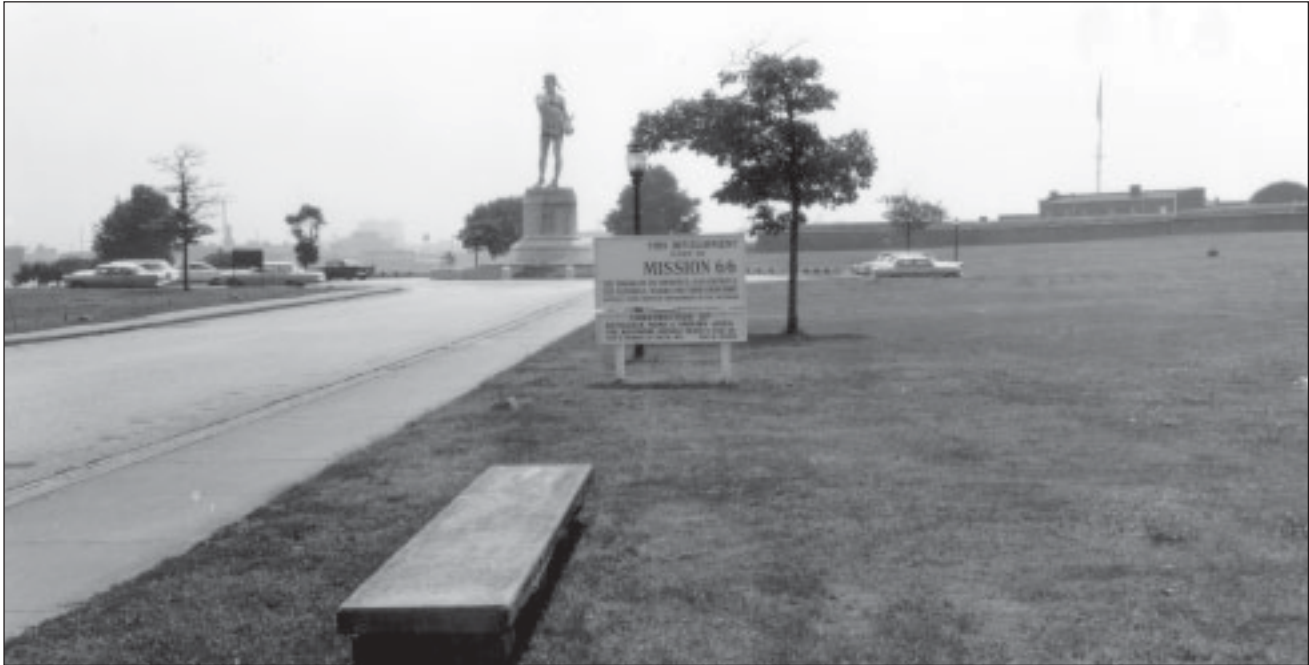
Figure 5.20. Prior to its relocation as part of the park's MISSION-66 development program, the Key Memorial's statue of Orpheus faced west to greet visitors arriving through the Fort Avenue gate. This arrangement was said to place too much emphasis on the monument, where planners hoped to emphasize the view to the Star Fort upon entry. Fort McHenry Library Special Collections, FOMC 1630A.

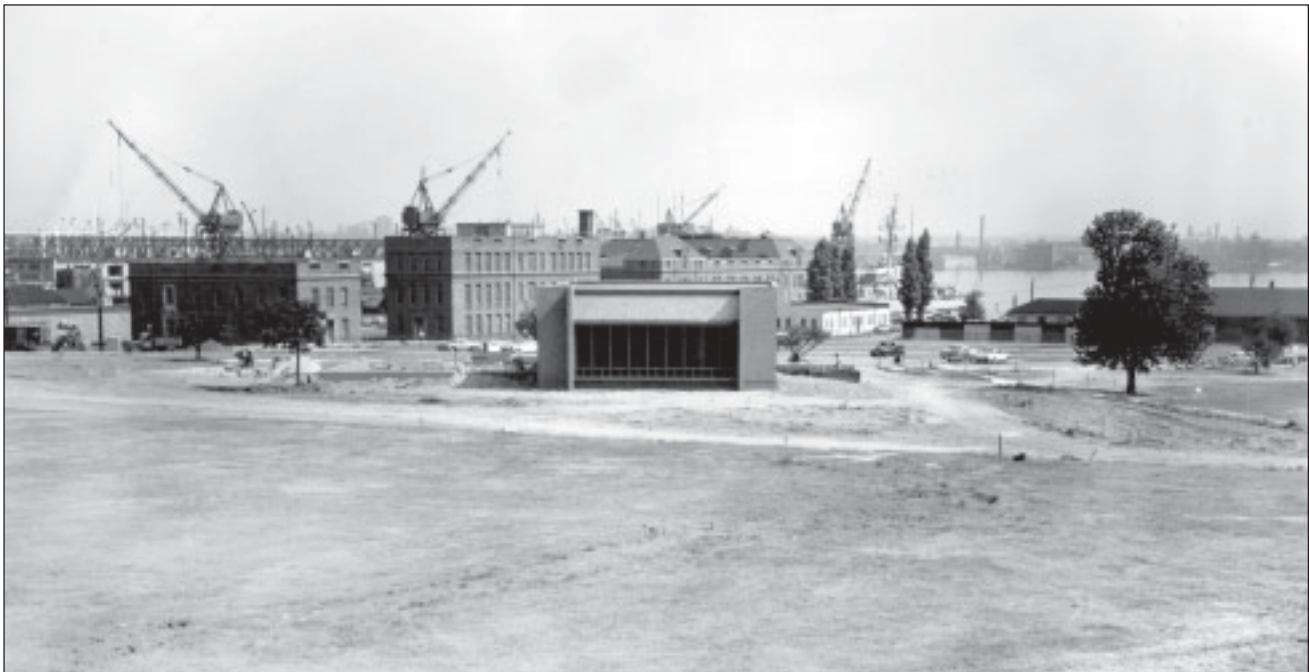
Figure 5.21. Construction progress photograph, 1963. The park's new visitor center building was designed to be inconspicuous and understated. Its north and south facades featured extensive window glazing, creating views out into the landscape. Fort McHenry Library Special Collections.

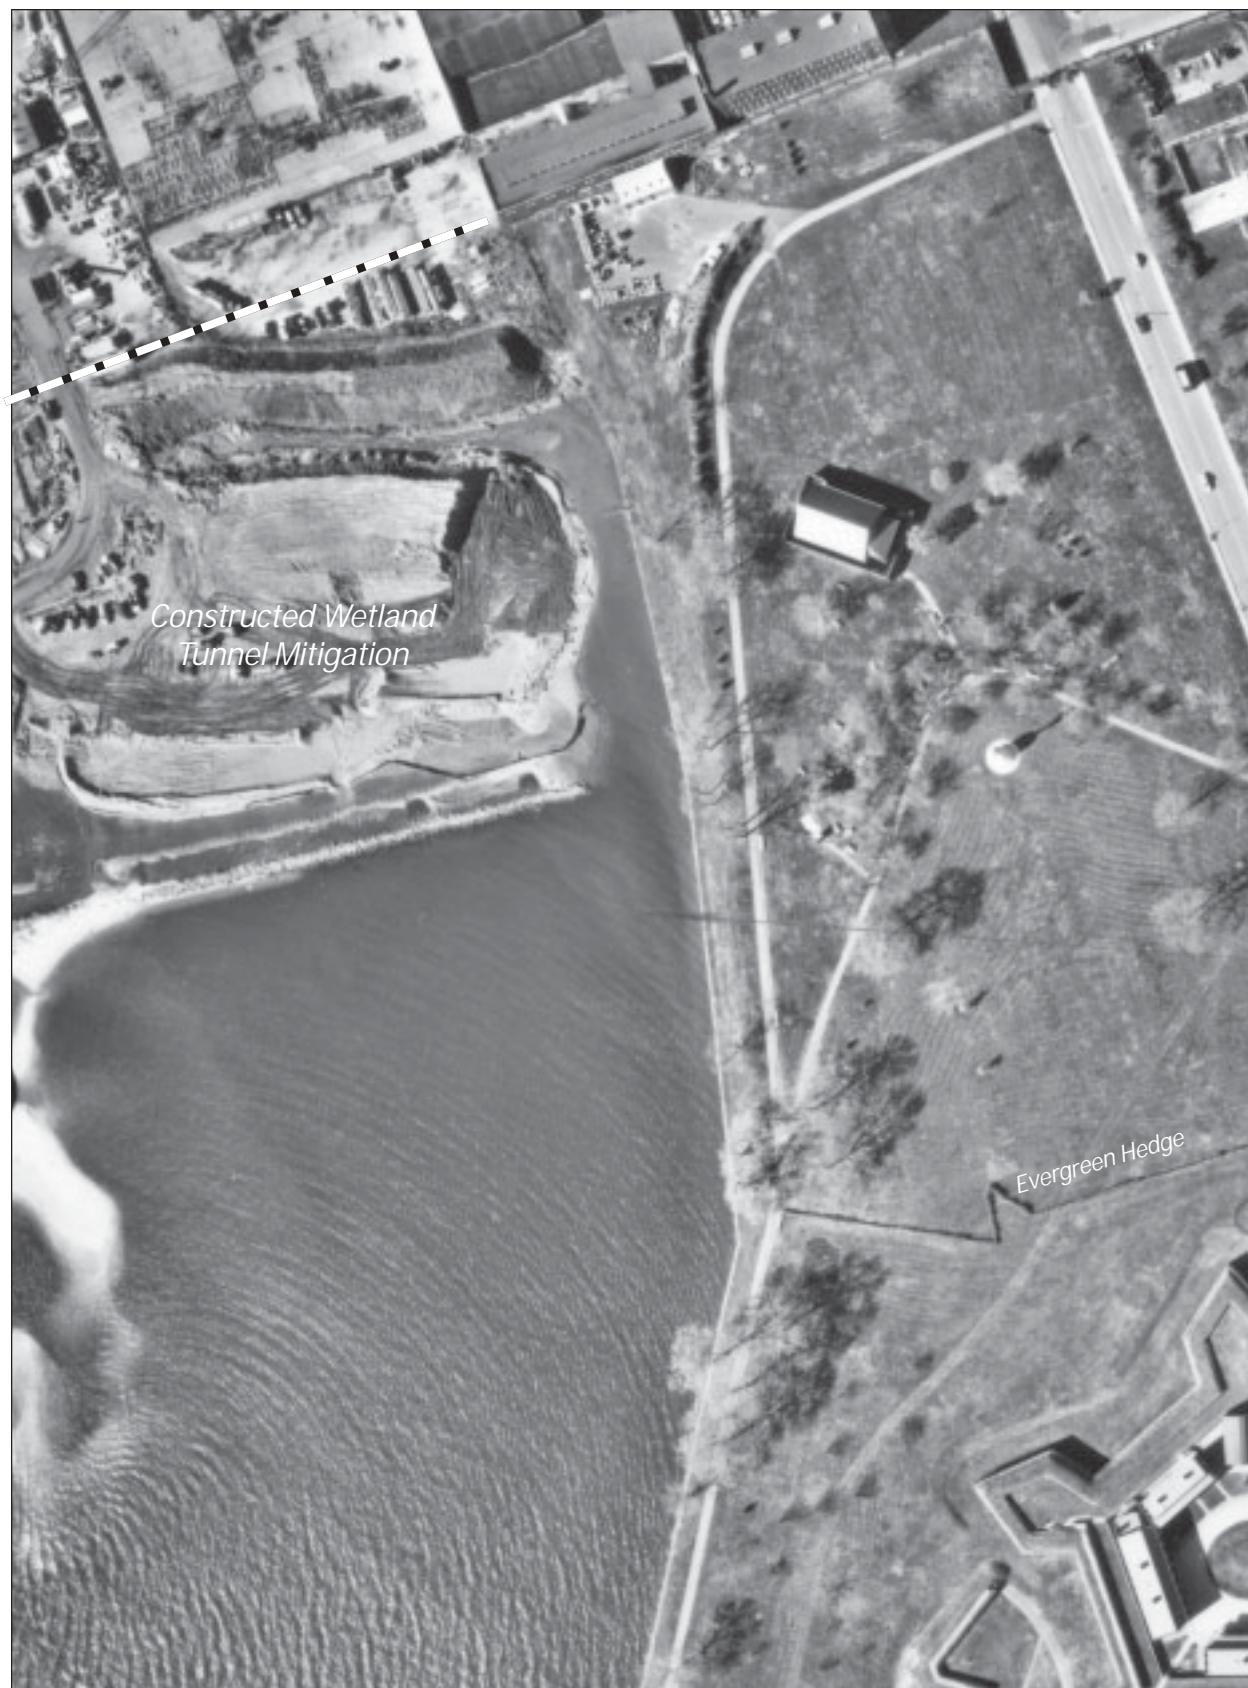
Figure 5.29. Aerial photograph, 21 November 1983. This image shows the area of artificial constructed wetland, built as environmental mitigation for the Fort McHenry tunnel project. Fort McHenry Library Special Collections.

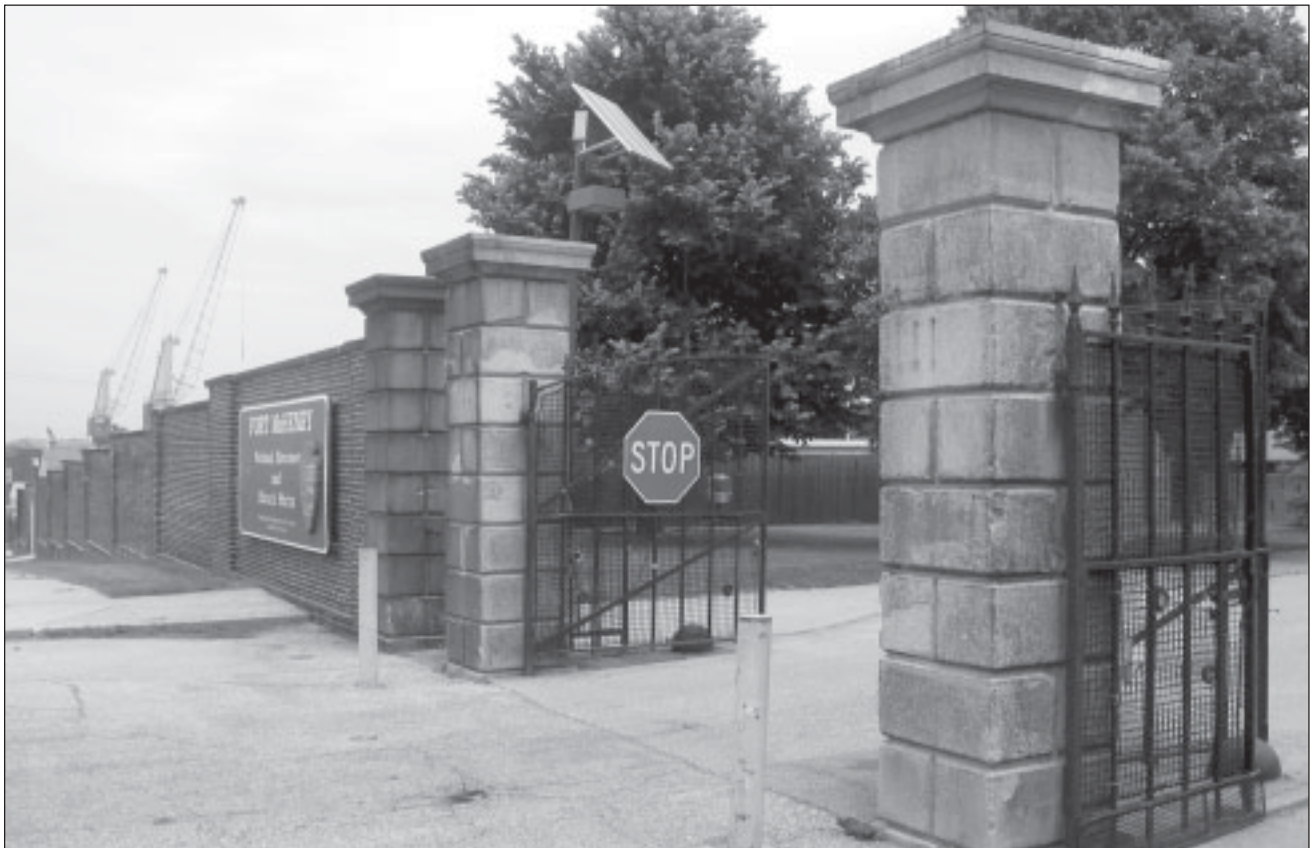
Figure 6.2 The entrance to Fort McHenry National Monument and Historic Shrine via Baltimore's Fort Avenue is through an entrance gate in an 1837 brick boundary wall. The entrance gate and its features were restored by the War Department in 1928. OCLP, July 2003.

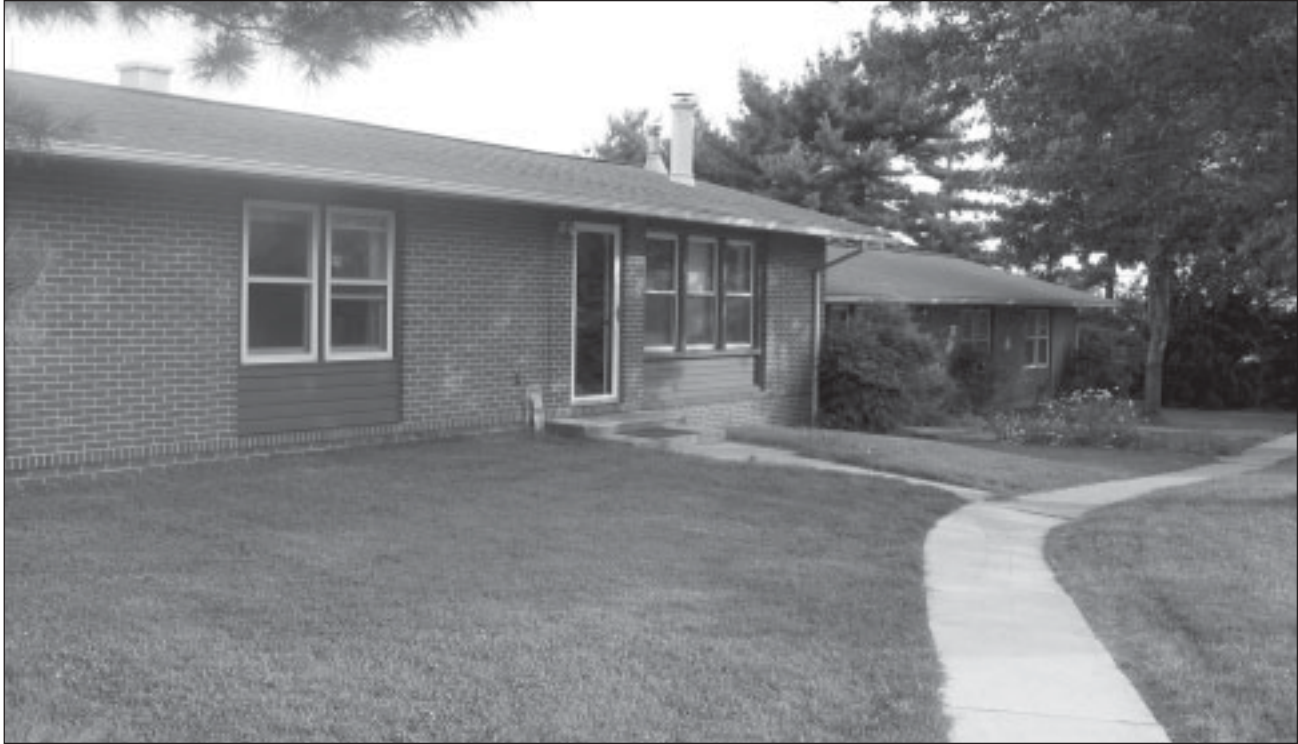
Figure 6.3 Immediately inside the Fort Avenue gate, a grouping of park maintenance and residential buildings can be seen to the north of the entrance drive. These were constructed during the early 1960s as part of the National Park Service “MISSION-66” park development program. OCLP, July 2003.

Immediately east of the park's front gate, modern brick buildings are found to the north and serve park housing, maintenance and administrative needs (*Figure 6.3*). To the south, additional maintenance operations are housed in a large pre-fabricated steel building (*Figure 6.4*). Trailers and

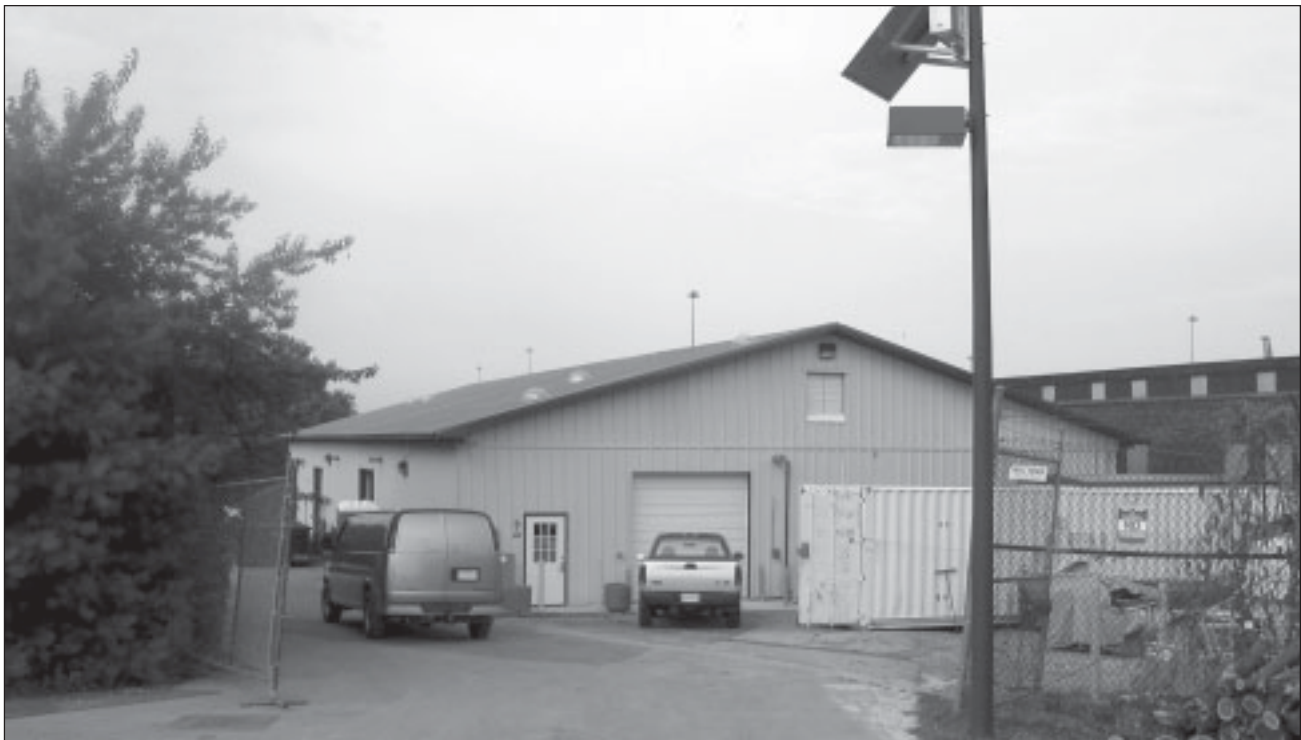
Figure 6.4 Inside the Fort Avenue gate, south of the entrance road, an additional park maintenance compound has been developed, using a salvaged metal building obtained from Gettysburg NMP. OCLP, July 2003.

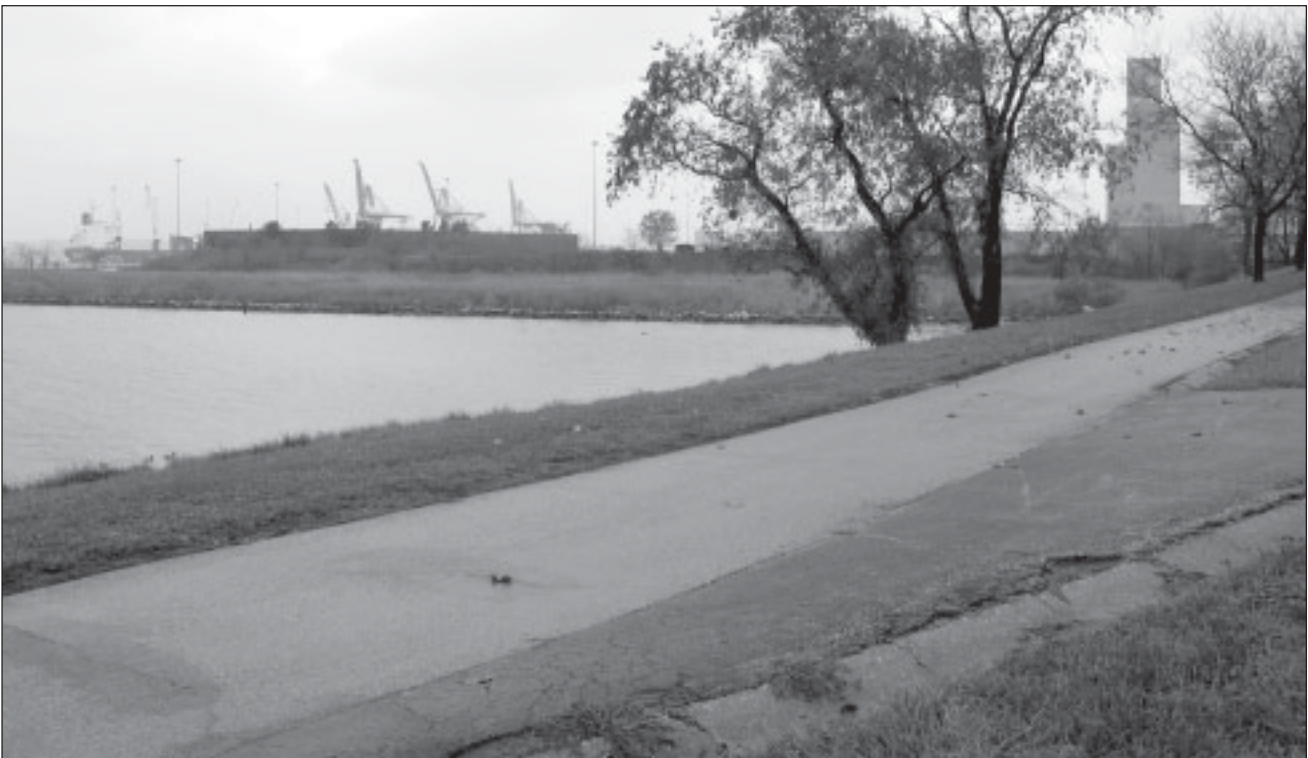
Figure 6.8 The southern boundary of the park is marked by the riverfront and its seawall, offering expansive views of the river. The area of wetland shown above was artificially created in the early 1980s, as part of the environmental mitigations related to construction of the Interstate 95 tunnel submerged off of Fort McHenry's shore line. OCLP, July 2003.

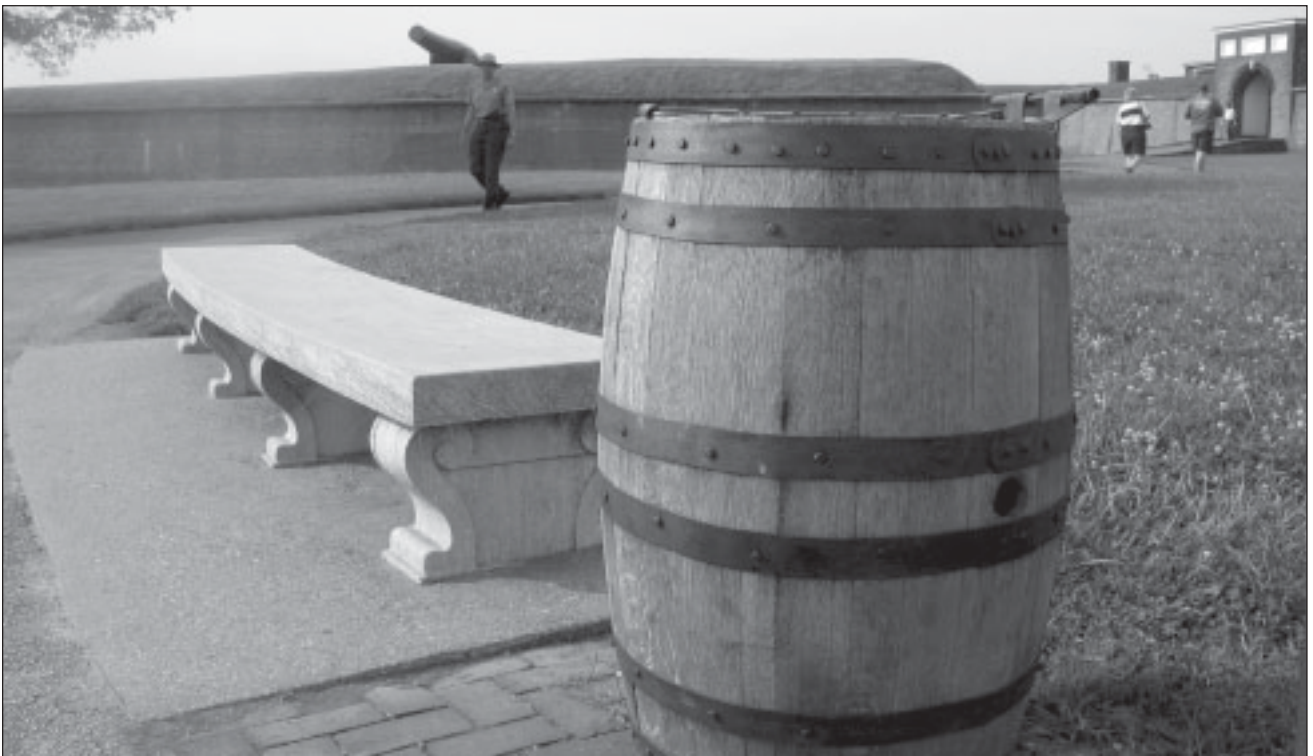
Figure 6.10 The path leading to the entrance to the Star Fort is served by paved pathway, benches, waste receptacles and informational and interpretive signage. The classically-styled marble bench shown above was once installed at the perimeter of a traffic circle containing the Key Memorial, and was moved to its current location in 1962. OCLP, July 2003.

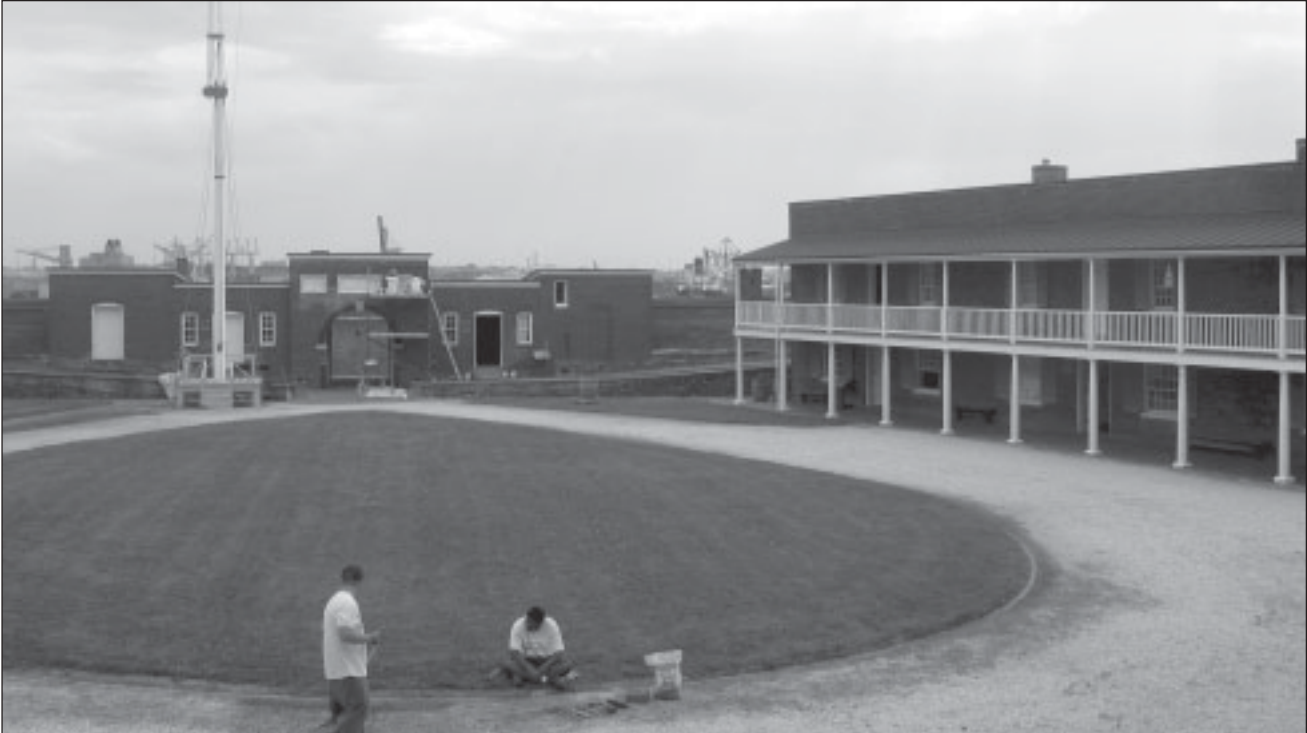
Figure 6.11 The ensemble of historic structures within the Star Fort together create an informal courtyard or parade. The teardrop-shaped carriage turn is believed to have appeared soon after the Civil War. Yet, soon after the historic bombardment the post flagstaff occupied a position on Bastion IV, rather than the location shown above. OCLP, July 2003.

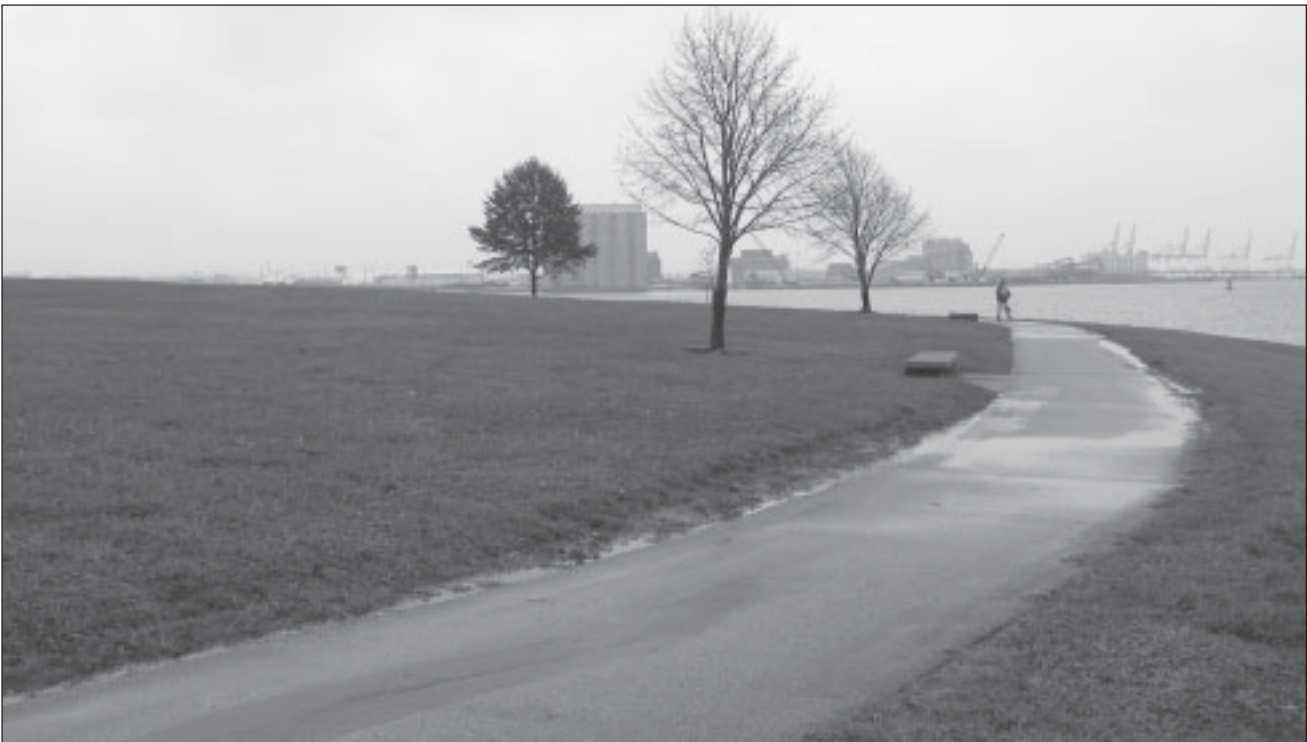
Figure 6.12 Fort McHenry's Seawall Trail was originally installed between 1928 and 1930 as part of the War Department development program for the new national park. This program of park developments included the demolition of General Hospital #2 buildings covering much of the grounds. OCLP, November 2003.

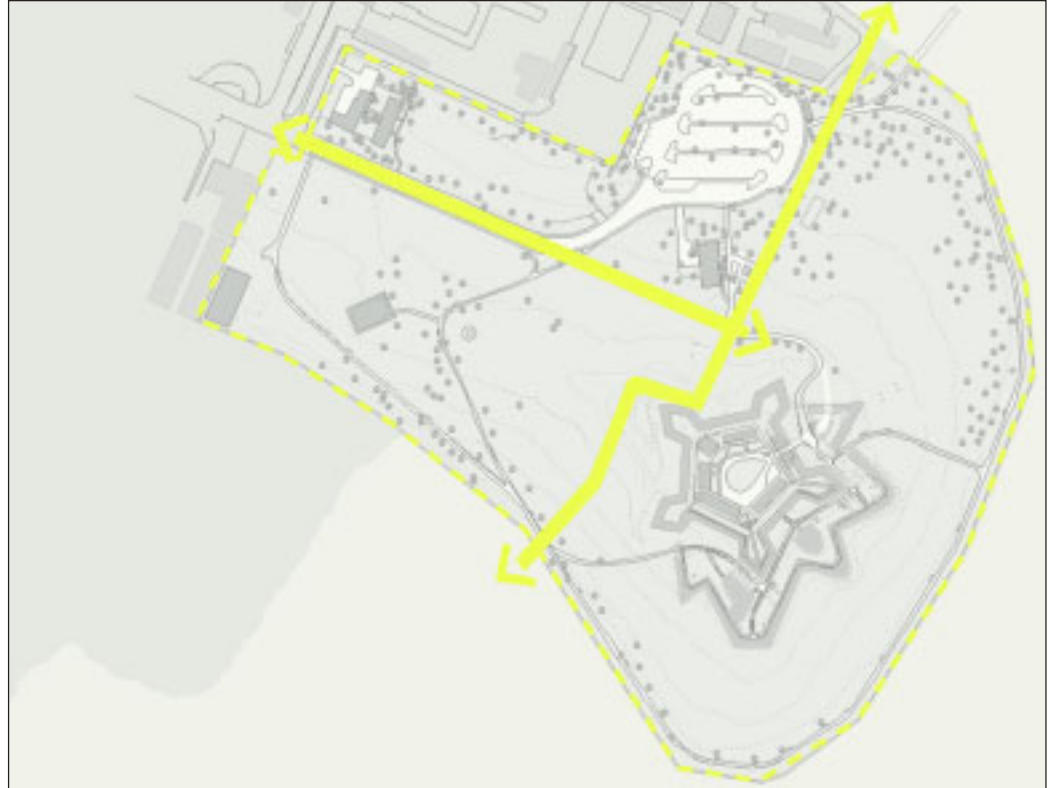
Figure 6.13. Diagram indicating the spatial organization of the Fort McHenry National Monument and Historic Shrine. The regulating lines shown on this diagram originated with the original subdivision of the property in the eighteenth century. OCLP.

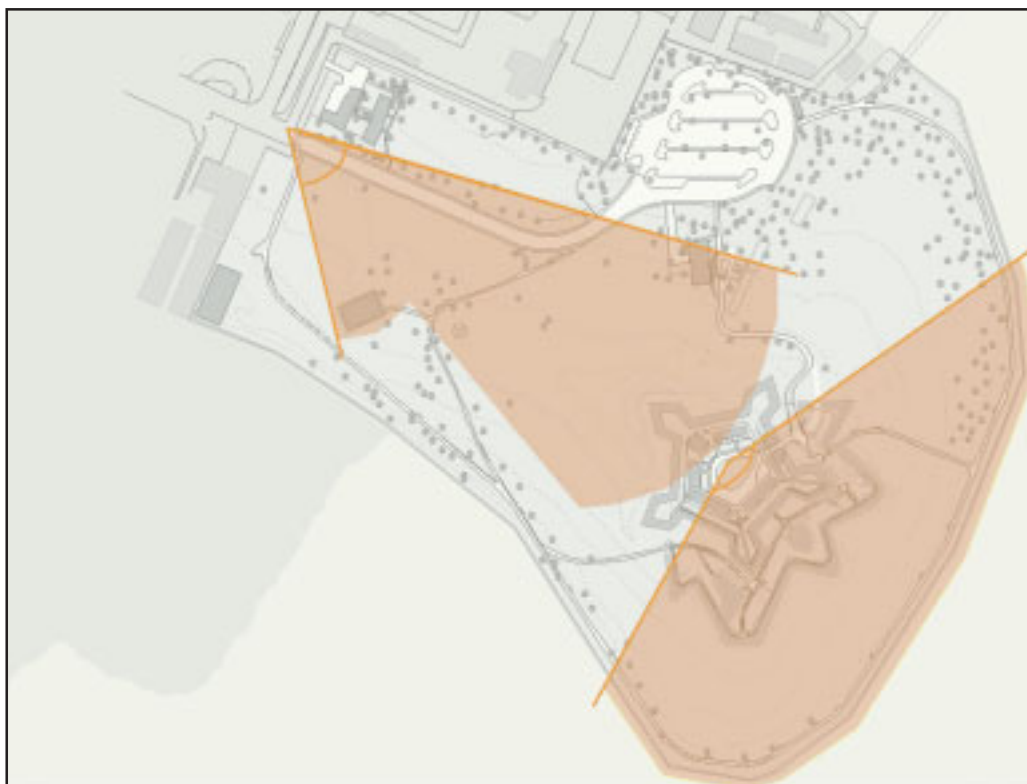
Figure 6.17. Diagram indicating major views and viewsheds. These areas are also strategic fields-of-fire that are significant in the military history of Fort McHenry. OCLP.

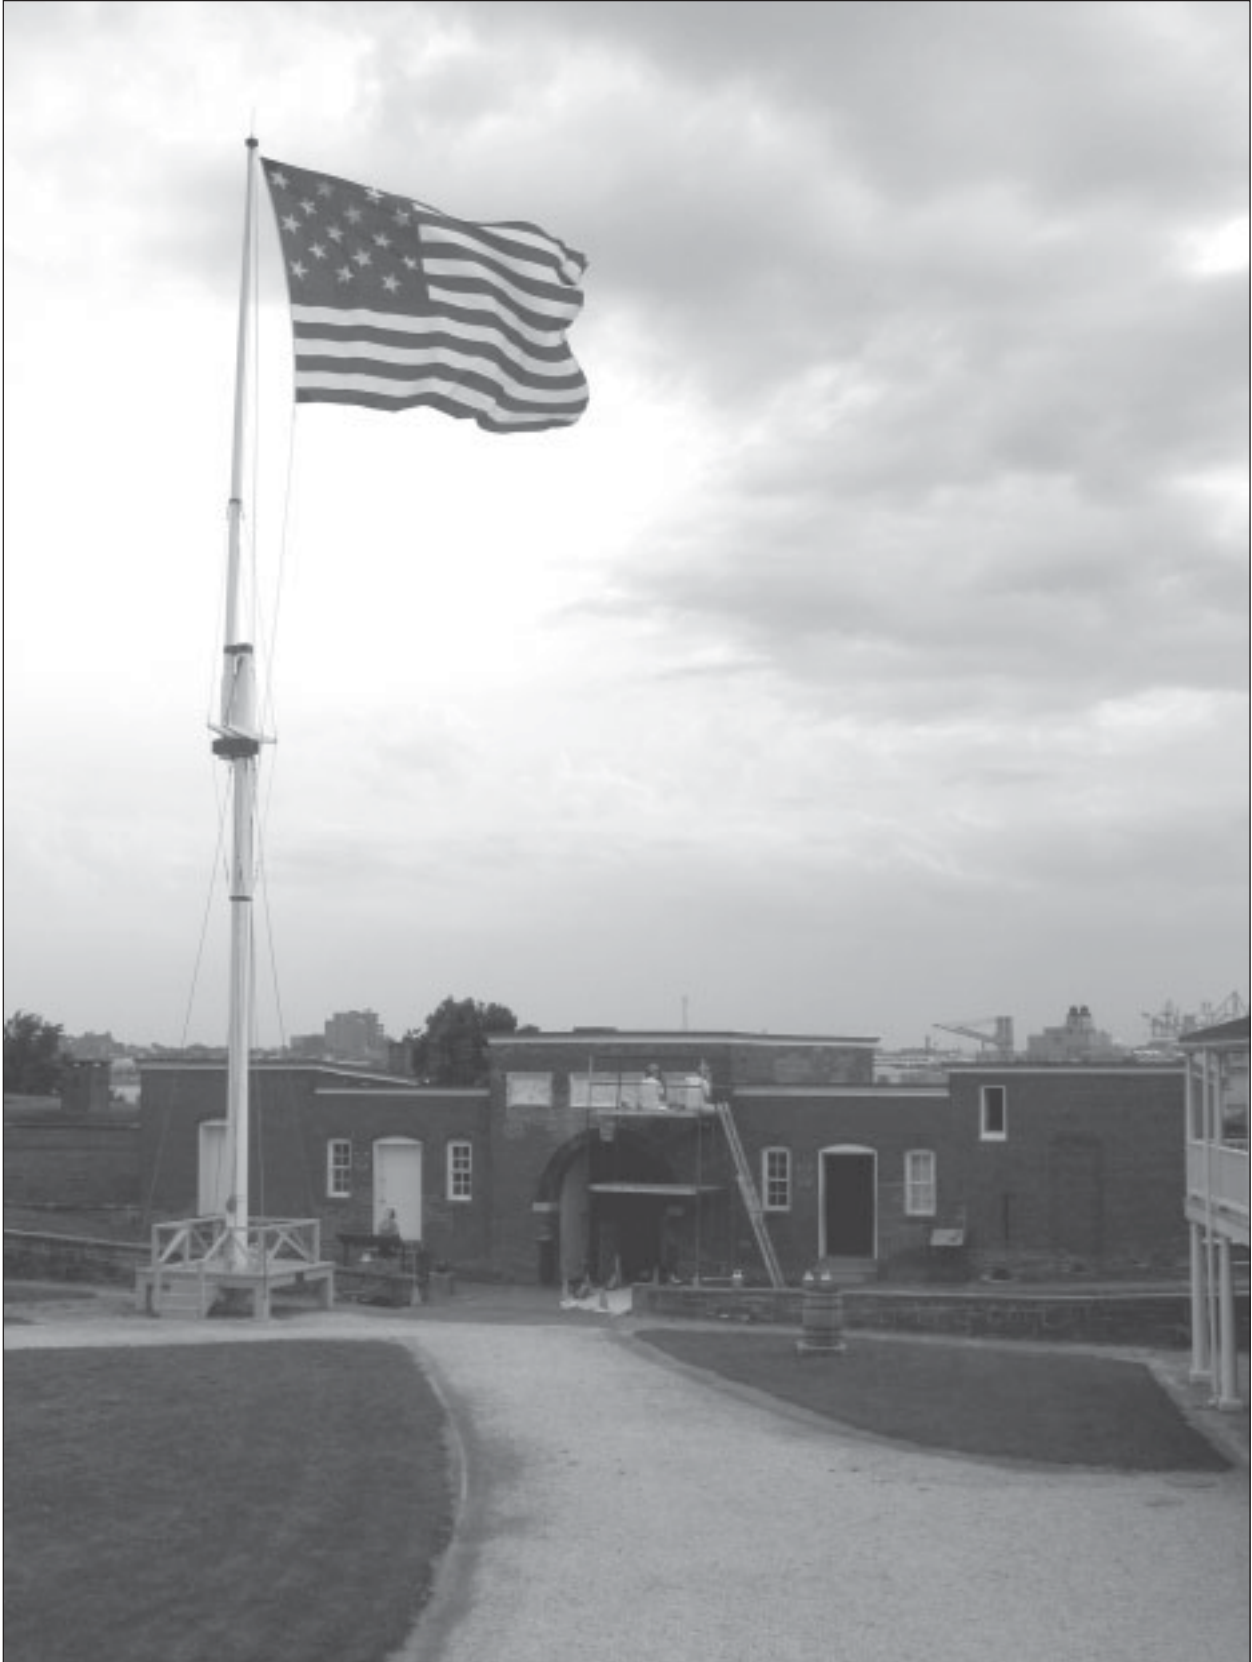
Figure 6.18 Below-ground cross braces belonging to the original flagstaff shown on 1803 drawing of the Star Fort were discovered during archeological investigations of the 1950's, leading to the relocation of the flagstaff in 1959. The flagpole and base were replaced in 1989 after being damaged in a storm. OCLP, July 2003.
