CULTURAL LANDSCAPE REPORT FOR FORT MCHENRY NATIONAL MONUMENT AND HISTORIC SHRINE

SITE HISTORY, EXISTING CONDITIONS AND ANALYSIS

FORT MCHENRY NATIONAL MONUMENT AND
HISTORIC SHRINE

August 2004

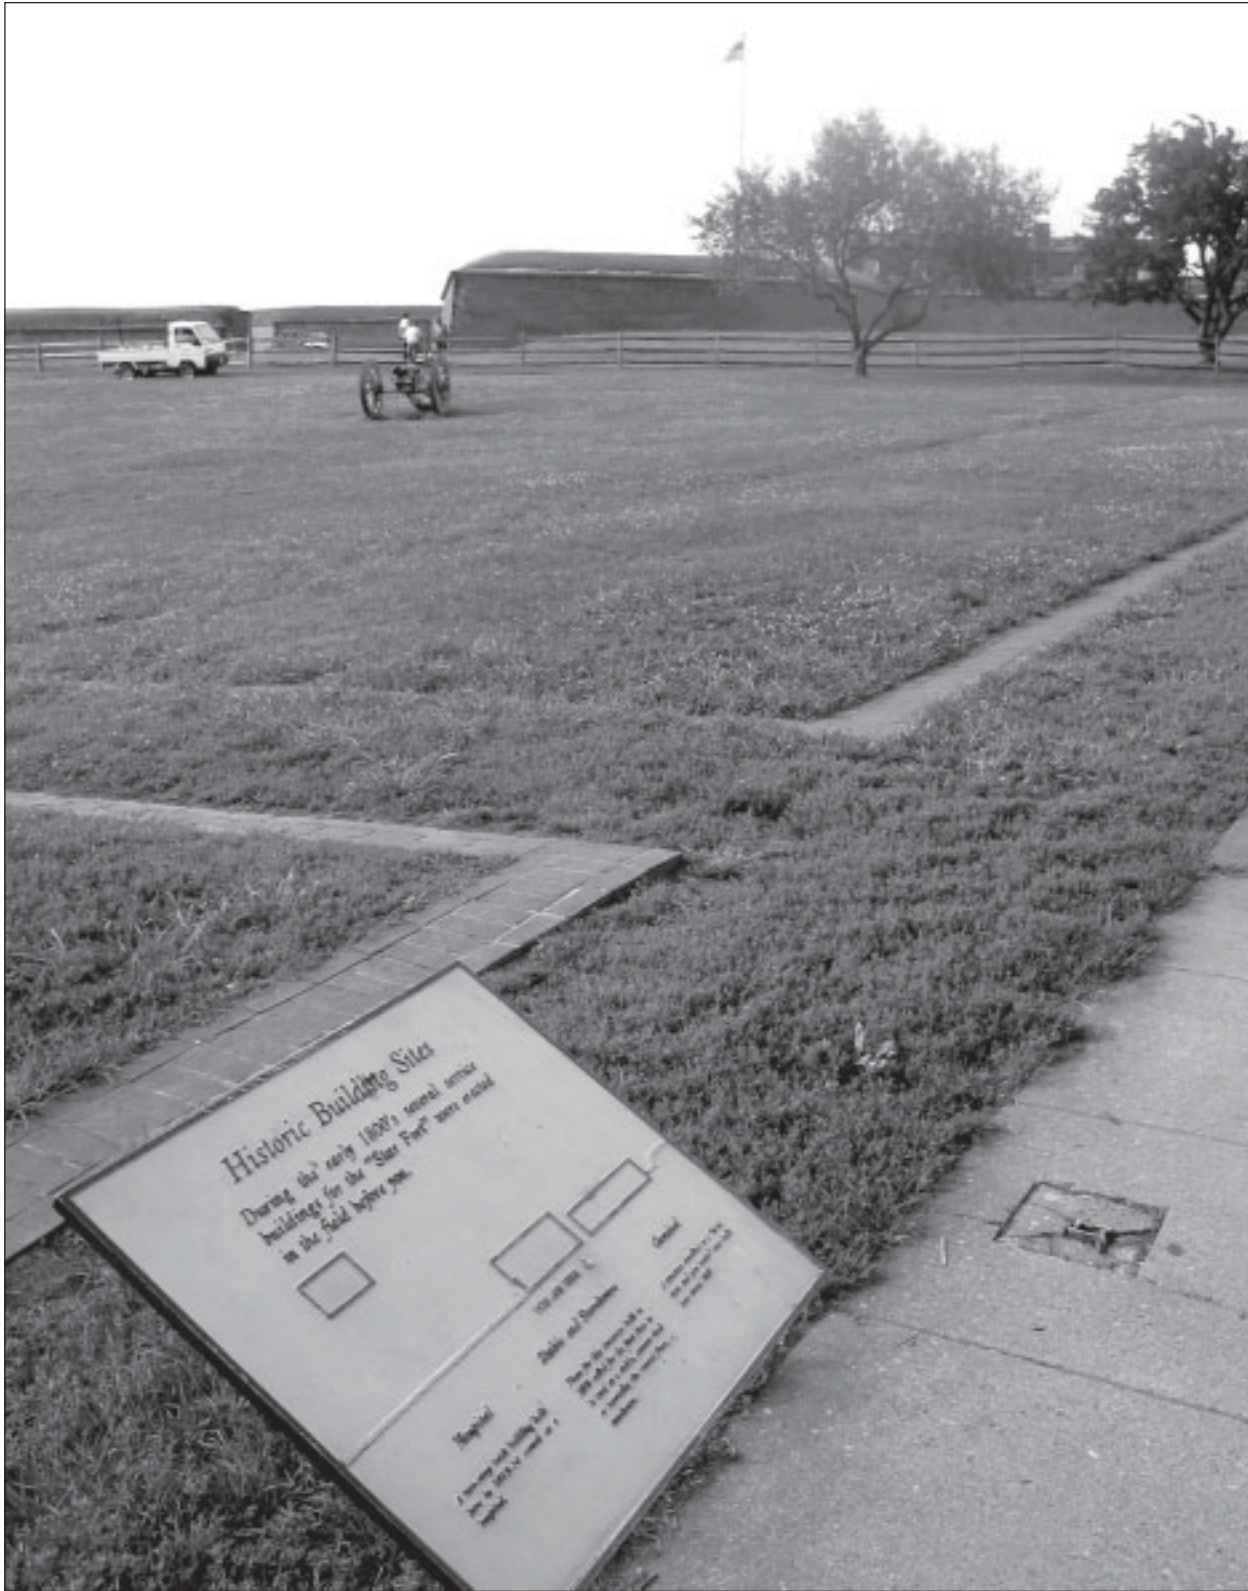
Figure 6.19 An extensive archeological record documenting Fort McHenry's physical history and material culture survives below-ground, preserved in the soil. The brick outlines shown above are interpretive markings showing the locations of former garrison buildings outside of the Star Fort. The brick outlines are not themselves historically significant. OCLP, July 2003.

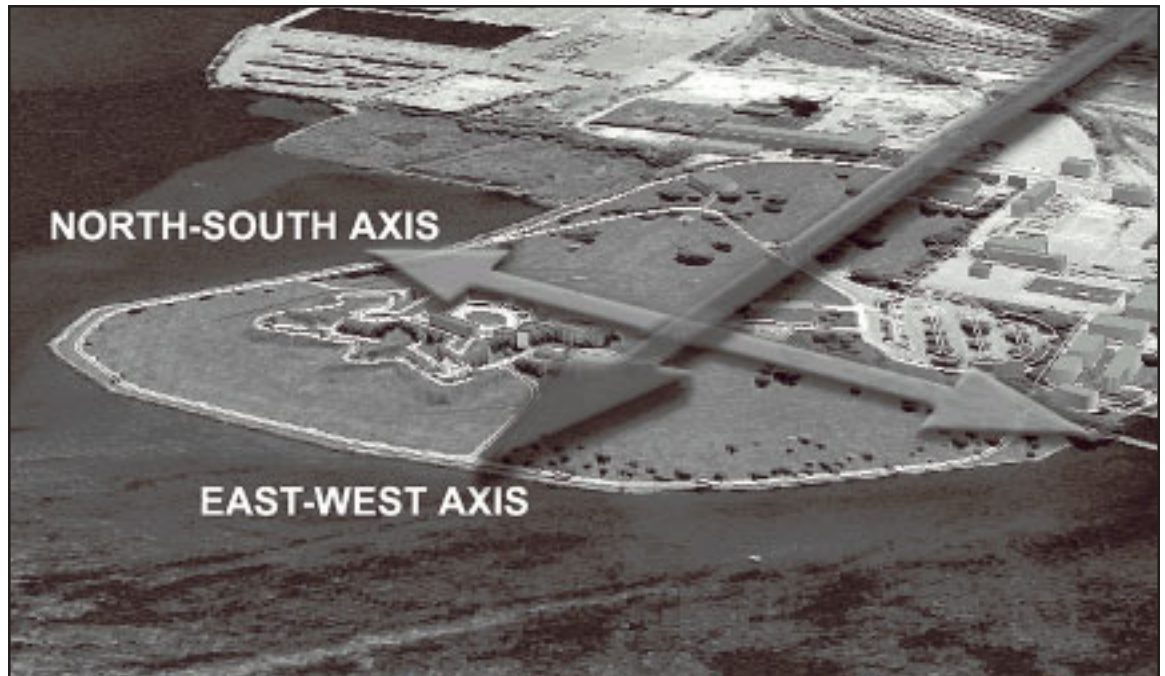
Figure 8.1. Diagram showing primary East-West site axis, and secondary North-South site axis that together organize the spatial characteristics of the property. Contributing. OCLP.

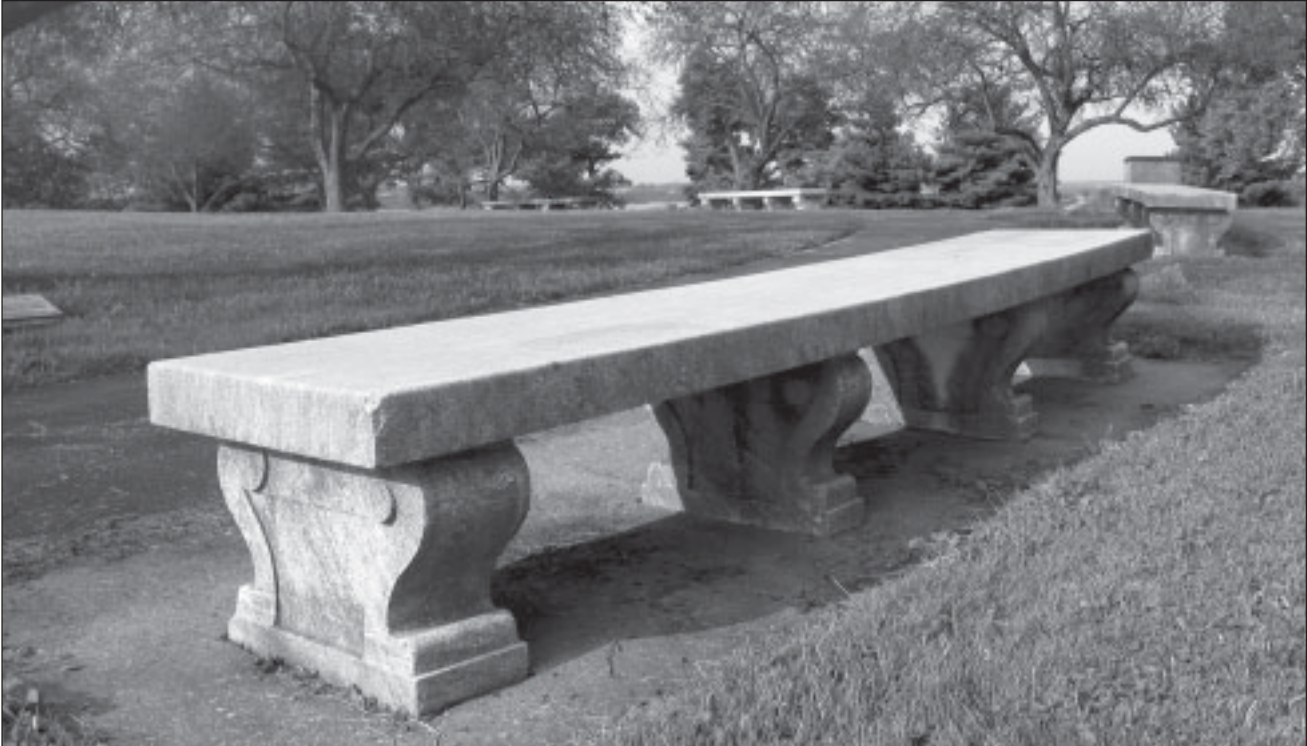
Existing Condition: The marble benches are about 12' long, with decorative carved scrollwork on the pedestal supports (*Figure 8.6*). The benches are in good condition, although their bases are currently embedded in a concrete base, raising the potential for future damage.

Figure 8.6 Classically Styled Marble Benches. Eight of these twelve stone benches were originally found at the perimeter of the traffic circle in the central driveway containing the Key Memorial. The remaining four benches were positioned south of the central driveway. These benches were moved in 1962, following the relocation of the memorial. Contributing. OCLP, July 2003.

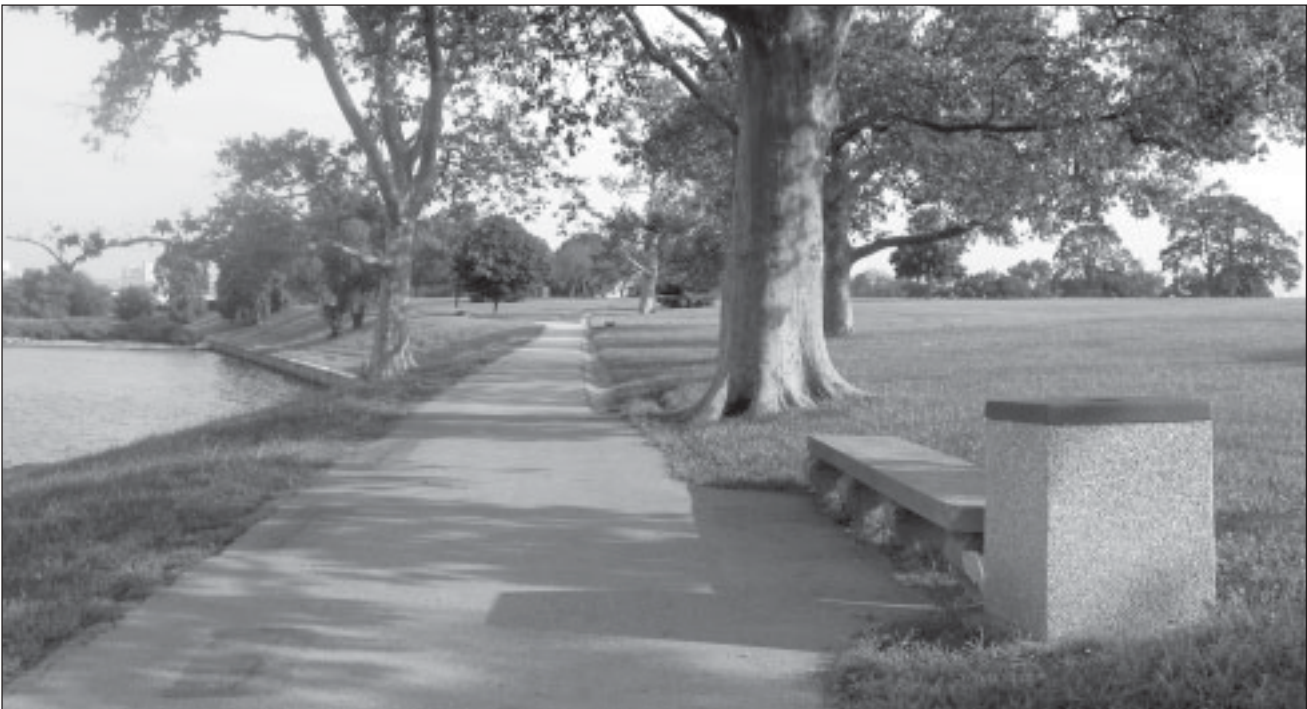
Existing Condition: These benches remain in good condition, however their bases have been embedded in concrete, raising the potential for future damage (*Figure 8.7*).

Figure 8.7 Classically Styled Concrete Benches. During the War Department's stewardship of "Fort McHenry National Park," seventeen additional benches were designed and installed on the outboard side of the Seawall Trail. These benches draw upon the design features of the earlier stone benches, yet were fabricated of inexpensive concrete. These benches have since been relocated to the inboard side of the Seawall Trail. Contributing. OCLP, July 2003.

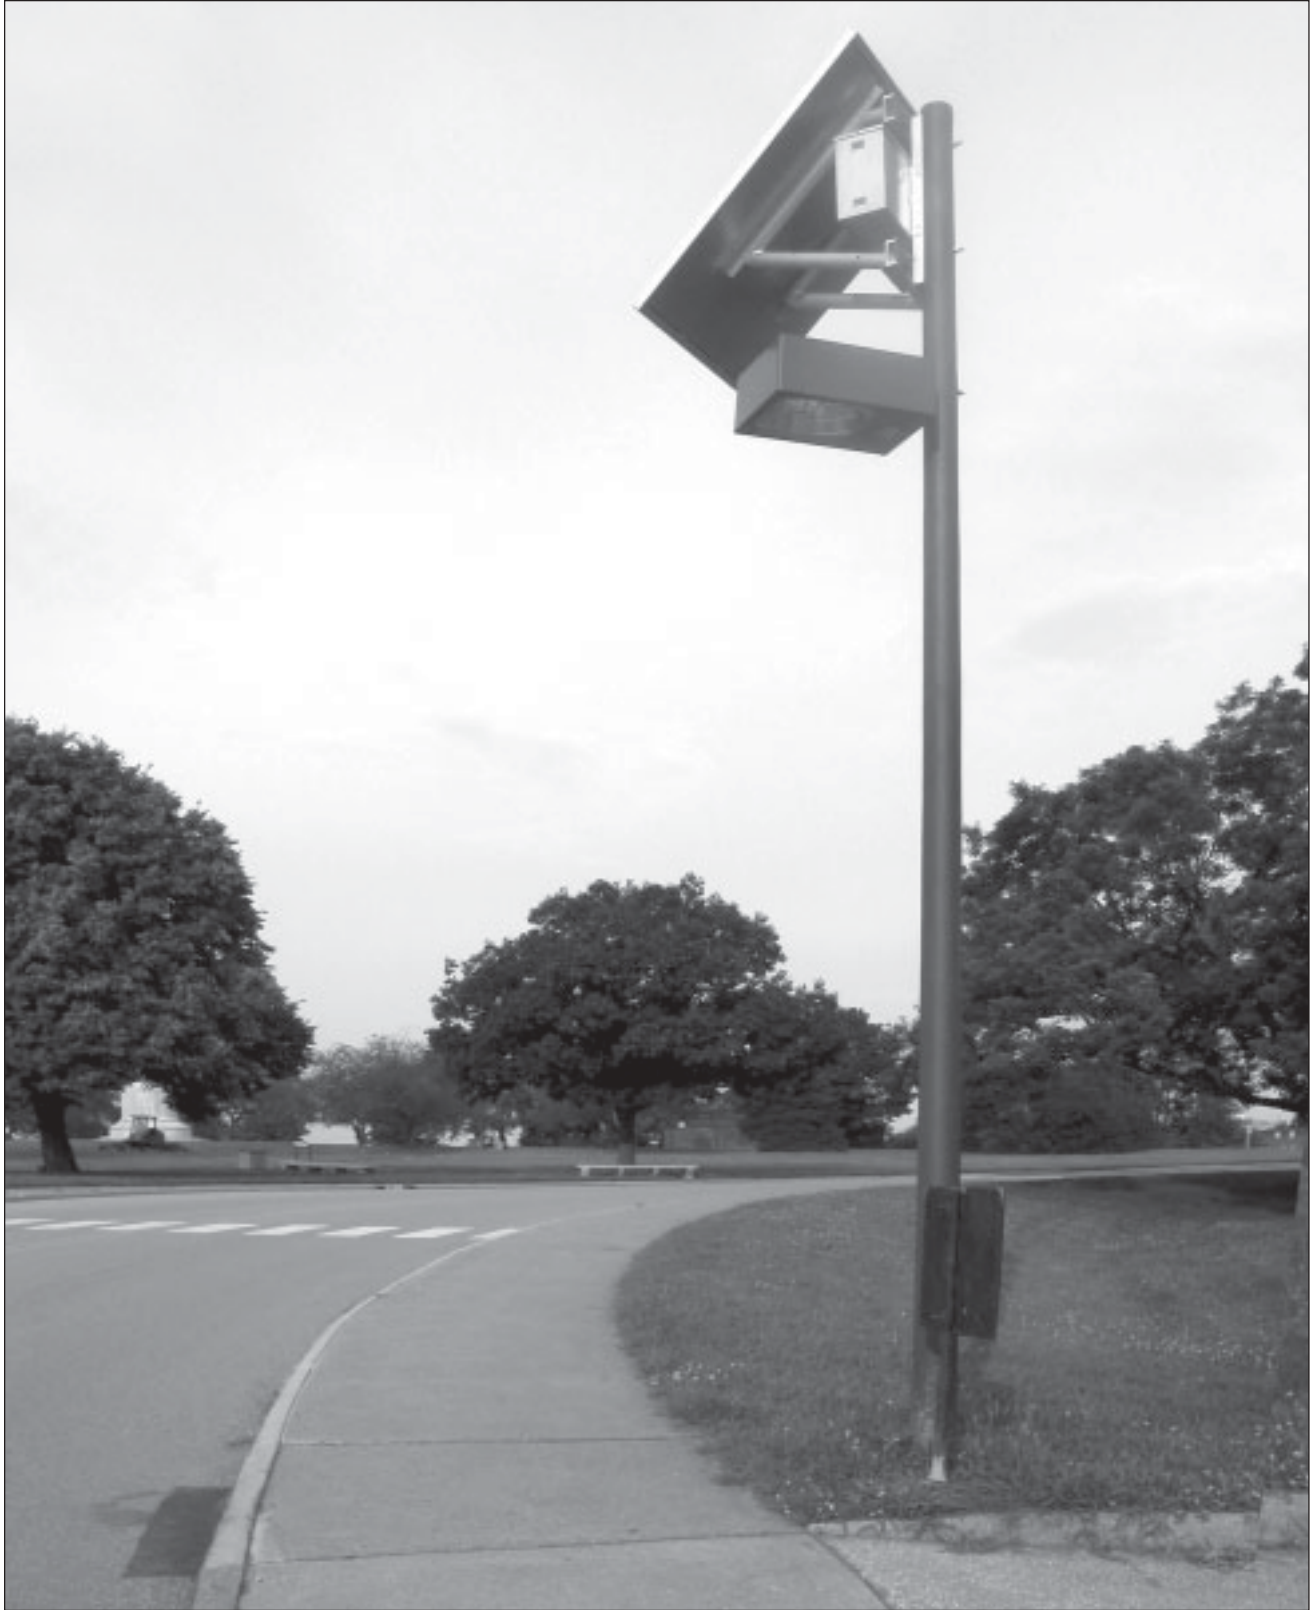
Existing Condition: These fixtures appear to be in good condition, however technical evaluation of their operation is outside the scope of this report (*Figure 8.8*).

Figure 8.8 The collection of outdoor lighting, both streetlights and pathlights, are of contemporary design, being installed following the end of the Fort McHenry's period of historic significance. Non-contributing. OCLP, July 2003.

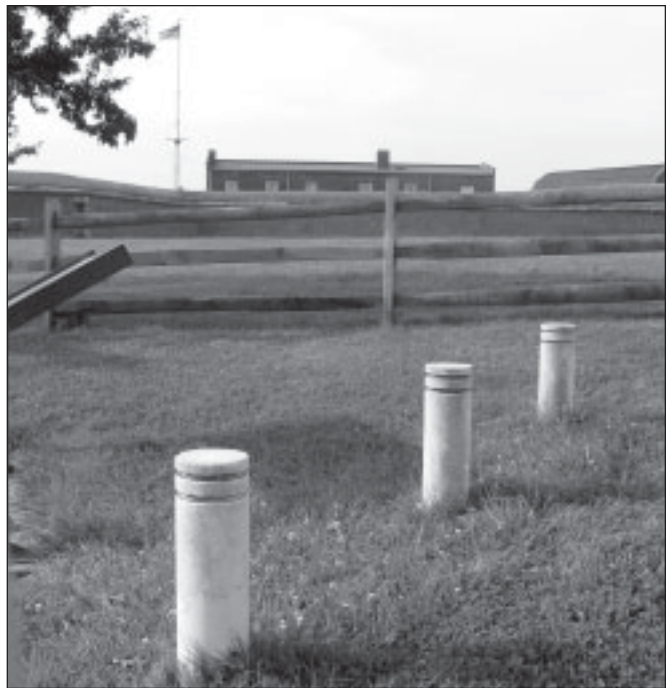
Existing Condition: The brick building outlines and the bollards marking the original alignment of the post entrance road were installed as part of the park development program of the 1960s (*Figure 8.10*).

Figure 8.10 Interpretive Devices. Fort McHenry features brick outlines showing the location of missing buildings, reconstructed earthworks, and as shown here, bollards marking the location of a former roadway. Non-contributing. OCLP, July 2003.

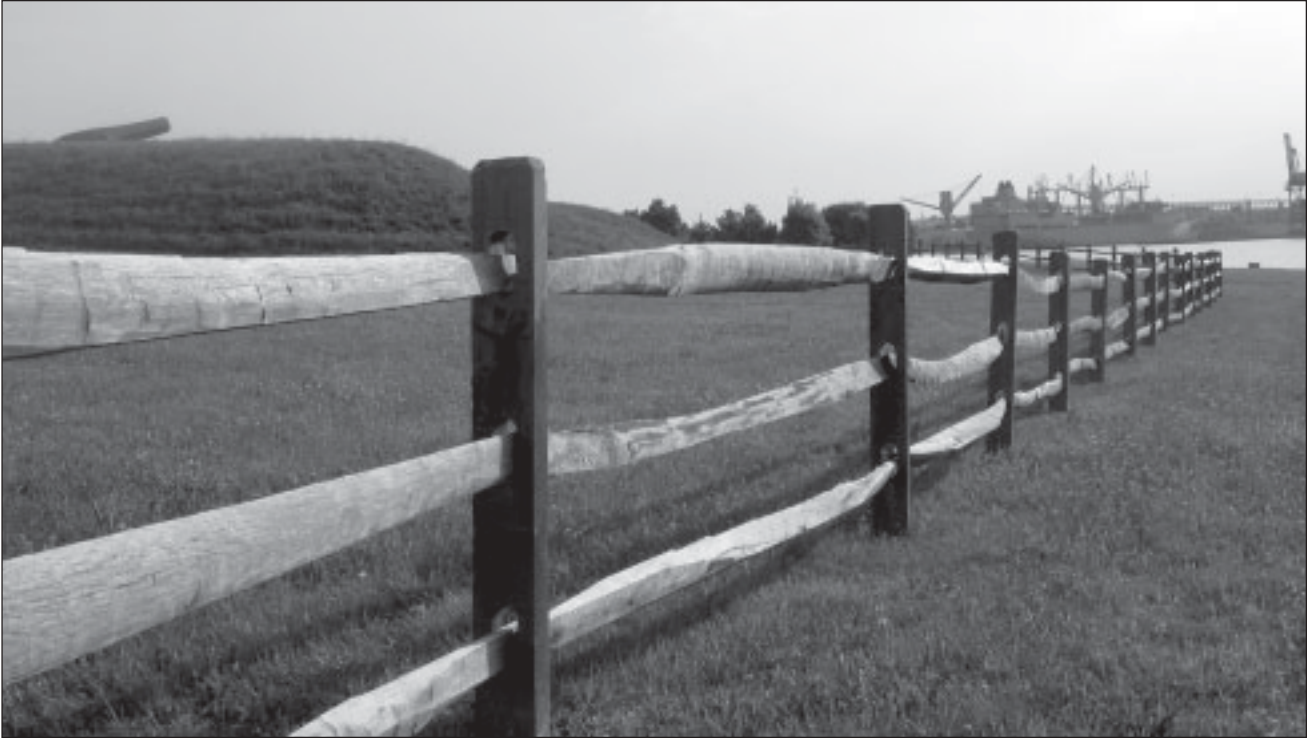
Existing Condition: Commercially available split rail fencing was installed in the approximate configuration of the prior fencing during the autumn of 2001 (*Figure 8.13*). While the choice of three rail fence sections is intended to evoke the design of the earlier fencing, images of the fencing in place during the historic period was not of this construction or materials.

Figure 8.13 Split-Rail Fencing. During the autumn of 2001, commercially-made split rail fencing was installed in the approximate configuration of the fencing found at Fort McHenry between 1839 and the mid-1880s. Non-contributing. OCLP, July 2003.

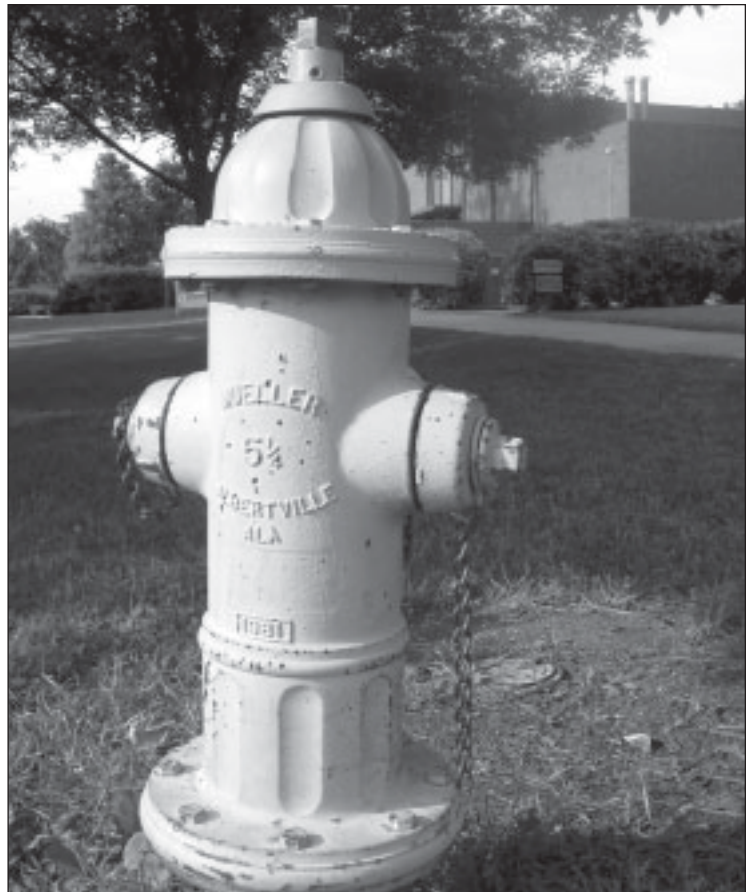
Existing Condition: The park's collection of fire hydrants appears to be in good condition, however, technical evaluation of their operation and suitability is outside the scope of this report (*Figure 8.14*).

Figure 8.14 Fire Hydrants. This fixture's main casting includes the date "1981." Non-contributing. OCLP, July 2003.

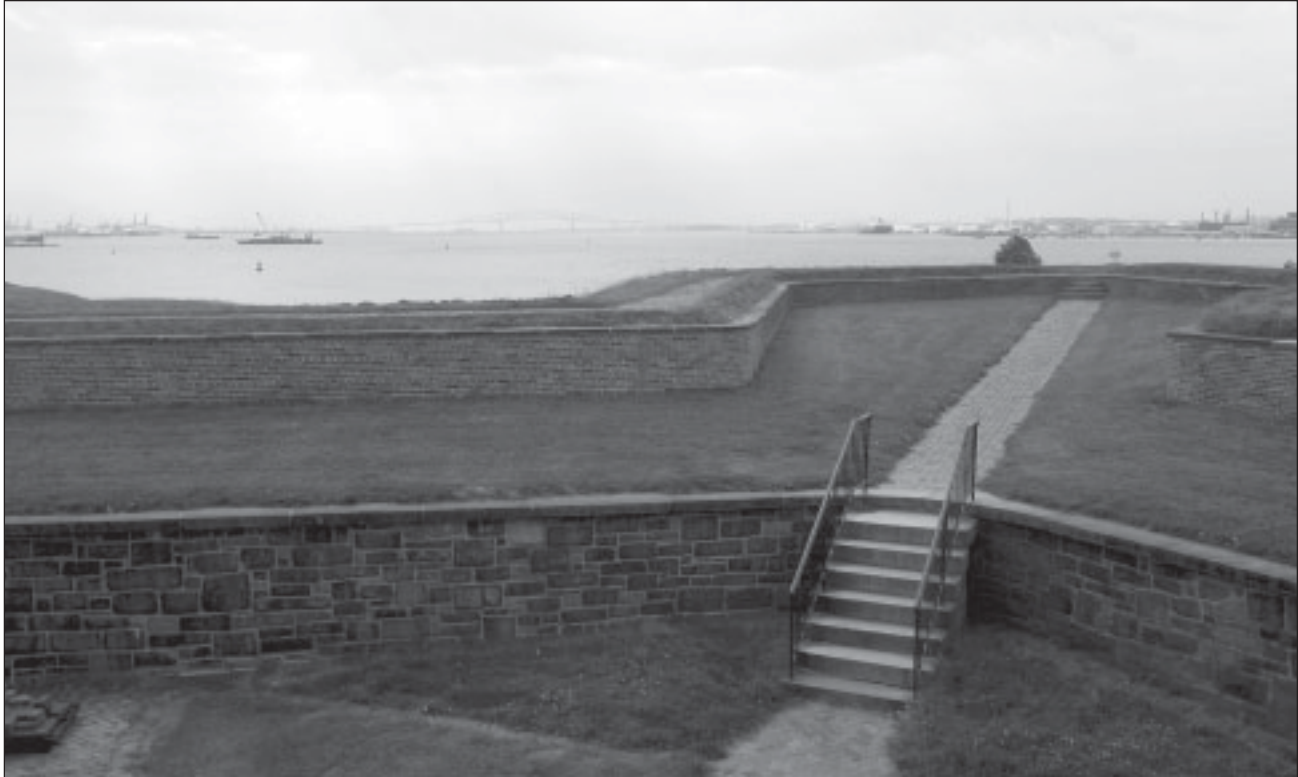
Existing Condition: The ramparts are comprised of several structural components constructed variously of earth and brick/stone masonry (*Figure 8.17*). In profile these exhibit an irregular stepped appearance. Proceeding from the exterior of the ramparts inward, the principal components are the scarp wall, earthen parapet, breast height wall, earthen terreplein, and parade wall

Figure 8.17 Star Fort Ramparts. Construction of the Star Fort Ramparts began in 1794; despite numerous repairs and alterations the configuration of the structure has been retained. The ramparts are comprised of several structural components constructed variously of earth and masonry. In profile these exhibit an irregular stepped appearance. Contributing. OCLP, July 2003.

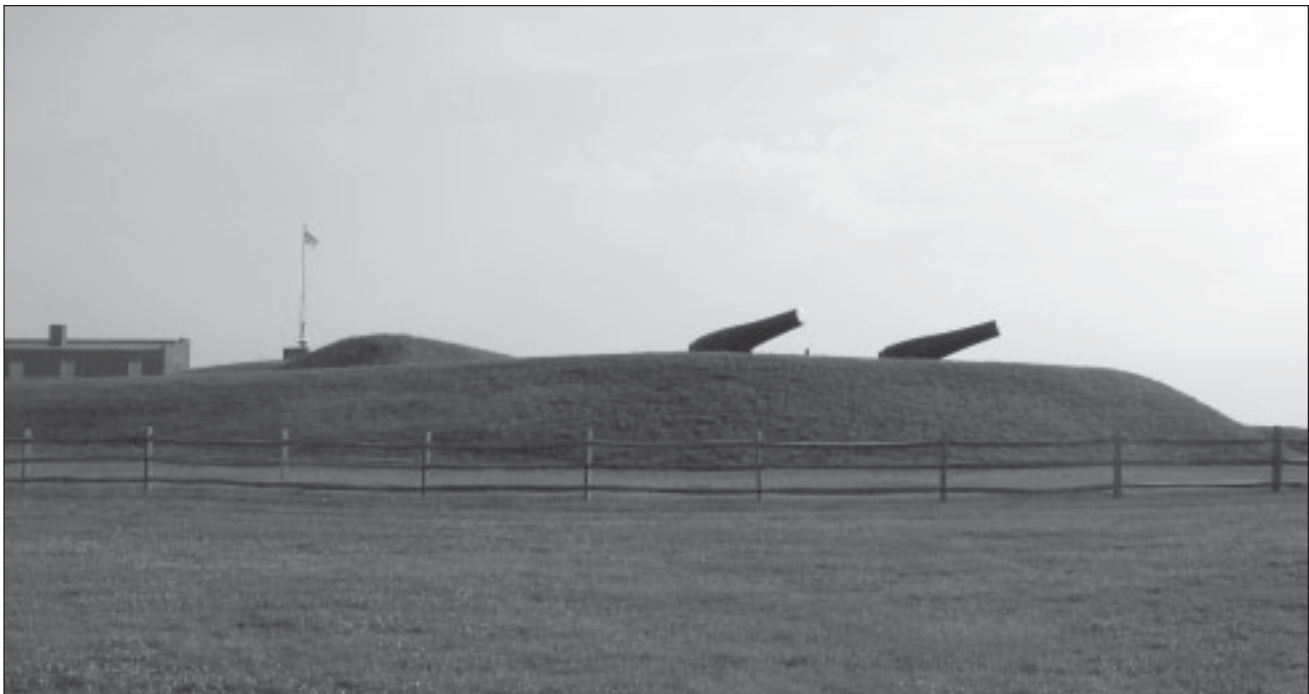
Existing Condition: Experiencing similar issues common to masonry features elsewhere at Fort McHenry, the magazines, bombproofs, and breast-height wall have experienced deterioration associated with moisture and poor drainage. The earthen slopes appear to be in good conditions (*Figure 8.18*).

Figure 8.18 Outer Battery. Fort McHenry's Outer Battery was built between 1836 and 1837. Featuring emplacements for thirty-nine guns, its purpose was to provide a first line of defense between the fort and the Seawall. Extensive modifications were made in 1866, following the end of the Civil War. Contributing. OCLP, July 2003.

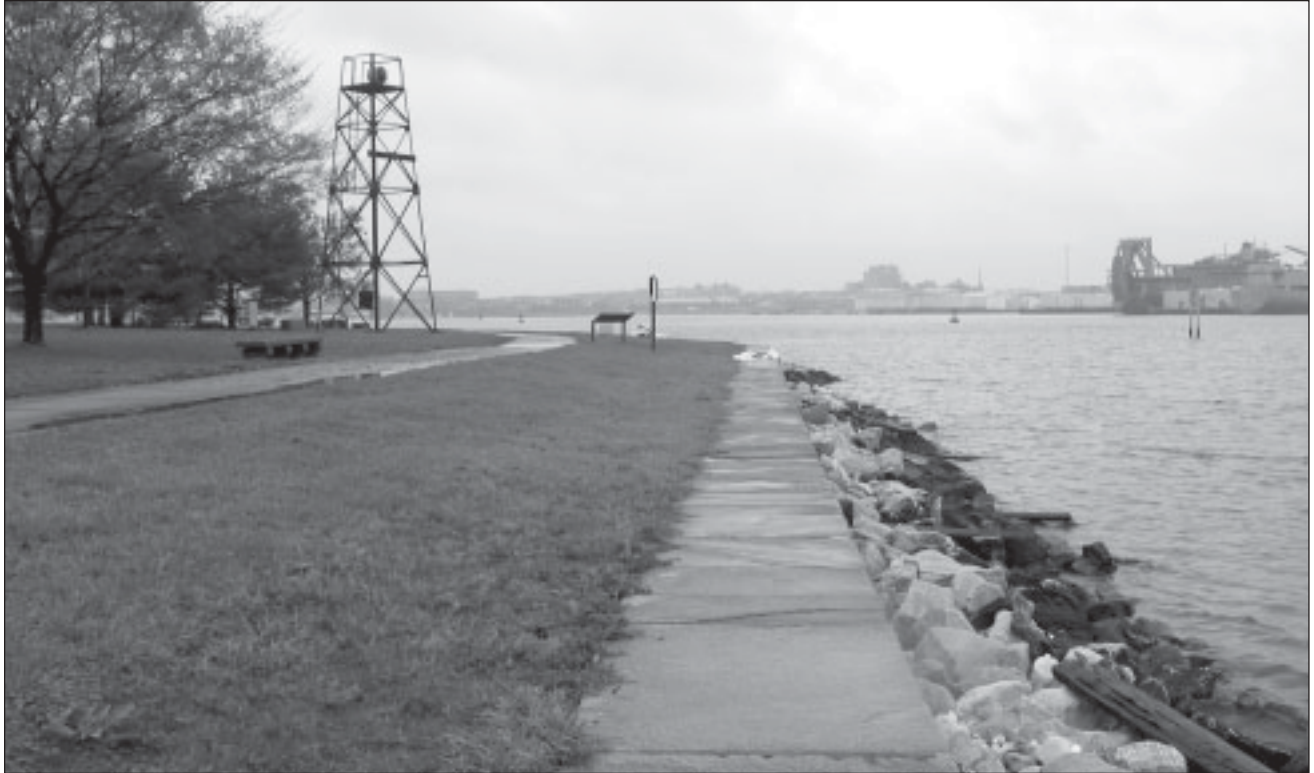
Existing Condition: The Seawall is a heavy masonry retaining wall, about three-quarters of a mile in length next to the water's edge (*Figure 8.19*).

Figure 8.19 Seawall. Construction of the Seawall began in 1816, after Fort McHenry's historic defense of Baltimore, and was not entirely completed surrounding the entire riverfront until the 1890s. Contributing. Navigational Range Light in this view dates to 1913. Contributing. OCLP, November 2003.

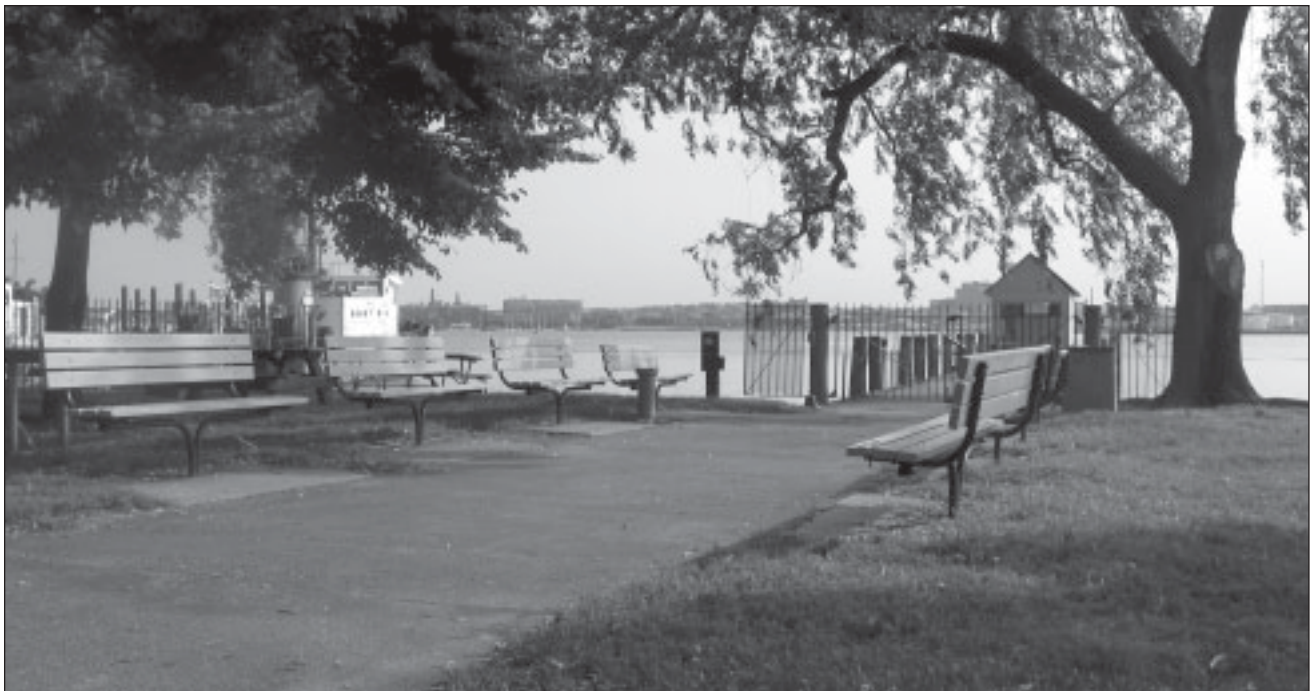
Historic Condition: A c.1977 boat dock and pier (located outside the park boundary near the end of the Seawall) is incorporated into the park's visitor circulation system. It is owned by the City of Baltimore and leased by the city to the Harbor Shuttle (*Figure 8.20*).

Figure 8.20 Tour Boat Dock. This dock, technically outside of the site boundary, serves an important function in the visitor circulation system. It is owned by the City of Baltimore. Non-contributing. OCLP, July 2003.

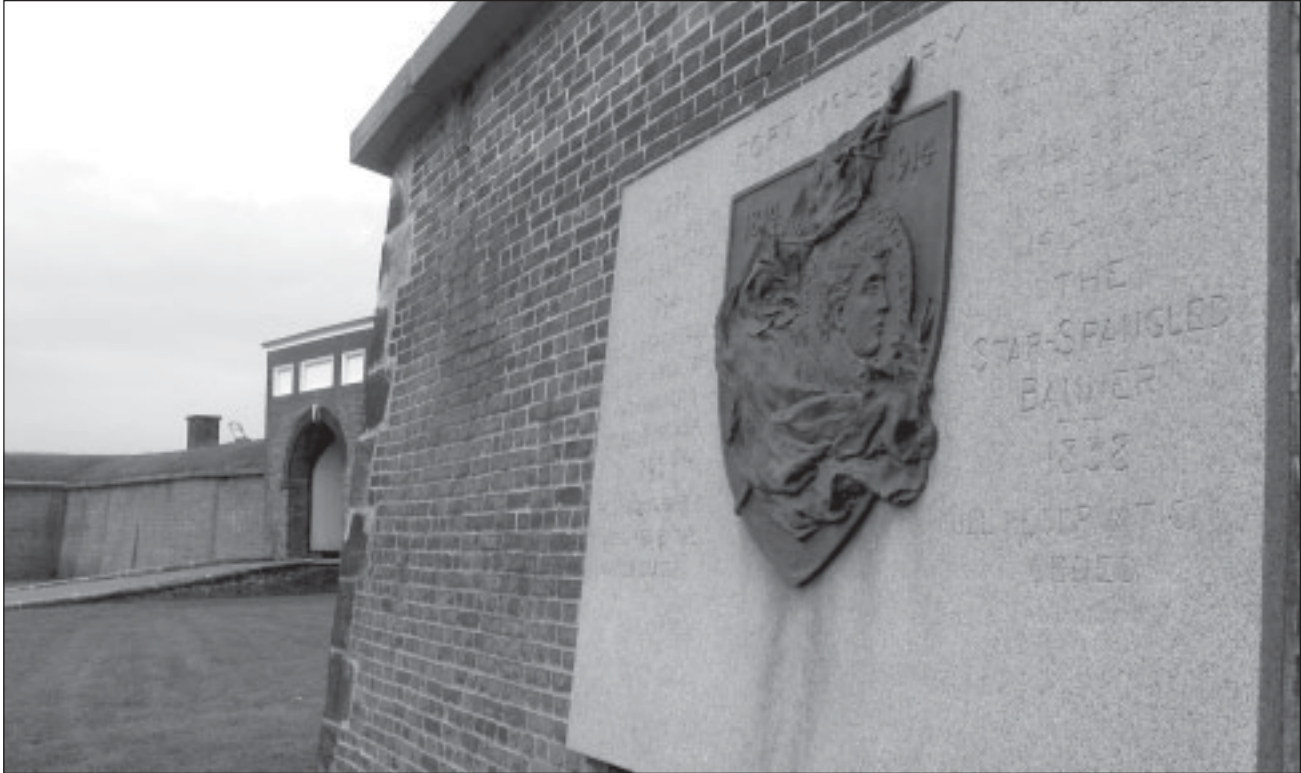
Existing Condition: The plaque is placed in the southeast scarp wall of bastion 1 about 4 ft. above ground level. Bronze was cleaned and waxed during the autumn of 2000 (*Figure 8.21*).

Figure 8.21 Francis Scott Key Memorial Plaque. This bronze and marble plaque was affixed to the southeast scarp wall of Bastion I in 1914, commemorating the centennial of the 1814 bombardment and Francis Scott Key's writing of "The Star-Spangled Banner." Contributing. OCLP, July 2003.

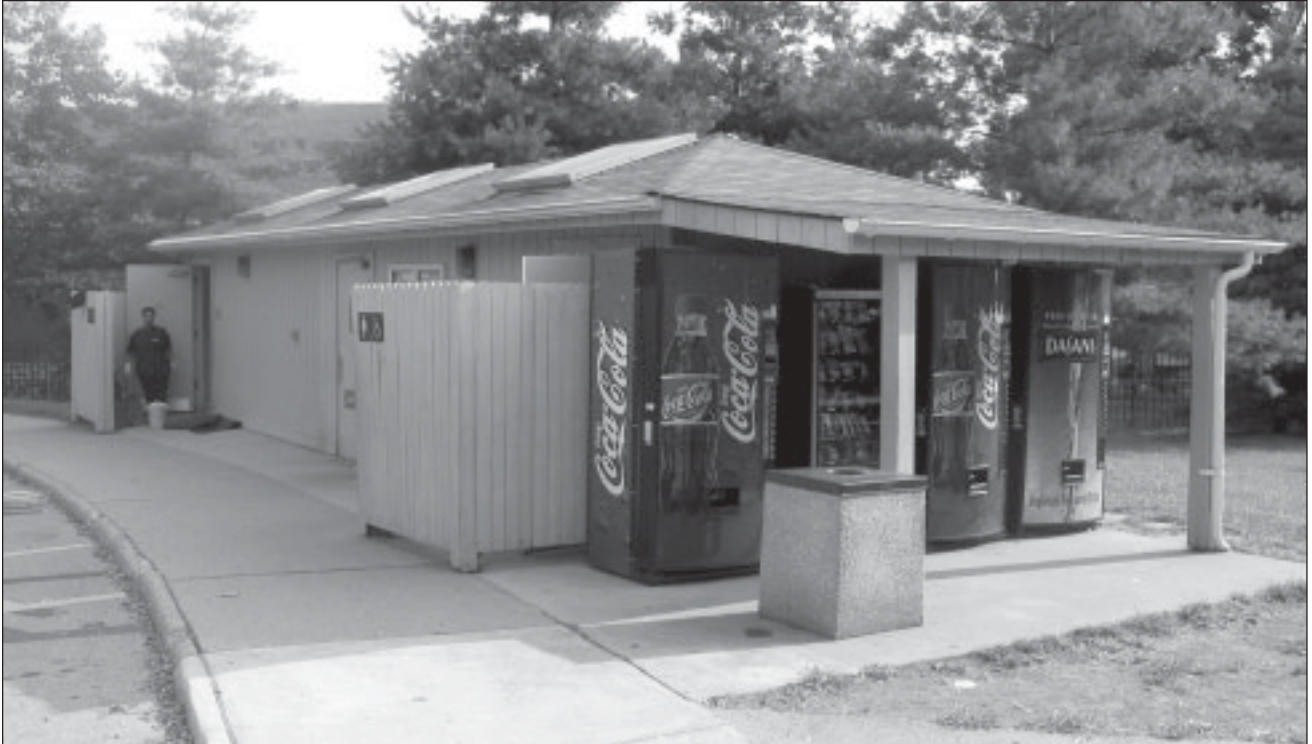
Figure 8.23 Comfort Station. This building, constructed in 1988, is located near the picnic area and tour boat dock. The one-story building measures 18' by 58'. The hipped roof building has entrances at either end with screened enclosures. Non-contributing. OCLP July 2003.

Existing Condition: The one-story wood frame restroom measures 18' by 58'. The hipped roof building has entrances at either end with screened enclosures. A central entrance provides access to plumbing and waste systems (*Figure 8.23*).

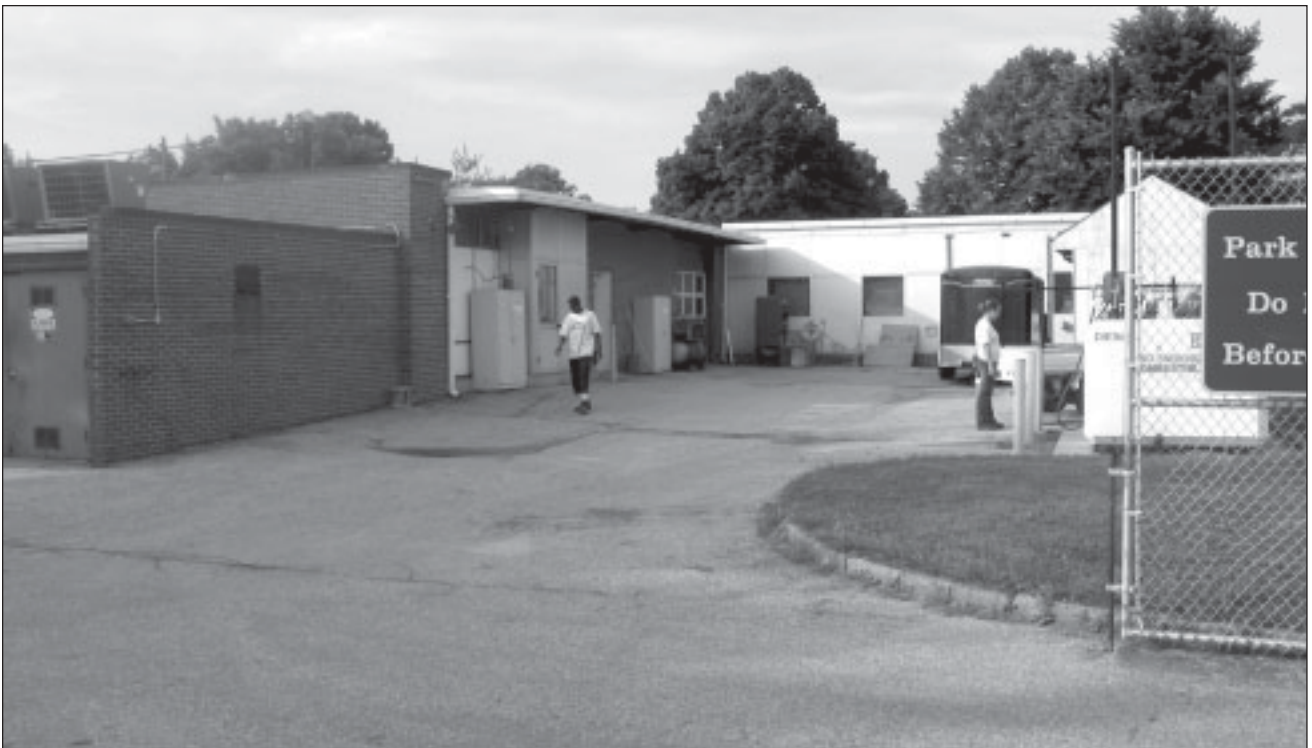
Figure 8.24 Maintenance Shop. The maintenance shop was built in 1963-64. It is located in the northwest corner of the monument grounds adjacent to the Park housing complex. Non-contributing. OCLP July 2003.

Historic Condition: The maintenance shop was built in 1963-64. It is located in the northwest corner of the monument grounds adjacent to the park housing complex (*Figure 8.24*).

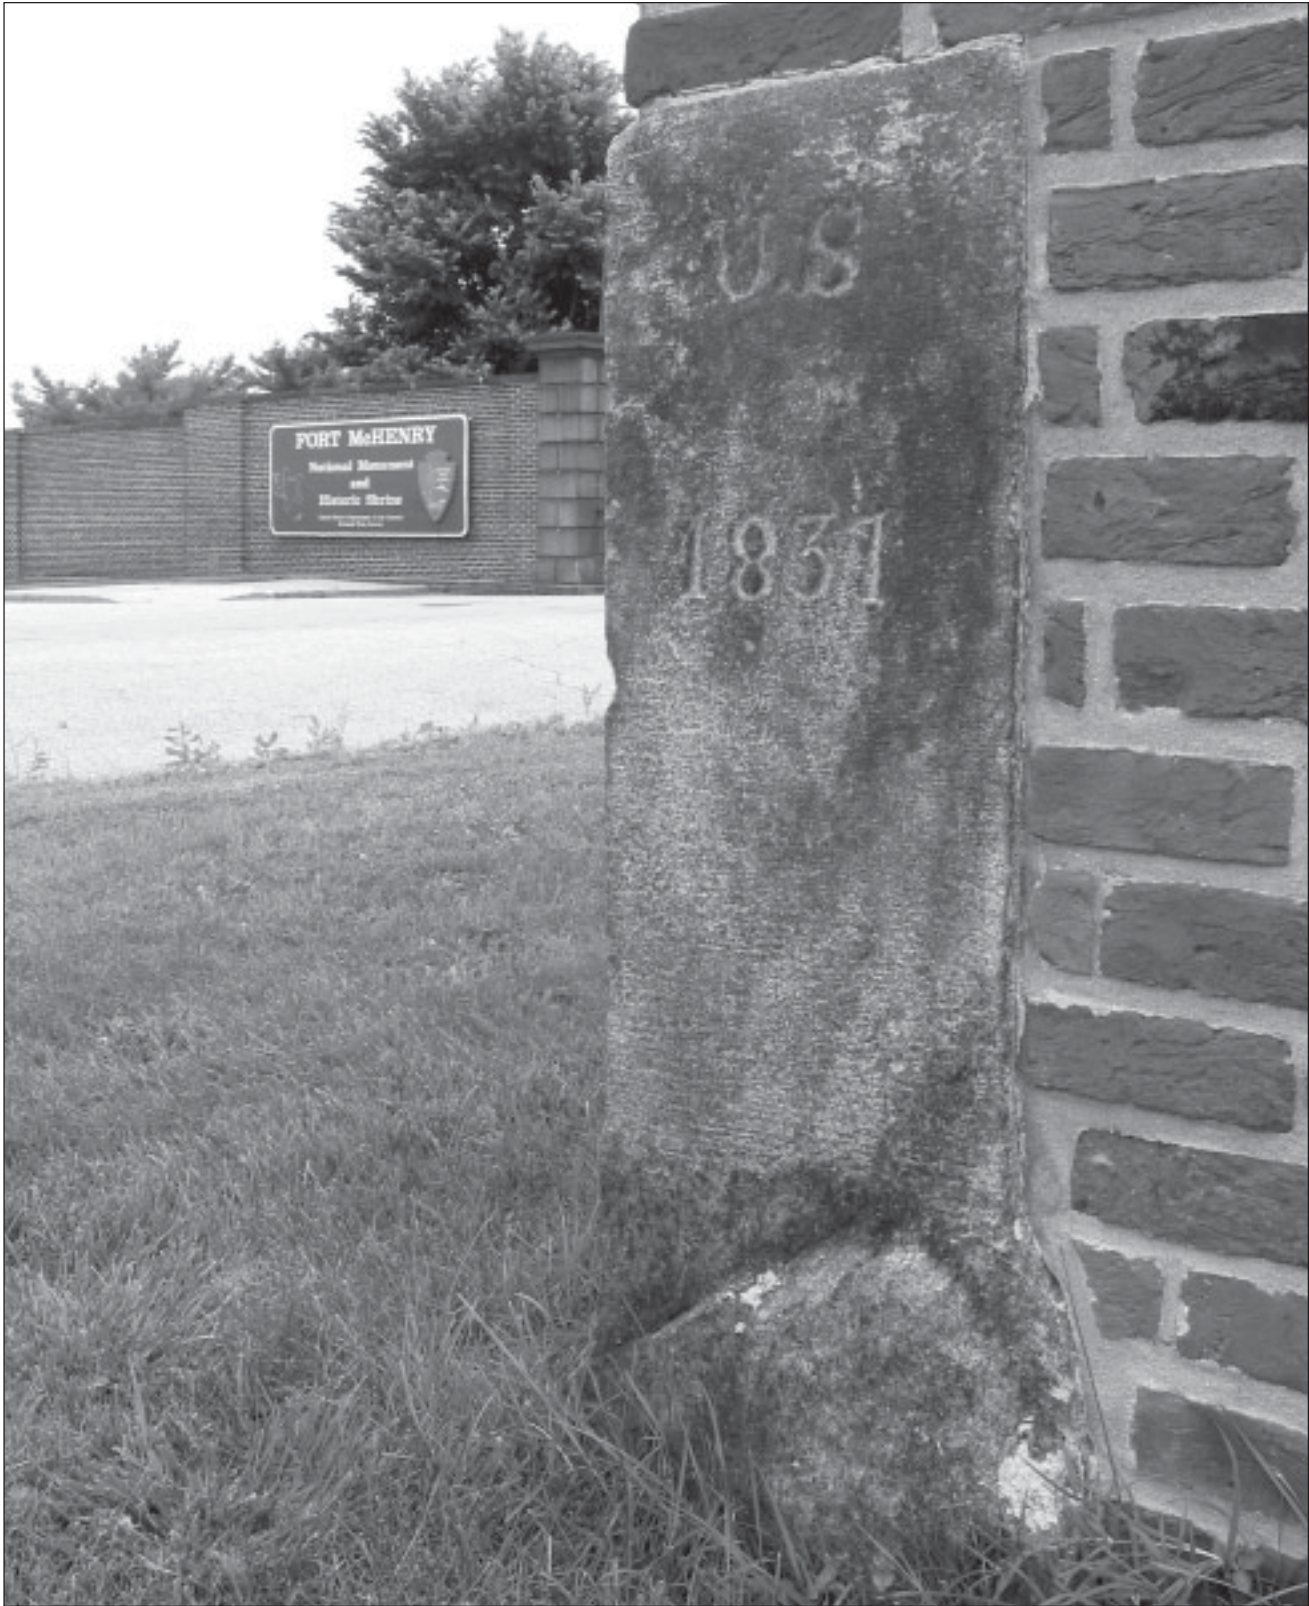
Figure 8.25: Boundary Wall and Entrance Gates. A ten-foot high brick wall marks Fort McHenry's western boundary. Contributing. OCLP, July 2003.

Existing Condition: A 10' high brick wall extends along the western boundary of the park 240' north and 575' south of the entrance (*Figure 8.25*). The wall is capped with granite coping, and strengthened at intervals by square brick piers, each of which is 26" wide.

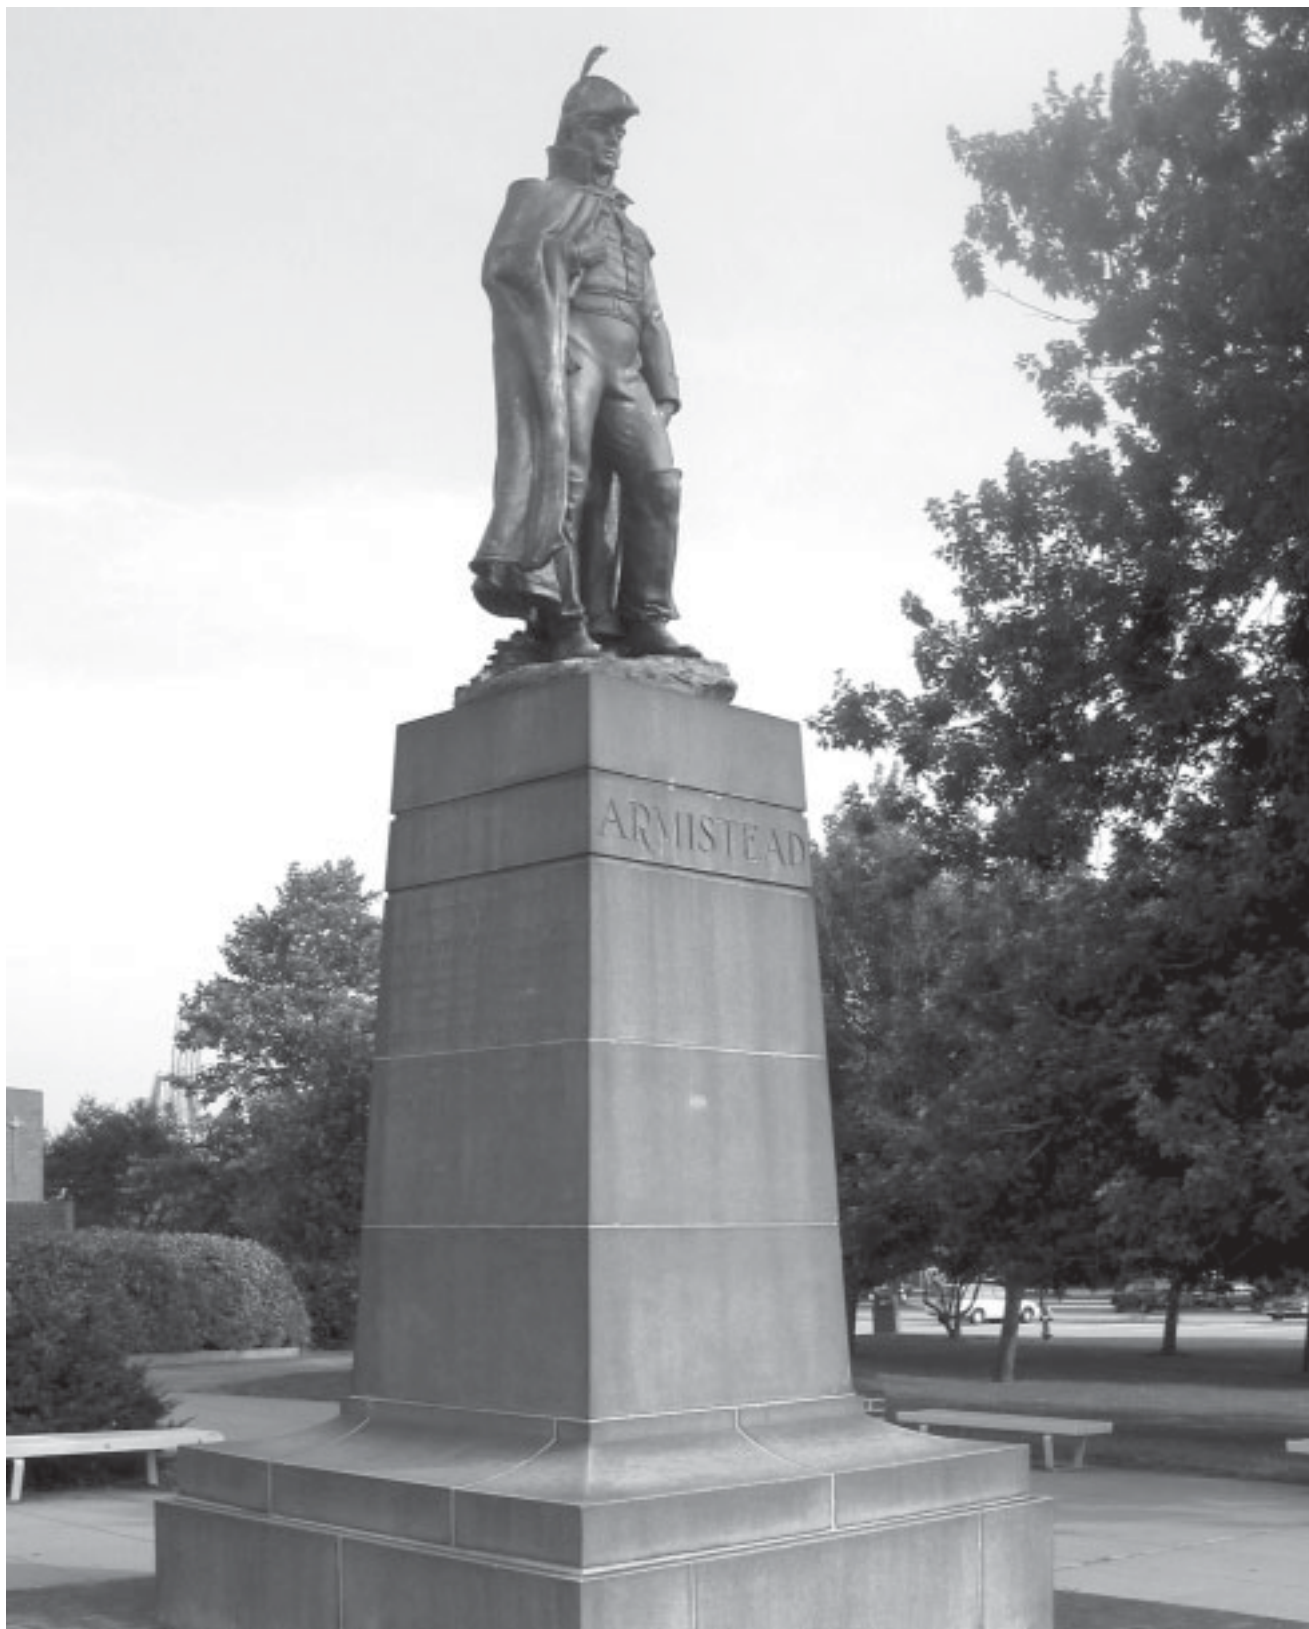
Figure 8.27 Armistead Monument. The standing figure of Major George Armistead, commander during the 1814 bombardment, was sculpted by Edward Berge in 1914. Originally located on the parapet of the Outer Battery opposite Magazine no. 2, it was moved in 1963 to its present location as the centerpiece of the plaza in front of the Visitor Center. Contributing. OCLP, July 2003.

Existing Condition: The nine-foot tall bronze statue is mounted on a nine-foot by nine-foot granite base with a height of 12' (Figure 8.27). The sculptural bronze was cleaned and waxed during the autumn of 2000.
