CULTURAL LANDSCAPE REPORT FOR FORT MCHENRY NATIONAL MONUMENT AND HISTORIC SHRINE

SITE HISTORY, EXISTING CONDITIONS AND ANALYSIS

FORT MCHENRY NATIONAL MONUMENT AND
HISTORIC SHRINE

August 2004

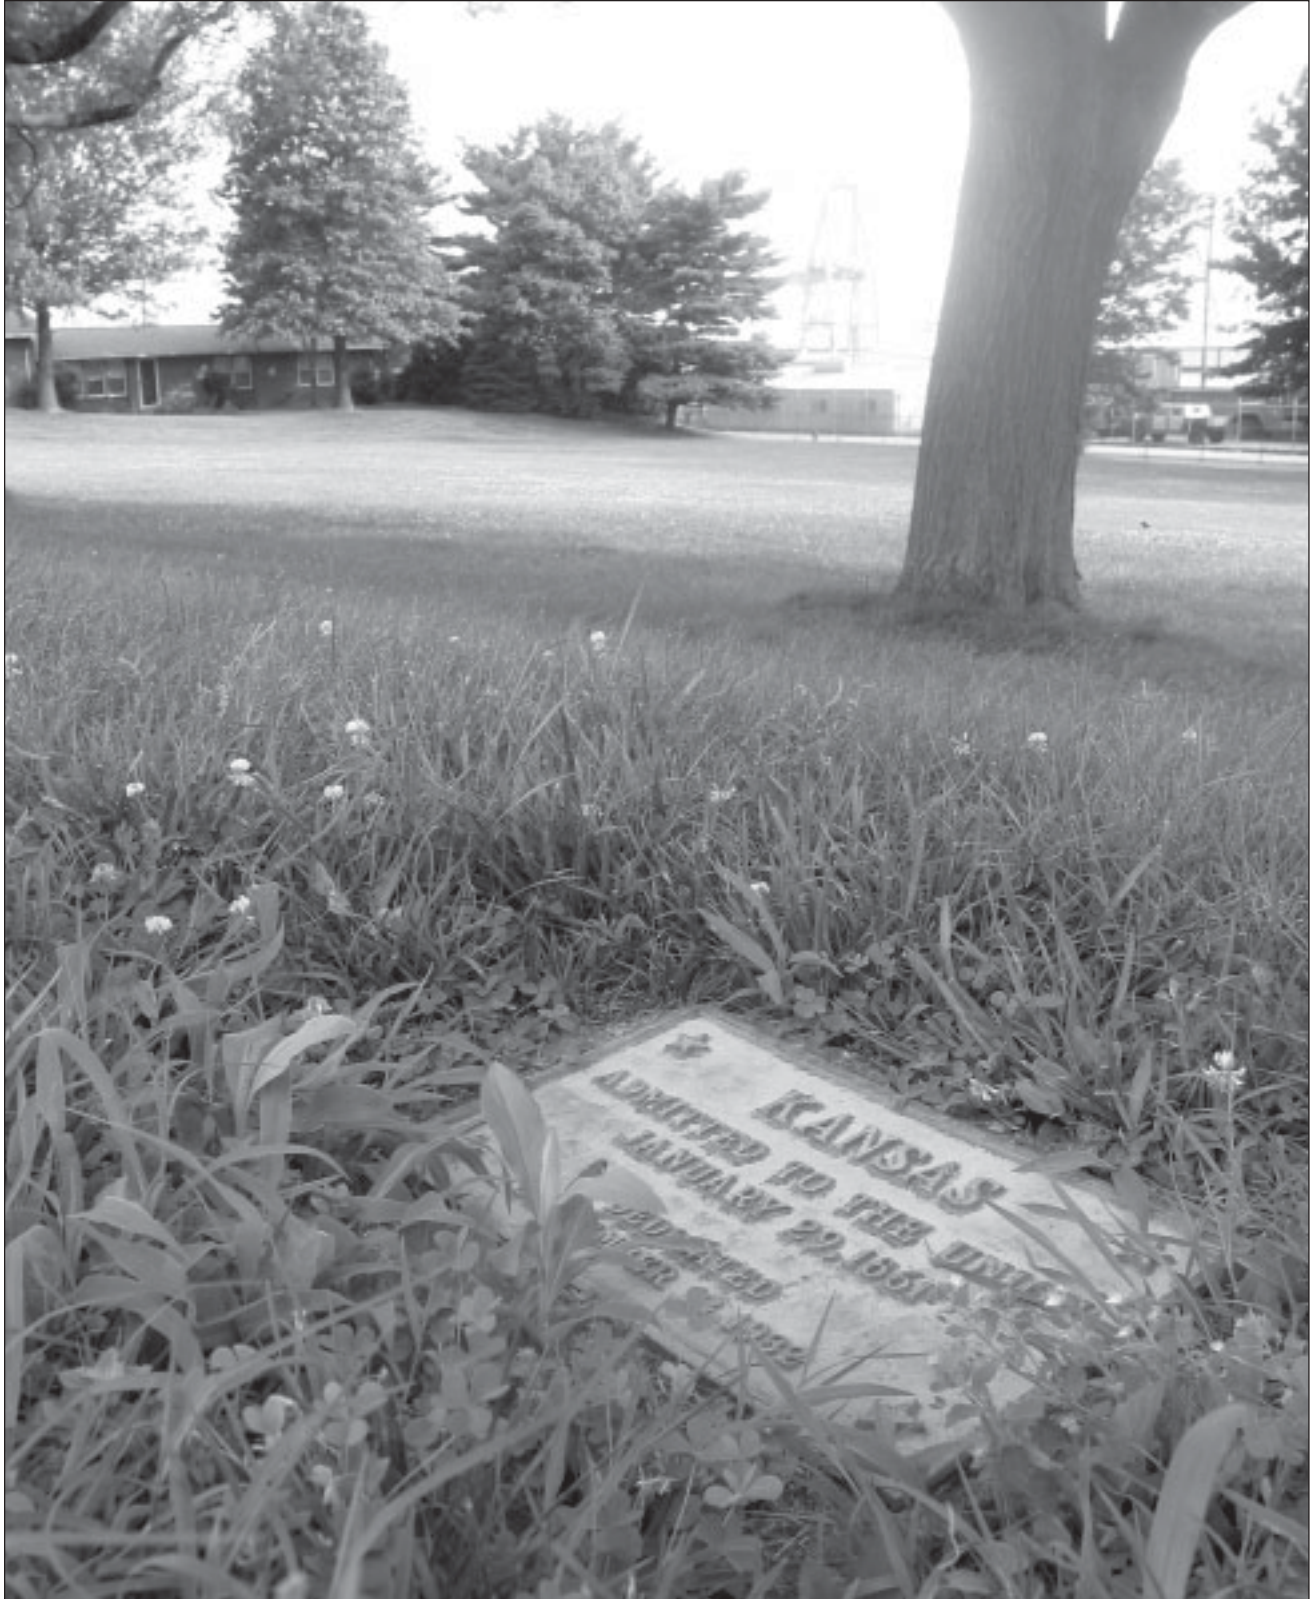
Figure 8.28 State Tablet Tree Plaques. These plaques were placed during the Defender's Day celebrations of 1932 to commemorate the entry of each of the states into the nation. Most of these plaques have lost the planting of a red oak tree associated with them, diminishing their integrity. Recent grading has furthermore buried much of the small monuments, which originally projected out of the surface of the ground, much like a small footstone found in cemeteries. Non-contributing, yet managed as a resource. OCLP, July 2003.

Existing Condition: These are concrete commemorative markers with brass plaques (*Figure 8.28*). They are located along the north side of the drive from the entrance gate.
