# CULTURAL LANDSCAPE REPORT FOR FORT MASON GOLDEN GATE NATIONAL RECREATION AREA

Volume One: Site History, Existing Conditions and Analysis

Prepared by:  
Amy Hoke, Historical Landscape Architect  
National Park Service  
Pacific West Region  
Seattle, Washington

September 2004

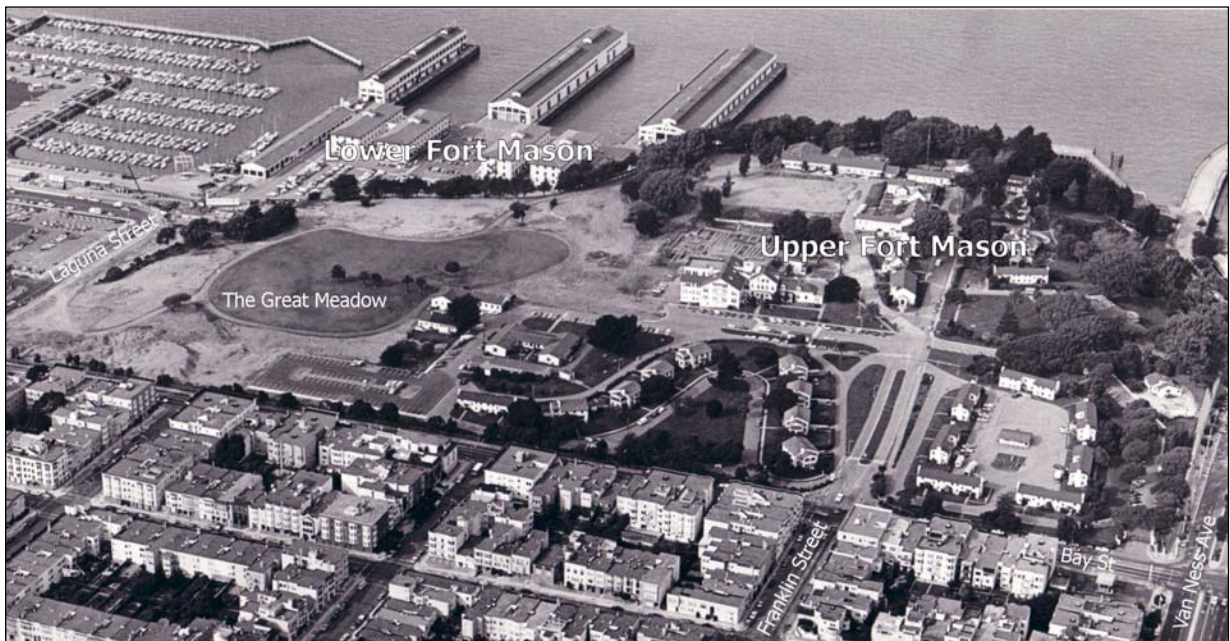
**Figure 1.2:** Oblique aerial photo of Fort Mason, GGNRA, c.1980. NPS, GGNRA Archives, Richard Frear Collection.

individual structures are locally significant, as a collection their significance extends to the national level. Of approximately seventy structures found at Fort Mason, fifty-five are historically significant according to current National Register of Historic Places documentation. Fort Mason currently serves as headquarters for the GGNRA and as home to the Fort Mason Center, a cultural center operating out of Lower Fort Mason (Figure 1.2). The headquarters for the San Francisco Maritime NHS are also located within lower Fort Mason.

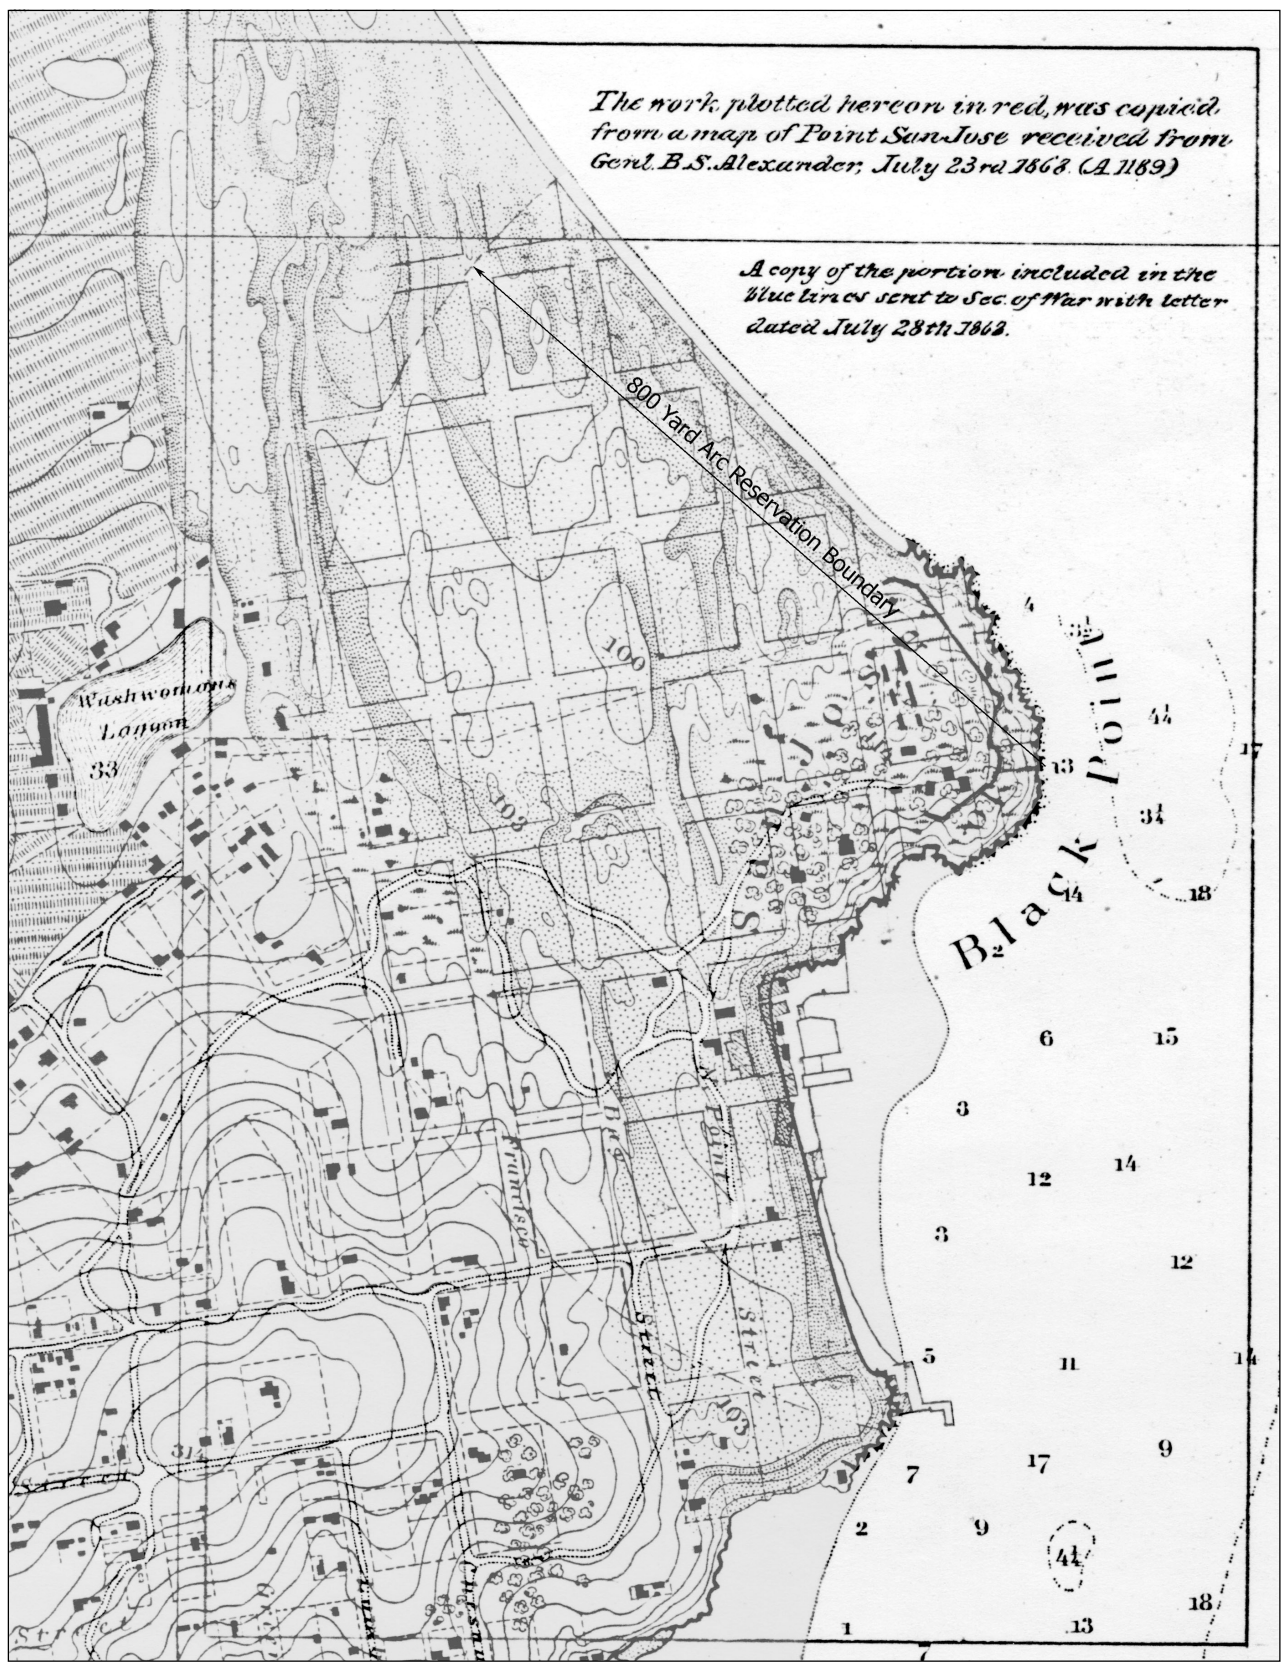
**Figure 2.2.2:** The U.S. military reservation at Point San Jose was isolated from the city by an expanse of sand dunes. The land surrounding the base would not become fully urbanized until the early 20th century. Detail from “City of San Francisco and its Vicinity” U.S. Coast Survey, A.D. Bache Superintendent. Published in 1859, with revisions noted in 1862 and 1868. National Archives, Cartographic Division, Fortifications File.

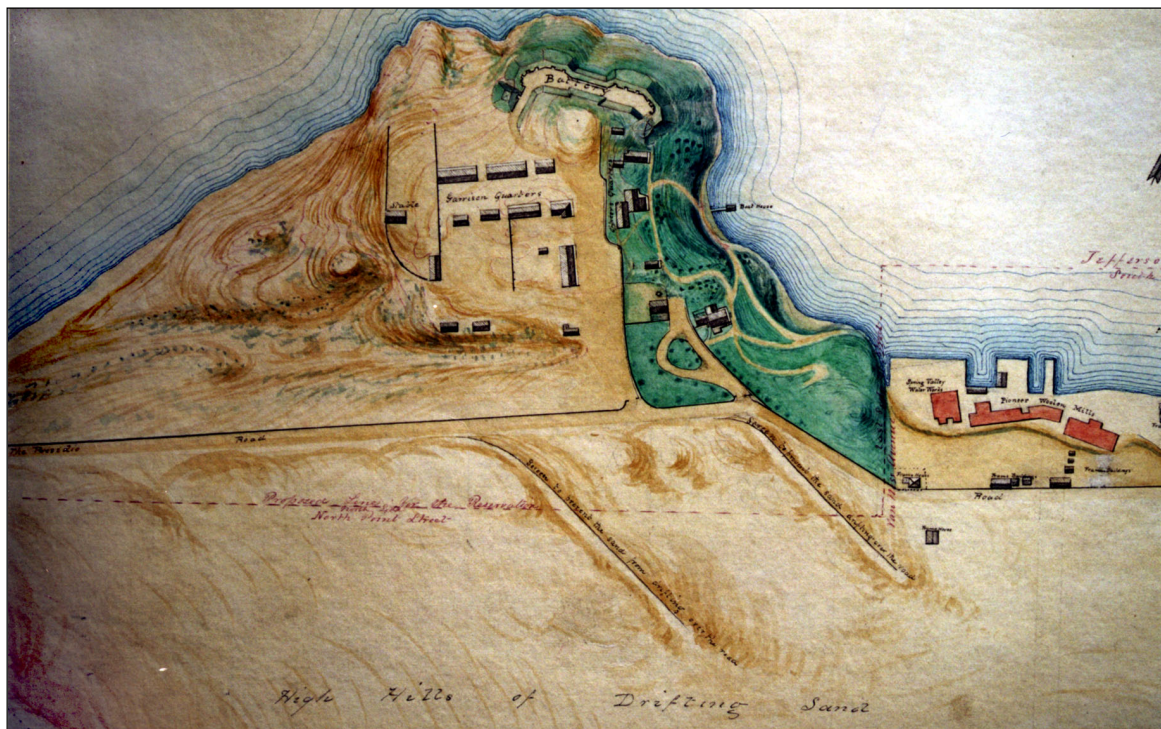
**Figure 2.2.7:** Rendered in watercolor, the earliest known plan of the entire U.S. military reservation at Point San Jose, documents a clear demarcation of the officer's residential zone from the enlisted garrison in the abundance and quality of vegetation. The location of wind fences appear prominently in this drawing, intended to block the pervasive westerly wind. Detail from: "Map of Point San Jose of Black Point," November 5th, 1867. National Archives RG 77, Cartographic Division, Fortifications File.

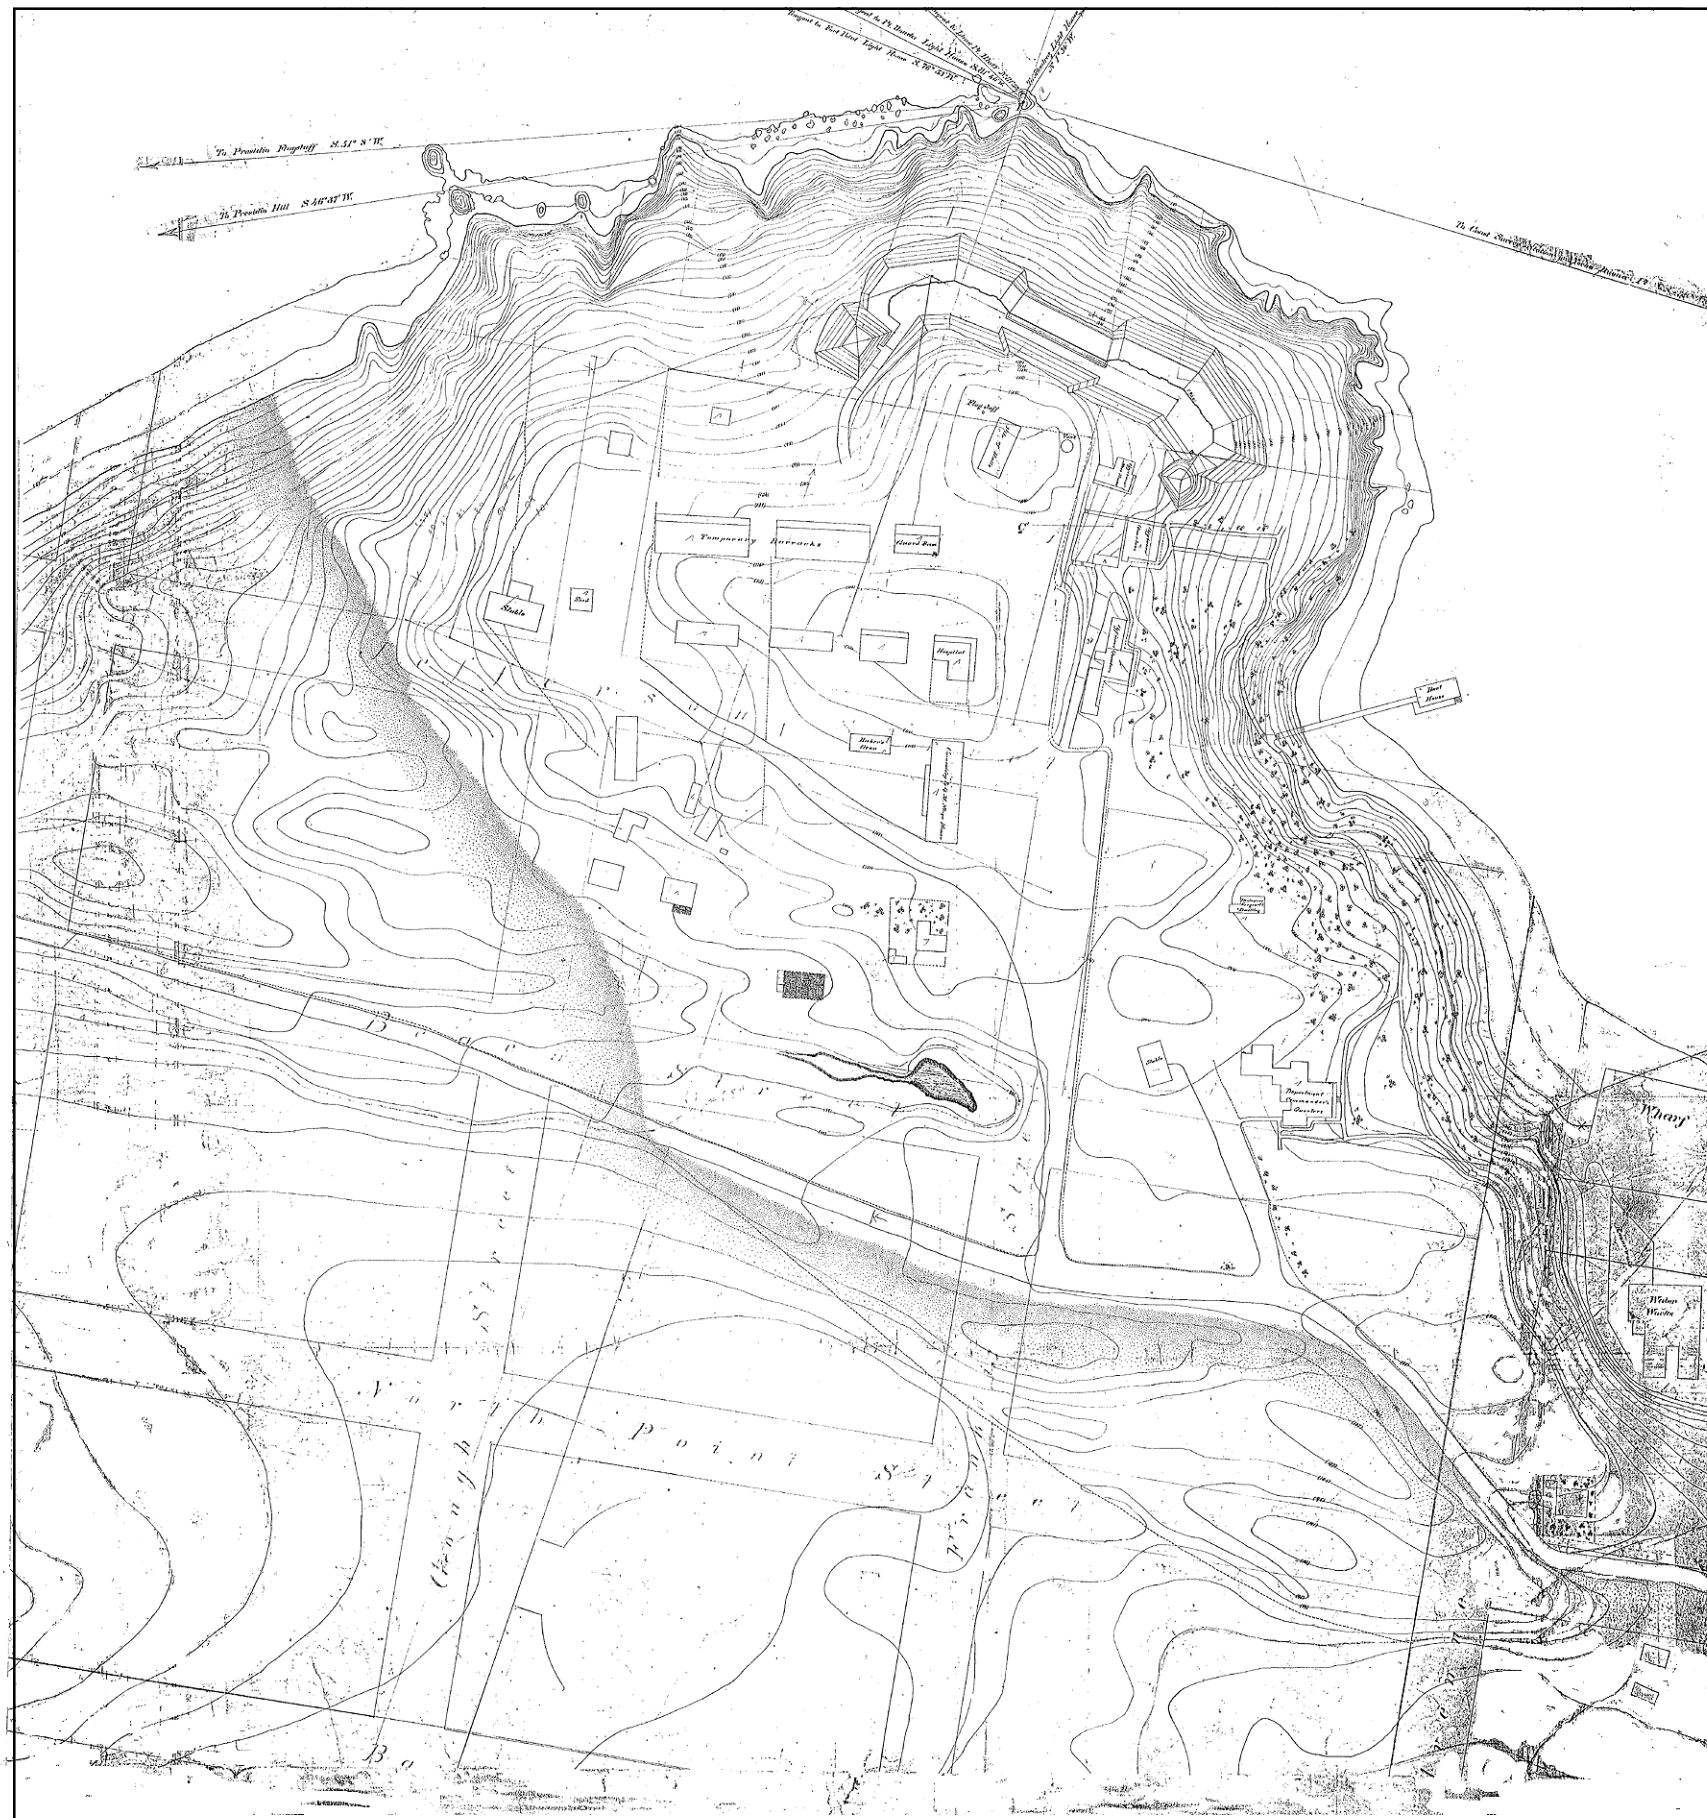
**Figure 2.2.8:** The first accurate survey of Point San Jose was completed in 1868 with assistance from William Hammond Hall, who later designed San Francisco's Golden Gate Park. "Map of Point San Jose, San Francisco Harbor, Cal. Made under the direction of the Board of Engineers Pacific Coast by Thos. H. Handbury 1st Lieut. Corps of Engineers and W. H. Hall, Asst. 1868." National Archives, RG 77, Cartographic Division, Fortifications File.

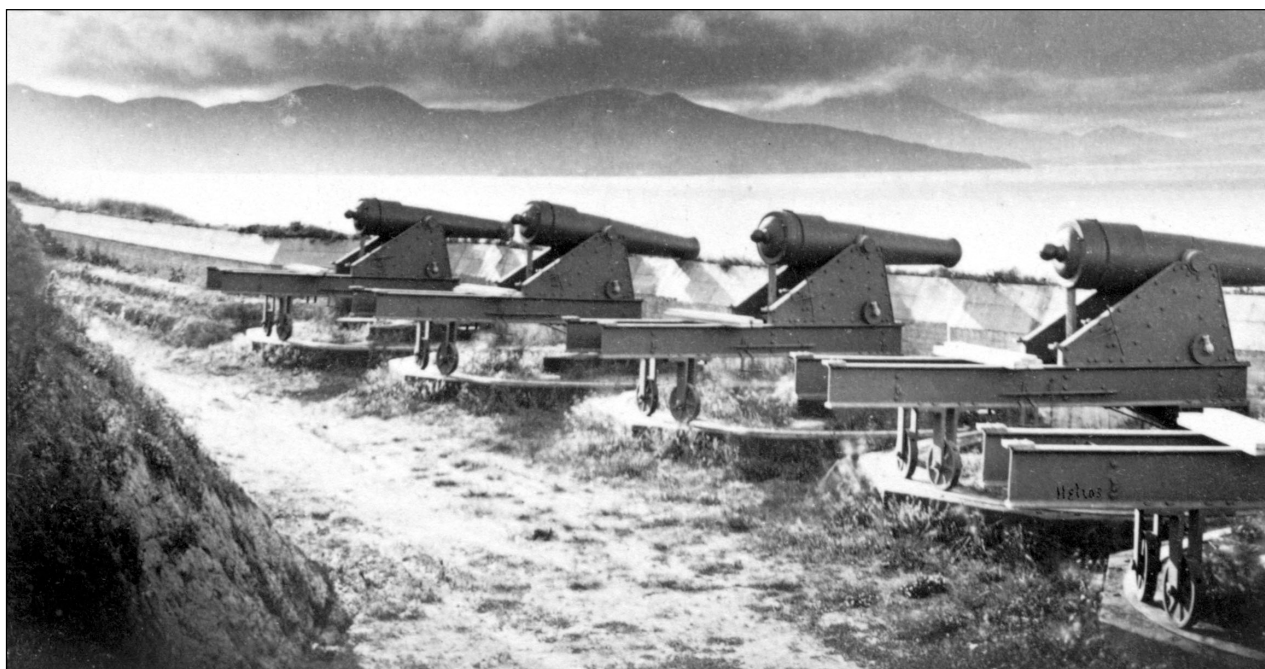
**Figure 2.3.2:** Following the end of the Civil War, austerity measures led to a period of relative neglect. This image is of Point San Jose's east battery, showing the panoramic views characteristic of a coastal battery. Image c.1869. UC Berkeley, Bancroft Library, Eadward Muybridge, Lone Mountain College Collection of Stereographs.

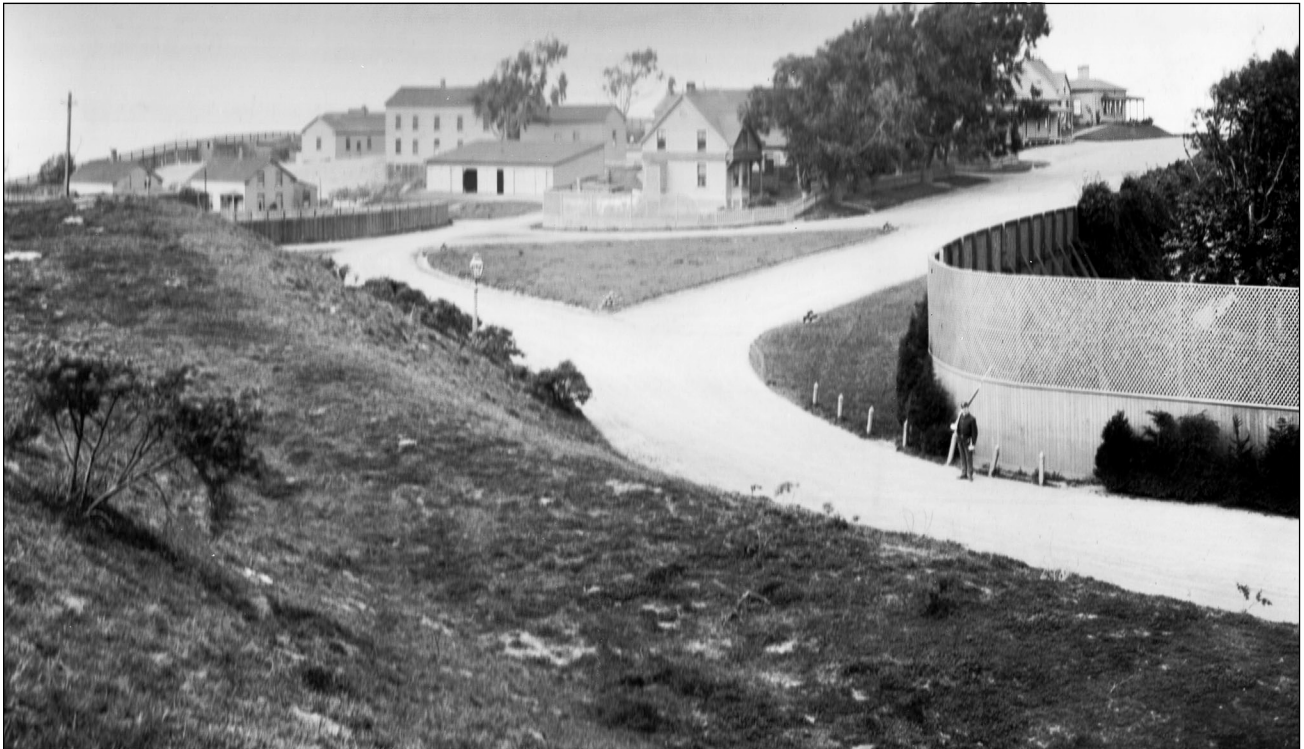
**Figure 2.3.5:** A series of photographs was commissioned of Army posts by the Quartermaster Department during the early 1890s. These flattering images of Fort Mason document some success in vegetating the sand dunes south of central cantonment in addition to the character of the circulation system and many small scale features. “General View of Post.” c.1891. National Archives, RG92, Still Photography Division. Box No. 10, Series F, (92-F-37-1).

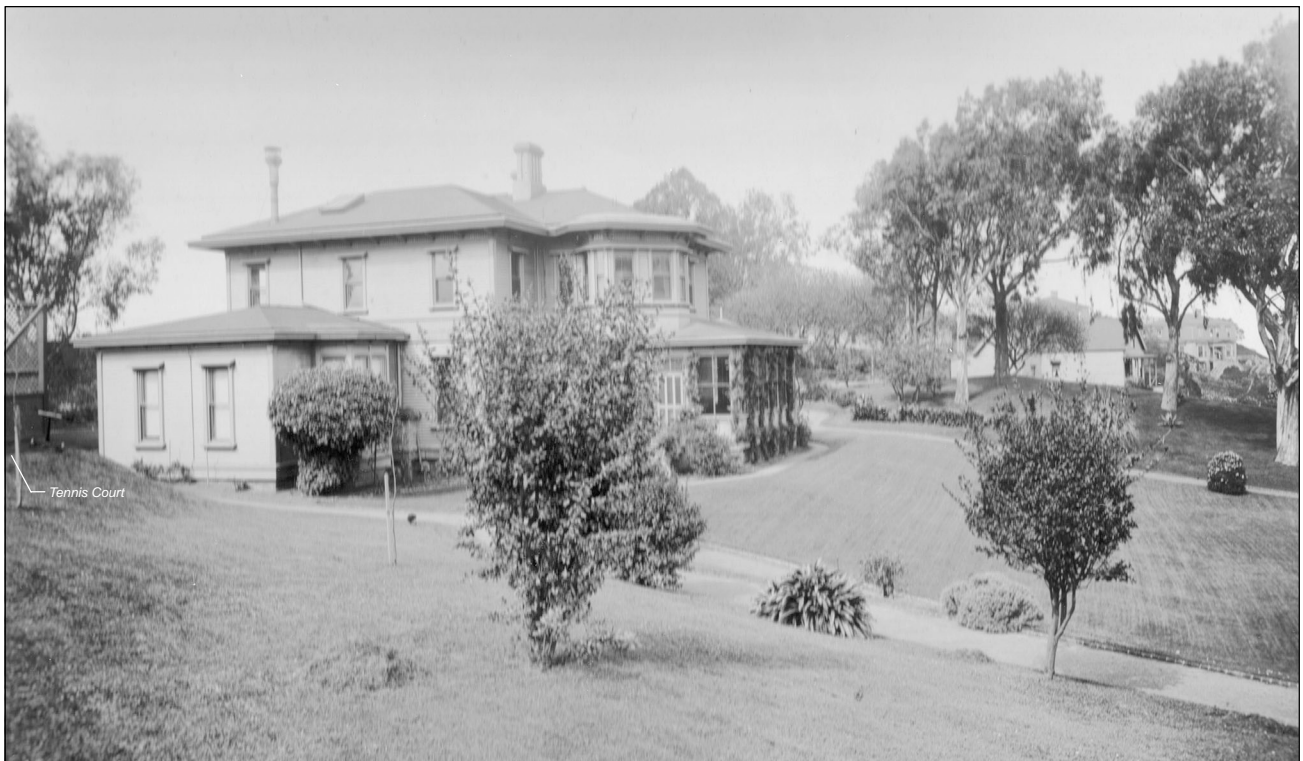
**Figure 2.3.6:** This image documents the east lawn of the Commanding General’s Quarters following the removal of the former Grisar dwelling and construction of McDowell’s new residence. Brick edged gravel pathways, a wooden tennis court fence, and mature Eucalyptus trees are found in view among other landscape features. “Commanding Officer’s Quarters,” c. 1891. National Archives, RG92, Still Photography Division, Box 10, Series F, (92-F-37-2).

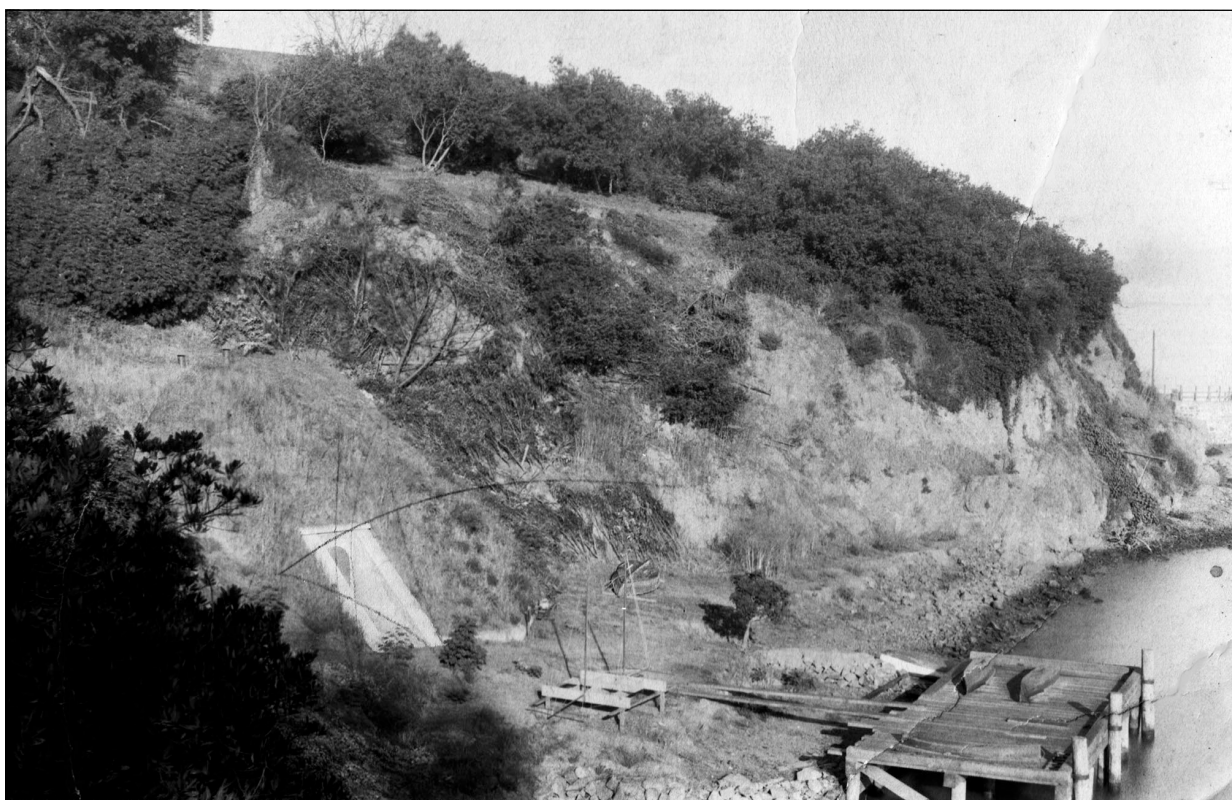
*Casemate at Point San Jose Completed August 1891*

**Figure 2.3.10:** A mine “casemate” intended to electronically control the detonation of mines placed in the harbor was built into the eastern slope of the point in 1890. Image 1891. National Archives, RG77, Still Picture Division, 77-F-5-2-Drawer 93.

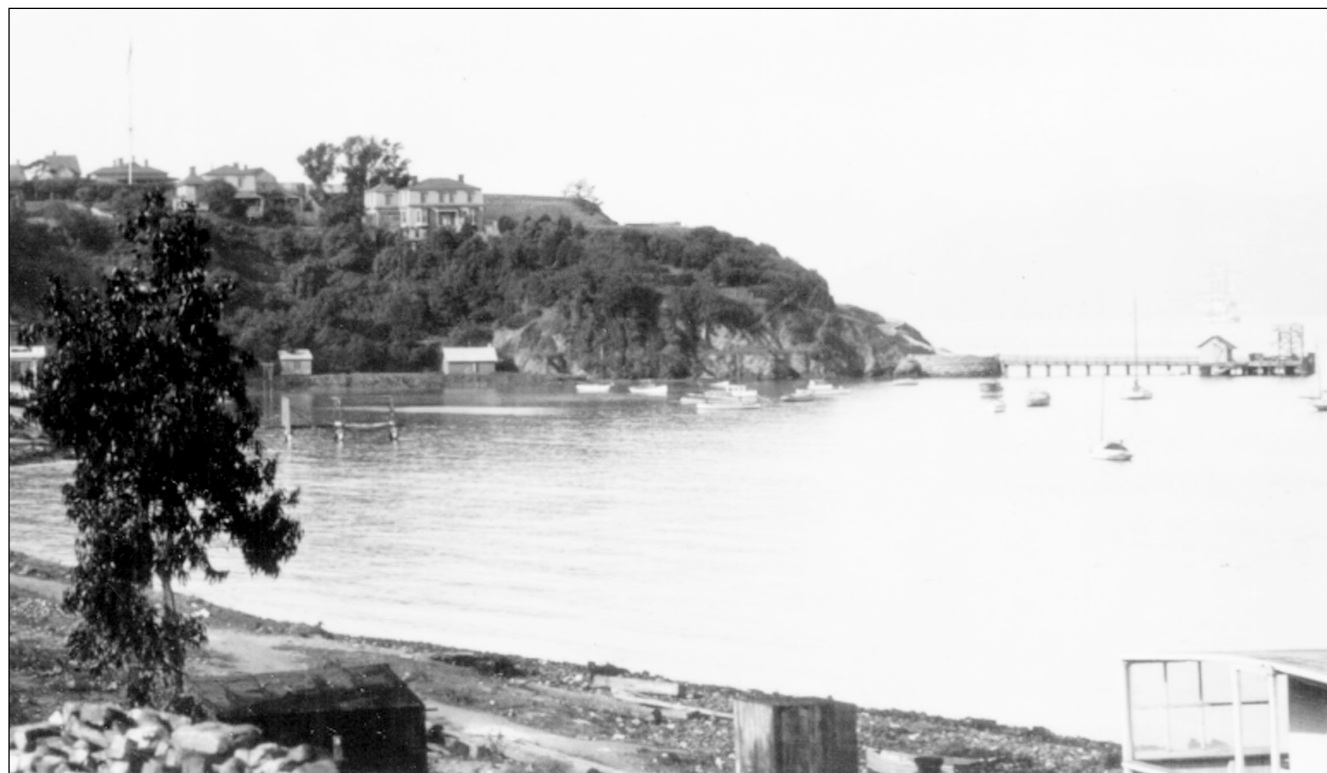
**Figure 2.3.14:** View of the northern extremity of Point San Jose from Black Point Cove, c1902. Image shows bare slopes and open prospects of the gun batteries. San Francisco Maritime National Historical Park, A11.332, Historical Documents Collection.

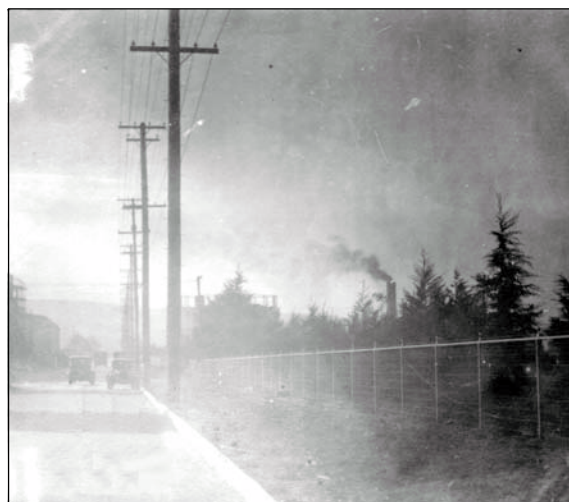
**Figure 2.5.4:** Although upper Fort Mason was open to visitors, wire fencing and Monterey Cypress were installed on the Bay Street frontage to clearly mark a separation between the city and the military reservation. Image from: "Completion Report on Construction of Ornamental Iron Fence at Fort Mason, California." National Archives, RG 77, Records of the Construction Division - Annual Construction, Maintenance, and Repair Reports (1924-1938) Box 135NM.

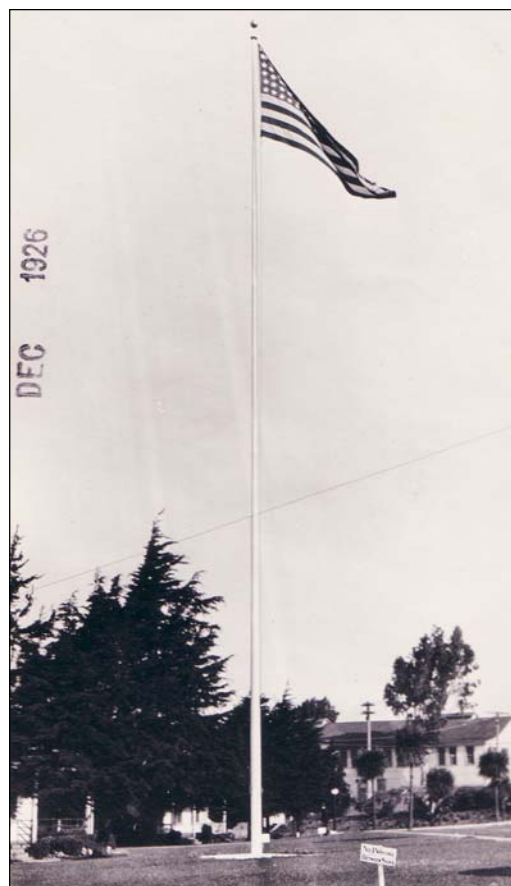
**Figure 2.5.8:** Flagpole, 1926. Note overhead utility lines. National Archives, RG 77, Records of the Construction Division - Annual Construction, Maintenance, and Repair Reports (1924-1938) Box 135NM.

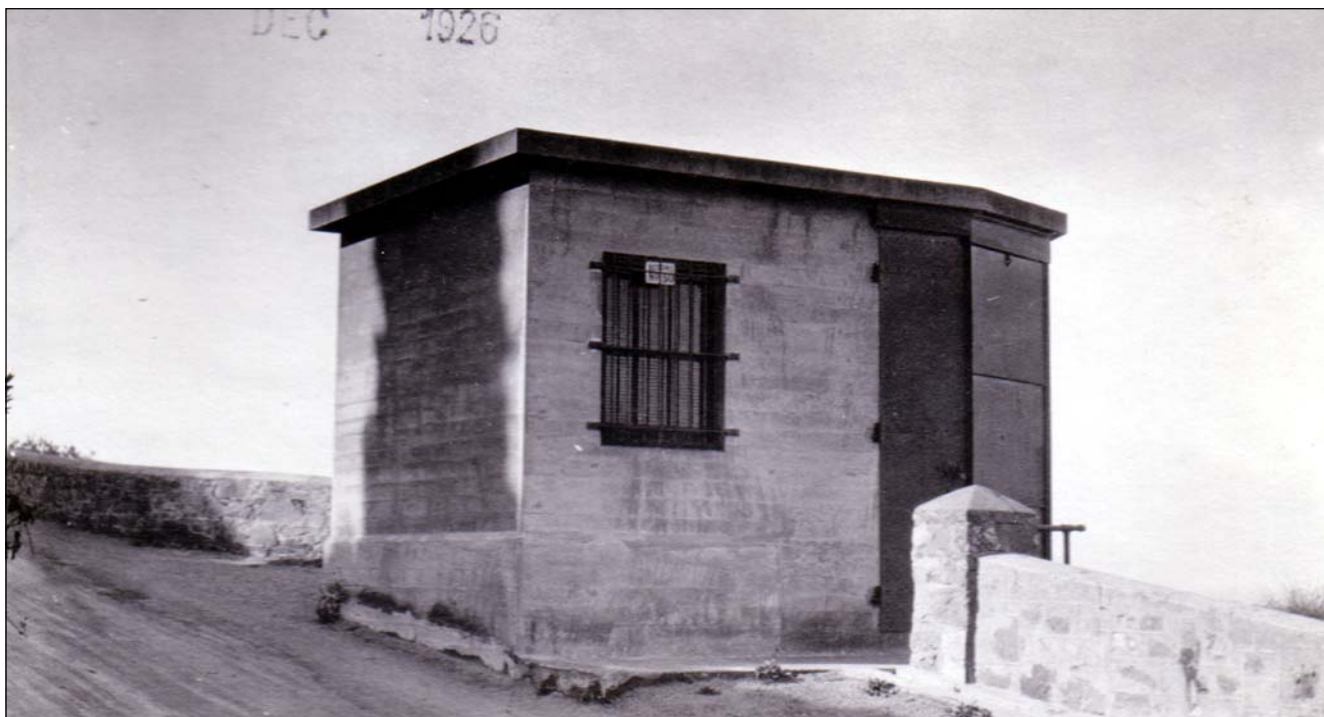
**Figure 2.5.14:** After the removal of Fort Mason's artillery in 1908, and prior to the invention of radar, powerful 60-inch searchlights became the last vestige of the fort's defensive mission. This was one of approximately one dozen similar installations located near the entrance to the bay, 1926. National Archives, RG 77, Office of the Quartermaster General, Records of the Construction Division - Annual Construction, Maintenance, and Repair Reports (1924-1938) Box 135NM.

**Figure 2.5.14:** After the removal of Fort Mason's artillery in 1908, and prior to the invention of radar, powerful searchlights became the last vestige of the fort's defensive mission, 1926. National Archives, RG 77, Office of the Quartermaster General, Records of the Construction Division - Annual Construction, Maintenance, and Repair Reports (1924-1938) Box 135NM.

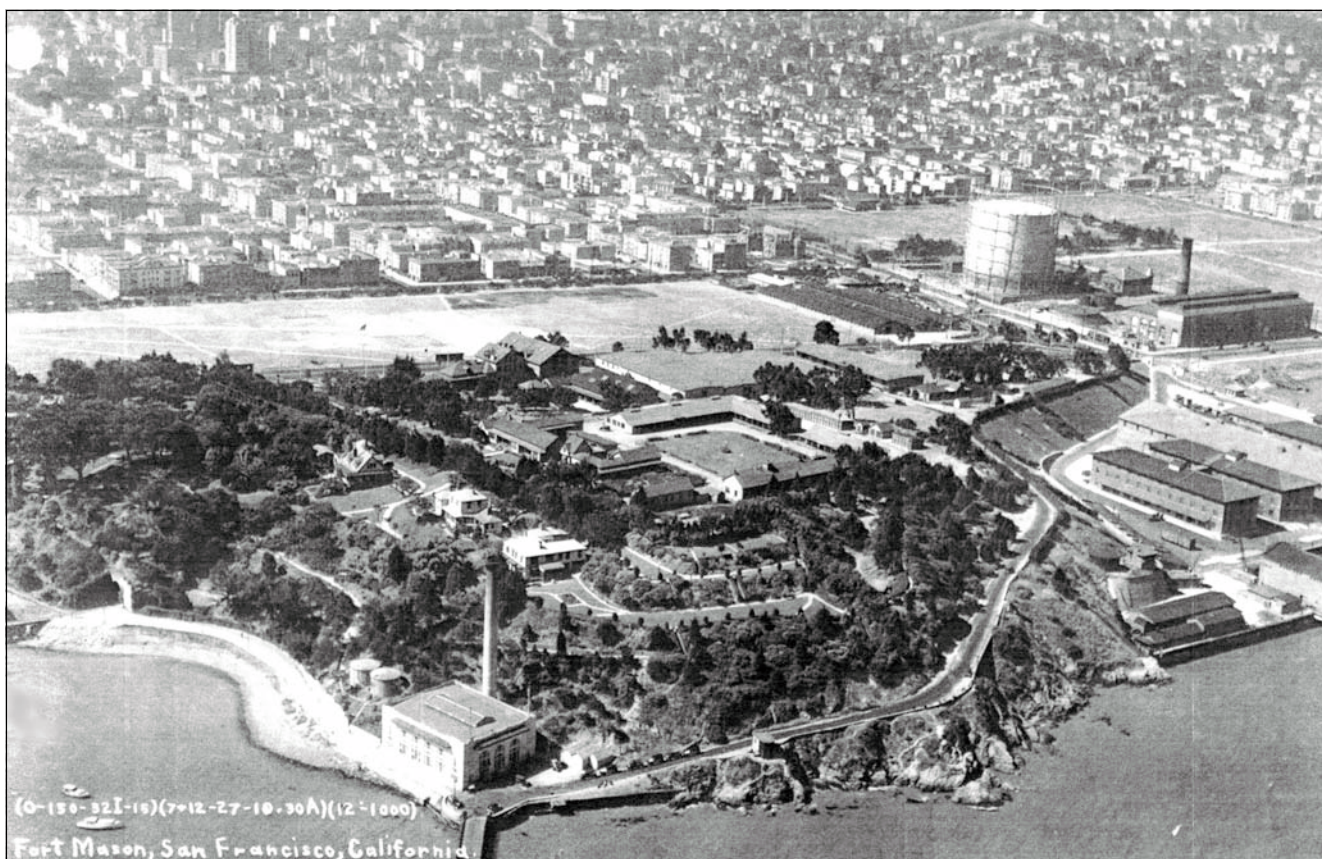
**Figure 2.5.15:** The terraces created by Fort Mason's one-time fortifications, became pleasant garden terraces offering panoramic views, as the fort's military mission had moved to the transport docks at lower Fort Mason. July 27, 1927. NPS, Golden Gate Recreation Area, Files of the Park Historian.

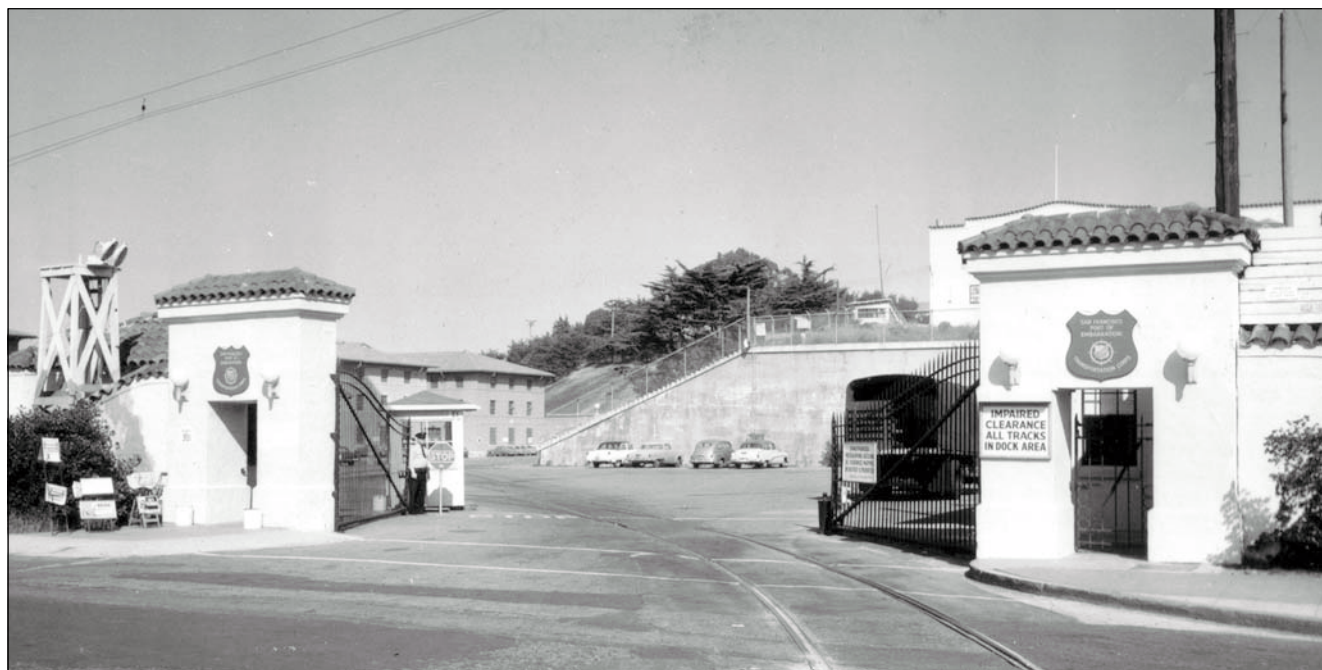
**Figure 2.5.16:** Paved surfaces and rooftops covered lower Fort Mason, a working industrial zone where visitors were not typically welcome. National Archives, RG111, SC Box 279 SC 460853.

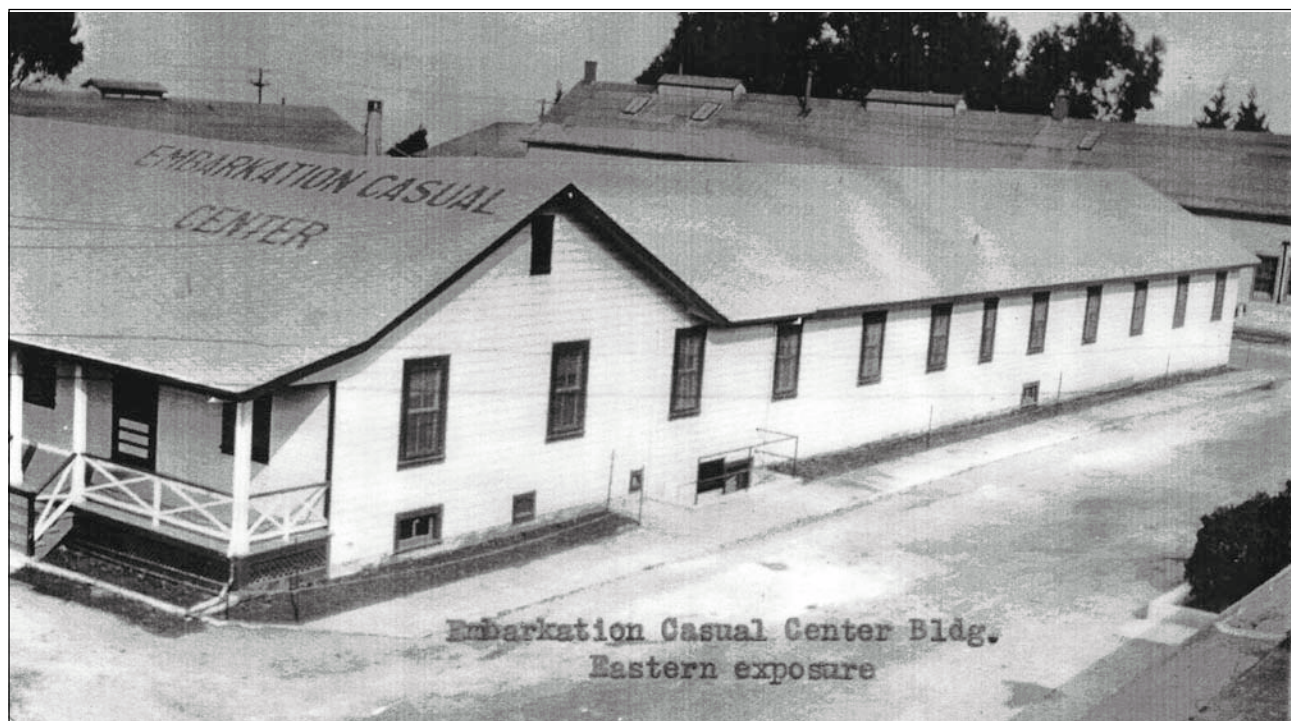
**Figure 2.5.19:** "Embarkation Casual Center Bldg. Eastern Exposure." September 28, 1929. National Archives, RG 77 Office of the Quartermaster General, Records of the Construction Division - Annual Construction, Maintenance, and Repair Reports (1924-1938) Box 135NM.

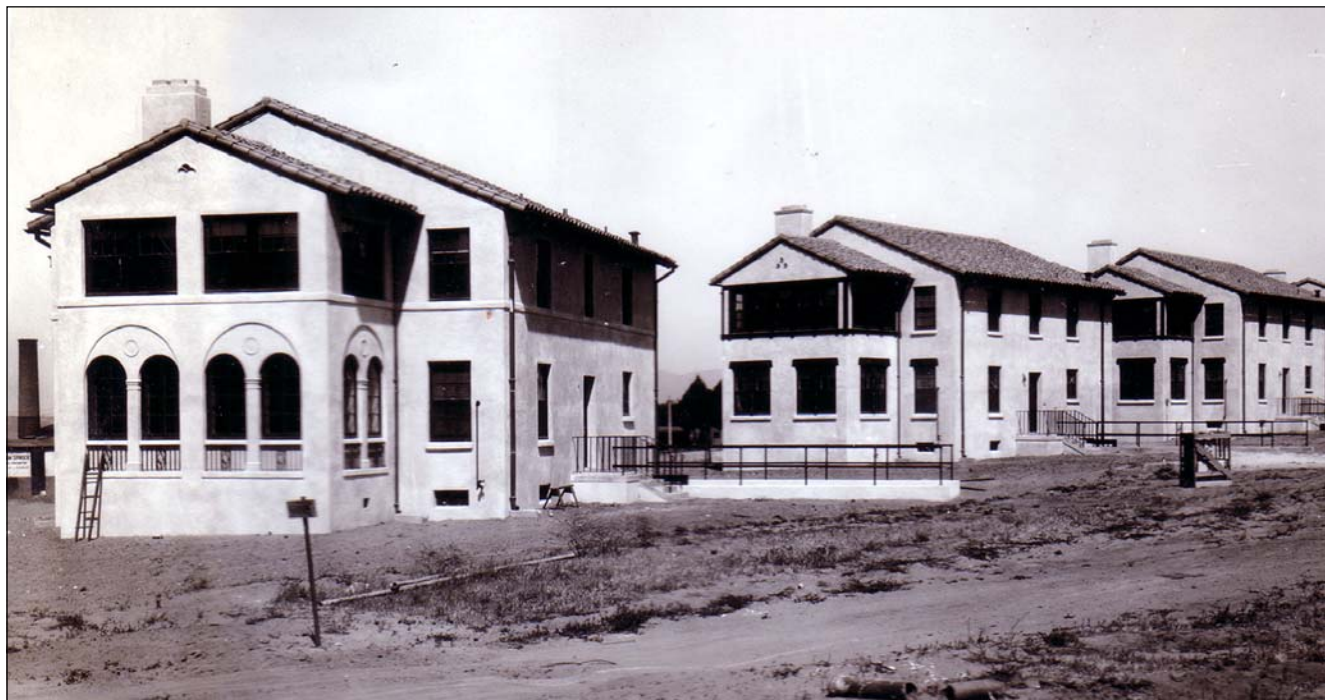
**Figure 2.5.21:** The eight sets of officers’ quarters built as part of the “N.I.R. Housing Project” were designed in the Mission Revival style used earlier at lower Fort Mason. This project, as well as the extension of the wharves and construction of wharf sheds at lower Fort Mason, were funded by the Works Progress Administration (WPA), as part of President Roosevelt’s “New Deal” economic stimulus plan. “Construction Completion Report,” August 23 1934. National Archives, RG 77 Office of the Quartermaster General, Records of the Construction Division - Annual Construction, Maintenance, and Repair Reports (1924-1938) Box 135NM.

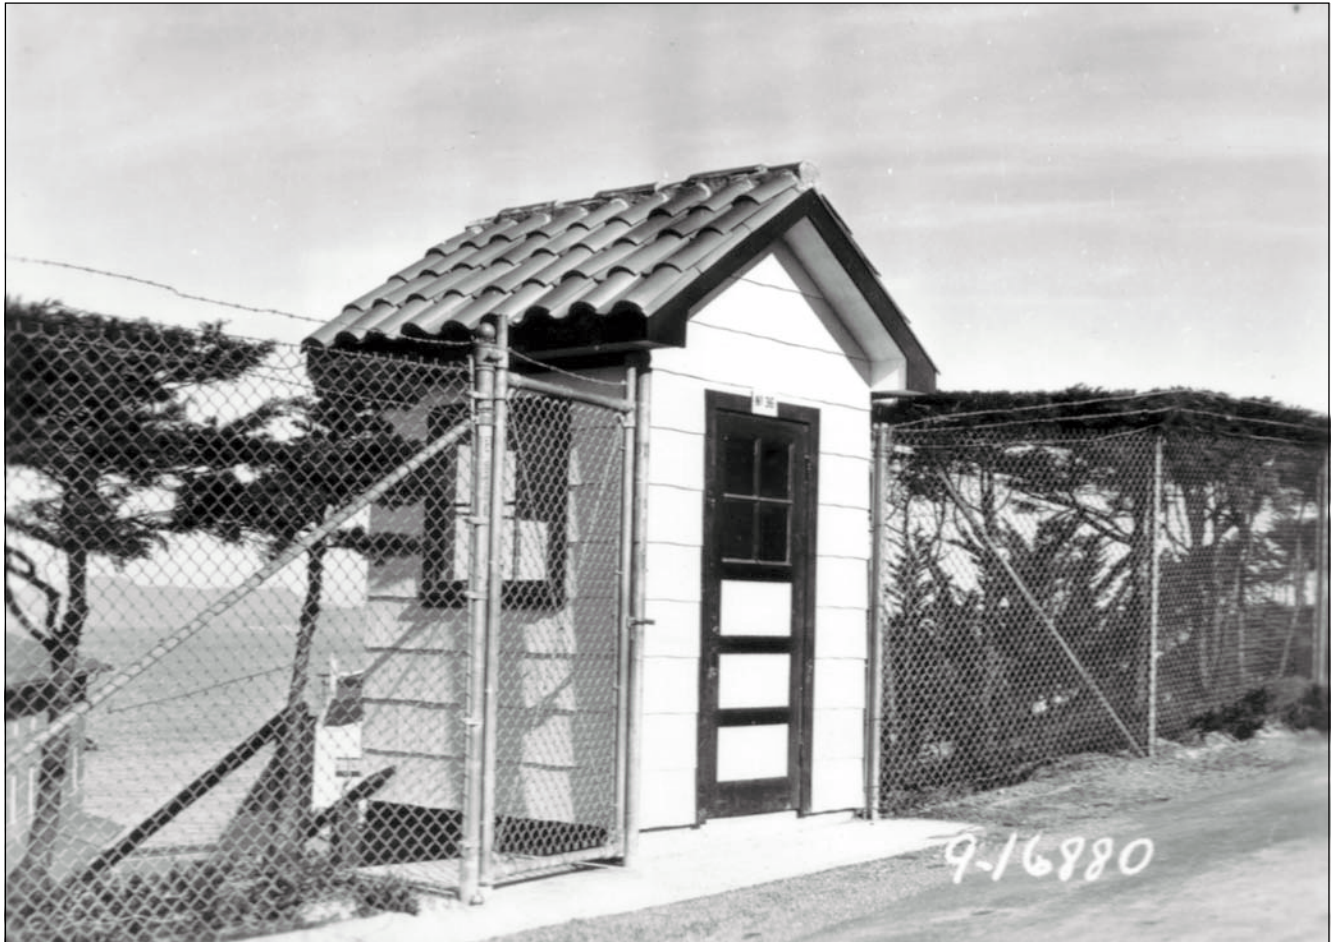
**Figure 2.5.22:** Red tile roofing, a characteristic feature of the Mission Revival was later applied to even the most humble architecture at Fort Mason. Note the consistent pruned height and scarcity of lower branches of the hedge material at the top of the slope at this date. Watch station, August 1939. National Archives, RG 77 Office of the Quartermaster General, Records of the Construction Division - Annual Construction, Maintenance, and Repair Reports (1924-1938) Box 135NM.

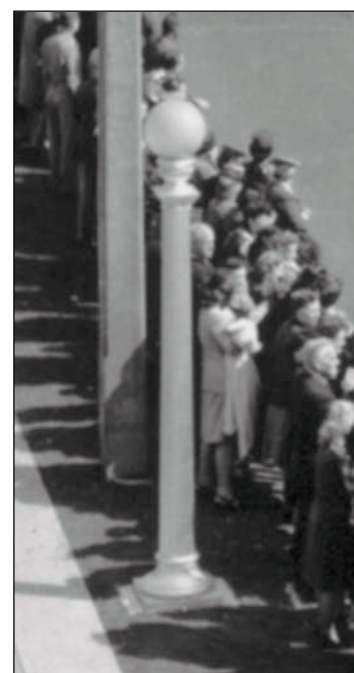
**Figure 2.5.26:** These decorative lamp posts were installed at Fort Mason in 1935 following the placement of overhead utility lines into underground conduits in 1934. The fixtures were Style #717 from the Union Metallic Lamp Standard Company. Detail from photograph of 8 March 1945. National Archives RG 111 - SC Box 156 - 311438.

Light fixtures, road signs, fencing materials and other small-scale features had received maintenance and replacement since the end of World War II. Overhead streetlights carried on cross-arm brackets became an important post-war addition, yet more typically, documentation of the appearance and disappearance of many small scale features remains incomplete for the end of this period.

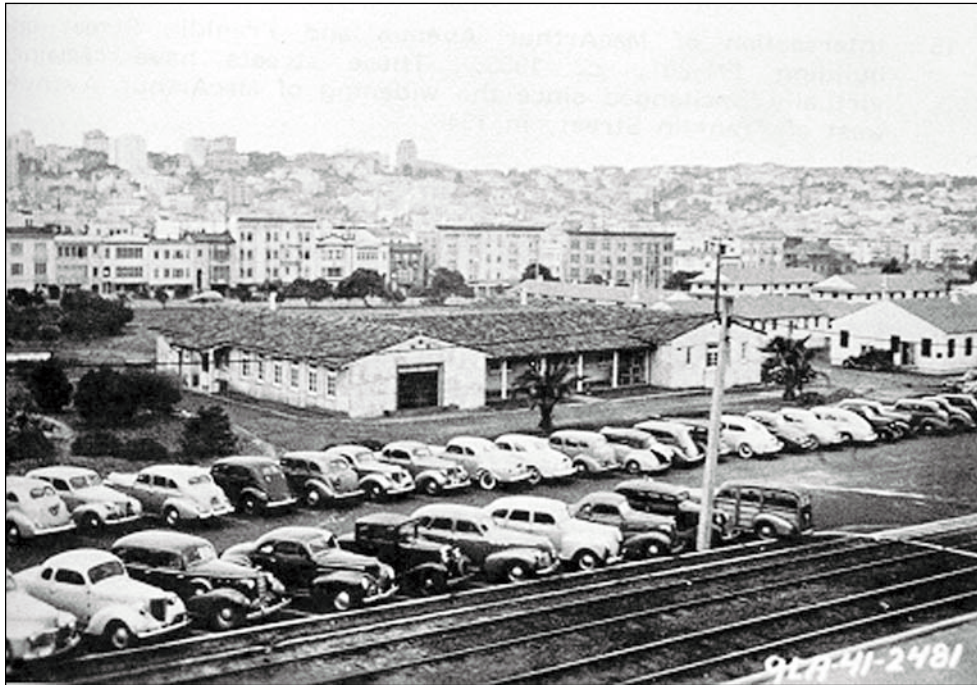
*Figure 2.5.27: Although better known for its work at state and national parks, the Civilian Conservation Corps (CCC) also worked at many military bases. Many changes were made to Fort Mason during the CCC program, including the parking area along MacArthur Avenue shown in this post-CCC photograph. Image copied from “Historic Structure Report, Western Grounds, Old Parade Ground and MacArthur Avenue,” Figure Number 13, Page 105, 1980.*

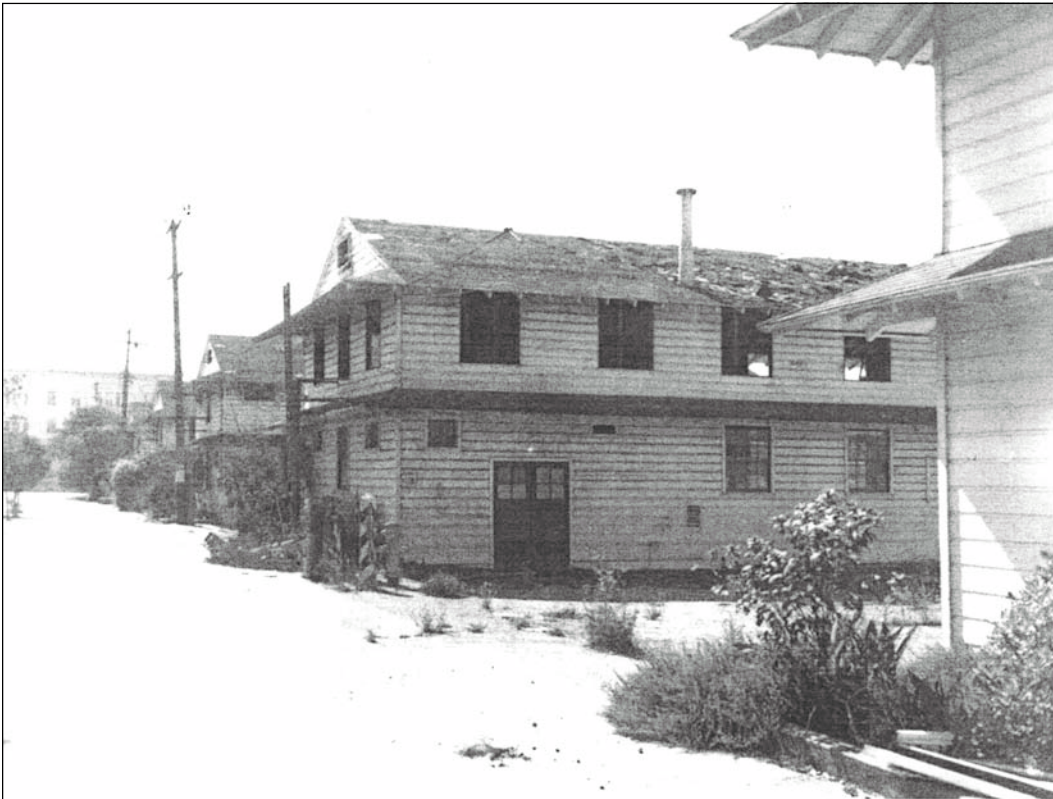
**Figure 2.6.12:** Many of the temporary buildings constructed at Fort Mason during the 1940's were in poor condition prior to the NPS acquisition of the property. The NPS was in the process of salvaging these buildings when this photograph was taken. Photo by John Martini, c.1977. NPS,GGNRA Archives, Interpretation Photograph Collection, GOGA-2316.

While many deteriorating buildings were razed during GSA administration, foundations were typically left in place, giving the ground surface the random and irregular qualities of a ruined city. Elsewhere, topography remained unaltered since the end of WWII. The circulation network of pathways and roads remained largely intact by 1972, but where buildings had been demolished leaving only the foundation, many of these roads and driveways led nowhere, further reinforcing the qualities of abandonment and ruin as weeds began to thrive in pavement cracks.
