# CULTURAL LANDSCAPE REPORT FOR FORT MASON GOLDEN GATE NATIONAL RECREATION AREA

Volume One: Site History, Existing Conditions and Analysis

Prepared by:  
Amy Hoke, Historical Landscape Architect  
National Park Service  
Pacific West Region  
Seattle, Washington

September 2004

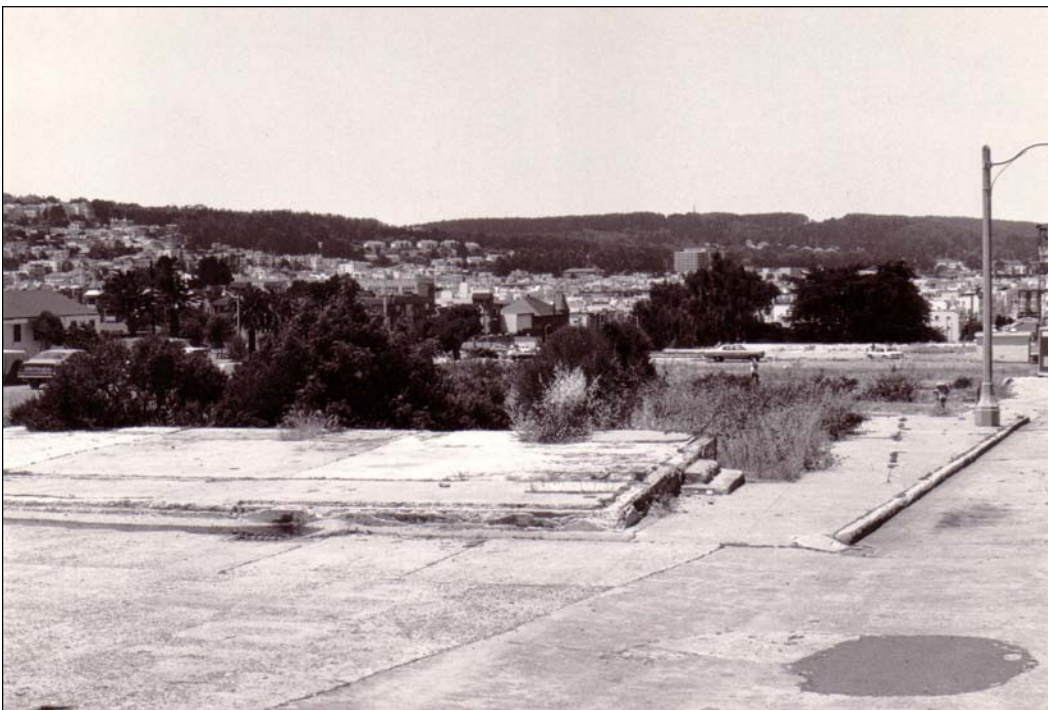
**Figure 2.6.13:** Many deteriorated temporary buildings were removed, leaving only the foundation, during the GSA administration of the site. Image c. 1970. NPS, GGNRA Archives, Richard Frear Collection.

While many deteriorating buildings were razed during GSA administration, foundations were typically left in place, giving the ground surface the random and irregular qualities of a ruined city. Elsewhere, topography remained unaltered since the end of WWII. The circulation network of pathways and roads remained largely intact by 1972, but where buildings had been demolished leaving only the foundation, many of these roads and driveways led nowhere, further reinforcing the qualities of abandonment and ruin as weeds began to thrive in pavement cracks.

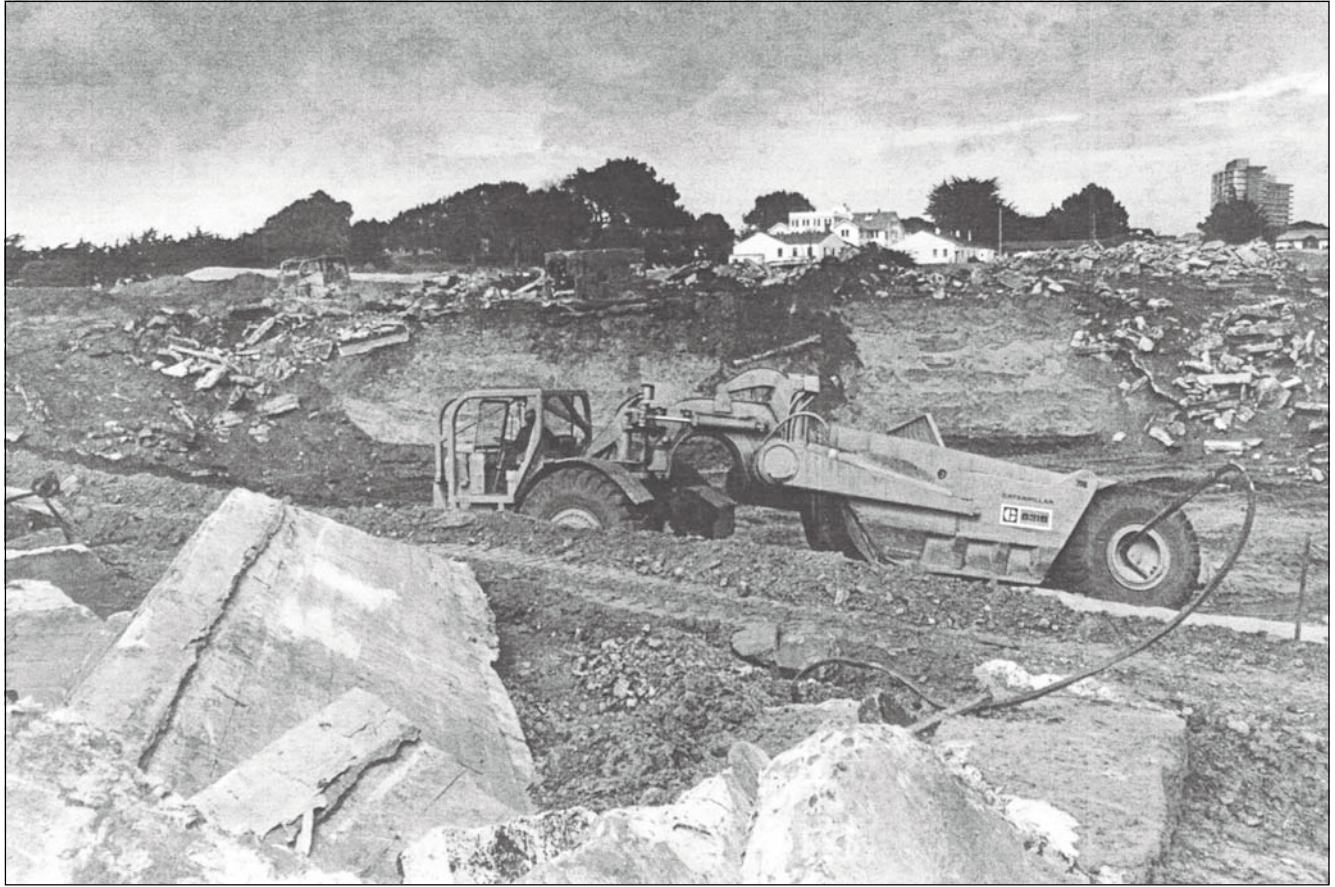
**Figure 2.7.6:** The creation of the “Great Meadow” suggested by the planning process, required the removal of dozens of building foundations and the western half of MacArthur Avenue. Image is c.1980. NPS, GGNRA Archives, Richard Frear Collection.

A significant aspect of the Great Meadow design was the removal of remaining building foundations as well as the western half of MacArthur Avenue - the historic east-west thoroughfare through the reservation (Figure 2.7.6). A single row of palm trees, formerly lining the southern edge of that roadway, became the only remaining indication of its location. In place of the concrete and asphalt, a large expanse of gently sloping open lawn was proposed. A subsurface irrigation system insured that the open space would remain green. Curvilinear concrete footpaths encircled the large central space with arterial branches north, south, east and west. The lawn was bound on the north by the row of Monterey cypress trees planted on the slope above the Lower Fort Mason retaining wall prior to World War I to tame the fierce westerly winds. The southern edge was defined by a berm planted with native species, somewhat reflective of the conditions of the reservation when it was primarily a sand dune known as Punta Medanos. During the 1980s, a number of outdoor sculptures by local artists were randomly placed around the Great Meadow, giving the open space the character of a large, informal sculpture park. The most enduring of these installations was a large abstract metal piece called the "snake sculpture" occupying a broad earthen pedestal created by a low concrete retaining wall surviving the recent demolition. Apparently, the snake sculpture remained in place much longer than the other artworks, its owner belatedly requesting its return long after the removal of others on exhibit.<sup>144</sup>

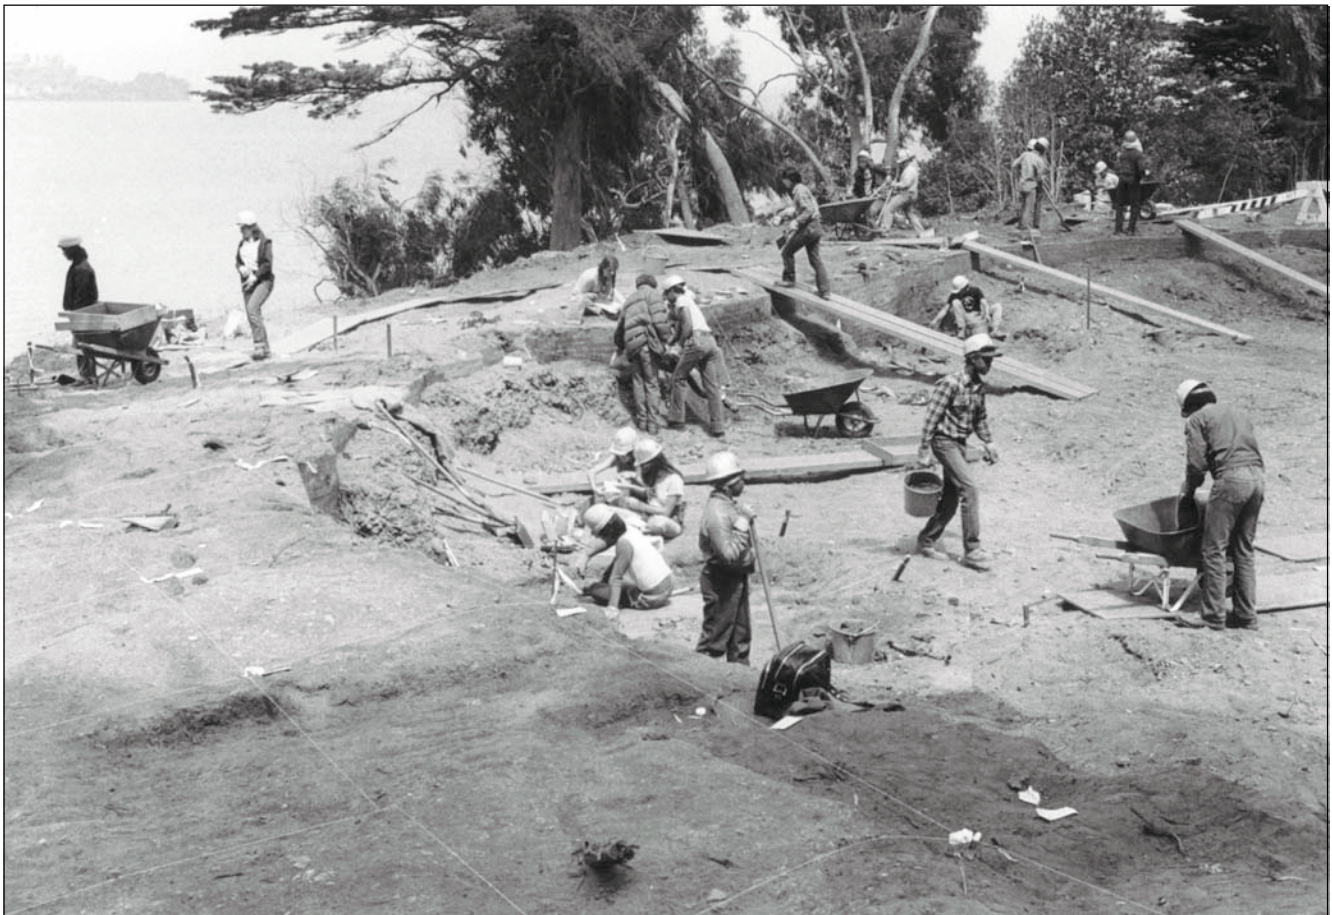
**Figure 2.7.9:** The earthen Civil War fortifications on the northern escarpment of Fort Mason were excavated during 1982 and 1983 and later restored. Views from this prospect remained open as late as the 1950's, after which vegetation was allowed to grow unimpeded. NPS, GGNRA, files of Park Historian.

Construction of a new picnic facility was planned for the tip of Black Point in 1982. The previous decade, Park Ranger John Martini had investigated the area for remnants of the Civil War Battery. His discovery of a broken brick wall and an underground concrete magazine was recorded with no additional examination of the area. The proposal for new construction in that same location prompted an archeological exploration. The written findings revealed the brick and mortar battery intact but suggested that the state of deterioration was due to soil acidity. A full excavation of the site commenced to prevent further damage. The project involved twenty local high school students (supervised by professional archaeologists) working over two consecutive summers (Figure 2.7.9). Close to 10,000 cubic yards of soil was removed before the earthworks were exposed and the excavation was complete.<sup>146</sup> In 1996, many years after repairs to the fortification's brick and mortar, a Model 1861 Rodman gun mounted on a barbette carriage was acquired from the Smithsonian Institution and emplaced at Fort Mason to evoke the period prior to 1900 when this battery remained part of San Francisco's inner harbor defenses.<sup>147</sup>

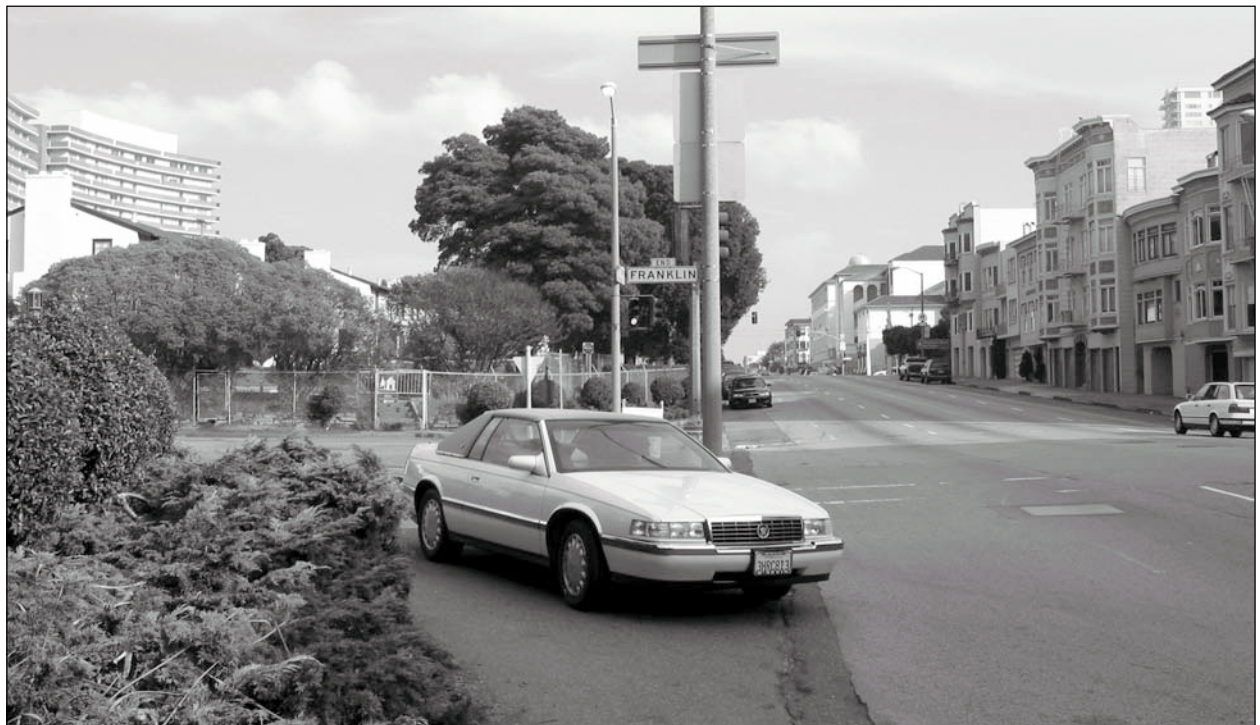
**Figure 3.1.2:** Landscape context. Vehicular access to Upper Fort Mason is by way of the park entrance at the corner of Bay and Franklin Streets. The north side of the intersection on park property is poorly served by walkways and configured with atypical acceleration/deceleration lanes. Photo by Olmsted Center for Landscape Preservation (hereafter OCLP), 12/02.

Less than idyllic traffic conditions occur in and around Fort Mason. A traffic safety study, completed in April 1999, examined the situation and identified the three locations within Fort Mason for study: Franklin Street/Bay Street intersection, Franklin Street/Pope/MacArthur intersection and the Upper Fort Mason parking area. Within the study period, 1994 – 1996, twenty-three accidents resulting in two injuries were reported at Fort Mason by the San Francisco Police Department. The large majority of these (nineteen) occurred at the Franklin Street entrance. Recommendations for reconfigurations of the roadways made it clear that a more detailed historic evaluation of the landscape was needed prior to any modifications (Figure s2.7.12 through 2.7.15).<sup>149</sup>

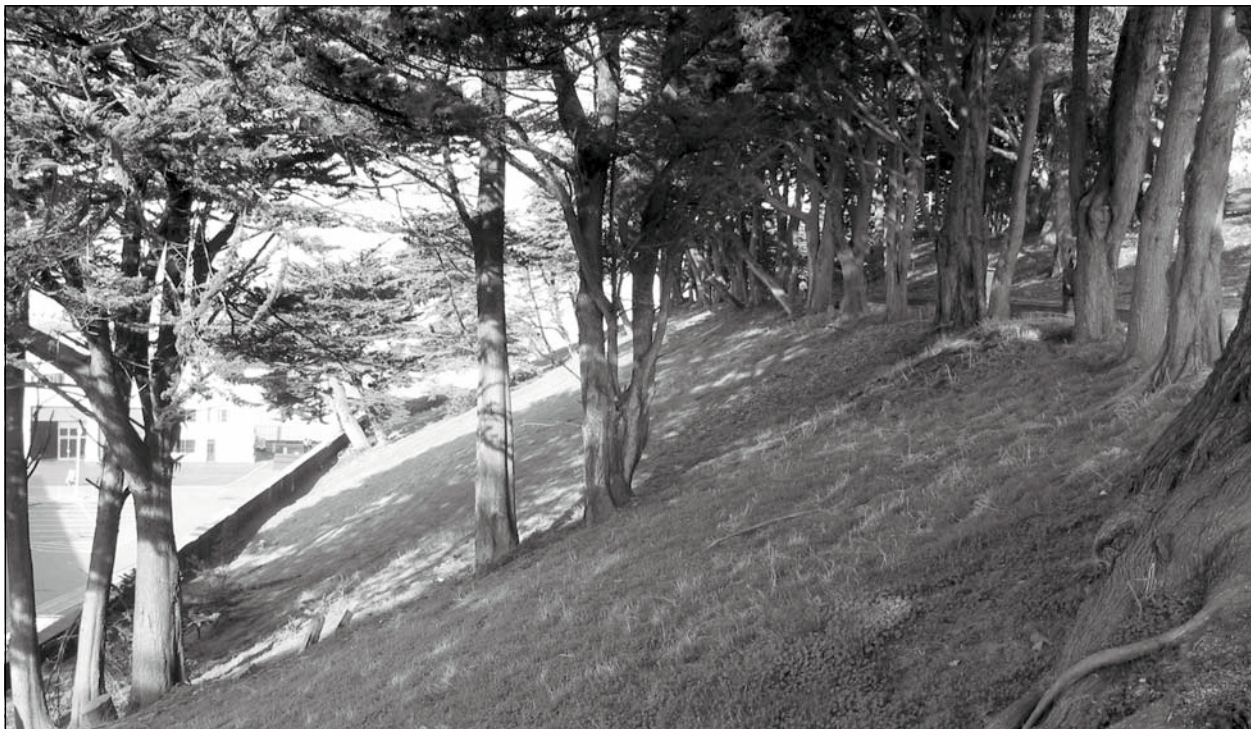
**Figure 3.1.7:** Ecological context. The cliffs once defining the northwestern edge of “Black Point” were stabilized with massive concrete retaining walls during construction of the transport docks at Lower Fort Mason. Plantings of Monterey cypress were installed to help break the pervasive westerly winds blowing through the Golden Gate, just one of a vast range of actions taken to modify the environment. 12/02 - OCLP.

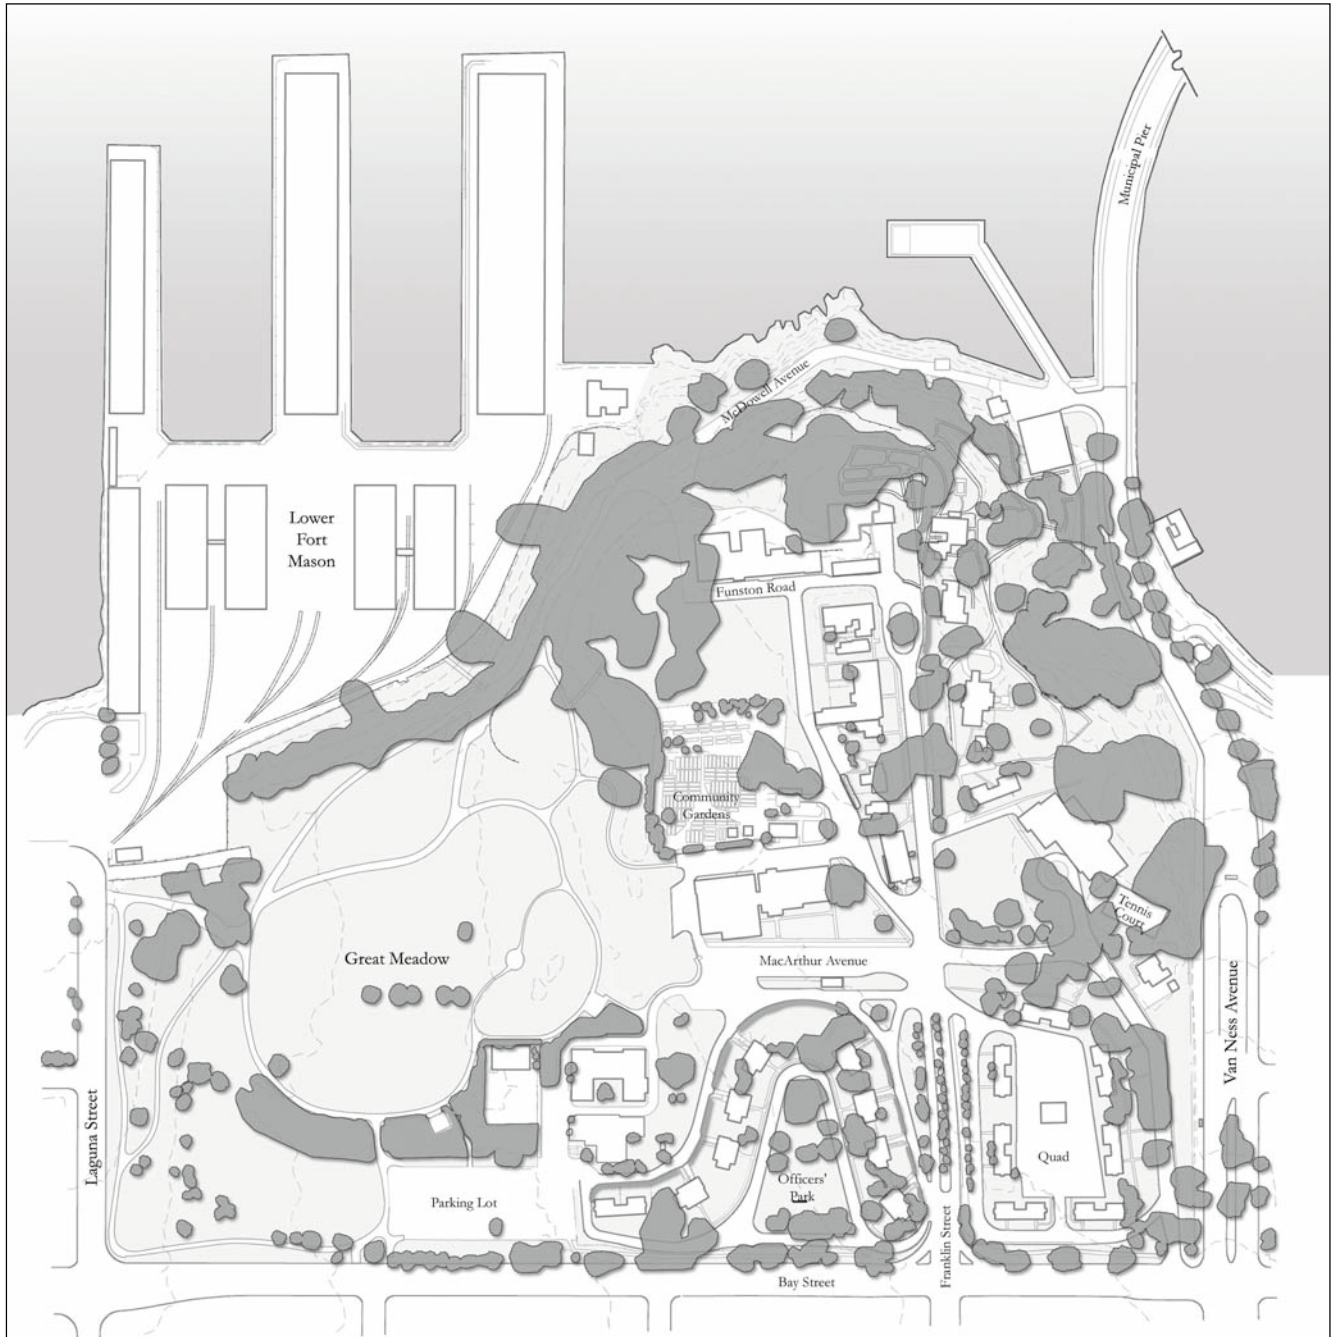
**Figure 3.1.12:** Vegetation massing diagram. In addition to buildings, roads, and topography, masses of trees are also important in defining outdoor spaces and subspaces within Fort Mason. The rows of trees found on Bay Street, combined with large trees growing on the steep slopes facing the Bay, nearly surrounds the property. OCLP.

**Figure 3.1.12:** Vegetation massing diagram. In addition to buildings, roads, and topography, masses of trees are also important in defining outdoor spaces and subspaces within Fort Mason. The rows of trees found on Bay Street, combined with large trees growing on the steep slopes facing the Bay, nearly surrounds the property. OCLP.

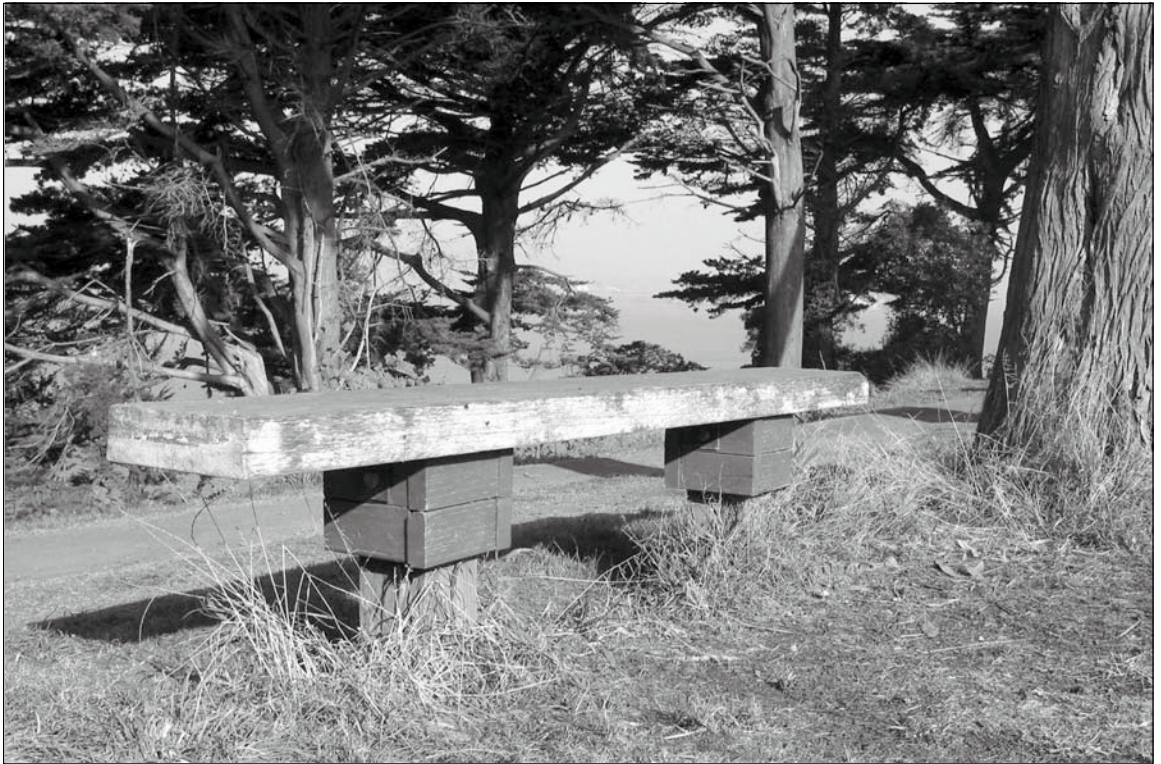
Existing Condition: A random collection of various benches are found installed throughout the property (Figures 5.1.1 and 5.1.2).

**Figure 5.1.1:** Benches. Non-Contributing. The style of free-standing benches, where used at all at Fort Mason historically, has not been documented. North Fortifications landscape character area. 12/02 - OCLP.

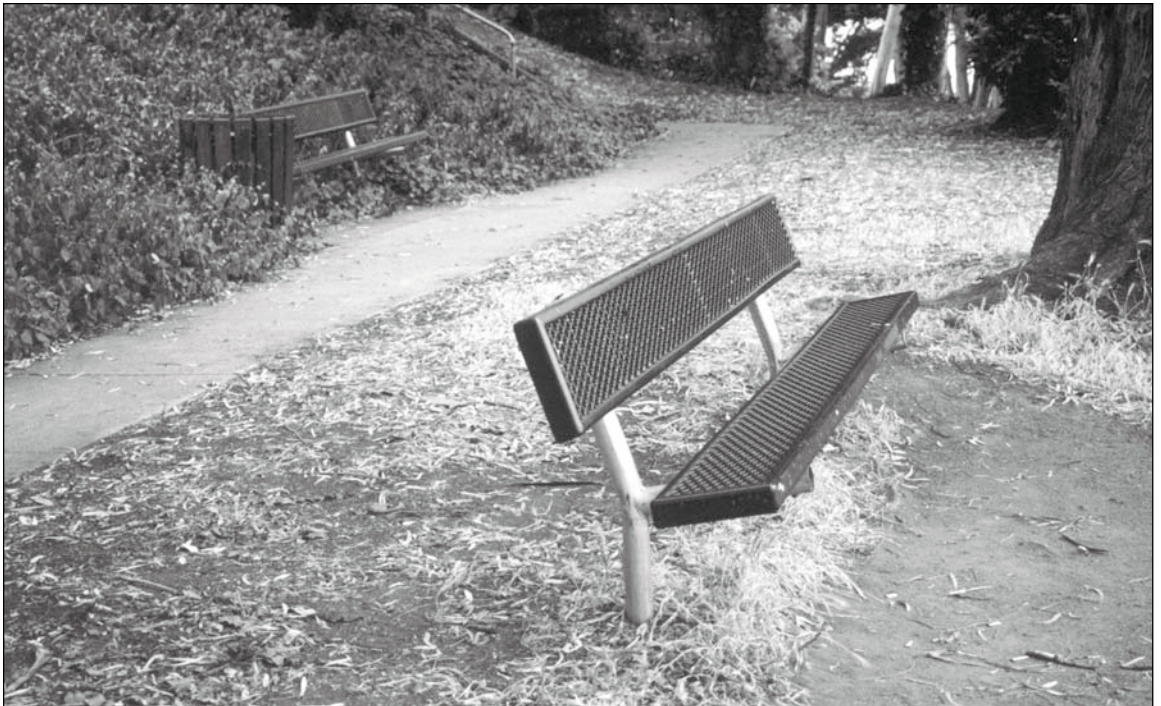
**Figure 5.1.2:** Benches. Non-contributing. Also note trash receptacle. North Fortifications landscape character area. 12/02 - OCLP.

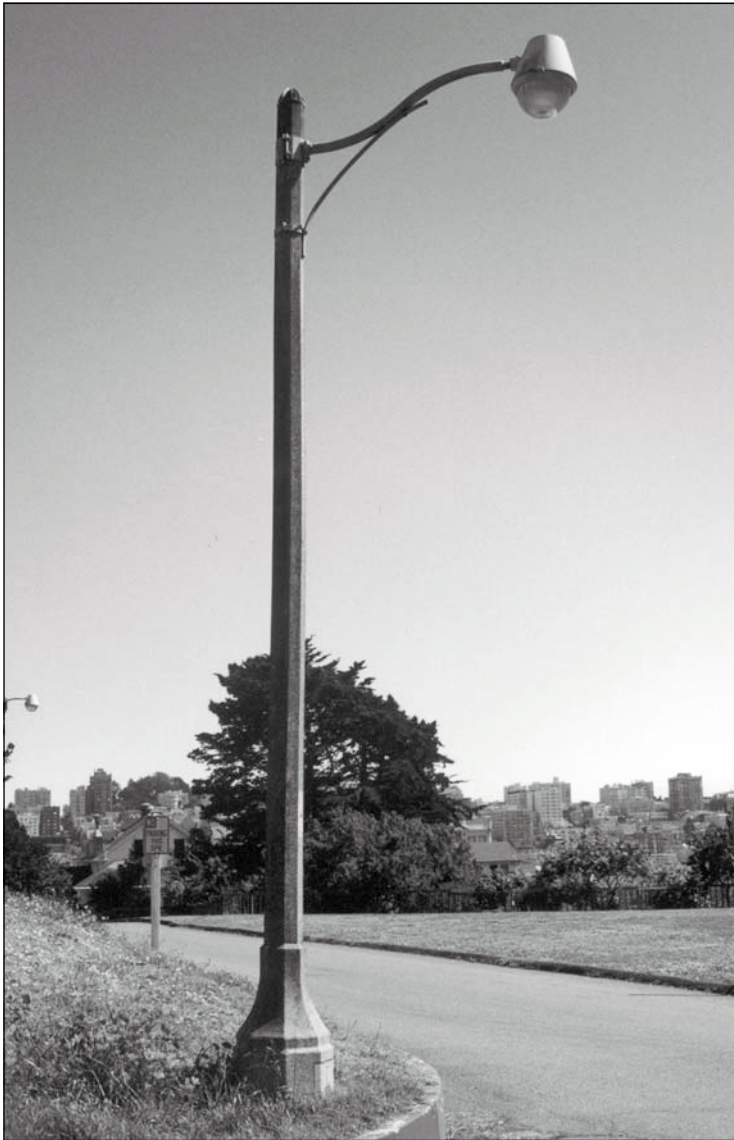
Existing Condition: Light grey aggregate and cast concrete light poles across the site are in good condition. The light poles are unremarkable in character and consist of a single luminary supported by a single "s" curved metal arm and a "c" curved metal brace. Approximately twenty-five feet in height (Figure 5.1.3).

**Figure 5.1.3:** Cast Concrete Light Poles. These features are known to be post WWII. Post maps suggest that they were installed c. 1960. Requires further evaluation. 7/02 - OCLP.

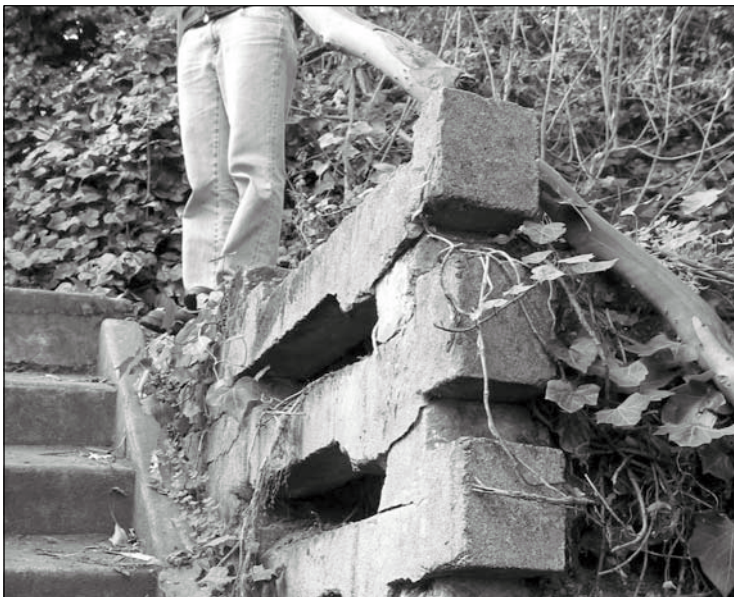
Existing Condition: While the physical condition of various cribbing assemblies varies greatly, the cribbing continues to perform its important role in stabilizing Fort Mason's sandy and erodible soil. The cast-concrete modules are designed to stack and interlock (Figure 5.1.4). Assemblies of these modules have been constructed torevet the unstable soils on the east and northern slopes of Black Point.

**Figure 5.1.4:** Concrete Slope Stabilization Cribbing. Requires further evaluation. 12/02 - OCLP.

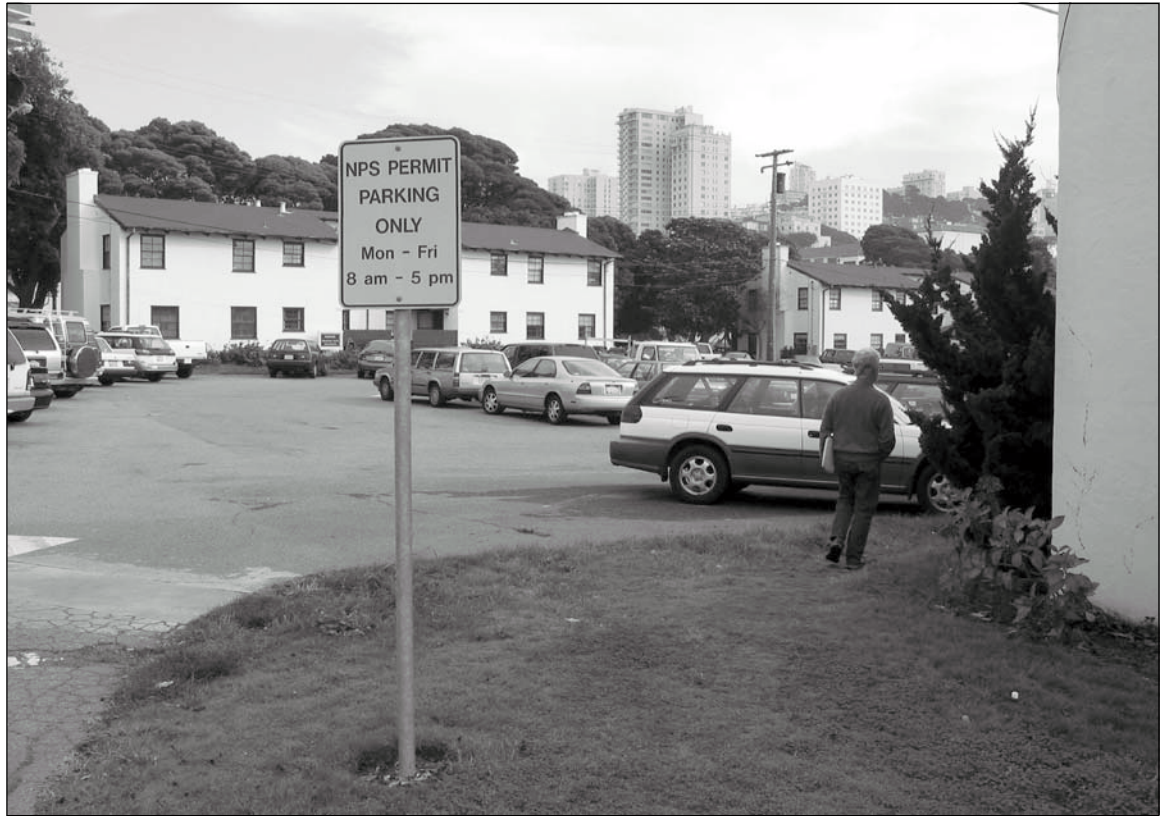
Existing Condition: Directional and regulatory signage currently on site are contemporary fixtures in good condition (Figure 5.1.5).

*Figure 5.1.5: Directional and Regulatory Signage. Non-contributing. 12/02 - OCLP.*

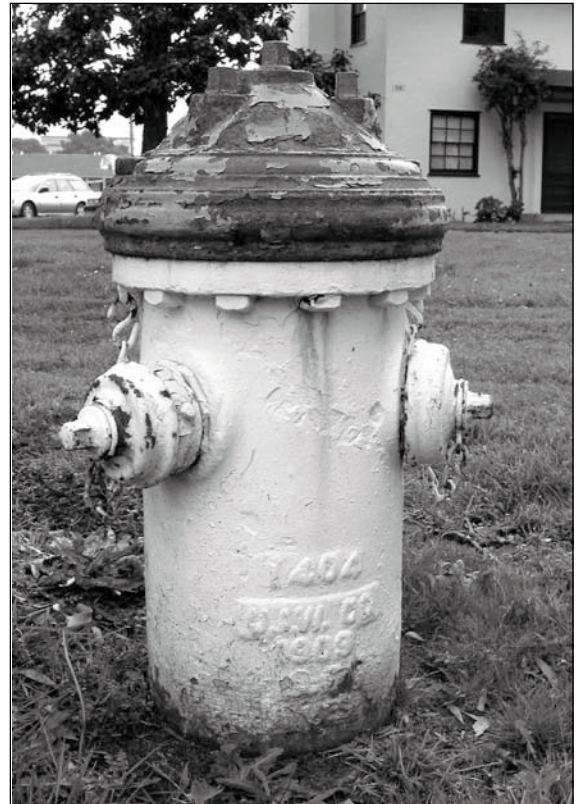
Historic Condition: The earliest fire hydrants found at Fort Mason feature the year "1909" cast into the hydrant body. This date coincides with a program of improvements to city infrastructure following the devastating earthquake of 1906 and the resulting fires that swept through the city.

Existing Condition: A wide variety of emergency fire hydrants exist throughout the site (Figures 5.1.6 and 5.1.7).

*Figure 5.1.6: Emergency High Pressure Fire Hydrant. These features, dated 1909, were installed 1910-1911 in conjunction with the city's emergency pumping stations at Van Ness Avenue and Townsend Street. Contributing. The status of other types of fire hydrants at Fort Mason requires further evaluation. 12/02 - OCLP.*

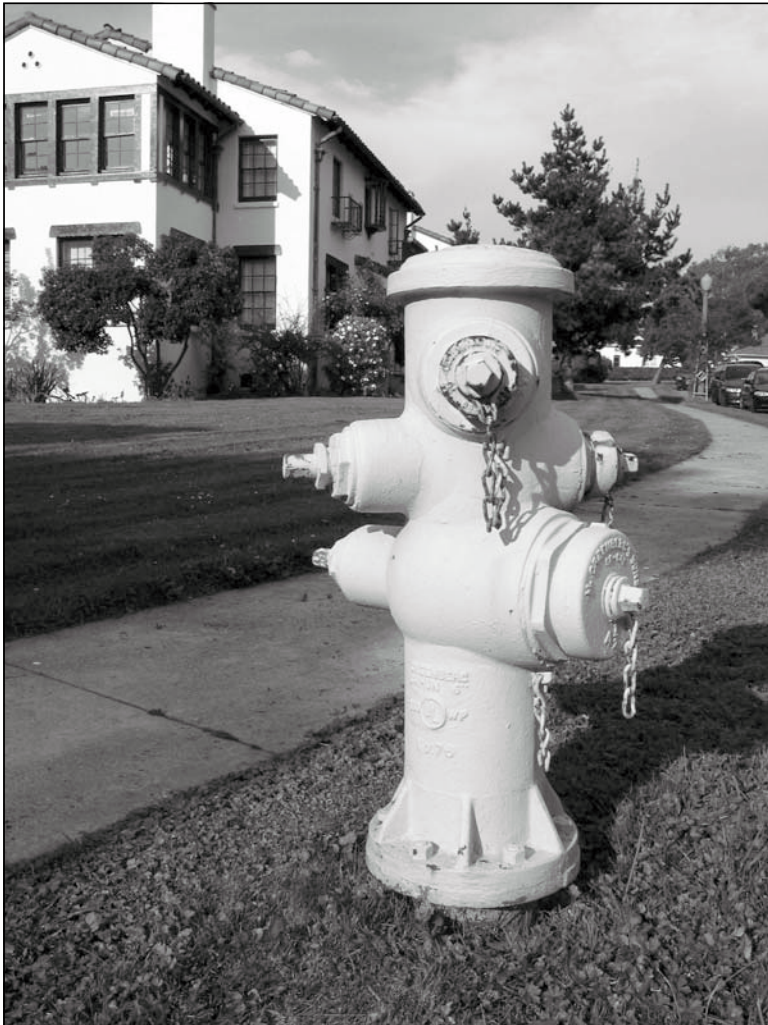
*Figure 5.1.7: The inventory of fire hydrants, other than the Emergency High Pressure Hydrants, requires further evaluation as to their historic status. 12/02 - OCLP.*

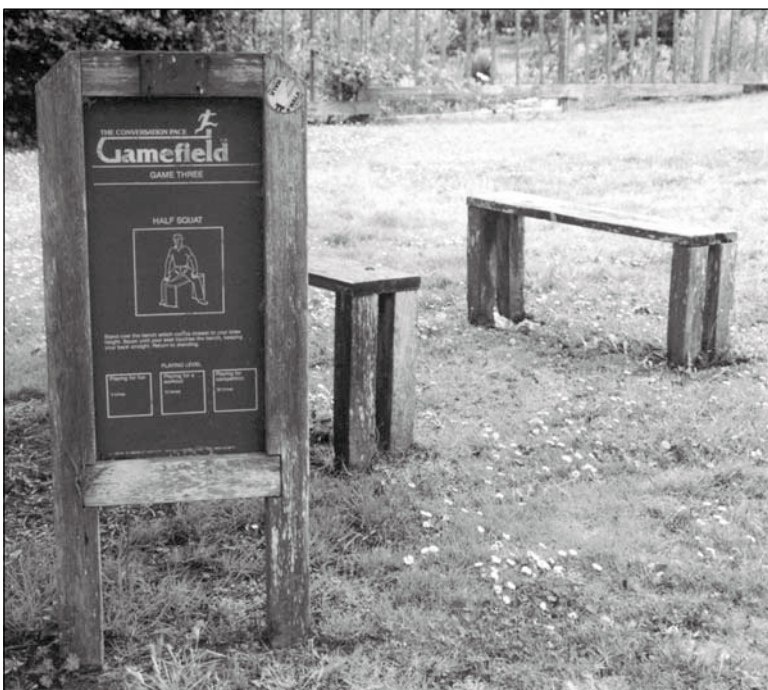
Existing Condition: This exercise equipment remains serviceable, yet is reaching the end of its useful life (Figure 5.1.8).

*Figure 5.1.8: "Gamefield" brand exercise equipment was installed throughout Fort Mason during the 1980s. Non-contributing. 12/02 - OCLP.*

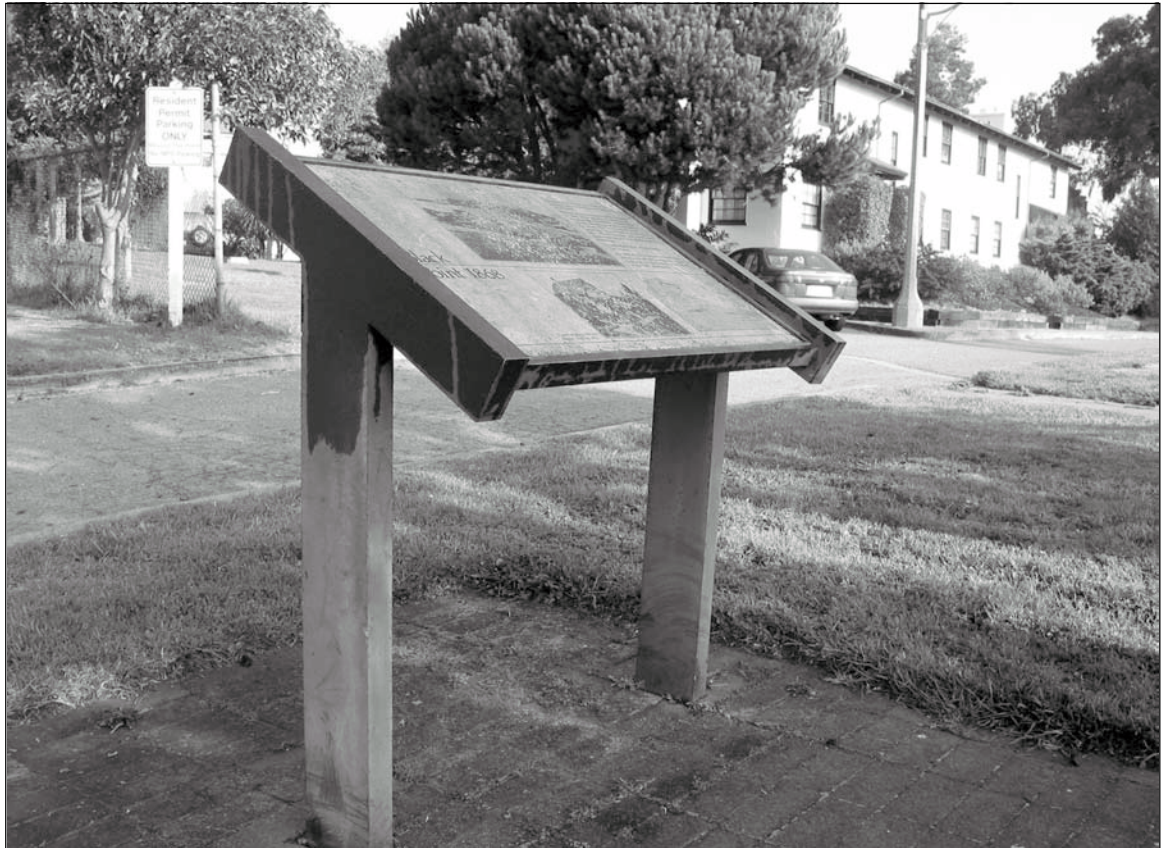
Existing Condition: Supporting metal frames appear to be in good condition, fiberglass panel inserts have become shopworn and require replacements (Figure 5.1.9).

**Figure 5.1.9:** *Interpretive Wayside Exhibits. These fixtures were installed throughout Fort Mason during the 1980s development of the park. Non-contributing. 12/02 - OCLP.*

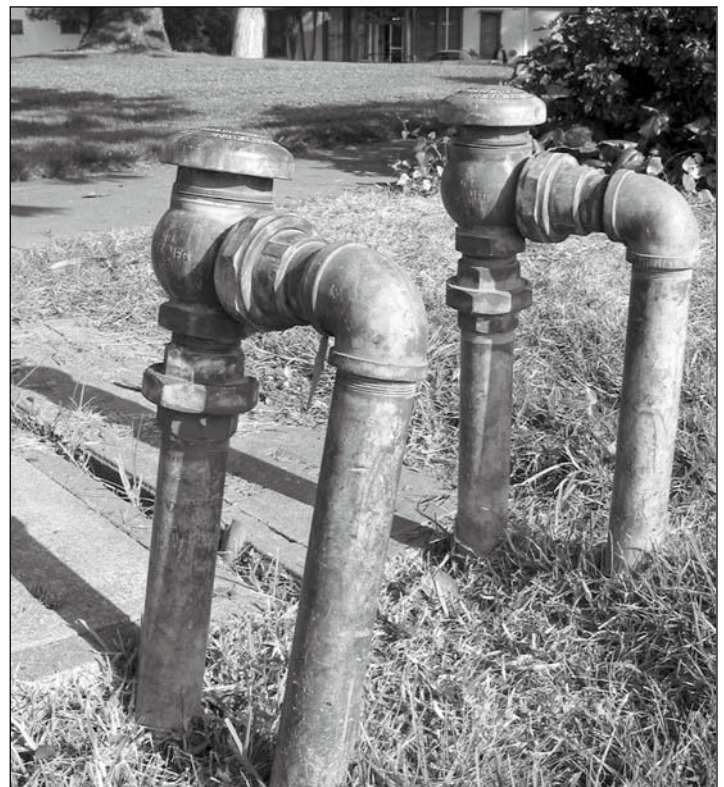
Existing Condition: System is comprised of vaults, above-ground valved subsurface pipes and sprinkler heads (Figure 5.1.10). The operational condition of the system is unevaluated.

**Figure 5.1.10:** *Irrigation System and Above Ground Fittings. While the subsurface irrigation system plays a critical role in maintaining the character of the Fort Mason landscape, the above ground expression of the system does not contribute. 12/02 - OCLP.*

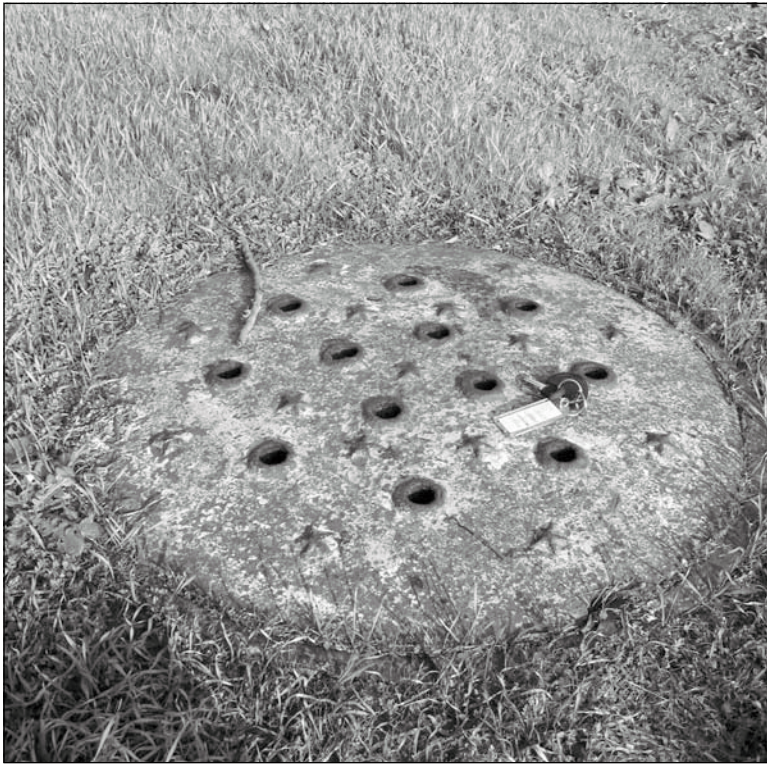
Existing Condition: Although an exhaustive inventory has not been attempted, many covers survive bearing the words "Signal Corps," while others bear a raised field of five-pointed stars (Figures 5.1.11 and 5.1.12).

*Figure 5.1.11: Manhole Covers. Many of the access covers to sewers and utility vaults bear military insignia, designations and decorations. Contributing. 12/02 - OCLP*

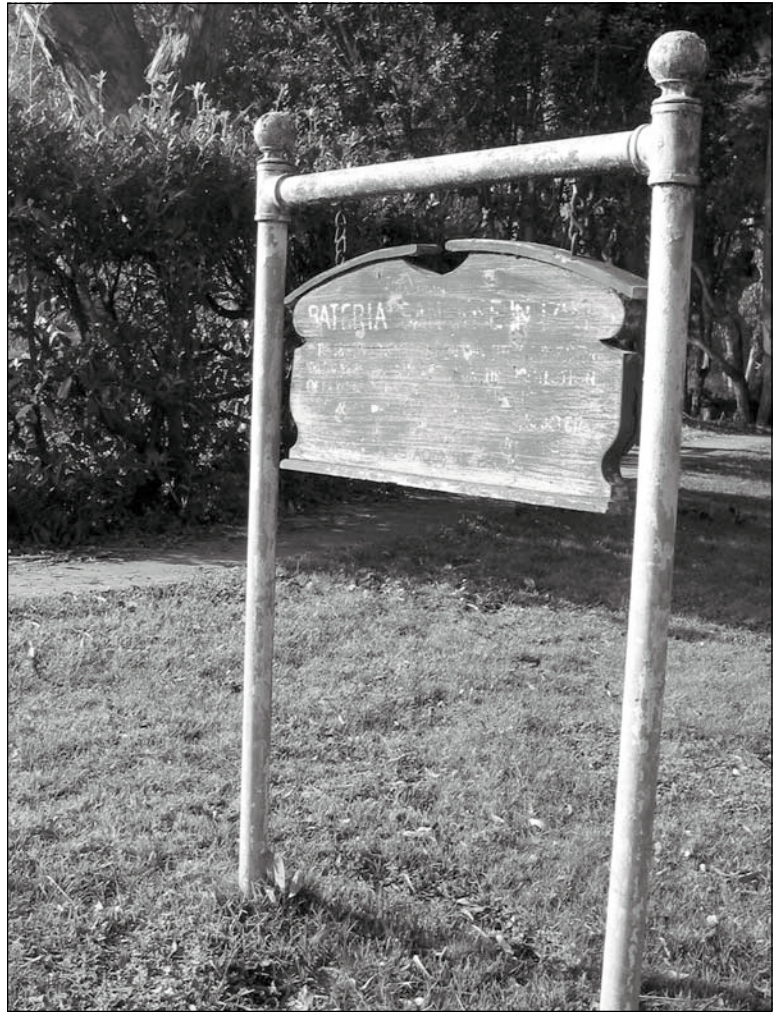
Existing Condition: Elaborately shaped Redwood sign panel hung from simple galvanized pipe supports (Figure 5.1.13). The accuracy of the wording of these signs is open to question.

**Figure 5.1.13:** Redwood Signs and Pipe Sign Supports. These were installed in 1939 to supplement a guidebook prepared by the WPA's Writer's Program. Contributing. 12/02 - OCLP,

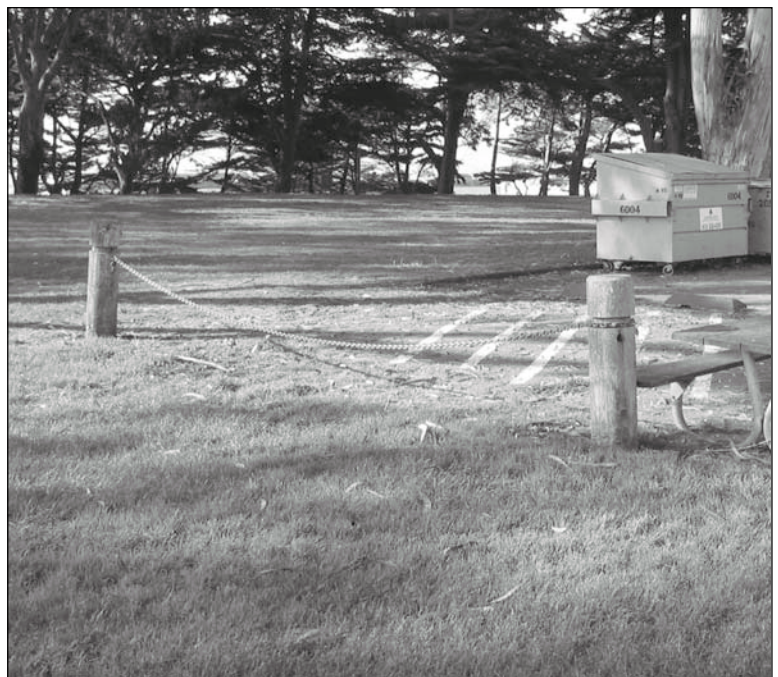
Existing Condition: Traffic control bollards in current use at Fort Mason are made of steel pipes of various diameters and wooden timbers. The steel pipes are painted bright colors to aid visibility (Figure 5.1.14).

**Figure 5.1.14:** Traffic Control Bollards. A variety of traffic control bollards are found throughout Fort Mason. The use of these features is consistent with historic practice - however the material expression of these features is noncontributing. This example is located in the Central Garrison landscape character area. Non-contributing. 12/02 - OCLP.

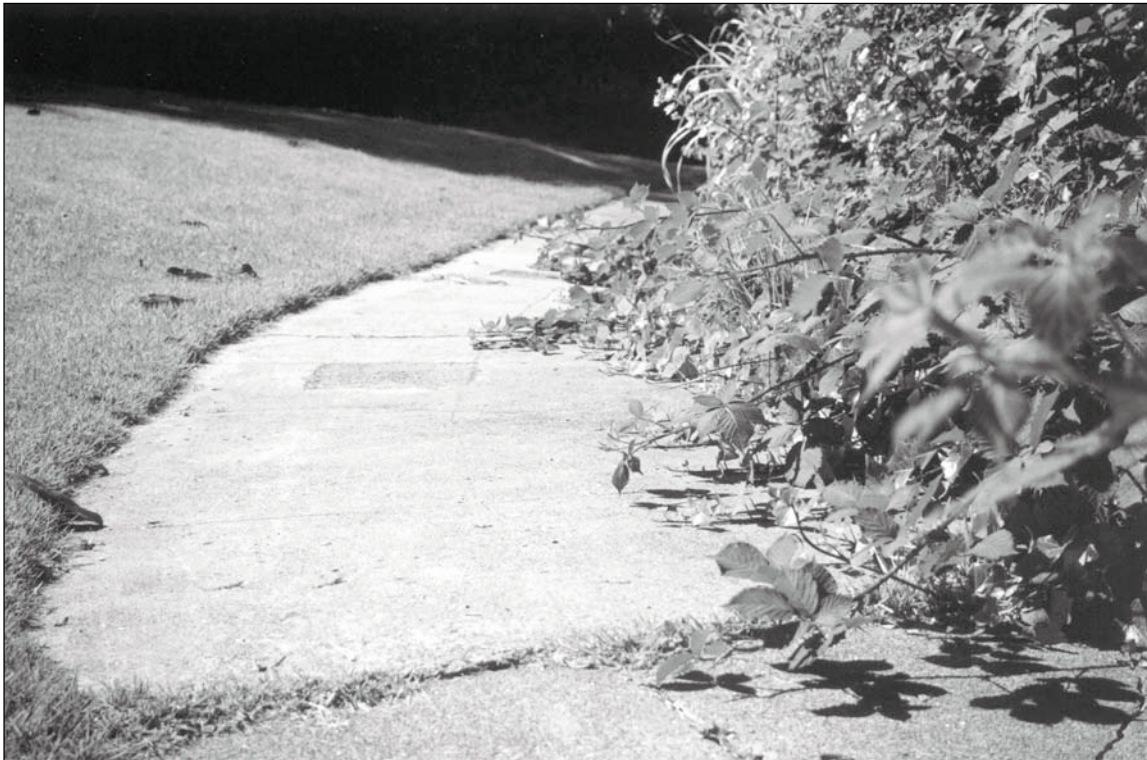
**Figure 5.2.6:** *System of Pedestrian Paths and Stairs. The pathway system is almost entirely paved with concrete - having widths between 30" and 42." As shown above, even the best maintained segments of this pathway system require attention. Contributing. 12/02 - OCLP.*

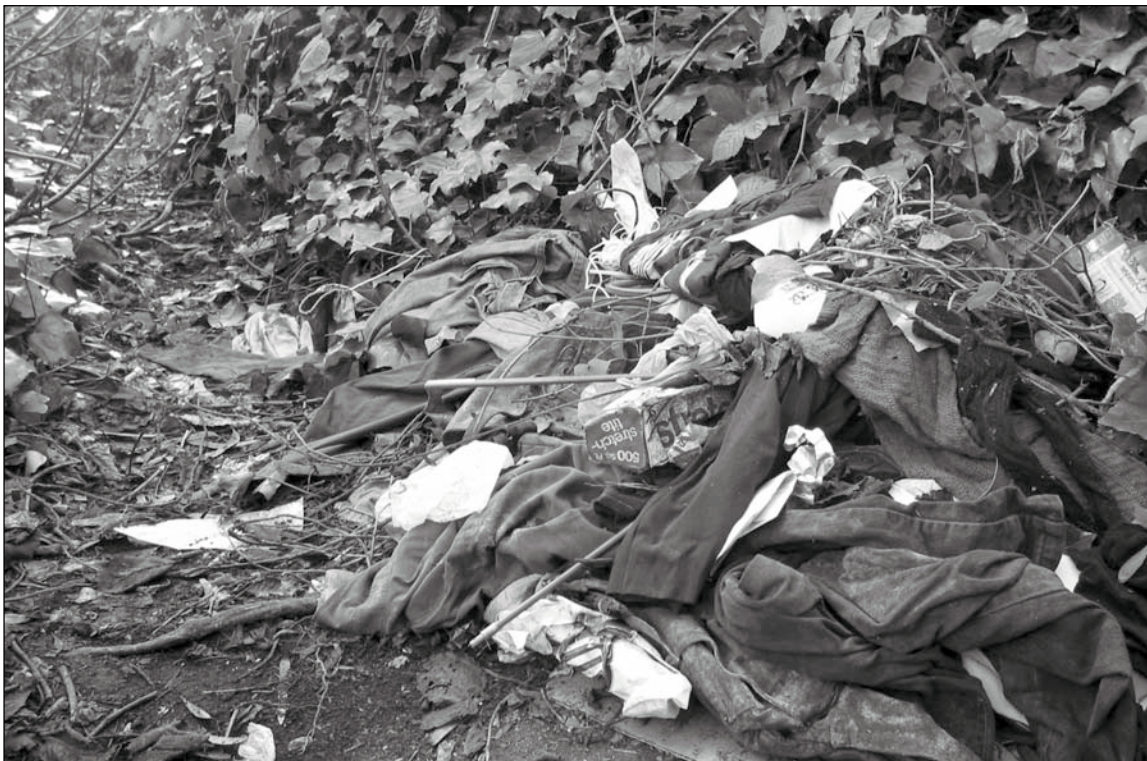
**Figure 5.2.7:** *System of Pedestrian Paths and Stairs. Pathway segments traversing the steep eastern slope of the East Black Point landscape character area have been abandoned and overgrown with vegetation. It is common to find the homeless within this isolated part of the landscape. 12/02 - OCLP.*

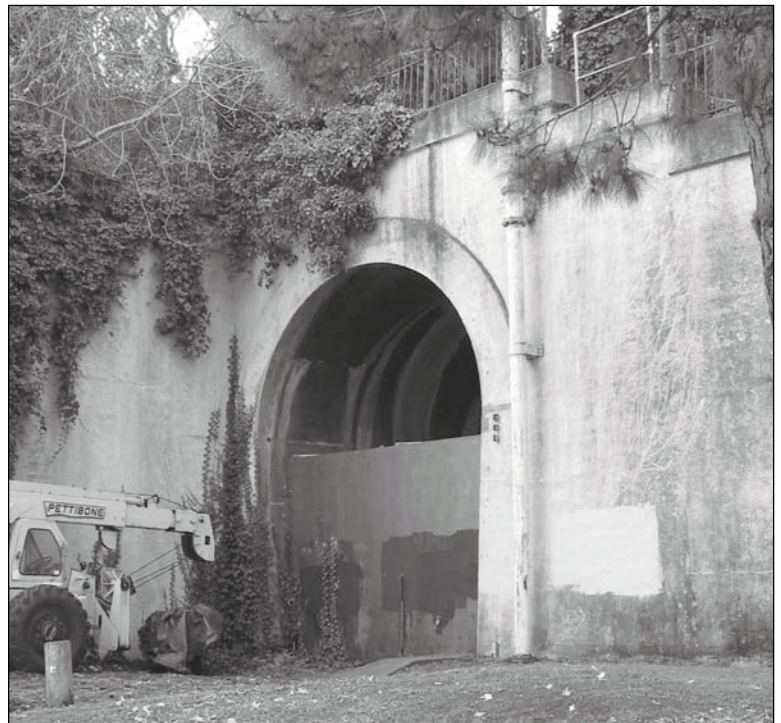
**Figure 5.2.9:** East Portal - Railroad Tunnel. This tunnel portal was built by the California State Board of Harbor Commissioners as part of the "Belt-Line" railroad serving the San Francisco waterfront c.1914. Contributing. 12/02 - OCLP.

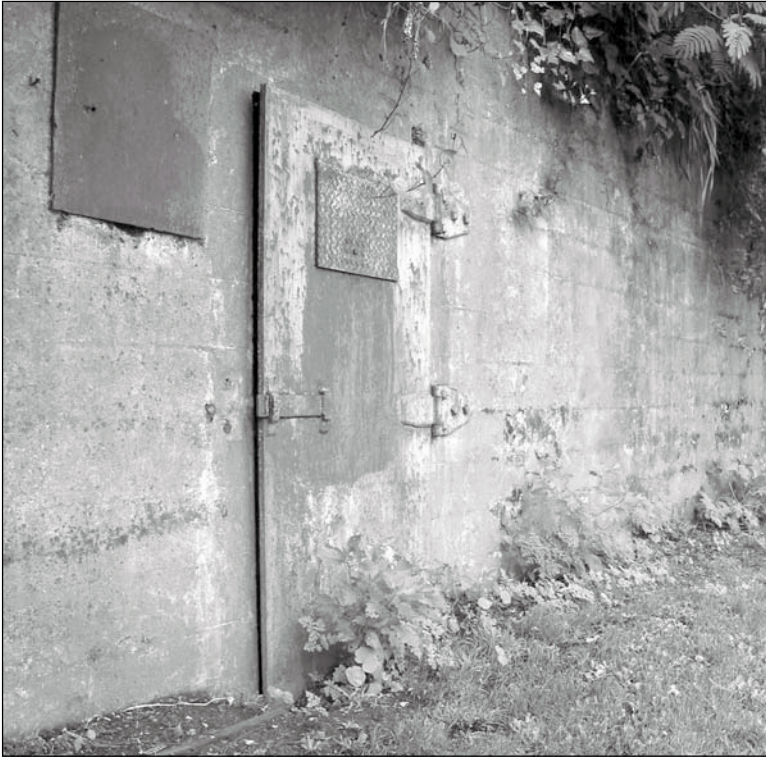
**Figure 5.2.10:** Mine Casemate and Mine Casemate Retaining Wall. Apparatus within this subterranean room controlled harbor mines between 1891 and 1945. The retaining wall was built c.1910 contemporary with the construction of the adjacent emergency pumping station. Contributing. 12/02 - OCLP.
