# CULTURAL LANDSCAPE REPORT FOR FORT MASON GOLDEN GATE NATIONAL RECREATION AREA

Volume One: Site History, Existing Conditions and Analysis

Prepared by:  
Amy Hoke, Historical Landscape Architect  
National Park Service  
Pacific West Region  
Seattle, Washington

September 2004

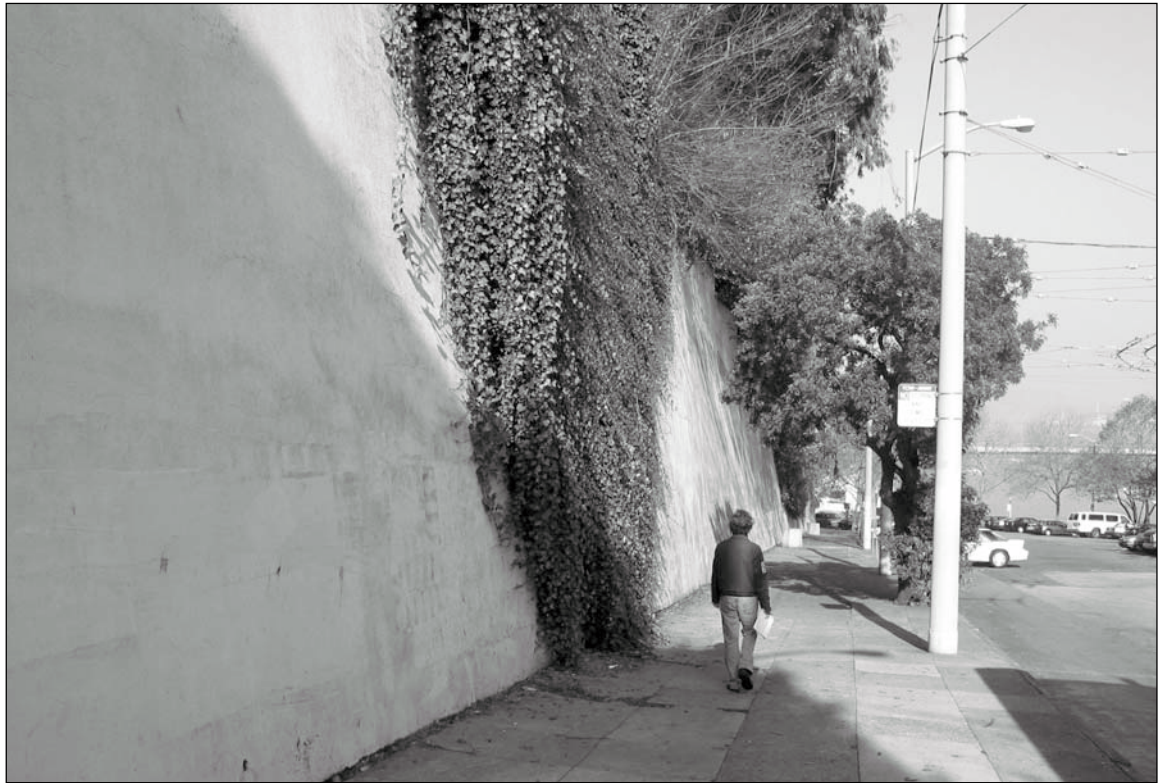
**Figure 5.2.12:** *Van Ness Avenue Retaining Wall.* This wall was built in two sections. The southern section appeared c.1900, associated with the relocation of the post entrance to the corner of Van Ness Avenue and Bay Street. The northern section was built c.1910, associated with the extension of Van Ness Avenue and the construction of the city's emergency pumping station. Contributing. 12/02 - OCLP.

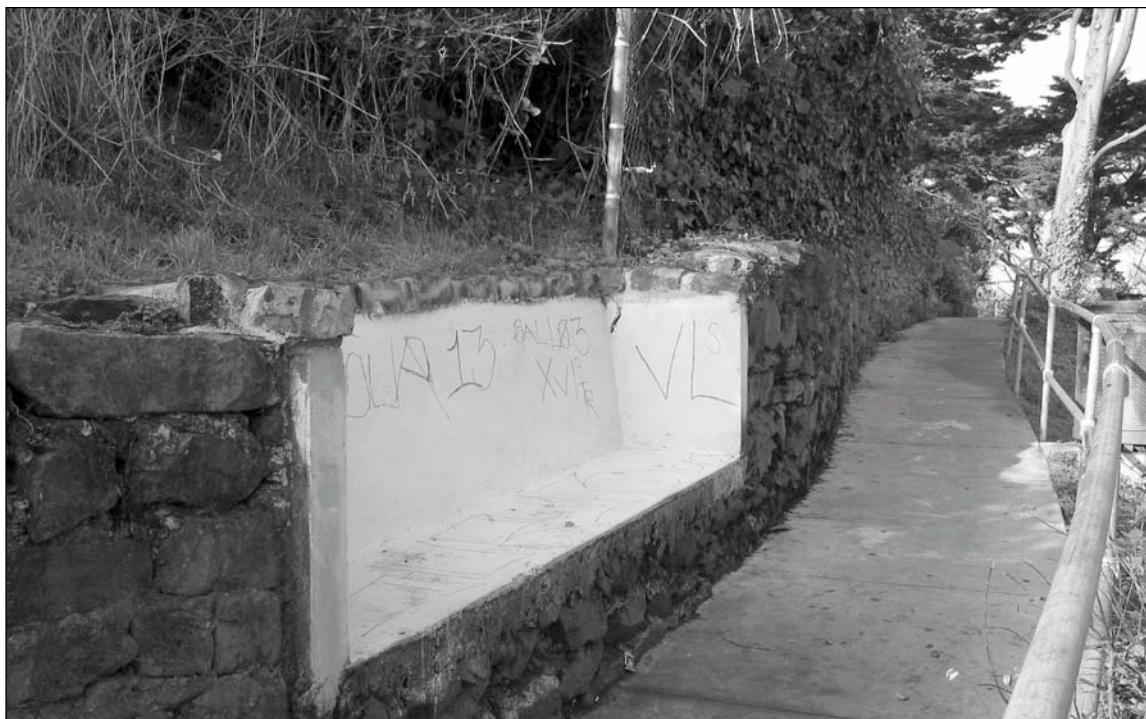
**Figure 5.2.15: Stone Retaining Walls with Built-in Seats.** After the U.S. Army's arrival in 1863, the garden pathways belonging to the formerly private residences were reused for the pleasure of the Officers' corps. This wall and seat is a fairly well-maintained example of many similar arrangements found on the east slope of the peninsula. Contributing. 12/02 - OCLP.

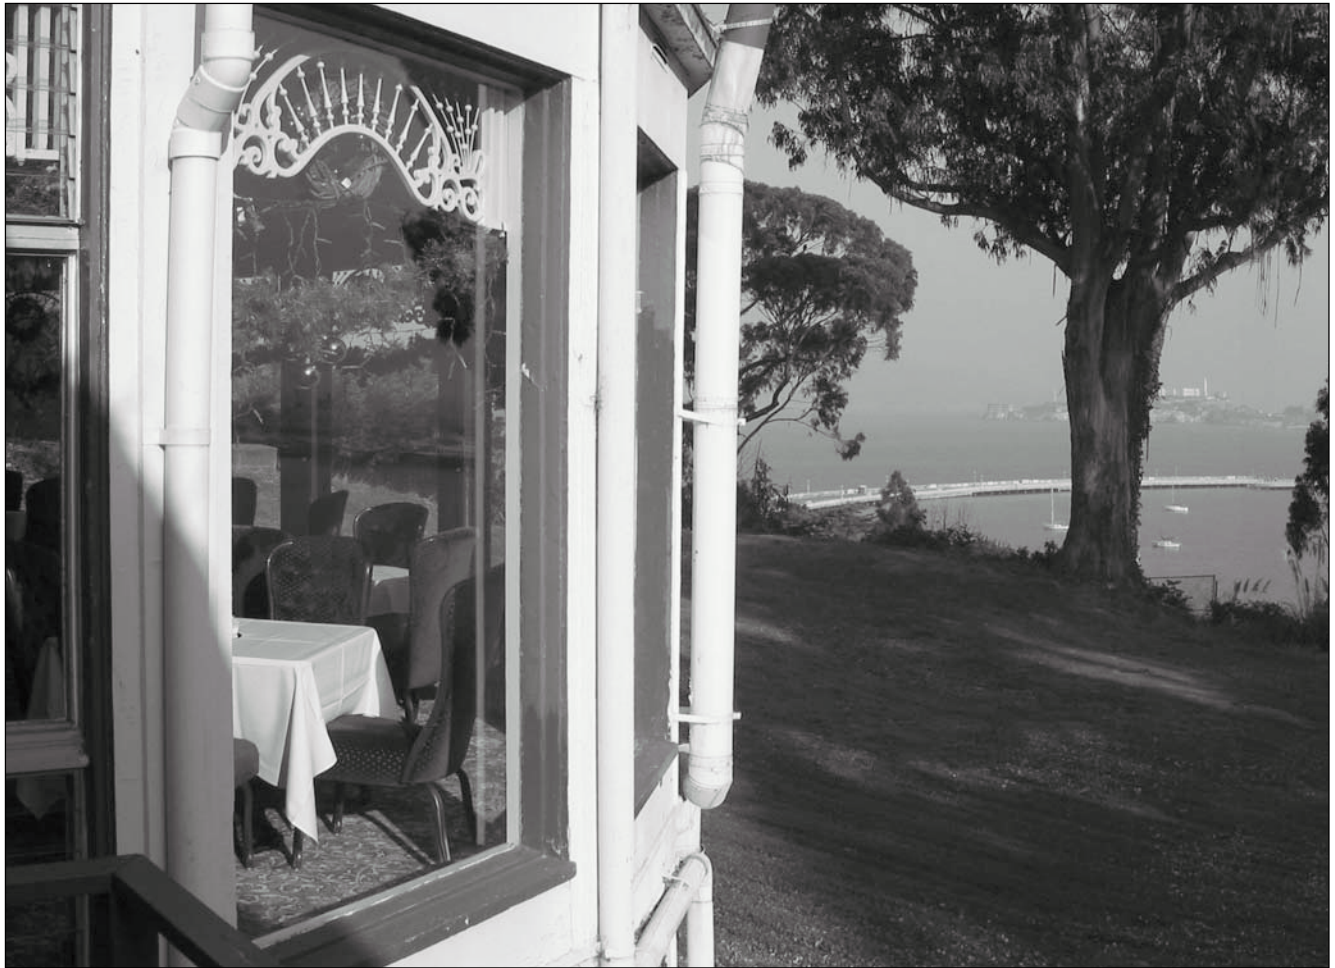
**Figure 5.2.16:** Framed Views of Black Point Cove from Officer's Quarters. Views of Black Point Cove were a major factor leading to the settlement of this area during the Gold Rush. Contributing. 12/02 - OCLP.

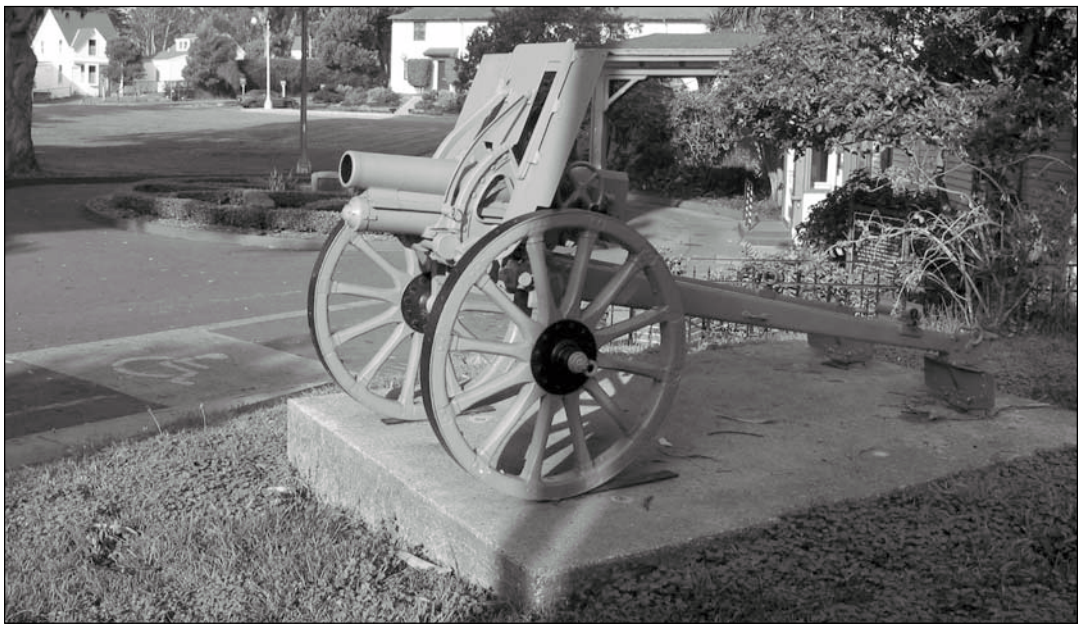
**Figure 5.2.17:** Captured Cannon and Platforms. Two Japanese field guns were captured c. 1943 by U.S. forces during World War II and considered trophy weapons. Photographs from the 1950s indicate that the guns were on the property, yet were not in their current location, until c. 1965 Contributing. 12/02 - OCLP.

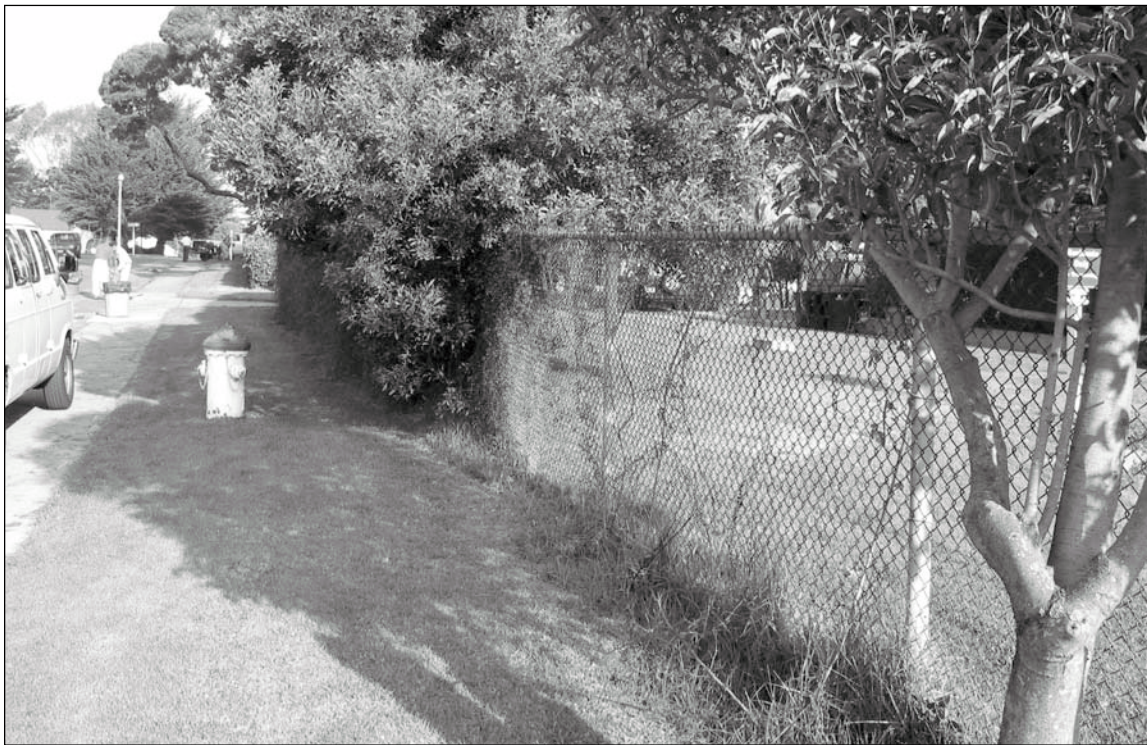
**Figure 5.2.18:** Chain-link fencing at Franklin Street Frontage. The date of the replacement of the original wooden fencing on this site with wire-fencing is uncertain, but is likely to have occurred prior to WWII. Feature requires further evaluation. 12/02 - OCLP.

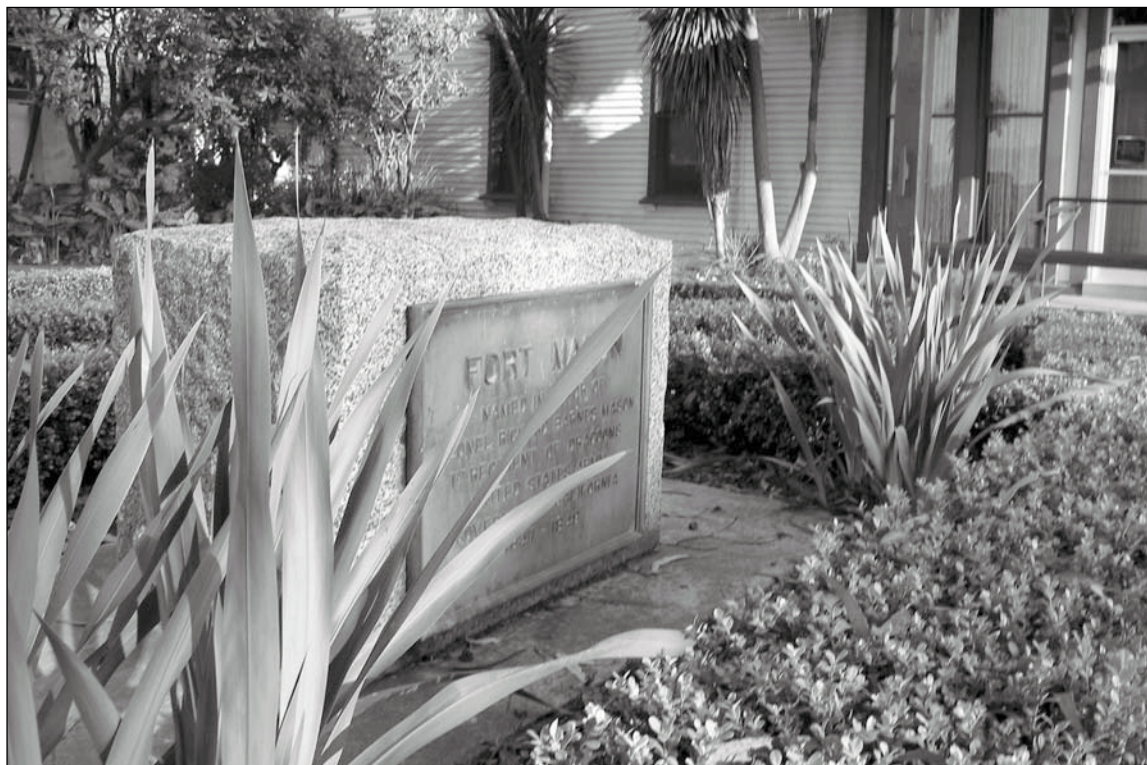
**Figure 5.2.19:** Granite Monument in McDowell Hall Carriage Turn. Until the early 1970s this site was occupied by a bronze 17<sup>th</sup> century Spanish cannon on a concrete plinth. The Spanish cannon was later moved to the Presidio. Non-contributing - managed as a resource. Also note geometric center planting. 12/02 - OCLP.

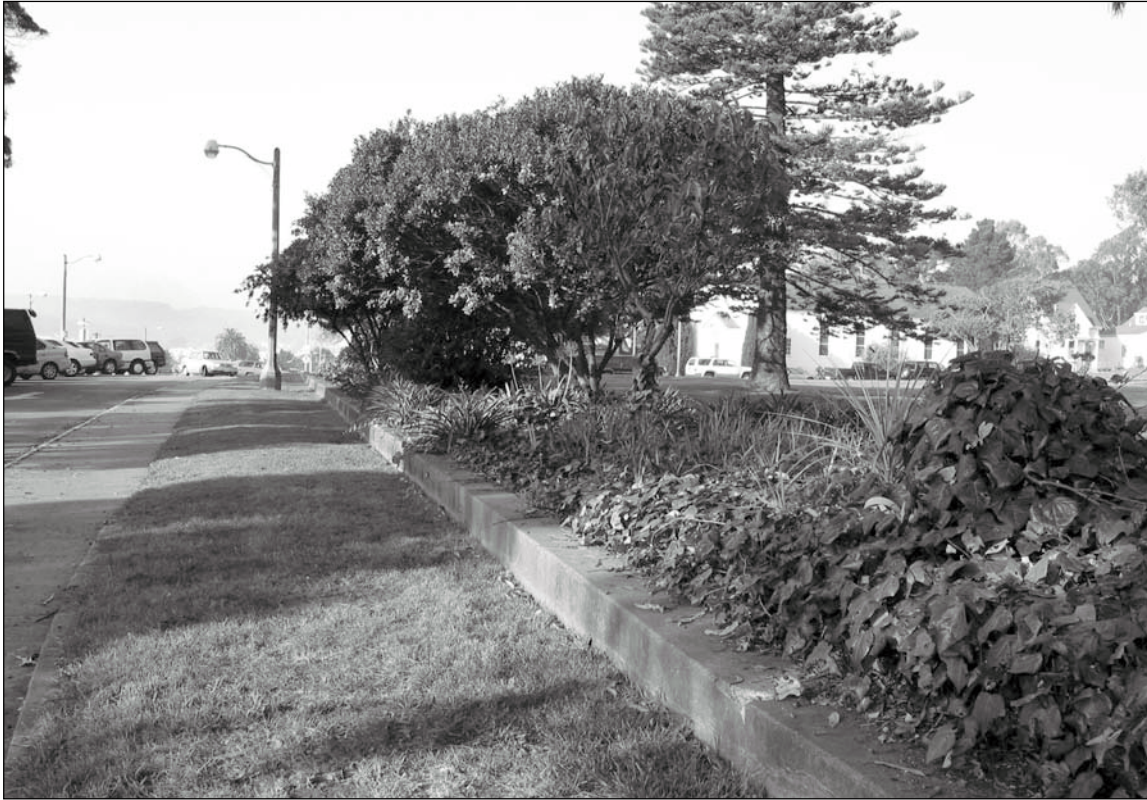
**Figure 5.2.20:** Concrete Edging - McDowell Hall West Lawn Shrub Border. This edging is a remnant of what was once a more extensive garden on the FM - 1 west lawn - removed in 1968. Contributing. 12/02 - OCLP.

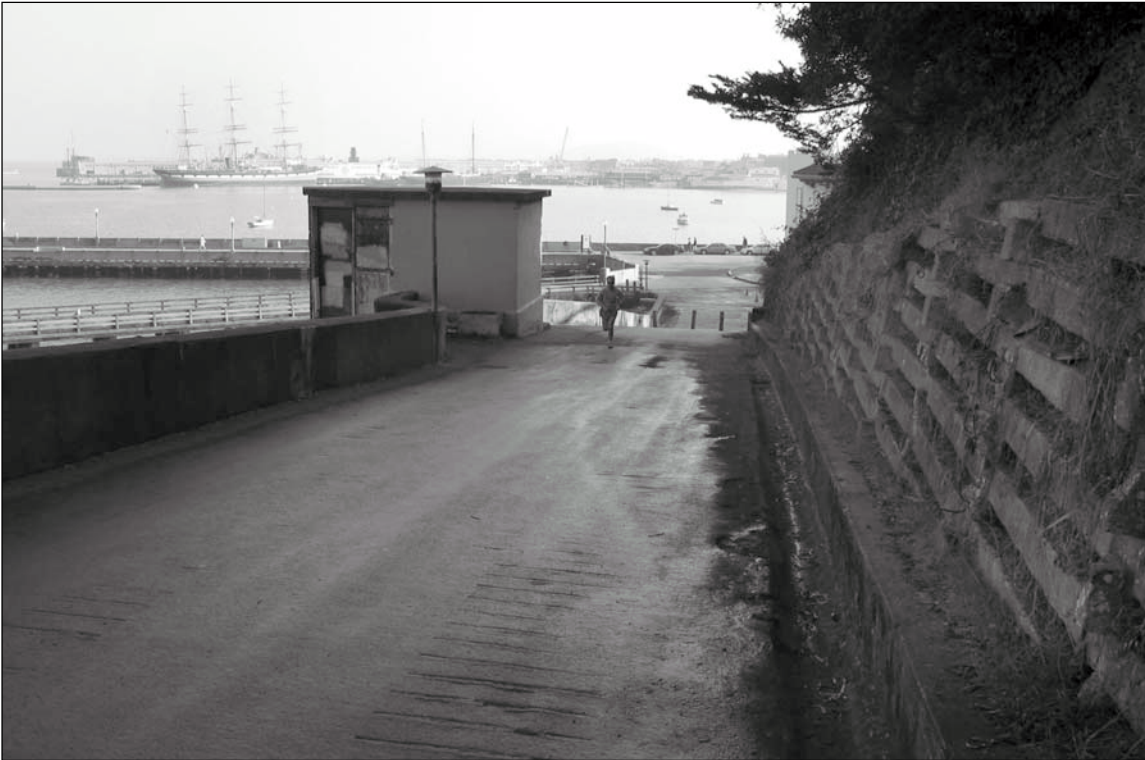
Existing Condition: Road features bituminous pavement, averaging 24' wide. Road begins at Pier #4 and climbs the hillside at a steep grade to its greatest elevation overlooking Lower Fort Mason (Figure 5.3.2). Road traverses the side slope of the hill, featuring retaining walls at both the cut and fill slopes. From the intersection with Battery Road, McDowell Avenue continues down grade to where it enters and terminates in the Great Meadow.

**Figure 5.3.2:** *McDowell Avenue. This road was constructed into the northern cliff of Black Point c.1877 to provide access to the Quartermaster Wharf (Pier 4). Contributing. 12/02 - OCLP.*

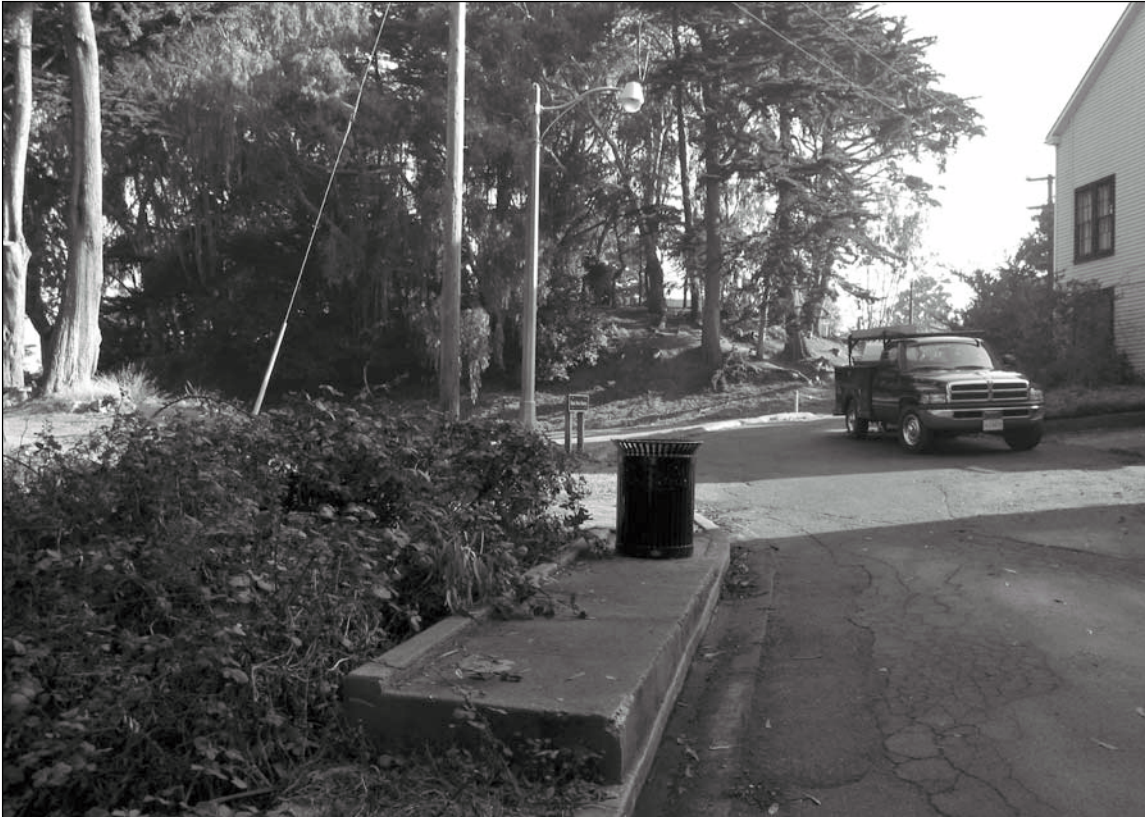
**Figure 5.3.3:** *Battery Road. Battery Road was originally constructed as part of McDowell Avenue c.1877. Its grade was substantially changed during the construction of Battery Burnham. Contributing. 12/02 - OCLP.*

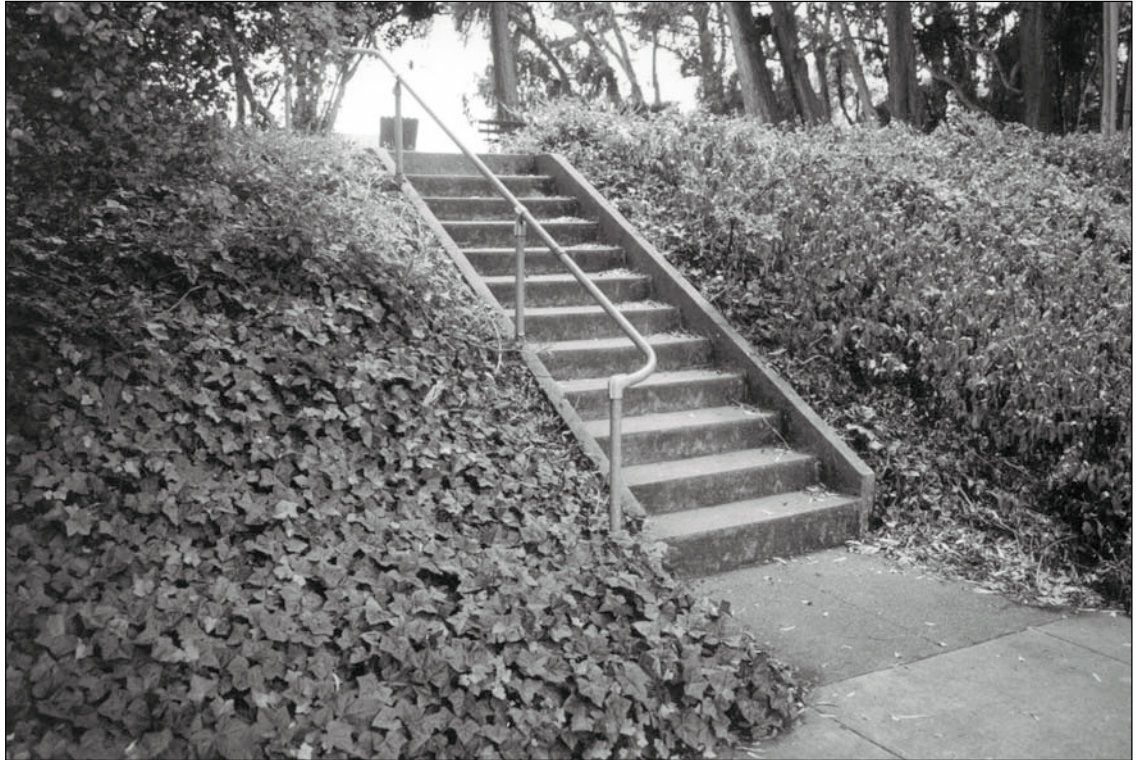
**Figure 5.3.4:** *System of Pedestrian Paths and Stairs. Pedestrian paths and walks are commonly surfaced with poured-in-place concrete. Concrete stairs are fitted with modern safety handrailings. Contributing. 12/02 - OCLP.*

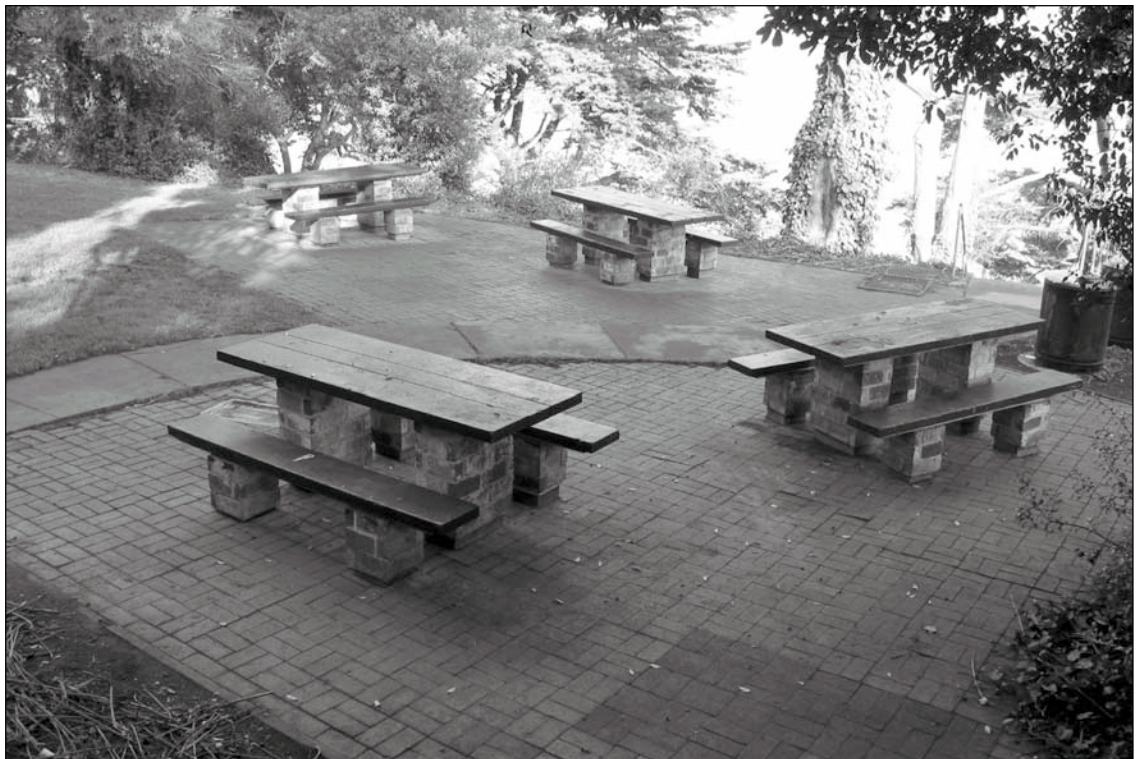
Existing Condition: The picnic area consists of two small areas of basketweave pattern brick pavement on either side of a pre-existing concrete walkway (Figure 5.3.5). There are two picnic table / bench assemblies on either side of the concrete walk. The tables and benches feature wooden surfaces mounted to brick piers.

**Figure 5.3.5:** *East Battery Picnic Area. This picnic area, paved in a basketweave brick paving pattern and furnished with a group of four table/bench combinations was installed c.1982. Non-contributing. 12/02 - OCLP*

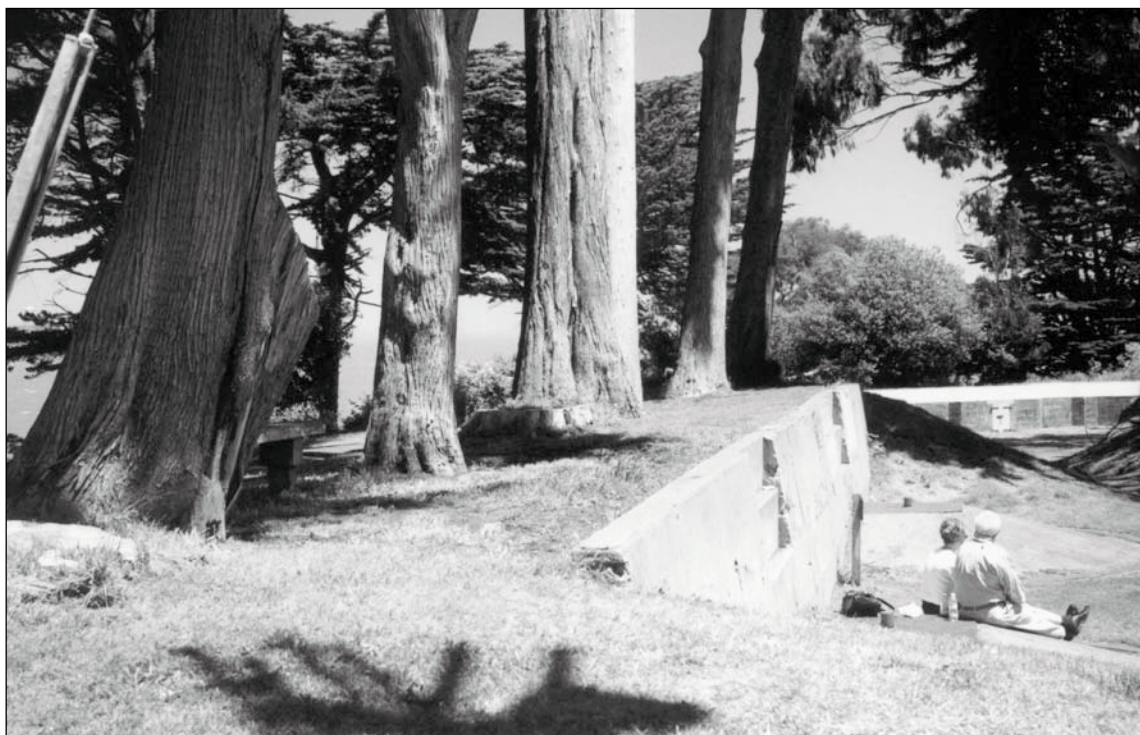
Existing Condition: A dense cover of Monterey cypress prevents most direct sun onto the turf, although it appears in good condition. Wear and tear from pedestrians is visible in limited areas.

**Figure 5.3.6:** Turf. A covering of non-native grass is a significant characteristic of the cultural landscape in the North Fortifications landscape character area. Contributing. 7/02 - OCLP.

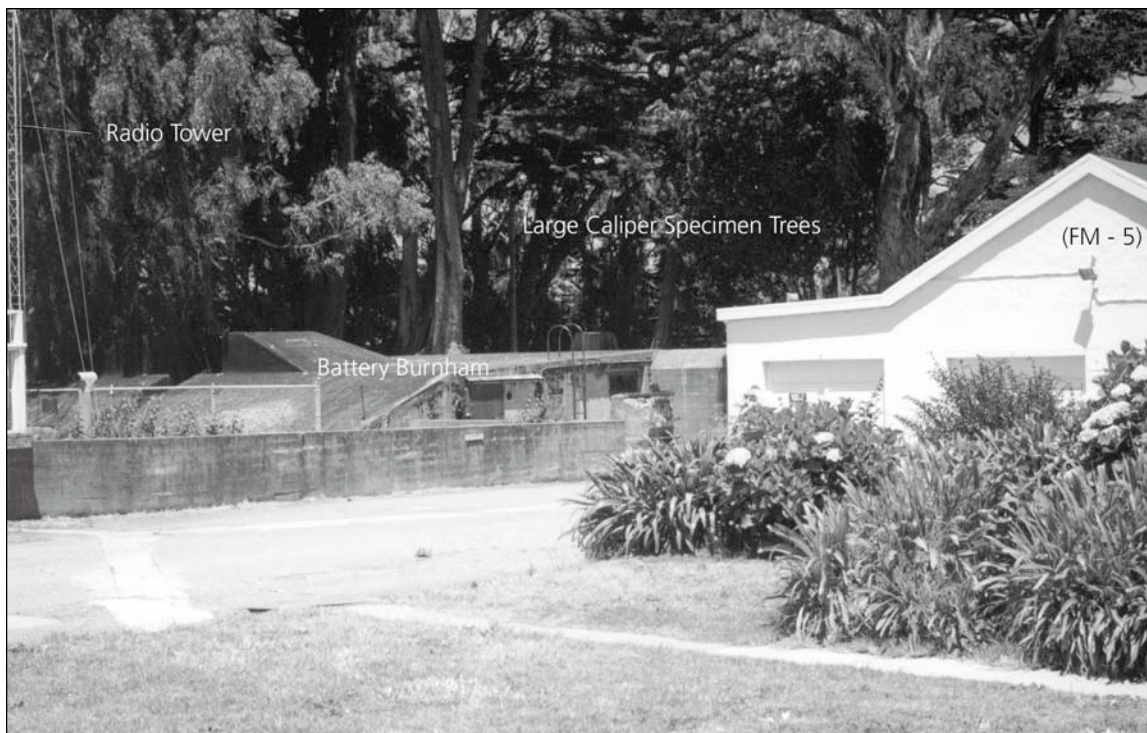
**Figure 5.3.7:** BLR Battery and Magazine (Battery Burnham). This fortification was part of the Endicott system of coastal defenses. Battery Burnham was armed with a single breech-loading rifle (BLR) between 1899 and 1909. A two-stall garage was built within its footprint c.1914. Contributing. Note the blocked view out to the bay from this historic artillery position, 12/02 -OCLP.

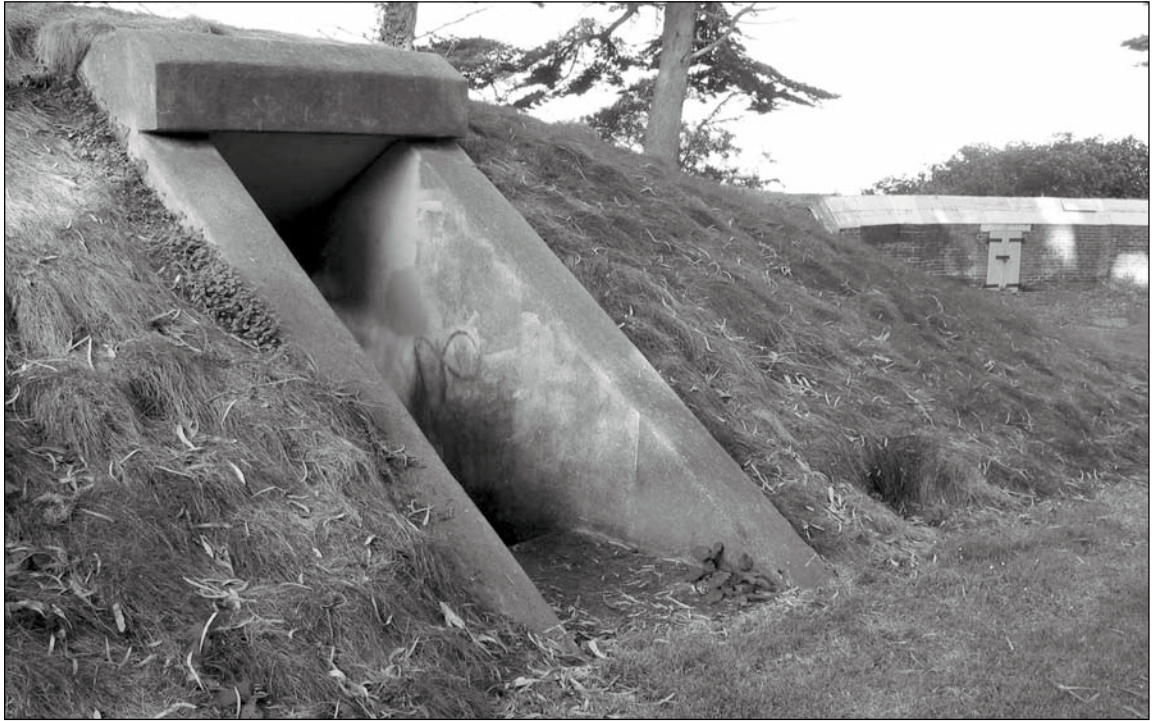
**Figure 5.3.8:** MLR Concrete Magazine, (FM - 250). This magazine was constructed c1898-1900, and was likely a replacement for a deteriorated earth-covered timber magazine at the same location. Contributing. 12/02 - OCLP.

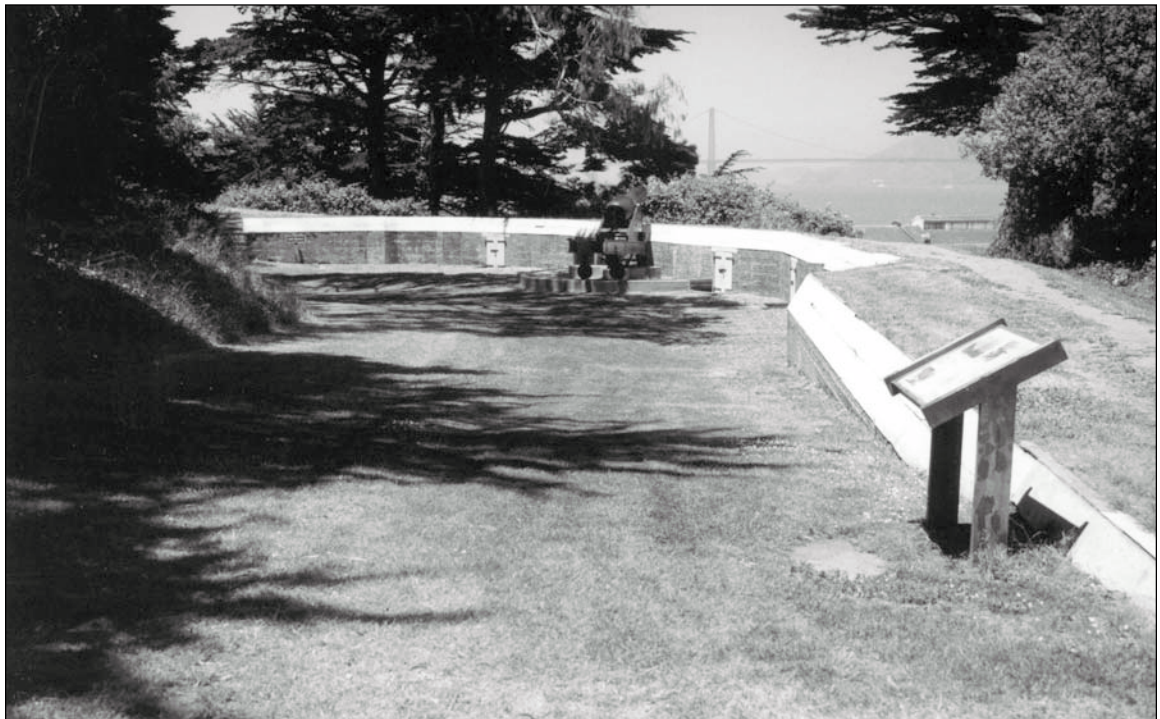
**Figure 5.3.9:** Civil War Era Gun Battery, (FM - 329). Only the western battery and central north-facing curtain wall of the Civil War fortifications survive at Fort Mason. They were uncovered and restored in 1982. Contributing. 7/02 - OCLP.

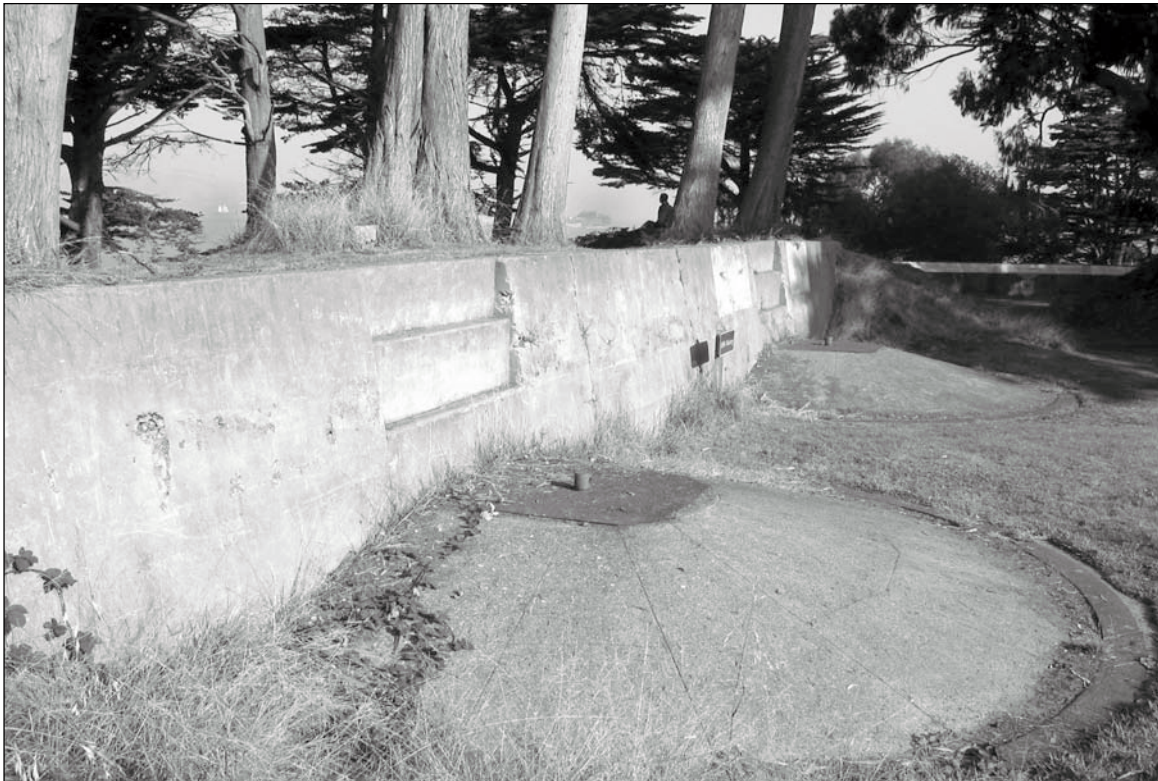
Existing Condition: Built of board finished concrete, the parapet wall is approximately sixty-three feet long and six feet from ground level to top of wall. Gun mounts are engineered ferro-concrete, protected behind a wide parapet of earth on its west facing side (Figure 5.3.10).

**Figure 5.3.10:** MLR Concrete Gun Platform, (FM - 329A). These two gun emplacements were begun as an emergency measure during the Spanish-American War. Contributing. 12/02 - OCLP.

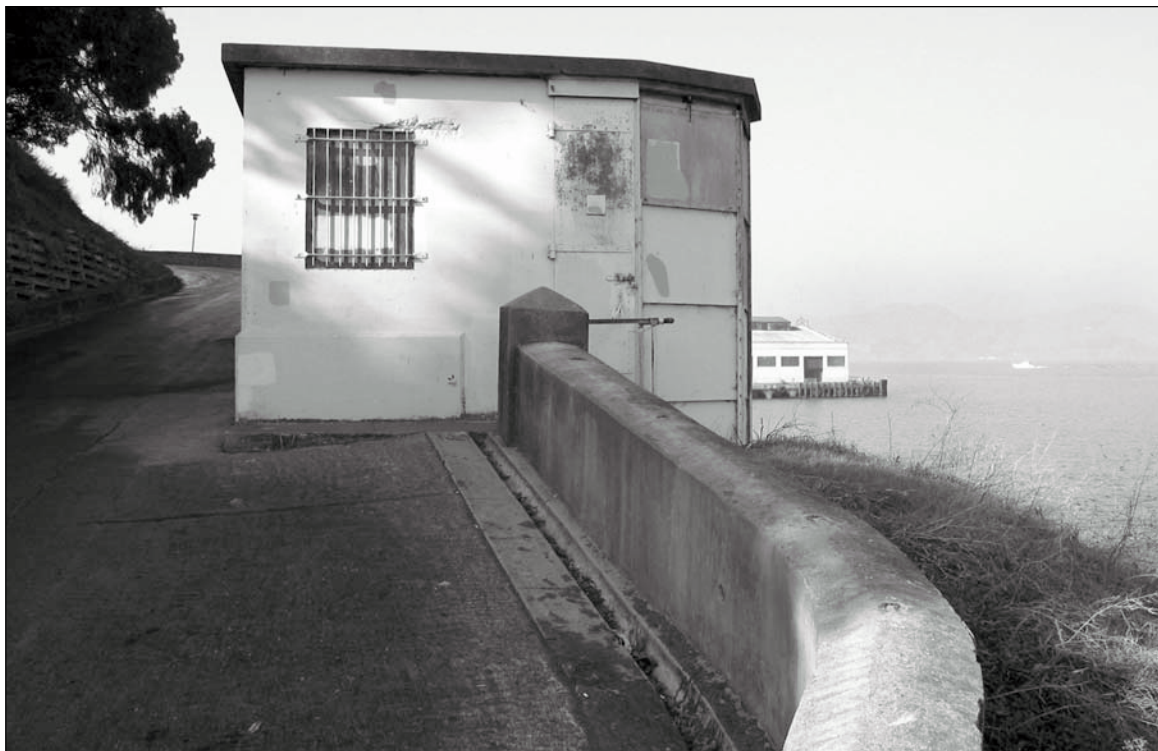
**Figure 5.3.11:** Searchlight shelter, (FM - 15). Constructed in 1911, prior to the invention of radar, this building and its searchlight continued the defensive mission of Fort Mason after the weaponry had been removed from Battery Burnham. Contributing. 12/02 - OCLP.

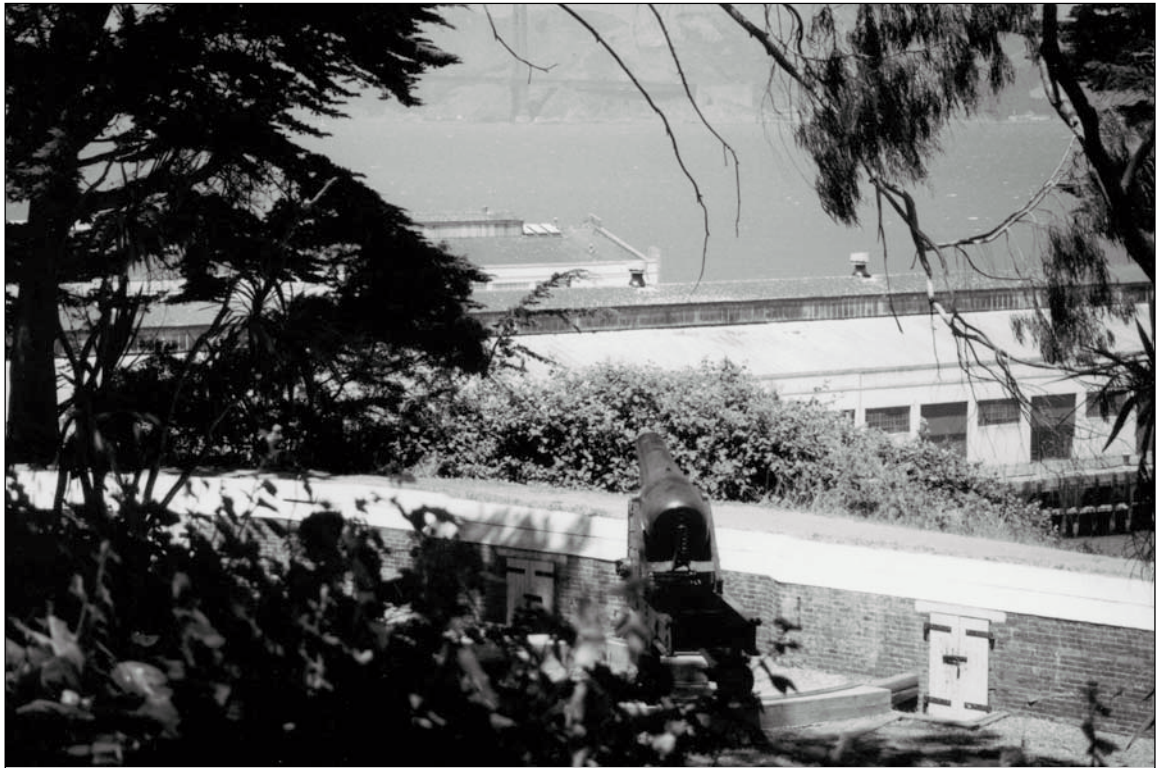
Existing Condition: The trees in the North Fortifications area have not been actively managed or regularly cared for since the 1960s when the Army began its phase-out from Fort Mason. The mature trees here consisted largely of a mixture of Monterey cypress and Blue Gum eucalyptus, creating a dense canopy. Less common species include: toyon, pittosporum, and cordyline. It is likely most of the specimens in this grove have self-seeded during the past fifty years, although some may have been intentionally planted during the 1920s.

**Figure 5.3.12:** Views of San Francisco Bay and Golden Gate. Open lines of sight or “field of fire” is a fundamental characteristic of coastal defenses. At Fort Mason, once panoramic views found in the North Fortifications landscape character area have been greatly constrained by the growth of unmanaged vegetation. Contributing. 7/02 - OCLP.

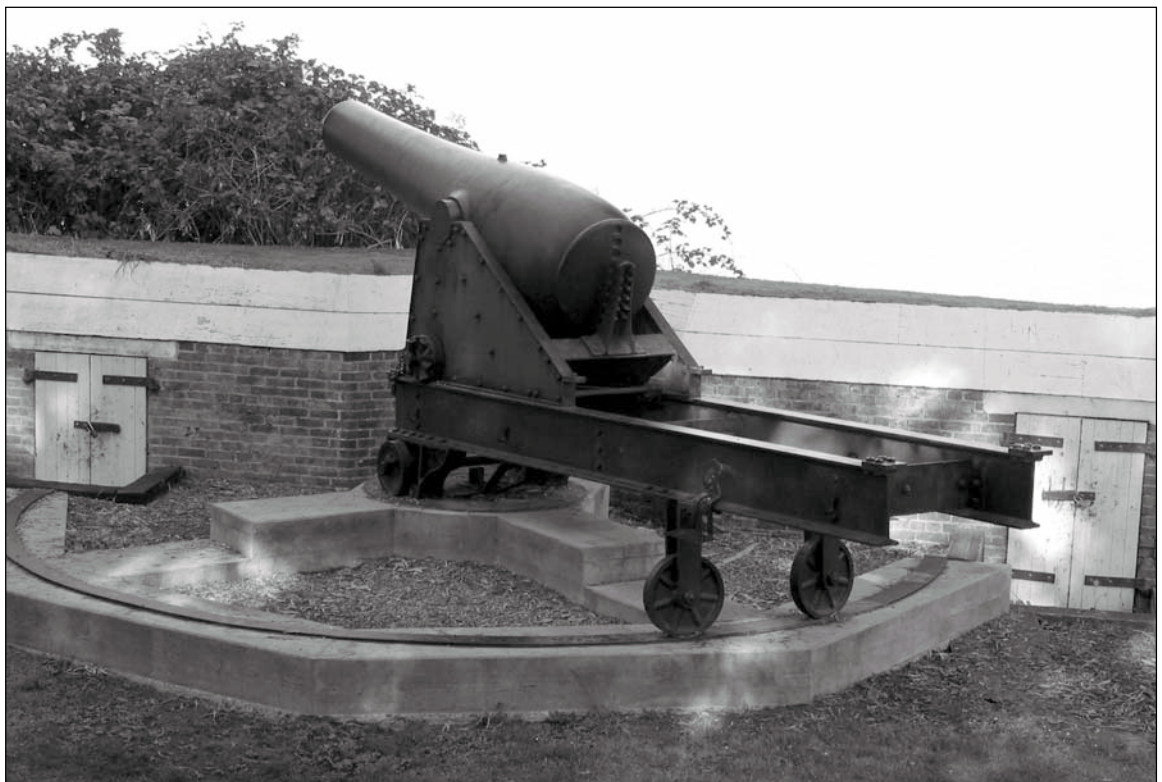
**Figure 5.3.13:** Rodman Gun and Carriage. This particular gun and gun carriage was emplaced following the restoration of the western battery in 1982. Contributing. 12/02 - OCLP.

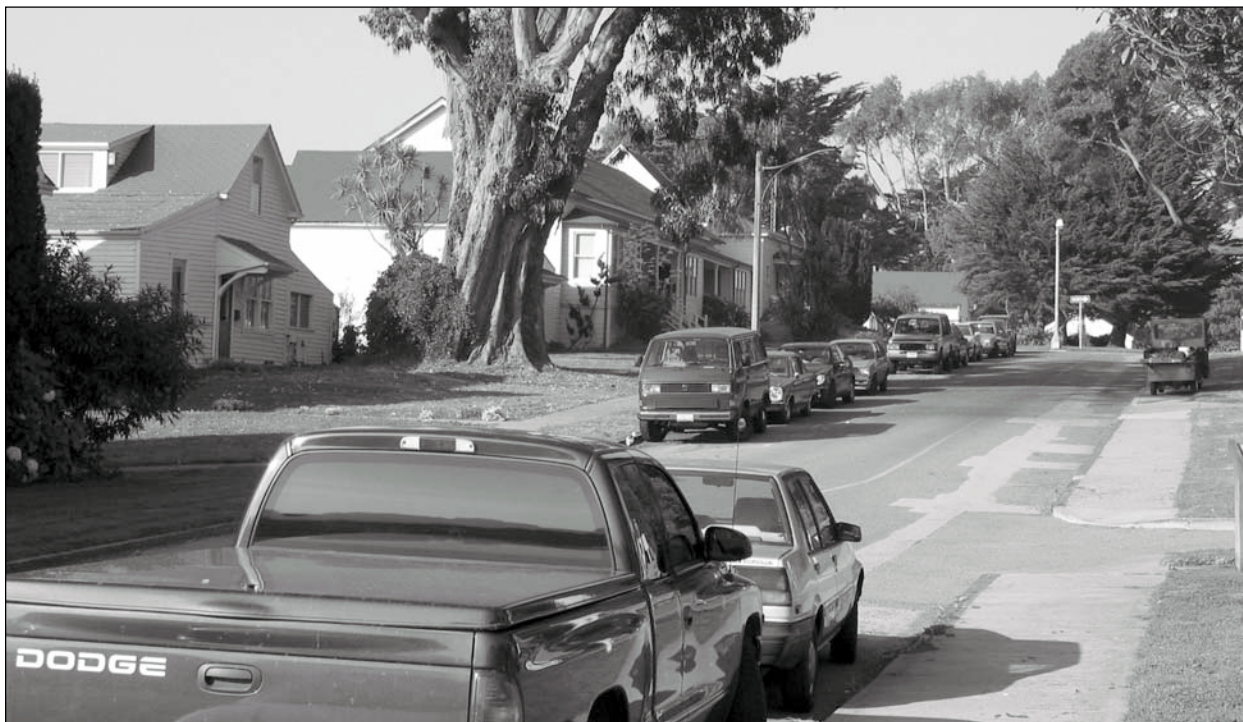
**Figure 5.4.2:** *Franklin Street (formerly Sheridan Road). This was the earliest roadway serving Fort Mason. This central north-south route through the property is likely to have predated the Army's occupation of the site in a rudimentary form, providing access to the civilian dwellings on Black Point. Contributing. 12/02 - OCLP.*

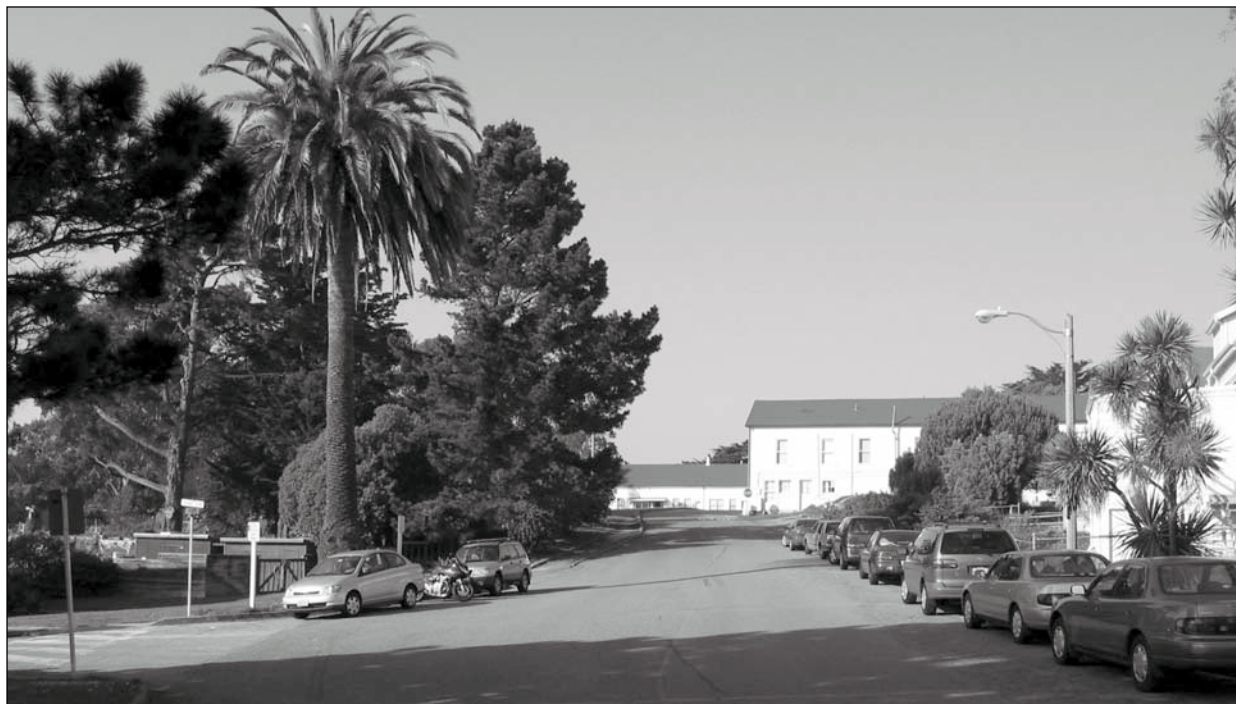
**Figure 5.4.3:** *Pope Road. Pope Road was created after the system of circulation at Fort Mason became more clearly defined during the 1880s and 1890s. Pope Road is one of two surviving roads at Fort Mason that once defined the edges of the formal Parade ground. Contributing. 12/02 - OCLP.*

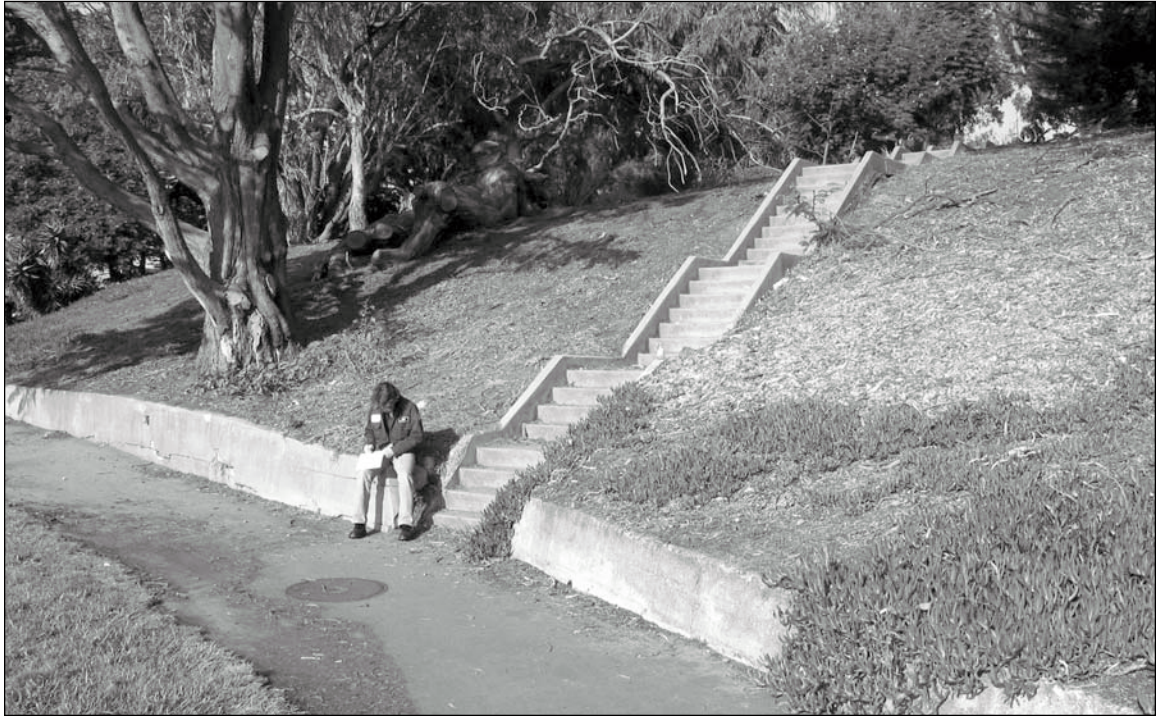
**Figure 5.4.4:** *Concrete Stair Between Parade Ground and Great Meadow, (FM - 407). This stairway was constructed c1938, replacing an earlier wooden stair at the same location. Contributing. 12/02 - OCLP.*

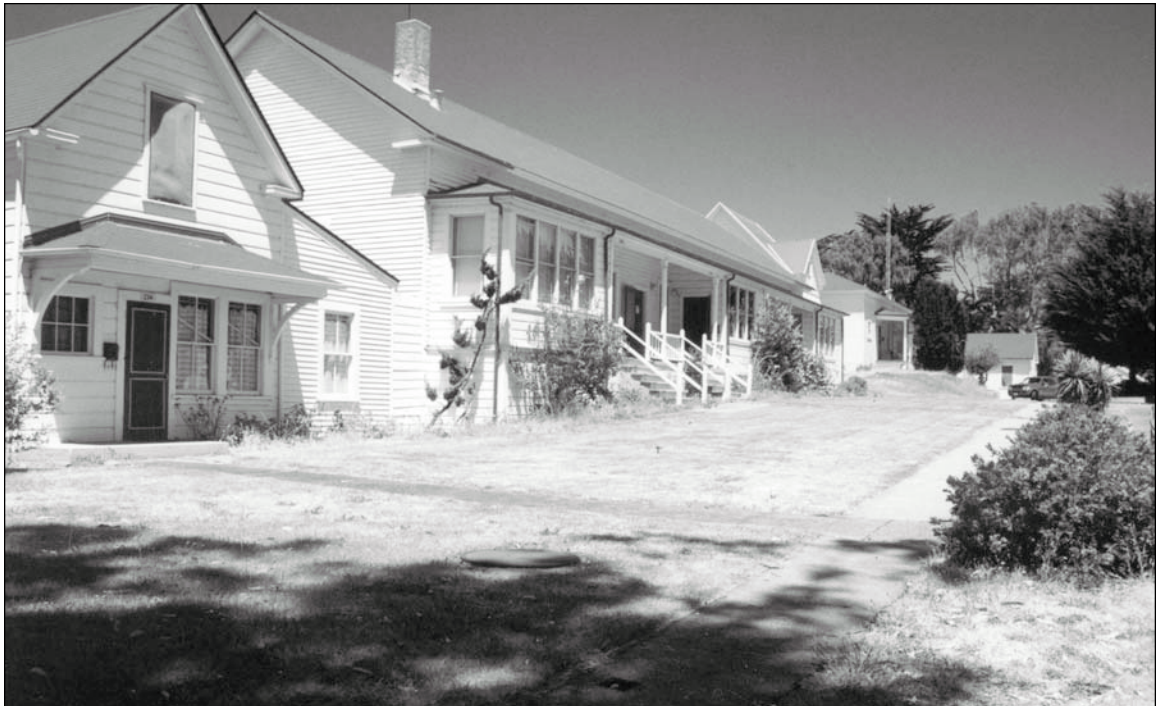
**Figure 5.4.5:** *Foundation Plantings. The foundation plantings found accompanying the NCO residences on Franklin Street were typically less extensive than those found at nearby officer's quarters. The existing conditions of plantings here is quite poor. Undetermined. Foundation plantings throughout Fort Mason require further inventory and analysis. 12/02 - OCLP.*
