# CULTURAL LANDSCAPE REPORT FOR FORT MASON GOLDEN GATE NATIONAL RECREATION AREA

Volume One: Site History, Existing Conditions and Analysis

Prepared by:  
Amy Hoke, Historical Landscape Architect  
National Park Service  
Pacific West Region  
Seattle, Washington

September 2004

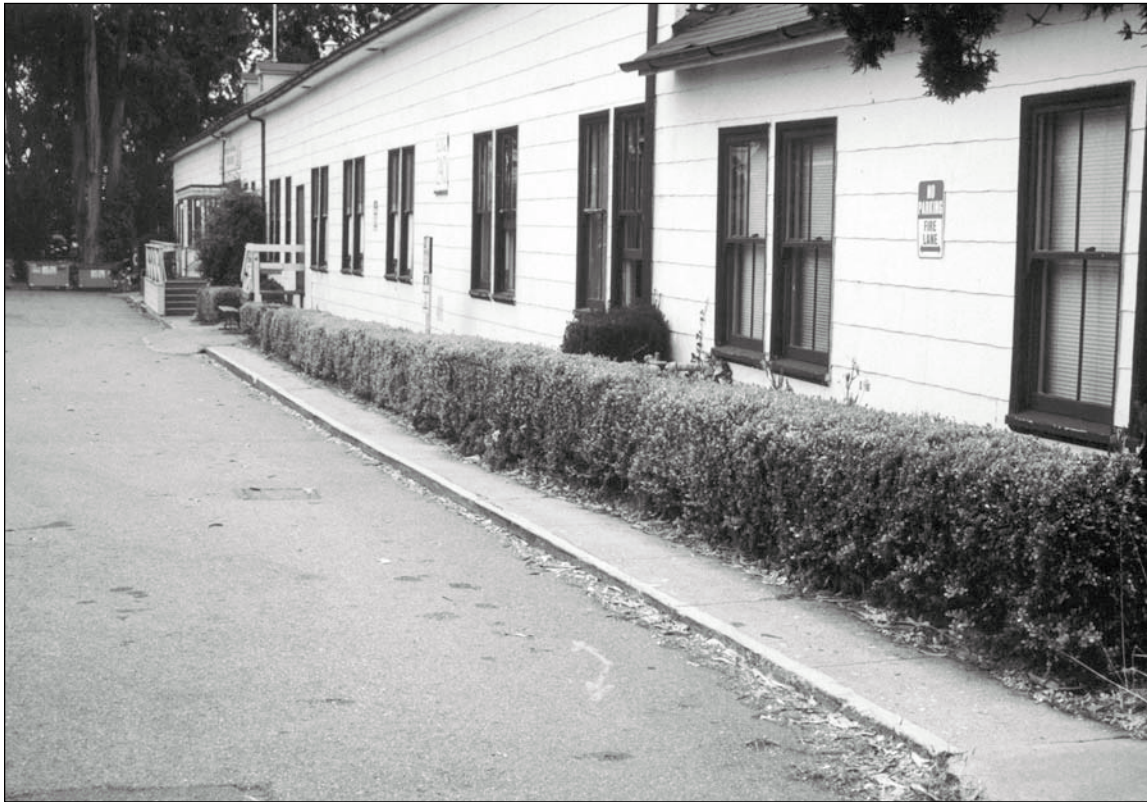
**Figure 5.4.6:** *Foundation Plantings.* The date of installation of the low boxwood hedge at the south facade of FM - 240 is unknown. Undetermined. Foundation plantings throughout Fort Mason require further inventory and analysis. 7/02 - OCLP.

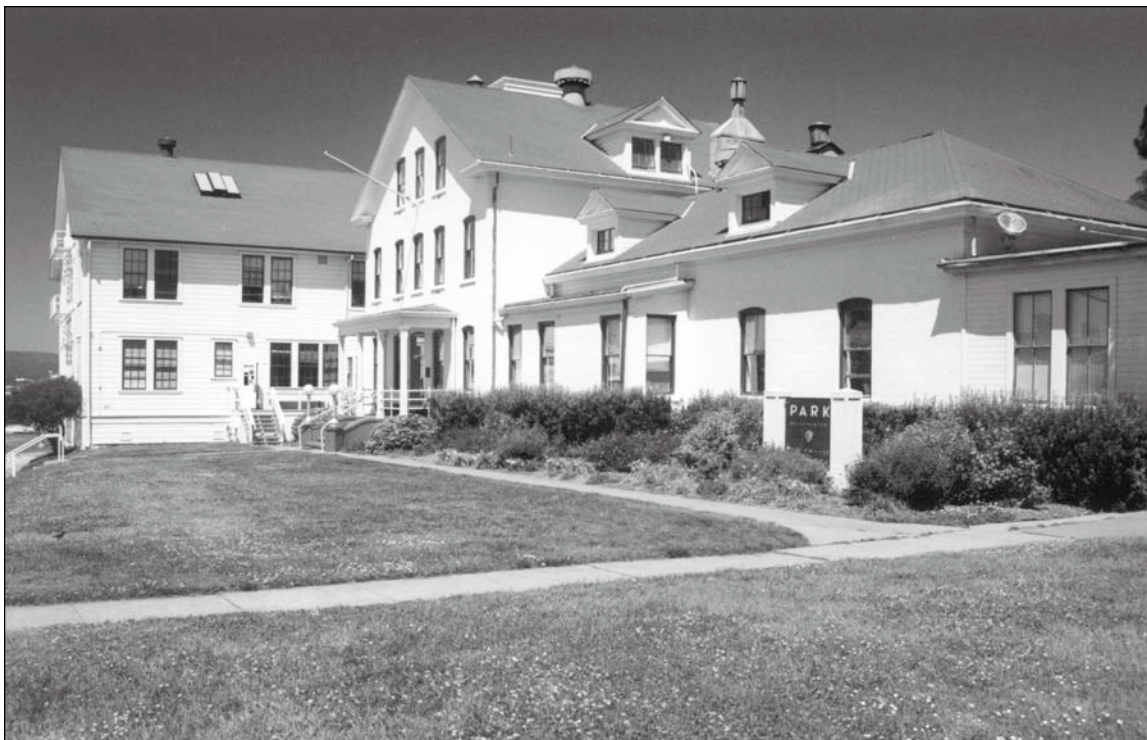
**Figure 5.4.7:** *Foundation Plantings.* The foundation planting on the south facade of FM - 201 was replaced by the NPS. The planting is accompanied by a large park sign identifying this building as GGNRA headquarters. Non-contributing. 7/02 - OCLP.

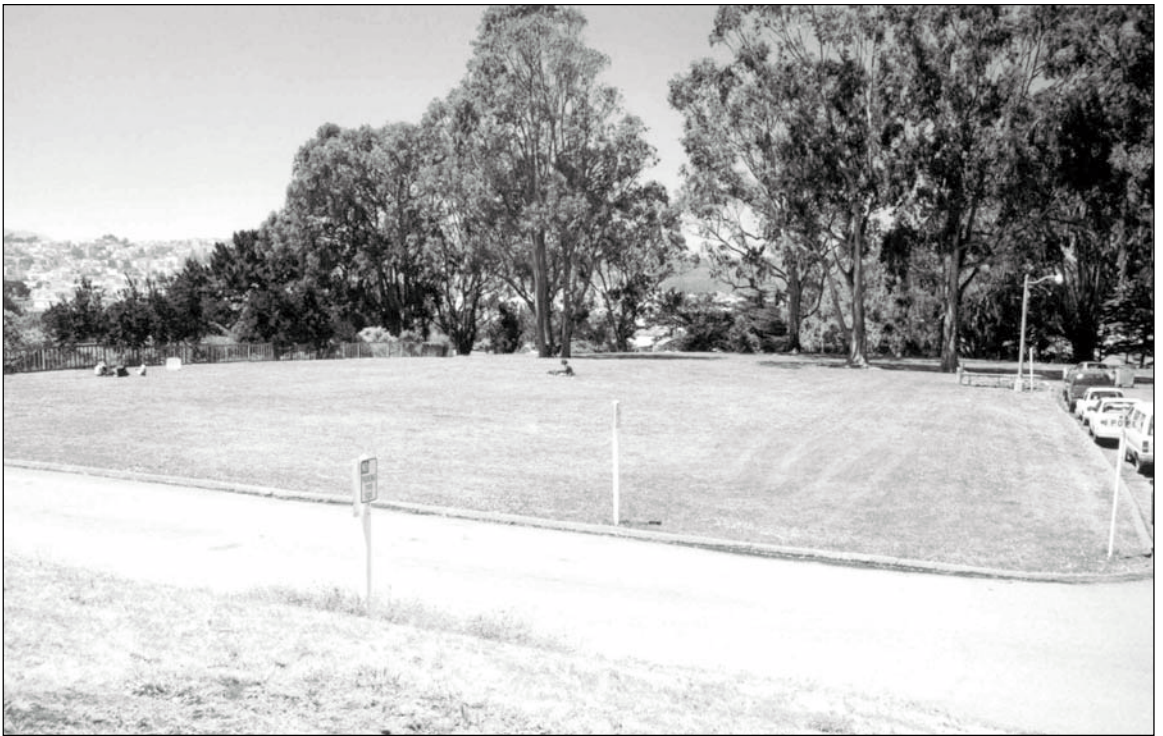
**Figure 5.4.9:** *Parade Ground (FM - 323).* Buildings covering Fort Mason's Parade were removed c.1972 in an attempt to restore this area to its pre-1929 configuration. The western and southern roads formerly fronting on the parade were removed in the 1980s. In the process, the parade's spatial volume was destroyed. Contributing. 7/02 - OCLP.

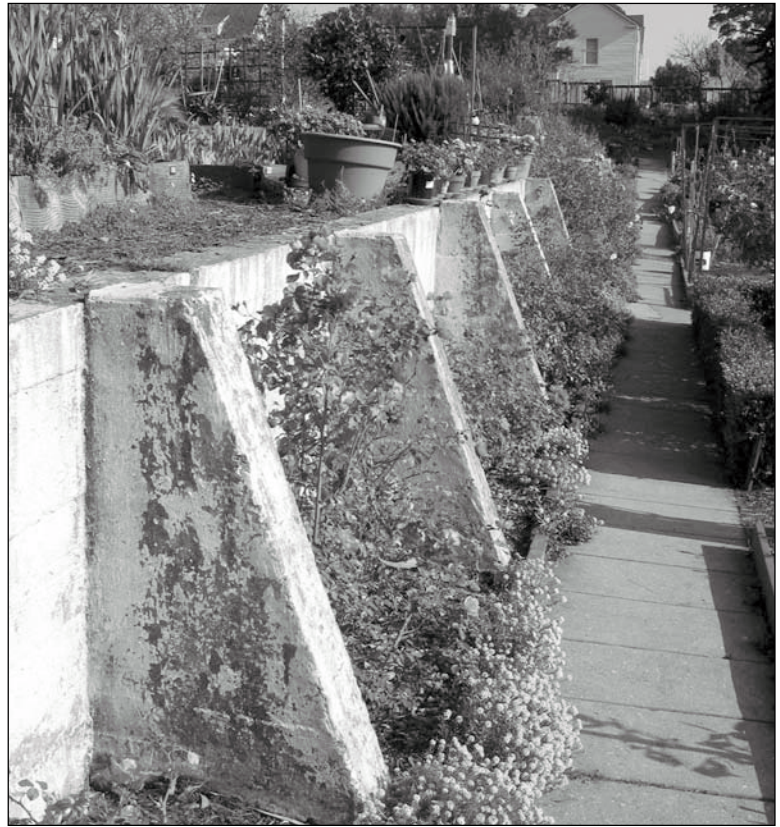
**Figure 5.4.12:** Foundation Remnant of Barracks, (FM - 256). Original building was constructed c1905-07 and removed between 1969 and 1972. Foundation is currently found on the northern edge of the Community Garden. Contributing. 12/02 - OCLP.

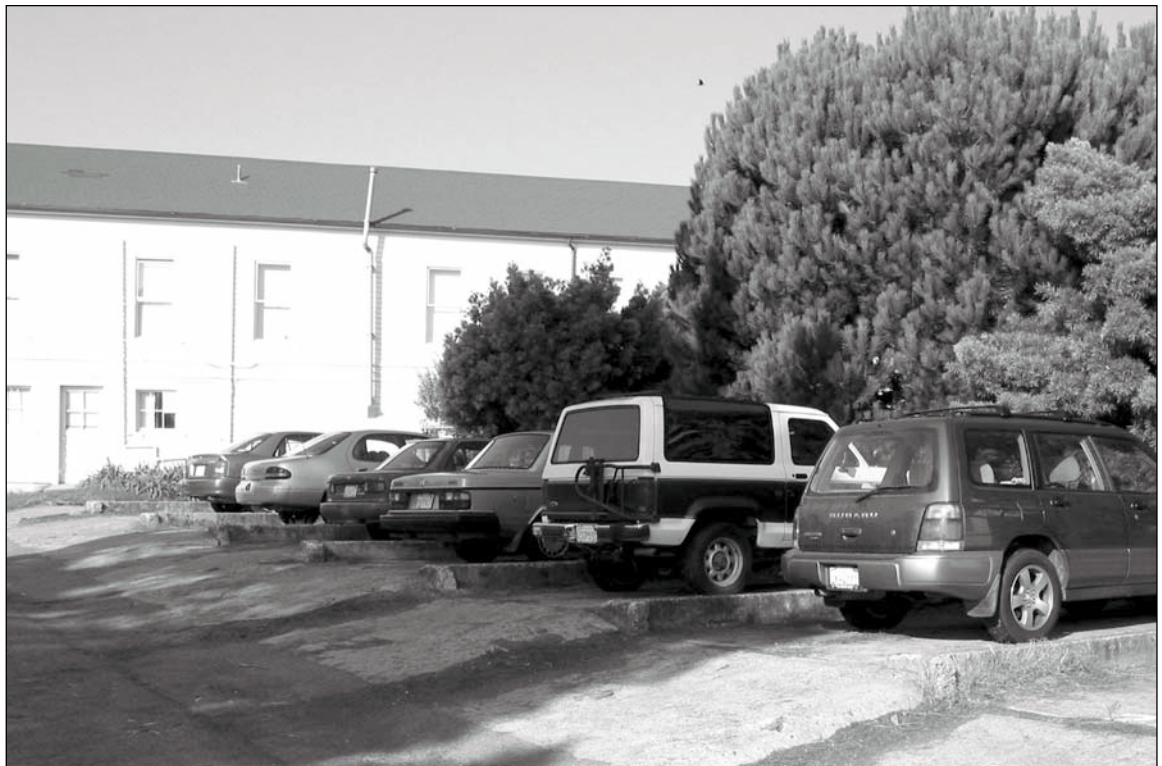
**Figure 5.4.13:** Stepped-Slab Garage Foundation Remnant. The garage once sitting atop this foundation was demolished between 1968 and 1972. Contributing. 7/02 - OCLP.

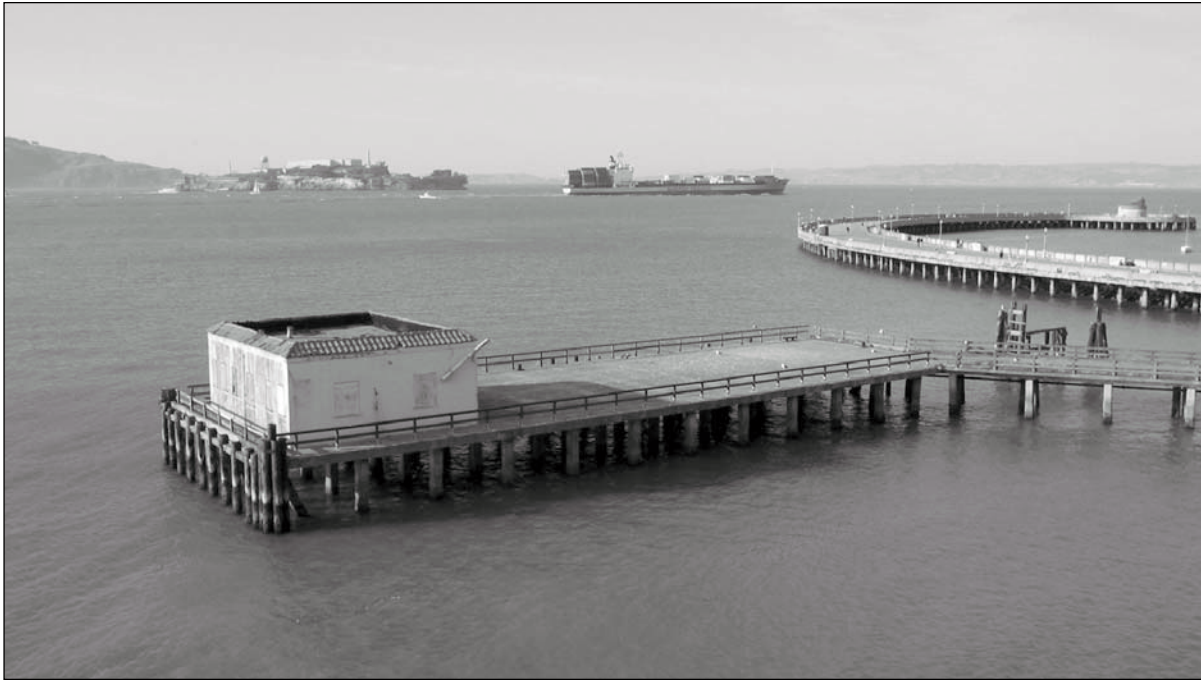
*Figure 5.5.2: Pier #4, (FM - 16). Contributing. 5/03 - OCLP*

Existing Condition: Wharf is in disrepair and closed to public access (Figure 5.5.2). Structure measures 50' x 150' with an approach way from the shore measuring 20' x 240'. Structure is composed of concrete decking on square concrete pilings, featuring wood handrails and wood bumper pilings.

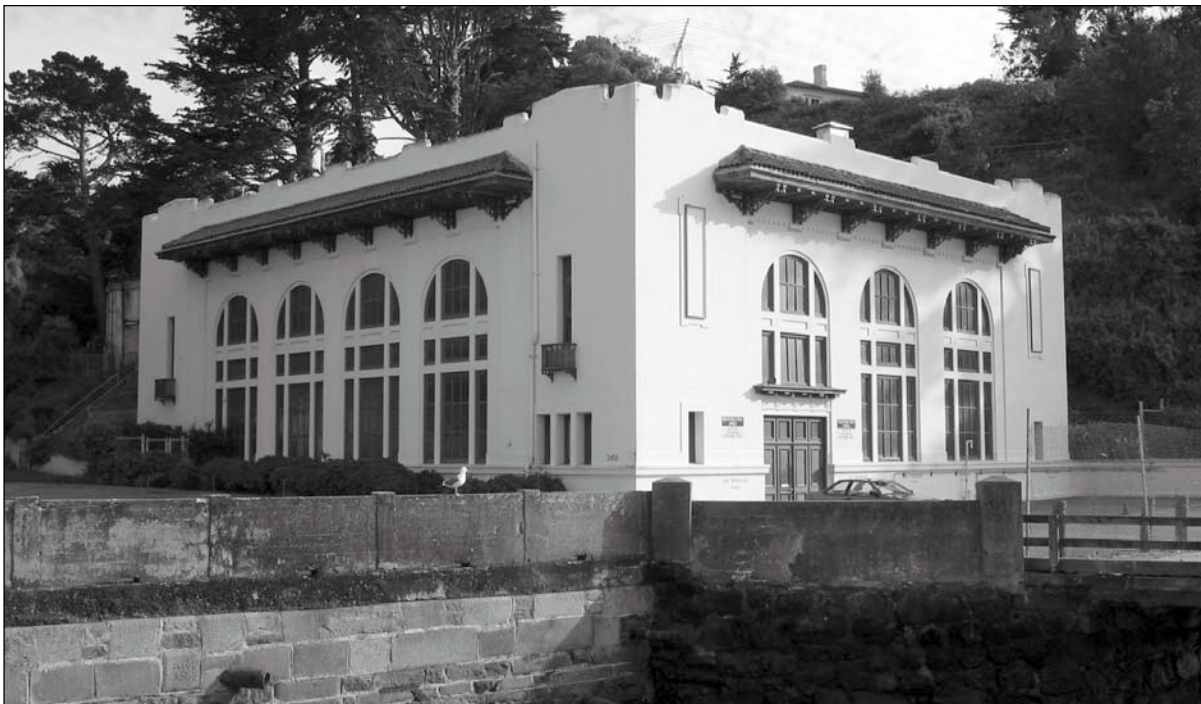
*Figure 5.5.3: Emergency Pumping Station, (FM - 403). Contributing. 5/03 - OCLP.*

Existing Condition: Monumental single story structure measuring 77' x 92'. Exterior finish is stucco. Building features a flat roof and enormous arch-top windows (Figure 5.5.3). An elaborate copper cornice decorates the east, south and north elevations. The west façade faces the steep adjacent hillside and is out of view and unadorned.

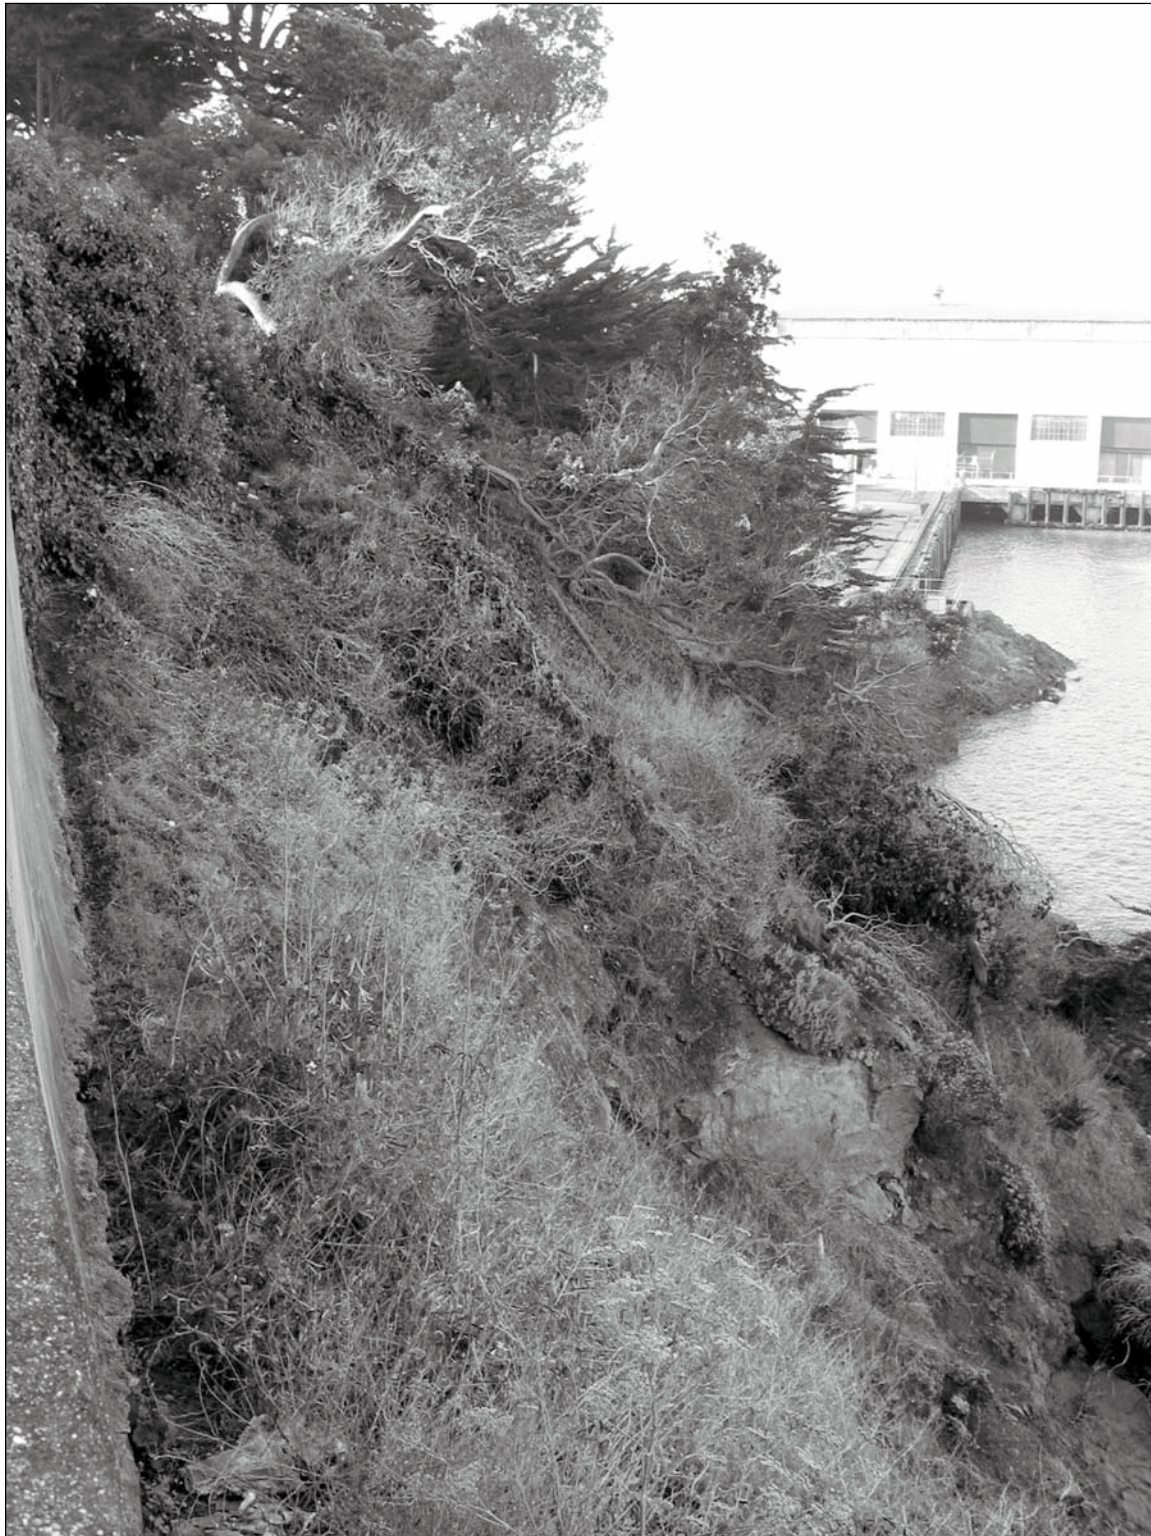
Existing Condition: Invasive species present. Existing conditions require additional detailed inventory outside the scope of this report (Figure 5.6.2).

**Figure 5.6.2:** *This area of Fort Mason's coastline represents a small area of unaltered coastal habitat within the city of San Francisco. Contributing. 12/02 - OCLP.*

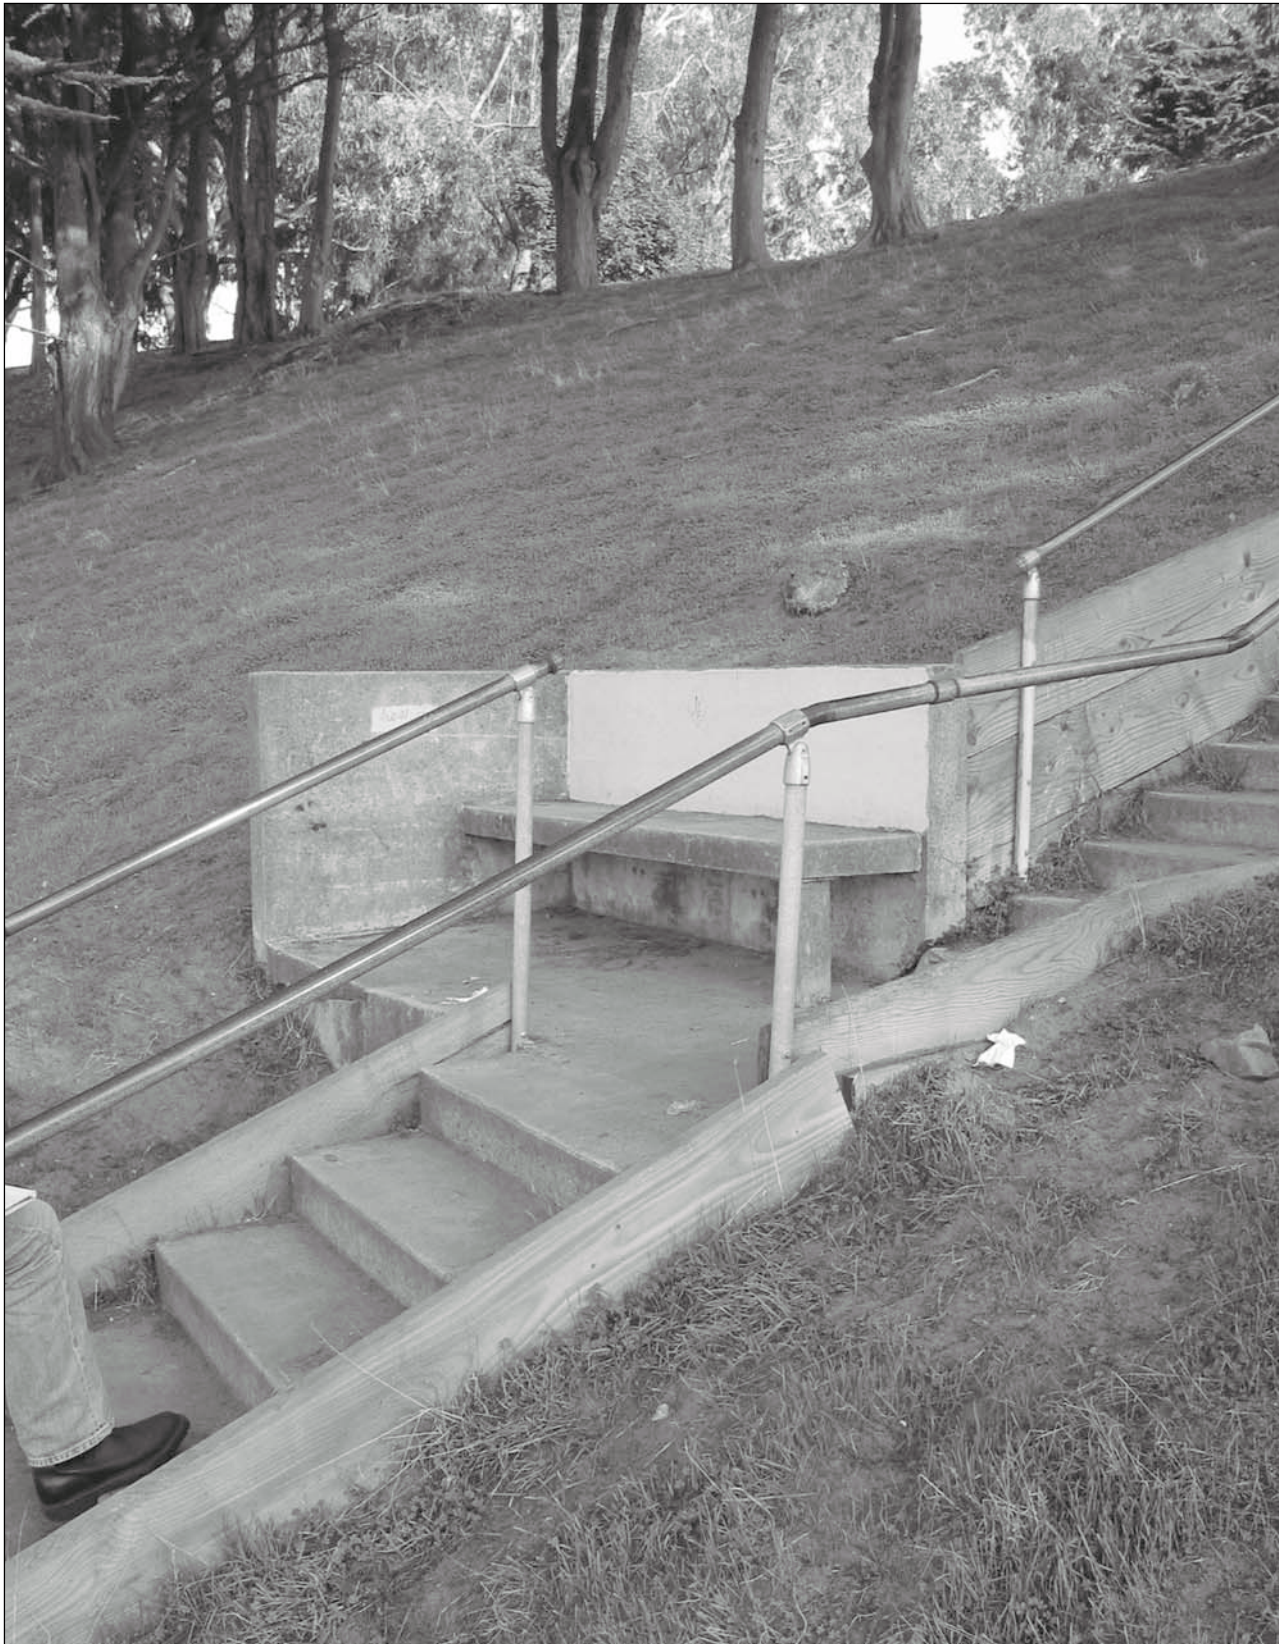
**Figure 5.7.2:** Stairs between Upper and Lower Fort Mason, (FM - 408). This set of stairs was built in 1938 replacing an earlier set of stairs first appearing on 1922 maps of the post. Contributing. Safety railings and wooden cribbing are non-historic. 12/02 - OCLP.

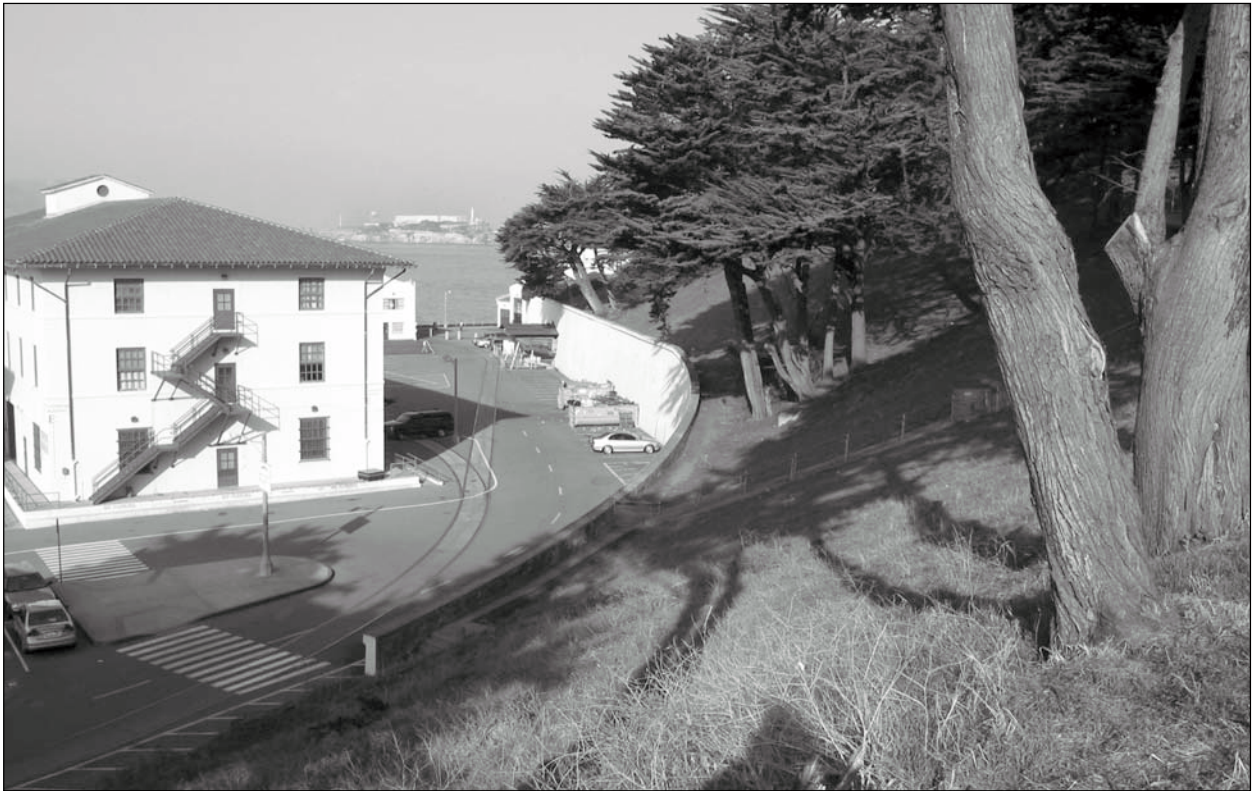
**Figure 5.7.3:** Turf. Cultivated turf grasses were used historically to stabilize the steep engineered slope of the Northwest Embankment landscape character area. Contributing. 12/02 - OCLP.

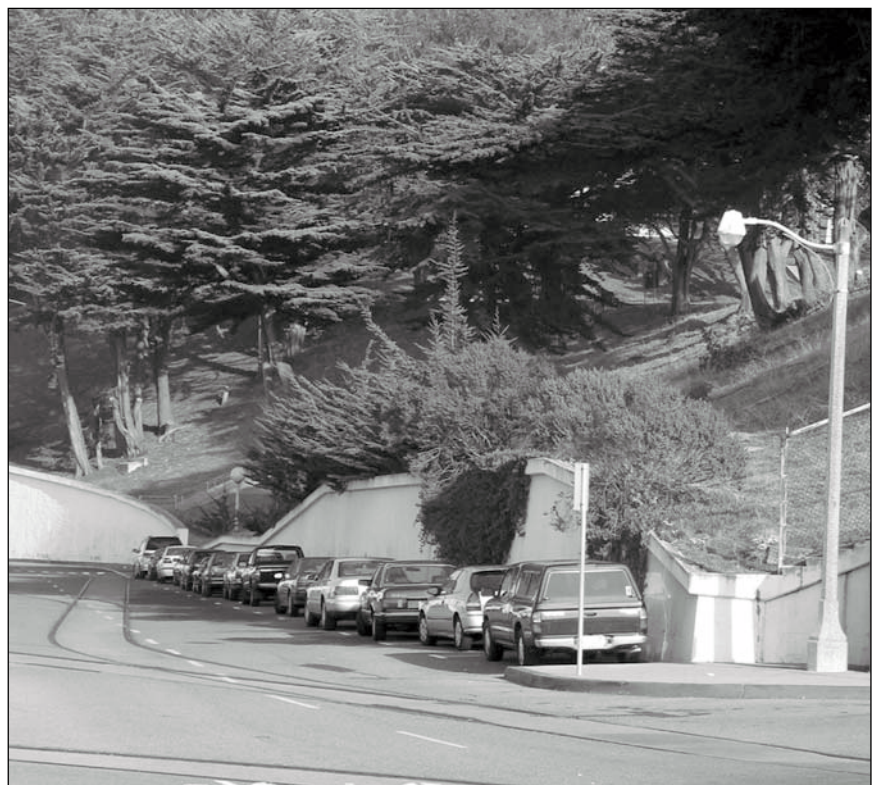
**Figure 5.7.4:** Monterey Cypress. The Monterey Cypress planted at the top of the embankment and in straight rows at right angles to the slope were intended to break the force of the westerly winds, while permitting views into Lower Fort Mason from Upper Fort Mason. Contributing. Young cypress found at the bottom of the slope are non-contributing. 12/02 - OCLP.

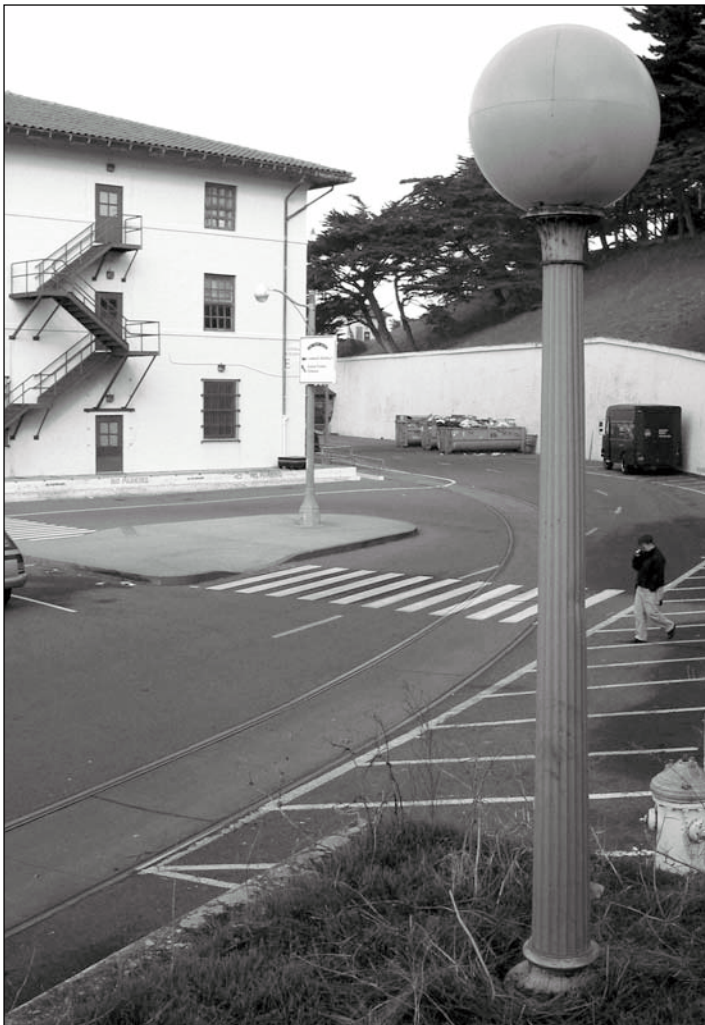
**Figure 5.7.6:** Union Metallic Lamp Standard Company Lightposts. These fixtures, installed c.1935, were once found throughout Fort Mason. They currently survive only as remnant features found within the narrow confines of the Northwest Embankment landscape character area. Contributing. Plastic replacement globes are non-historic - and larger than those found on the original fixtures. 12/02 - OCLP.

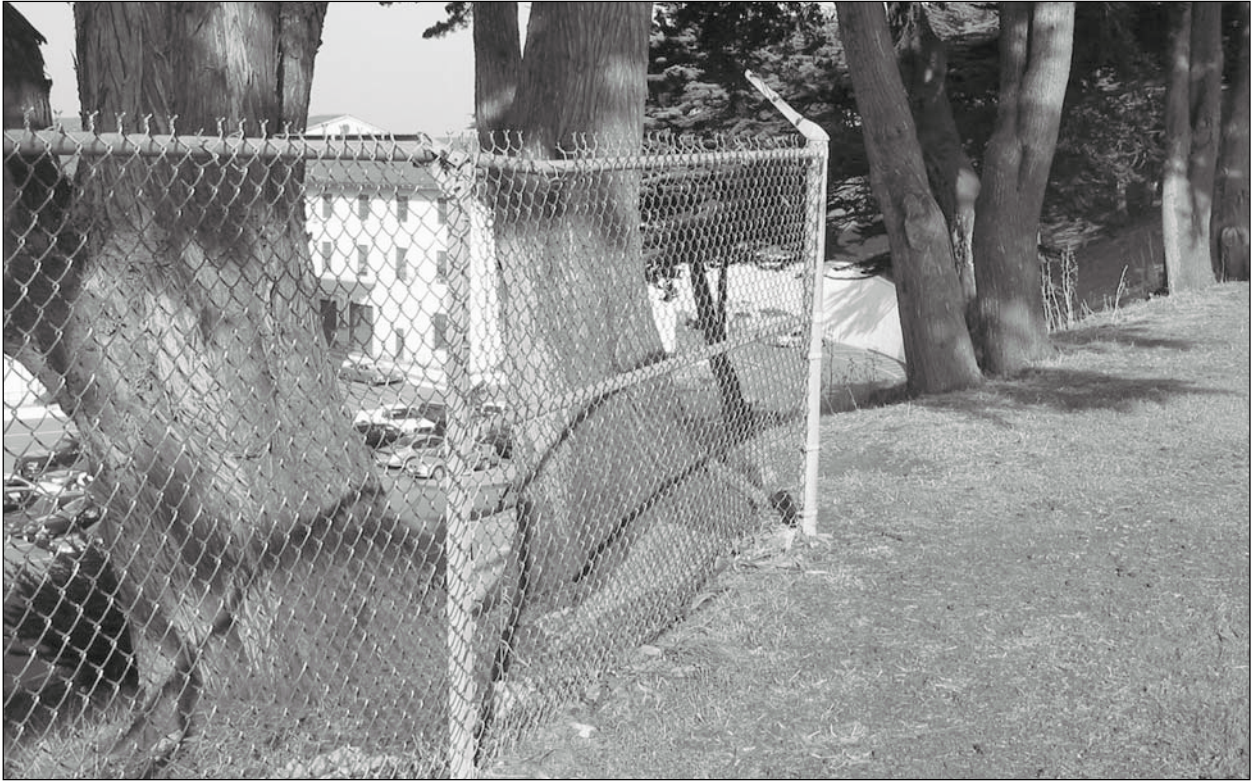
*Figure 5.7.7: Chain-link Fencing at Top of Slope. While Fort Mason was largely considered an “open” post for much of its history, access was more restricted to Lower Fort Mason. The fence fragment shown here is part of a fence that once ran the entire length of the top of the Northwest Embankment. Contributing. 12/02 - OCLP.*

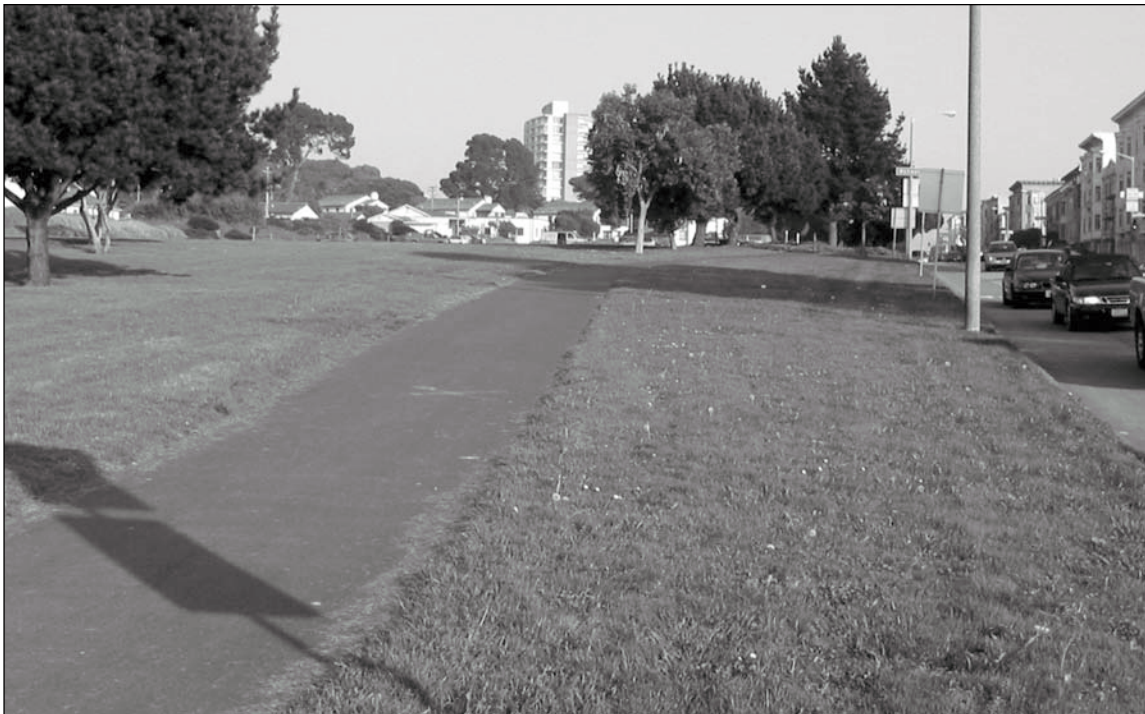
**Figure 5.8.3:** *Street Trees North Side of Bay Street.* The row of street trees on the north side of Bay Street survives, although with a significant gap toward the south side of the Great Meadow area as shown. Contributing. 12/02 - OCLP.

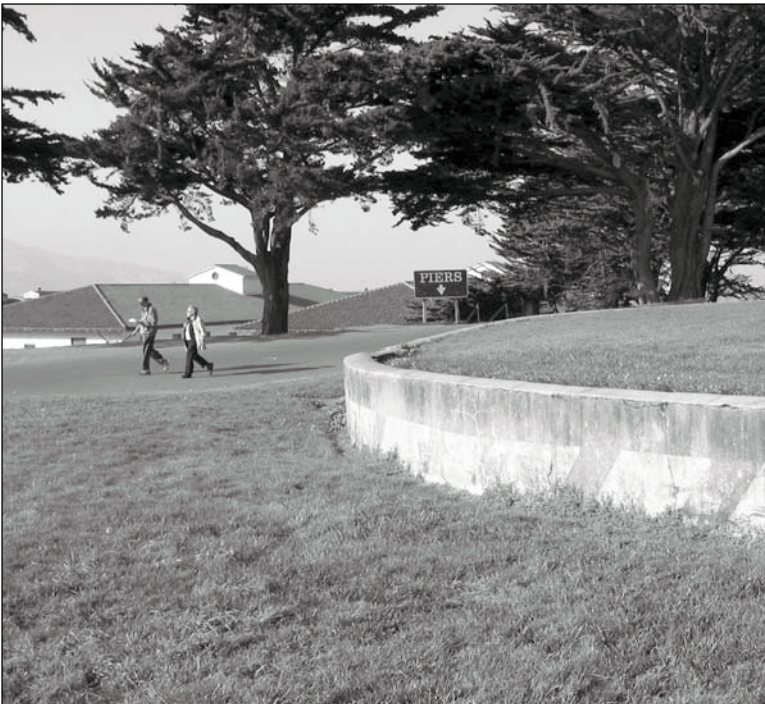
**Figure 5.8.7:** Curved Concrete Retaining Wall. This low concrete retaining wall first appears in photographs of Fort Mason in 1921. It marks the former intersection of McDowell Avenue and Scholfield Road. Contributing. 12/02 - OCLP

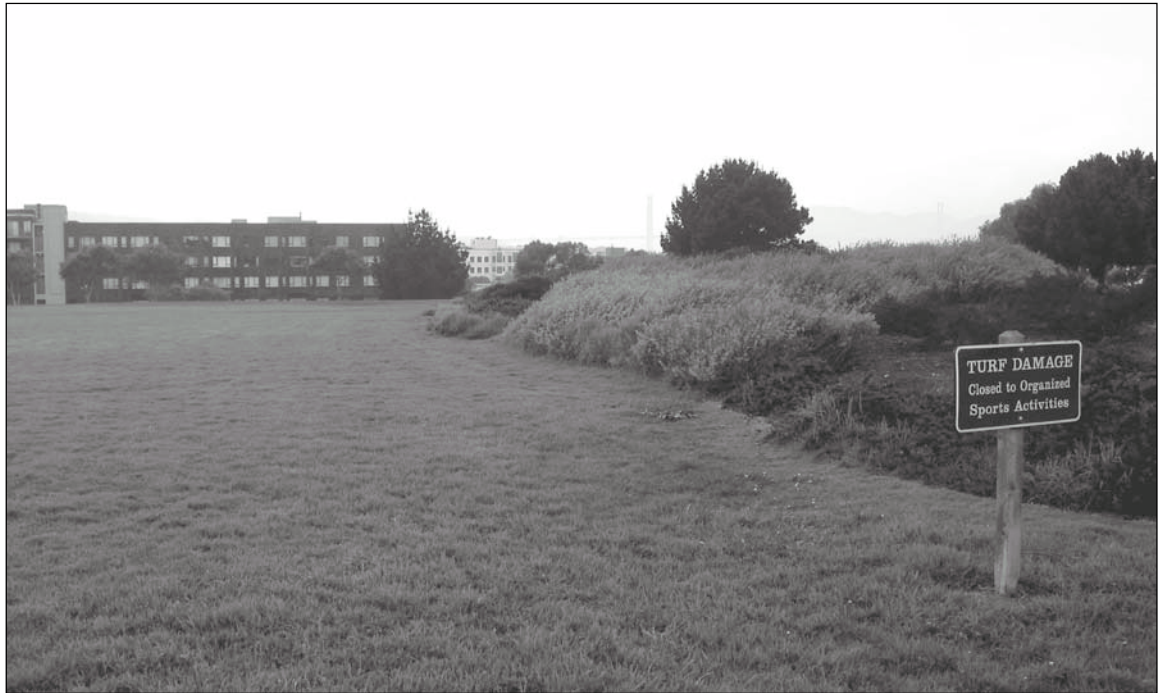
**Figure 5.8.8:** *Planted Berms and Designed Topographic Undulations. These berms, planted with native vegetation, were introduced by the NPS as part of the development of the Great Meadow greenspace at Fort Mason. Non-contributing. 12/02 - OCLP.*

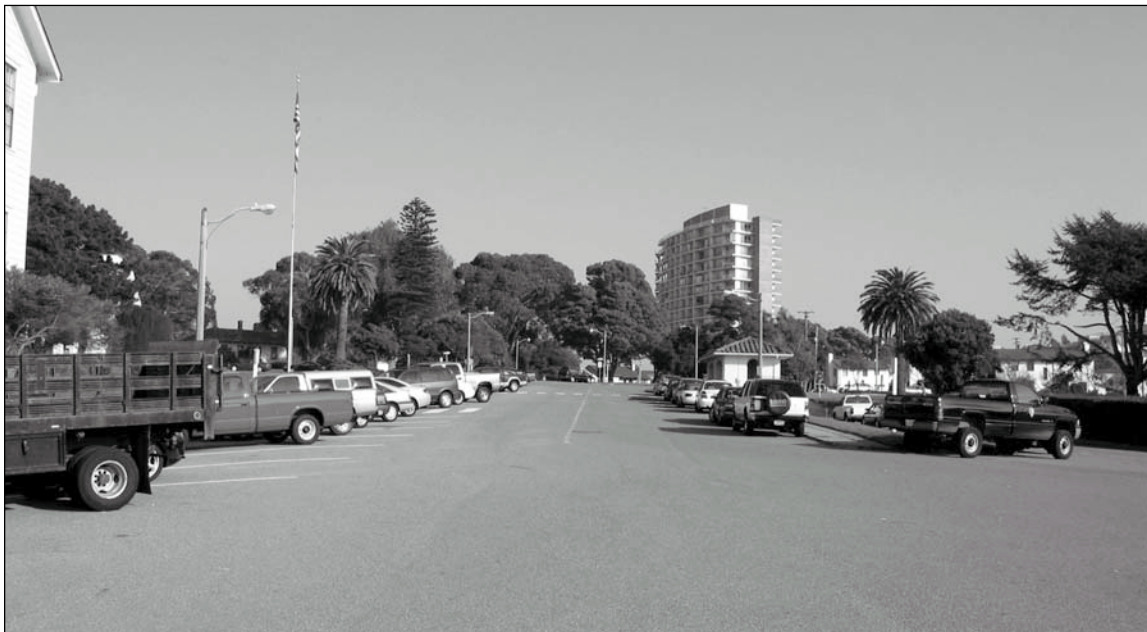
**Figure 5.9.2:** *MacArthur Avenue. This east-west road was constructed in 1914 by the proprietors of the Panama-Pacific International Exposition and once featured a streetcar line within its median strip. Contributing. 12/02 - OCLP.*

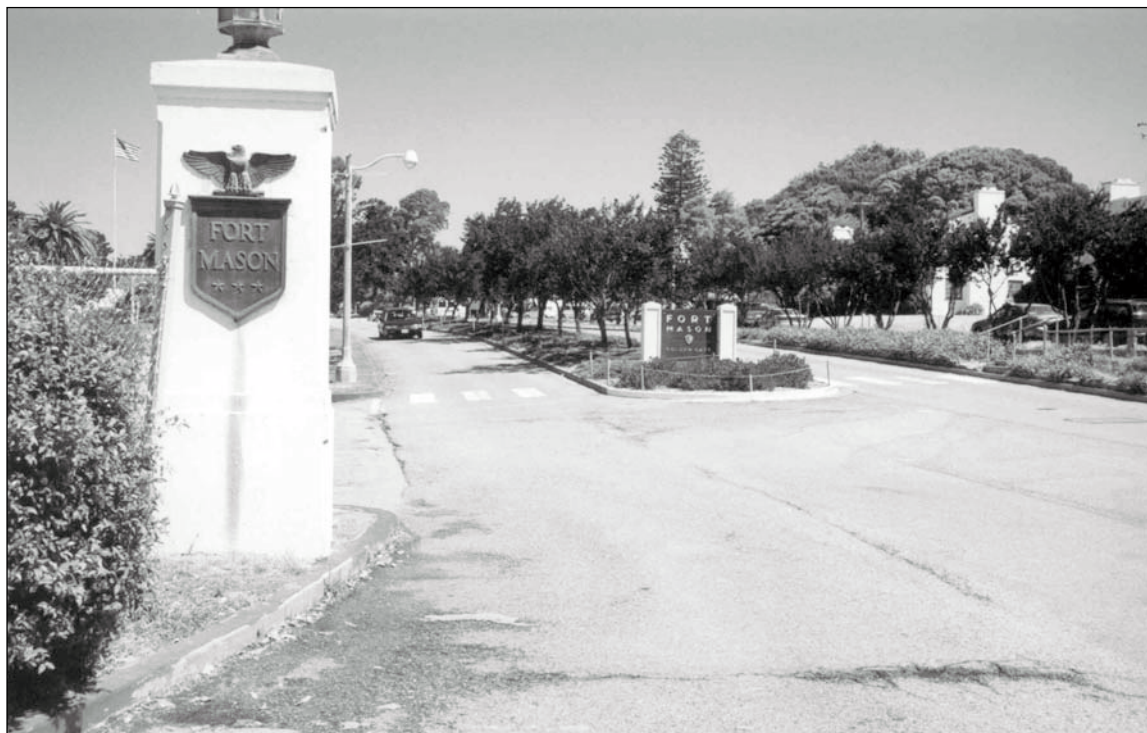
**Figure 5.9.3:** *Franklin Street Extension, (section between Bay Street and MacArthur Avenue). This section of road was constructed between 1944 and 1947 as an improvement to an entrance in the same location. Contributing. The center median was added by the NPS in 1974. 7/02 - OCLP.*

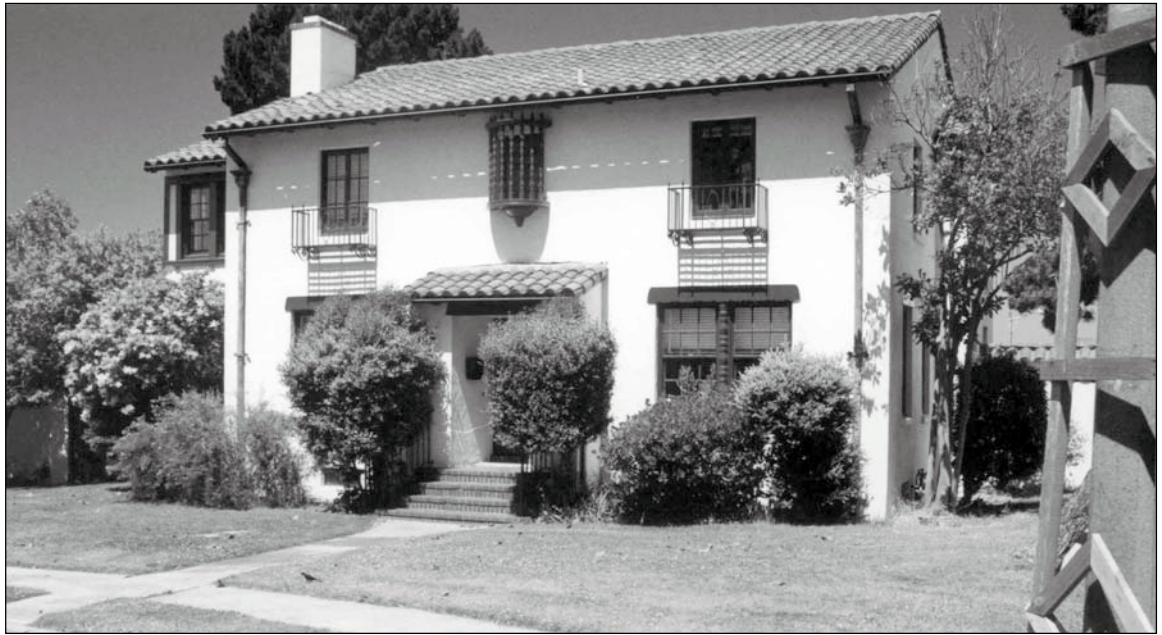
**Figure 5.9.4:** Foundation Plantings - Officers' Park. The plant materials found within the foundation plantings are extremely overgrown. It is likely that many individual plants date to Fort Mason's period of significance. Foundation plantings throughout the property require further inventory and analysis. As shown above, pruning by a trained horticulturist is also needed. Requires further evaluation. 7/02 - OCLP.

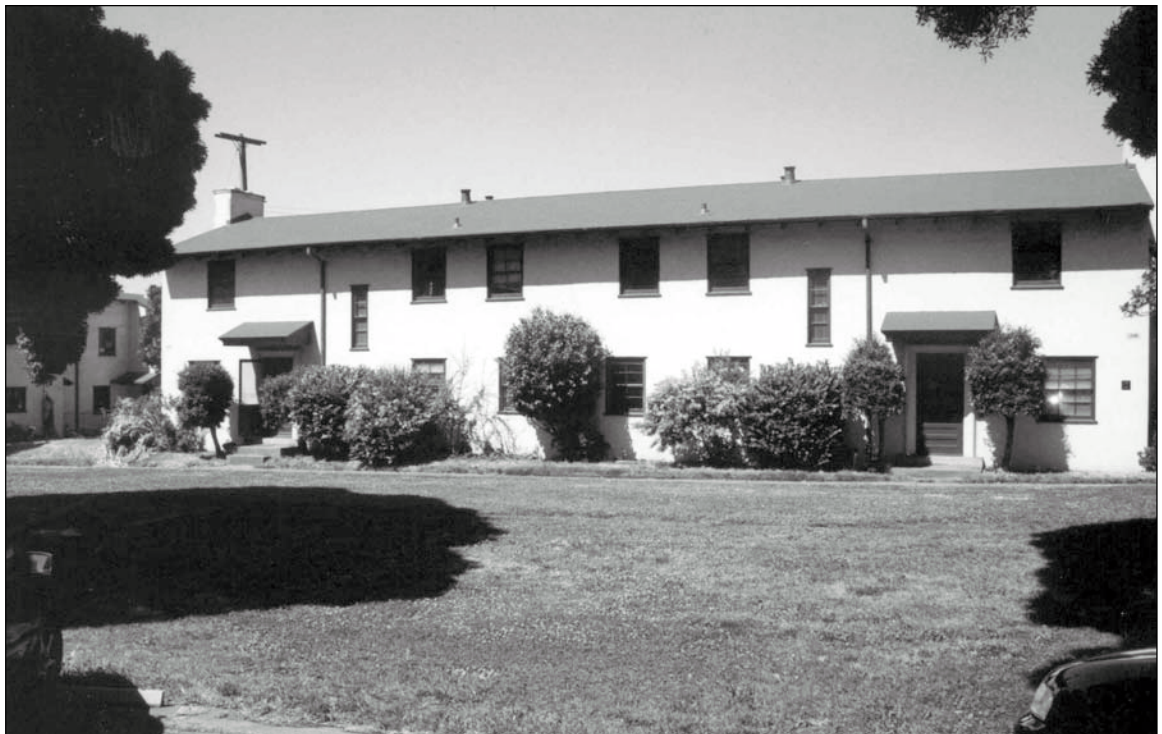
**Figure 5.9.5:** Foundation Plantings - the "Quad." Foundation plantings are consistently overgrown in the "Quad" portion of the South Expansion landscape character area. Requires further evaluation. 7/02 - OCLP.

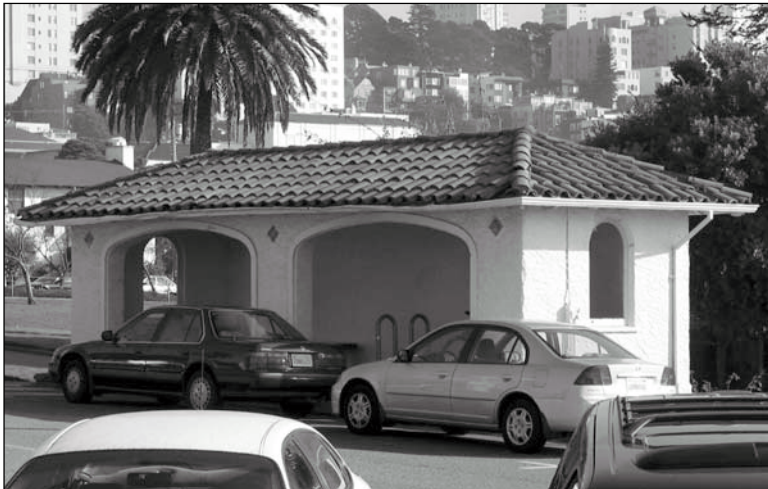
**Figure 5.9.6:** *Streetcar Waiting Station, (FM - 40). This small building was originally constructed in 1914, and subsequently remodeled by the Army in 1928. Contributing. 12/02 - OCLP.*

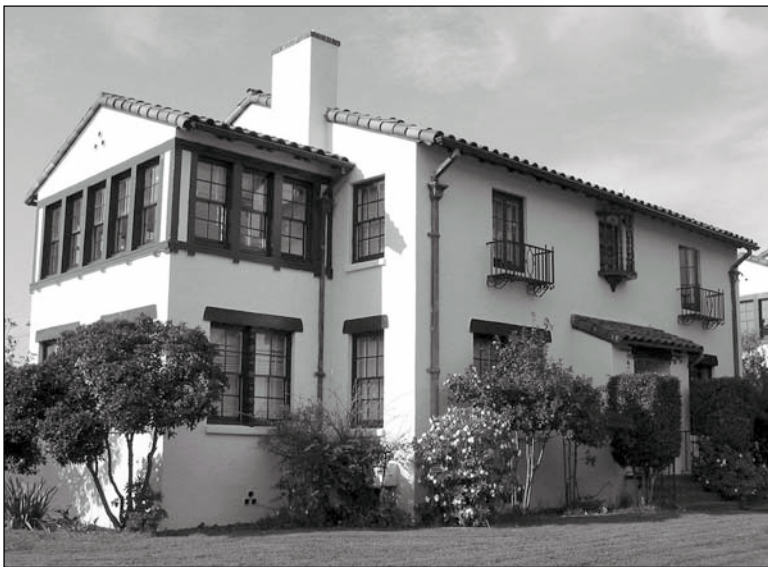
**Figure 5.9.7:** *Officers' Park Housing Complex, (buildings FM - 41 through 44 and 46 through 49). This housing complex was completed in 1934. Contributing. 12/02 - OCLP.*

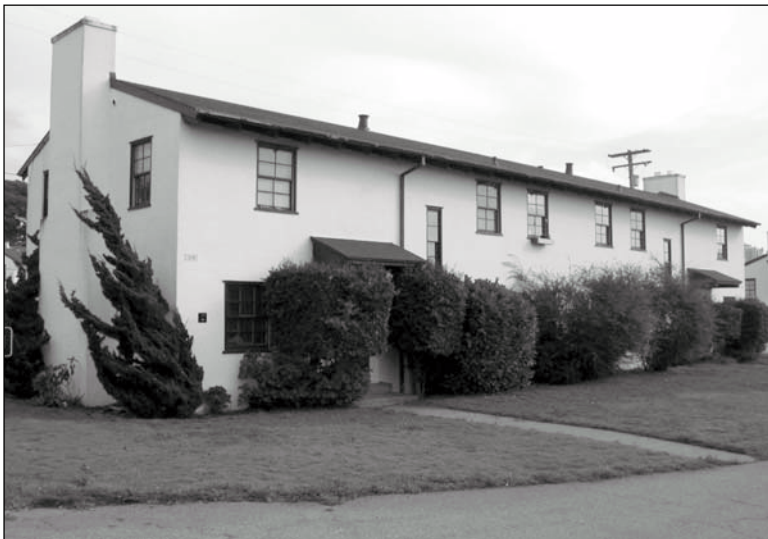
**Figure 5.9.8:** *The "Quad," Capehart-Wherry Housing Complex, (buildings FM - 32 through 39). This complex of eight duplex quarters and central laundry was constructed sometime between 1947 and 1953. Contributing. 12/02 - OCLP.*
