# CULTURAL LANDSCAPE REPORT FOR FORT MASON GOLDEN GATE NATIONAL RECREATION AREA

Volume One: Site History, Existing Conditions and Analysis

Prepared by:  
Amy Hoke, Historical Landscape Architect  
National Park Service  
Pacific West Region  
Seattle, Washington

September 2004

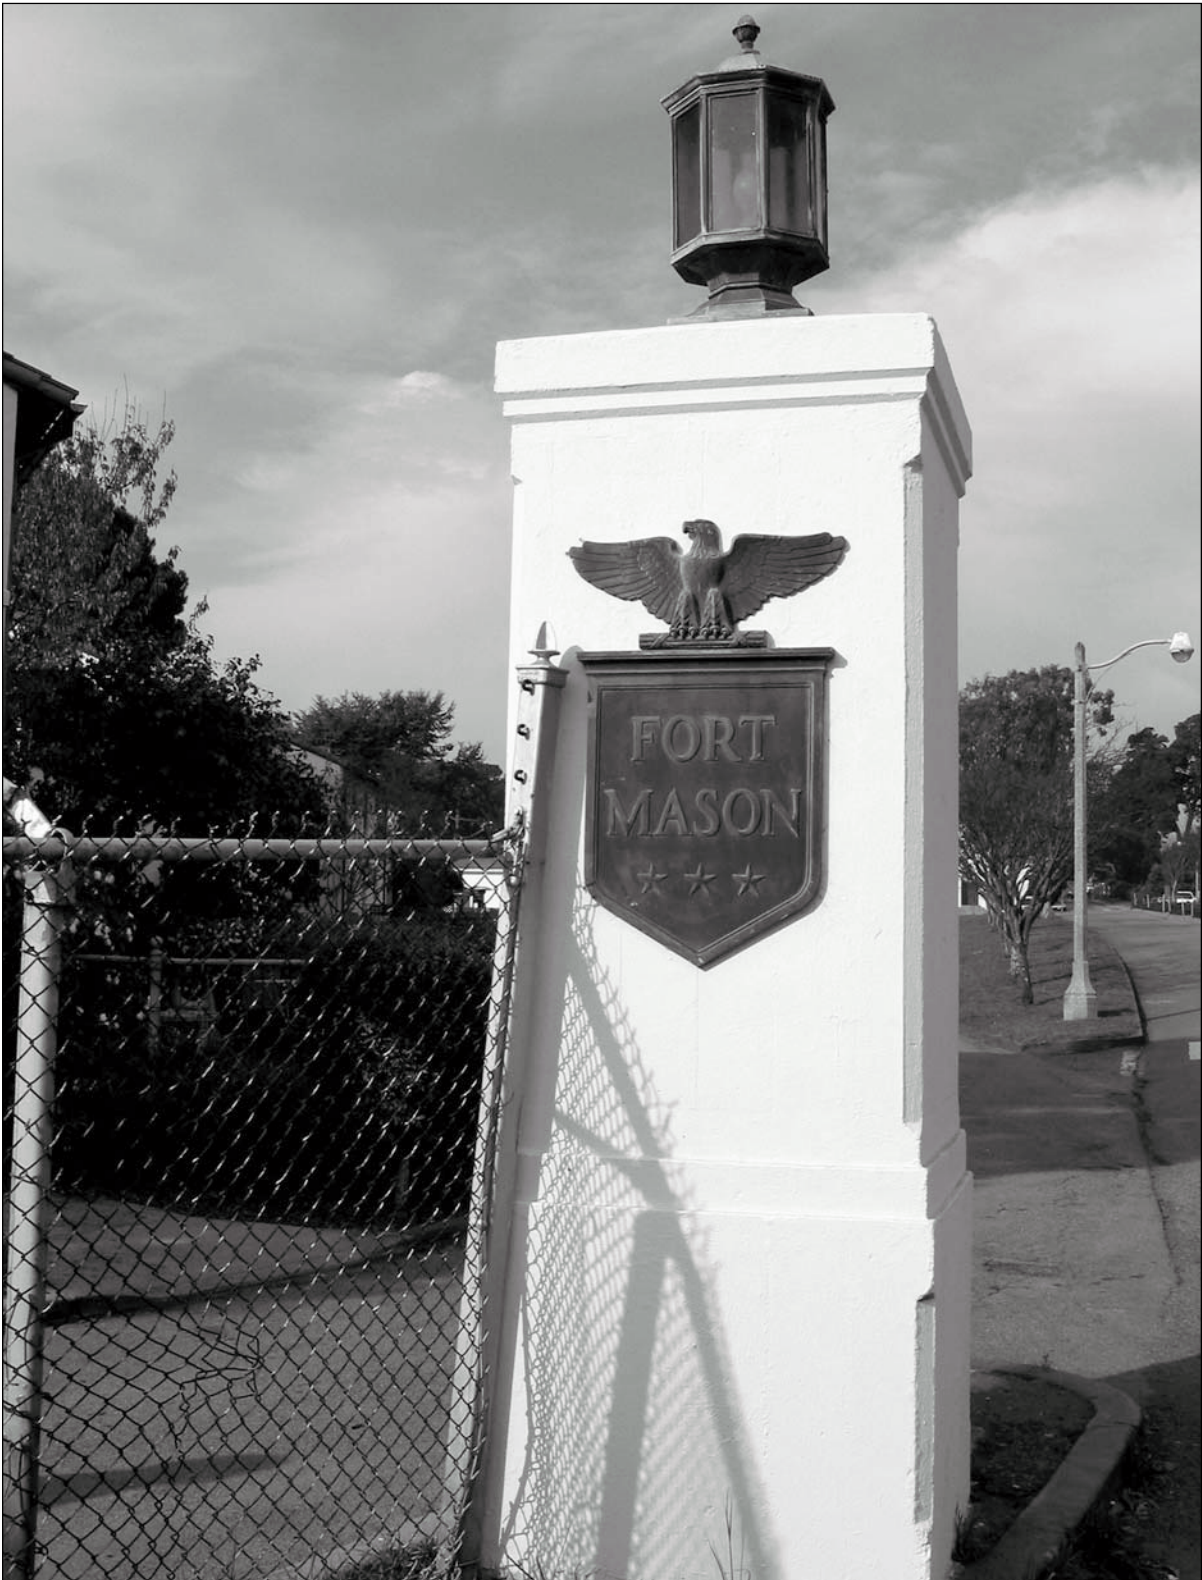
**Figure 5.9.9:** *Franklin Street Entrance Gate Pillars, (FM - 19). These gate features were constructed c1944-1947, contemporary with the construction of the Franklin Street extension. The bronze plaques bearing the words “Fort Mason,” accompanied by three stars, were formerly mounted on the post gate at the corner of Bay Street and Van Ness Avenue. Contributing. 12/02 - OCLP.*

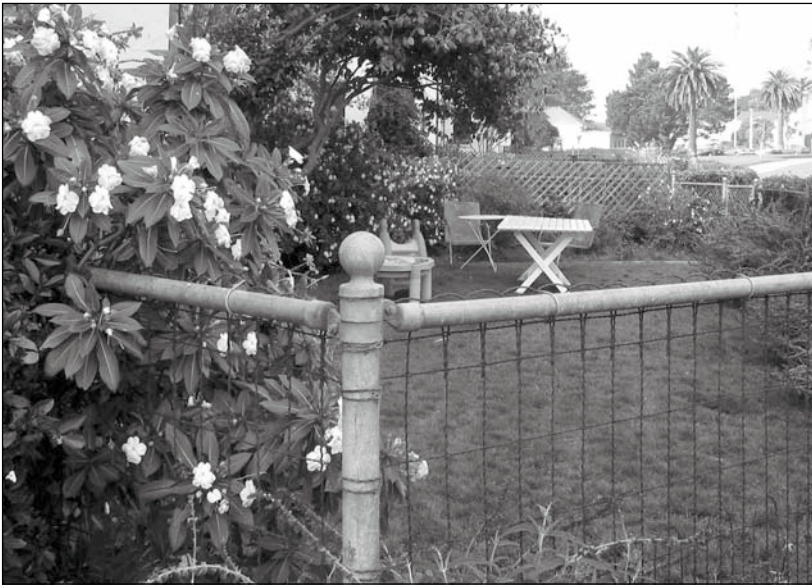
**Figure 5.9.10:** Woven-wire Domestic Fencing - Officers' Park. Contributing. 12/02 - OCLP.

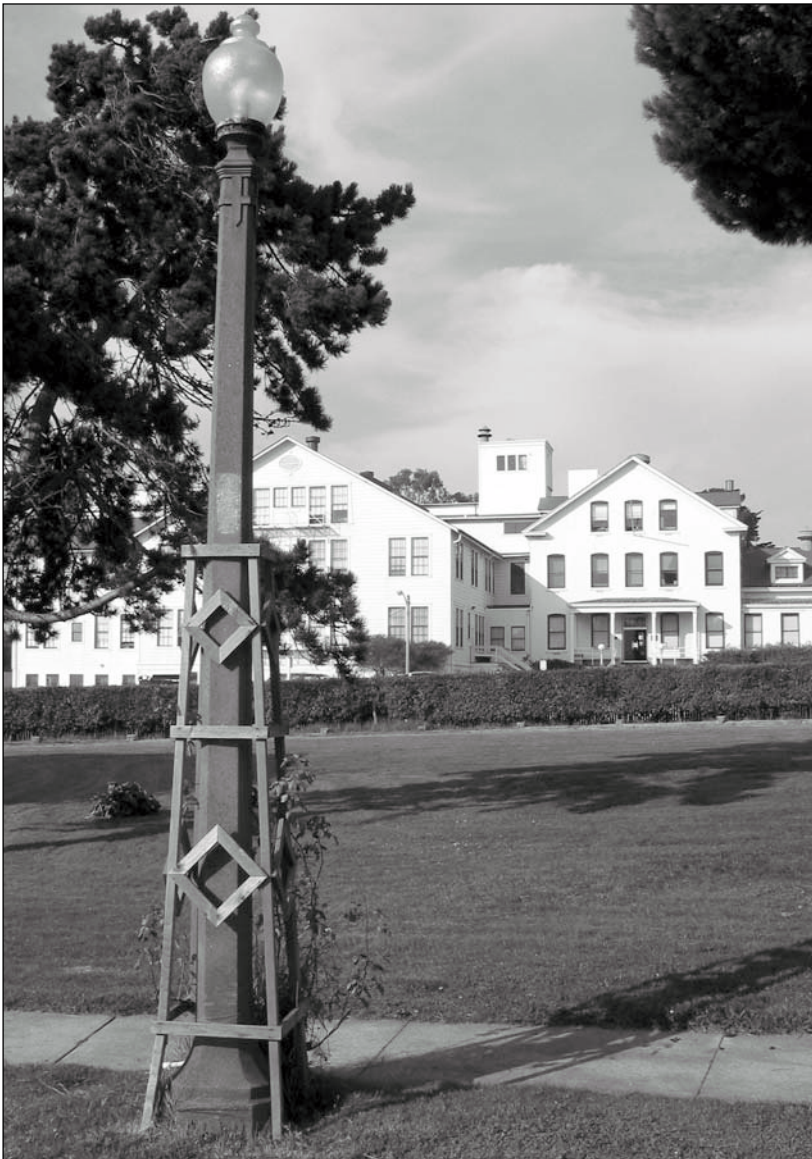
**Figure 5.9.11:** Cast-concrete Lightpoles - Officers' Park. Contributing. Neither the plastic replacement globes or the lattice vine supports are historic. 12/02 - OCLP.

Historic Condition: The date of appearance of hollow cast concrete light poles at Fort Mason is undetermined. However a review of period photography suggests that they were installed following the end of WWII.

Existing Condition: Light grey exposed aggregate concrete light poles are in good condition throughout the site. The light poles are unremarkable in character and consist of a single "cobra head" luminaire supported by a single "s" curved metal arm and a "c" curved metal brace. Approximately twenty-five feet in height.

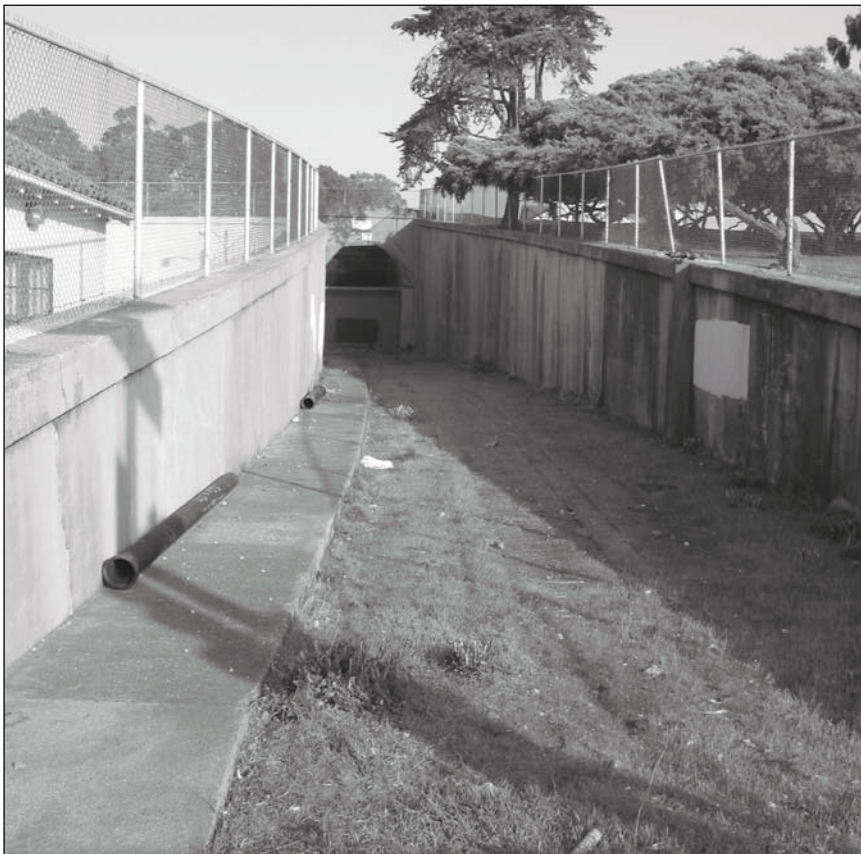
**Figure 5.10.3:** West Portal - Railroad Tunnel, (FM - 300). Constructed 1914. Contributing. 12/02 - OCLP.

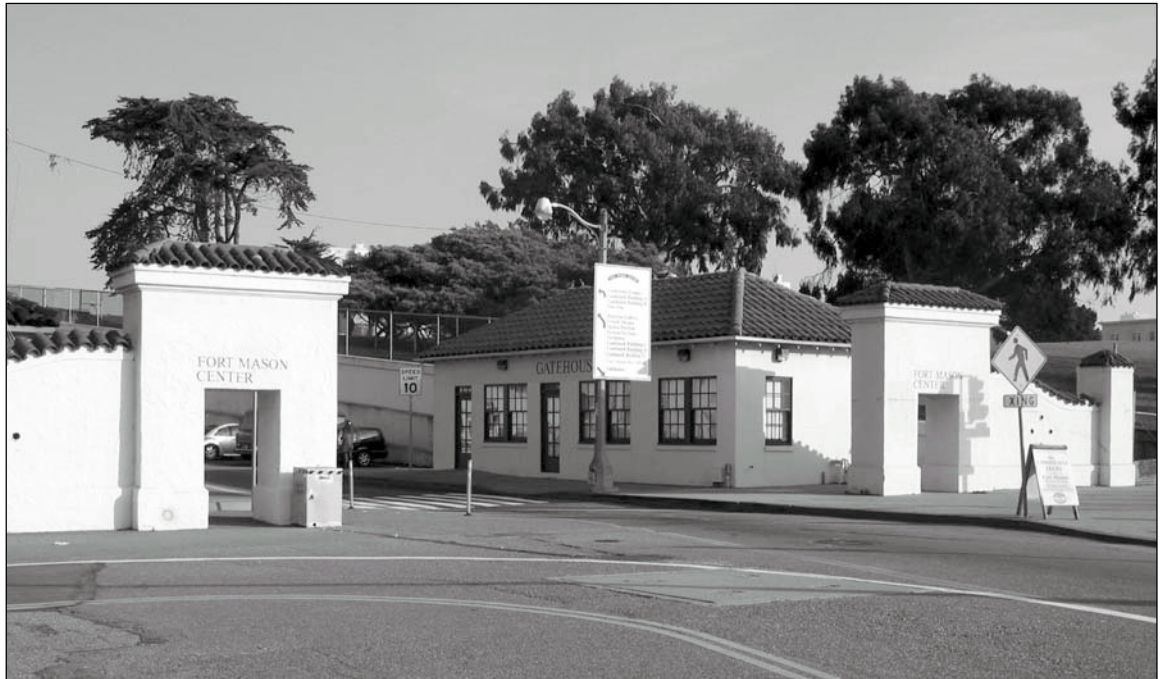
**Figure 5.10.4:** Lower Entrance Gate (FM - 301). This gateway into Lower Fort Mason was constructed c.1926, controlling access into what was once the Army's second largest shipping and logistical center. Contributing. 12/02 - OCLP.

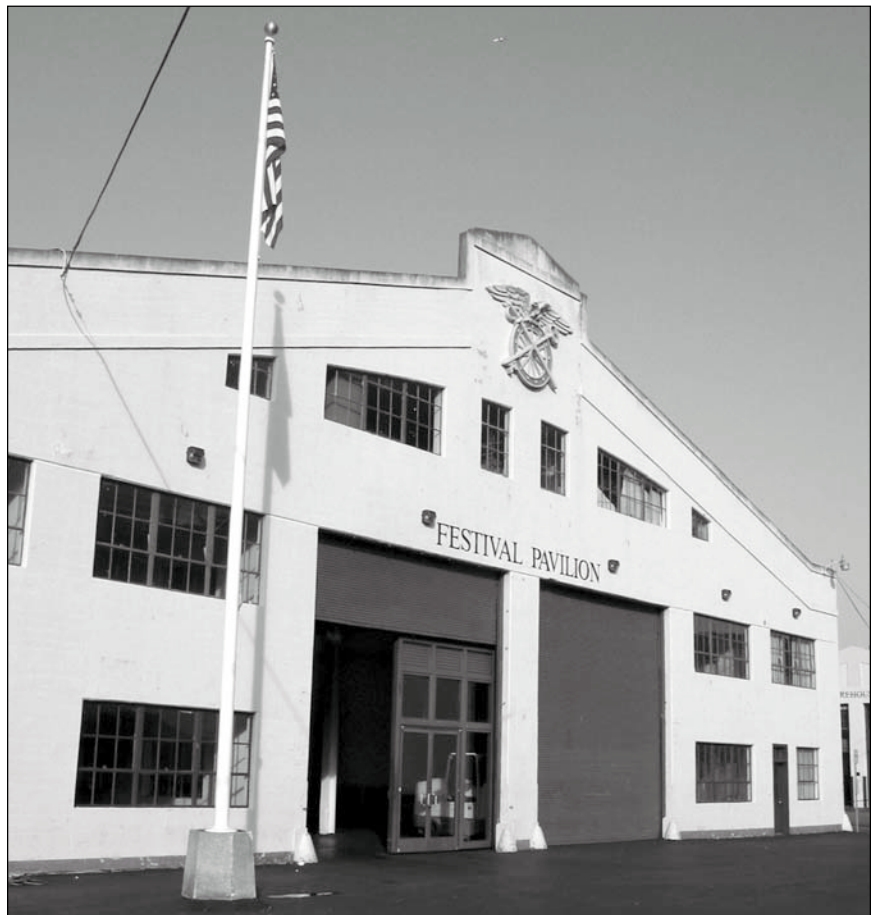
**Figure 5.10.5:** Pier and Pier Shed #3, (FM - 320 and FM - 321). Constructed in 1912, the pier and the pier shed were extended northward in 1933. Contributing. 12/02 - OCLP.

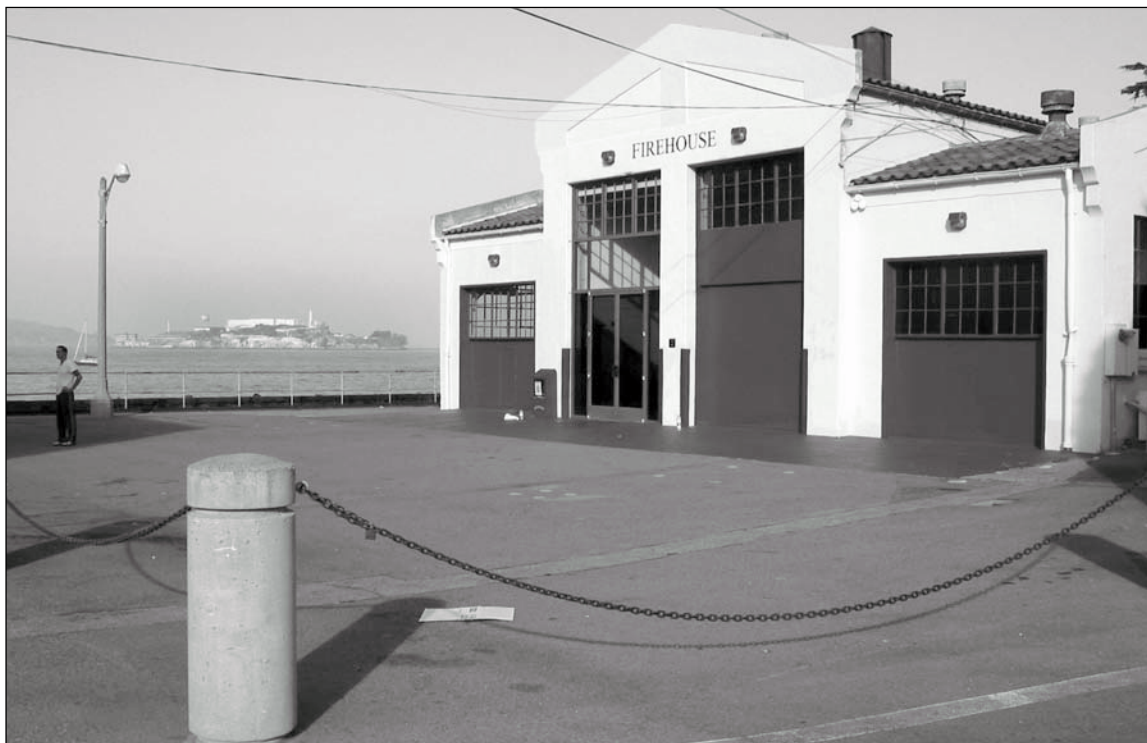
**Figure 5.10.6:** Firehouse - Formerly Battery Charging Station, (FM - 322). This building was constructed in 1935. Contributing. Concrete traffic-control bollards and chains are found throughout Lower Fort Mason. These are non-contributing. 12/02 - OCLP.

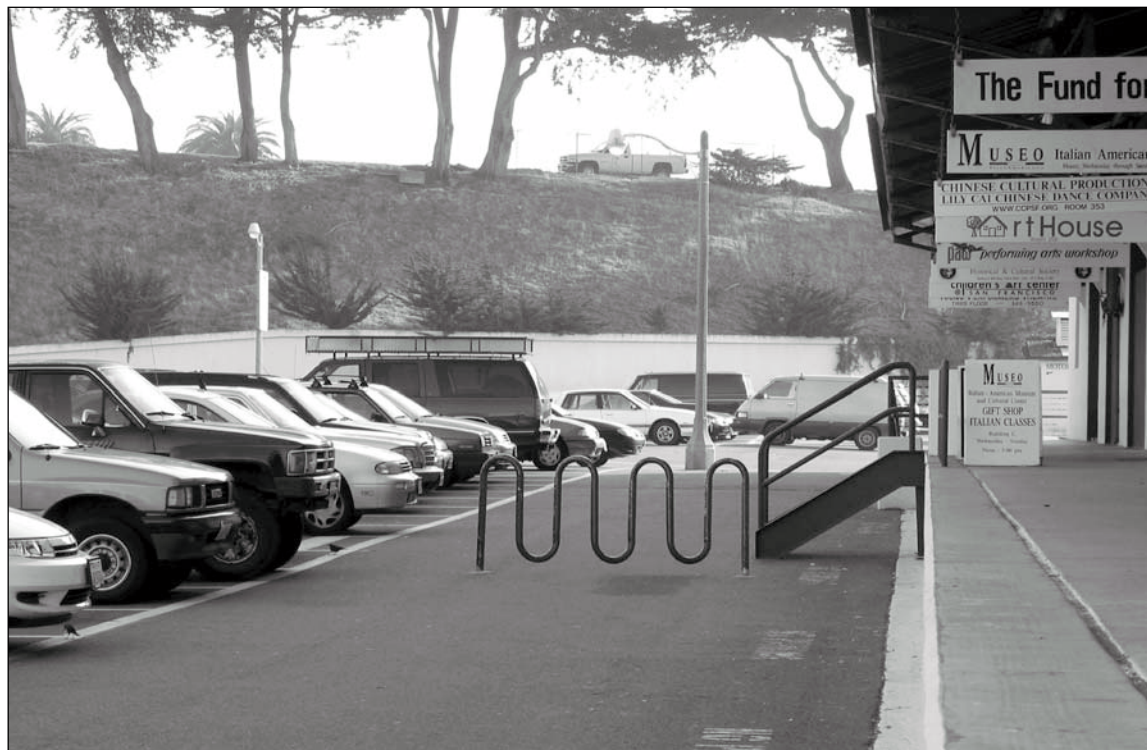
**Figure 5.10.7:** Bicycle Racks. Features such as this were installed during the 1970s and 1980s to facilitate the re-use of Lower Fort Mason as a cultural center. Non-contributing. Also note the tenant signage on the building. Non-contributing. 12/02 - OCLP.

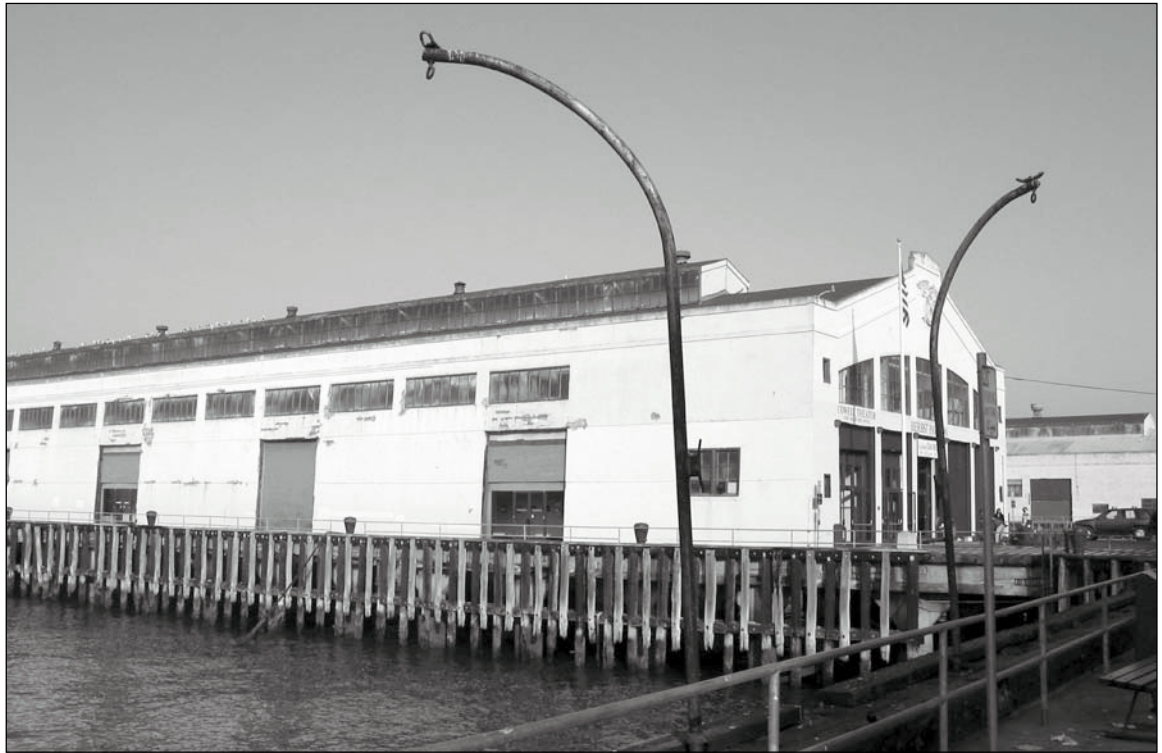
**Figure 5.10.8:** When found in pairs, small hoists such as this are known as “davits.” These are used to move small boats in and out of the water. This pair of davits is in poor condition and is likely to date to the period of significance. Contributing. Pier #2 and Pier Shed #2 are shown in the background. 12/02 - OCLP.

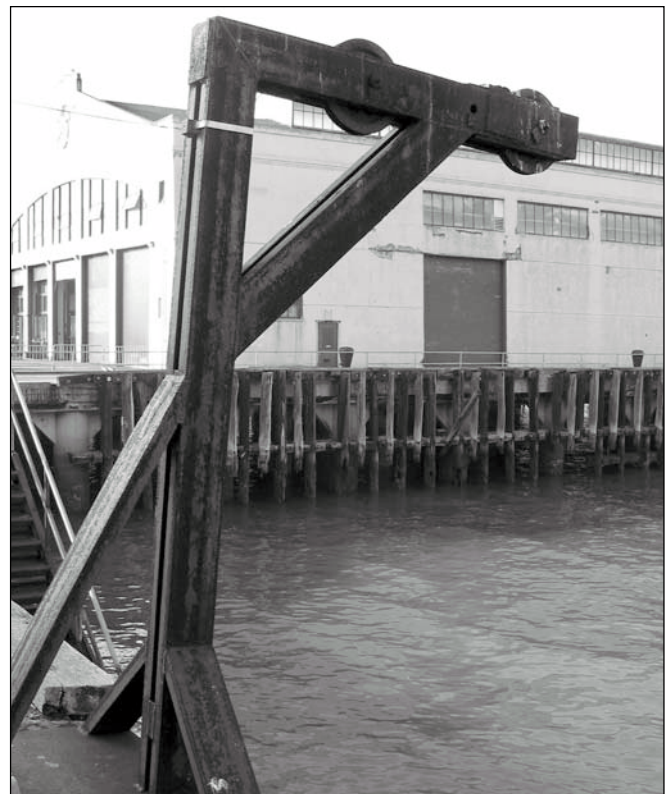
**Figure 5.10.9:** When found singly and mounted as shown, hoists such as this were used for loading and unloading heavy or awkward cargoes onto small craft. This particular fixture is said to have served the launch to Alcatraz between 1961 and 1963. Contributing. 12/02 - OCLP.

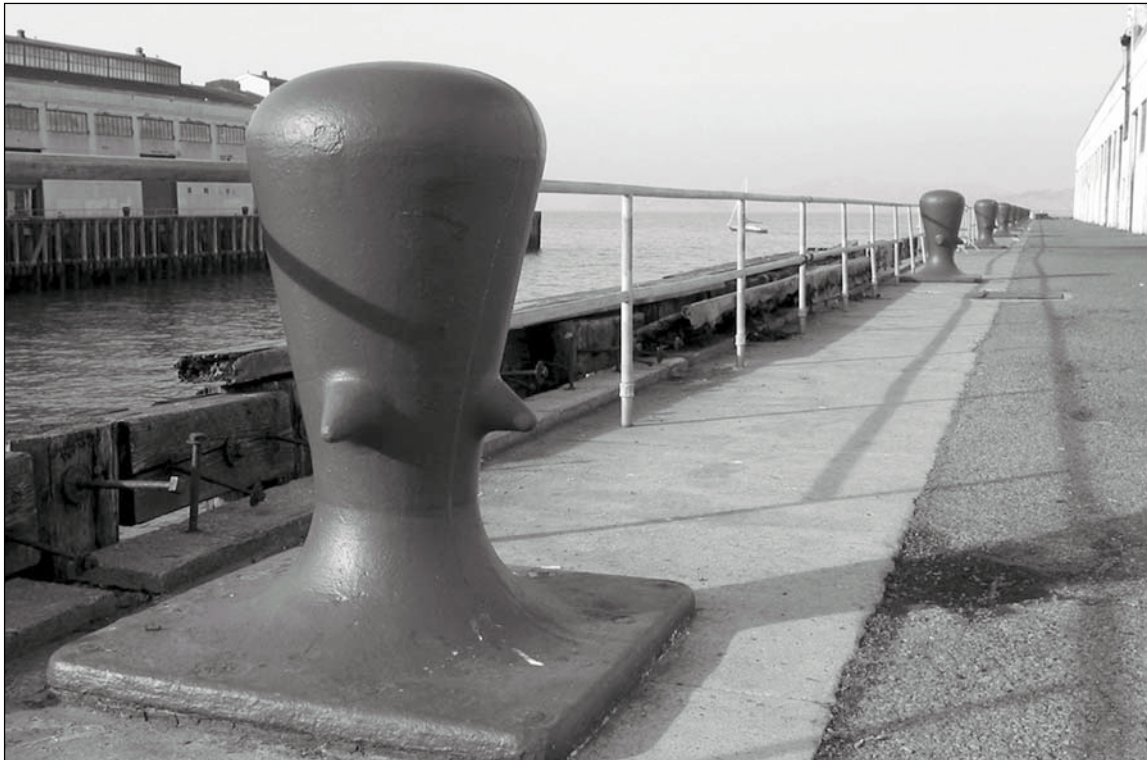
**Figure 5.10.10:** *Mooring Bollards. Large marine bollards such as this were once used to moor large ocean-going ships. Contributing. 12/02 - OCLP.*

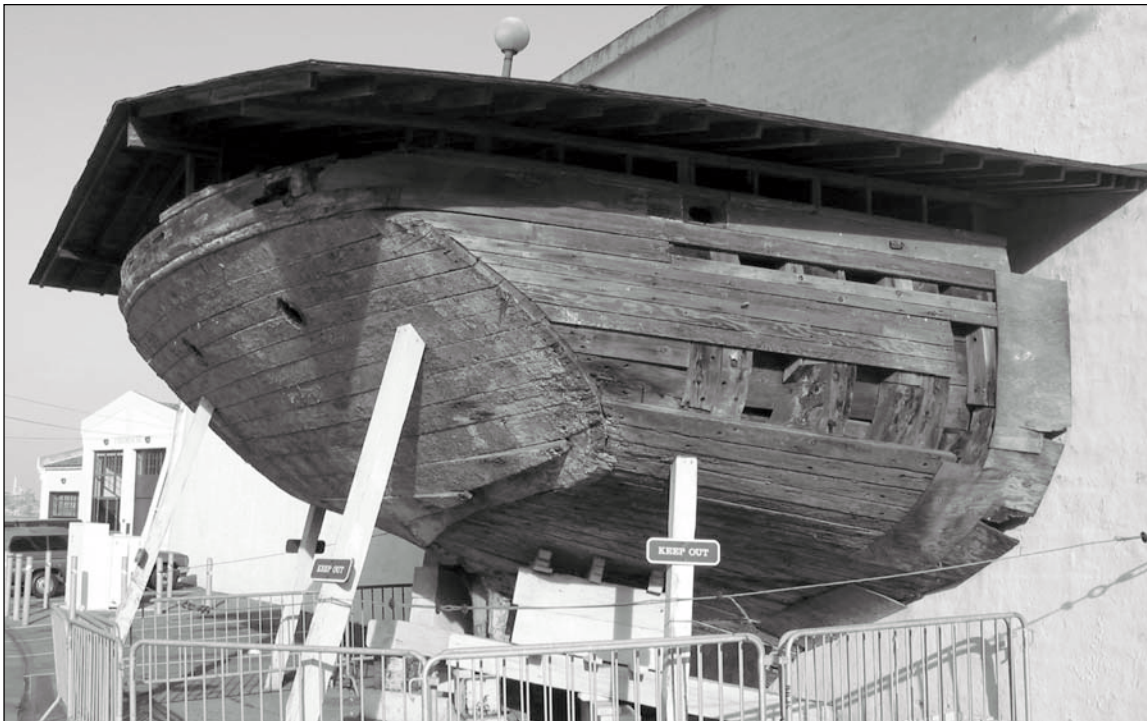
**Figure 5.10.11:** *Sailing Ship Fragment. This ship's stern is from the "Galilee," a packet ship that once ran between San Francisco and Tahiti. The vessel was built in Benicia, California by Captain Matthew Turner. The stern was moved to Fort Mason from Sausalito c.1975. Non-contributing. 12/02 - OCLP.*

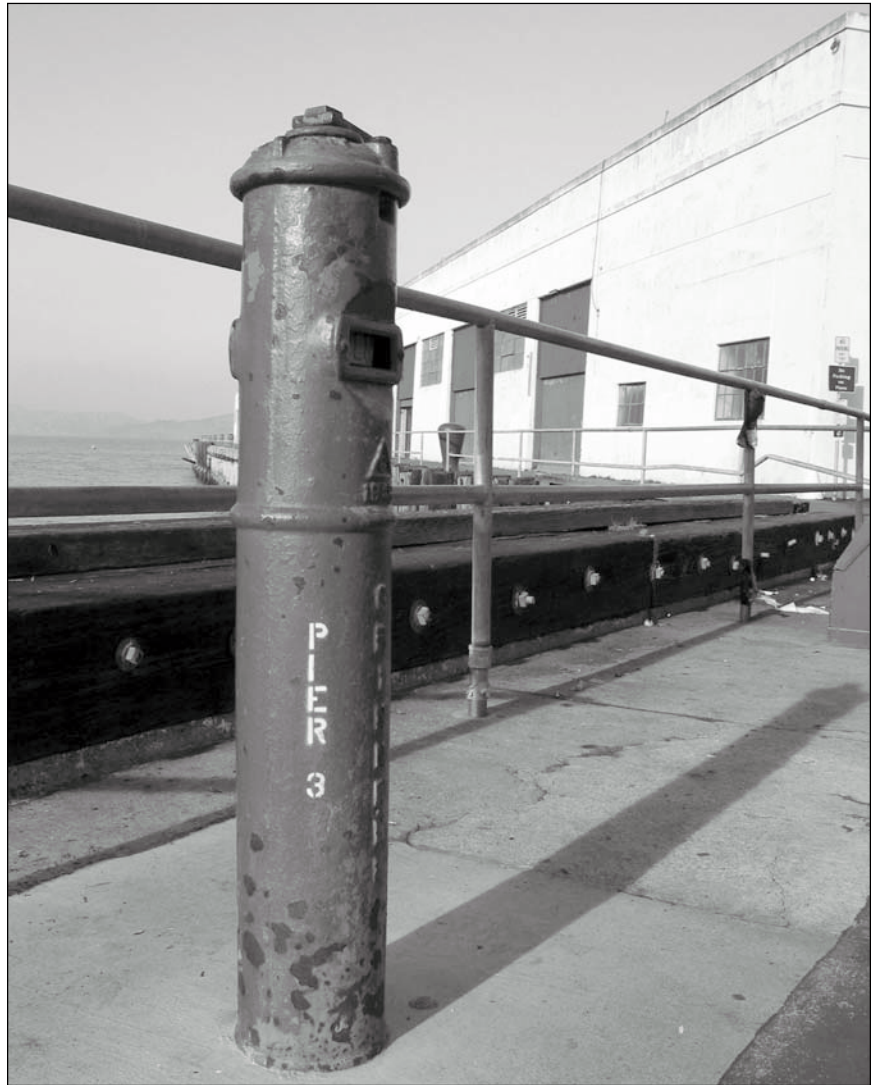
**Figure 5.10.12:** *Waterfront Safety Railings and Fire Hydrant. Metal railings were added to the piers at Lower Fort Mason after it had ceased to serve as a working waterfront. Non-contributing. The fire hydrant fixture also shown above is recommended for contributing status, however this may require further evaluation. 12/02 - OCLP.*
