THE BAKER RANCH

GLEN CANYON
NATIONAL RECREATION AREA

A HISTORY

JANUARY 1, 1970

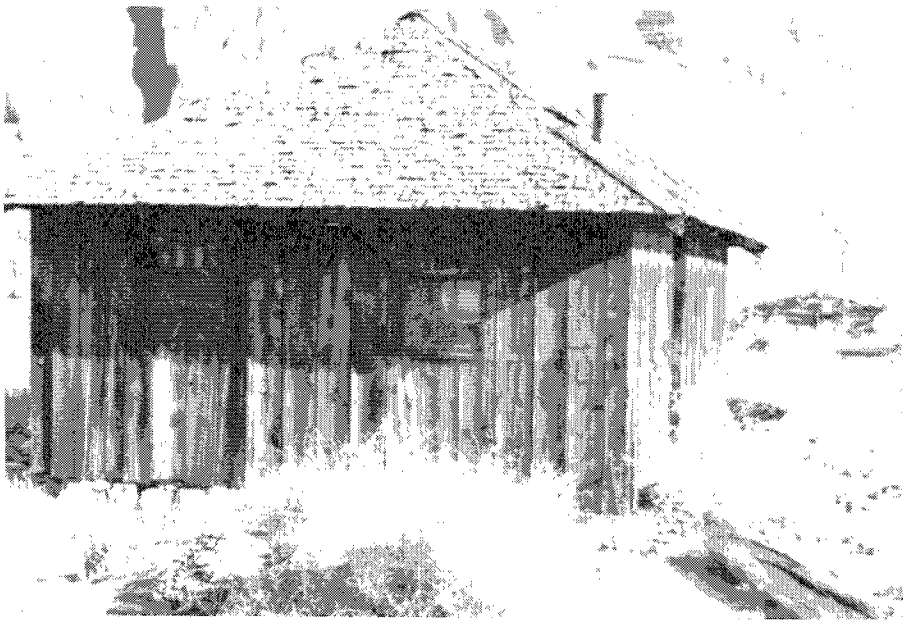
7 A. Rear of the Main House

The washpan hanging in the window gives evidence that the house was used until recent times. Inside the structure is additional evidence of its use as an overnight camping stop: several jars of matches, a hat hung by a wire from a rafter to protect it from mice, and a 1964 Chevrolet Truck catalogue.

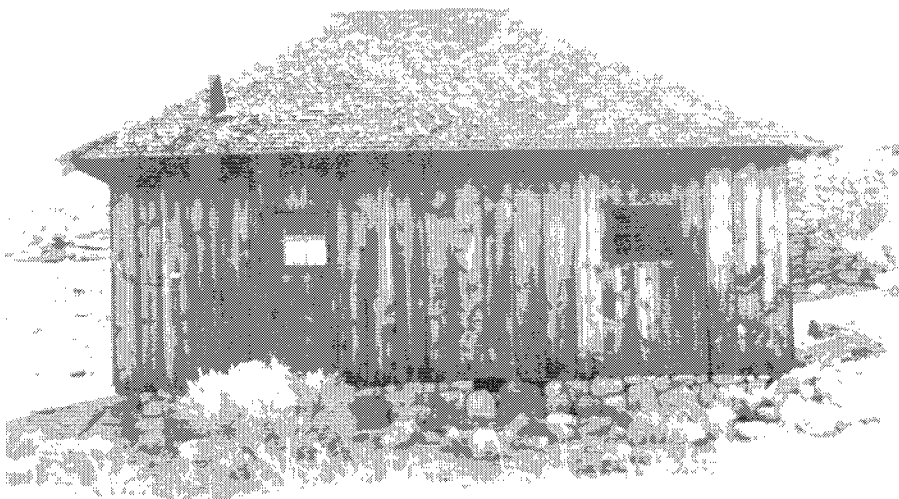
7 B. Side of Baker Ranch House

To the left of the house can be seen part of the blacksmith shop. On the right a portion of the storage cellar is visible. Note especially the size of the planks used in building the structure.

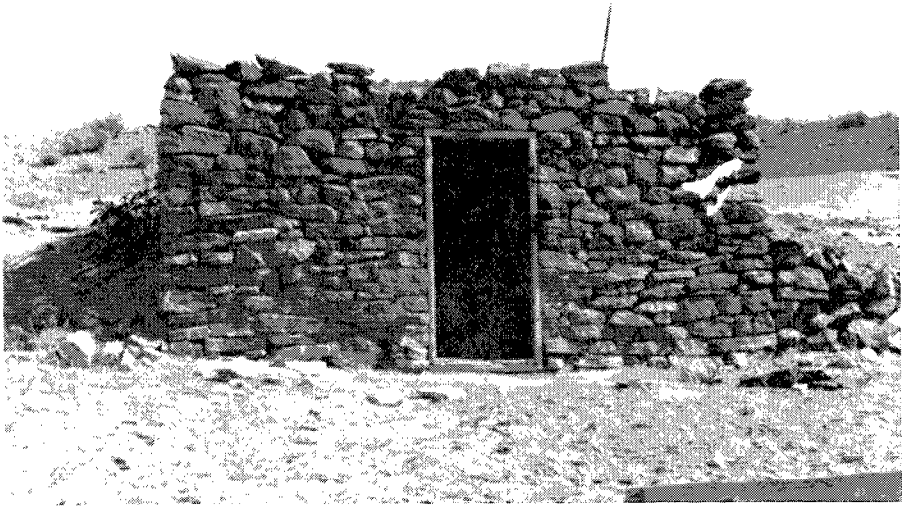
8A. Rock Store Room, 1960

This photograph taken by Crampton in 1960 shows the front of the store room as it looked about ten years ago. Glen Canyon Historic Sites Survey, RG 3, Box 4, Western History Collection, University of Utah Library.

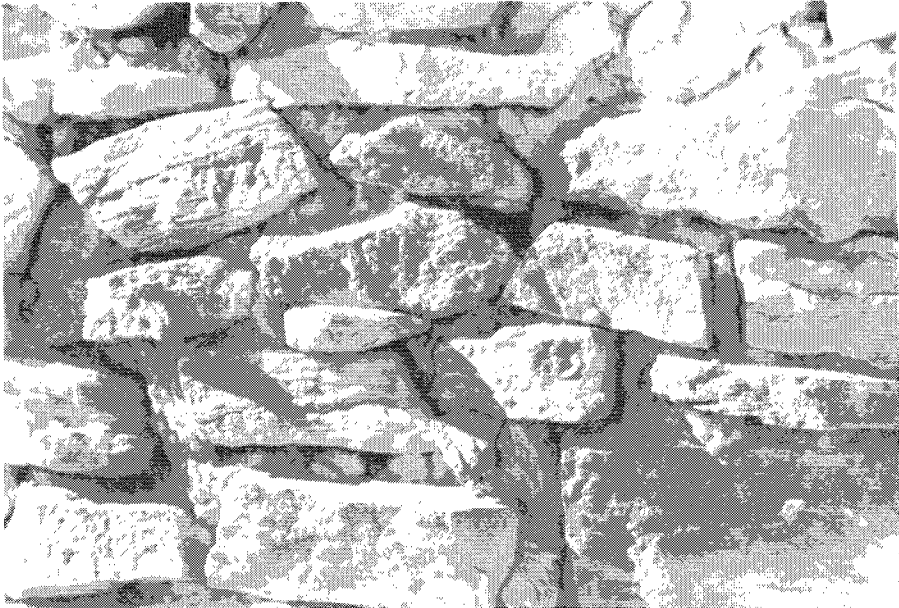
9 B. Rock Work Detail

Thomas Smith must have taken considerable time and care in gathering the rock and erecting this structure. The mortar binding the rocks together has not deteriorated appreciably in the last half-century.

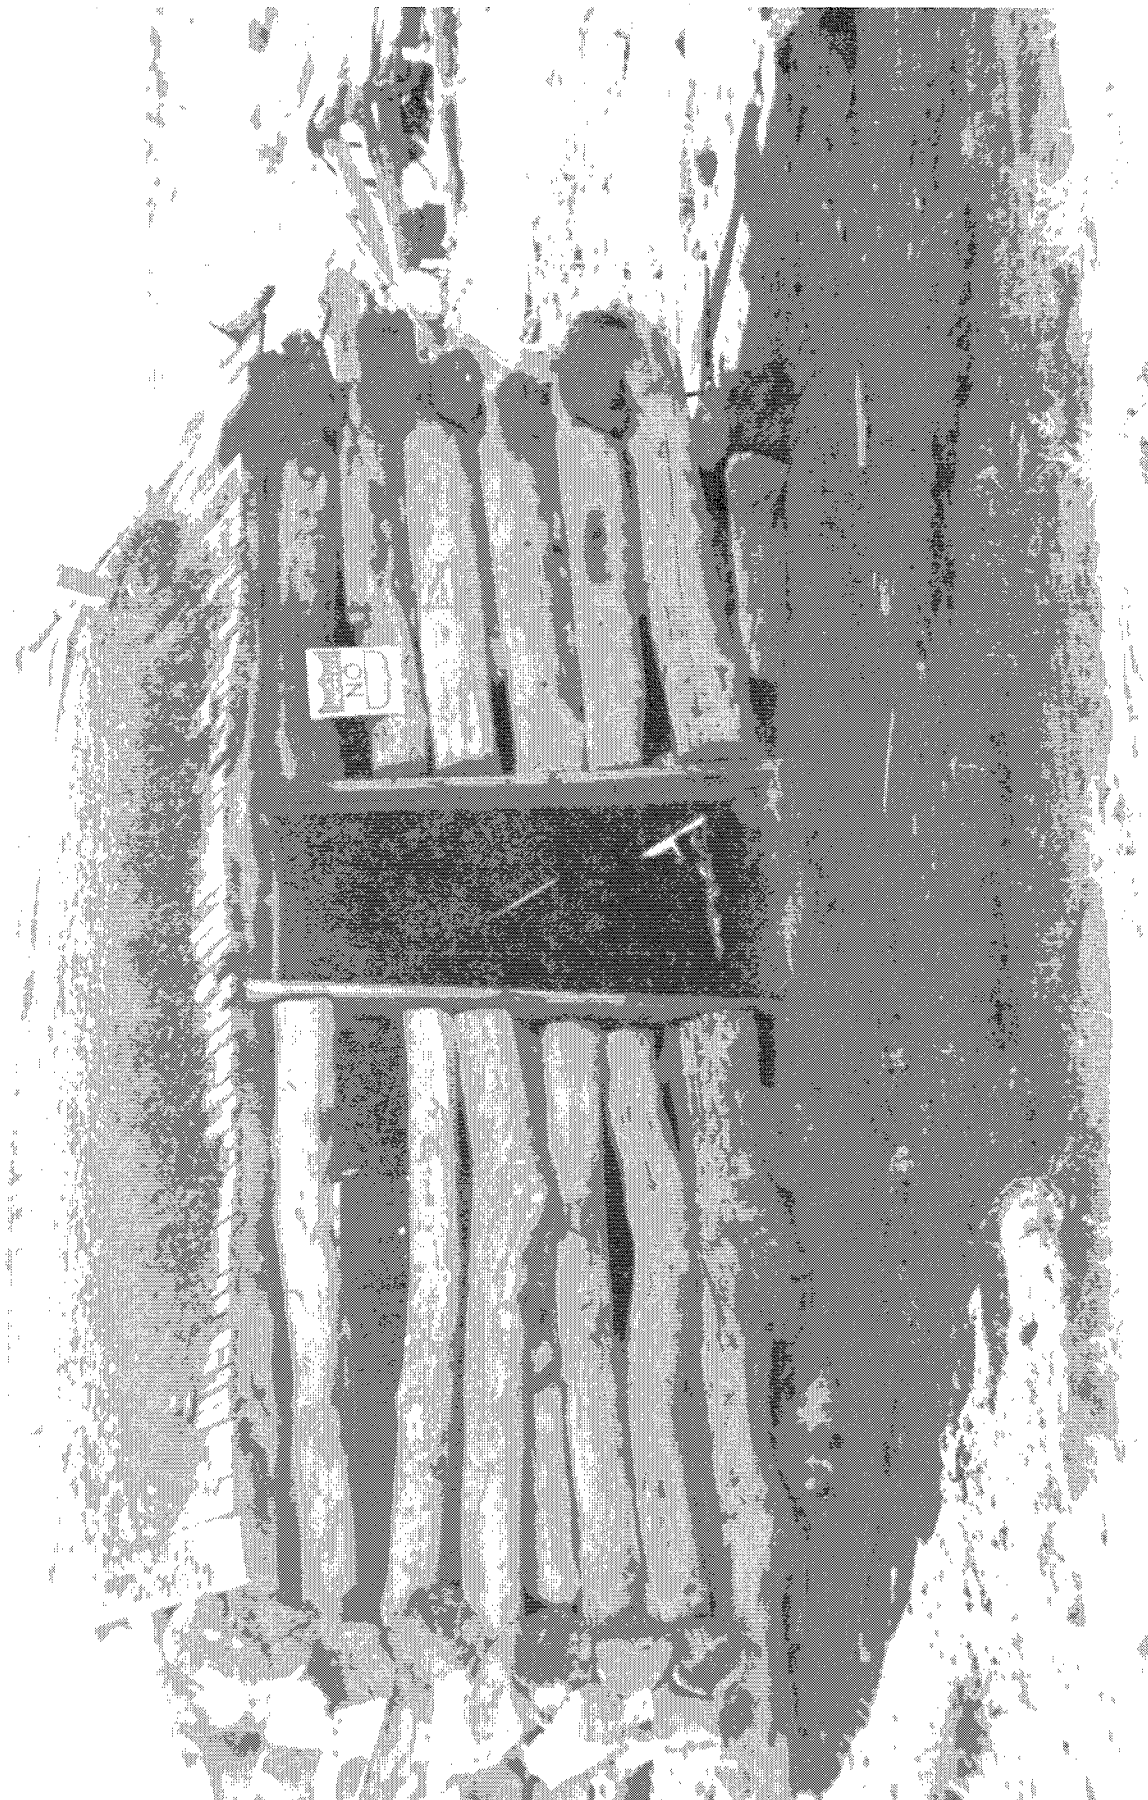
11. The Baker Ranch Granary in 1969

In the nine years since Dr. C. Gregory Crampton visited and photographed the site, the granary has changed very little. Some of the chinking has fallen from between the logs and the roof has lost a bit more of its dirt cover. Most noticeable is the absence of the plank fence on the right side of the building. To the right rear in the photo can be seen a portion of the blacksmith shop.

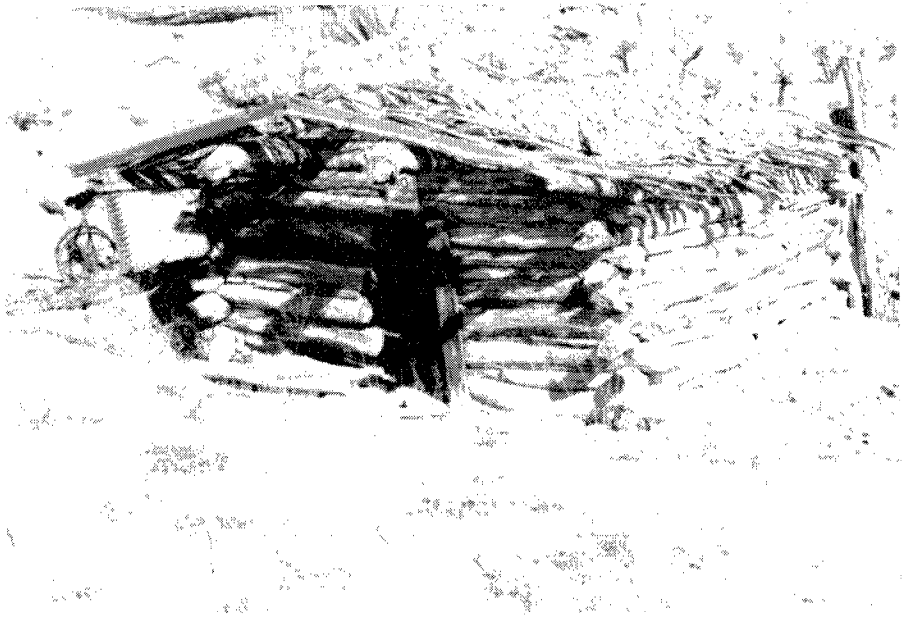
14 A. Front and Side of the Chicken House

Though badly deteriorated, the chicken house is of interest for several reasons. First, there appears to have been considerable drifting of dirt around the structure. Second, the roof seems to be made of saplings covered with dirt. This is in contrast to the granary, which was built about the same time but has a plank roof covered with dirt. On the left can be seen the mowing machine mentioned earlier.

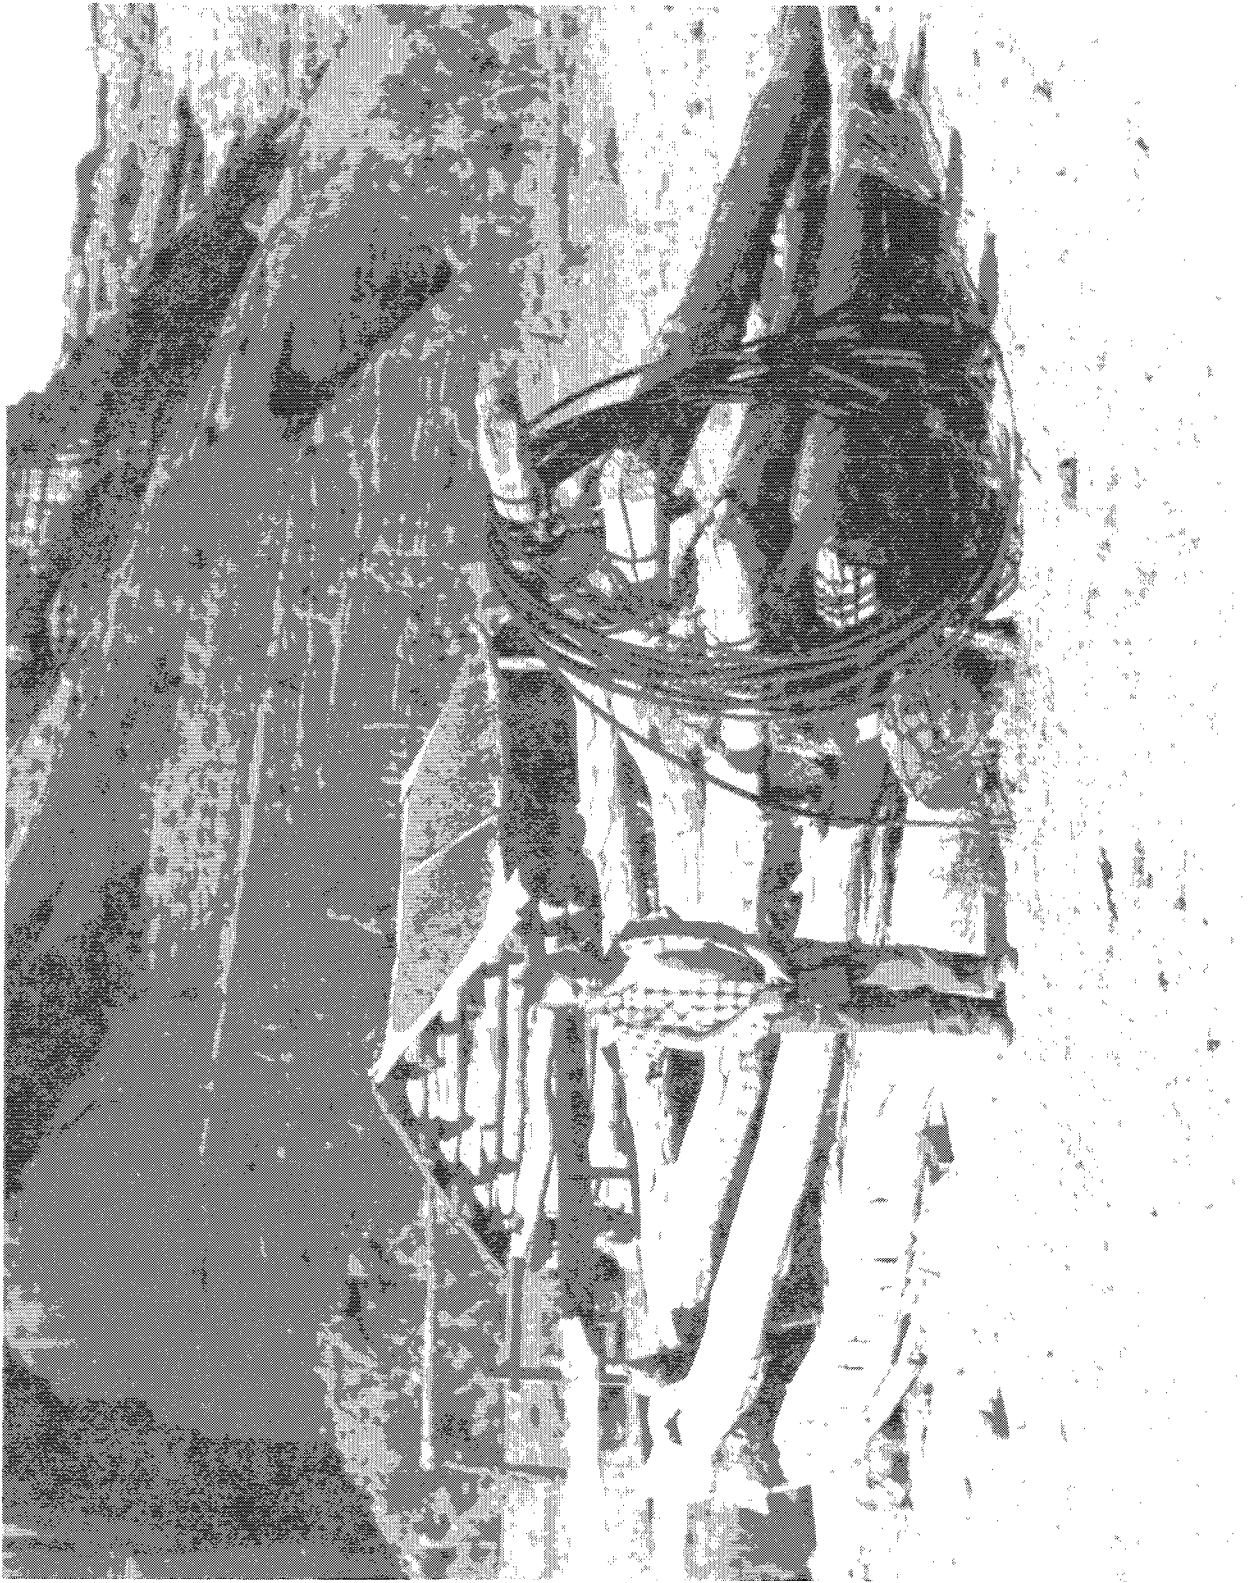
15. Ruins of the Blacksmith Shop in 1960

A comparison of this photograph with the two that follow will show how some of the corrals and pens have disappeared in the last decade. There is evidence of a pen attached to the granary in 1960. Where the steel cable came from is not known. Very possibly it was salvaged from one of the dredging operations that took place along the Colorado River. Photograph, taken by Dr. Crampton, is part of the Glen Canyon Historic Sites Survey Material in the Western History Collection of the University of Utah Library.

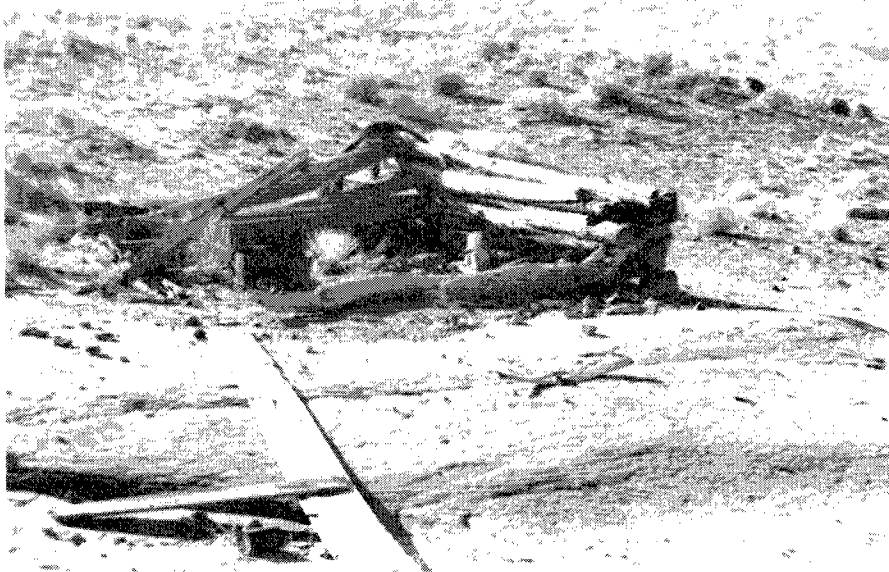
16 A. Ruins of the Blacksmith Shop, 1969

Most of the logs have remained intact during the last ten years. The steel cable can still be seen hanging from the corner. The plank in the foreground may have been part of the corral or pen visible in the previous photo.

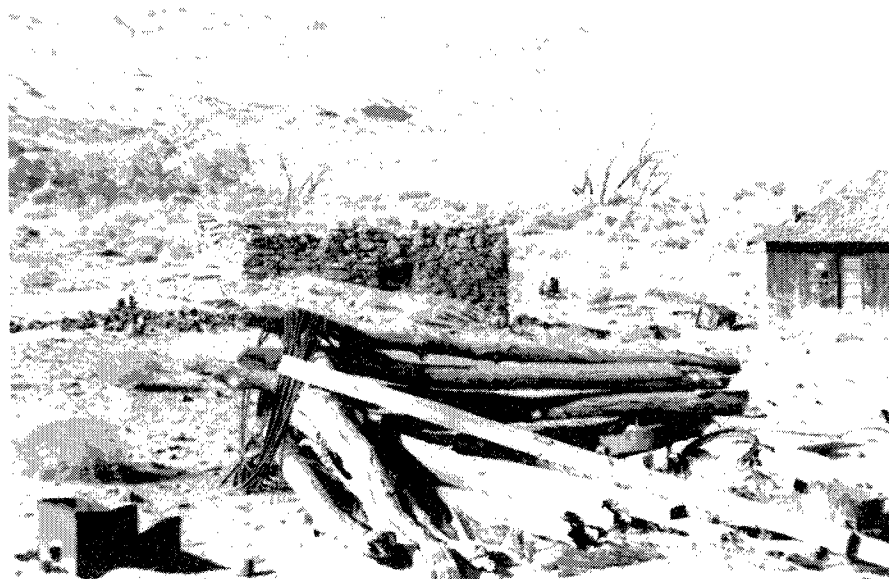
16 B. Ruins of the Blacksmith Shop, 1969

In the foreground can be seen some of the other scrap that is found near all the buildings. On the left of the picture is a pile of tin cans and rubbish that lies between the blacksmith shop and the rock storage cellar. A portion of the main house can be seen on the right.
