ARCHAEOLOGICAL EXCAVATIONS AT THE
NORTH WEST COMPANY'S DEPOT
GRAND PORTAGE, MINNESOTA IN 1970-71,
BY THE MINNESOTA HISTORICAL SOCIETY
ALAN R. WOOLWORTH - 1975

ABSTRACT

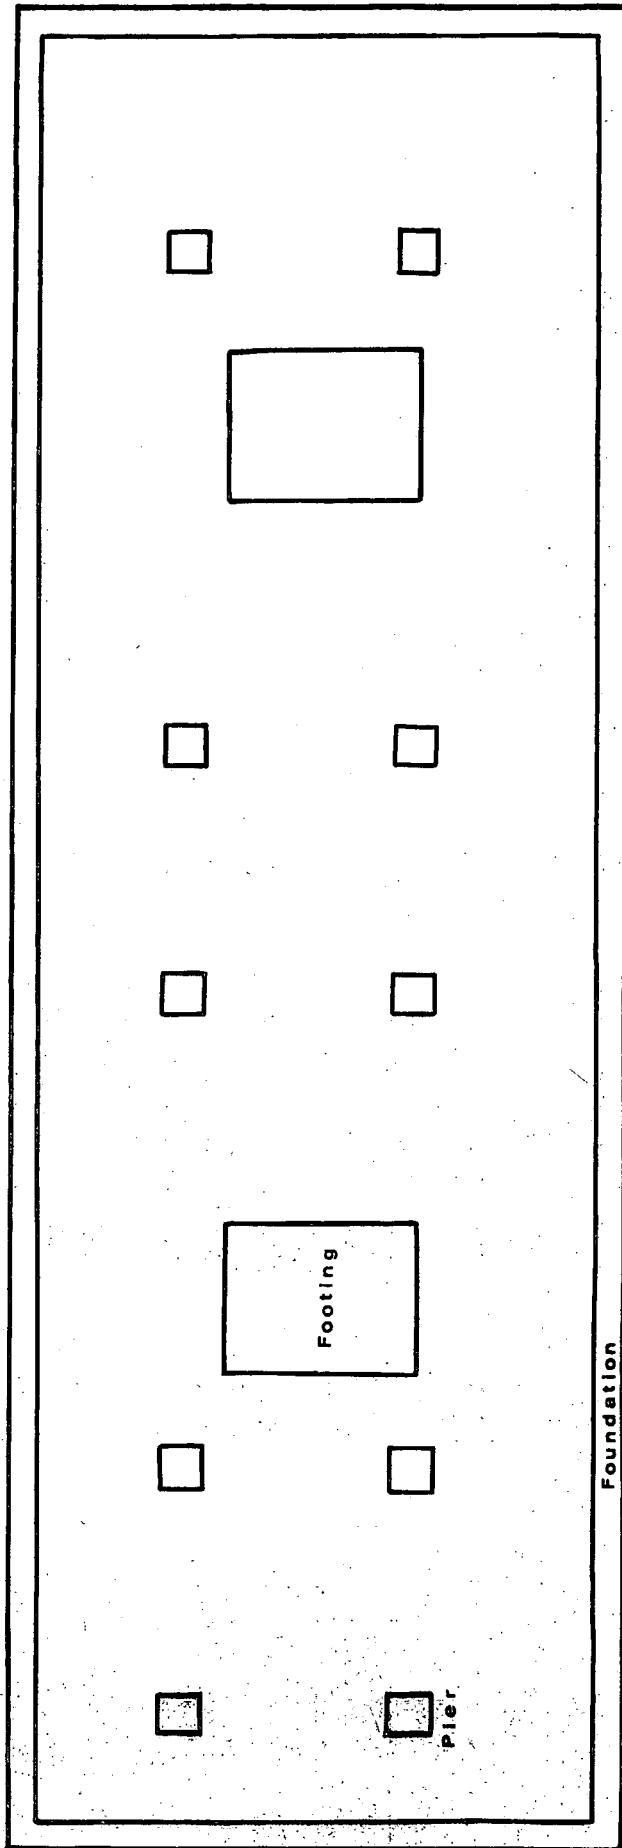
TEXT FIGURE 5

FOUNDATION, PIERS AND FIREPLACE FOOTINGS

of matched concrete piers which had once supported stringers under the floor joists. They were 2' by 2'. Their presence was noted as they had been formed over square pits dug into the earth. Conceivably, they could have had an effect upon structural or other remains at the site. Also very noticeable were two massive concrete fireplace footings. One of them was at the eastern end of the enclosure, the other at the western end of it. These measured approximately 7' by 12' and had a considerable elevation as they had once risen to the finished floor level within the Great Hall. Strewn about within this area were large quantities of ashes and some other debris from the fire which had destroyed the Great Hall in July of 1969. A "cleaned up" version of this map is included within the present report as : "Foundation, Piers, and Fireplace Footings" (Text Figure No. 5).

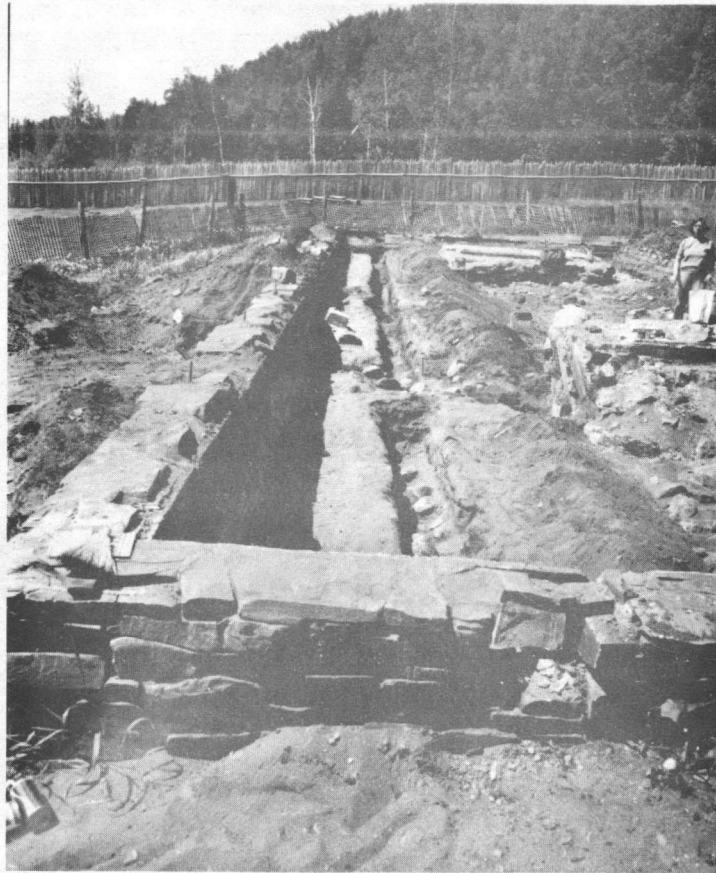
Figure 1: The Great Hall foundations, and an exploratory trench. View is West.

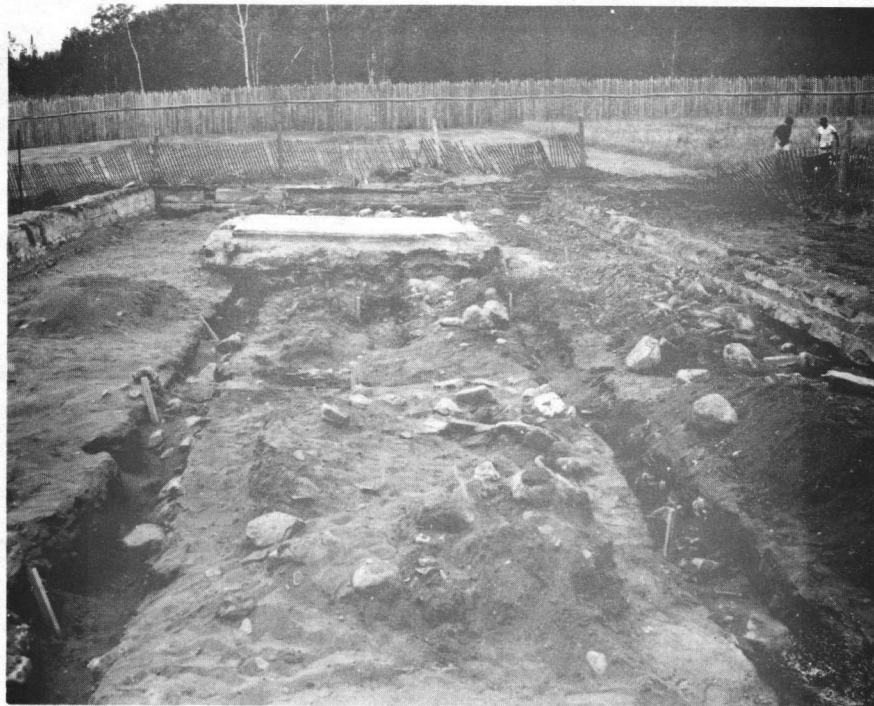
Figure 2: Exploratory trenches on the interior of the Great Hall Foundations. View is West.

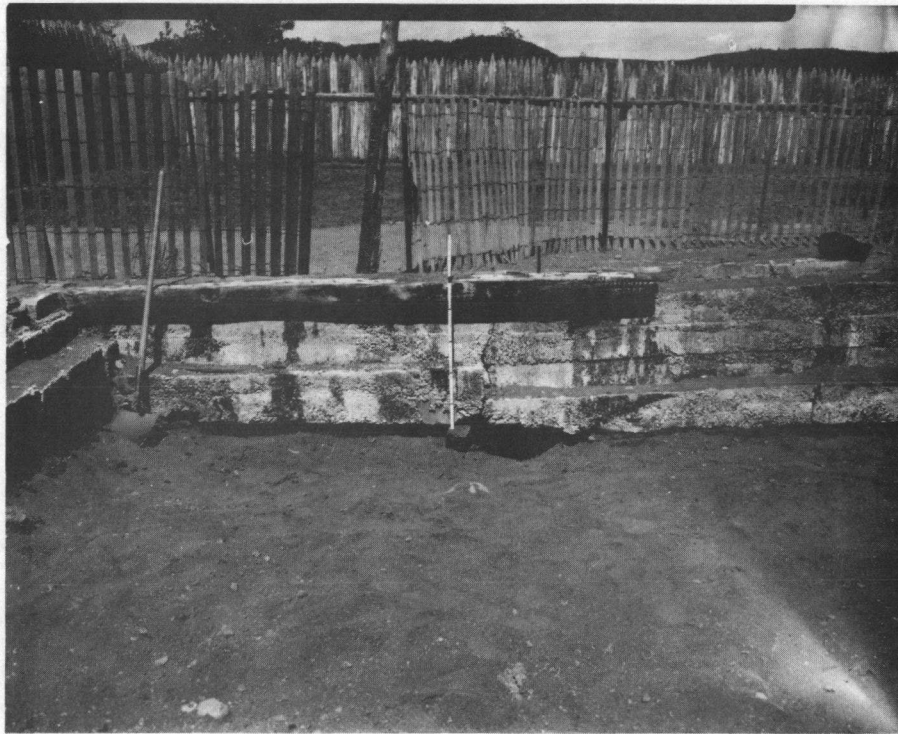
Figure 3: Exposed foundations on the interior of the Great Hall.
View is East.

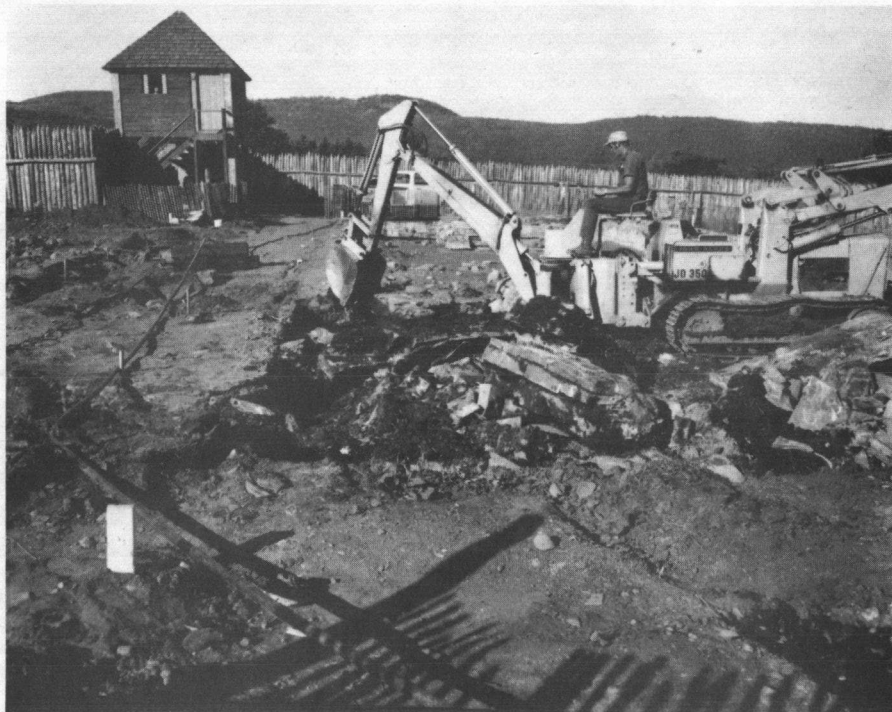
Figure 4: Removal of the Great Hall foundations.
View is East.

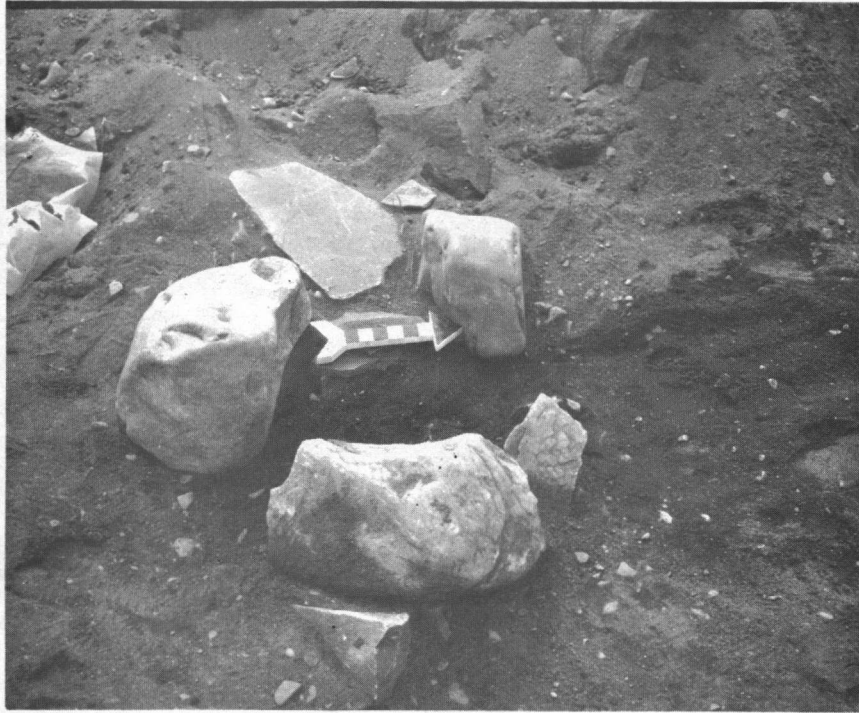
Figure 9: Stone-braced porch post in front of the Great Hall.

A total of 15 posts were found in front of the Great Hall; undoubtedly others had once existed but had been destroyed by human activity since its abandonment about 1803. Five of these posts were round with rounded moulds. The other ten had square or rectangular outlines and were obviously dug with a square shovel or spade.

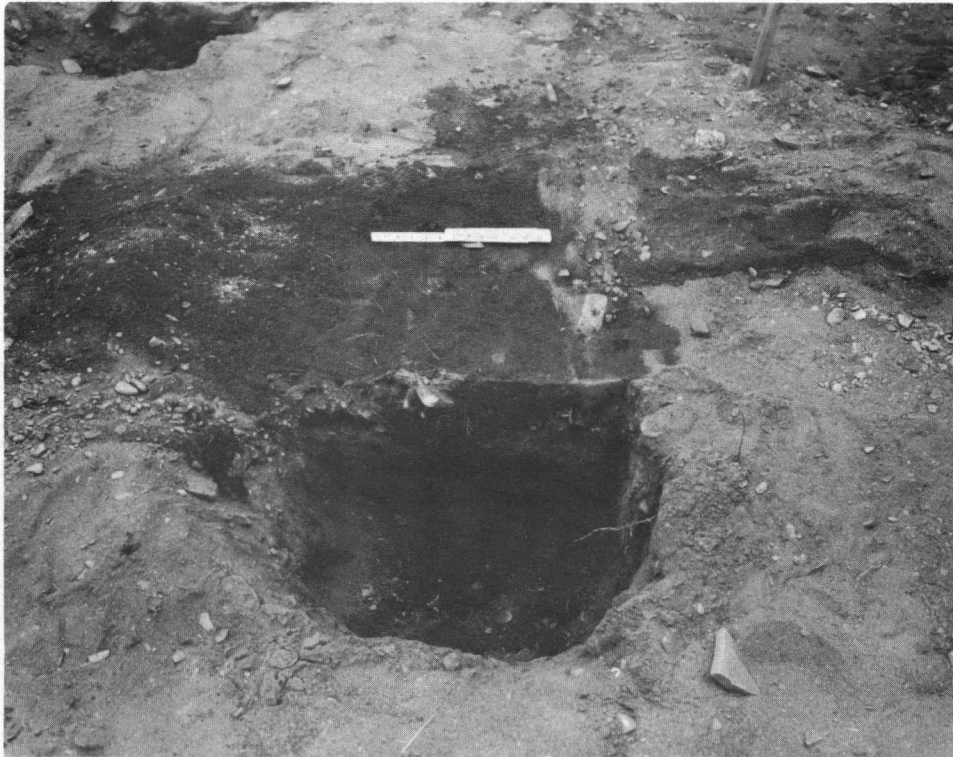
Figure 10: Profile view of a porch post in front of the Great Hall.

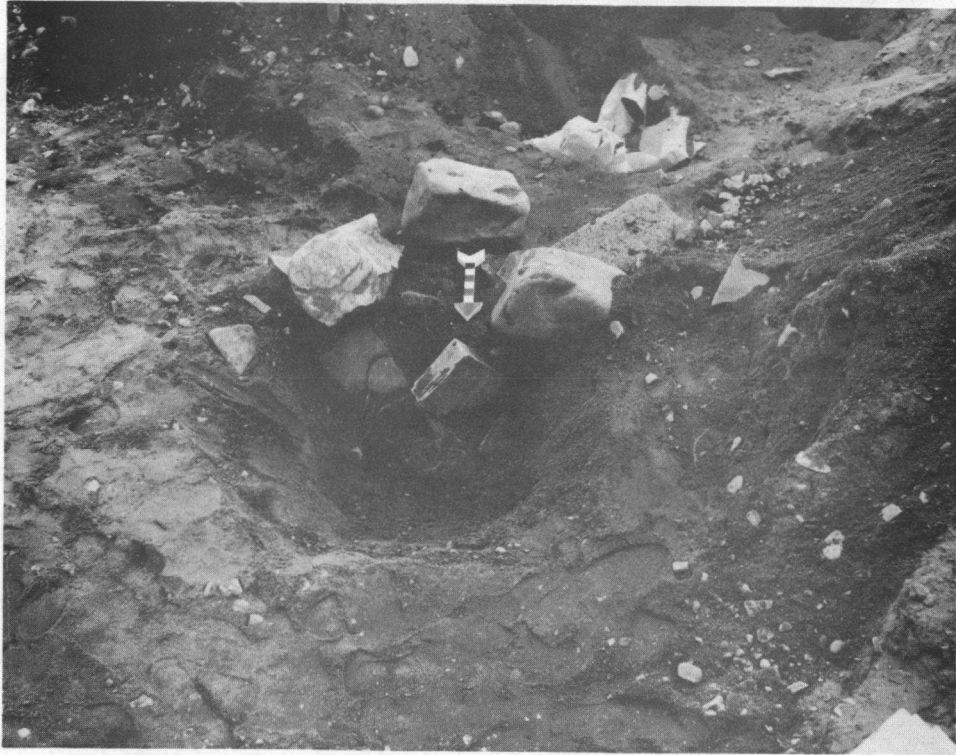
Figure 11: Stone-braced porch post in front of the Great Hall.

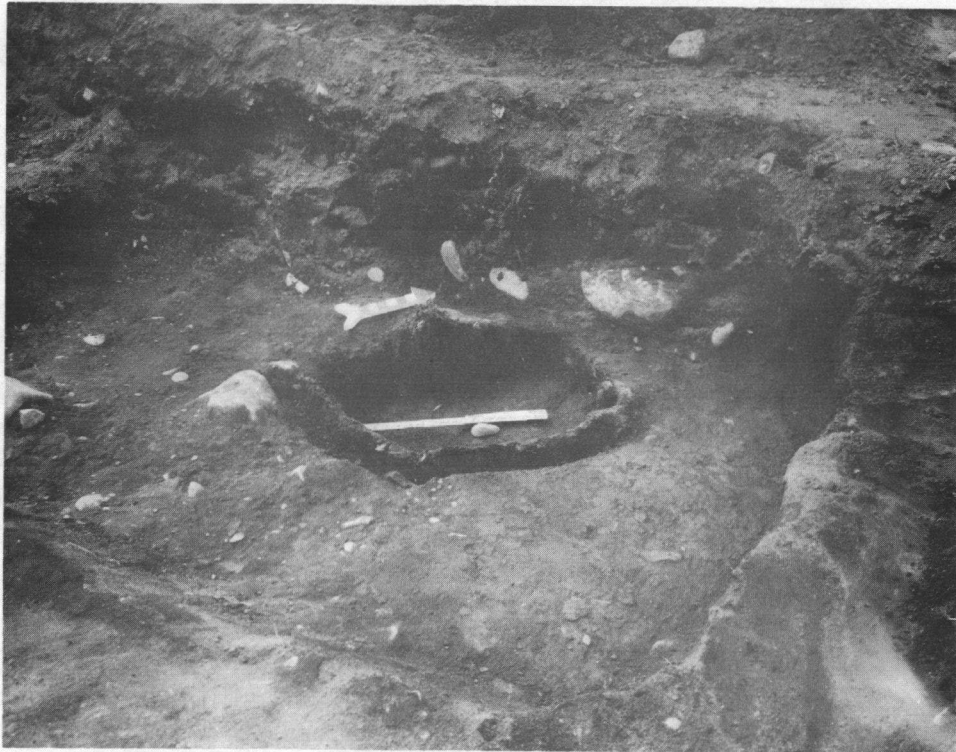
Figure 12: Fur trade era well located northeast of the Great Hall.

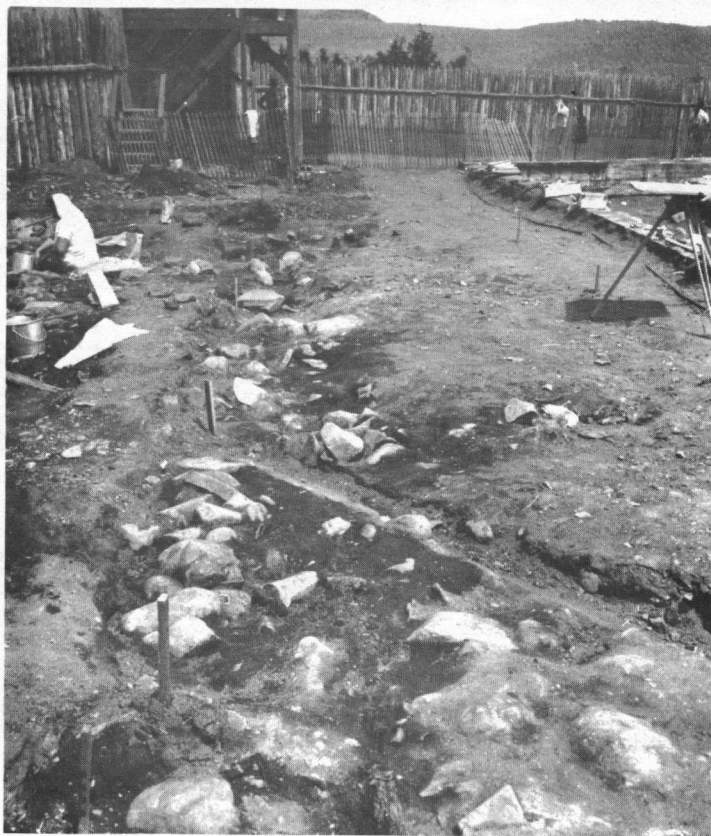
Figure 13: The outline of a fur trade era drain trench is shown by the lines of boulders. View is East.

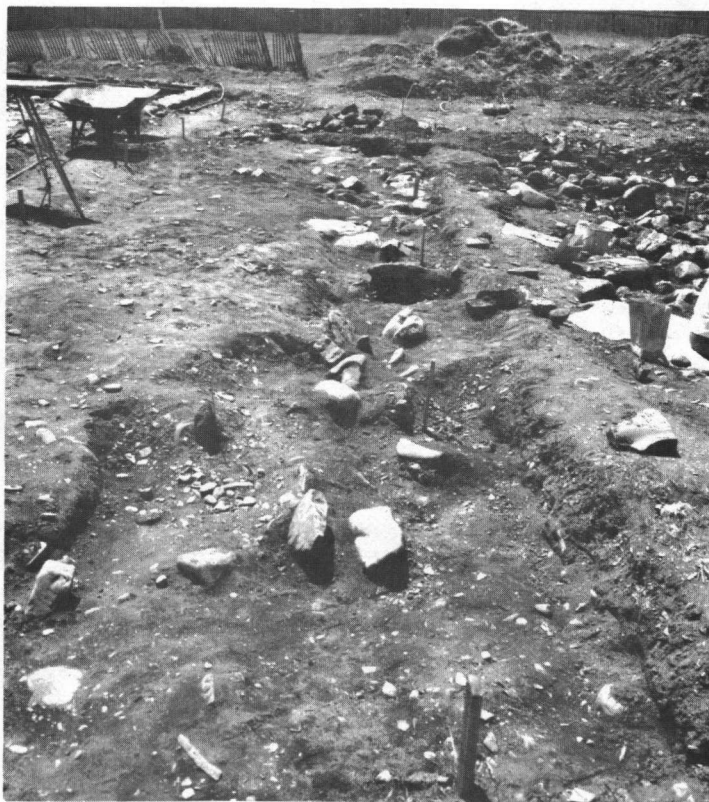
Figure 14: The fur trade era drain trench from its eastern extremity. View is West.

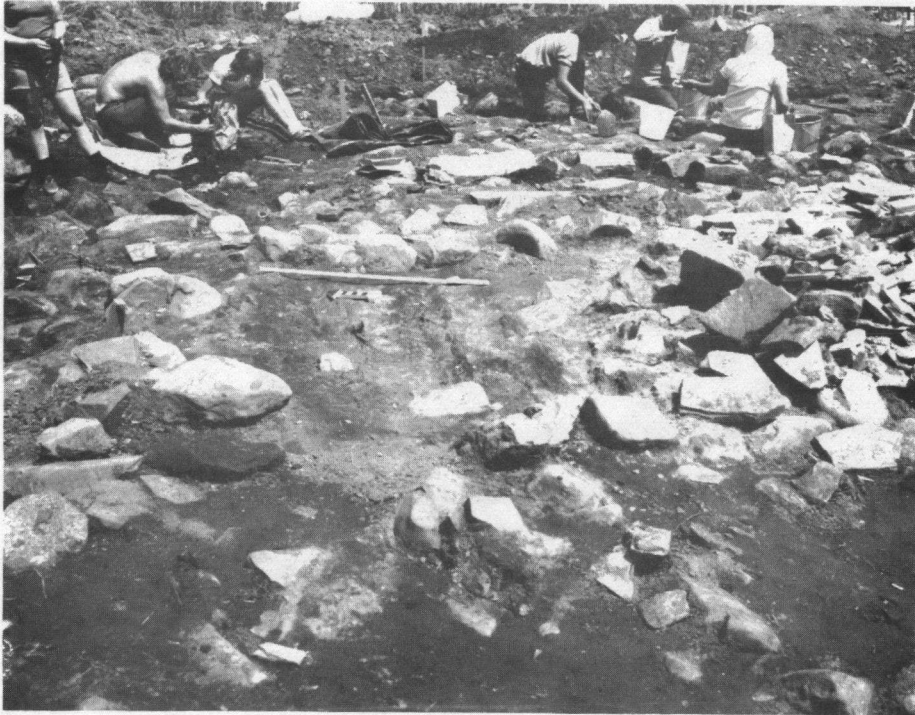
Figure 15: Kitchen Structure. The unexcavated stone lined "Cooler".
View is Southeast.

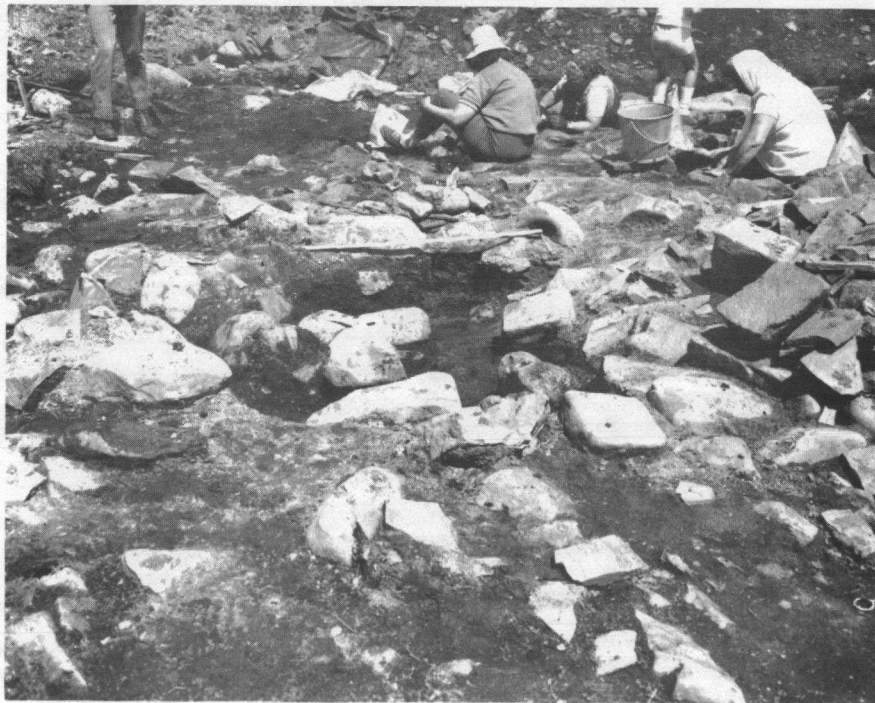
Figure 16: Kitchen Structure. The Partially excavated "Cooler".
View is Southeast.

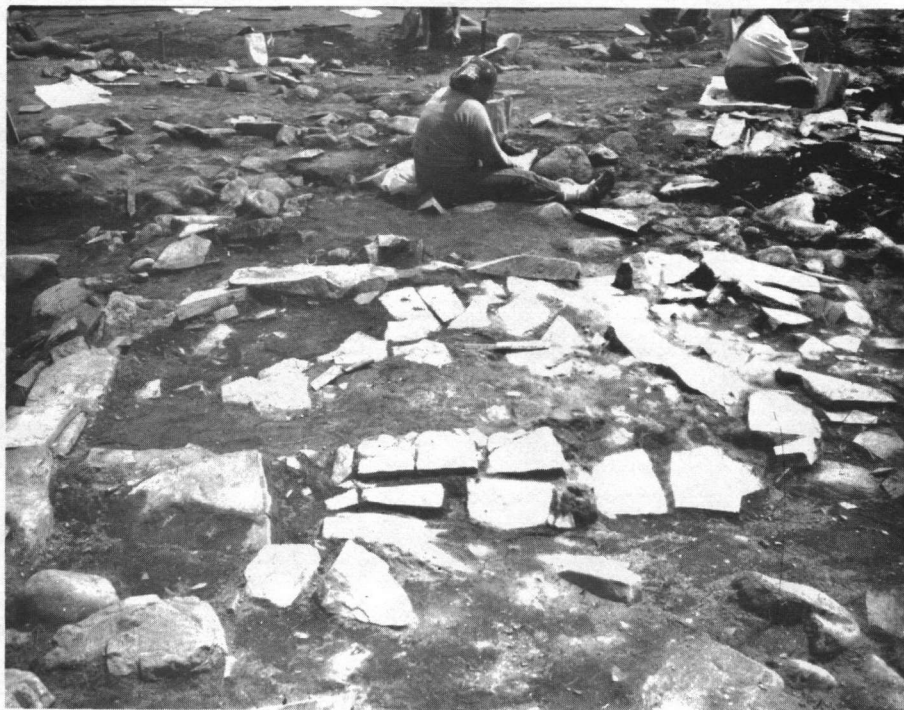
Figure:17: Kitchen Structure. The unexcavated stone lined fireplace.
View is Southeast.

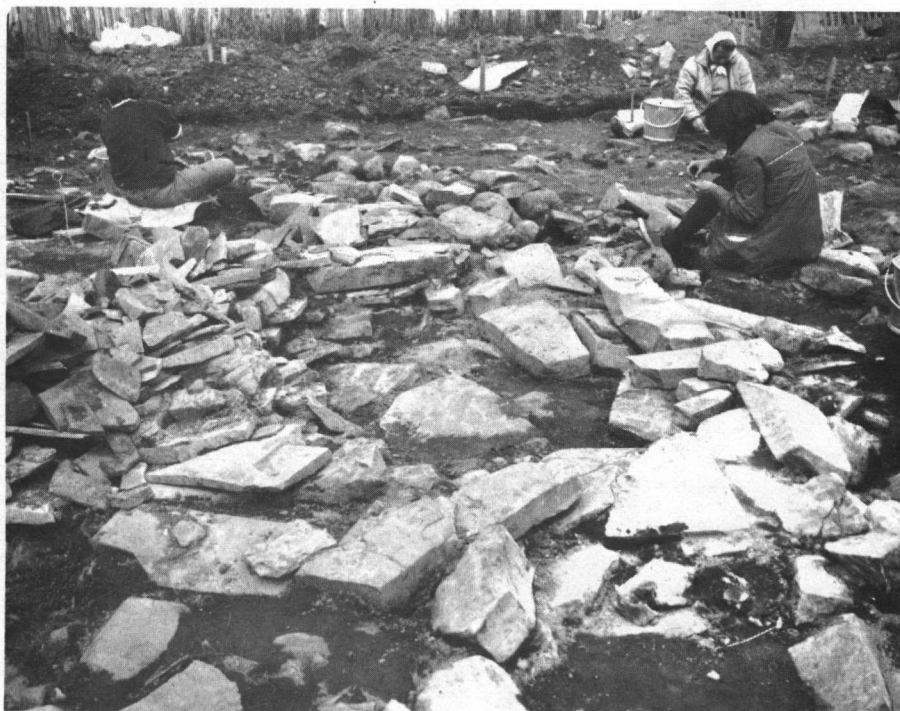
Figure 18: Kitchen Structure. The excavated stone lined fireplace.
View is North.

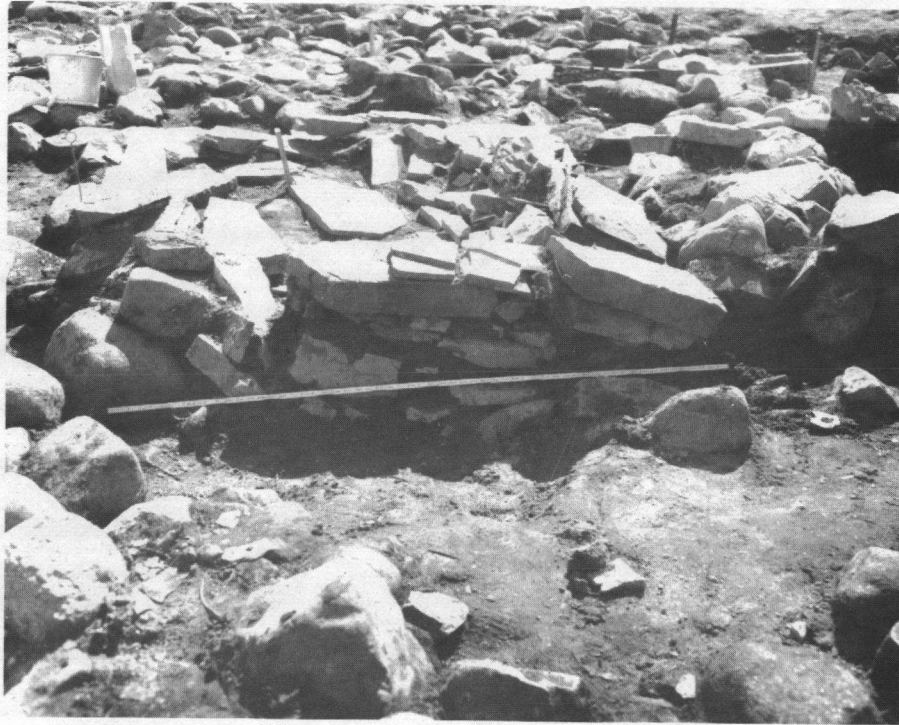
Figure 19: Kitchen Structure. Eastern face of the fireplace. Note the courses of stone. View is West.

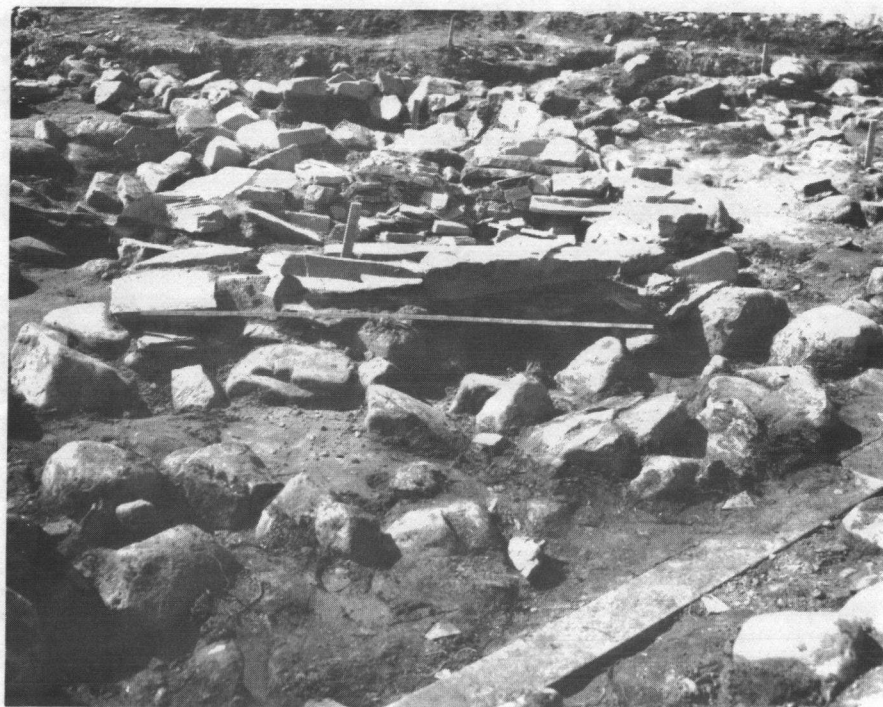
Figure 20: Kitchen Structure. Southern face of the fireplace. View is Northwest.

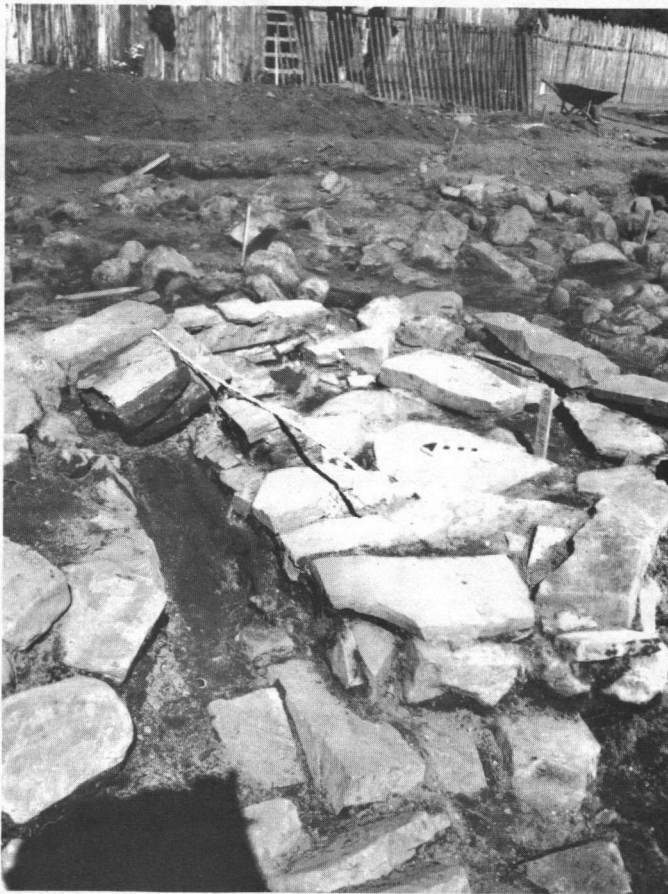
Figure 21: Kitchen Structure. Northern face of the fireplace.
View is East.

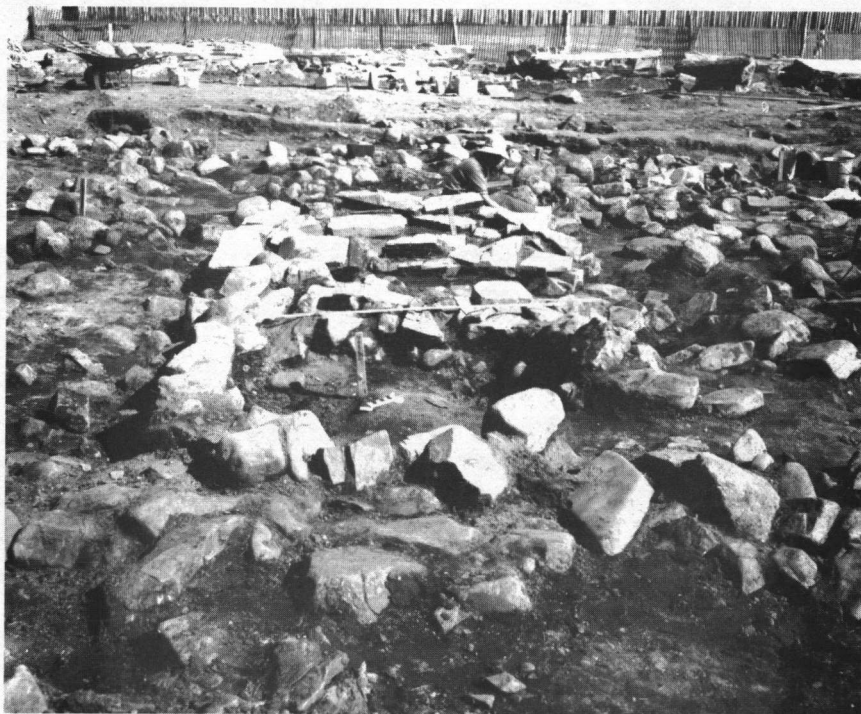
Figure 22: Kitchen Structure. General view of the excavated "Cooler" and fireplace.
View is Southeast.

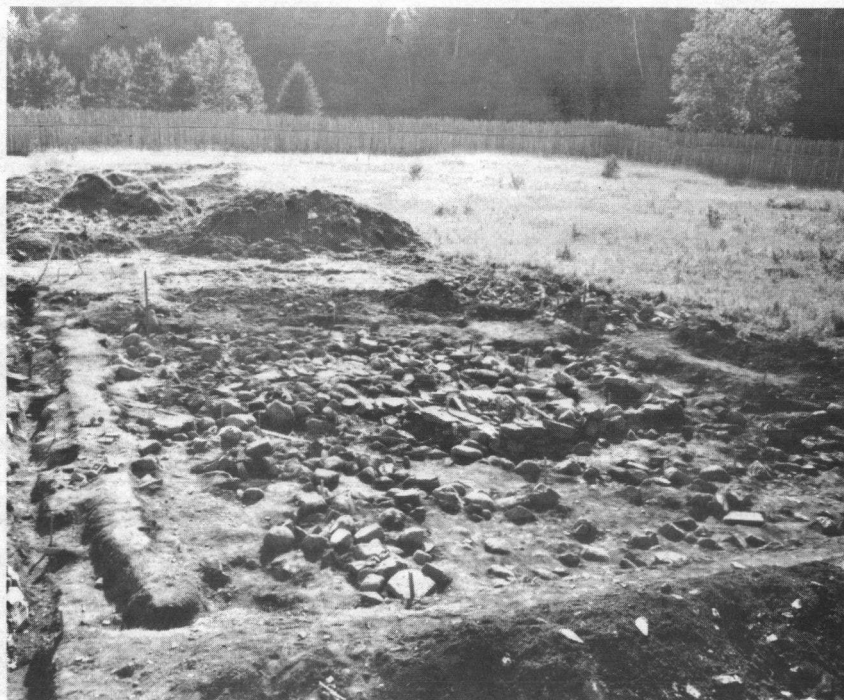
Figure 24: Kitchen structure. General view of the completed excavations of this building in 1970. The fireplace and "Cooler" are in the right center. Other stones are natural. View is west.

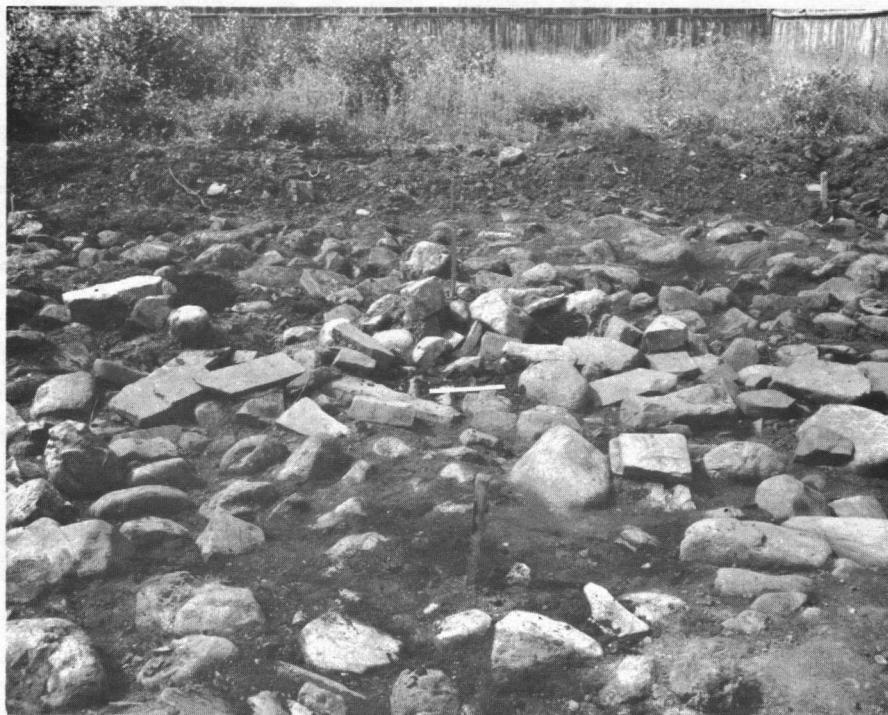
Figure 25: Kitchen Structure. Shale slabs in the northwestern portion of this building in 1971. View is North.

Gradually, large numbers of glacial boulders and pieces of flat, angular shale were uncovered. All stone was left in place until the excavation had been almost completed. Special efforts were made to map the shale slabs as they had been used for structural purposes. Many of them lay around the fireplace and had clearly been a part of it or of the chimney. The entire area was covered by a mantle of rounded glacial boulders. Many artifacts and segments of flooring were found above them. Eventually,

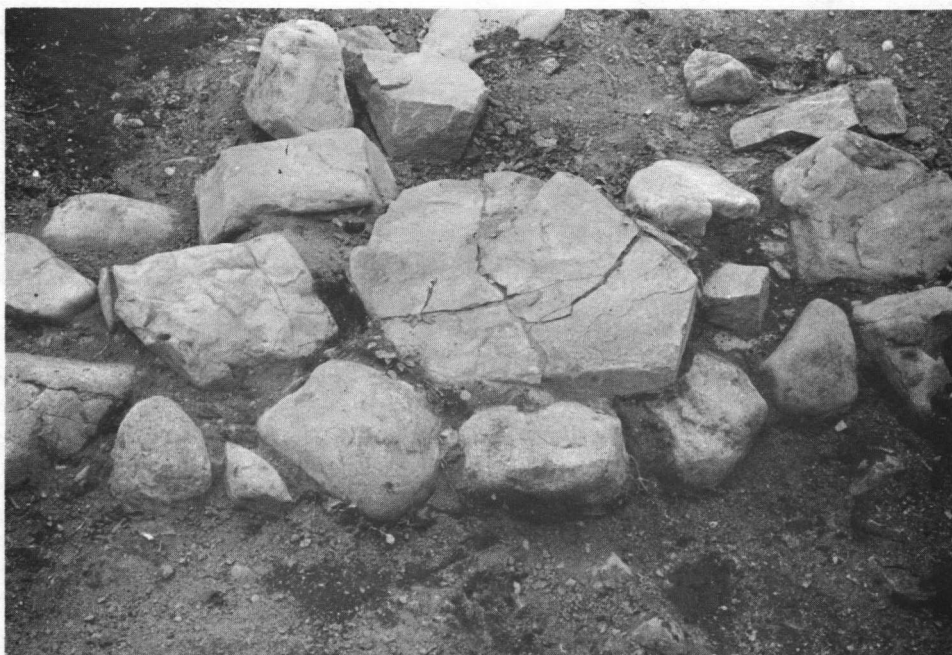
Figure 26: Kitchen Structure. Shale slab surrounded by round stones. It served to support the southeastern corner of the building. Located at 20E-40N. From the 1971 excavations.

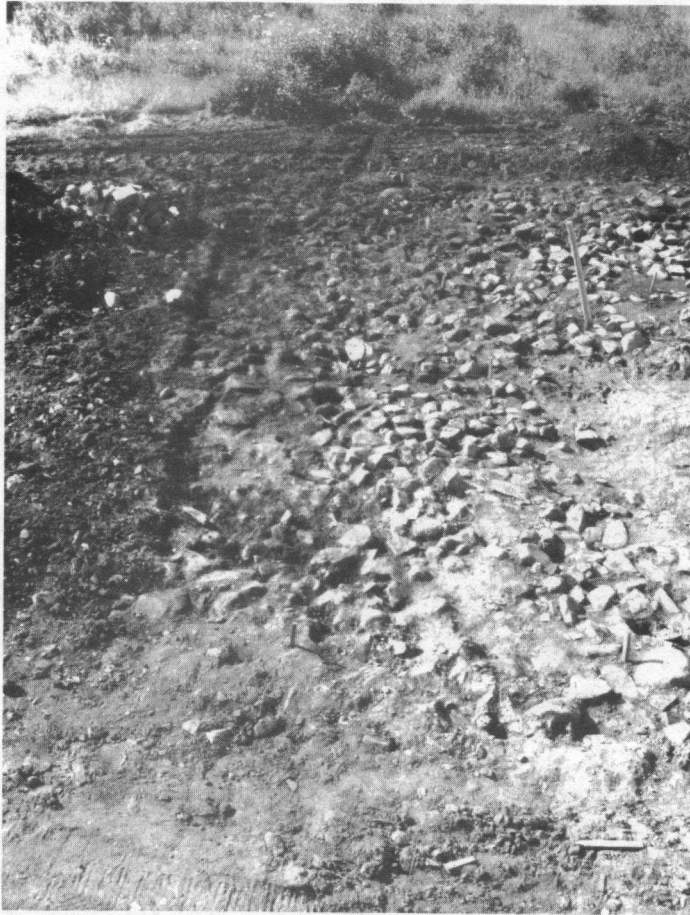
Figure 27: Kitchen Structure. General view of excavations in the western portion of the building in 1971. Exposed boulders are natural. View is North.

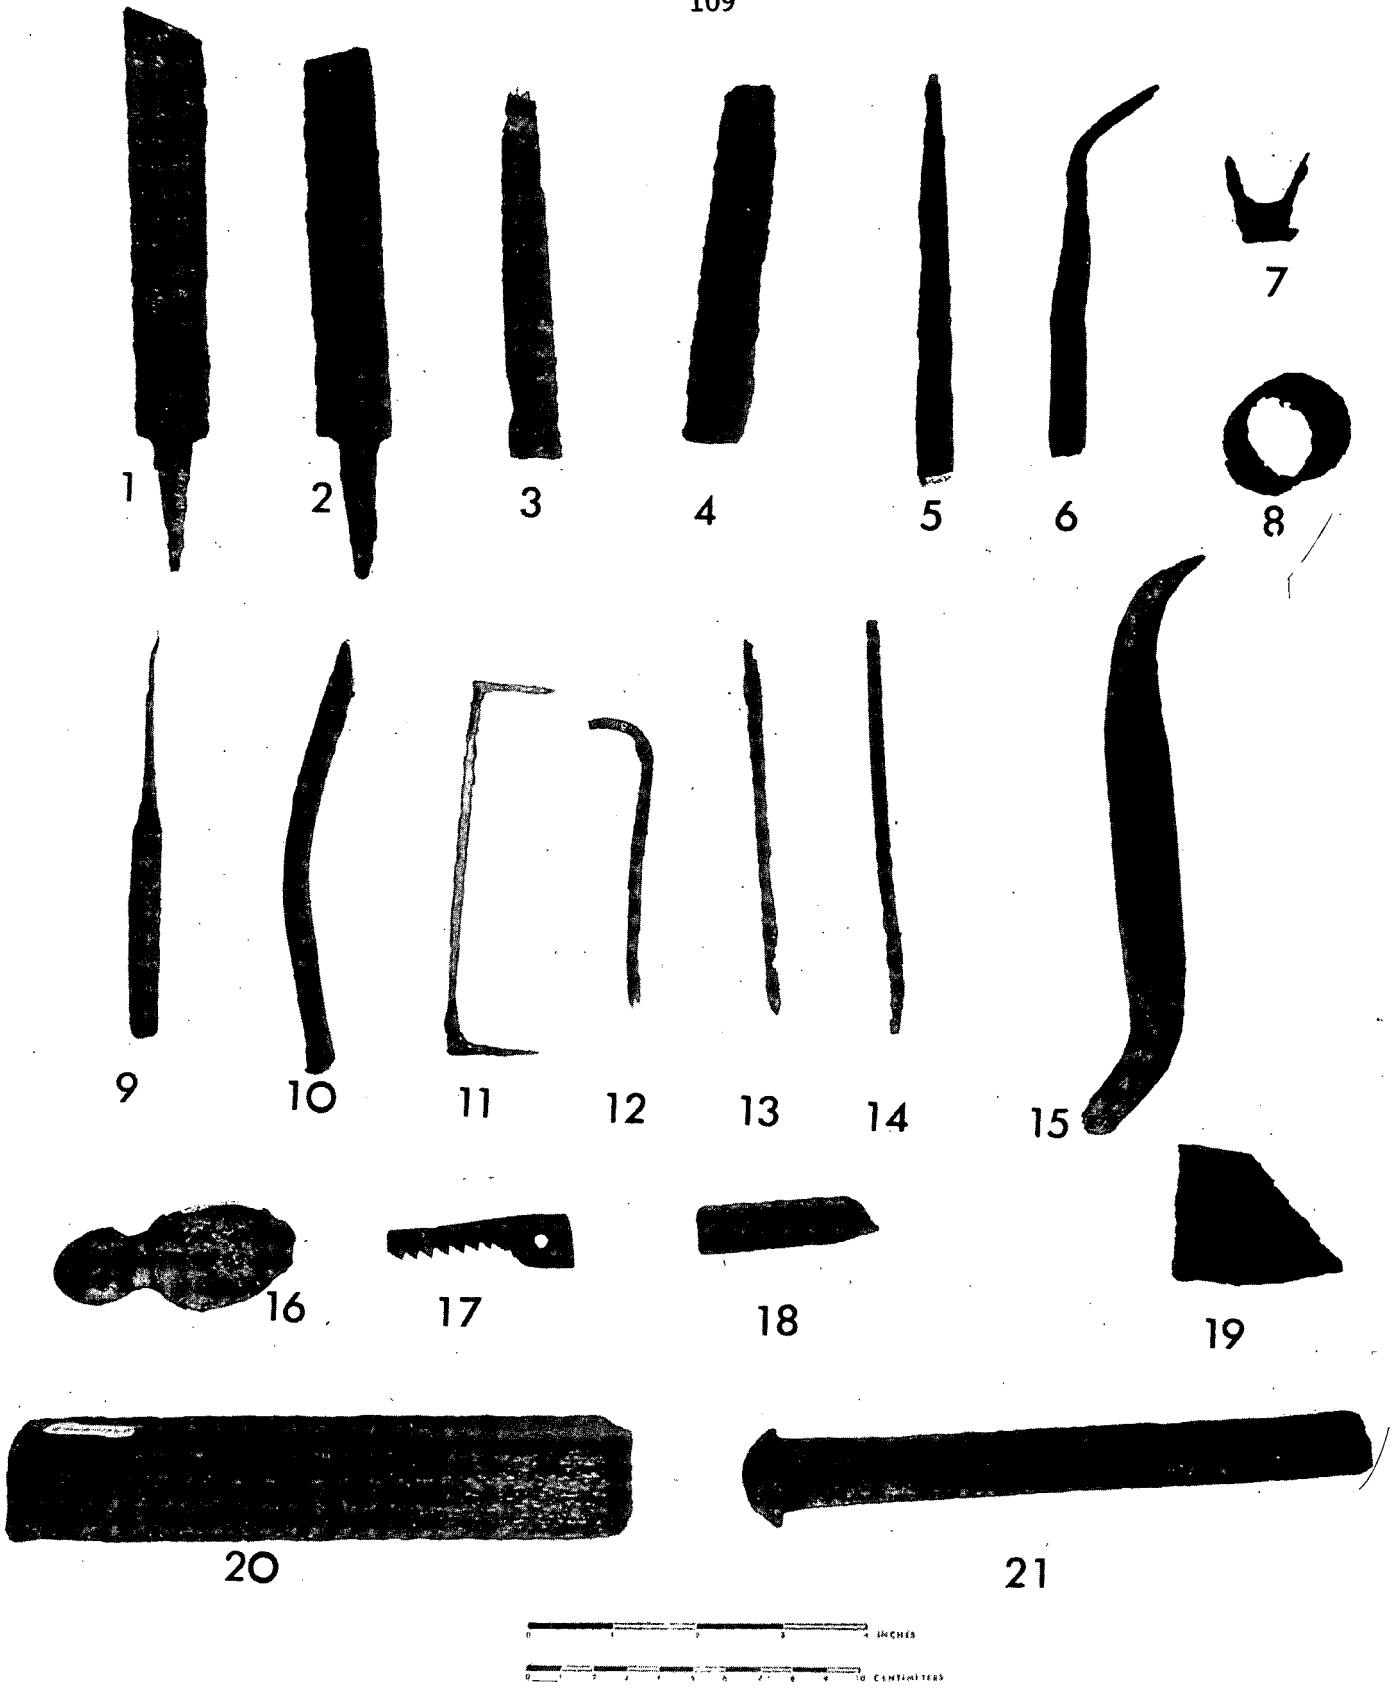
Figure 30: Tools. Files, Scraper, Hammer head, Handle reinforcing ring.

Files (9) (Nos. 1538, 1578, 677, 1855, 1579, 1745, 1797, 336-5-15 and 336-13-9). There are portions of four flat files in this assemblage. No. 1538 is the largest. It is 6-1/2" long, 7/8" wide and 3/16" thick. Its hafting end bears a conventional "tail" in the form of an isosceles triangle. Although the teeth are badly rusted, it appears to be a flat mill bastard file. No maker's mark is visible on the tang. This specimen would have, of course, been used for modifying metals. The second flat file No. 1578 is a smaller specimen. It measures 4-1/2" long, 5/8" wide and is slightly less than 1/8" thick. It bears regular rows of fine teeth and would have been used also for metals.

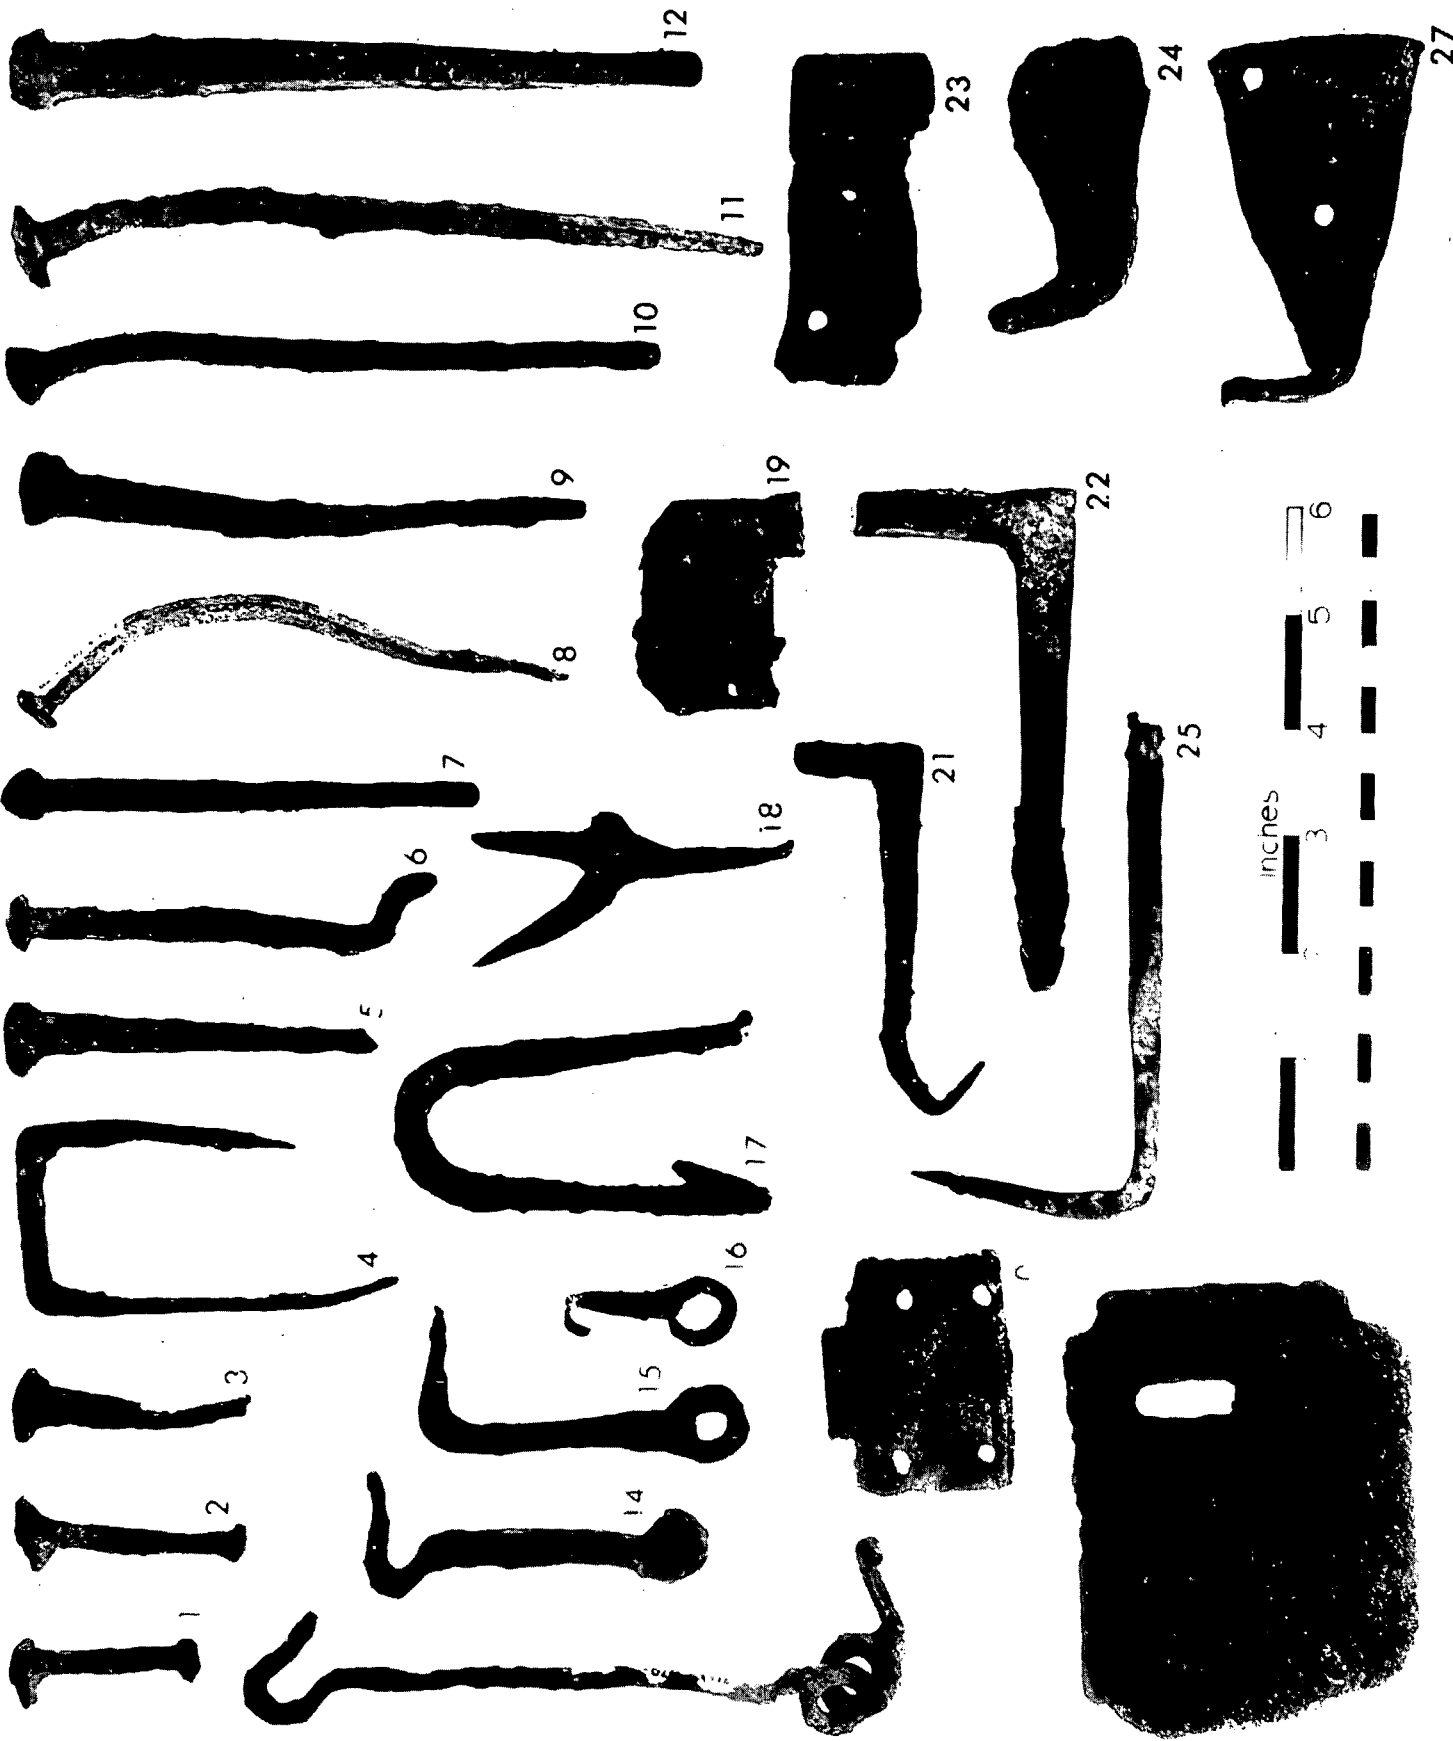
Figure 31: Building Hardware. Bolts, Nails, Hooks, Staples, Pintles, Hinges, and Lock Fragment.

Item 26, No. 1100. Portion of a large door lock.
